**BAT SURVEY AT -
MORANS FARM
PENDLETON**

Demolition of redundant farm buildings (B1, 2, 3) prior to the construction of 4no Holiday lodges.
Impact of development in relation to potential bat habitat:-
Removal of buildings, survey to assess if roost habitat will be removed.

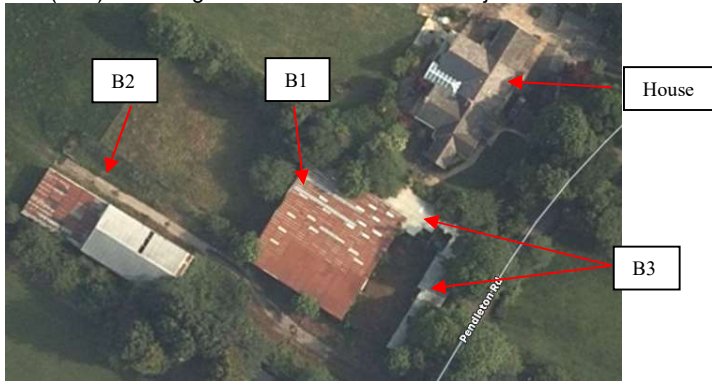
S.W elevation of B1

courtyard section

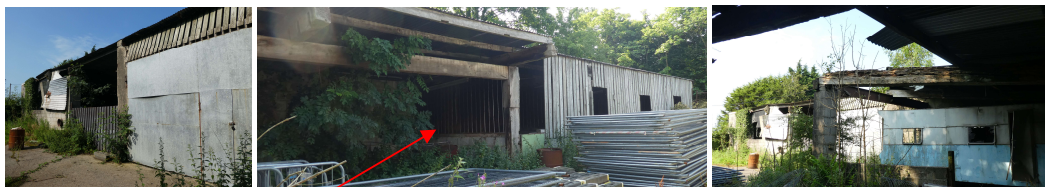
(B3)

Courtyard elevations

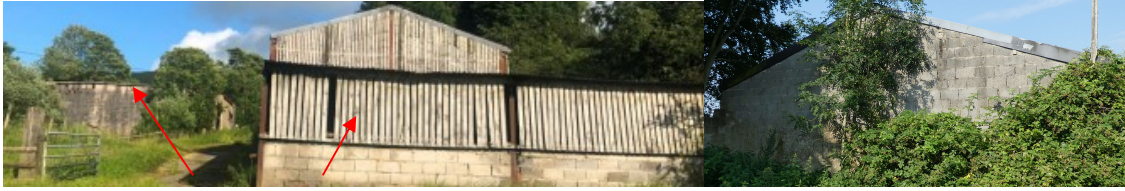
N.W elevation of (B1) and (B2)

S.E elevation (B2)

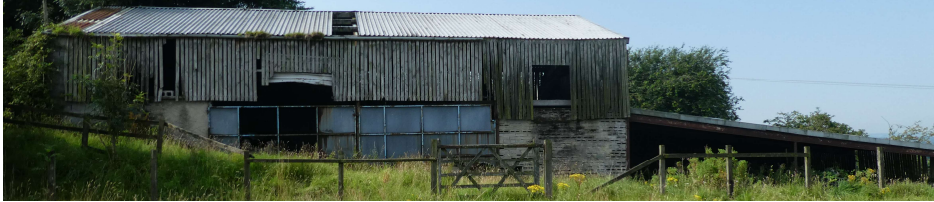
N.E elevation (B2)

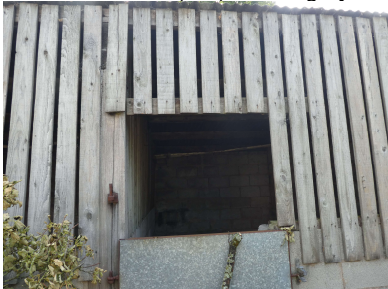
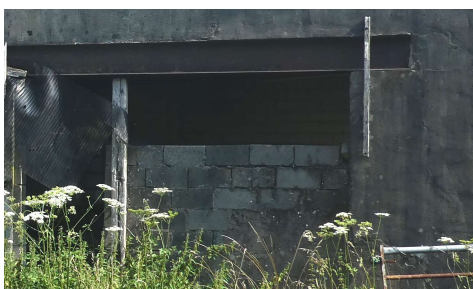
All the walls are block work with sections of Yorkshire boarding. Most of the walls are exposed concrete block but the side walls on (B1) have a grey render finish.

All the buildings are freely accessed via numerous openings in walls and gaps in boarding, part of the courtyard is formed by roof only.

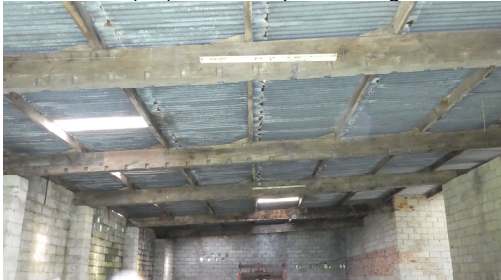
The roofs of (B1) is a mono pitch corrugated steel sheet with clear panels over timber beams.

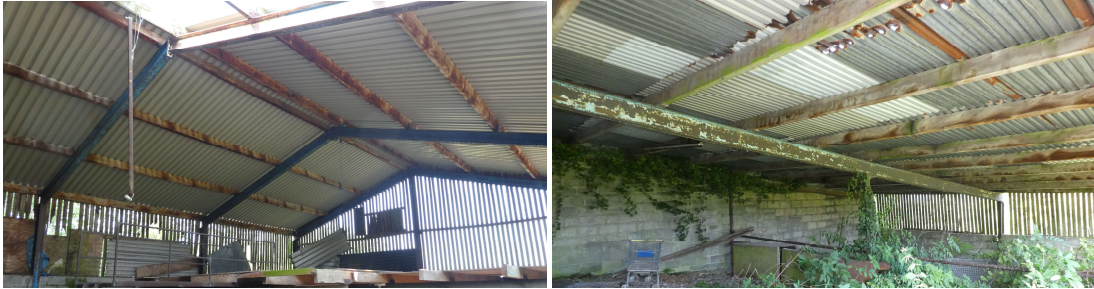
B2 has a pitched roof with a lean too section adjacent to the north west gable both sections have a steel corrugated sheet finish over timber or steel frame/purlins.

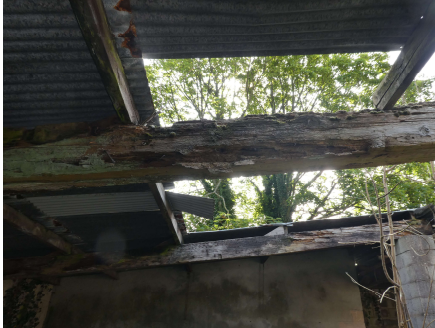
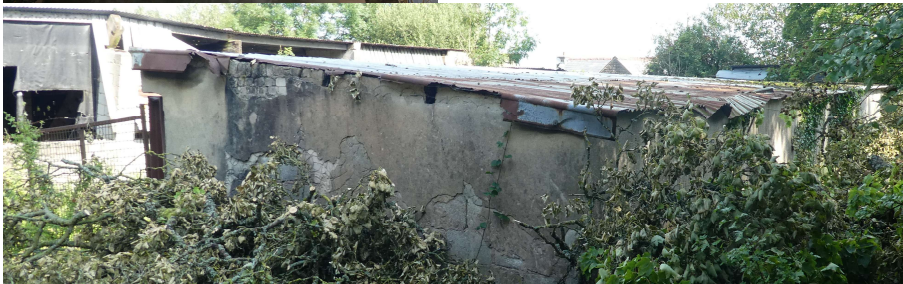
B3 has a mono pitch roof with a steel sheet finish over timber purlins / beams.

All the roofs have some sections missing allowing free access ,however most of the sheet laps are tight fitting and did not provide any bat roost potential. In B3 some of the roof timbers are rotten however it was possible to examine them to ensure bats have not found any crevice roost potential.

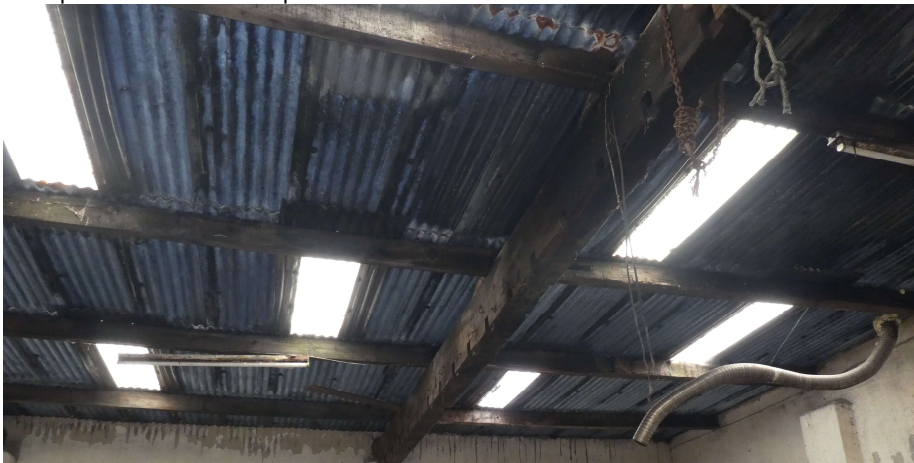
None of the buildings had enclosed roof voids all the structures were visible and could be closely examined for roost potential with the exception of the south west end of B3 which was not accessible.

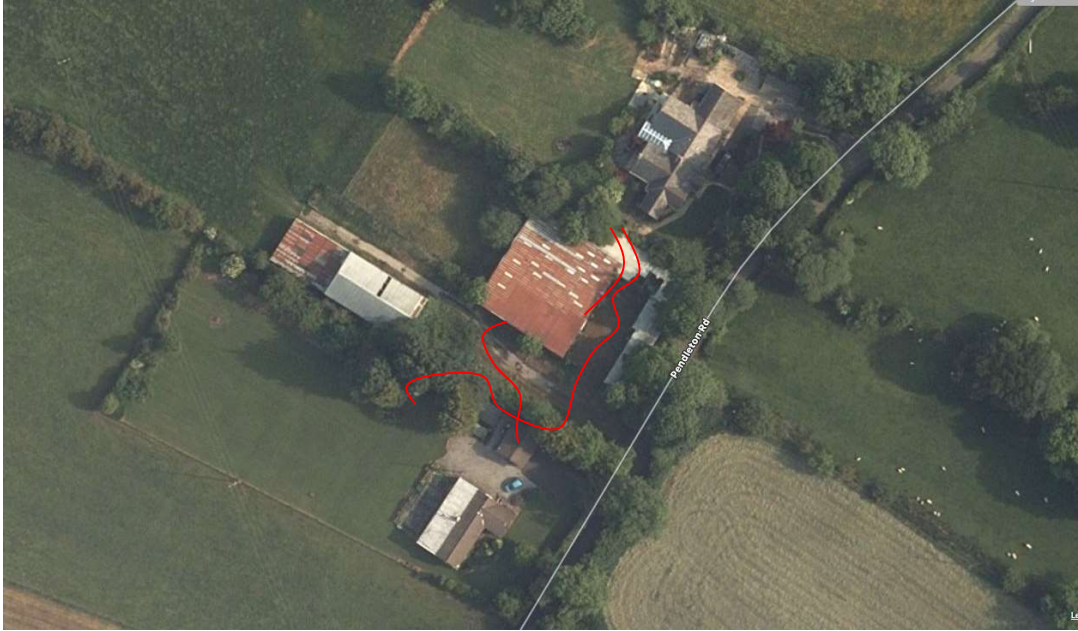
8.40 pm the detector picked up an echolocation prior to the emergence of the first Pipistrelle bat from the direction of the house adjacent to the north east boundary, the activity increased during the survey with approx 4no bats foraging on the routes indicated, passing through B1. The main forage route was over the courtyard in a north east to south west direction .The north west section of the site and B2 did not record any forage activity or emergence.

The floors and any surfaces in the buildings were examined for any of the above listed evidence the result was negative , however during the emergence survey a couple of the foraging bats entered through the door opening in B1 south east elevation and exited through the south east opening as indicated above.

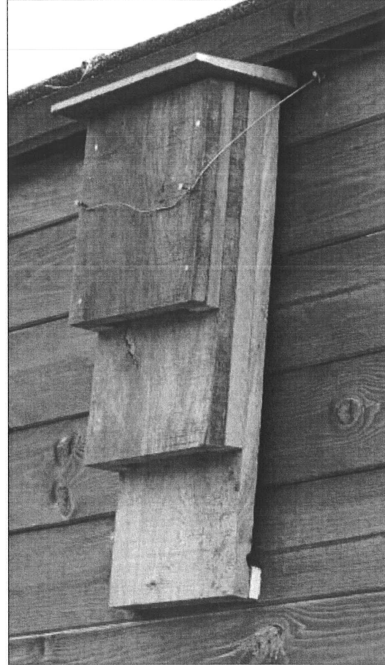
The Kent bat box

The only critical measurement is the width of the crevices—these should be no larger than suggested. Other measurements are approximate.

Box to be made from untreated rough-sawn timbers
Timber should be c,20mm thick
The box should be rainproof and draught-free
Crevices can be between 15 and 25 mm wide
Fixing may be by use of brackets, durable bands or wires

No mitigation or further survey effort required however due to the location it is suggested that roost potential should be enhanced by attaching 1no Kent bat box to each lodge. See details below.
