**BAT SURVEY AT -**

135 HENTHORN ROAD  
CLITHEROE

REFERENCE NO. 6140

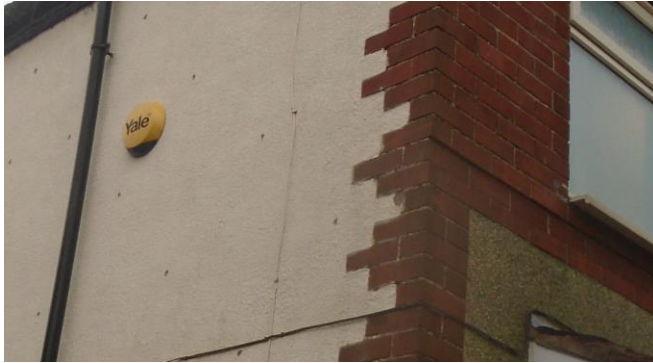
The walls are brick cavity, exposed brick to the front elevation and smooth render finish above a brick plinth to the side and rear elevation.

The bricks, pointing and render walls are in perfect condition with no access points.

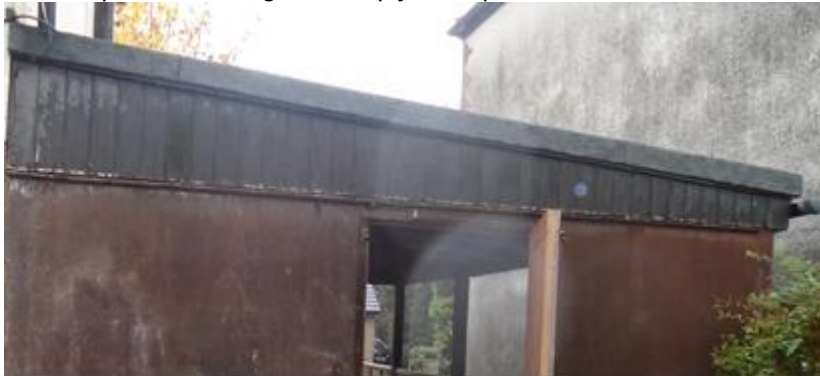
The car port has a single sheet ply back panel with a vertical boarded section above.

All the timber boarding on the car port is single skin and in reasonable condition it does not provide any potential bat habitat.

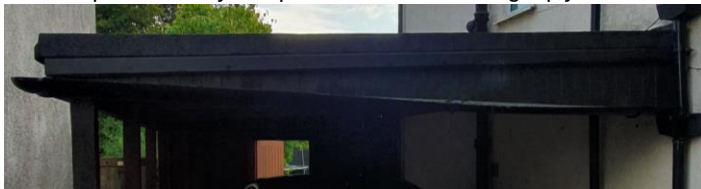
The car port is a very low pitch lean to roof, single ply sheet over timber rafters with felt finish

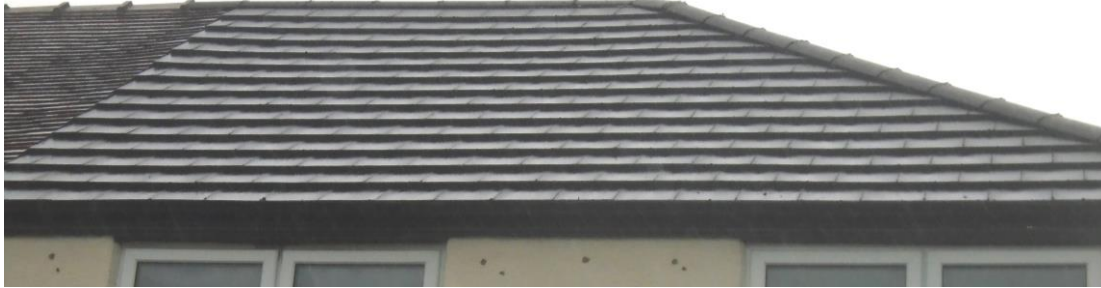
The roof is hipped with tile finish, the roof was renewed approx. 10 years ago.

The timber fascia boards are flush with the wall with no significant gaps, there is a small boarded soffit to the front elevation which is tight fitting and in good condition. The tiles and ridge and hip tiles are all in excellent condition with no possible access points, cracks or crevices.

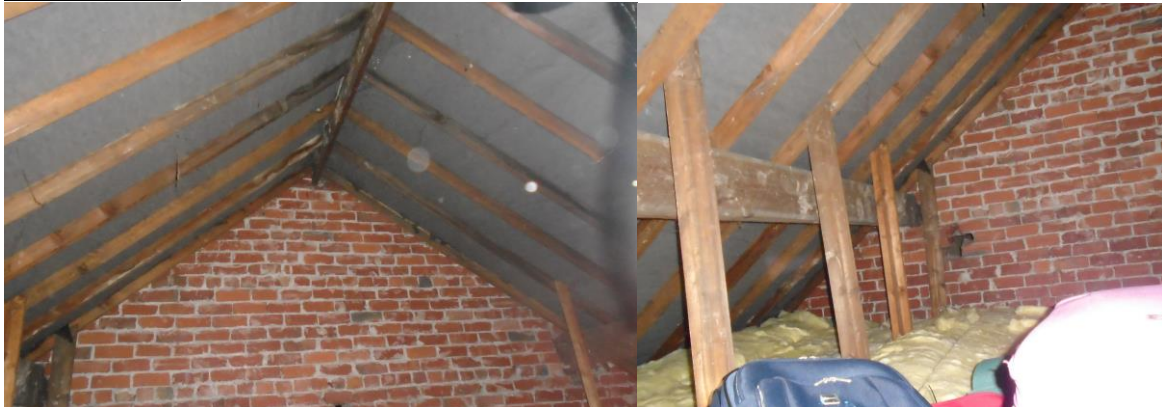
The roof space timbers were in good condition with no cracks or crevices. The felt was relatively new and in excellent condition. A thick layer of insulation was laid over the ceiling joists, the surface was closely examined for droppings and insect remains, the space was clean.

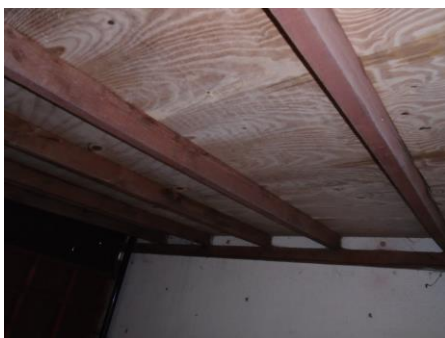
The carport did not have a roof void, the structure did not provide any gaps or potential bat habitat.
