## Ecological Constraints Plan – Alston/Spade Mill Pipeline

## Target Notes – Ecological Constraints Plan

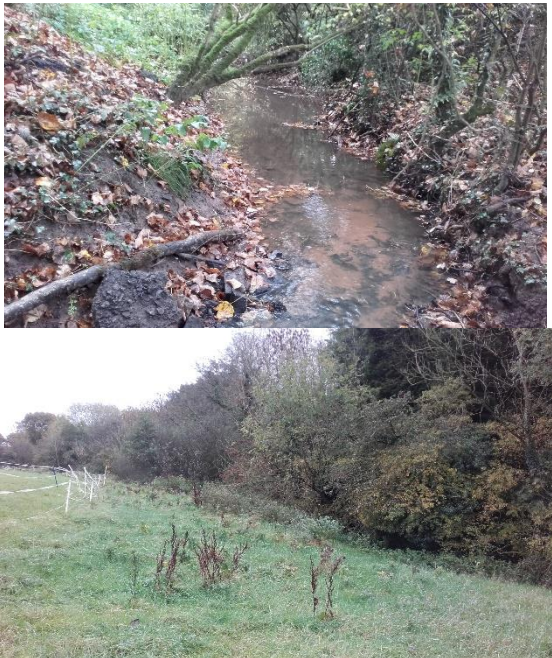
| No | Description | Photograph |
|---|---|---|
| 1 | <p>An extension of Dean Brook, running through Sections 4 &amp; 5 of the survey area and situated within in a wooded clough.</p> <p><i>Potential suitable habitat for otter, water vole, badgers, roosting bats and nesting birds. Also a Habitat of Principal Importance (HPI).</i></p> | |

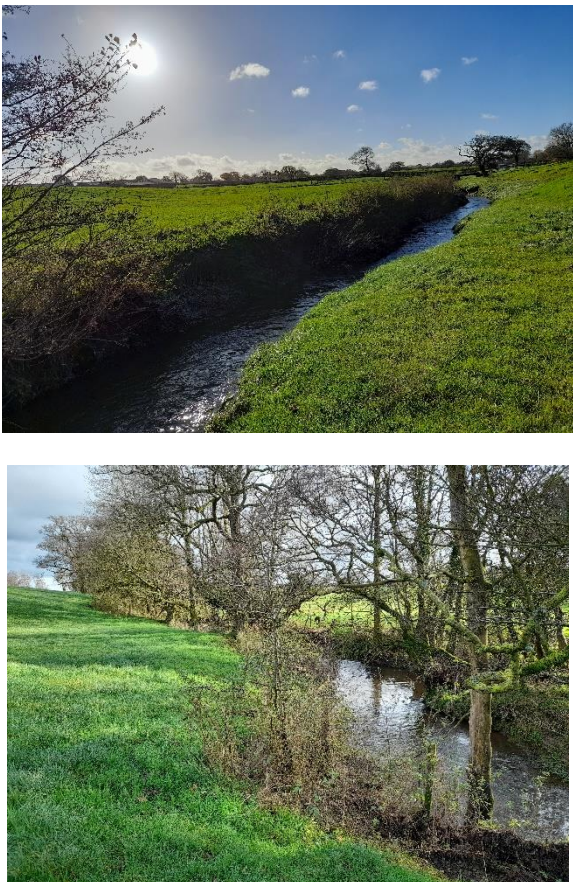
| No | Description | Photograph |
|---|---|---|
| 2 | <p>A section of Blundel Brook which runs through Sections 6, 7 &amp; 8 of the survey area. In Section 6 it is situated between improved fields with only some scattered trees and scrub along its banks, which are dominated by grasses and tall ruderal vegetation. In Sections 7 and 8, semi-mature and mature trees continuously grow along at least one bank of the watercourse and willow scrub is present within the brook in several sections.</p> <p><i>Potential suitable habitat for otter, water vole, roosting bats and nesting birds. Also a Habitat of Principal Importance (HPI).</i></p> | |

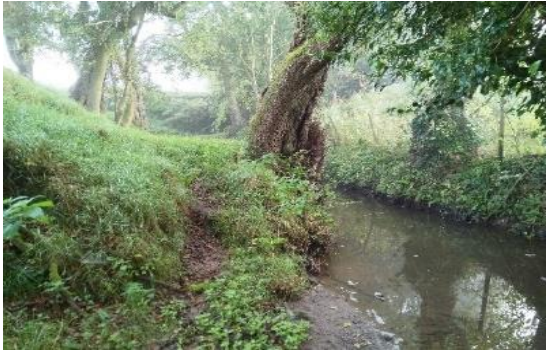
| 3 | <p>Savick Brook is situated in Section 10 of the route, within a narrow wooded clough.</p> <p><i>Confirmed suitable habitat for otter and badger (prints of both species found as well as a photo of an otter)</i></p> <p><i>Potential suitable habitat for water vole, roosting bats and nesting birds. Also a Habitat of Principal Importance (HPI).</i></p> | |

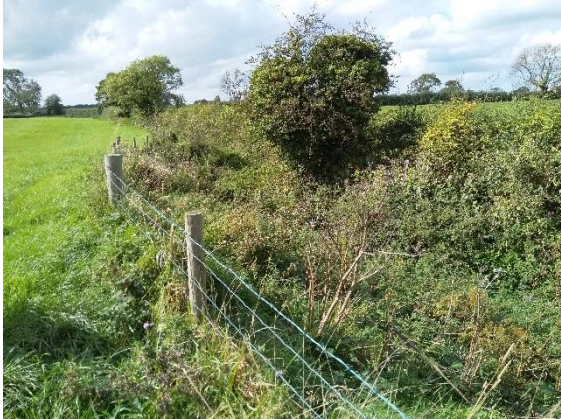
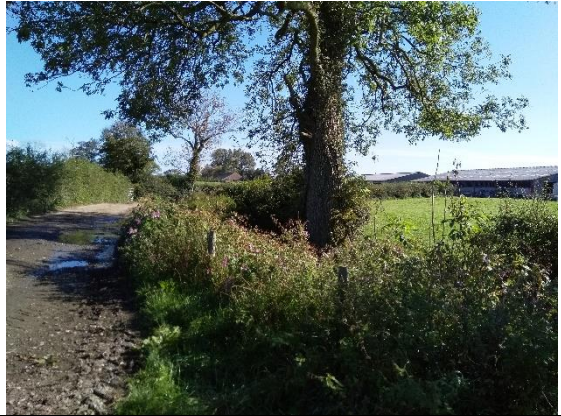
| 4 | <p>A tributary of Savick Brook also extends into Section 11. This section is located in a deep ditch running along hedgerows and passes adjacent to an access road and improved fields.</p> <p><i>Potential suitable habitat for water vole, badgers and nesting birds.</i></p> | |

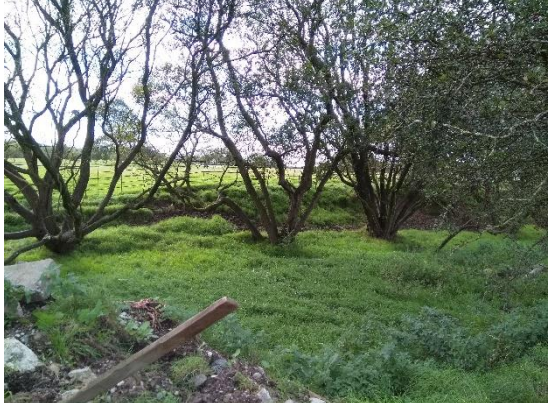
| 5 | <p>A wooded marshy depression dominated by willow in Section 9.</p> <p><i>Confirmed suitable habitat for badgers (outlier sett found, potentially inactive)</i></p> <p><i>Potential suitable habitat for nesting birds, roosting bats and common amphibians.</i></p> | |

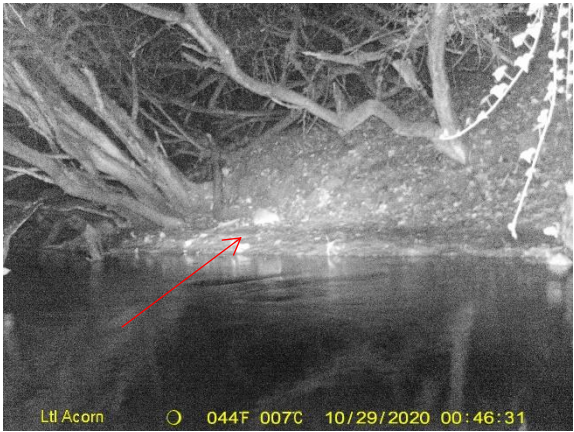
| 6 | <p>A hedgehog was recorded during the trail camera survey along the banks of the brook in Section 4.</p> | |

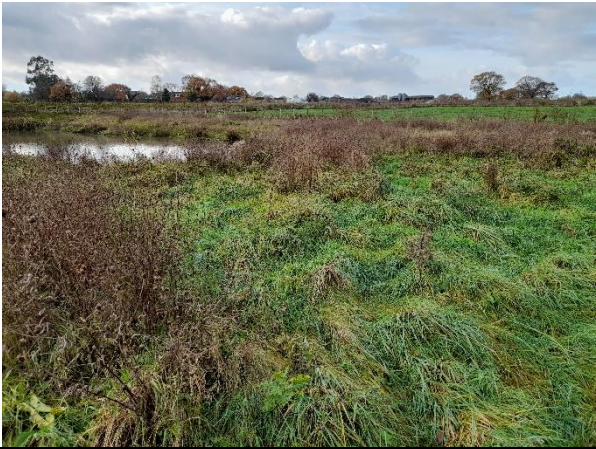
| 7 | <p>Small field containing large pond surrounded by semi-improved grassland with moderate botanical diversity. Newly planted hedgerow delineates fences.</p> <p><i>Potential suitable habitat for amphibians, nesting birds, small mammals and invertebrates.</i></p> | |

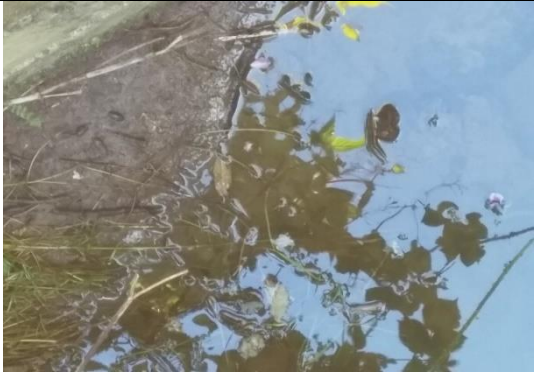
| 9 | <p>Droppings of a consistent size and shape to water vole located adjacent to brooks / streams (not confirmed due to similarity to other mammal droppings).</p> | |

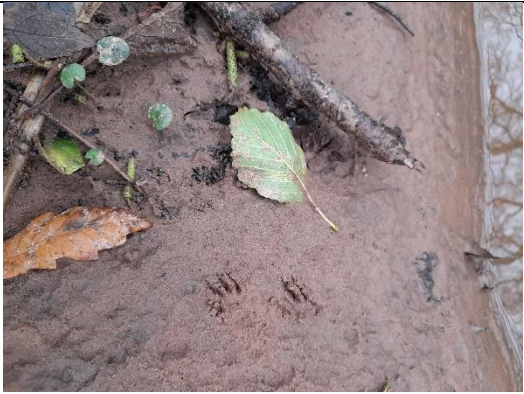
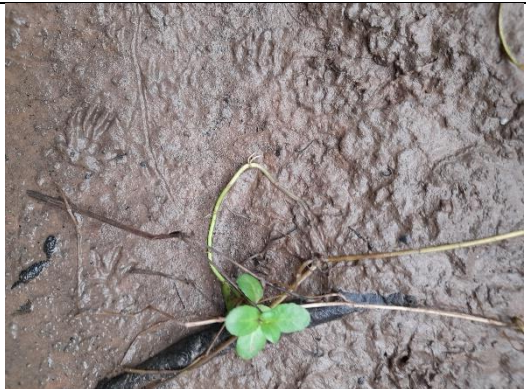
| 10 | <p>Small mammal prints which are potentially associated with water vole (but could be rat)</p> | |

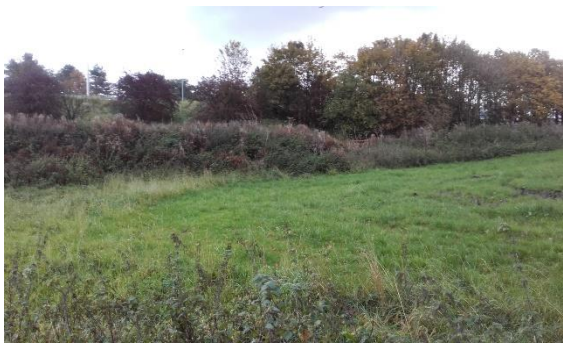
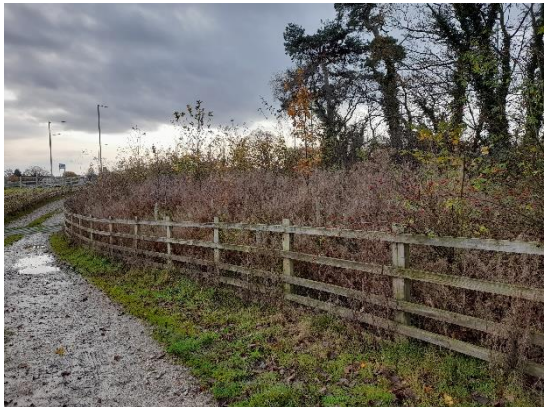
| 11 | <p>Small areas of tall ruderal vegetation throughout the survey area.</p> <p><i>Suitable terrestrial habitat for amphibians</i></p> | <br> |

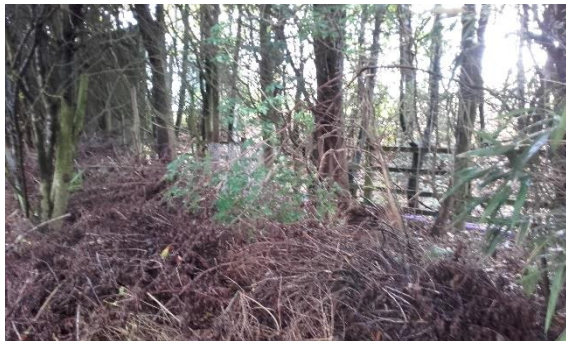
| 12 | <p>Piles of dead wood, brash or rubble</p> <p><i>Potential hibernacula for common amphibians and small mammals including hedgehog.</i></p> | |

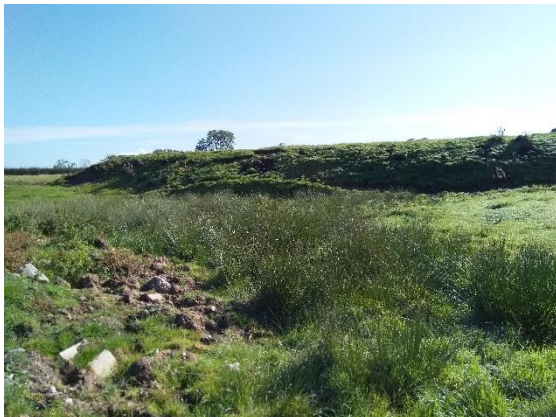
| 13 | <p>Small areas of marshy grassland throughout the survey area</p> <p><i>Suitable terrestrial habitat for common amphibians</i></p> | |

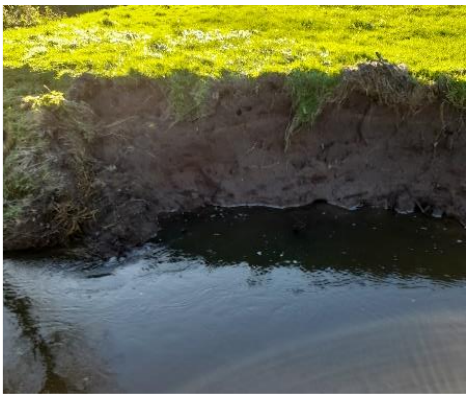
| 14 | <p>Sand martin burrows in the banks of a brook in Section 6</p> | |

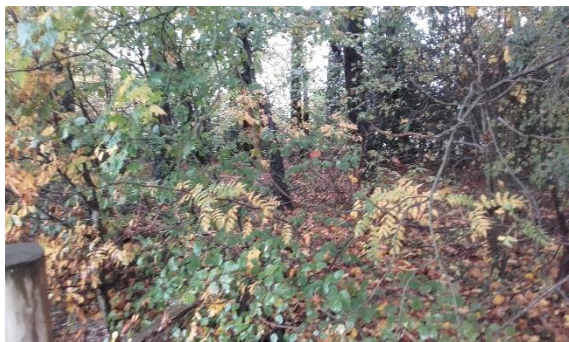
| 17 | <p>Small stand of woodland to the south of Whittingham Lane.</p> <p><i>Potential suitable habitat for roosting bats, nesting birds, badgers and small mammals including hedgehog.</i></p> | |

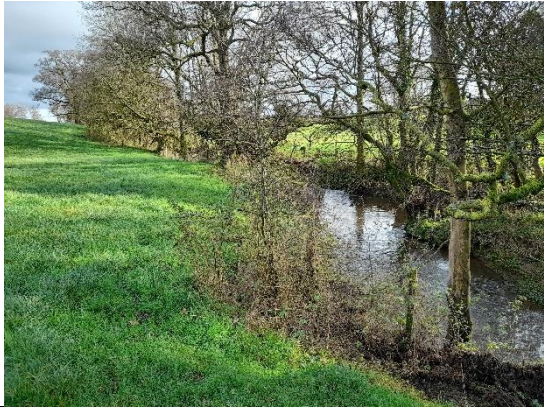
| 19 | <p>Blundel Brook within Sections 7 &amp; 8 - trees are continuously present along the brook but the understorey is very open, dominated by improved grassland or tall ruderal vegetation, and overall forms a narrow, exposed vegetated corridor</p> <p><i>Potential suitable commuting habitat for otter and water vole. Potential nesting bird habitat.</i></p> | |

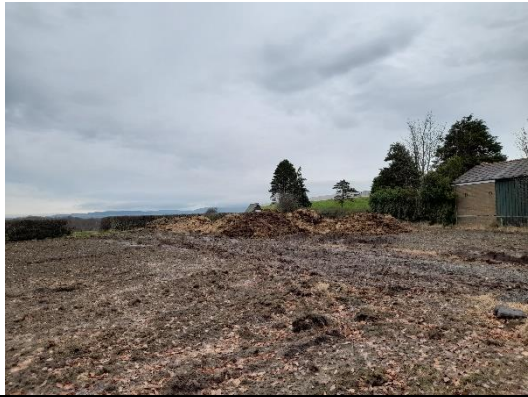
| 20 | <p>Pile of manure on arable field, adjacent to hedgerow.</p> <p><i>Potential suitable terrestrial habitat for common amphibians</i></p> | |

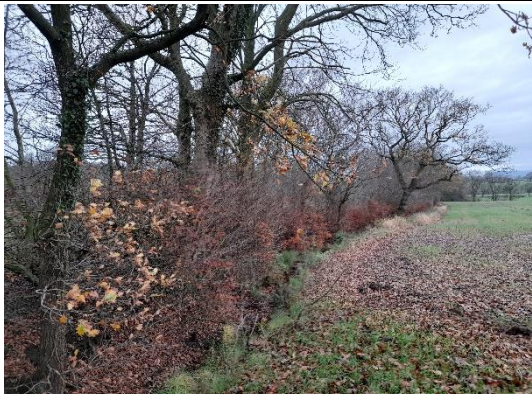
| 21 | <p>Disused road / track between two hedgerows with scattered trees. Tall ruderal, semi-improved grassland and scrub now fully established on top of old track.</p> <p><i>Potential suitable habitat for roosting bats, foraging / commuting bats, nesting birds and small mammals including hedgehog.</i></p> | |

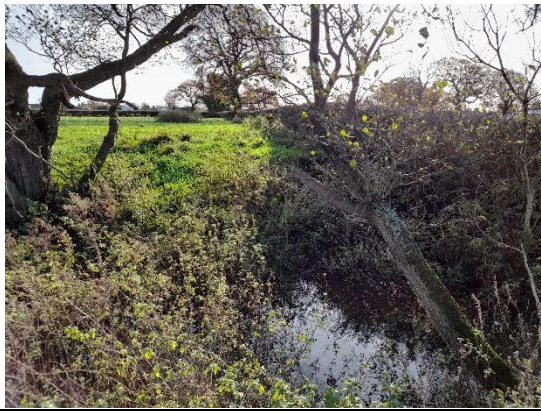
| 23 | <p>Flooded corner of field in a depression. Potential pond, unsurveyed during eDNA surveys, but limited GCN potential as very small shallow pool of water even after recent heavy rain and likely dries frequently. No further GCN survey required.</p> <p><i>Potential suitable habitat for common amphibians.</i></p> | |

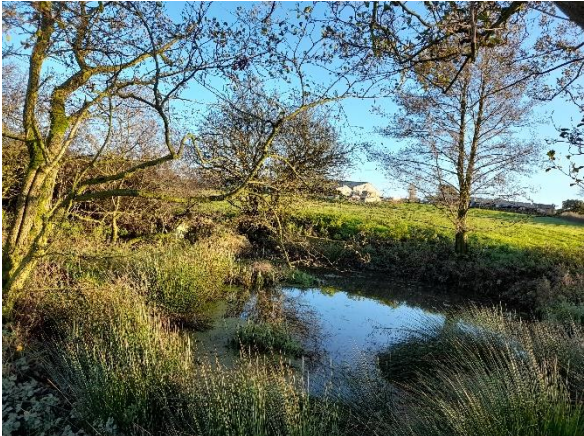
| 24 | <p>Previously unmapped pond in Section 6. Situated within a depression in an improved grassland field. Hawthorn scrub and mature alder surrounding the pond and emergent soft rush, reeds, duckweed are present.</p> <p><i>Potential suitable habitat for amphibians including great crested newt – previously unsurveyed (during eDNA surveys).</i></p> | |

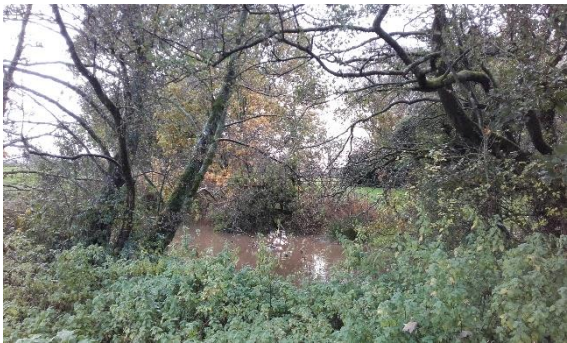
| 25 | <p>Previously unmapped pond in Section 3. Small pond in improved grassland field, adjacent to woodland with overhanging alder. Tall ruderal vegetation dominated by nettle creates a 2 m vegetation buffer around the edge of the pond, with comfrey and soft rush also present. Poor water quality and approximately 70% shaded.</p> <p><i>Potential suitable habitat for amphibians including great crested newt – previously unsurveyed (during eDNA surveys).</i></p> | |

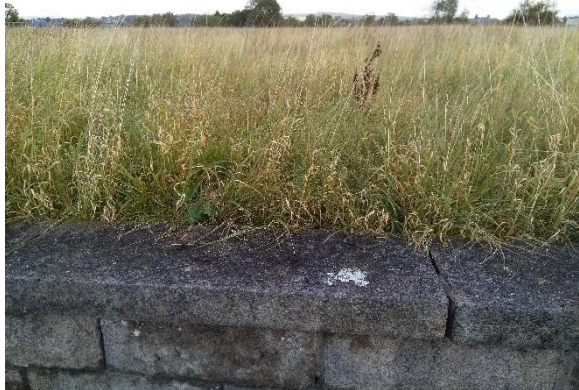
| 26 | <p>Disused filter bed on a mound. Dominated by semi-improved grassland, contained within stone walls.</p> <p><i>Potential suitable habitat for nesting birds</i></p> | |

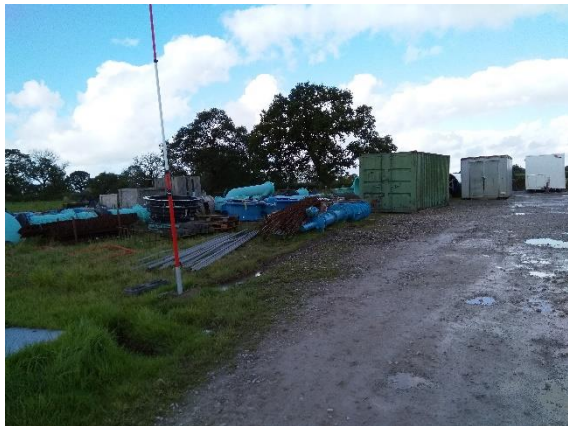
| 27 | <p>Piles of pipes and material storage on bare ground.</p> <p><i>Potential hibernacula for small mammals including hedgehog.</i></p> | |

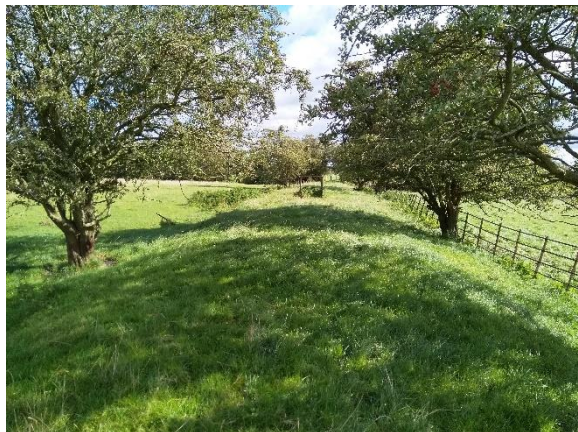
| 30 | <p>Disused railway on small embankment. Dominated by semi-improved grassland, with scattered hawthorn scrub.</p> <p><i>Potential suitable habitat for nesting birds.</i></p> | |

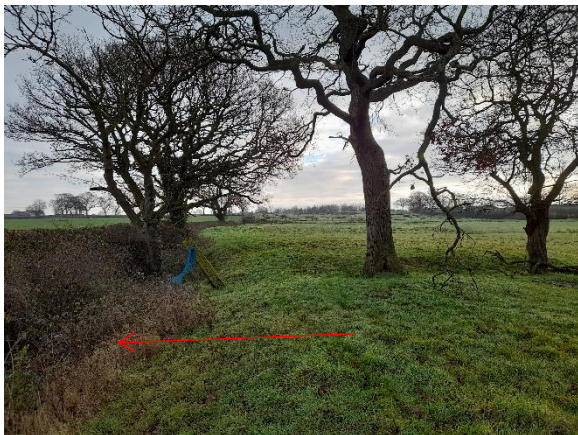
| 31 | Badger hairs and a push-through were recorded beneath the scrub / hedge in Section 7. | |

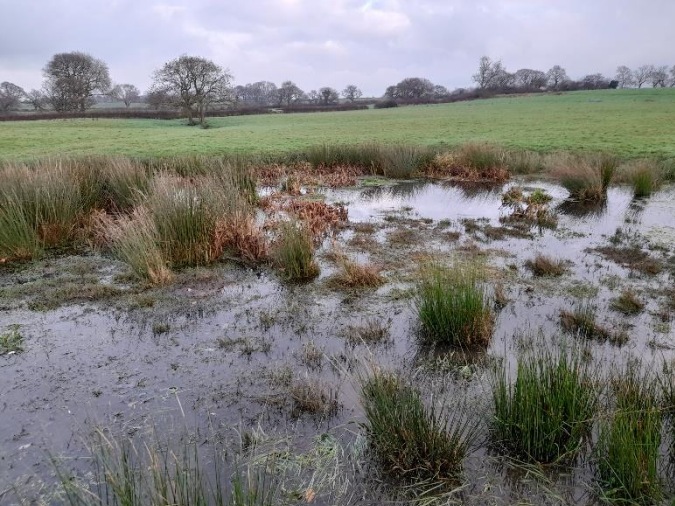
| 33 | <p>Previously unmapped pond in Section 7. Small pond in improved grassland field, likely dries into a small pond. Only minor marginal soft rush vegetation present and a single alder tree.</p> <p><i>Potential suitable habitat for amphibians including great crested newt – previously unsurveyed (during eDNA surveys).</i></p> | |
