# **Preliminary Bat Roost Assessment Report**

**Mayfield,  
Whalley Road,  
Simonstone,  
BB12 7HT**

**17.12.2020**

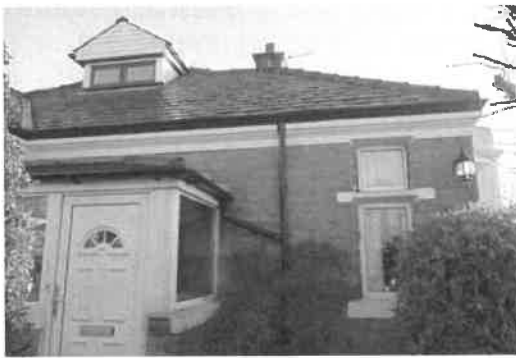
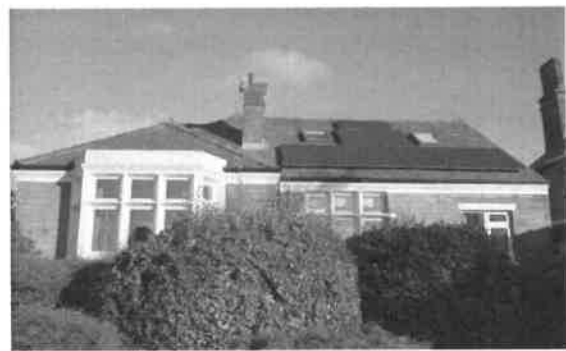
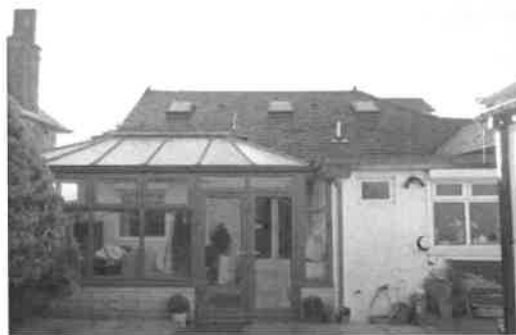
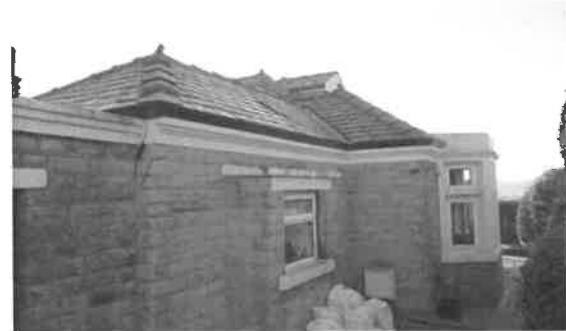
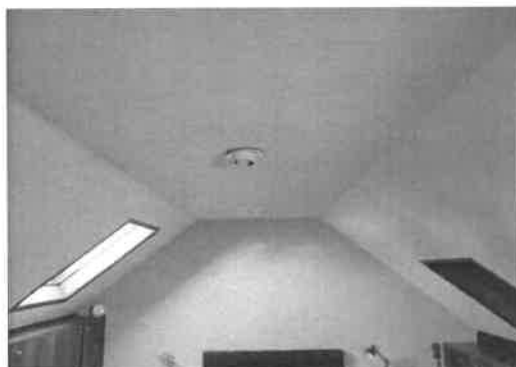
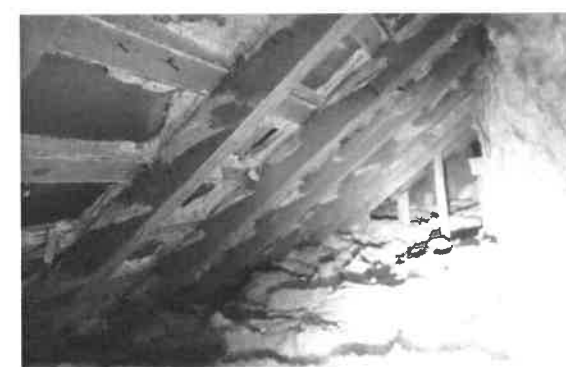
The property consists of a detached stone built dormer bungalow with a multi pitched slate roof. External walls are well pointed with no obvious cracks, gaps or crevices present. Roof slates are close fitting with no slipped, lifted or missing tiles present, lead flashing where present is close fitting. Ridge tiles are pointed and well sealed. Eaves are pointed and well sealed. The main building has a flat roofed single storey extension and upvc conservatory present on the northern facade.

The property has a limited roof void available at the eaves with the central roofspace consisting of living accommodation with vaulted ceilings. Roof slates are unlined with a plaster and lathe construction. The building is well maintained, well sealed and can be considered to offer negligible roosting bat potential.

The property is well maintained, well sealed and was assessed as offering negligible roosting potential with no obvious gaps or crevices suitable for roosting bats.

No physical evidence of bats, grease marks or urine splashing was recorded on or within the building despite suitable horizontal surfaces being present and undisturbed.

No evidence of roosting bats was observed within or on the exterior of the building.

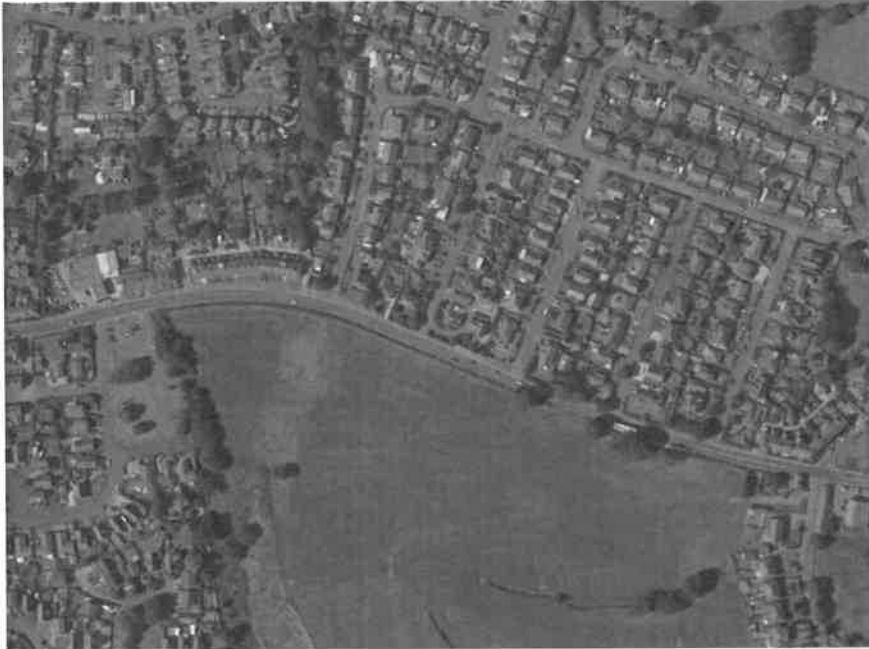
## Habitat

The property is located in a semi rural position with surrounding habitat dominated by a mosaic of semi improved grassland, mature domestic garden with some tree cover and semi natural woodland cover. Connectivity to the wider landscape is moderate.

Bat foraging potential can be considered low to moderate.
