**BAT SURVEY AT -  
16 WELLBROW DRIVE  
LONGRIDGE**

DATE AND TIME OF VISIT  
15 th Dec 2020 9.30 am

REFERENCE NO. 6217

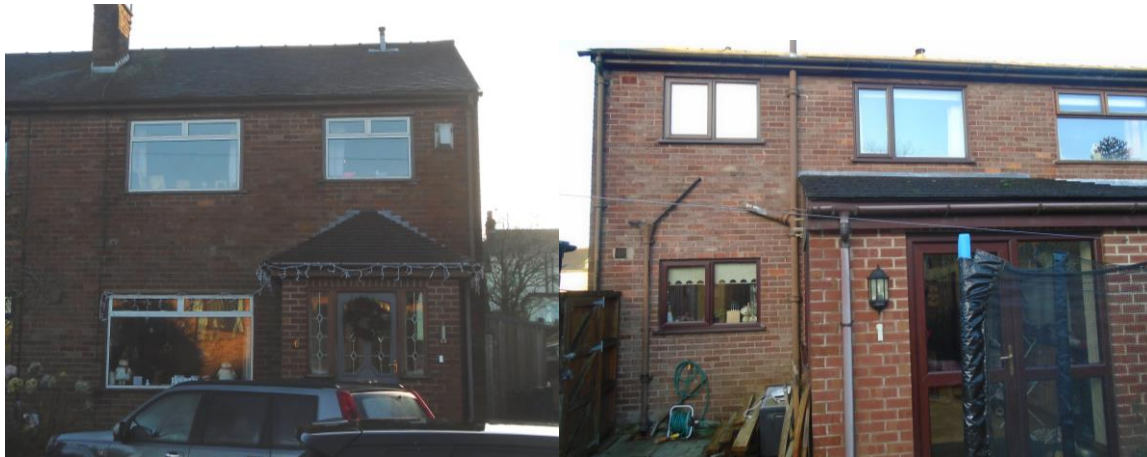
The property is a semi detached dwelling probably dating from the 1970's/80's. it has a single storey later extension to the rear .

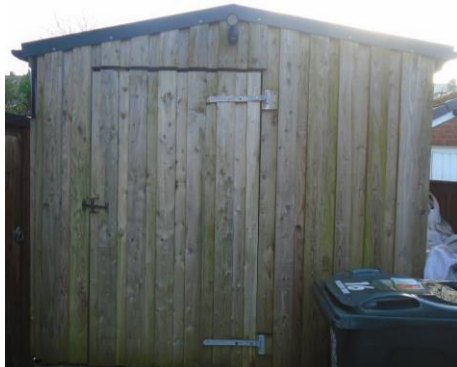
The shed is detached and located in the rear garden.

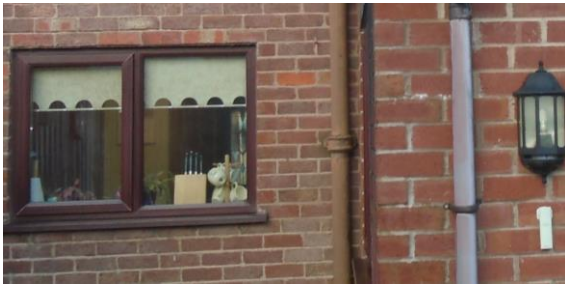
The walls are brick .

The house walls are in excellent condition with no access points, cracks or crevices.

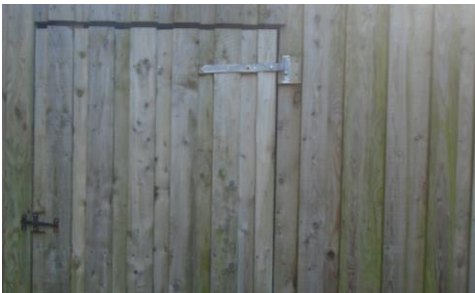
The shed walls are timber boarded.

The shed walls are single leaf timber vertical boarding, in excellent condition no access points or any crevices suitable for bat ingress.

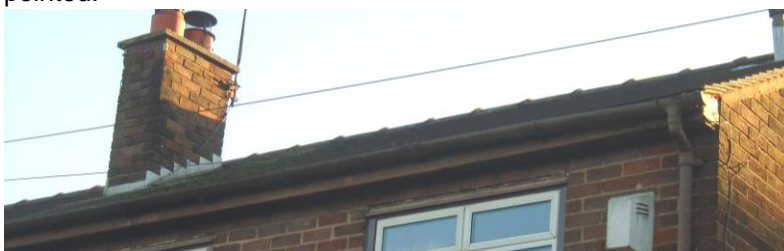
The front roof pitch

The roof is pitched with tile finish with a small overhang at the eaves with a timber soffit. The verge is pointed.

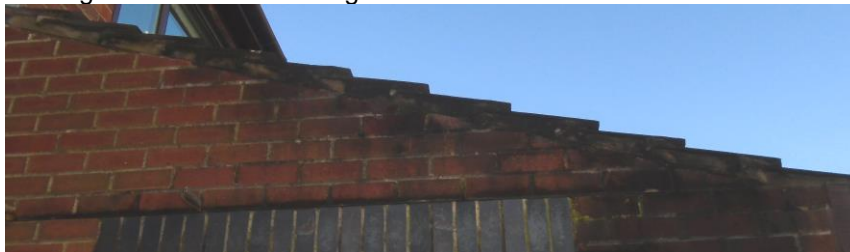
The verge of the extension

As is illustrated below all the verge pointing is in excellent condition, the tiles are all tight fitting as are the ridge tiles and the flashing at the lean to wall abutment.

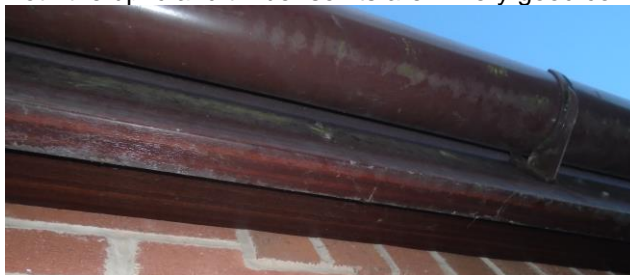
The upvc fascia and soffit to extension

Both the upvc and timber soffits are in very good condition and do not provide any access points.

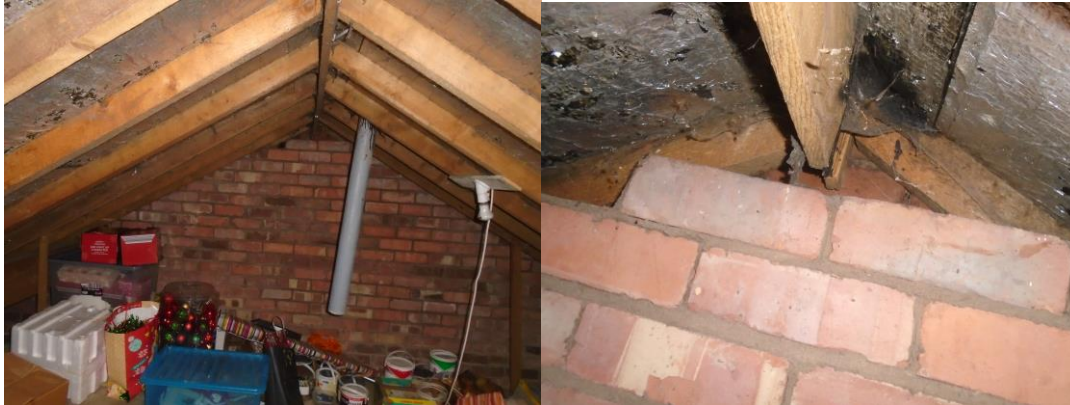
House roof void.

The roof space was fully accessible and used for storage with a boarded floor. The rafters and purlins were in good condition and did not provide any habitat potential for bats. The space did not provide any roost or forage potential.

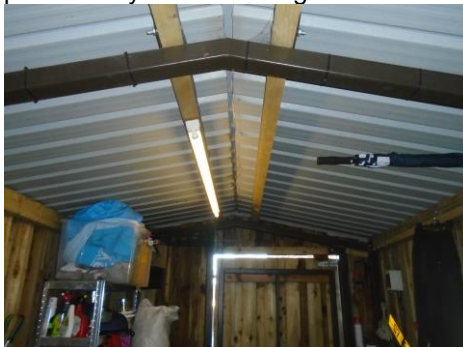
The shed roof structure is steel frame with timber purlins, the structure is relatively new and does not provide any roost or forage habitat for bats.
