**BAT SURVEY AT -**  
Garage at 3 Bank Cottages  
Billington

DATE AND TIME OF VISIT  
8 th Dec 2020 10 .45 am

REFERENCE NO. 6001

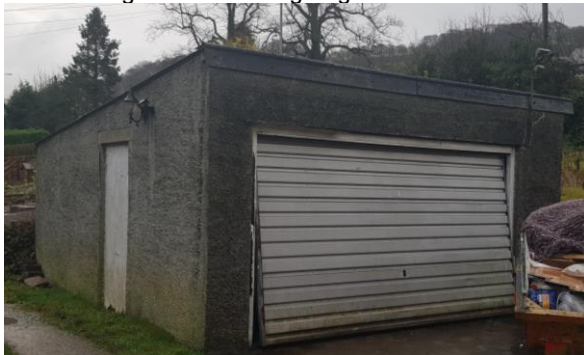
The building is a detached garage constructed at a later date than the cottages adjacent.

Front west and side north elevations

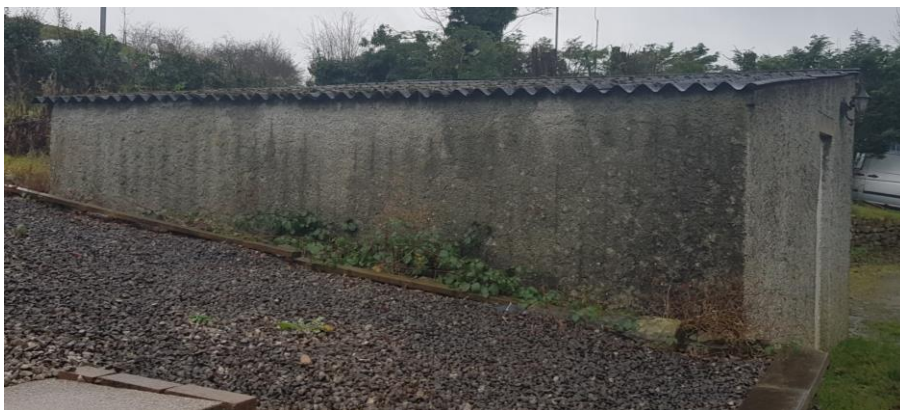
East rear elevation

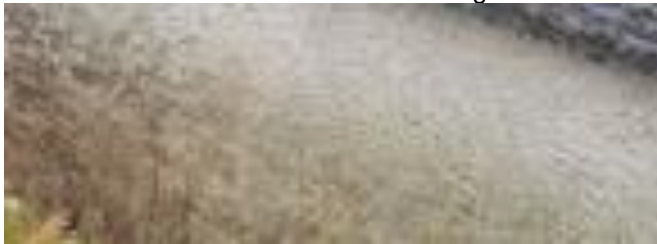
The walls are concrete block with a rough render finish externally.

The walls are in good condition and do not have any access points or cracks /crevices in the render which have the potential to provide habitat for bats.

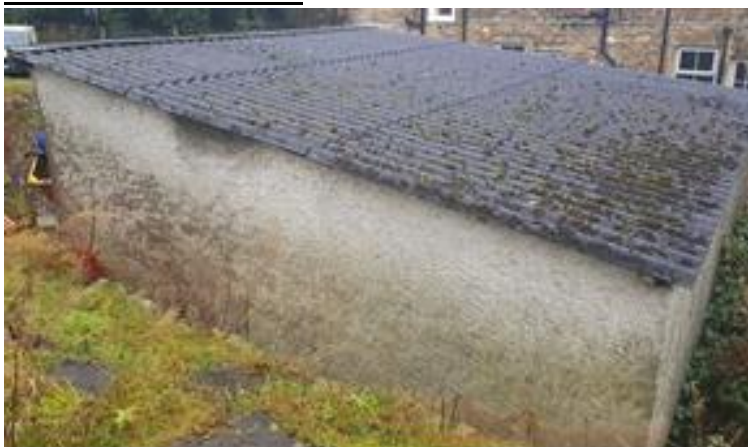
The roof is a mono pitch with a fibre cement concrete sheet finish, with verge trim to front elevation.

The sheets are in good condition with tight laps, the front trim is flush to the wall. The side verges are well pointed and the rear corrugations are pointed and do not provide any access points.

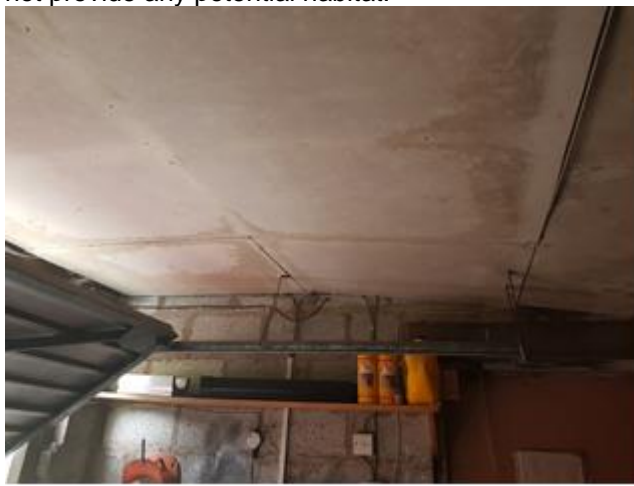
There is no enclosed roof space the structure is plaster boarded to the underside. The space does not provide any potential habitat.
