**Taylor Wimpey**

**REMEDIATION STATEMENT**

**(Contamination Proposals)**

**Henthorn Road, Clitheroe**

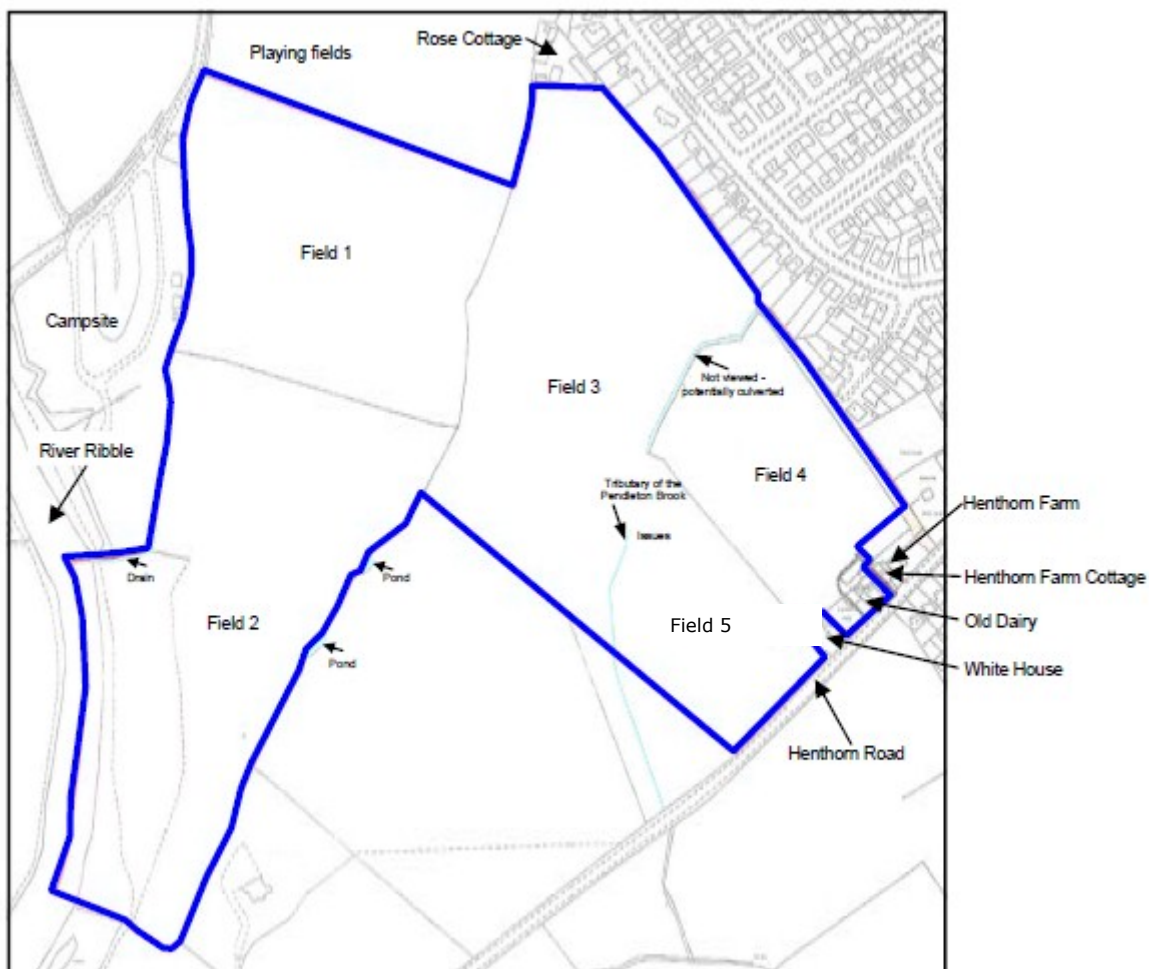
For ease of reporting the same description for the fields in the JPB reports has been adopted divided into five fields numbered 1 to 5, as shown below

Field 1 forms the south western area of the site. The field is roughly triangular in shape, the field slopes steeply west towards the River Ribble. The field is accessed via a gated area from Field 3.

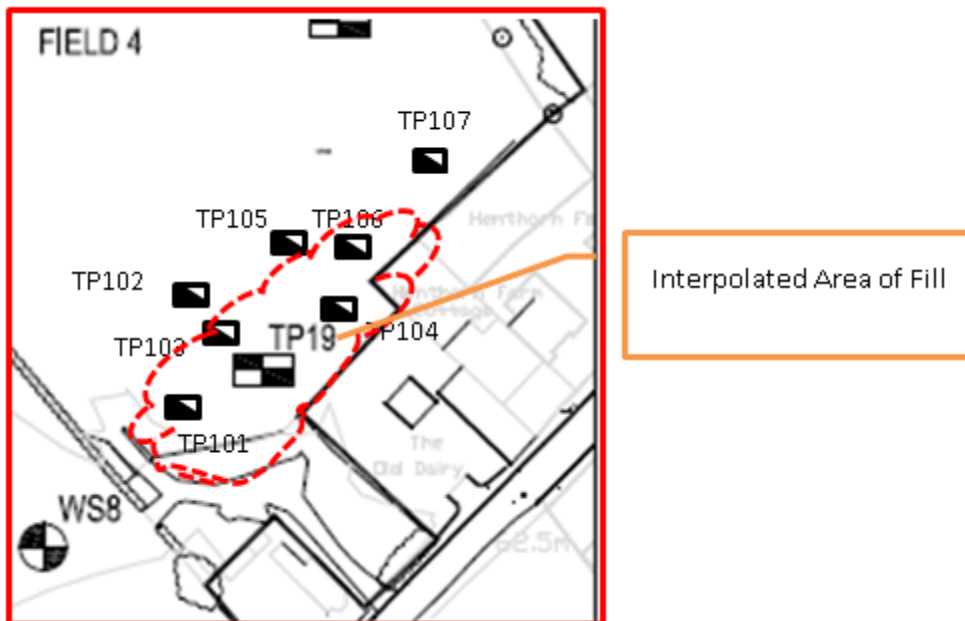
Made ground extended to 1.7m in TP19 – and within the area extended to 1.3m and relatively well delineated the extent (see sketch below)

The fill within these additional trial holes were typical of general demolition material as per the JPB report, with the addition of tarmac road planning's in places.

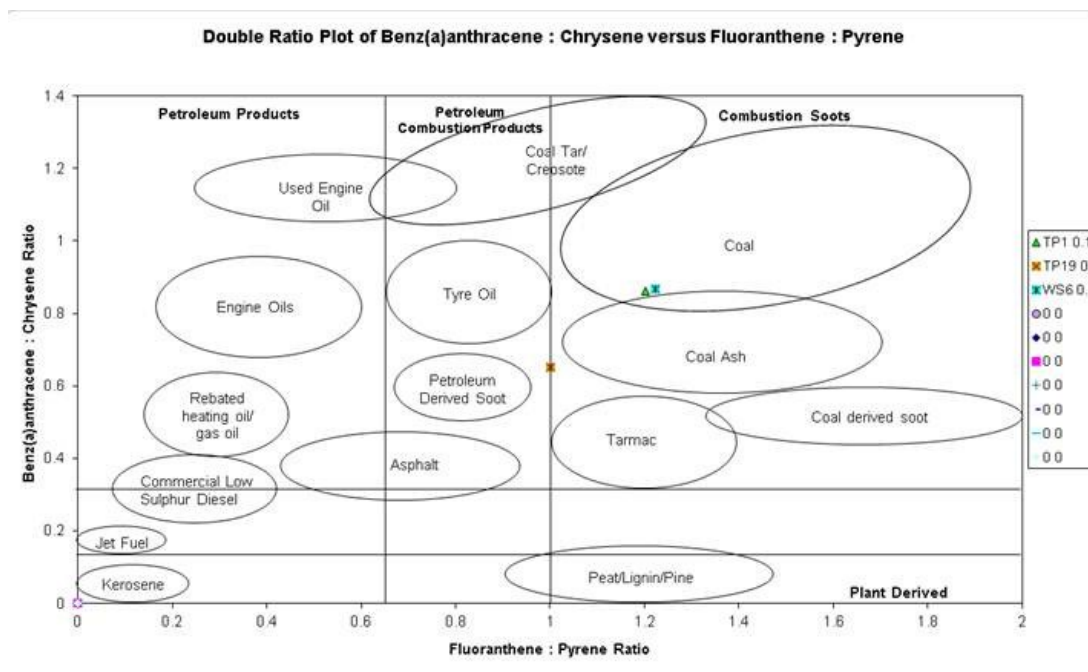
Samples taken were 'fingerprinted' using double ratio plots (see below)

TP19 correlates with the tarmac found in the Betts trial pits. Allowance for 600mm of clean cover for garden in this locality should be made.

Trial pits we undertook in Field 5 found coal fragments / gravel of coal in the natural drift – again correlating with the fingerprint.

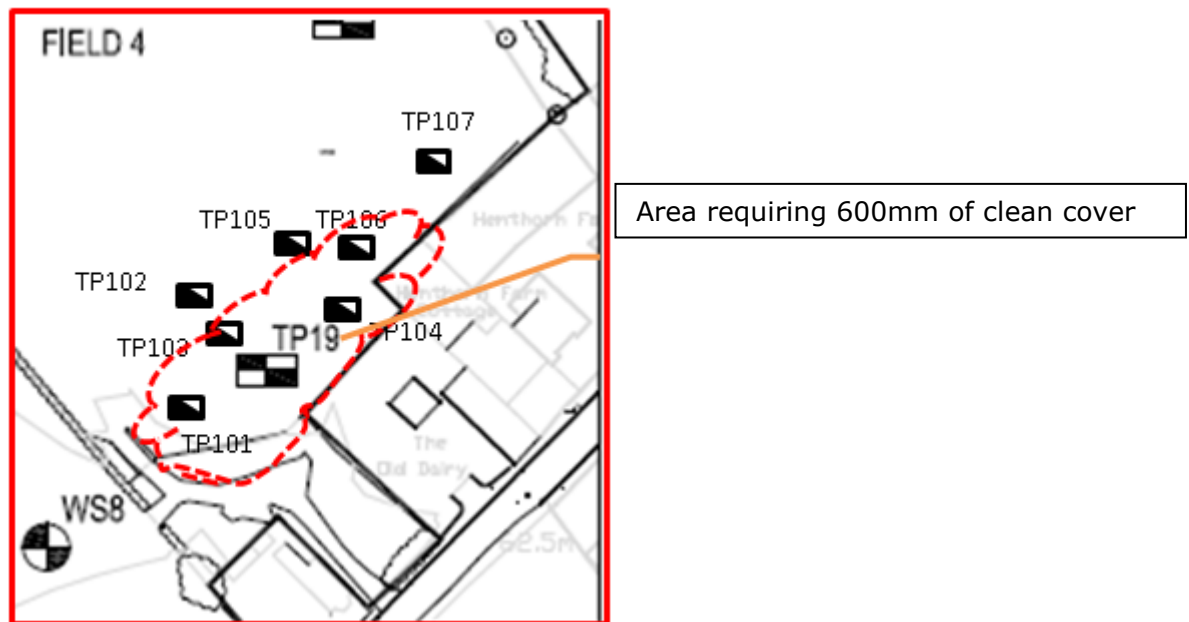
The Remediation Strategy for the site only requires cover system to the area around TP19. 600mm of cover is required using validated soils and thicknesses.

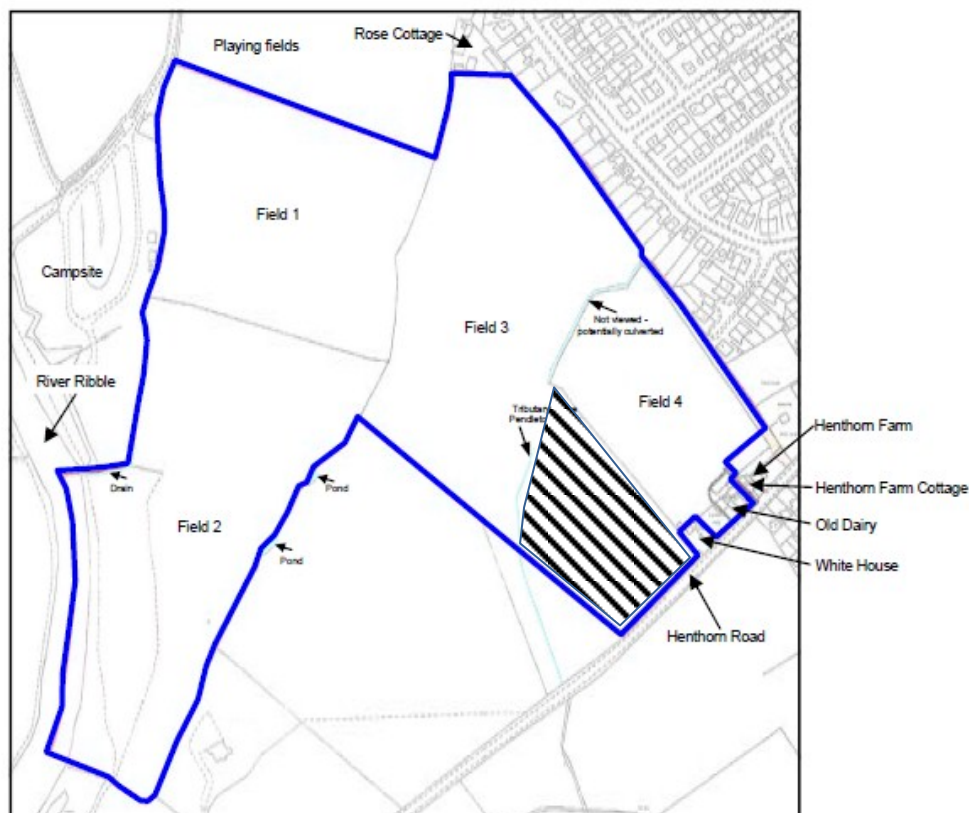
Field 5 (hatched below) has demonstrated slightly elevated 'coal' derived PAH's. Whilst the risk is deemed negligible for domestic garden use it is suggested that this topsoil is stripped and stockpiled for reuse in areas of lower risk i.e. public open space.

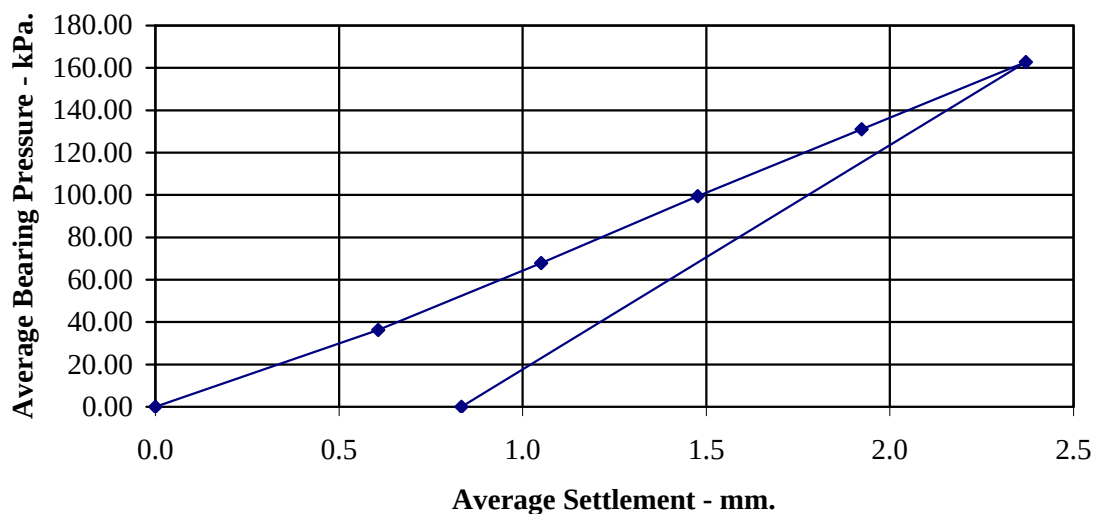
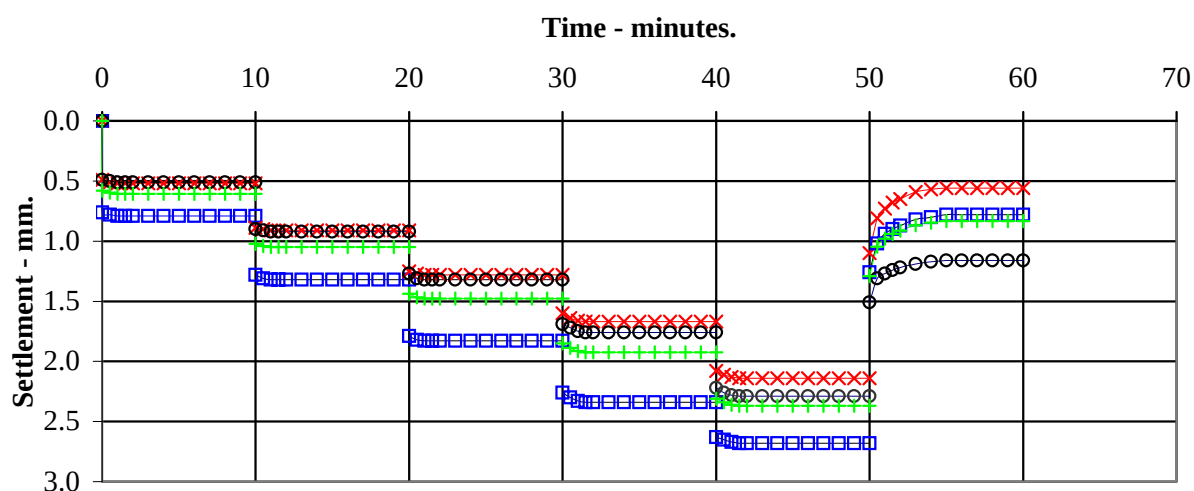
Brown slightly gravelly  
slightly sandy CLAY.

—x— Settlement Gauge 1 —□— Settlement Gauge 2 —○— Settlement Gauge 3 —+— Average Settlement

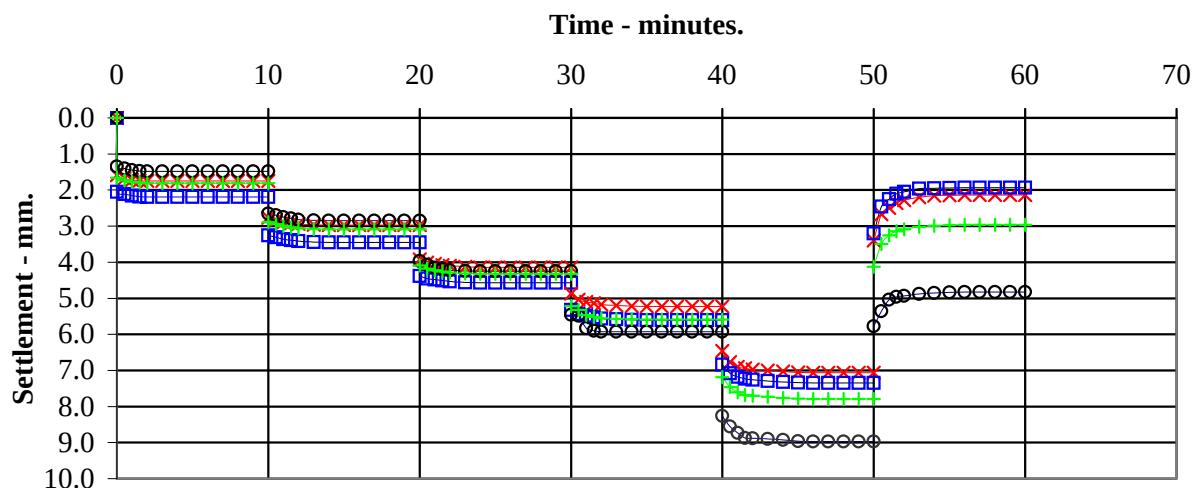
Brown slightly gravelly sandy CLAY.

—x— Settlement Gauge 1 —□— Settlement Gauge 2 —○— Settlement Gauge 3 —+— Average Settlement

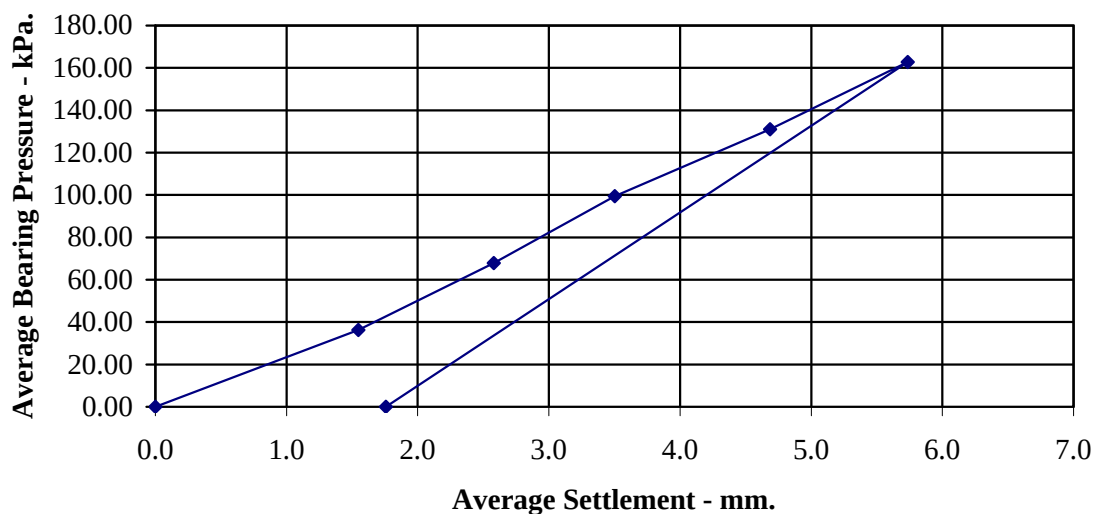
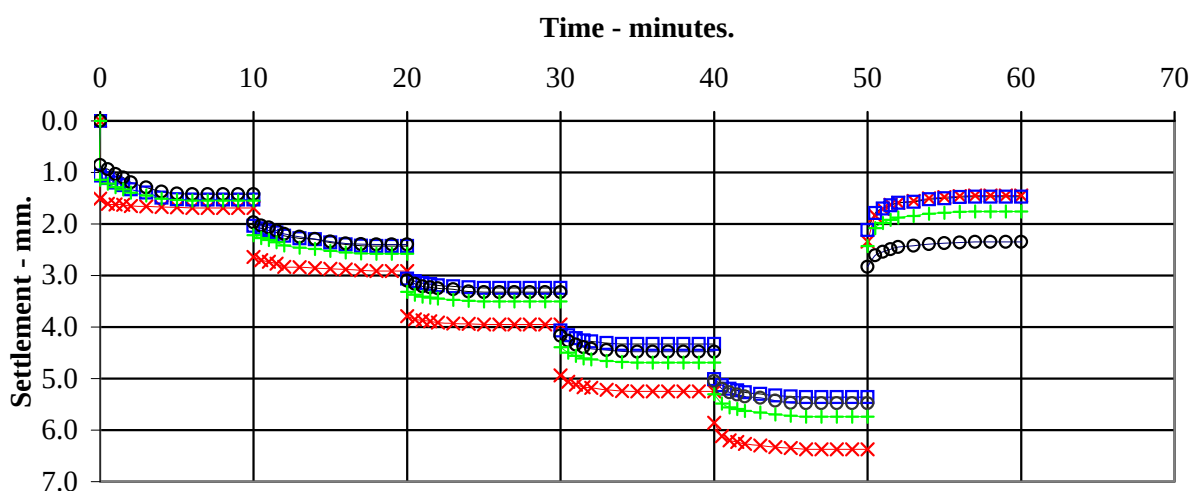
Brown slightly gravelly sandy CLAY.

—x— Settlement Gauge 1 —□— Settlement Gauge 2 —○— Settlement Gauge 3 —+— Average Settlement

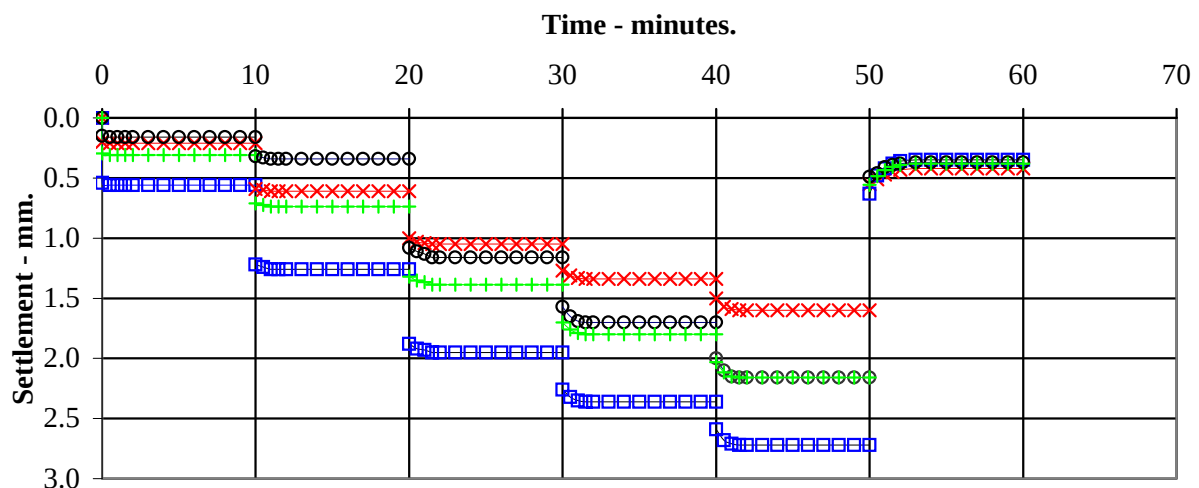
Brown gravelly slightly sandy CLAY.

—x— Settlement Gauge 1 —□— Settlement Gauge 2 —○— Settlement Gauge 3 —+— Average Settlement

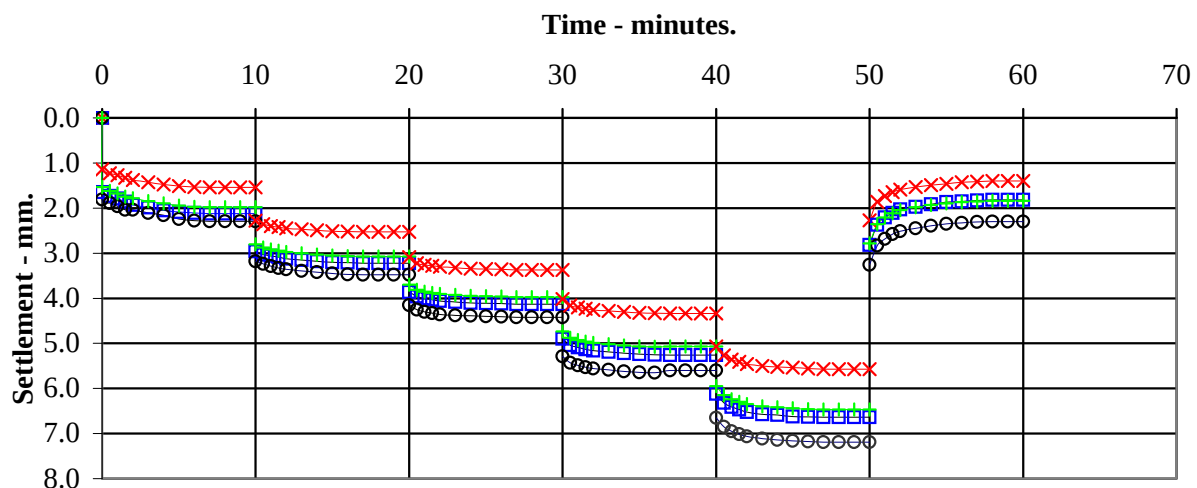
Brown slightly gravelly sandy CLAY.

—x— Settlement Gauge 1 —□— Settlement Gauge 2 —○— Settlement Gauge 3 —+— Average Settlement

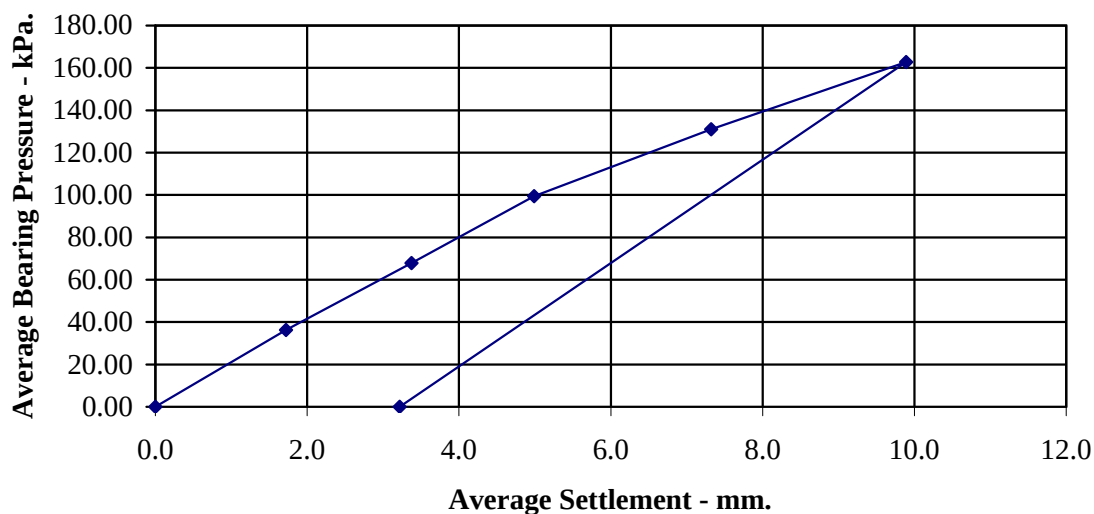
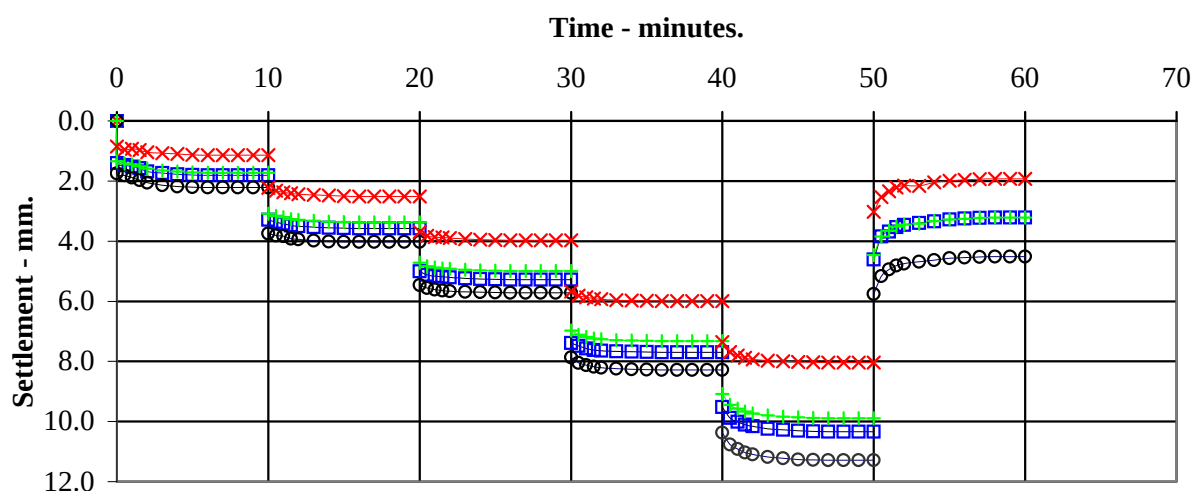
Brown slightly gravelly  
slightly sandy CLAY.

—x— Settlement Gauge 1 —□— Settlement Gauge 2 —○— Settlement Gauge 3 —+— Average Settlement
