Re: Proposed development at School House Farm, Osbaldeston Lane, Osbaldeston, BB2 7HL (Central grid reference: SD 64804 32098)

Thank you for your request for a bat survey at the above site. I understand that the proposed development is for a two-storey extension and refurbishment to the existing dwelling house.

2.0 Methodology

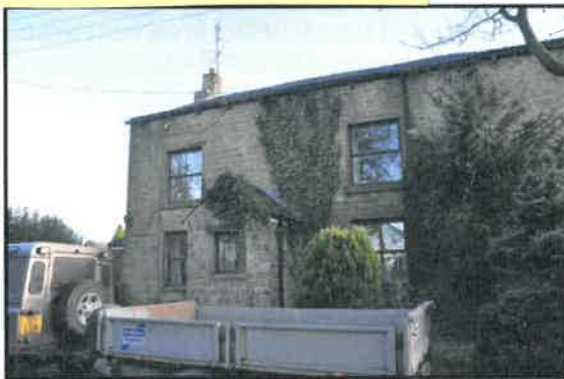
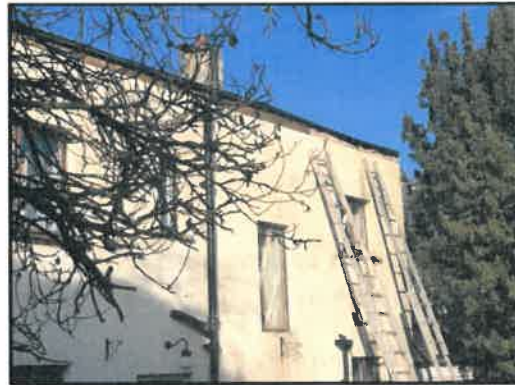
School House Farm comprises an unoccupied, two storey dwelling house with a small front porch and adjoining single garage. There is also an adjoining outbuilding to the west which was not included in the survey.

The walls are constructed of stone, with render on the gable wall (east) and rear (south) elevation. All windows and doors are timber framed. All external walls, windows and doors are well sealed with no visible gaps or cracks.

View of School House Farm, front (north) elevation (lhs) and rear (south) elevation(rhs)

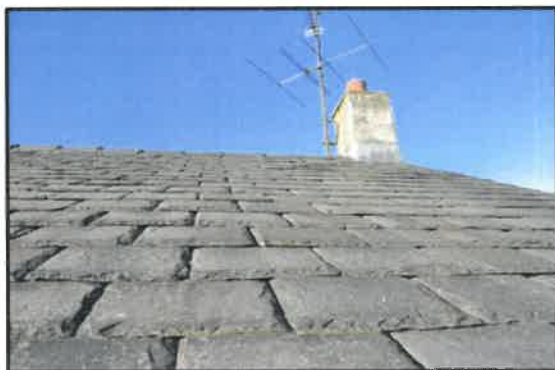
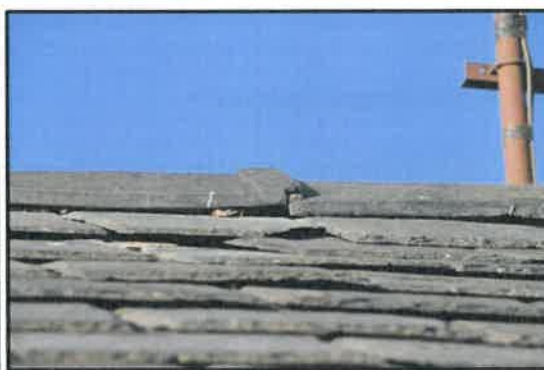
The roof above the dwelling house is dual pitched and the roof above the garage is hipped; both are covered with slate. There is a single chimney at the east gable which is part rendered with lead flashing at the base. There are occasional gaps associated with the slate covering and lead flashing on the main house but the garage roof is tightly sealed with no visible gaps.

- Low potential – gaps associated with roof coverings

Image slate roof coverings (lhs) and image showing example gaps between slate at the ridge (rhs)

Protected Species	Impacts /Predicted Impacts	Action Required
Bats	<p>It is advised that there is no evidence to suggest that bats pose a constraint to the proposed development.</p> <p>It is advised that there are potential roost features suitable for bats associated with roof coverings on the dwelling house. In this location and landscape setting, these features have low potential for bats to use throughout the year.</p> <p>All bat species are afforded full protection under and The Conservation of Habitats and Species Regulations (Amendment) (EU Exit) Regulations 2019.</p> <p>It is our professional judgement that there <i>is</i> a reasonable likelihood of bats roosting at another time.</p>	<p>Advice (mitigation): As a precaution, a suitably qualified Ecologist should be present during works involving disturbance of roof coverings e.g. to tie in the existing roof to the new extension. At any time.</p> <p>Advice (mitigation): All personnel involved in proposed development works should be carefully advised about bats by a professional Ecologist, so that all works are undertaken with a clear understanding about legal aspects, precautions to be adopted and what to do if a bat is found. Prior to development.</p> <p>Advice (mitigation): If bats are found at any time during the development, work must stop until advice has been sought from an appropriately experienced Ecologist. If the development will affect bats, a licence may be required and suitable mitigation put in place. At all times.</p> <p>Recommendation (mitigation and enhancement): Any new lighting associated with the proposed development should be designed to reduce light spill upwards to maintain the current lack of artificial lighting conditions within the area. This will help to avoid any impacts on bat activity, including foraging and commuting. During and post development.</p>

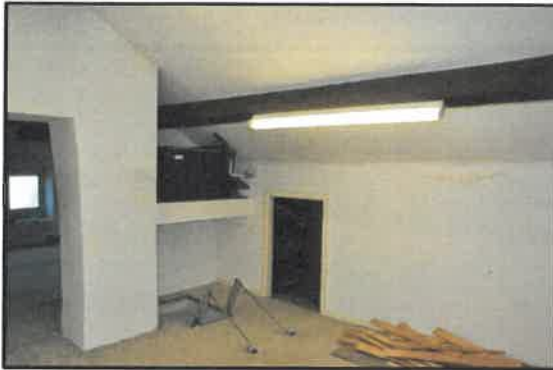
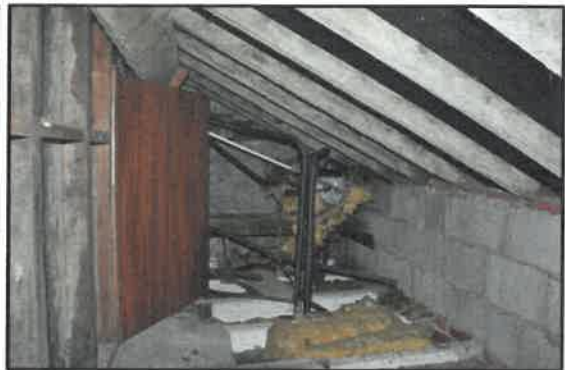
Most of the roof space inside the main house has been converted into living space. There are 2 internal rooms at second floor level with plastered walls and ceilings. There is access from the southern room into a narrow, enclosed roof void containing hot water pipes and cabling. Timber roof supports, bitumastic roof liner and rock wool insulation are present within this void. No potential access points for use by bats were found within this void.

Image of living space in the roof (lhs) and view of enclosed roof void (rhs)

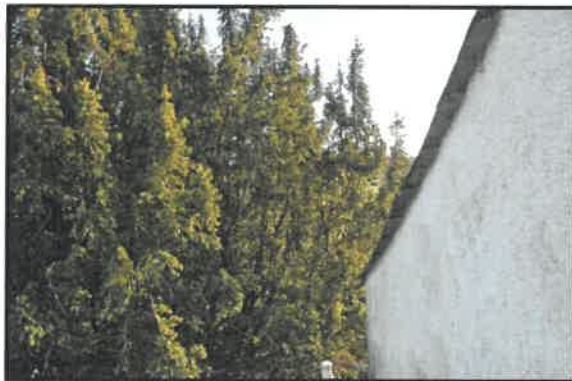
View of gable end (sealed with no gaps) with mature yew tree in background (lhs) and view of open fields immediately adjacent to the rear garden (rhs)

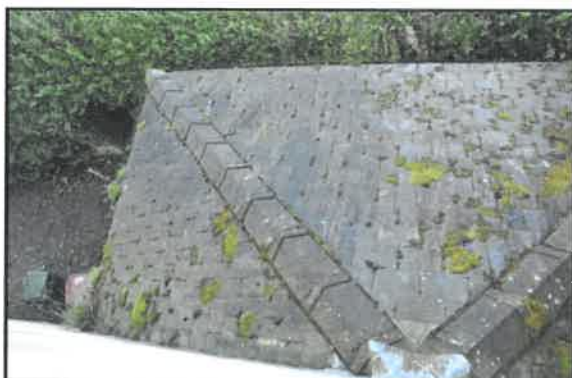
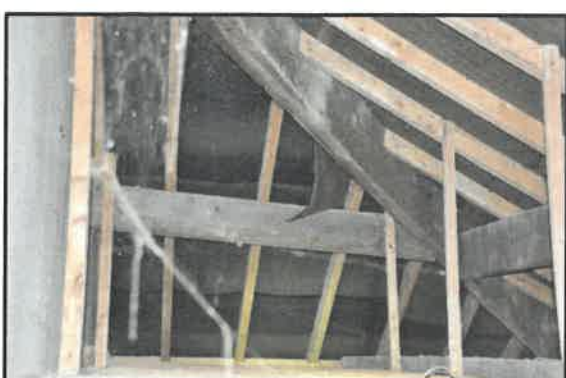
Internal ceiling panels were removed to access the roof void above the garage. Timber roof supports were heavily cobwebbed, bitumastic liner was intact and rock wool insulation was present along the roof edges and on the floor. Not potential access for bats into the roof void was found.

View of garage roof coverings (lhs) and roof void above garage (rhs)
