**BAT SURVEY AT -  
6 PENDLE VIEW  
GRINDLETON  
BB7 4QU**

DATE AND TIME OF VISIT  
13th Aug 2020 1.45pm

REFERENCE NO. 6078

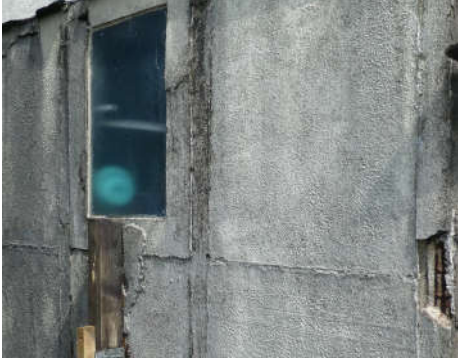
The garage walls are prefabricated concrete

The garage walls although not in good condition having a small area which has crumbled does not provide any access points into the building. The crevice was at low level and was easily examined, it did not provide any bat roost potential.

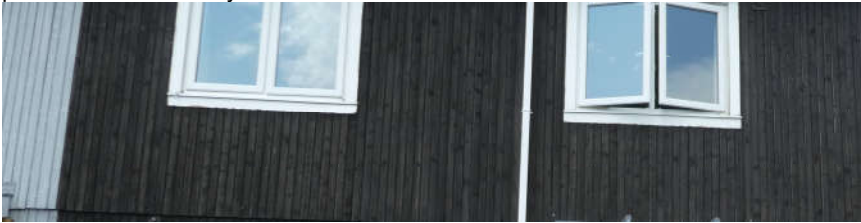
The house walls are vertical timber boarding fixed over a timber frame on a brick base wall with render finish, plasterboard internally.

The timber boarded walls are in reasonable condition with no areas of rot or missing boards. The boards are very tight fitting and do not have a void behind which could be accessed by bats.

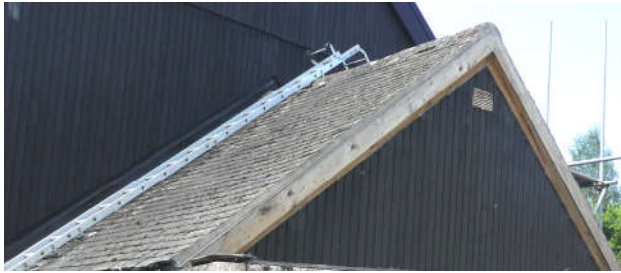
Single storey roof

The main house roof will not be affected by the proposal however the single storey roof will be disturbed. The pitched construction has a concrete tile finish with a timber boarded verge which has been replaced quite recently. See photo below.

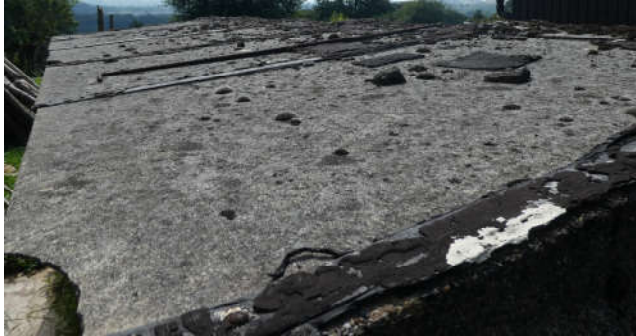
Garage roof

The garage roof is a very low pitch with a bitumus felt finish over fibre cement board.

The roof covering on the garage is tight fitting with no gaps which would enable bat access, the structure does not provide any roost potential.

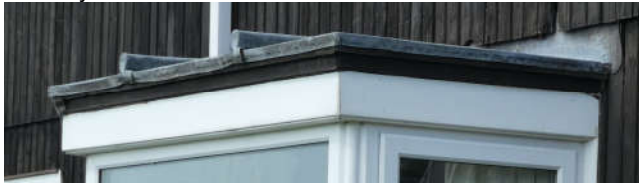
Bay window roof

The bay window roof is a lead flat .

The bay window to be removed has upvc fascias and a lead flat with rolls. It is in excellent condition all joints and flashings are tight fitting with no possible access or roost points.

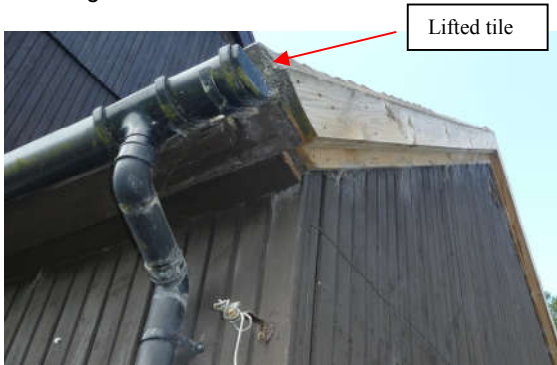
Lifted tile

The single storey roof has very tight fitting tiles with no gaps except for a lifted tile at the rear corner eaves. The gap was examined with the aid of an endoscope the result was negative with no signs of past or current use. The barge boards and fascias have been renewed recently and are in excellent condition and tight fitting.

The house is located in an optimal forage and roost potential area however the buildings affected did not have any access points or crevices with the potential to provide bat roost habitat. The exception being the lifted tile on the south east corner of the single storey roof, it is important to **block this potential access point immediately to prevent bat access prior to the project commencing on site.**

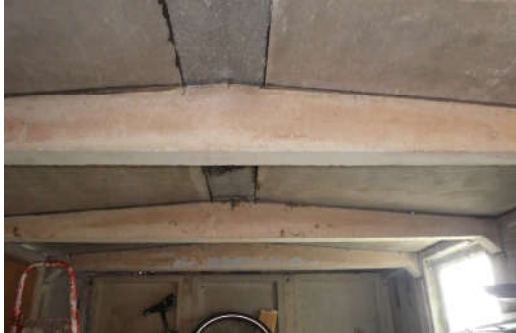
The garage did not have an enclosed roof space the concrete beams with boards over were fully visible, The space did not provide any potential bat roost habitat.
