## Outline Bat Mitigation Strategy

Mitton Road,  
Whalley,  
Lancashire,  
BB7 9JS

Prepared on behalf of:  
Prospect (GB) Ltd

Quality Management Approved prior to Issue			
Report Ref:	SE0909-03_F01a_BMP_AS		
Site Address:	Mitton Road, Whalley, Lancaster, BB7 9JS		
Doc Title:	Outline Bat Mitigation Strategy – Mitton Road		
Issue Date:	12/01/21	Revision No:	c
Prepared by:	Amy Stanley BSc (Hons), PG Dip, ACIEEM	Signature:

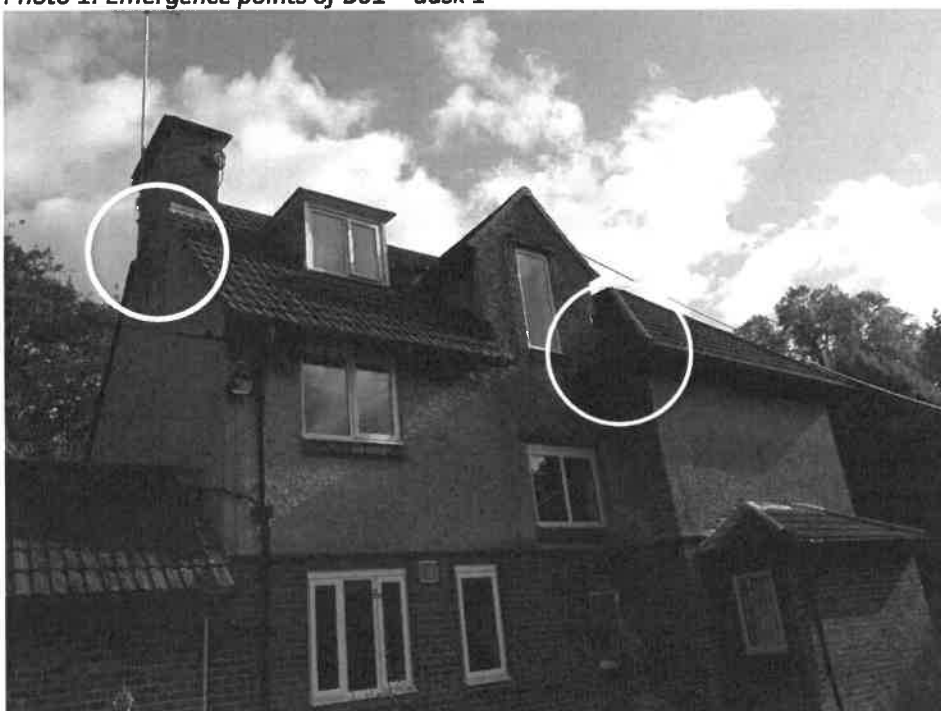
2.7.1 **B01 (Woodlands)** was found to hold moderate bat roosting potential, and initial survey requirements were 2 surveys to determine presence/absence of roosting bats. Internal inspection found bat droppings in roof voids 1 (roof apex) and 2 (southern void), which were sampled and tested, and found to be from Brown Long-eared bats.

2.7.2 Bat activity surveys found several Common Pipistrelles emerging from various locations around the building, on both surveys. Further surveys will be necessary to characterise roosts during optimal bat survey season.

***Photo 1: Emergence points of B01 – dusk 1***

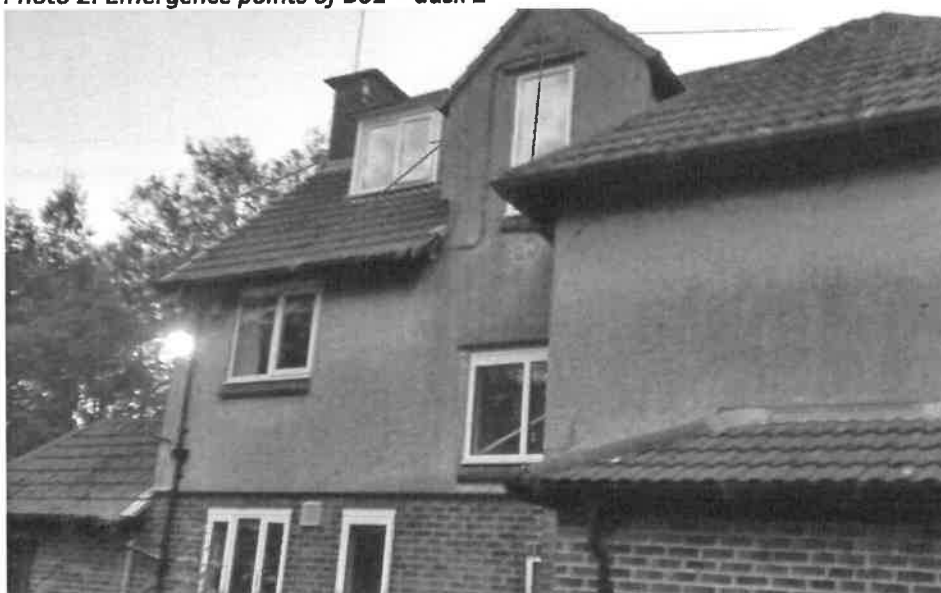
***Photo 2: Emergence points of B01 – dusk 2***
