Site Investigation Report

for land at

Mitton Road, Whalley

22 October 2020

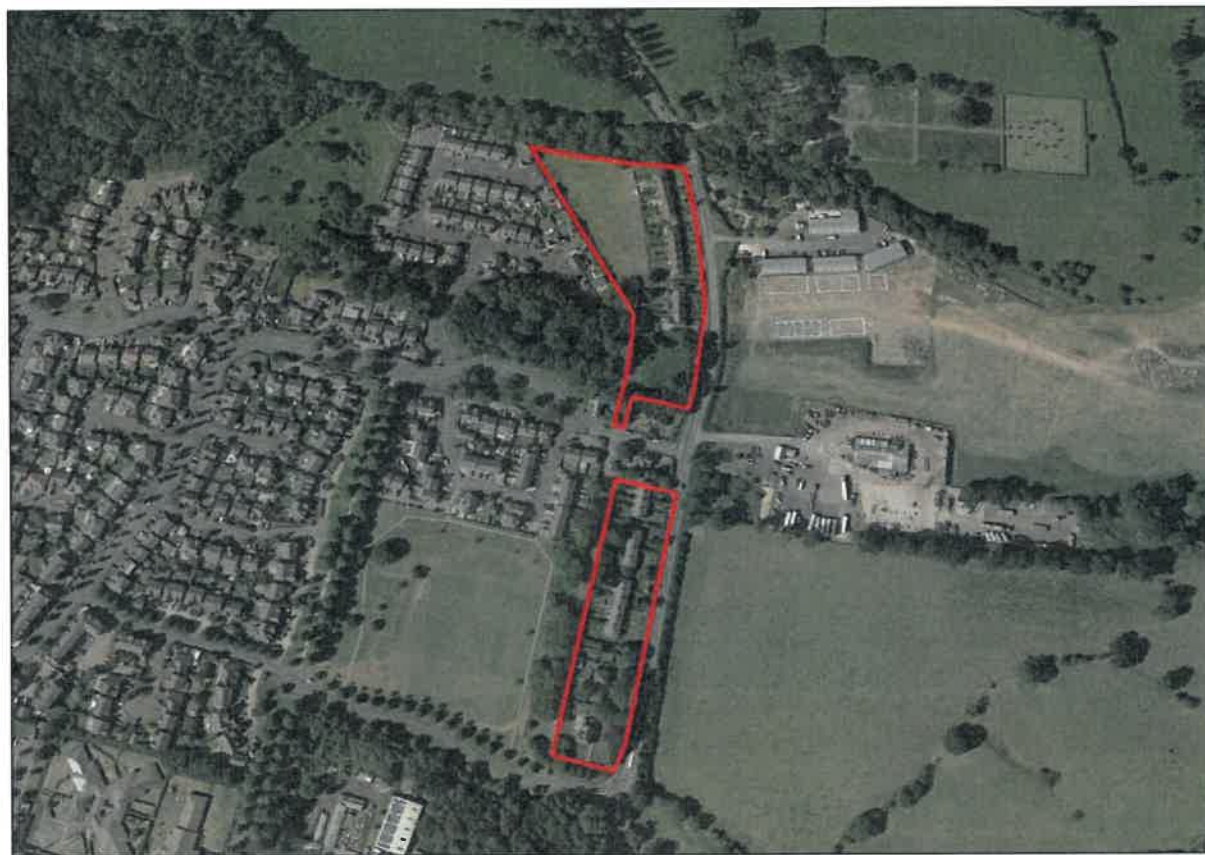
Figure 1: Annotated aerial photograph from Google Earth with approximate site boundaries.

The site consisted of residential housing, open landscaping, an access road, garages and areas of dense vegetation. The site was divided into a northern and southern parcels, separated by Pendle Drive and residential properties fronting the road (refer to Figures 1 and 2). The topography of the site was relatively flat, with a 2m high, raised embankment within the northern parcel along the northern part of the western site boundary.

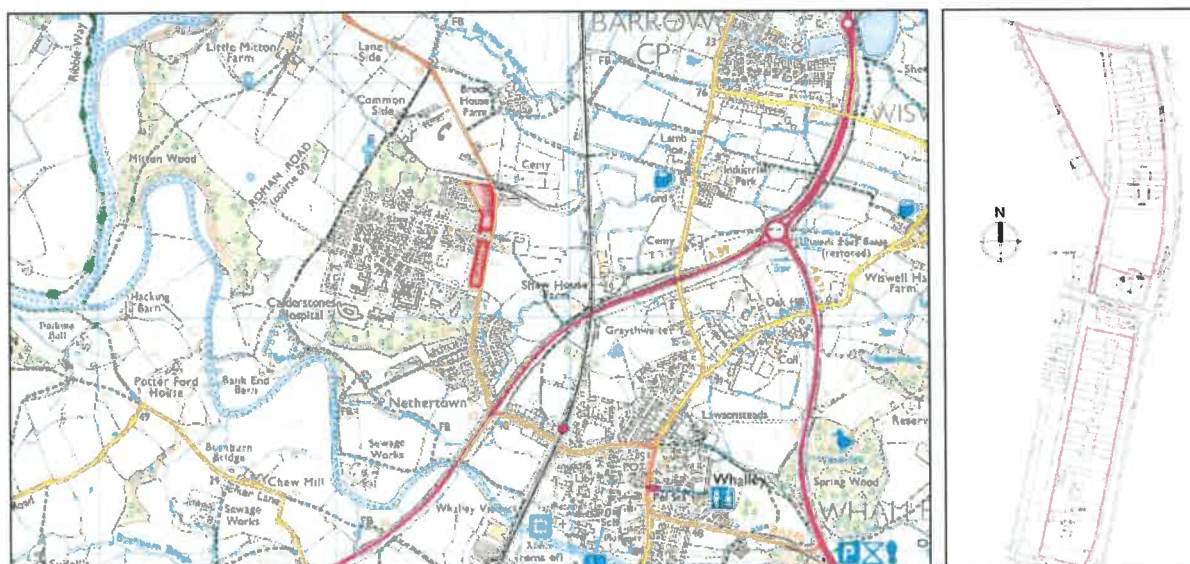
Figure 2: Existing site layout with northern and southern parcels.

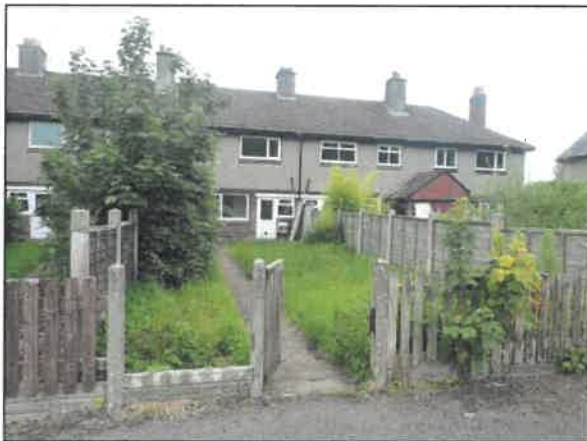
The houses were early 20th Century construction, of brick and rendered construction with pitched slate roofs (refer to Photograph 1). The houses contained individual gardens to the front and rear, separated by timber fencing. To the rear of the houses was a tarmac private access road, with 2 No. blocks of adjoining garages (refer to Photograph 2) for the housing.

Photograph 1: Residential Housing blocks viewed from the rear.

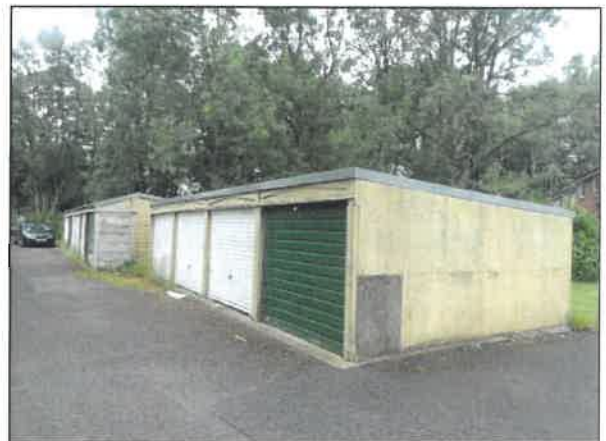
Photograph 2: Garages and access road to the rear of the housing.

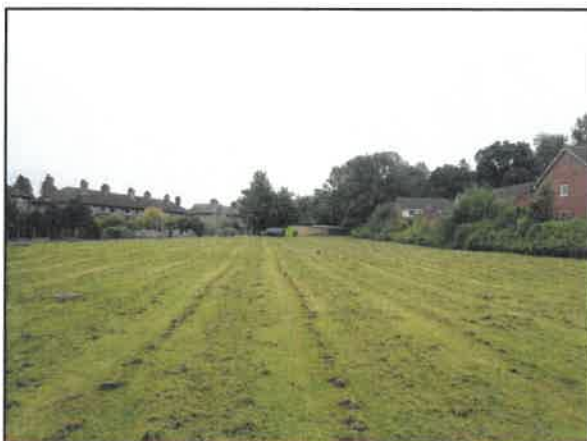
The north western part of the northern parcel comprised a large open grassed space (refer to Photograph 3), triangular in shape, with 3 no. raised manhole chambers from an active foul sewer. The western boundary parallel to this open space comprised significant suspected Himalayan Balsam (refer to Photograph 4) within an embankment approximately 2.5m in height, raising to the adjacent housing.

Photograph 3: Open grassed area in the north west of the northern parcel

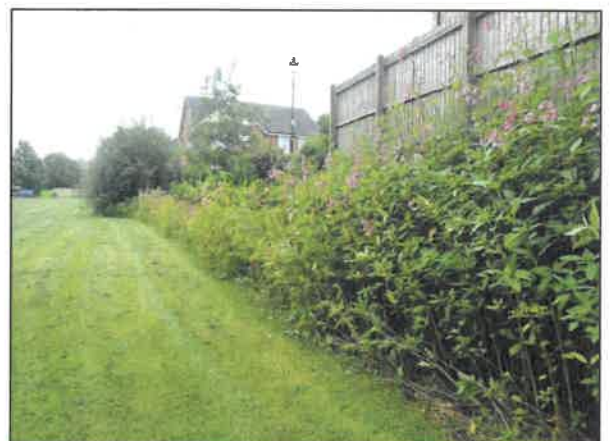
Photograph 4: Embankment on the western boundary of the northern parcel containing suspected Himalayan Balsam.

Extensive areas of suspected Himalayan Balsam were identified during Coopers site description, as referenced in Section 5, approximate areas of which are recorded on Coopers Site Plan, Drawing No. 7583/01 in Appendix 13. Surveys by qualified specialists are recommended to identify if any significant plant species are present where treatment would be required.

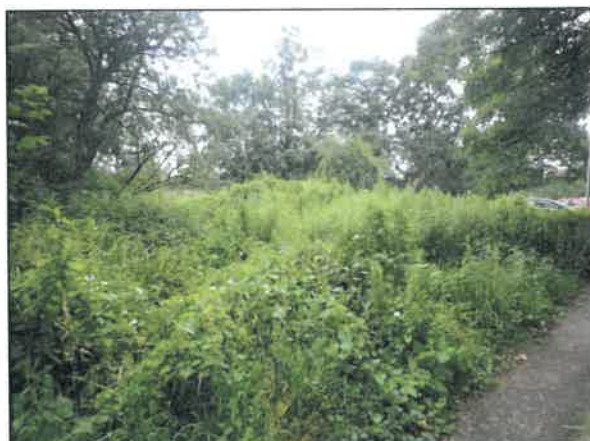
The southern part of the northern parcel contained an area of dense vegetation and trees (refer to Photograph 5) with further extensive growths of suspected Himalayan Balsam.

Photograph 5: Area of dense vegetation and trees in the southern part of the northern parcel.

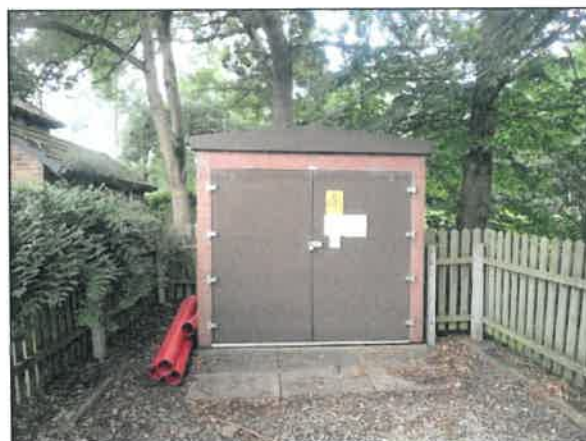
Photograph 6: Electrical substation to the immediate south of the northern parcel.

The land adjacent to the northern parcel consisted of Milton Road to the east, an electrical substation (refer to Photograph 6) and houses fronting Pendle Drive to the south, an area of mature woodland and residential houses to the west, and woodland within a disused railway cutting to the north. The railway cutting was densely vegetated, with areas of toppled trees, although no detailed inspection of the slope was possible to determine evidence of slope instability. The railway cutting had been infilled under the bridge beneath Milton Road close to the north eastern corner of the site (refer to Photograph 7). The bridge contained a memorial plaque to the former hospital and the use during WWI for treatment of soldiers (refer to Photograph 8)

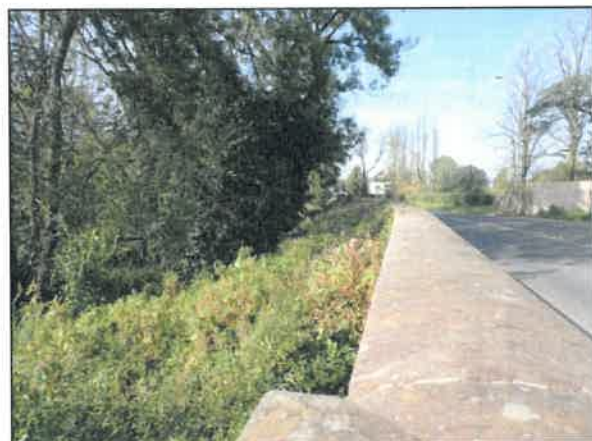
Photograph 7: Infilled bridge beneath Milton Road of the former railway cutting.

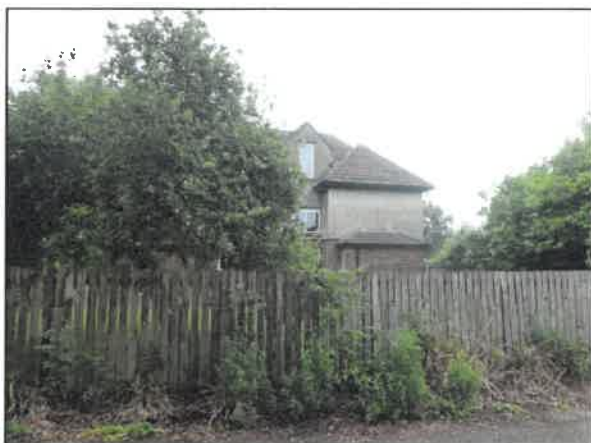
The southern parcel consisted of entirely residential housing fronting Milton Road to the east and associated front and rear gardens. The housing within the central and northern areas comprised 3 No. blocks of two storey mews houses (4-6 houses to each block) of similar construction/age to the northern parcel. The southern area contained two detached houses (refer to Photograph 9) of similar age and construction as the mews buildings and larger garden areas.

Photograph 9: Detached residential house in the southern part of the southern parcel.

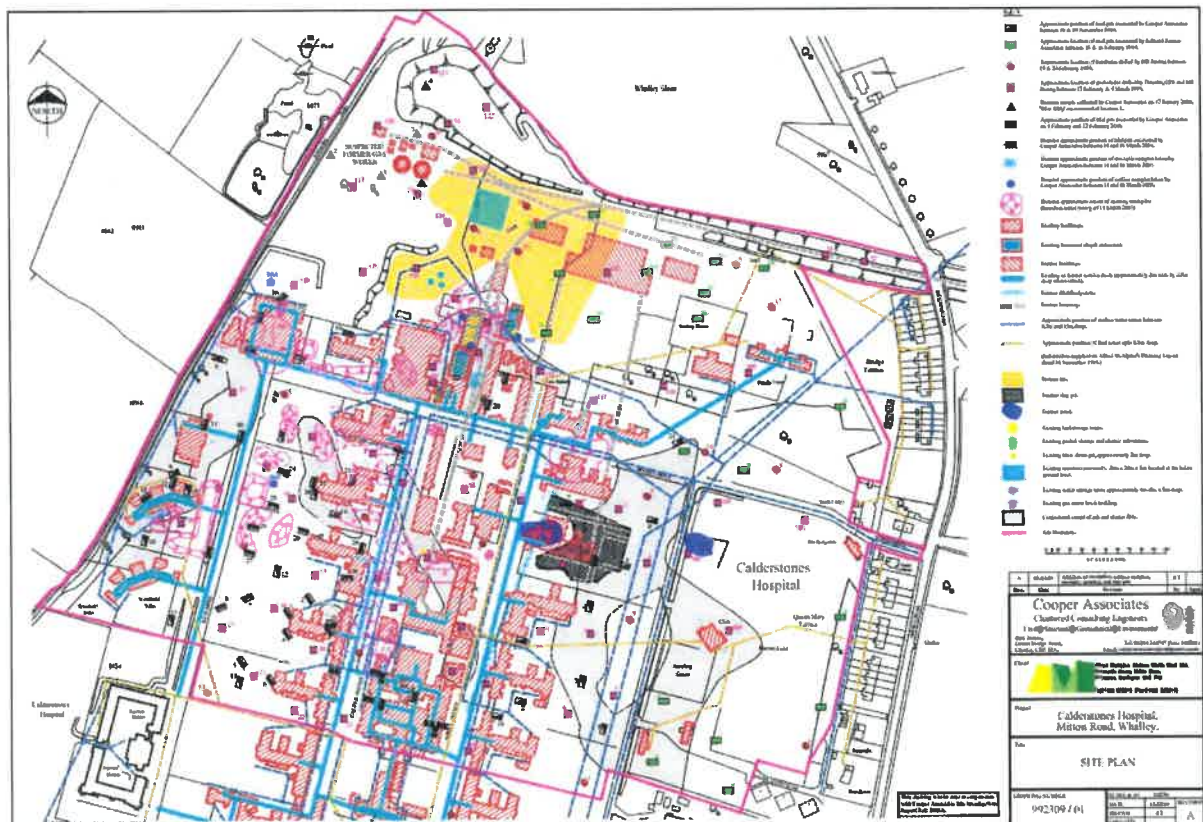
Figure 4: Former Calderstones Hospital site investigation plan by Coopers (then Cooper Associates), recorded features and exploratory holes to the west of the site..

Cooper Associates (former trading name of Coopers) investigated the land to the east of the site from 1999-2006 on behalf of various residential developers as part of the Calderstones Hospital redevelopment (project number 2309 – refer to Figures 3 and 4). Information and records relating to the ground conditions close to the boundary of the site or in relation to source/pathway models have been included in relevant sections of this report.

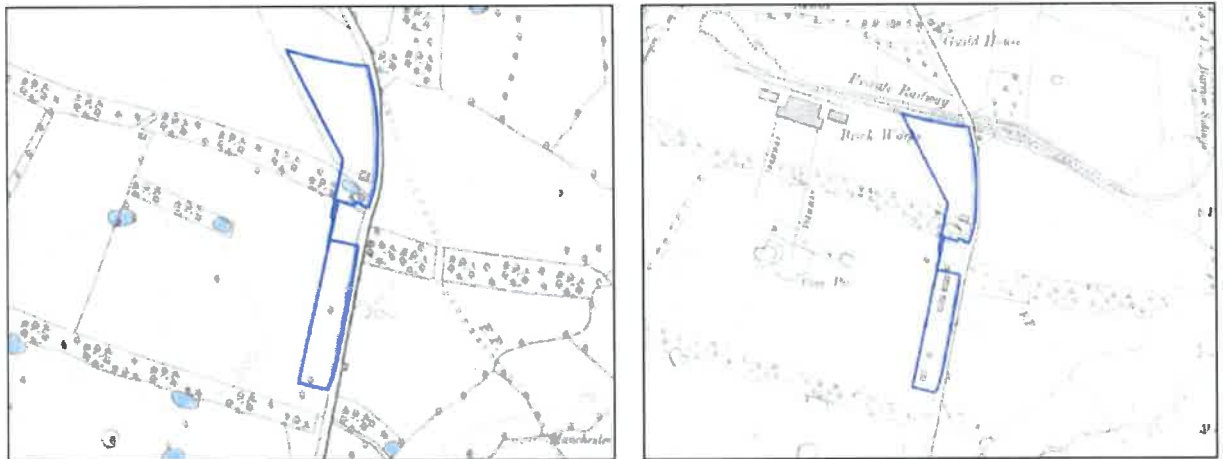
1846-1892: The site consisted of agricultural land with a section of woodland in the south of the northern parcel (refer to Figure 6). To the east of the site was Mitton Road, by 1892 the higher resolution maps indicate the presence of 2 No. former ponds within the woodland in the southern part of the northern parcel, with a small building, likely to be a farm house, situated close to the ponds.

Figures 6 and 7: 1892 (left) and 1912(right) Ordnance Survey Map with approximate site boundary

1910-1912: The 1910 map edition records residential housing in the southern part of the site. Adjacent to the northern boundary of the northern parcel was a railway cutting, referenced as "private railway" running under Mitton Road, and connecting to a large brickworks, situated approximately 90m to the west of the site (refer to Figure 7). The brickworks contained referenced tramways connecting to a clay pit, approximately 200m to the east of the site. A large zone of spoil heap was recorded at the end of the private railway line, 250m to the west of the site.

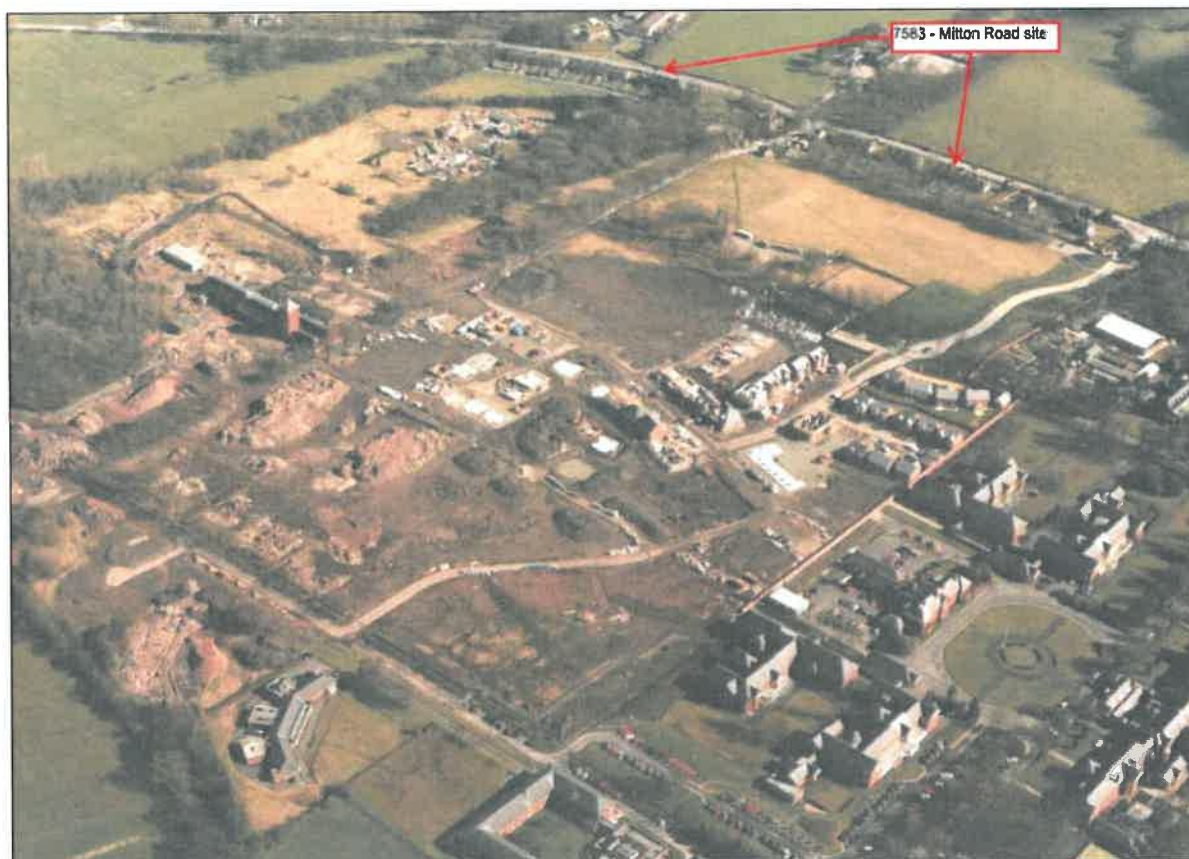
Figure 9: Annotated oblique view aerial photograph from 2001 provided as part of Coopers ground investigation of the adjacent Calderstones Hospital site.

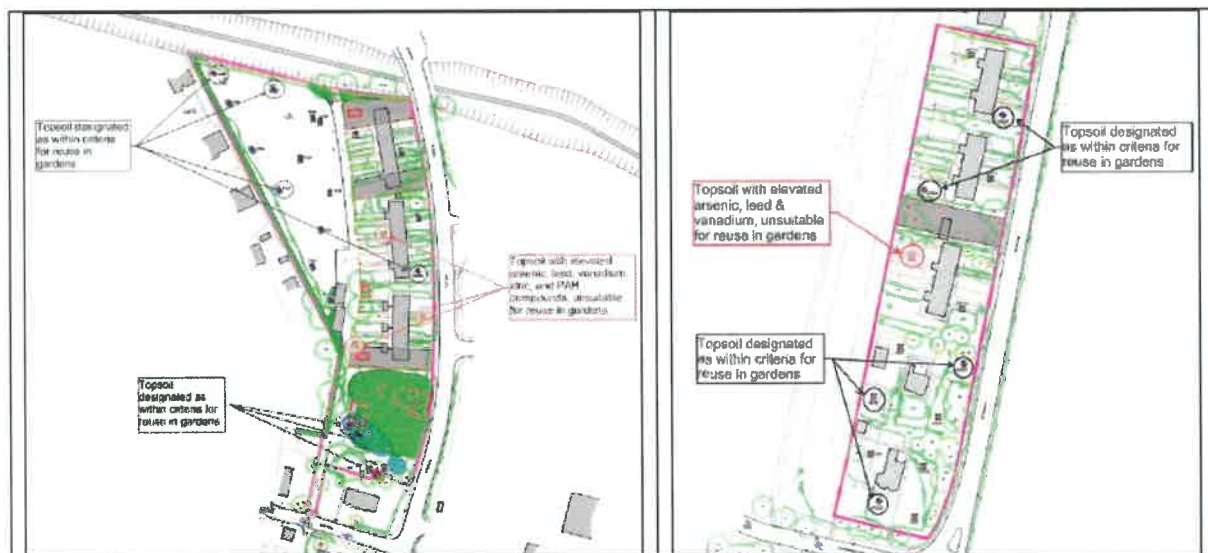
Figures 10 and 11: Showing areas where topsoil was identified to contain elevated concentrations of inorganic and PAH compounds within northern parcel (left) and southern parcel (right). NTS.

As detailed in Section 16.3 the topsoil within 4 No. of the 8 No. samples taken from the terraced/mews gardens identified elevated concentrations of inorganic and PAH contaminants. These were sporadic across the gardens and therefore considered likely to relate to activities of the individual residents rather than in relation to the soils originally placed in the residential gardens prior to construction of the houses. An indicative plan showing the locations of topsoil testing across the site is shown in Figures 10 and 11 below.

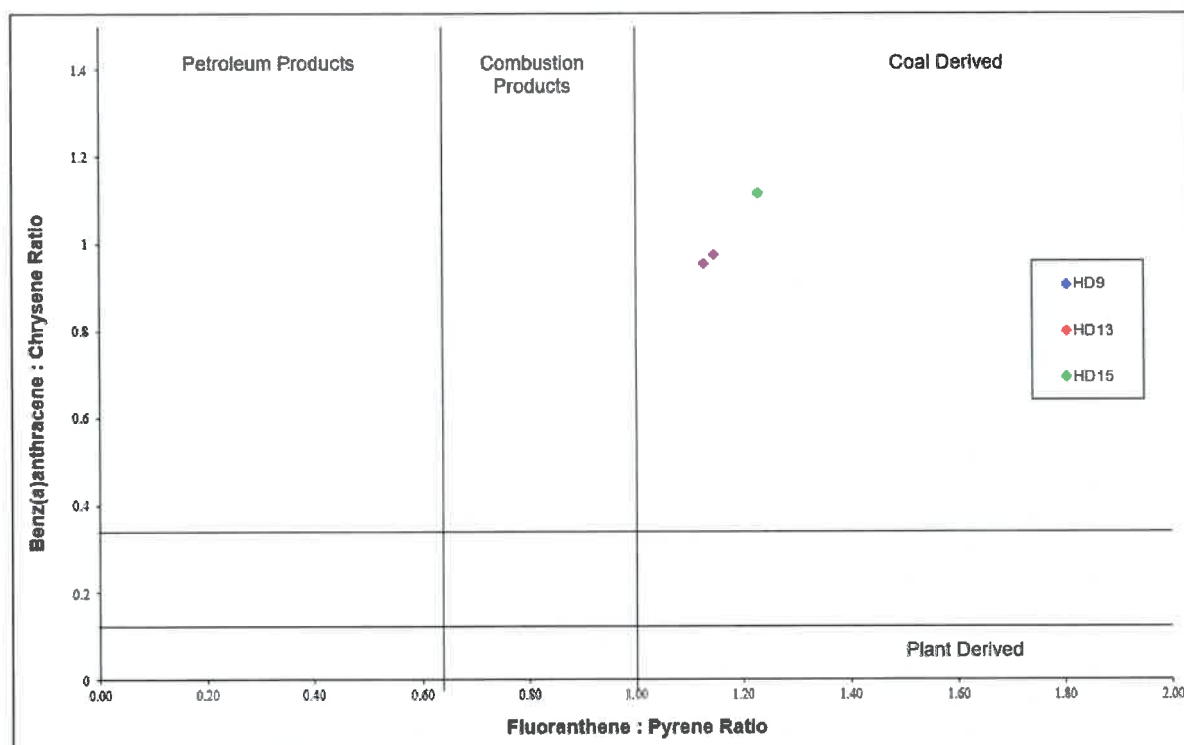
Figure 12: Source Signature Double Ratio Plot of forensic PAH assessments.

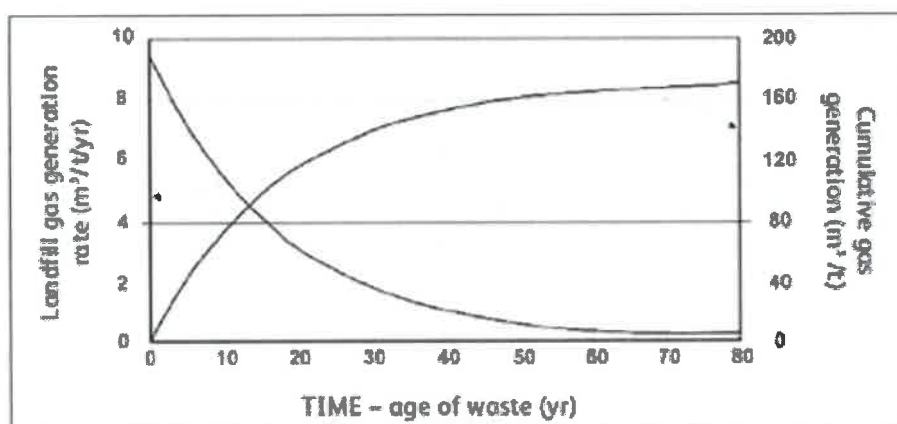
Figure 16: Typical landfill gas generation by time, from CIEH (2007)

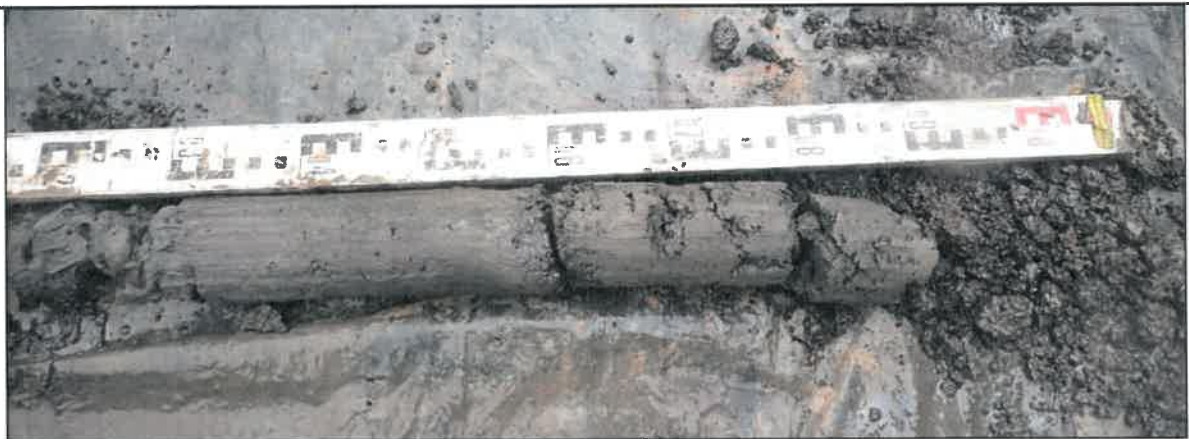
Photograph 10: Showing nature of pond infill materials within borehole WS04.

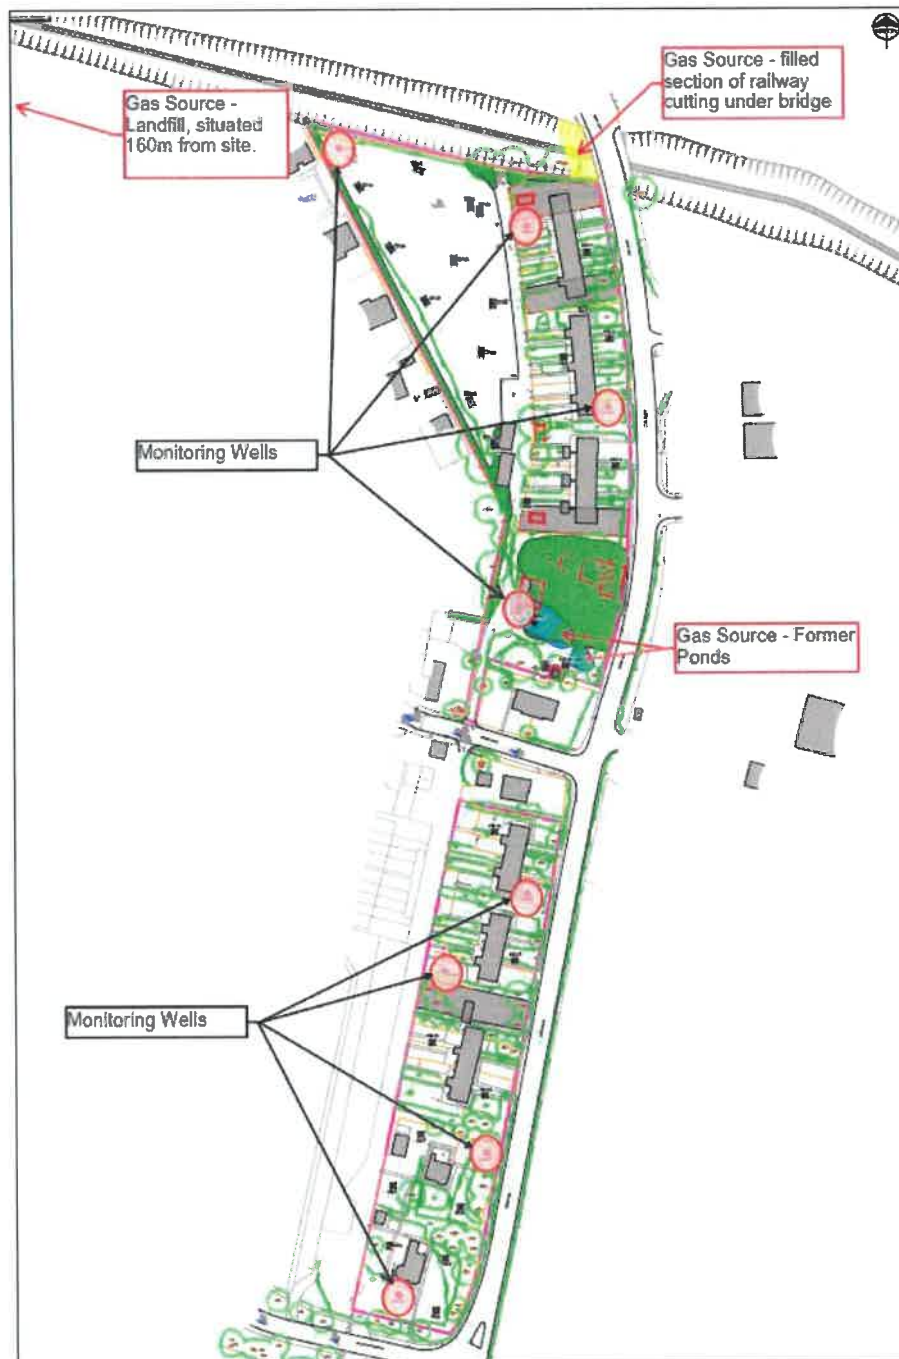
Figure 21: Showing gas monitoring positions in relation to the source location of hazardous ground gas.

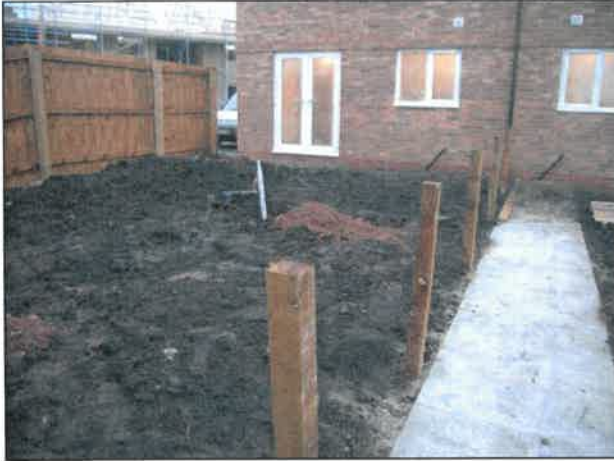
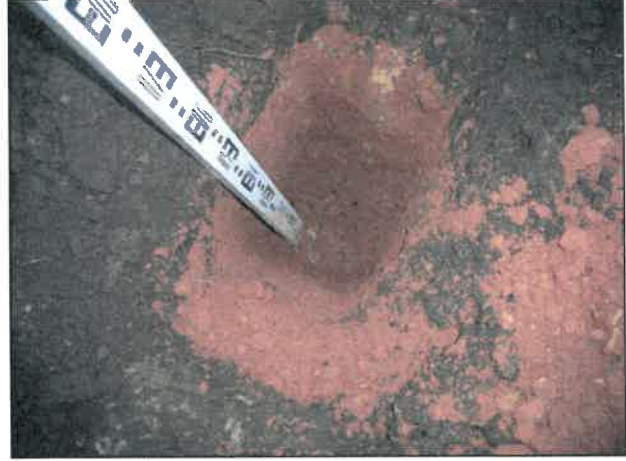
Photographs 11 & 12: Examples of validation photographs demonstrating validation hole location and soils forming inert cover

- Photographic evidence to demonstrate the location of the validation hole, the nature of the inert material and the depth of cover (refer to Photographs 11 to 14).

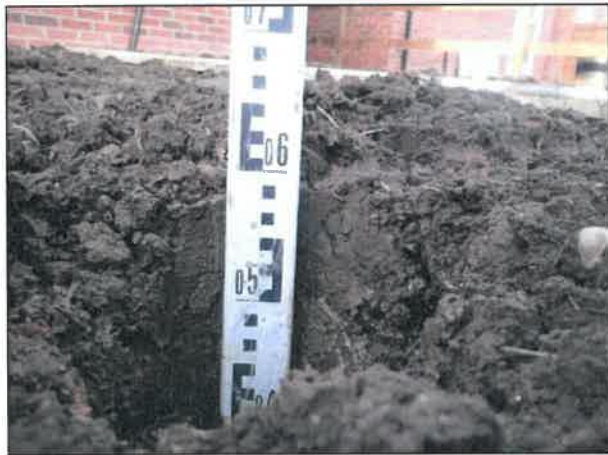
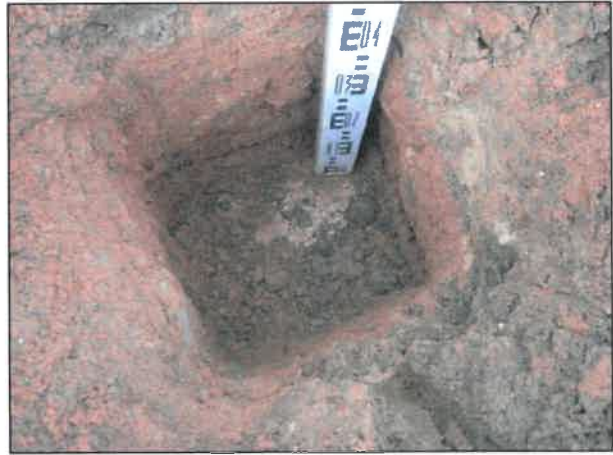
Photographs 13 & 14: Examples of validation photographs demonstrating inert cover depth and geotextile

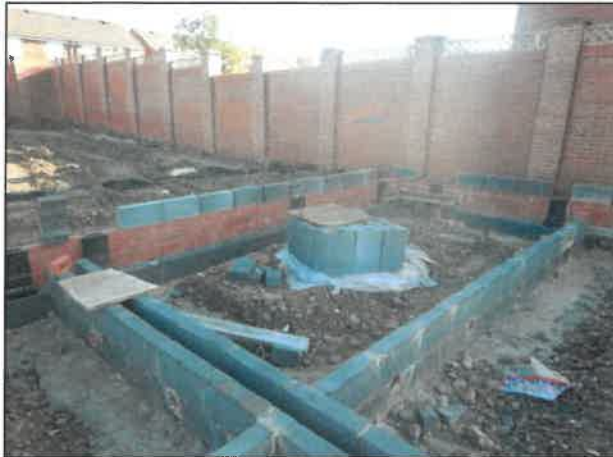
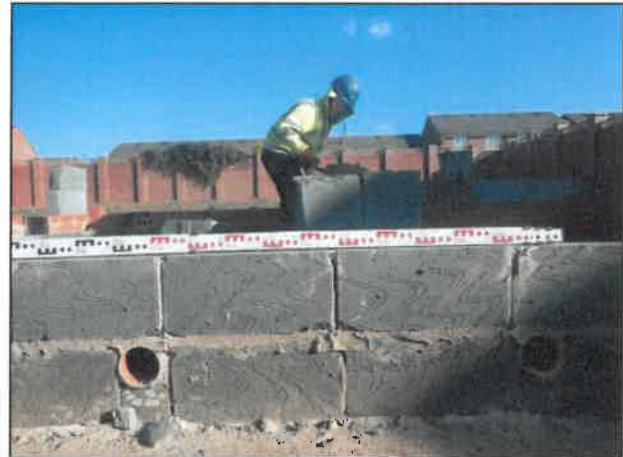
Photographs 15 and 16: Confirm presence of internal venting pipes, diameter and spacing. The typical spacing is 1 No. 75mm diameter pipe every 1m. This can change depending upon the pipe diameter, and the presence of spaces below the blocks and between the beams (dependant upon site specific construction variations) or changes by . This may not be able to be directly observed on each plot, depending upon the site specific design of gas protection measures. If not recorded then observation of other plots under construction, or requesting photographs to be taken by construction management can be deemed appropriate depending upon confidence in the construction as site progresses

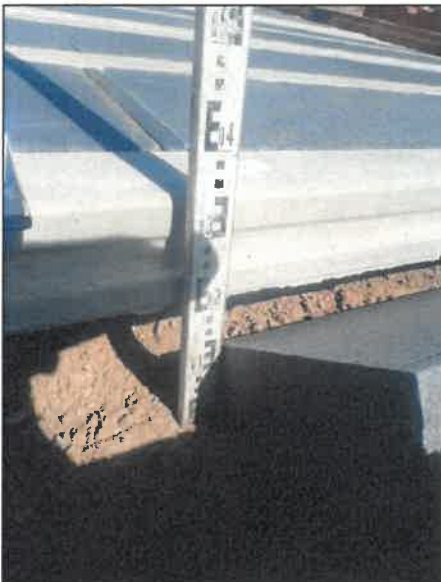
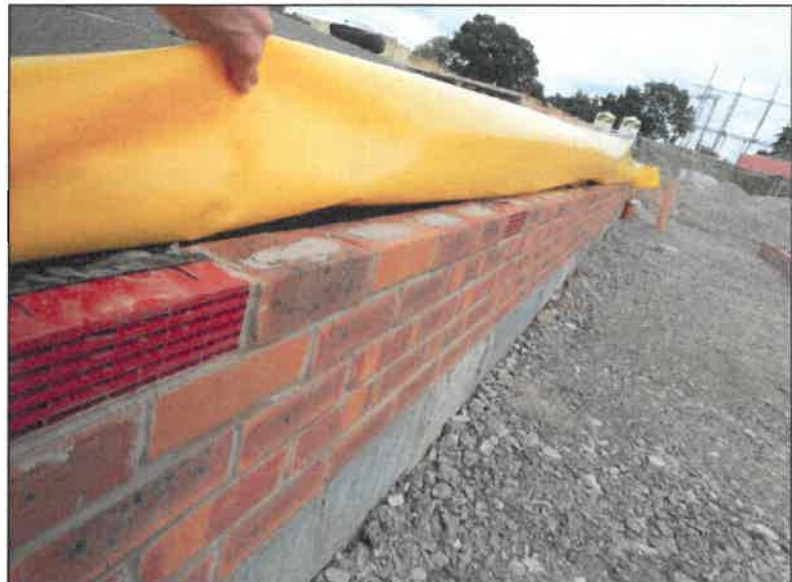
Photographs 17 and 18: Verify presence of cranked vents along the external walls and sufficient spacing. Areas of access points to internal garages or external adjoining garages may not be possible to have cranked venting and alternative construction options should be discussed where necessary. Plots with stone venting to include photographs demonstrating the cranked vents are aligned with the stone

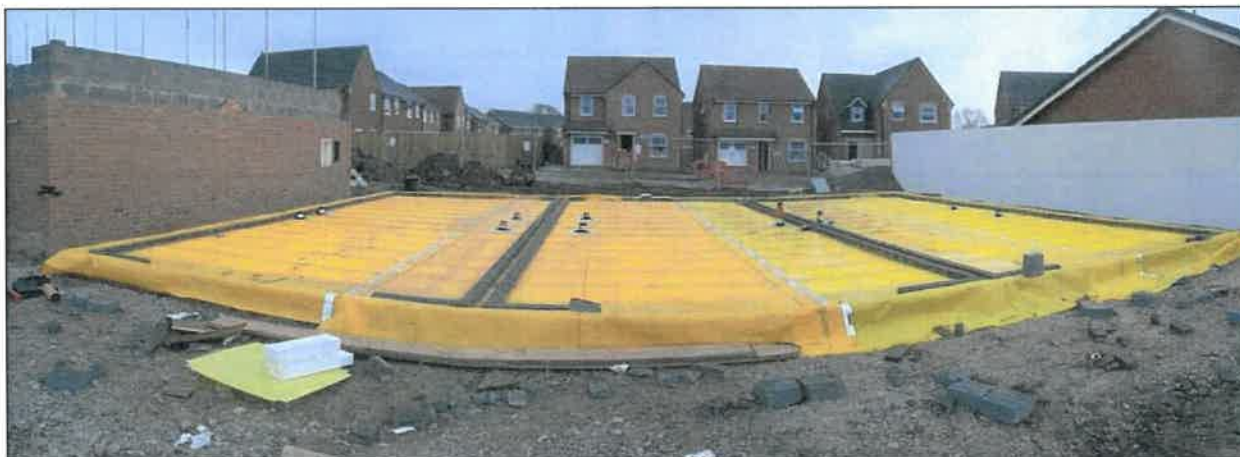
Photograph 19: Check general condition of membrane for punctures/tears etc – take panoramic photograph showing general condition

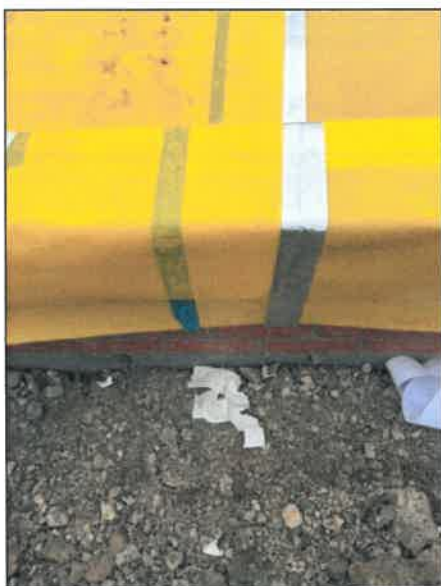
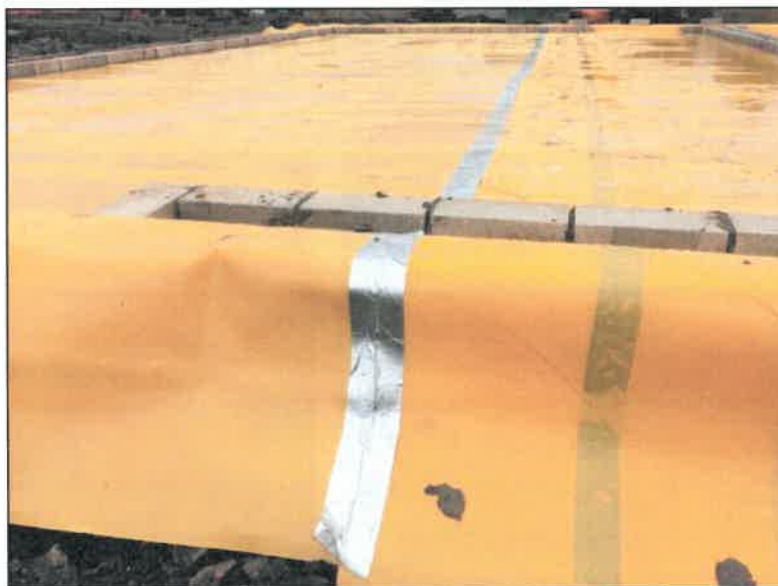
Photographs 20 and 21: Check >150mm overlaps of membranes and proprietary tapes placed and sealed with photographs taken

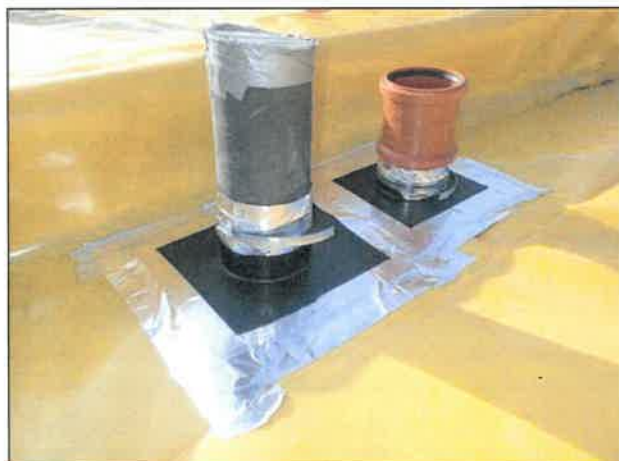
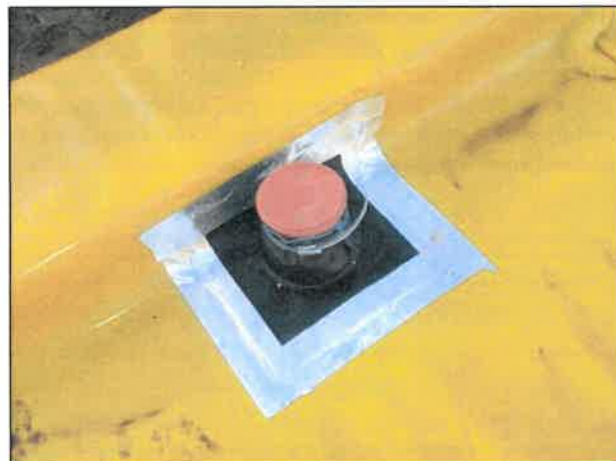
Photographs 22 and 23: Check tophat is sealed to membrane and pipework with tapes, and Jubilee clip

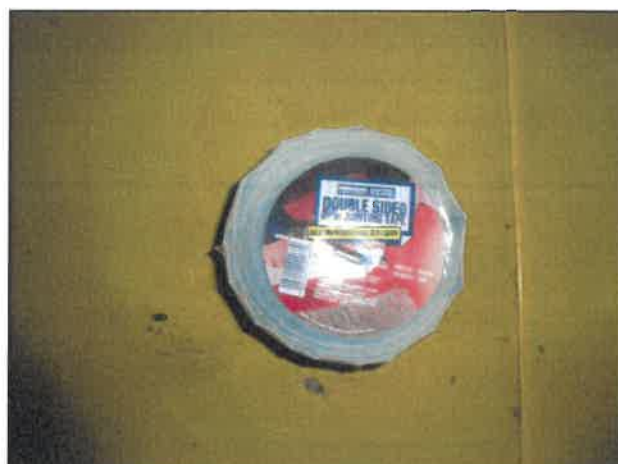
Photographs 24 and 25: If new delivery of product types is present and copies of supply tickets are not available then inspect product labels to confirm manufacturers and product types

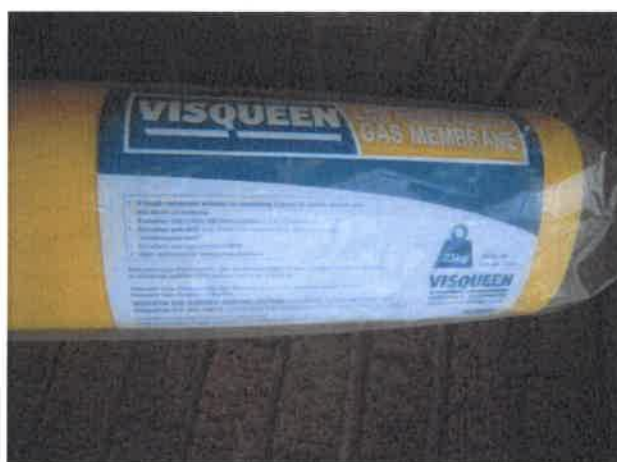
Photograph 26: If no product labels are present then inspect stores for product types

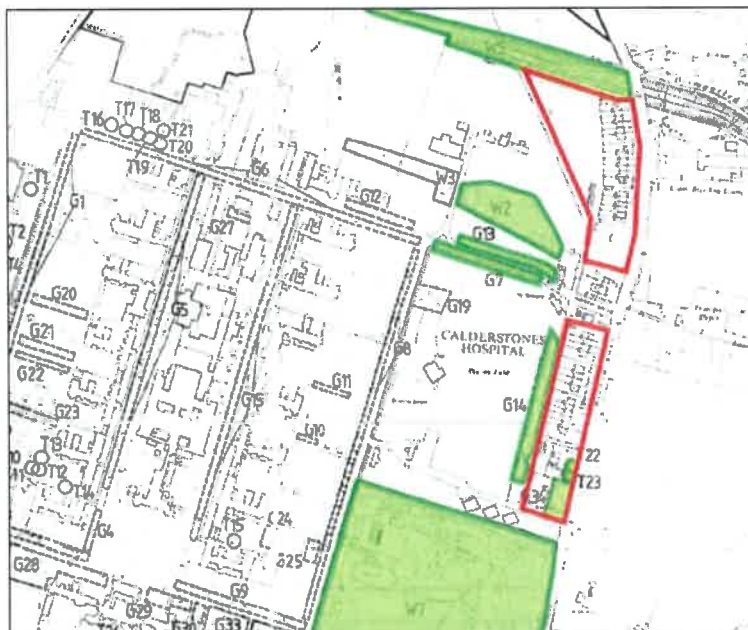
Previously supplied TPO plans for adjacent developments indicate the presence of a group TPO and two individual TPOs for trees in the south of the site, a copy of which is contained in Appendix 1. Other group TPOs were in the vicinity of the site, with annotate extract shown in Figure 30 (below). It is therefore advisable for arboricultural consultants to undertake consultation with the local authority regarding any TPOs on or close to the site and agree all proposals for tree felling with the local authority prior to felling.

Figure 30: Showing highlighted groups and individual trees covered by Tree Preservation Orders in relation to approximate site boundary.

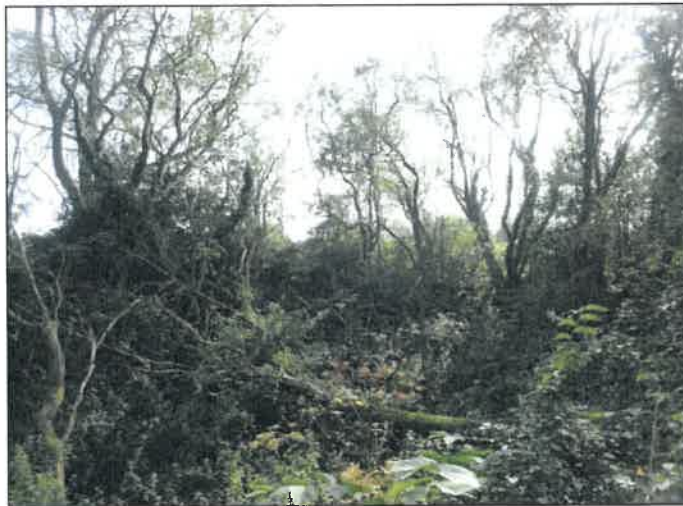
Photograph 27: Toppled trees and dense vegetation within former railway cutting to the north of the northern site boundary.

To the north of the northern parcel is a former railway cutting partially filled within a tunnel beneath Mitton Road. No topographic survey has been undertaken along this slope and beyond the site boundary. Coopers undertook a walkover along the former cutting, with no clear evidence of failures, although individual toppled trees were present and the dense vegetation limited detailed inspections (refer to Photograph 27).

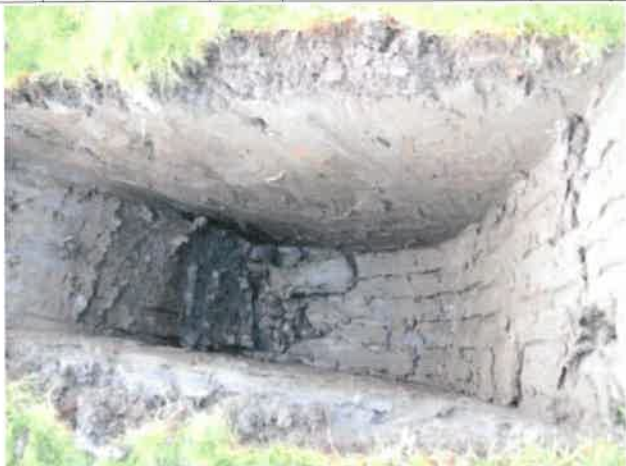
Location CAT scanned prior to excavation.
 Sides stable during excavation.
 No groundwater encountered during excavation.
 Please note that discolouration of photographs may occur when viewed on screen as a PDF, or when printed as a hard copy.
 Trial pit backfilled with arisings upon completion.

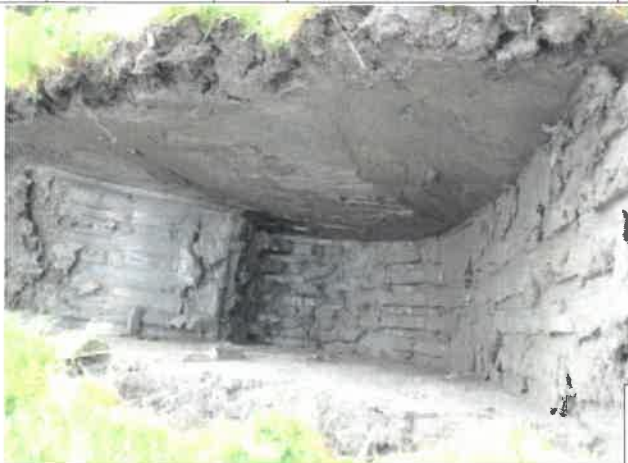
Location CAT scanned prior to excavation.
Sides stable during excavation.
Minor seepage at 1.00m on east side of trial pit during excavation.
Please note that discolouration of photographs may occur when viewed on
screen as a PDF, or when printed as a hard copy.
Trial pit backfilled with arisings upon completion.

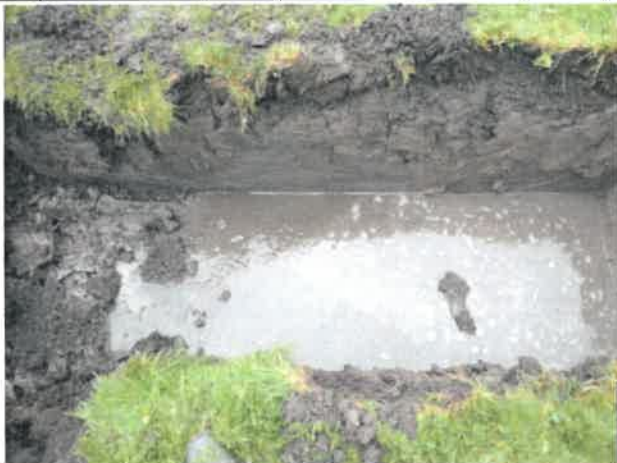
Location CAT scanned prior to excavation.
 Sides stable during excavation.
 Rapid ingress from culvert at 0.70m during excavation.
 Please note that discolouration of photographs may occur when viewed on
 screen as a PDF, or when printed as a hard copy.
 Trial pit backfilled with arisings upon completion due to ingress from culvert.

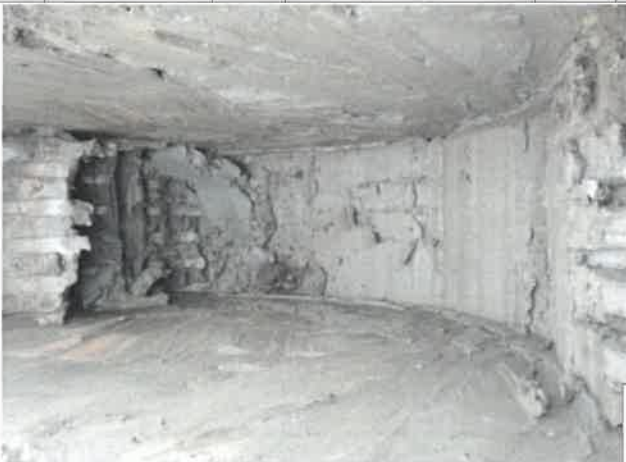
Location CAT scanned prior to excavation.
 Sides stable during excavation.
 Seepage at 1.60m on north side of trial pit during excavation.
 Please note that discolouration of photographs may occur when viewed on screen as a PDF, or when printed as a hard copy.
 Trial pit backfilled with arisings upon completion.

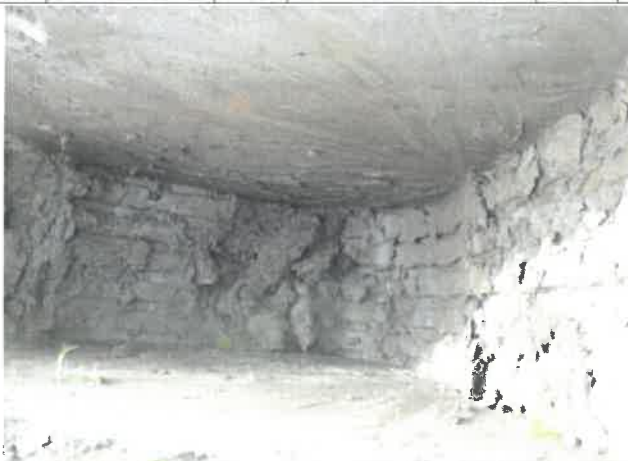
Depth (m)	Sample / Tests	Water Depth (m)	Field Records	Level (mOD)	Depth (m) (Thickness)	Description	Legend	Water
0.10	B				(0.20)	Turf over dark brown, silty, clayey TOPSOIL.		
0.30	SV 140kPa				0.20	Stiff, high strength, grey mottled brown, silty, gravelly CLAY. Gravel is fine to coarse, sub-angular to sub-rounded of natural stone.		
0.50	B							
0.60	SV 140kPa							
0.90	SV 148kPa							
1.30	SV 156kPa							
1.50	B				(2.80)			
1.80	SV 140kPa					Below 1.80m: Grey, slightly silty		
2.00	B							
2.30	SV 152kPa							
2.50	SV 152kPa					At 2.50m: 1 No. small boulder measuring 1.00 x 0.50 x 0.60m		
2.80	SV 140kPa							
2.90	B				3.00	Complete at 3.00m

Location CAT scanned prior to excavation.
 Sides stable during excavation.
 No groundwater encountered during excavation
 Please note that discolouration of photographs may occur when viewed on screen as a PDF, or when printed as a hard copy.
 Trial pit backfilled with arisings upon completion.

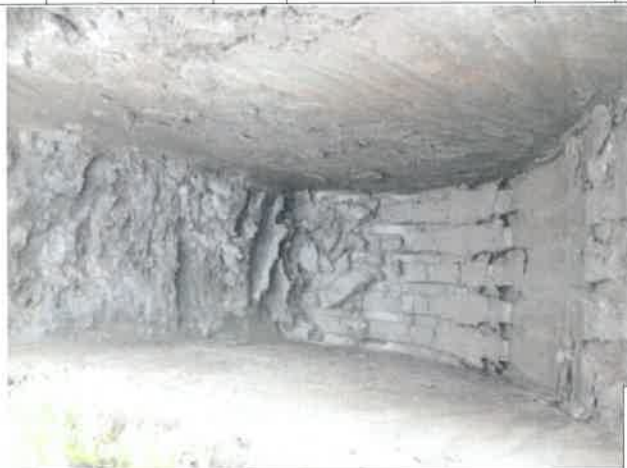
0.40	B							
0.60	SV 100kPa							
			Minor seepage on south side(1) at 0.80m.					
1.10	SV 132kPa							
1.40	SV 132kPa							
1.40	B				(2.65)			
1.80	SV 136kPa							
						Below 2.10m: Lenses of silt		
2.40	B							
2.70	SV 128kPa				2.90			
						Complete at 2.90m

Location CAT scanned prior to excavation.
 Sides stable during excavation.
 Minor seepage at 0.80m on south side of trial pit.
 Please note that discolouration of photographs may occur when viewed on
 screen as a PDF, or when printed as a hard copy.
 Trial pit backfilled with arisings upon completion.

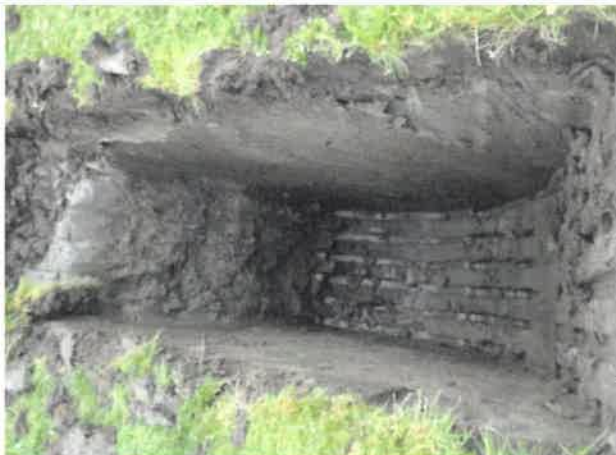
2.85	Complete at 2.85m

Location CAT scanned prior to excavation.
 Sides stable during excavation.
 Minor seepage at 0.80m on south side of trial pit.
 Please note that discolouration of photographs may occur when viewed on screen as a PDF, or when printed as a hard copy.
 Trial pit backfilled with arisings upon completion.

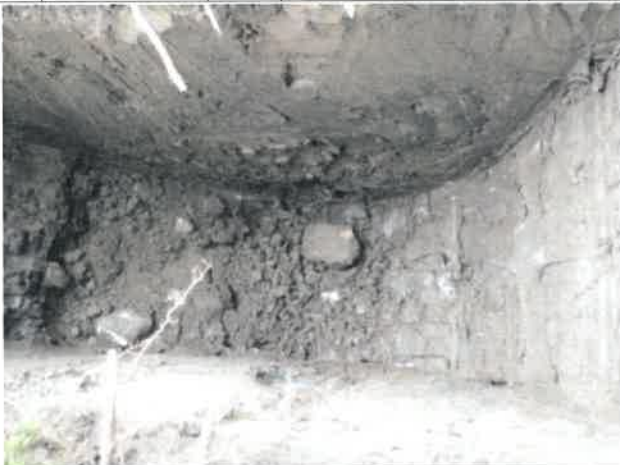
2.60	B				2.65	Complete at 2.65m

Location CAT scanned prior to excavation.
 Sides stable during excavation.
 No groundwater encountered during excavation.
 Below 2.00m clay friable and no shear vane readings taken.
 Please note that discolouration of photographs may occur when viewed on screen as a PDF, or when printed as a hard copy.
 Trial pit backfilled with arisings upon completion.

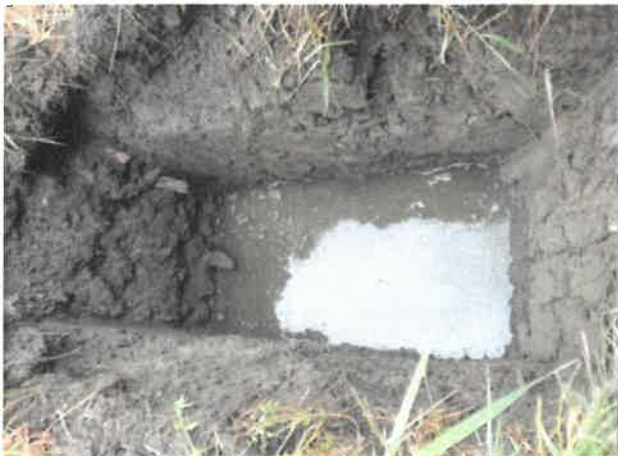
2.10 2.10	SV 20kPa JV		Strong ingress on all sides(1) at 2.00m.		2.00	Soft, low strength, grey, very silty CLAY.

(0.90)				
2.60	SV 20kPa				2.90	Complete at 2.90m

Location CAT scanned prior to excavation.
 Minor spalling between 1.50-2.50m during excavation.
 Strong ingress at 2.00m on all sides of trial pit during excavation. Ground water level remained at 2.00m at time of backfill.
 *Based upon trenchside stability characteristics.
 Please note that discolouration of photographs may occur when viewed on screen as a PDF, or when printed as a hard copy.
 Trial pit backfilled with arisings upon completion.

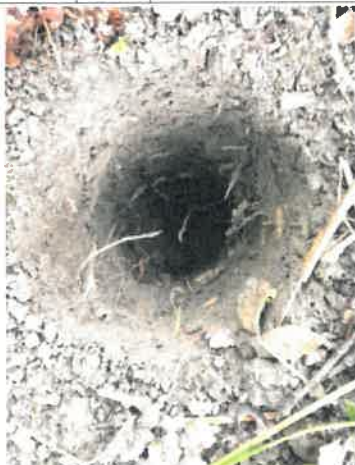
Sides stable during dig.
 No groundwater encountered during dig.
 Hand dug pit next to sub station for PCB testing.
 Please note that discolouration of photographs may occur when viewed on screen as a PDF, or when printed as a hard copy.
