Site Investigation Report

for land at

Mitton Road, Whalley

22 October 2020

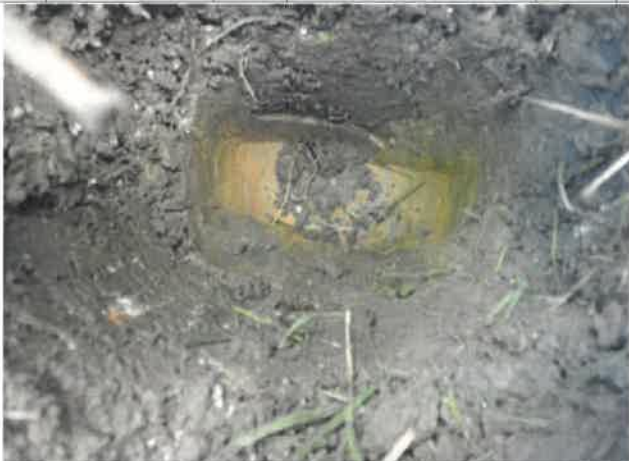
Trial Pit
 Number
HD06

Machine : Manual Excavation Method : Hand Dug		Dimensions 0.30 x 0.45 x 0.30m		Ground Level (mOD)		Client Prospect Homes Ltd		Job Number 7583	
		Location (Observed measurements)		Dates 28/08/2020		Engineer Coopers (Chester) Ltd		Sheet 1/1	
Depth (m)	Sample / Tests	Water Depth (m)	Field Records	Level (mOD)	Depth (m) (Thickness)	Description		Legend	Water
0.20 0.40	JV JV					Dark brown, silty, clayey TOPSOIL.		 	
					0.30 (0.15)	Firm to stiff, light brown mottled grey, silty CLAY.			
					0.45	Complete at 0.45m

Sides stable during dig.
 No groundwater encountered during dig.
 Backfilled with arisings upon completion.
 Please note that discolouration of photographs may occur when viewed on screen as a PDF, or when printed as a hard copy.

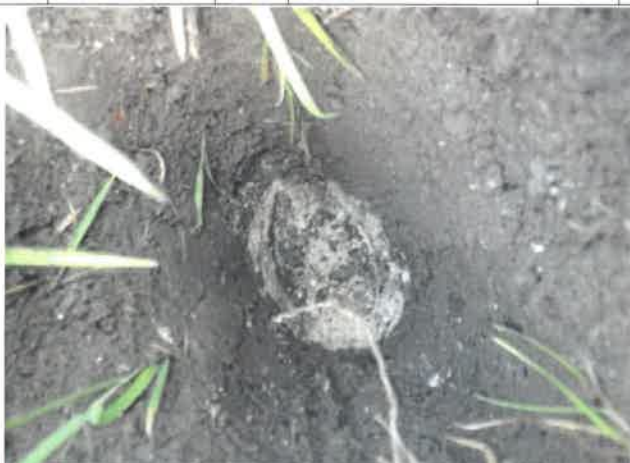
Depth (m)	Sample / Tests	Water Depth (m)	Field Records	Level (mOD)	Depth (m) (Thickness)	Description	Legend	Water
0.20	JV				(0.30)	MADEGROUND (similar to topsoil). Dark brown, clayey, fine to coarse SAND with some roots.		
0.35	JV				0.30 (0.15) 0.45	MADEGROUND. Light brown, fine to coarse SAND with 1 No. quarter fragment of brick.		
						Complete at 0.45m

Sides stable during dig.
 No groundwater encountered during dig.
 Please note that discolouration of photographs may occur when viewed on screen as a PDF, or when printed as a hard copy.
 Backfilled with arisings upon completion.

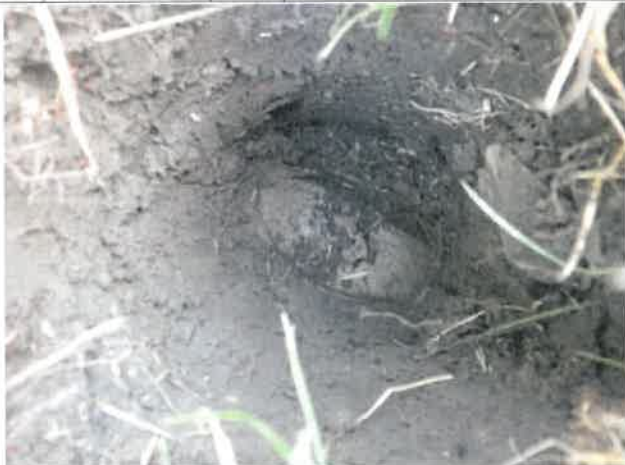
Depth (m)	Sample / Tests	Water Depth (m)	Field Records	Level (mOD)	Depth (m) (Thickness)	Description	Legend	Water
0.10	JV				(0.25)	MADEGROUND (similar to topsoil). Dark brown, sandy CLAY with some roots and small fragments of brick 5cm x 4cm.		
0.30	JV				0.25 (0.18) 0.43	MADEGROUND. Firm, brown/grey, silty CLAY with pieces of plastic and glass. Complete at 0.43m

Sides stable during dig.
No groundwater encountered during dig.
Please note that discolouration of photographs may occur when viewed on screen as a PDF, or when printed as a hard copy.
Backfilled with arisings upon completion.

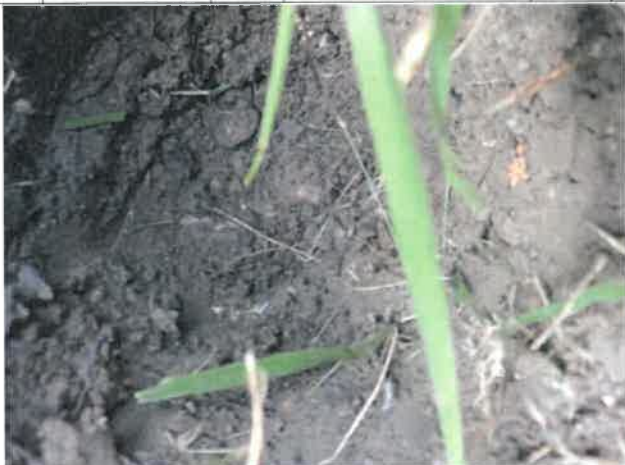
Depth (m)	Sample / Tests	Water Depth (m)	Field Records	Level (mOD)	Depth (m) (Thickness)	Description	Legend	Water
0.15	JV				(0.20)	MADEGROUND. Brown, silty, sandy TOPSOIL with some fine roots.		
0.25	JV				0.20 (0.15) 0.35	MADEGROUND. Firm, brown/grey, silty, gravelly CLAY. Gravel is fine to coarse, angular to sub-angular natural stone. At 0.30m: 1 No. half brick Complete at 0.35m

Sides stable during dig.
 No groundwater encountered during dig.
 Please note that discolouration of photographs may occur when viewed on screen as a PDF, or when printed as a hard copy.
 Backfilled with arisings upon completion.
