**BAT SURVEY AT -
SUNRIDGE
YORK LANE
LANGHO**

**DATE AND TIME OF VISIT
8th Dec 2020 10.00 pm**

REFERENCE NO. 6174

SUNDERLAND PEACOCK & ASSOCIATES LTD
HAZELMERE, PIMLICO ROAD, CLITHEROE

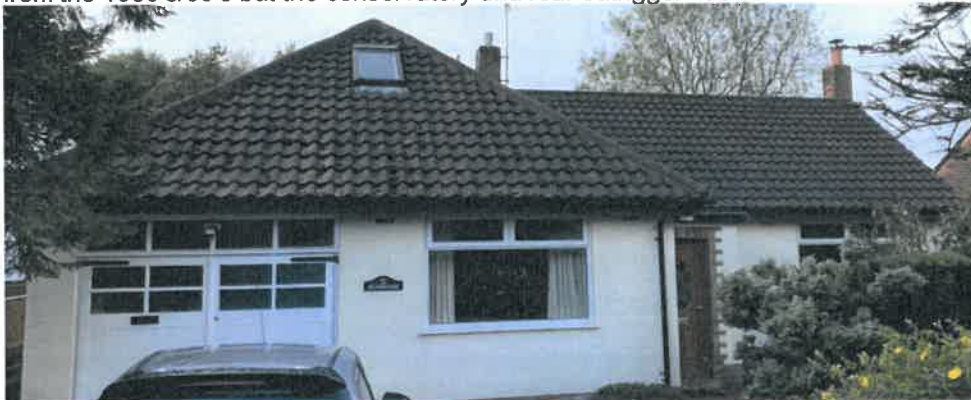
Front elevation

The property is a detached bungalow with a partially converted roof space. The house probably dates from the 1950's/60's but the conservatory and rear outrigger has been added at a later date.

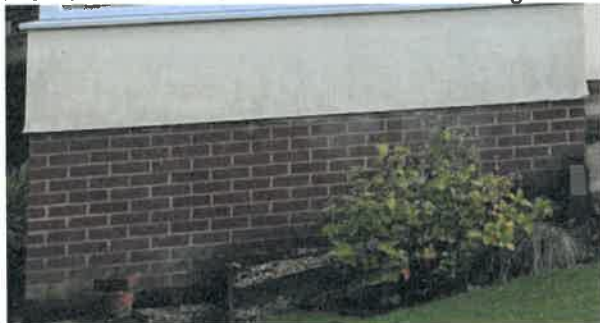
The walls are brick with a render finish at a higher level leaving an exposed brick plinth.

The walls are in good condition as is the pointing there are no access points or crevices suitable for bats.

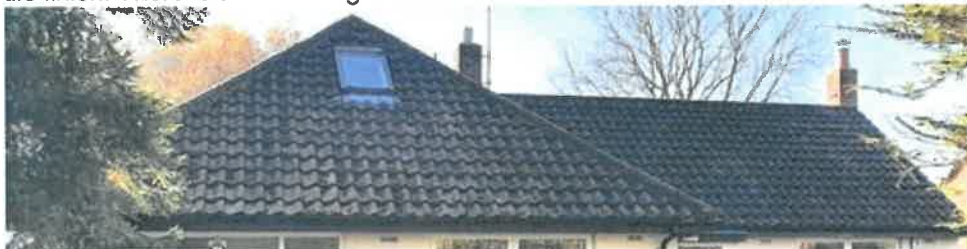
The roof is pitched with a hipped front outrigger and a gabled outrigger to the rear all with a profile tile finish. There is an overhang at the eaves with boarded soffits.

The front roof pitch with velux window.

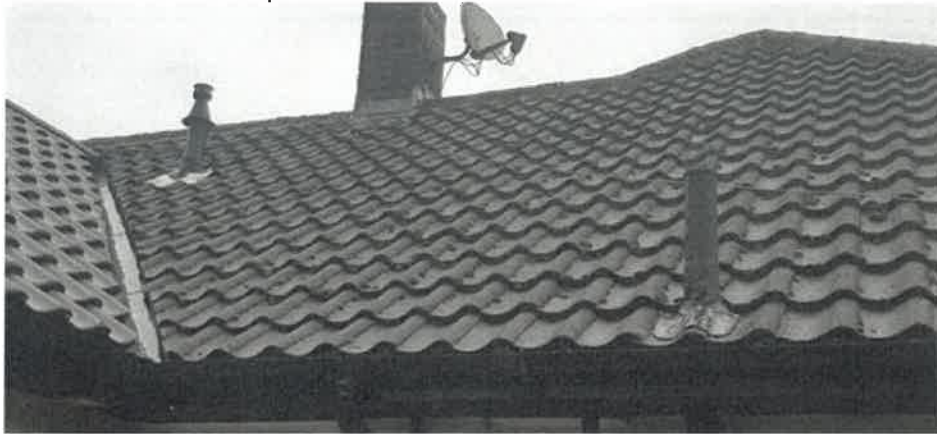
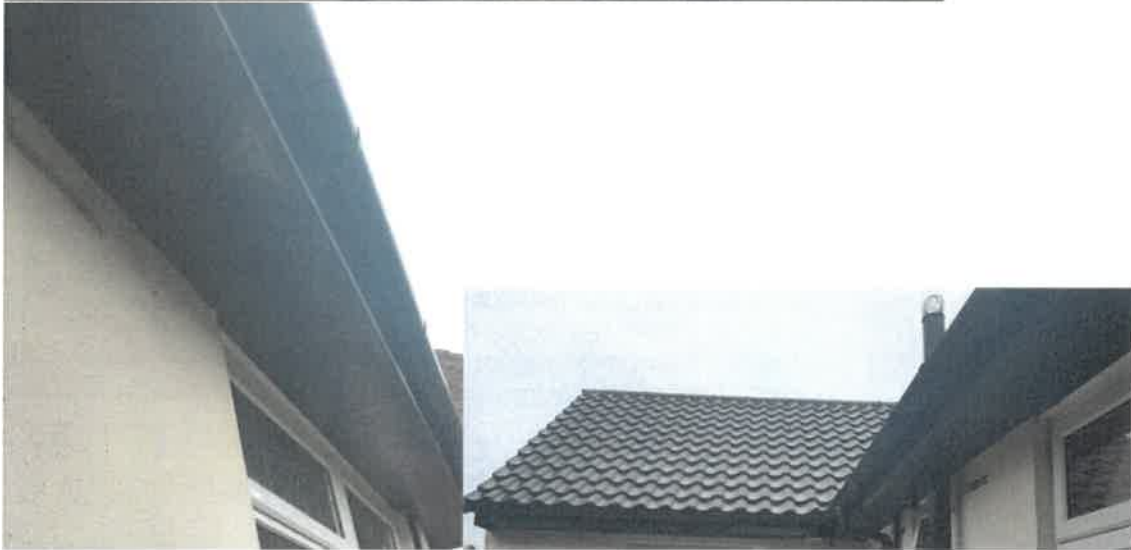
The roof tiles are in very good condition with no significant cracks or loose tiles. The ridge / hip tiles are well pointed.

The flashings are all tight fitting and the valley gutters are in good condition and do not form any gaps or access points.

The soffits are tight fitting and in good condition with no access points.

There were no access points into the roof structure.

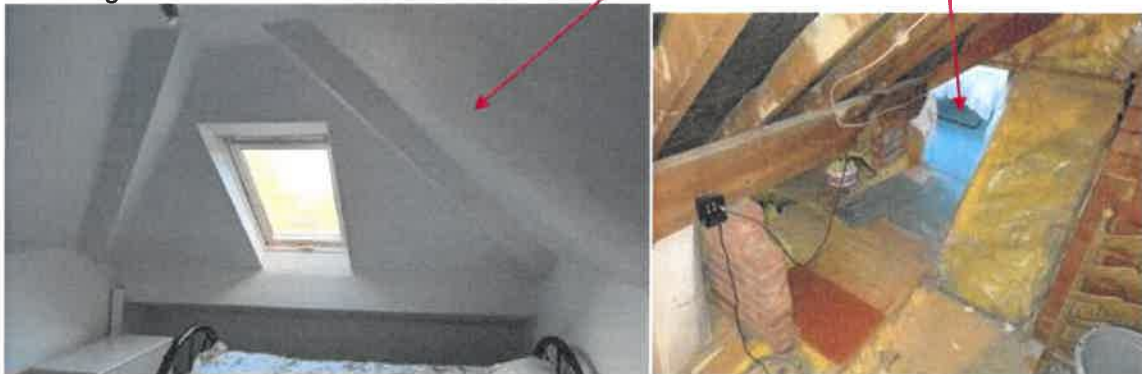
The roof space has been partially converted to form a room, there is an access hatch through to the remaining roof void.

The structure is rafters and felt over timber purlins. The timbers are in good condition, the felt is tented in some areas which enabled inspection between felt and tiles. there were no bats present nor any signs of any historic presence. The floor is mainly boarded the space is used for storage ,the outrigger sections are insulated with quilt both surfaces were examined for dropping or insect remains the result was negative. This space is considered low potential for roosting bats due to the lack of potential access points and no evidence of current hibernation was found.

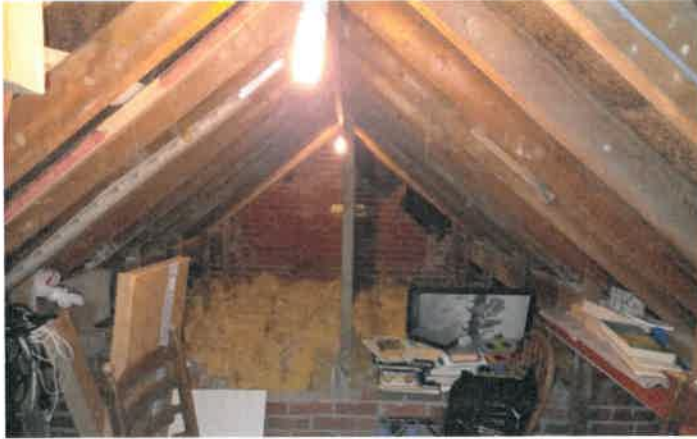
Roof void

The roof space was thoroughly examined for all the above listed signs. The quilt and the floor were inspected for dropping or feeding evidence, nothing was recorded.

The lack of evidence at this property indicates that the conversion of this roof space will not impact on any local bat population nor is it likely that any bats will be uncovered or disturbed during the tile removal. It is not considered necessary to carry out an emergence survey nor is there a requirement for a mitigation scheme.
