**Re: Proposed development at Treetops, Longsight Road, Clayton-le-Dale, BB1 9EX
(central grid reference: SD 67228 33741)**

Thank you for your request for a bat survey at the above site. I understand that the proposed development is for a rear single storey extension and a first-floor extension to the existing dwelling house.

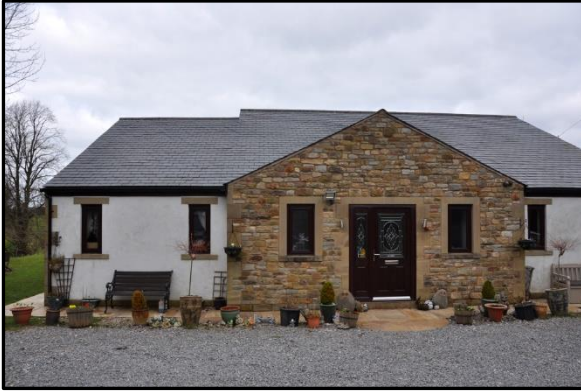
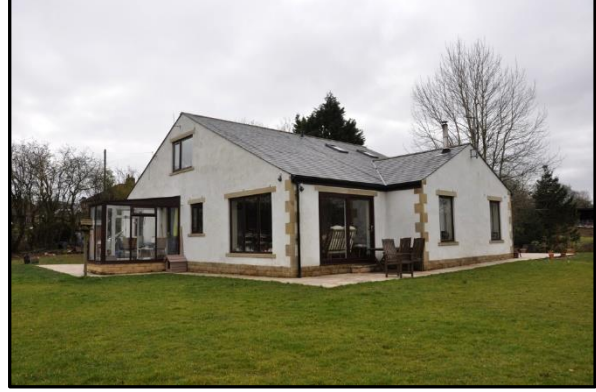
Treetops comprises an occupied, detached dwelling house constructed of stone and rendered walls with upvc windows and doors; all of these are sealed tight with no visible gaps. There is a multi-pitch slate roof with Velux windows, the ridge is sealed but there are occasional gaps present between the slates as a result of the natural fit of this material. Most of the roof edges are mortared and sealed, apart from one gable apex to the north and the roof corners to the west elevation. These features are open and are suitable for use by nesting birds. Bird boxes are also attached to the building to the north elevation.

View of Treetops front (south) elevation and rear (north) elevation

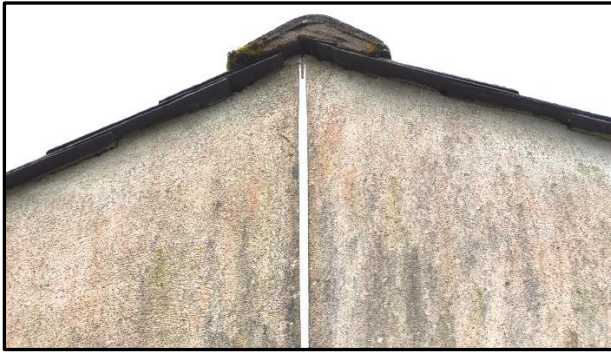
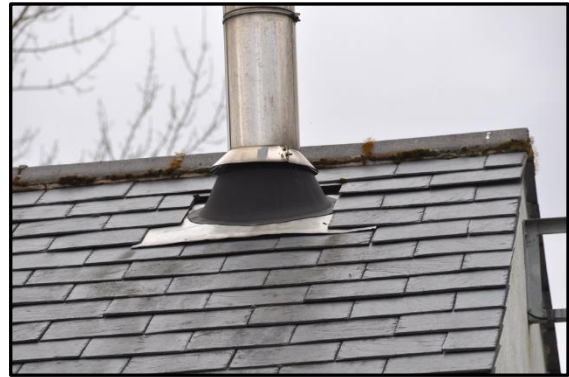
- Low potential – gaps associated with slate roof coverings

View showing sealed roof edges (lhs) and roof covering with occasional gaps present between slates (rhs)

Protected Species	Impacts /Predicted Impacts	Action Required
Bats	<p>It is advised that there is no evidence to suggest that bats pose a constraint to the proposed development.</p> <p>It is advised that there are potential roost features suitable for bats associated with timber soffits at the gable ends of the house and garage. In this location and landscape setting, these features have low potential for bats to use throughout the year.</p> <p>All bat species are afforded full protection under The Conservation of Habitats and Species (Amendment) (EU Exit) Regulations 2019</p>	<p>Advice (mitigation): As a precaution, a pre-commencement bat survey by a suitably qualified Ecologist should be carried out immediately prior to any proposed works (this could include supervising contractors during a roof strip). A pre-commencement survey will help avoid unlawful disturbance to bats and bat roosts before any development takes place- it is therefore specified to be used as a final precautionary approach once planning permission has been granted. Immediately prior to the development</p> <p>Advice (mitigation): All personnel involved in proposed development works should be carefully advised about bats by a professional Ecologist, so that all works are undertaken with a clear understanding about legal aspects, precautions to be adopted and what to do if a bat is found. Prior to development.</p> <p>Advice (mitigation): If bats are found at any time during the development, work must stop until advice has been sought from an appropriately experienced Ecologist. If the development will affect bats, a licence may be required and suitable mitigation put in place. At all times.</p> <p>Recommendation (mitigation and enhancement): Any new lighting associated with the proposed development should be designed to reduce light spill upwards to maintain the current lack of artificial lighting conditions within the area. This will help to avoid any impacts on bat activity, including foraging and commuting. During and post development.</p>

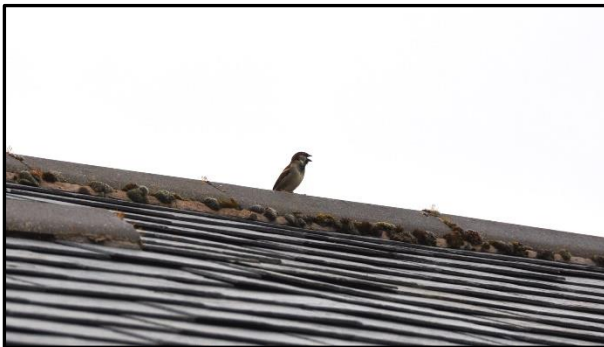
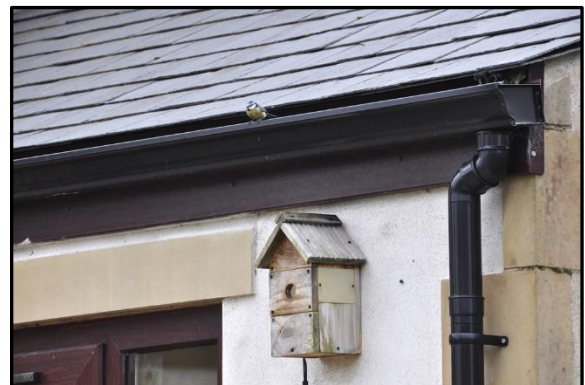
Prospecting house sparrows and blue were seen investigating roof edges and bird boxes during the surveys.

There is high potential for nesting birds to be present within gaps at the roof edges and bird boxes and garden vegetation during the nesting season (February to September).

House sparrow (lhs) and blue tit (rhs) observed prospecting for nest sites during the survey

Protected species	Impacts /Predicted Impacts	Action Required
Nesting birds	<p>It is advised that there is high potential for birds to be nesting within roof edges during the bird nesting season (February to September).</p> <p>Under the Wildlife and Countryside Act 1981 (as amended), wild birds are protected from being killed, injured or captured, while their nests and eggs are protected from being damaged, destroyed or taken.</p> <p>There is no provision under the Wildlife and Countryside Act 1981 (as amended) for licensing the disturbance of nesting birds or the destruction of nests which are in use for the purpose of development.</p> <p>If enforcement action were taken the developer would need to rely on the 'incidental result of an otherwise lawful operation' defence if it were not possible to avoid an offence being committed. This defence can only be tested in court and it is therefore important to ensure all possible mechanisms for avoiding an offence are considered.</p>	<p>Advice (mitigation): It is advised that the most appropriate way to address the risk to nesting birds is: Avoid disturbance to the building and nest boxes during the nesting season. Or If works cannot be delayed the proposed work area should be carefully checked, immediately prior to works commencing. Checks should be carried out by a suitably experienced ecologist. If the risk of nesting birds remains, then monitoring for nesting bird activity should continue for the duration of works. Prior to any work commencing (checks) and throughout works in nesting season (monitoring).</p> <p>Advice (mitigation): If works are to be undertaken during the nesting season, all people working at the proposed development site should attend a toolbox talk delivered by an appropriately experienced person, to be made aware of the likelihood of encountering nesting birds and how to identify them, the legal protection of nesting birds and their own responsibilities as regards implementation of precautionary measures. Prior to any work commencing.</p>

Protected species	Impacts /Predicted Impacts	Action Required
Nesting birds Continued		Advice (mitigation): If birds are found to be nesting within or in close proximity to the work area during proposed works, it will be necessary to stop and establish an exclusion area. The extent of the exclusion area, which should be determined by a suitably experienced ecologist, will depend on the bird species and the nature of the proposed works. At all times.

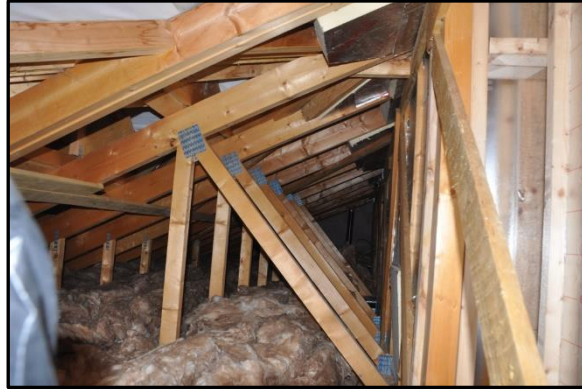
The first-floor rooms are built within the majority of the roof space with only narrow voids present along the eaves to the north and south elevations. These voids were accessed via wall access hatches and contain deep rock wool insulation, timber truss roof supports, block interior walls and modern roof membranes. The northern void is used for storage and the southern void remains unused. Both voids are sealed internally and the roof membranes are intact.

View of roof void, showing modern liner, truss supports and rock wool
