## HERITAGE STATEMENT TO SUPPORT PLANNING APPLICATION 3/2021/0280

### FOR PROPOSED CONVERSION OF BARN TO TWO DWELLINGS AND CONVERSION OF AGRICULTURAL BUILDINGS TO PROVIDE HOME OFFICE SPACE AND GARAGES

#### AT NEWHURST FARM, BOLTON-BY-BOWLAND, BB7 4NZ

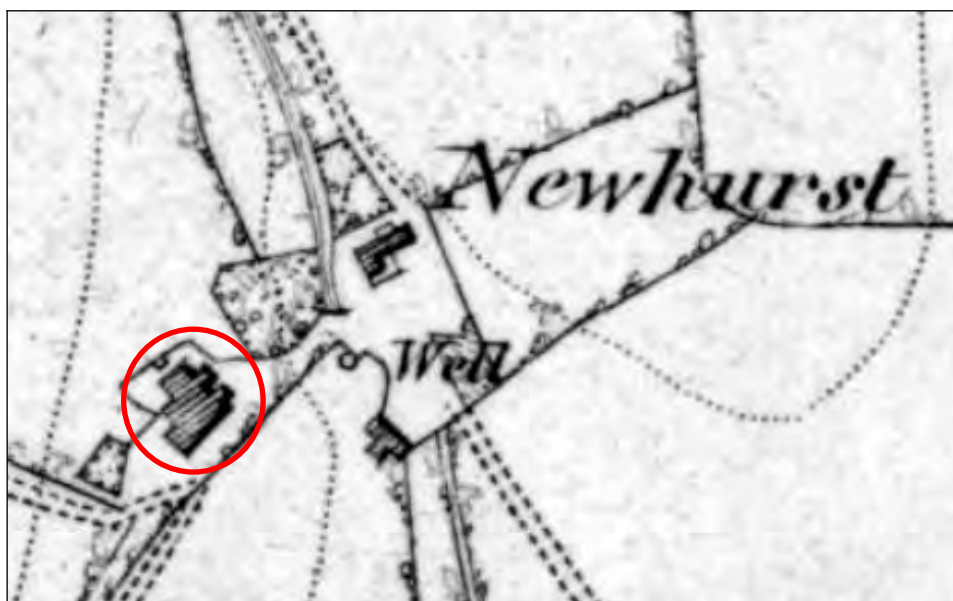
Figure 1: OS 1:10560 map, 1850

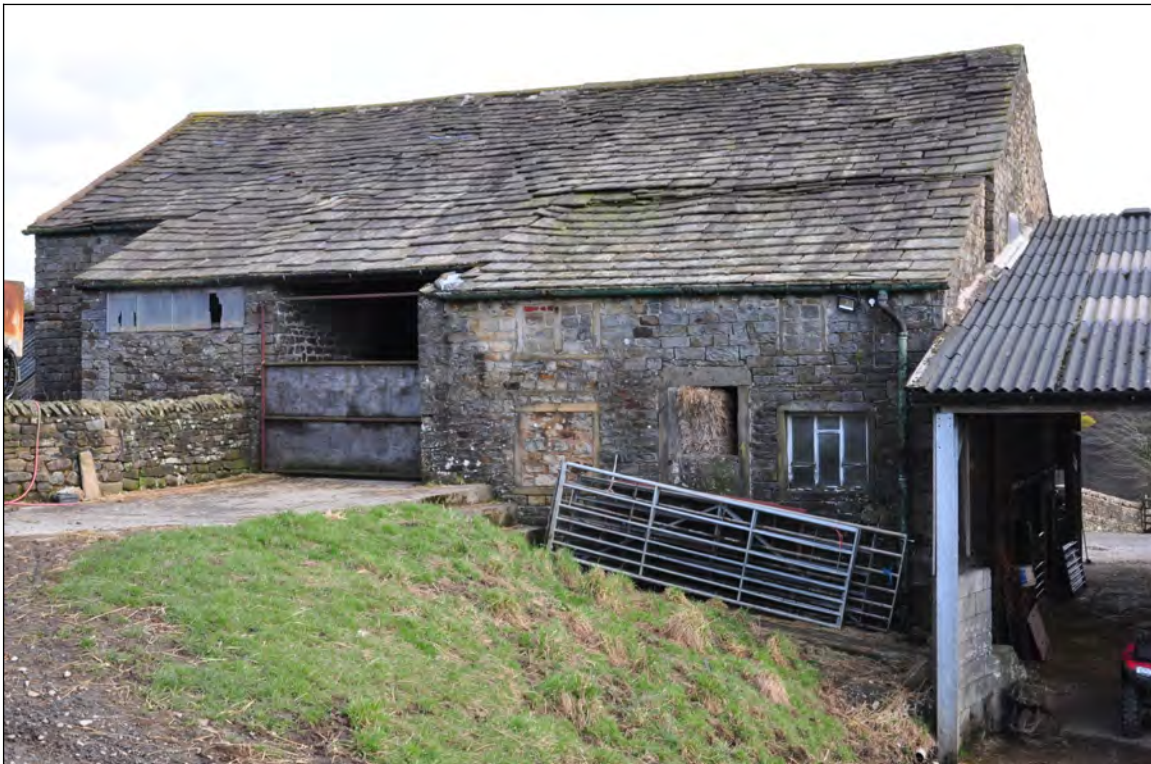
- 5.1 The stone building is a bank barn in form, probably dating from the second half of the 18th century, and with a curious twin porch arrangement to its south-west side (as shown on the 1908 map), which appears to be original, and suggests it was intended to be shared by two occupiers (photo 1). At the south corner of the barn is a domestic extension, late 18th or early 19th century, which communicated with the south-east bay of the barn, which was itself adapted to residential use. All parts are now in agricultural use.

Photo 1: South-west front of barn, with twin porches to hayloft (left) and domestic extension (right)

building's agricultural character. The left-hand cart entry would be reinstated as an entrance, so enhancing significance.

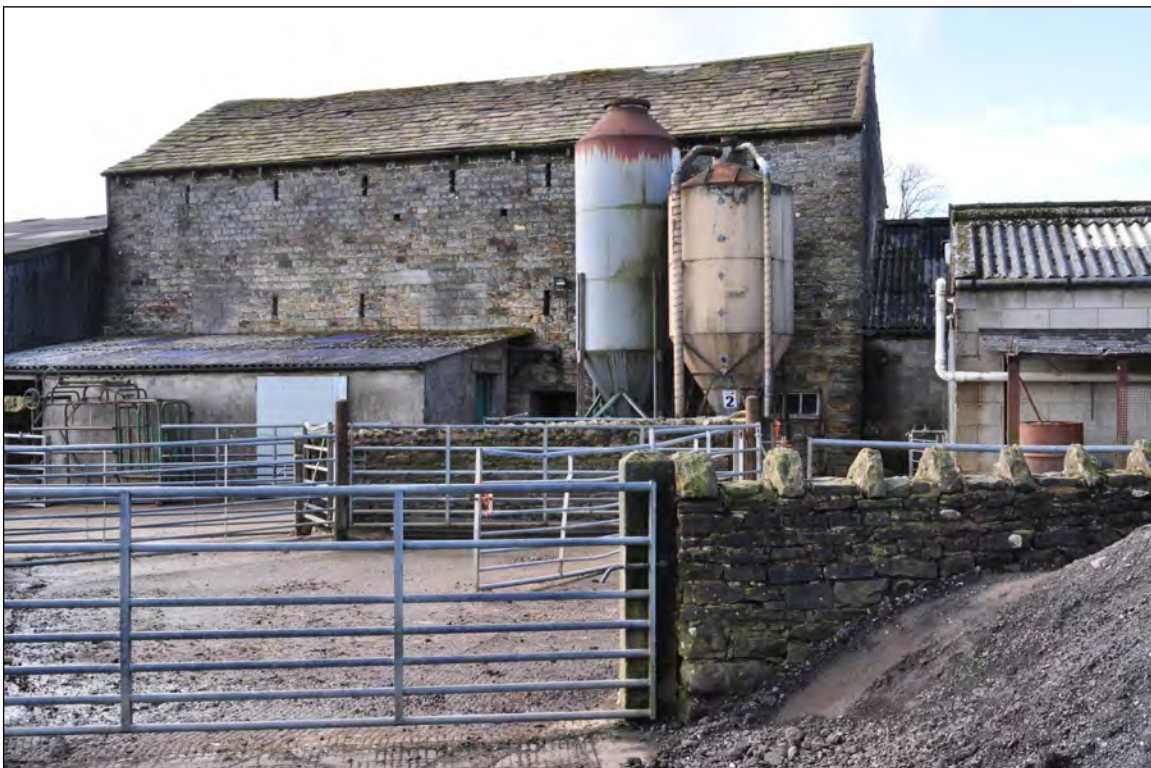
- 5.3 While there are twin cart entries in the south-west side, there appears to have been only a single winnowing doorway in the opposite, north-east side (although feed silos conceal some of this elevation) (photos 2 and 3). This is now blocked up, but is notable for the quality of its tripartite lintel, with joggled skewbacks to the central member. Intact original openings in this side of the building are otherwise confined to a regular arrangement of breathers, in two rows, and a

Photo 2: North-east rear, with modern additions

- 7.2 The most obvious improvement would arise through the removal of the majority of the modern accretions, which conceal much of the building's exterior from view, in particular the portal frame shed, and the pair of feed silos. Those 20th century additions proposed for retention would be improved by being clad with stone, and having new slate roofs to replace the existing asbestos cement coverings.

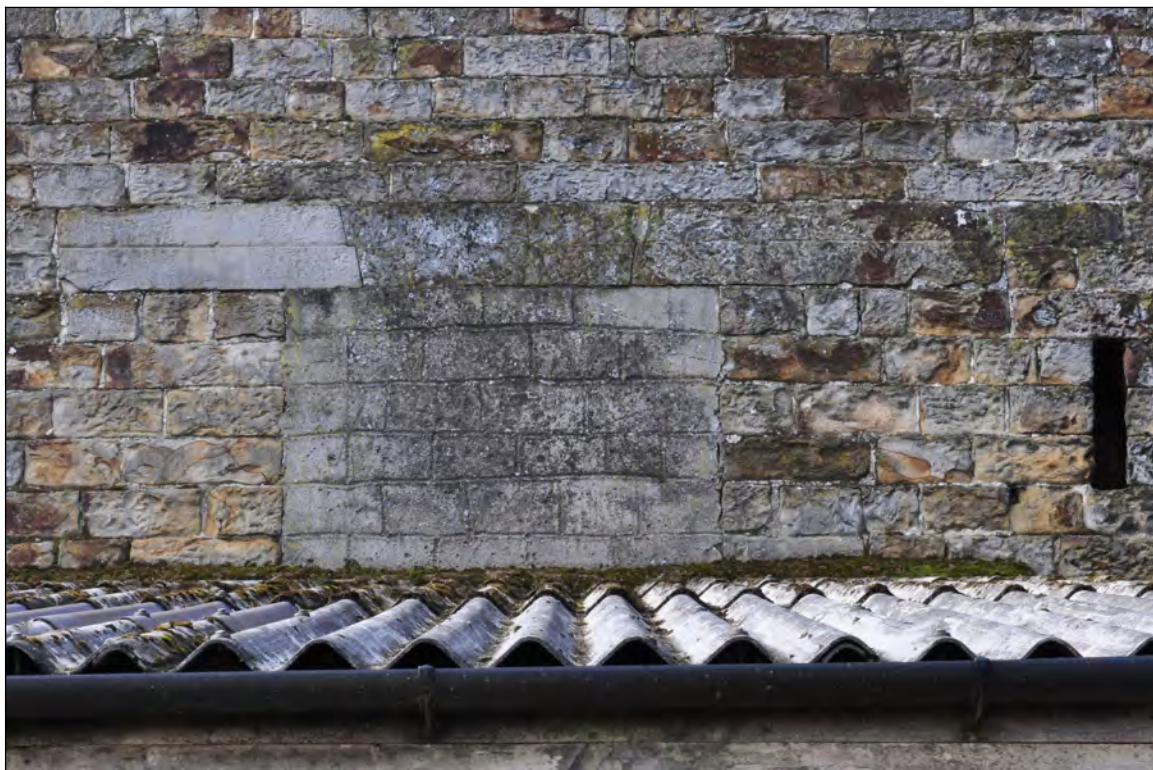
Photo 3: Blocked winnowing door to hayloft in north-east side, with distinctive lintel

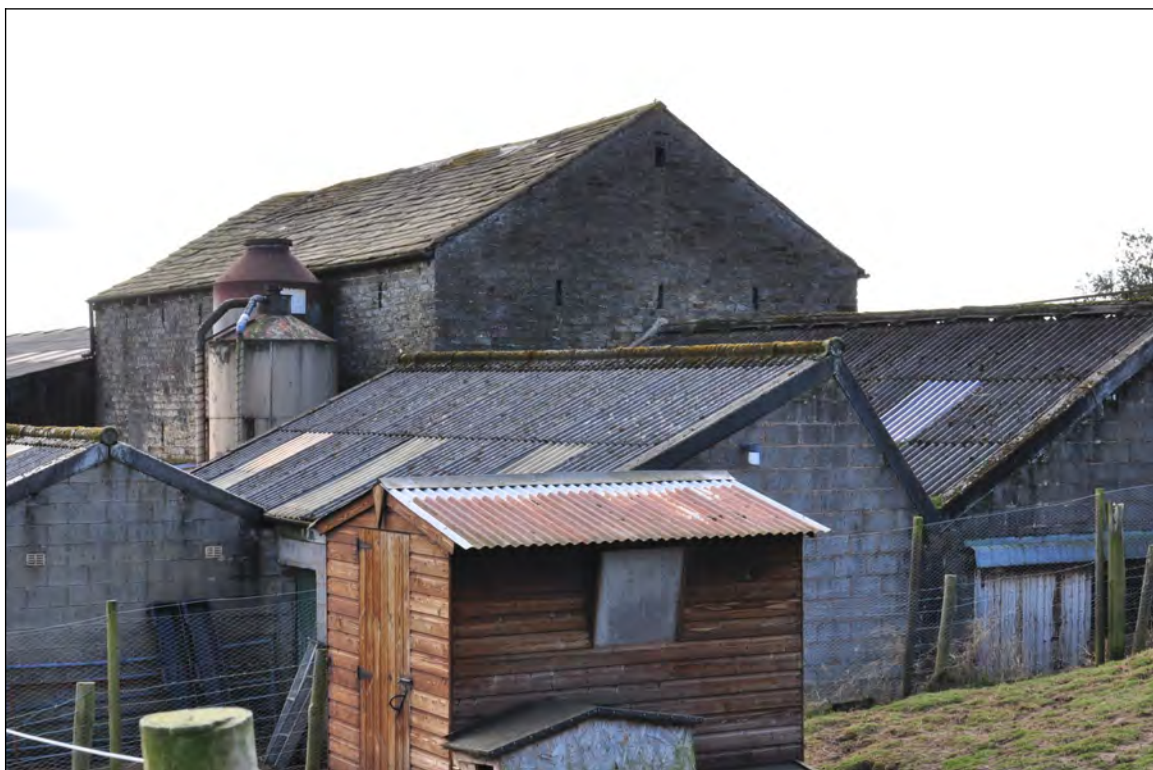
- 5.5 The north gable has a similar wide entrance at ground floor level, above which are further breathers, and a plain owl hole (photo 4).
- 5.6 There is a substantial dividing wall on the ground floor of the barn, but not within the hayloft, in line with the division between the two cart entries above. It now has a wide doorway through, beneath RSJs, and is rendered. The two ground floor spaces which this separates contain a mid 20th century shippon arrangement, with rendered walls and concrete boskins, and nothing of the historic layout, likely to have contained two timber framed shippons, survives (photo 5). The first floor is carried on steel beams and has been replaced in its entirety.

Photo 4: View from north, showing extent of modern additions, most of which would be removed

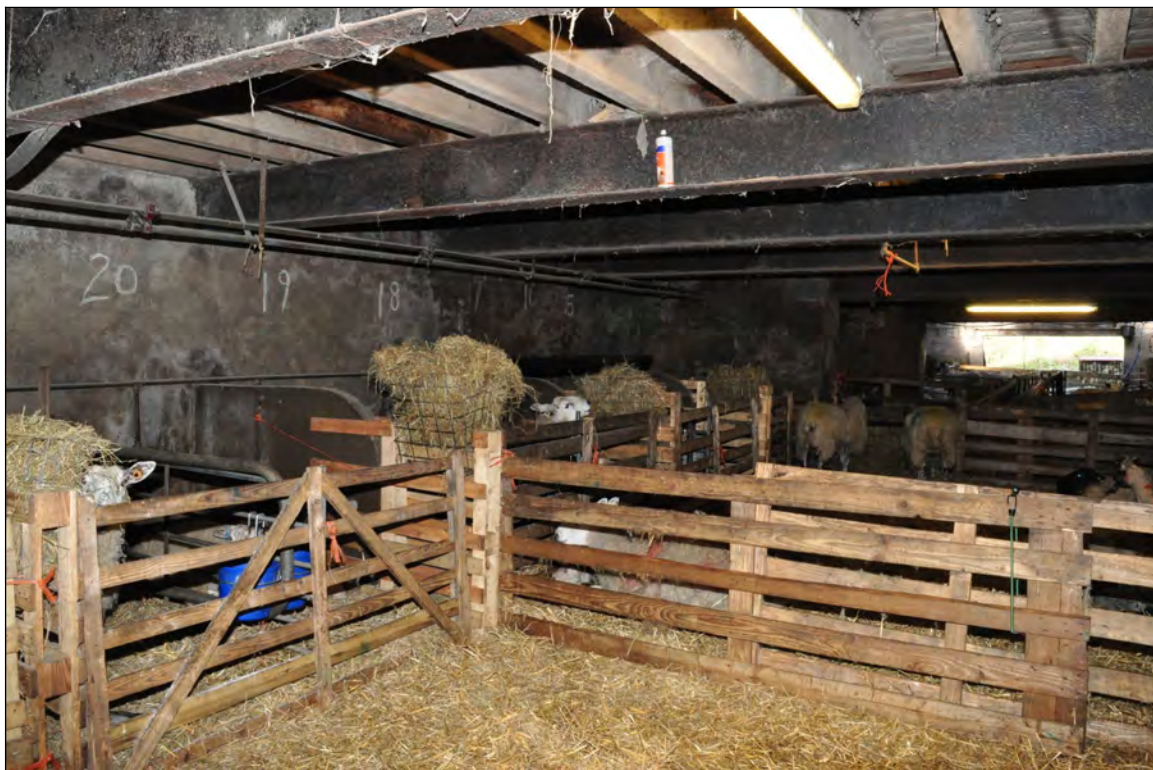
Photo 5: Ground floor. Entirely modern in character

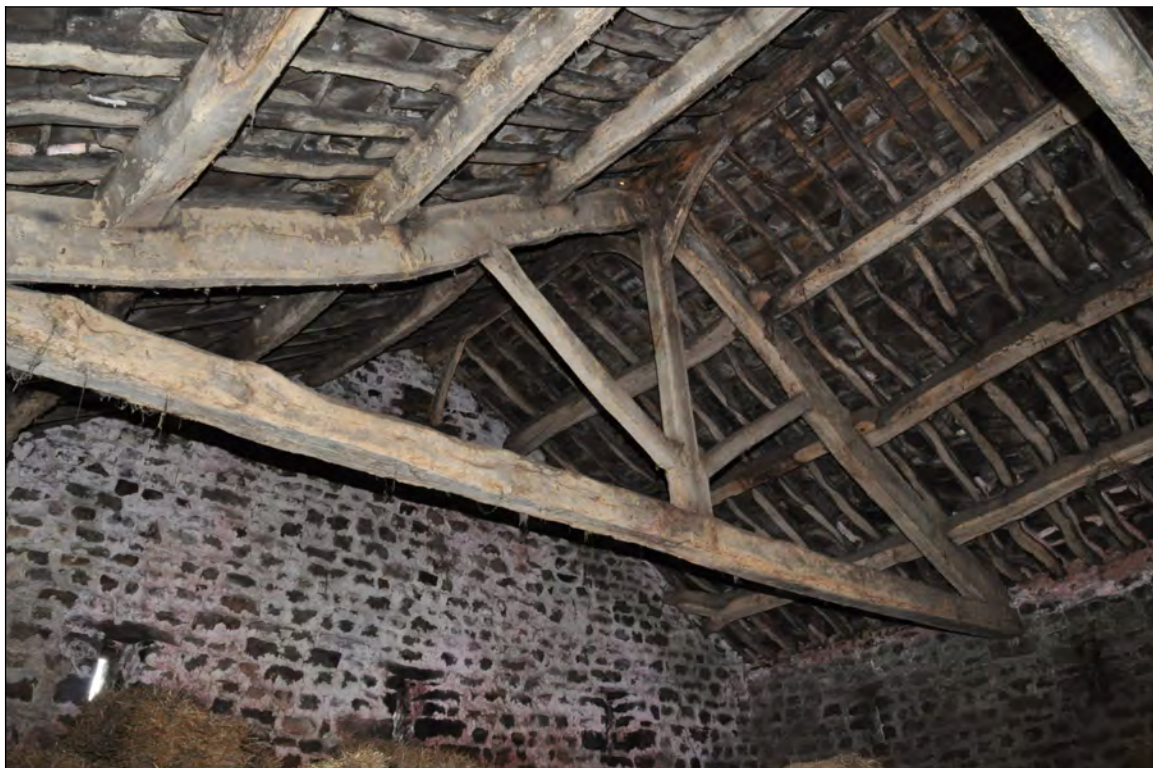
- 5.8 The roof structure appears entirely original, is constructed from local hardwood, and contains four trusses of uniform design, with king-posts and V-struts, very typical of the 18th century. However there are also small ridge braces, which are a much less common feature of such roofs. The rafters are very irregular and short in length, which contributes to the roof's distinctive appearance (photo 6).

Photo 6: Roof structure over hayloft

- 7.4 Significant aspects of the interior (which presently are very largely confined to the upper floors) would be retained where possible, and in property one, the historic roof structure would remain visible over the first floor.

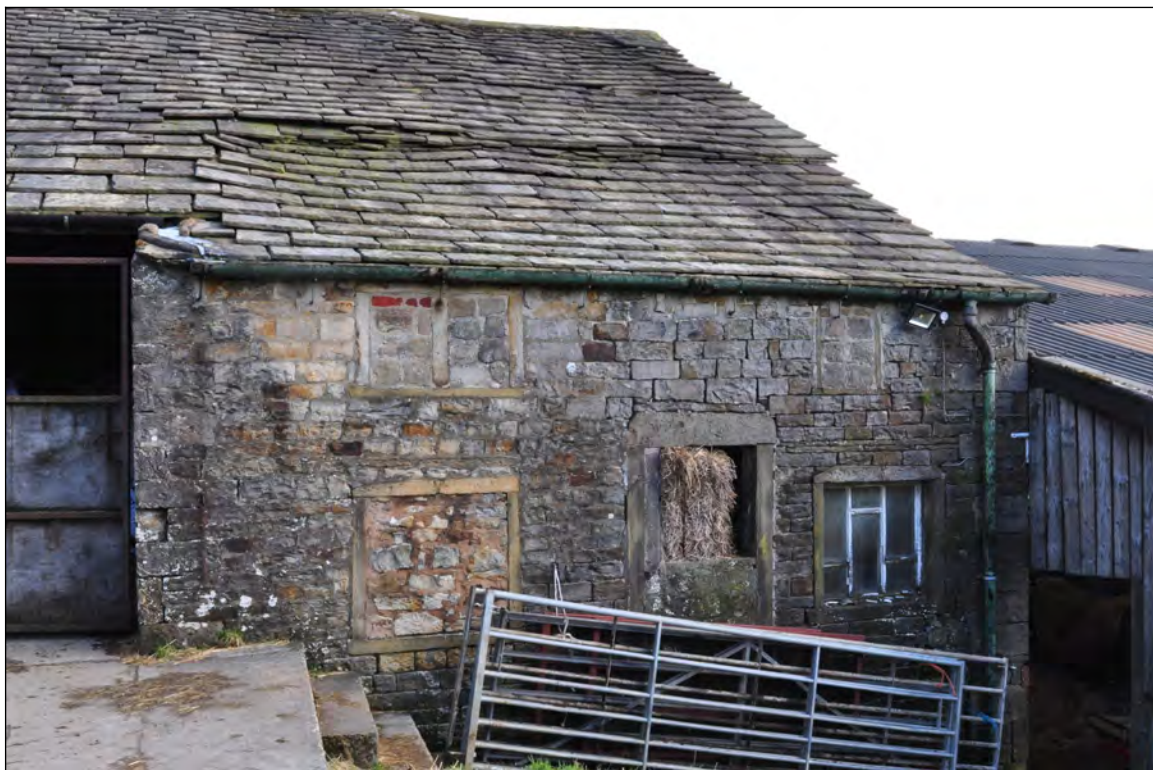
- 5.9 The domestic extension or cottage at the south corner of the barn has a ground floor entrance in the south-east side, but a first floor doorway and window openings in the south-west side (photo 7). These all vary in their forms, implying less concern over appearance than is apparent within the original building. There were three floor levels; the attic floor survives, but the first floor has been removed. The latter contains a stone fireplace (infilled, but designed for a hob-grate), in the south-east end (photo 8).

Photo 7: Domestic extension

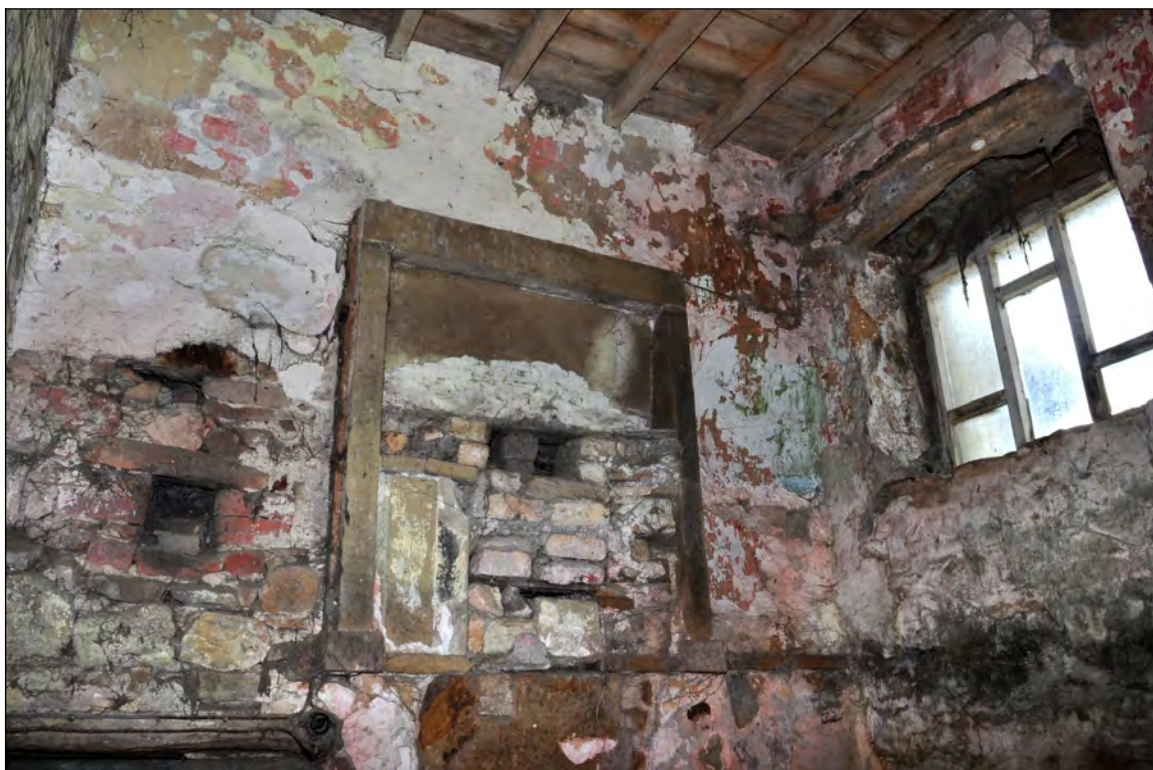
Photo 8: Fireplace and attic floor above, within domestic extension
