Brockhall Farm, Old Langho, Billington Archaeological Desk-based Assessment and Historic Building Survey

OA Reference No: 2020-21/2089

Archaeological Desk-based Assessment and Historic Building Survey

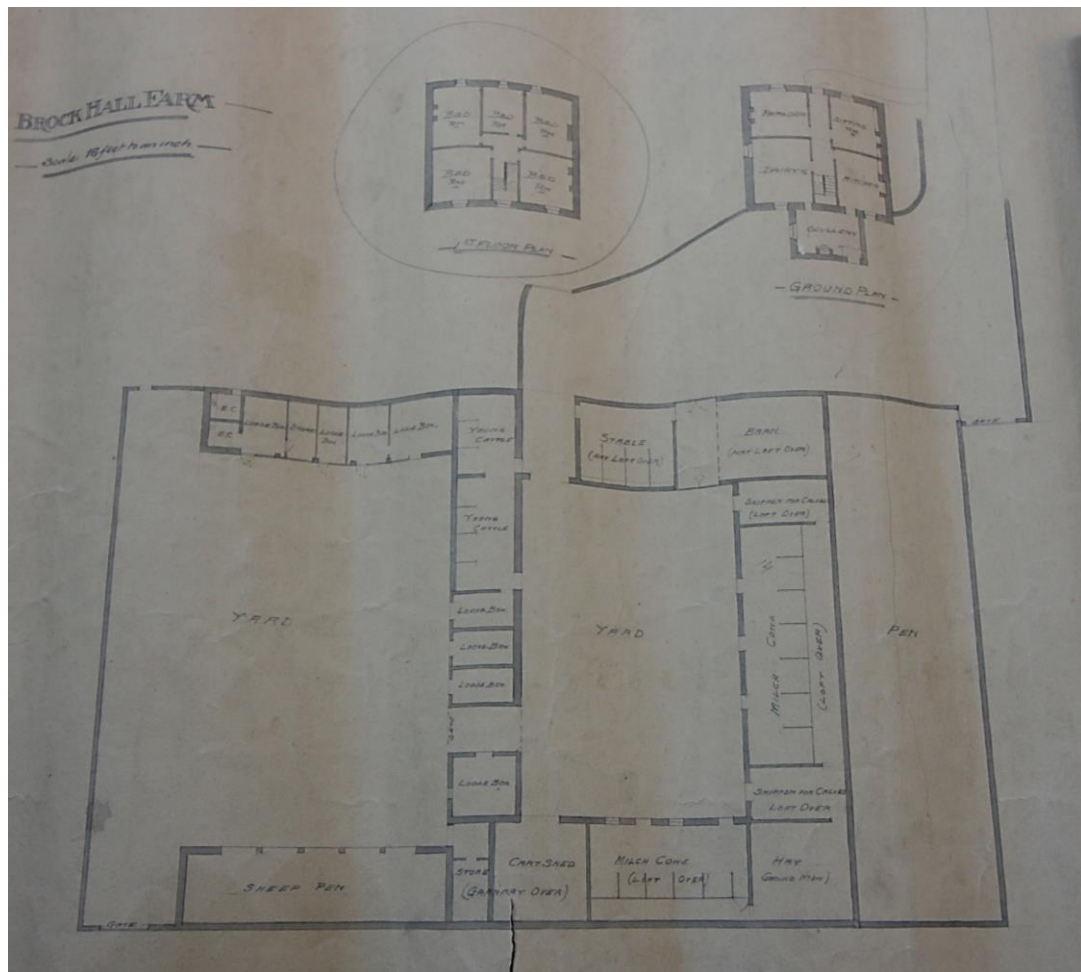
Plate 5: Brockhall Farm 'as existing' prior the construction of the hospital farm buildings, held by Mr. Willan. To aid legibility of the descriptions, north is down

- 5.5.13 Plans of the former Brockhall farmhouse (Plate 5) illustrate that it had been designed as a double pile house with a plan form suggestive of a late eighteenth or early nineteenth century date (*eg* Brunskill 1970). Reflecting contemporary sources indicating Brock Hall had been converted into a farmhouse (Abram 1877; *Section 5.5.6*) details on the plan suggest that that the building had been modernised. The ground floor consisted of a parlour and sitting room at the front of the house with a dairy and kitchen to the rear. The western and eastern rooms were separated by a wide hallway leading to a rear stairwell lit at first at the floor level by a stairlight. There was an external scullery abutting the north of the stairwell wall, on the ground floor, probably a downhouse, with entrances from both the dairy and the kitchen, and an exit to the north. It also had a boiler type arrangement on its north wall. The west wall of the house appears to have contained a very large fireplace, which had been split into two parts by the dividing wall between the sitting room and the kitchen, with additional smaller fireplaces added in both rooms. The central void, possibly infilled, is shown to be shared between the two rooms. The presence of such a large fireplace suggests that the double pile house indicated on the plan may have been converted from an earlier hall house, possibly originally open to the ceiling.

- 5.5.14 The farm ranges and foldyards on the 'as existing' architects plan (Plate 5), which are not portrayed on the 1756 map (although a yard is mentioned), are of a classic mid-to-late eighteenth century design (Brunskill 1982). The easternmost yard depicted extending beyond walls seemingly attached to the farmhouse seems likely to be an addition; the one and a half or two storey stable and barn part of that layout are closest to the house and may have been part of an earlier range with the walls forming a courtyard and barn behind (to the north of) the house. The single storey easternmost range comprises an entrance to the east yard; loose boxes and stores; a series of stalls for young cattle; gated access between the two yards, another loose box and a sheep pen at the yard's northern end. The west side of the range, with two storeys, comprises an entrance from the farmhouse yard, a stable and barn (with haylofts above); a milking parlour with calf shippens either end (with lofts above), backing onto a long pen. On the north side of the yard, there is additional milking cow accommodation, hay storage and a cart shed (with a granary over).

medieval Brock Hall, appears externally to be wholly of a twentieth century date and will not be impacted by the proposed development. The farm buildings recorded in the mid-nineteenth century and on 'as existing' plans (Plate 5) appear to have been replaced wholesale during the construction of the extant model farm buildings in the first decade of the twentieth century.

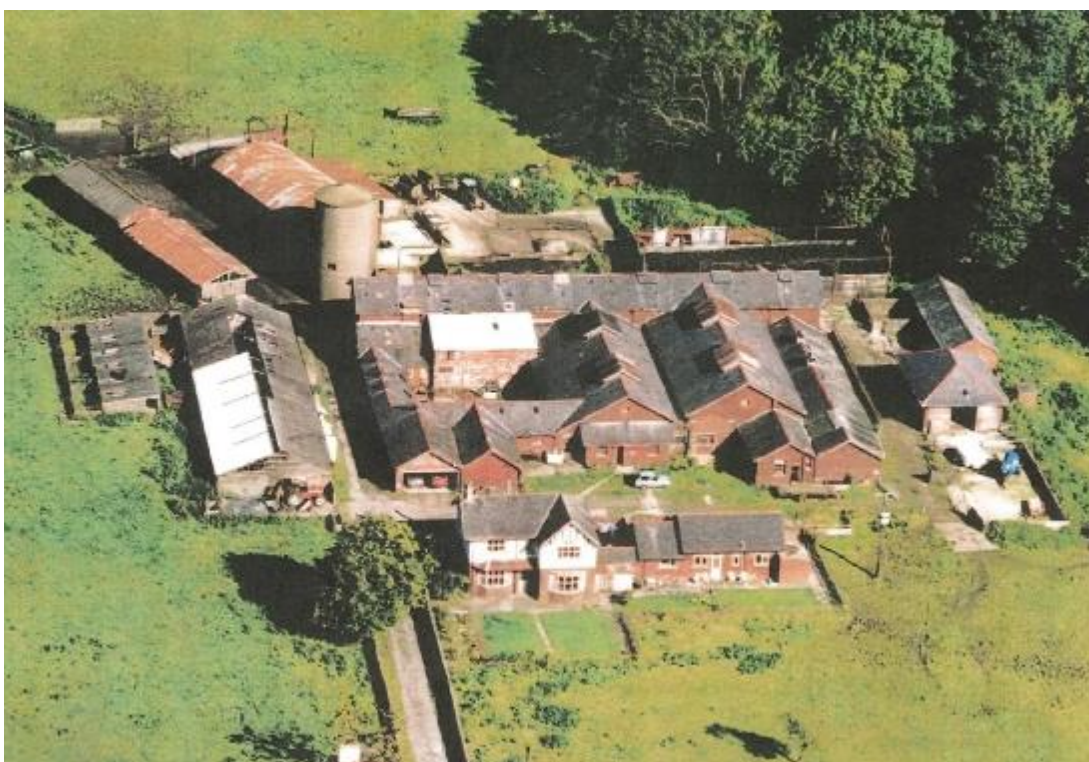
Plate 11: Brockhall farm, facing north-west, provided by Mr Willan, date unknown (most ancillary buildings to the north and west of the central range are presently roofless)

- 5.6.2 **Overview of Existing Buildings:** the presently extant farm consists of a Central Block comprising a two-storey northern range, with single-storey eastern and western ranges flanking a central Shippon, with a Covered Yard to its east, and Enclosed Courtyard to its west (Plate 11; Fig 8). The principal elevation lies to the south, facing the rear of the Farmhouse and converted Dairy across an open yard (Plate 12). To the east of the Central Block lies a single-storey structure presently used as a cattle shed, with a Piggery to its north (Plate 13). There is a large Piggery and associated Farrowing Pen. The northern part of the farmyard is occupied by a series of buildings concerned with crop storage, including, in the north-western corner of the farmstead, an Implement Shed, a range of Dutch Barns, and a concrete Silo. The Silo dates to after 1910 when the 1913 OS mapping was revised, and before 1929, when the 1932 map (Fig 6) was revised. It appears to have been cast *in situ*, with visible lift lines and later repairs evident externally (Plates 14 and 15).

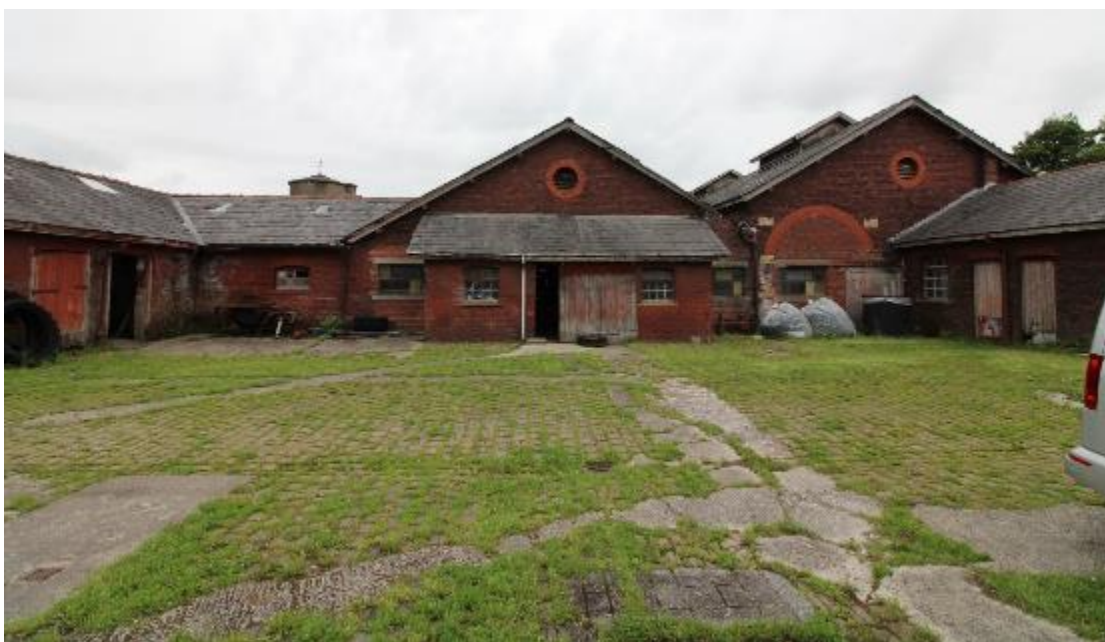
Plate 12: Principal elevation of the Central Block facing north

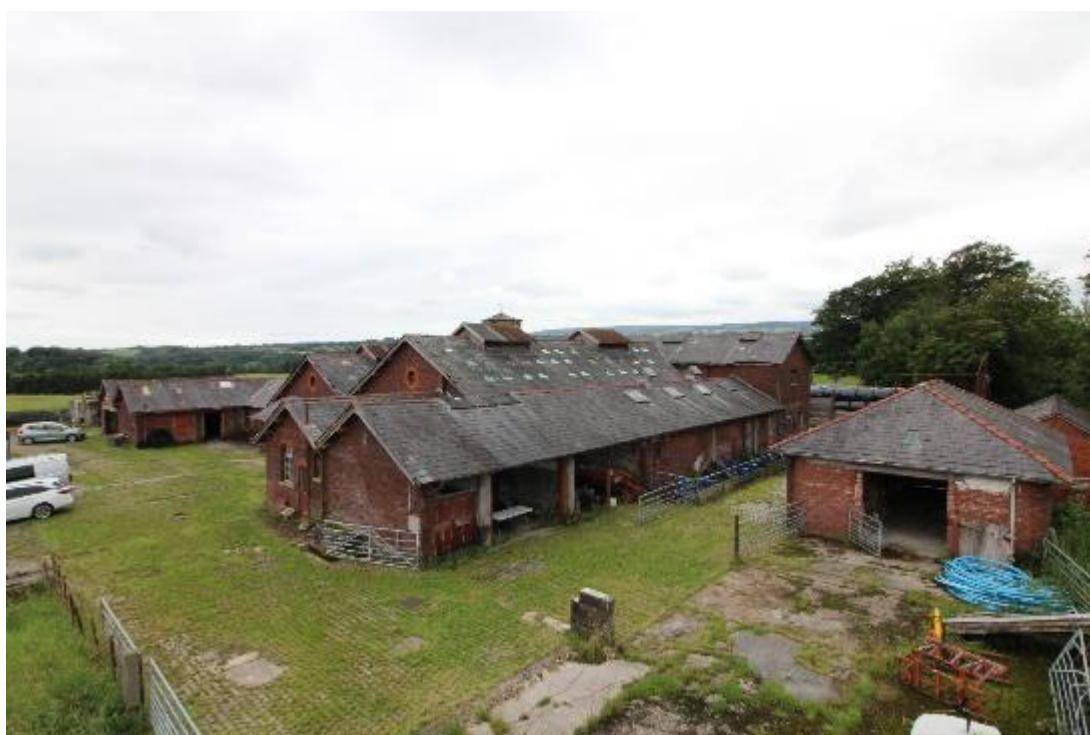
Plate 13: Brockhall Farm, facing north-west

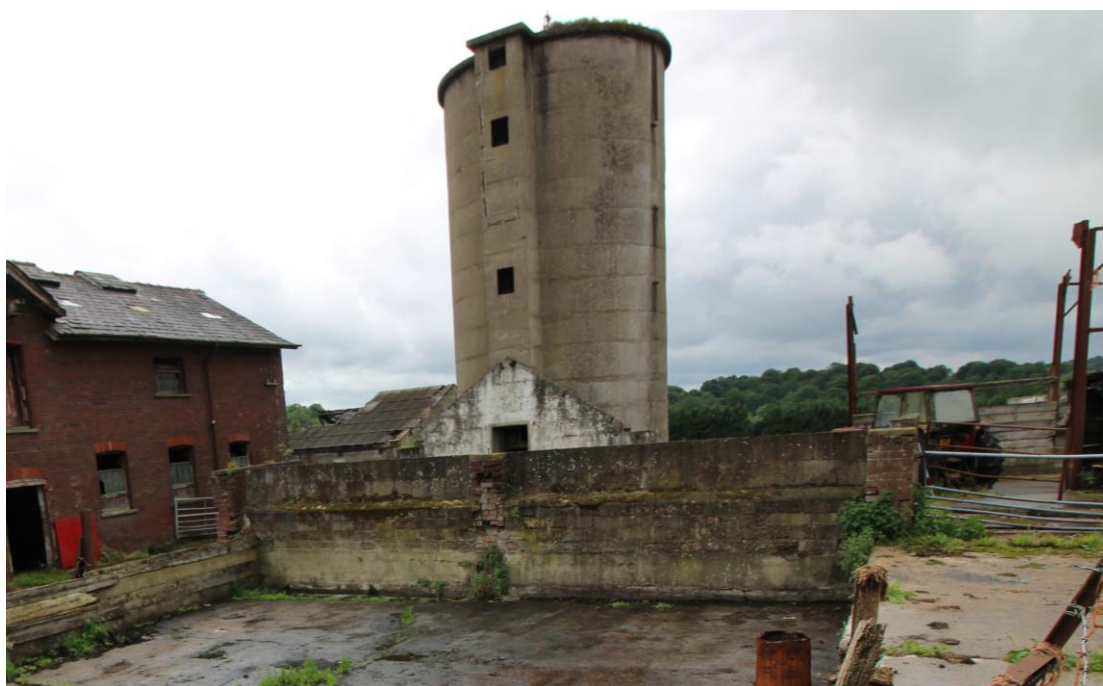
Plate 15: The Silo and site of the former Potato Shed, facing west

- 5.6.10 Subsequent additions to the farm during the first half of the twentieth century saw the expansion of the accommodation for pigs, and the erection of additional crop and equipment storage buildings easily accessible from the northern range (Fig 14). These included the Silo tower (Plates 14 and 15) which was constructed, seemingly in mass concrete, between 1910 and 1929. At a wider scale this dates to a period where these features became popular, following the development of the circular silo tower in the United States in the last two decades of the nineteenth century (Falk 2015; Historic England 2017a; International Silo Association 2020). Advances in the industrialisation of farming, particularly dairying, were driven by increased requirements for large-scale fodder production, and went together with the expansion of concrete construction in the same period (*eg* Addis 1997; Urqhart 2013). Concrete silos began to appear on English farms in the 1880s, and during World War One, but the silage movement saw exponential growth after c 1939 (English Heritage 2013; Historic England 2017a; Wade Martins 2002).

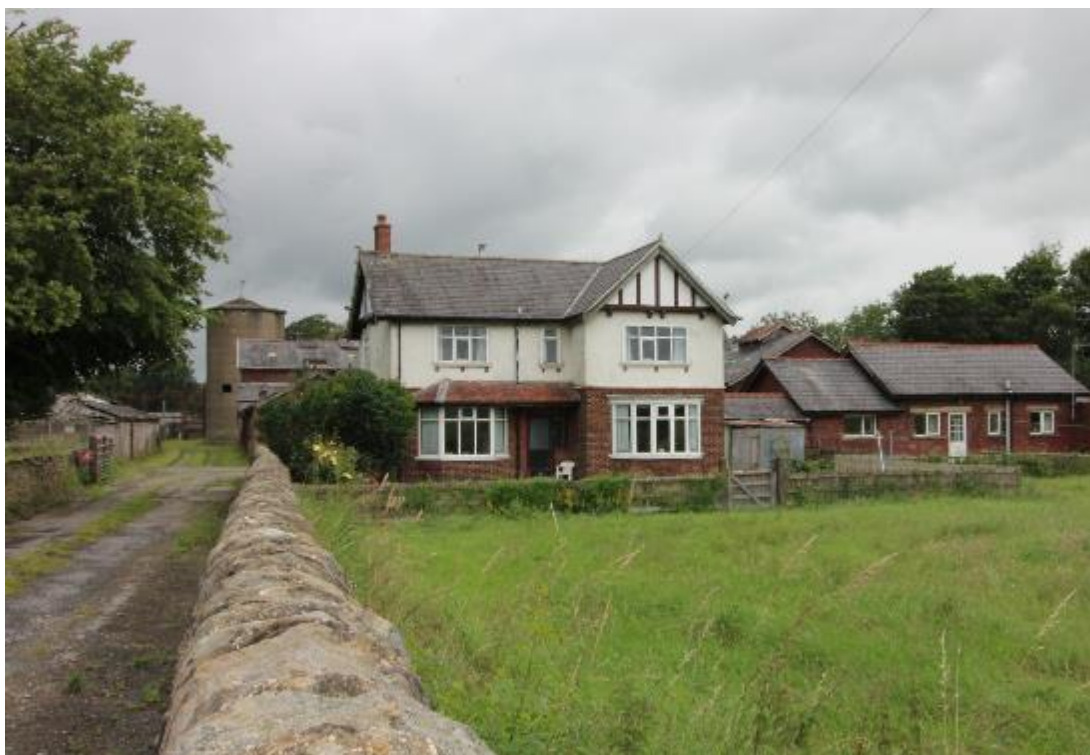
- 5.6.3 **Farmhouse and Dairy:** the Farmhouse was a two-storey detached rectangular building standing at the south-western corner of the complex adjacent to the farm's entrance track (Fig 8). Built in a mock Tudor style using red brick, the principal elevation displays a shallow gabled projection to the east of centre, bay windows to the ground floor and a covered front doorway. The design is unpretentious and a typical example of the standardisation in housing design during the inter-war construction boom (Plate 16). The rear elevation facing the farmyard is of wholly functional character. (Plate 17).

Plate 16: Southern elevation of the Farmhouse, facing north

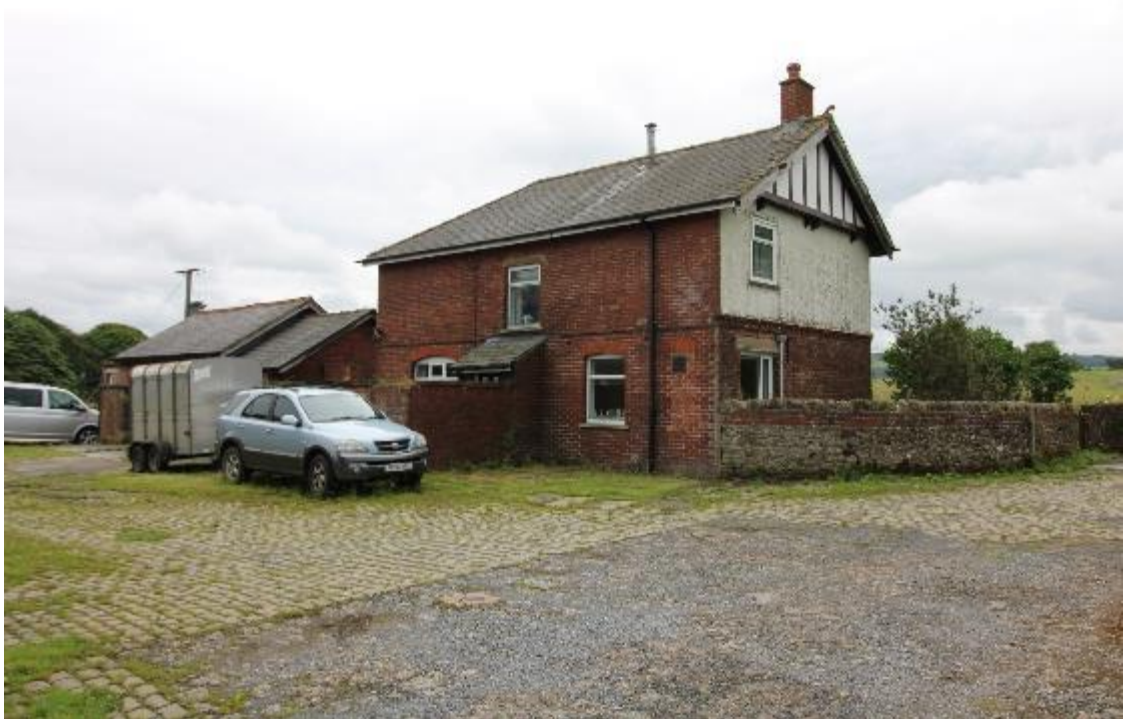
Plate 17: Northern elevation of the Farmhouse, facing south-east

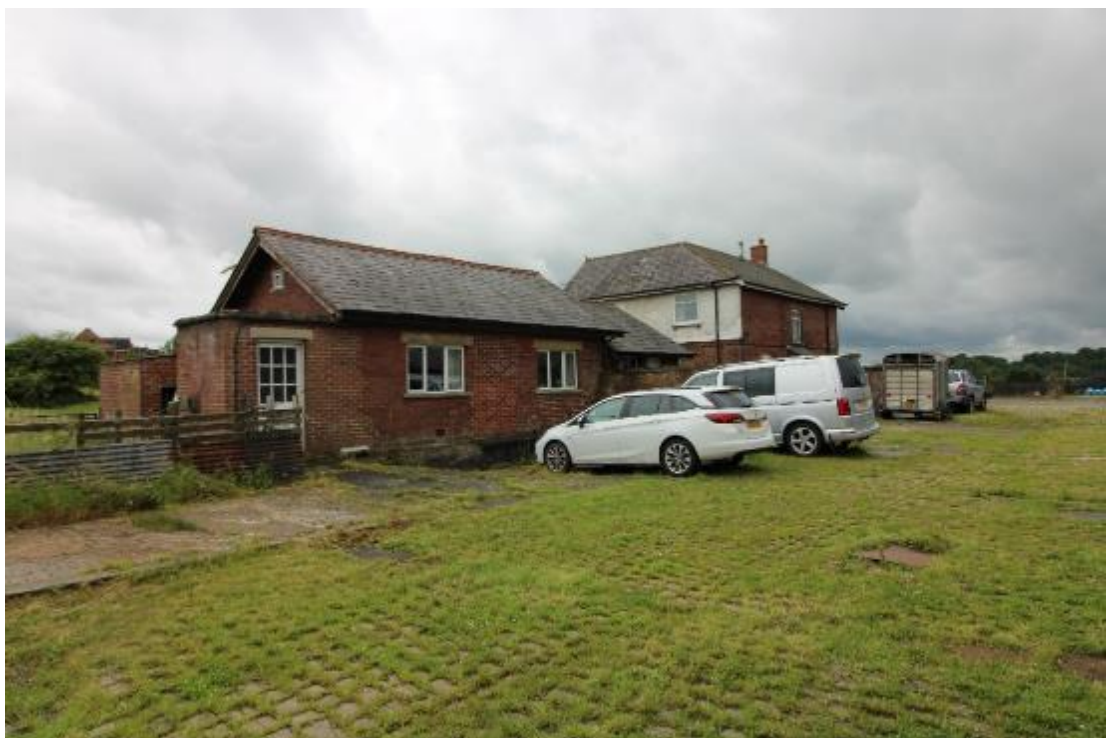
- 5.6.4 The Farmhouse was adjoined to the east by a much altered small, rectangular, single-storey Dairy of broadly contemporary date (Plate 18). The Dairy was constructed in red brick and had a gable slate roof, but its conversion to residential accommodation had necessitated substantial modifications to its northern and southern elevations. This, along with multiple extensions to the east and west, and the complete reorganisation of the interior, had changed the building out of all recognition.

Plate 18: The Dairy, converted to residential use, facing south-west

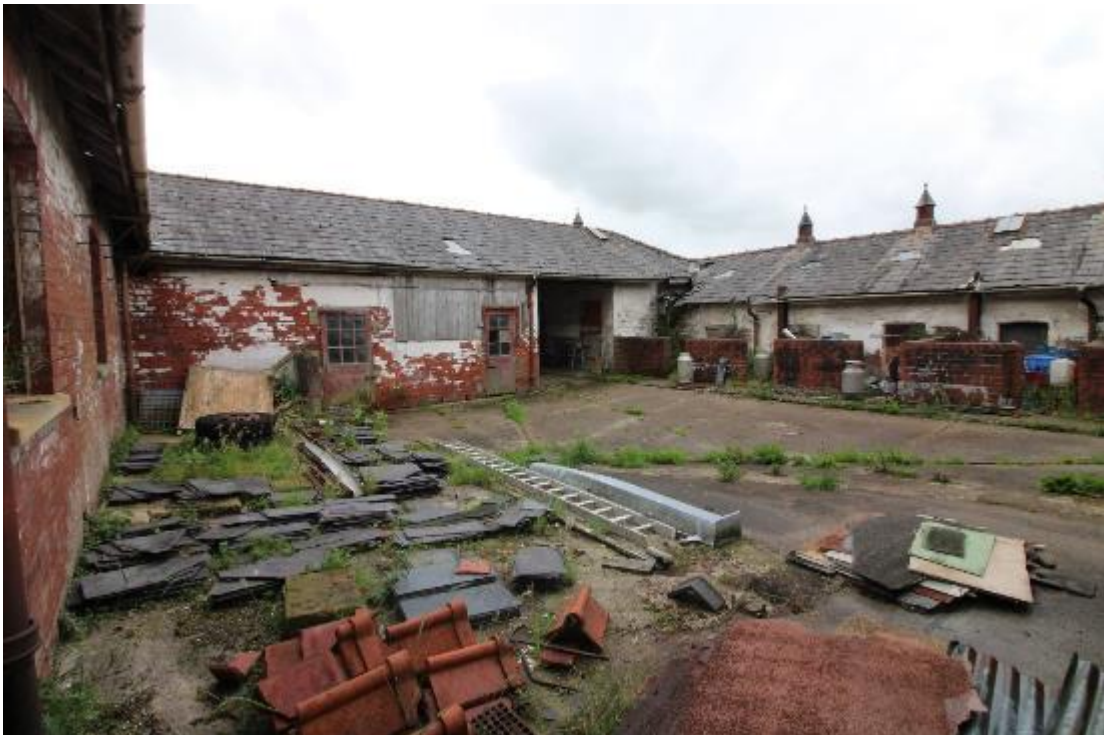
Plate 19: The Enclosed Courtyard to the west

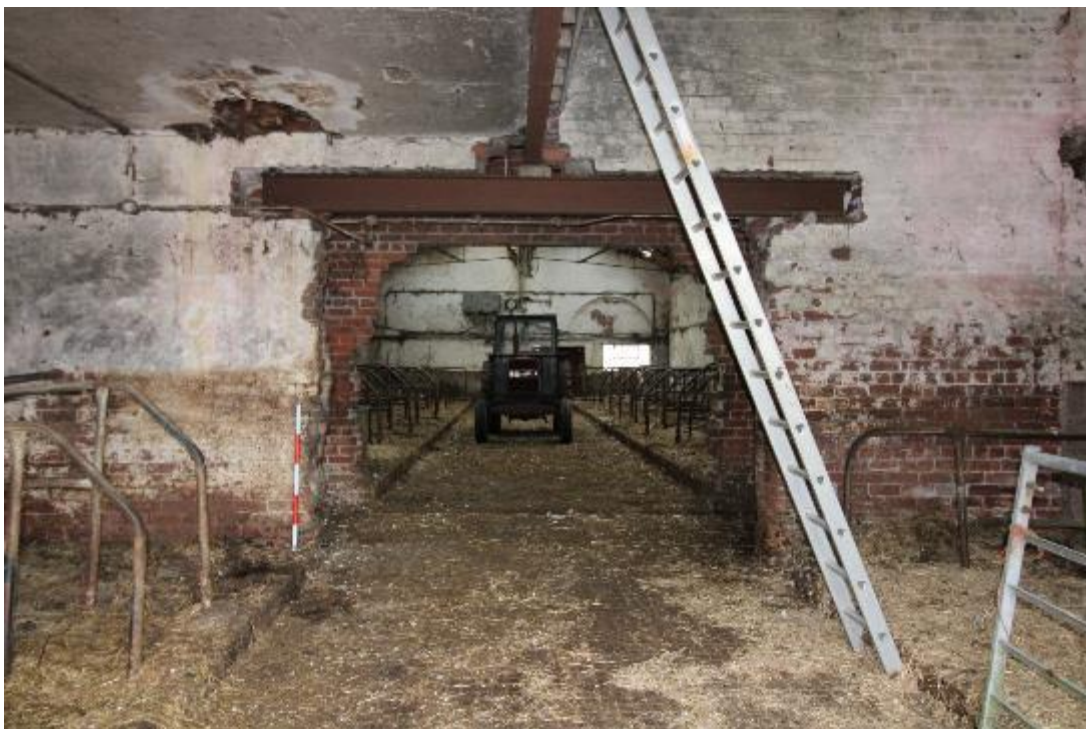
Plate 20: Knocked-through entrance into the converted Covered Yard

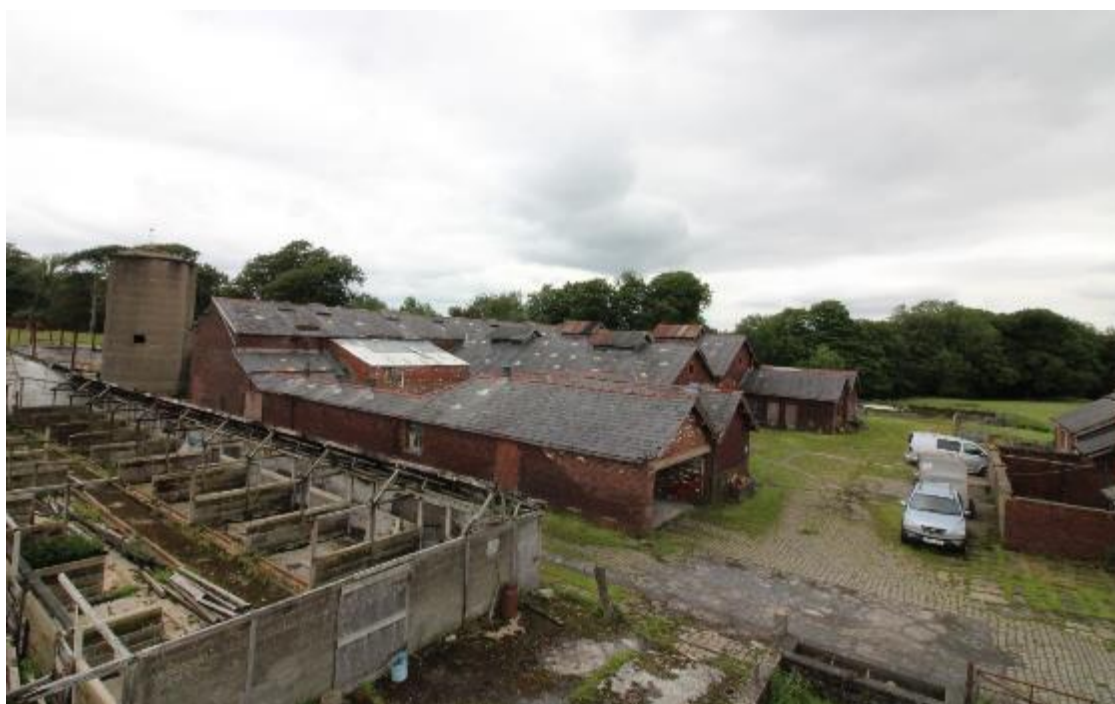
- A.3.2.1 **Southern Elevation:** The southern part of the Central Block consisted of a centrally placed Shippon, with a Covered Yard to the east, Enclosed Courtyard to the west and outbuildings fronting onto a large open yard (Plate 21) (Fig 9-10). The yard was paved with stone setts, the surface of which was bifurcated with concrete-covered drainage runs. The yard lay adjacent and to the north of the brick-built Farmhouse and converted Dairy, which were not part of the development area or Historic Building Survey.

Plate 21: Central Block, with yard to right of frame and Farmhouse beyond, facing north-east

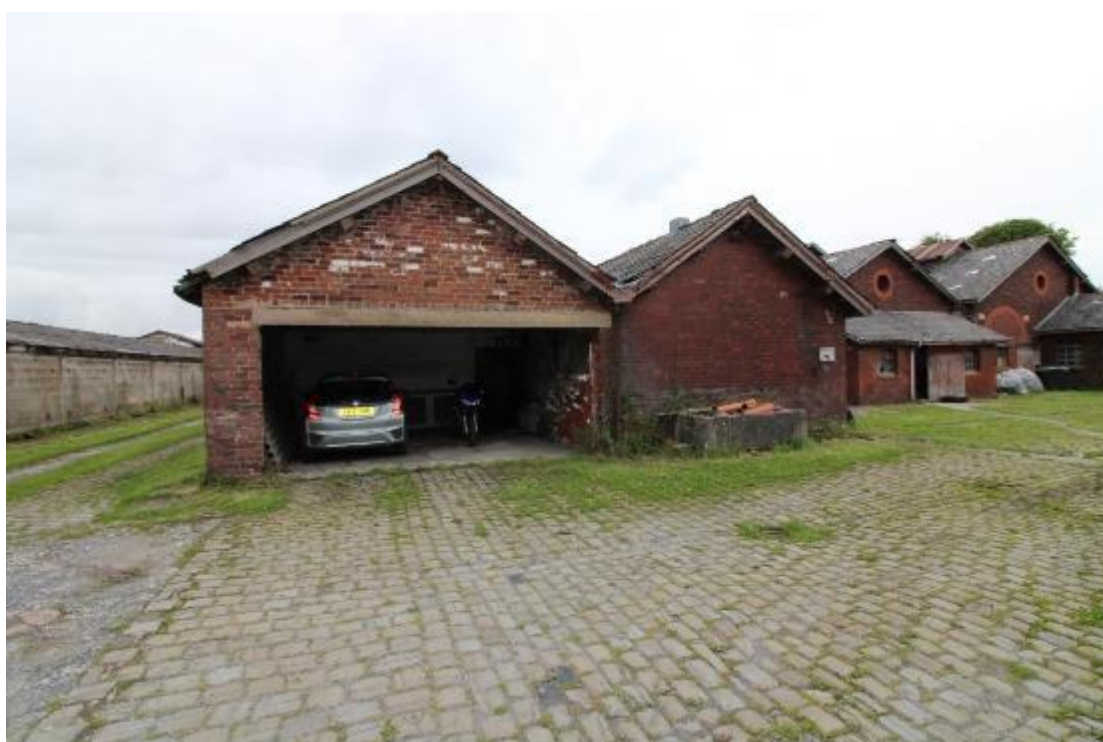
- A.3.2.2 At the south-western corner of the Central Block was an open-fronted Garage, with a slated pitched roof and a wide aperture supported by a concrete lintel. Upwards of the lintel, bricks of different materials/colours had been used, some bearing traces of limewash (Plate 22). Part of the western elevation of the building had been re-built using the same mixture of bricks, possibly following a collapse.

Plate 22: South-western corner of the Central Block

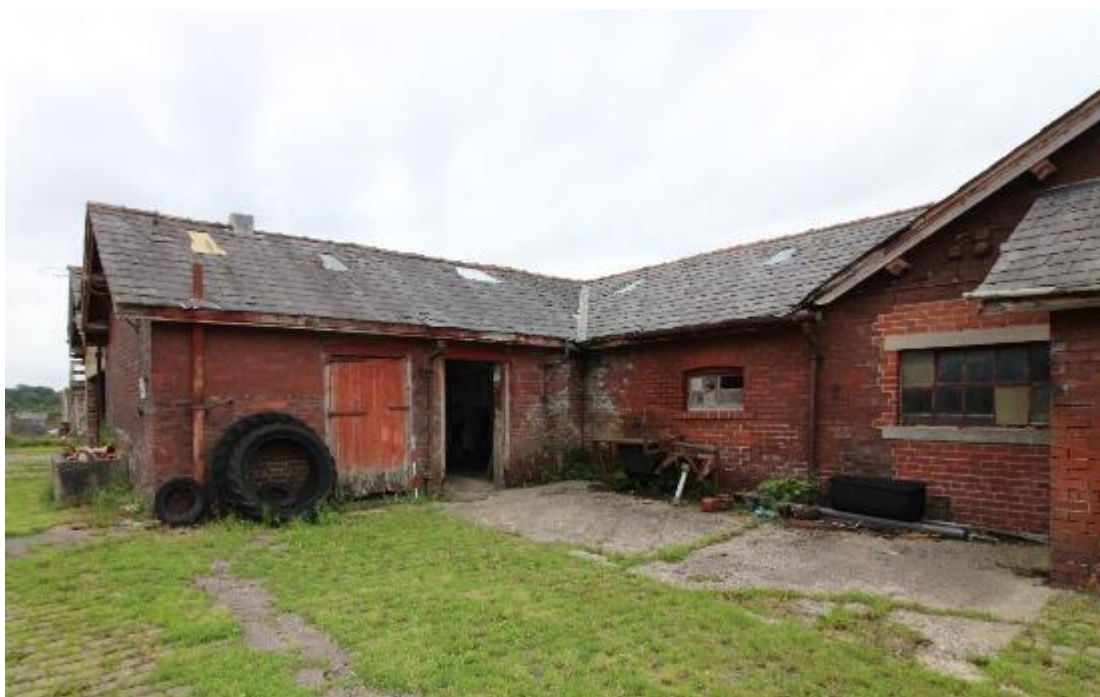
- A.3.2.3 Adjacent to the Garage was the gable end of a building, which had a water trough appended to its south-facing gable. It was constructed of homogenous dark red brick, one header course for every five stretcher courses. The east-facing elevation of this building incorporated two single-width doorways, one retaining a plank-built red painted door (Plate 23). The apertures were supported by brick arches.

Plate 23: The south and east-facing part of the southern yard, facing north-west

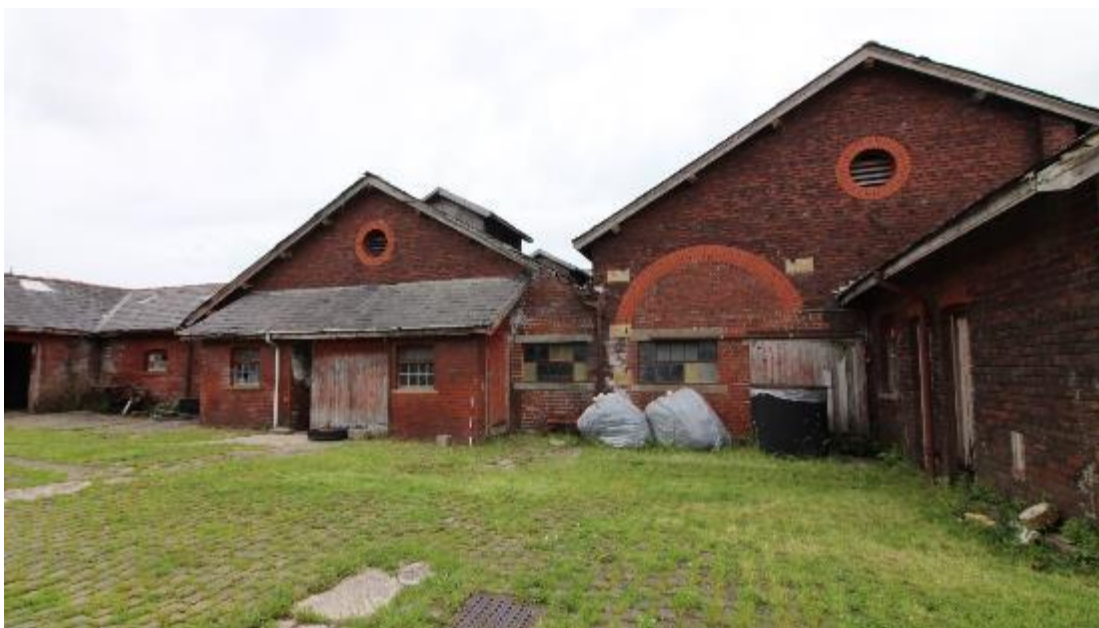
- A.3.2.4 Towards the centre of the southern elevation of the Central Block was a range of south-facing buildings as illustrated on the archival plan (Plate 8). At its western extent was the former location of a gateway into the western Enclosed Courtyard, since infilled and roofed over. To its east lay the gabled central Shippon. There were several phases of brickwork within this stretch of wall: that filling in the gated entrance to the Enclosed Courtyard (there was a small arched window within the infill) and, to its immediate east, brickwork infilling an original doorway into the Shippon (adjacent to the lean-to entrance with a sliding door central to two arched windows). Part of the infill of the doorway west of the present entrance to the Shippon was a long narrow five by two light window with a concrete header and sill. Another example infilled a doorway in the same position to the east of the lean-to. Above this, the pitched gable had a round ventilation hole lined with orange bricks, in contrast with the dark red ones used for the main walls (Plate 24).

Plate 24: The south-facing facades of the central Shippon and Covered Yard

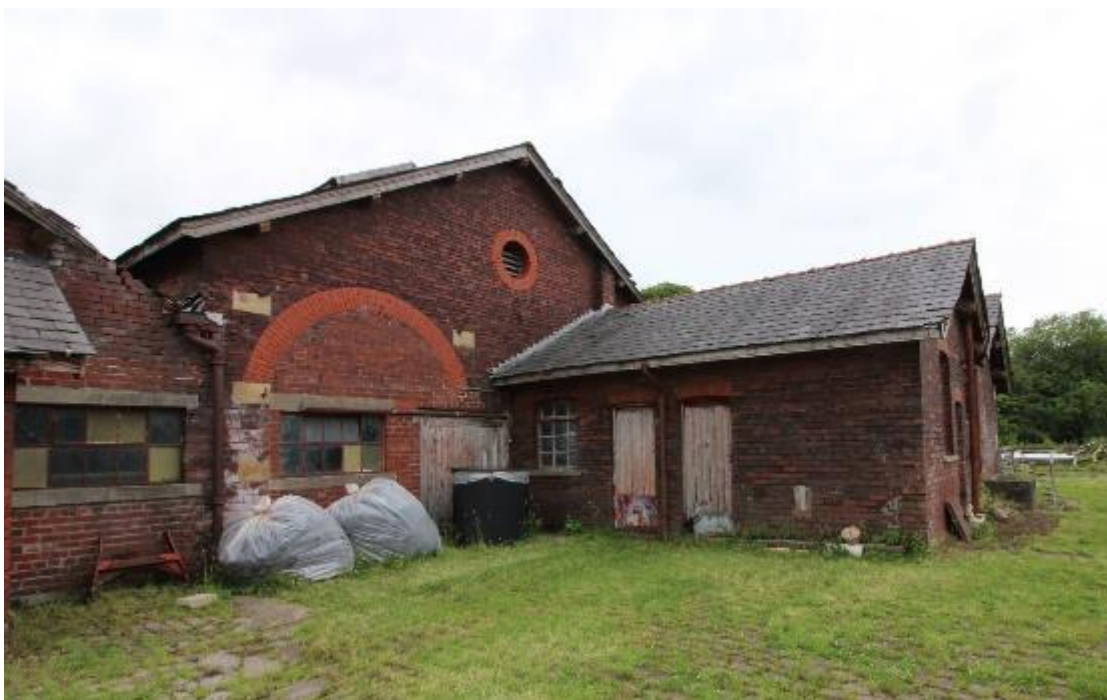
- A.3.2.5 The Covered Yard comprised a two-storey south-facing gable incorporating an infilled wagon entrance, the aperture defined by an archway of orange brick contrasting with the dark red brick used in the building's construction (Plate 25). Sandstone blocks within the wall retained the iron fittings which once supported the gates, including a pair above the base of the arch (which are unlikely to be original as they would have obscured the brick detailing) supporting the upper gates. The infill of the aperture was of dark orange brick and included a window pocket formed by concrete lintels and a window identical to those infilling doorways in the entrance to the central Shippon. Archive plans show the wagon entrance, with single storey and additional double storey timber doors (Plate 8). East of the windows within the infill, in the south-eastern corner of the elevation, was a mid-twentieth century sliding door into the Covered Yard. The gable of the Covered Yard, a half-storey higher than that to the west (and seemingly contemporary as there was no relationship visible in the brickwork), incorporated a round ventilation hole lined with orange bricks, in contrast with the dark red ones used for the main walls.

Plate 25: The south and west-facing part of the southern yard, facing north-east

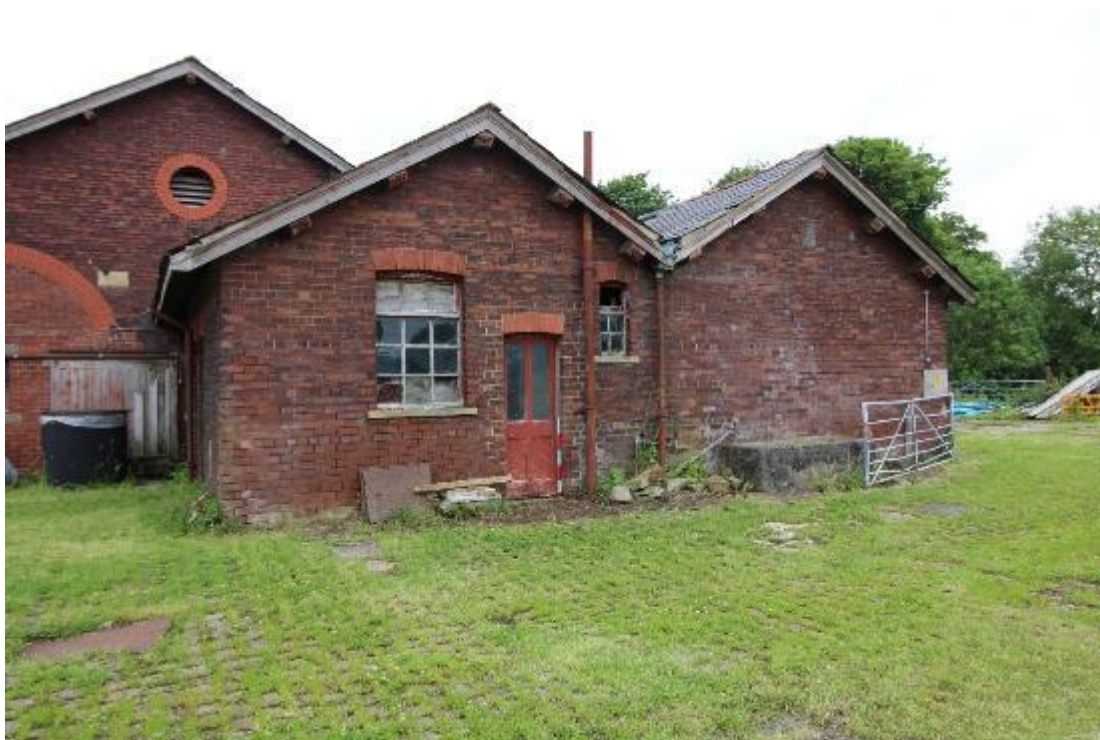
- A.3.2.6 The south-eastern part of the yard mirrored that to the south-west, being formed of two single-storey pitched roof buildings with south-facing gables (Plate 26). That to the west had two openings facing onto the yard, separated by a brick wall. The Men's Room to the north was lit by a west-facing four by three-light window and the Tool House to the south was served by an identical window and a doorway leading to a narrow WC cubicle (with a high vanity window and a semi-glazed door) in its gable end. All of the openings were defined by brickwork arches; brickwork around the WC doorway and window was of a slightly different character however, and these features seem to have been later insertions (Plate 26). The eastern gable wall had no features other than a water trough fed by the downpipe taking water from the valley between the two gabled roofs; a lead pipe entering the wall of the WC suggests this water source was also used as a flush.

Plate 26: Eastern end of the southern elevation, showing inserted doorway to WC

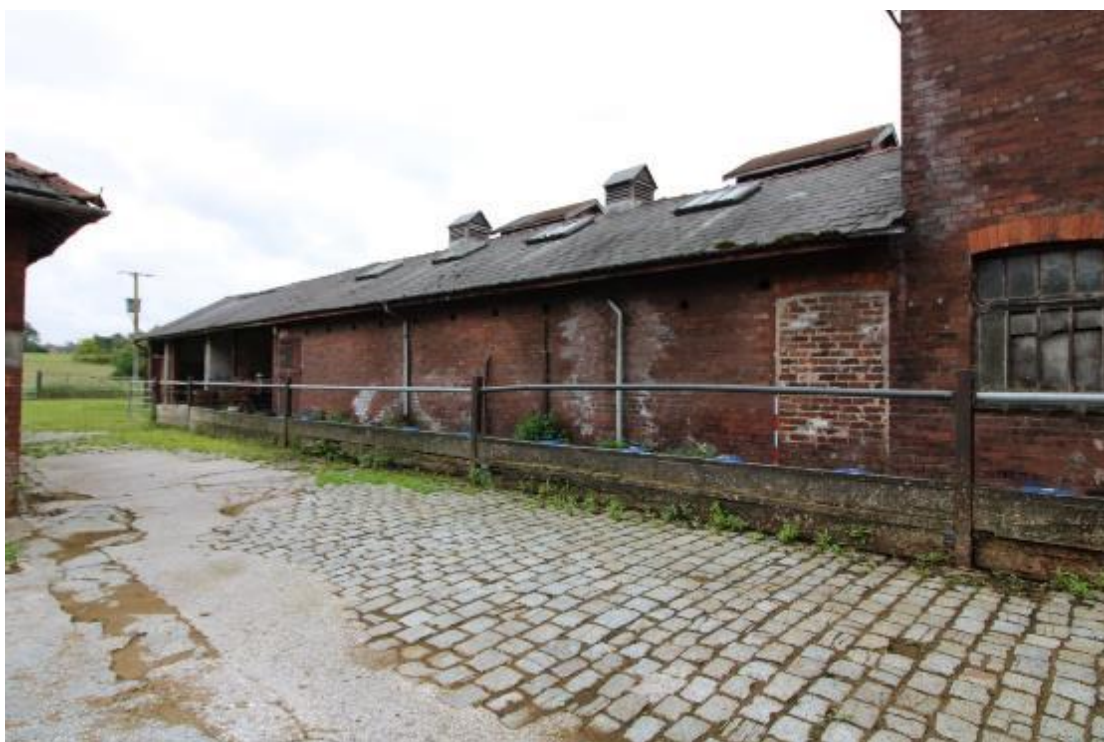
A.3.2.7 Eastern Elevation: The eastern range of the Central Block was composed of five single-storey bays; the northernmost two were brick-fronted and labelled on archive plans as Shippon for Calves and Bull Box (Plates 10 and 27) with access from inside via the Covered Yard, suggesting that the external door to the Bull Box was an addition. Two of the bays were open-fronted and the southernmost was sealed by a pair of timber doors; these bays (Cart and Implement Sheds) were defined by partitions of concrete blockwork to which brickwork detailing had been added, and a single cast iron post provided roof support in the centre of the central bay (Plate 28). In front of the Bull Box and Calving Shippon was a narrow-gated yard or walkway, and a bricked-up doorway which gave access to the northern end of the Covered Yard's feeding passage (Plate 27).

Plate 27: Northern end of eastern range, facing south-west, with 1m scale

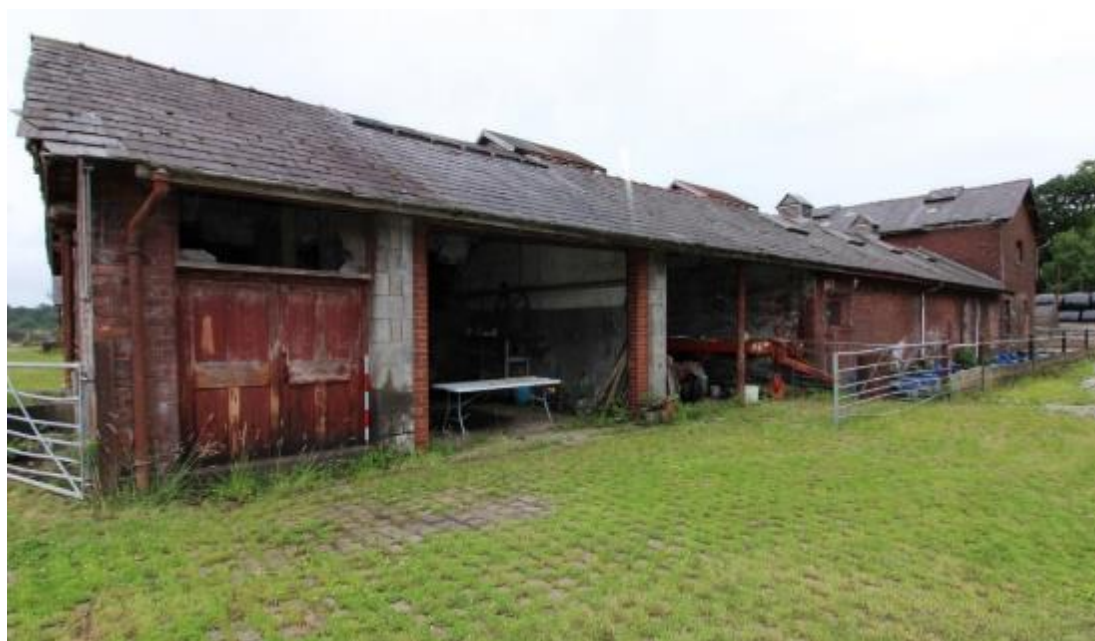
Plate 28: Southern end of eastern range, facing north-west, with 1m scale

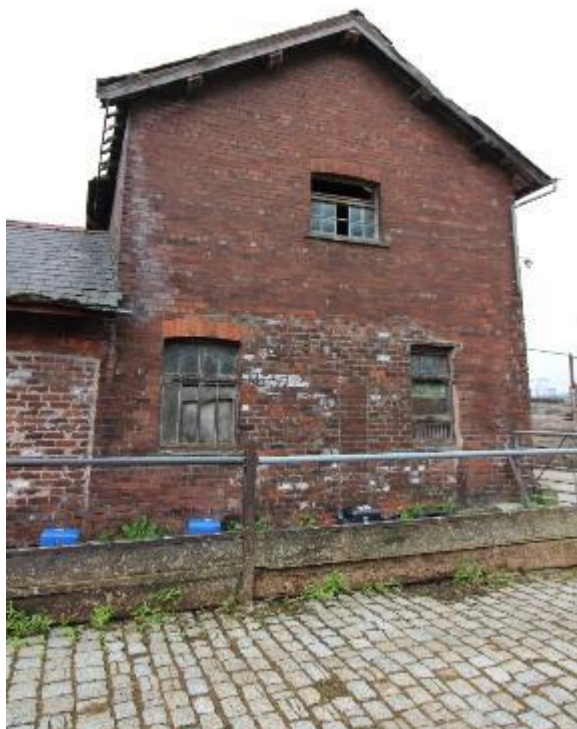
A.3.2.8 The northern end of the eastern elevation of the Central Block was defined by the two-storey gable end of the northern elevation (Plate 29). There was a central window at first-floor level and two windows on the ground floor. The northern ground-floor window was the only one not defined by an orange brick arch; a brickwork column in the centre of the wall indicates it was formerly open-fronted or incorporated a wide doorway at ground-floor level with the aperture infilled and a ventilated window pocket inserted.

Plate 29: Eastern gable of northern range

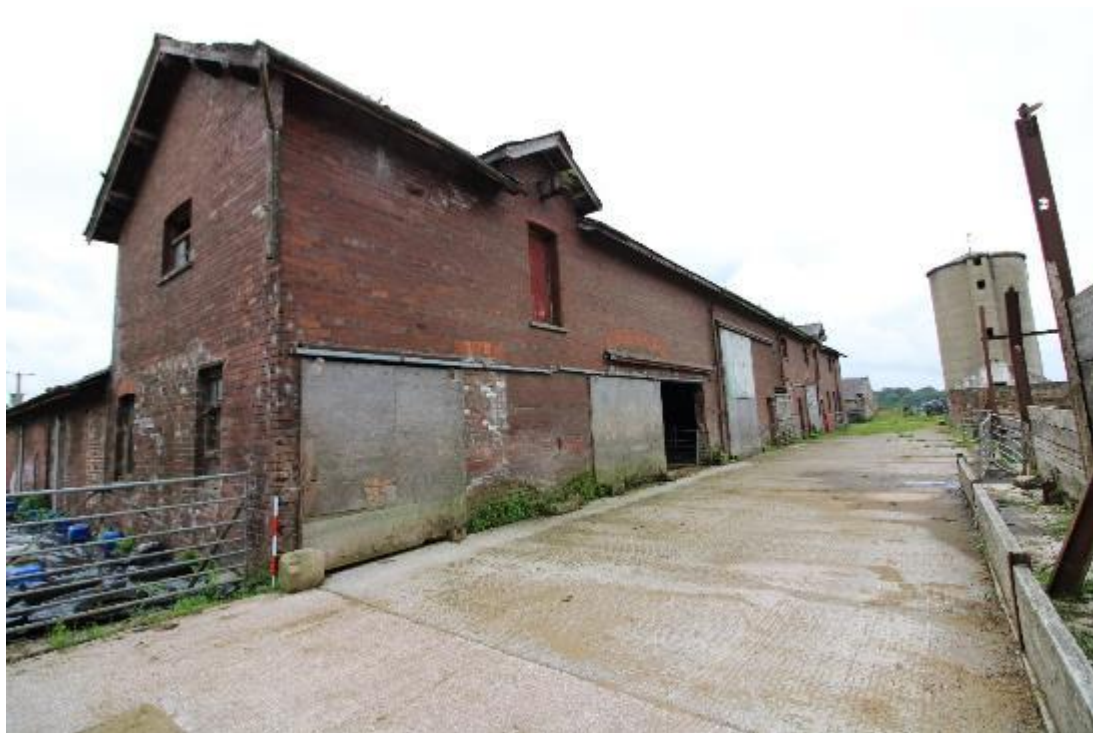
Plate 30: Northern elevation of northern range, facing south-west

A.3.2.10 At the east end of the northern elevation was a blocked ground-floor window, the blocking composed of mixed bricks (some with limewash adhering) (Plate 30). This was partly obscured by a modern sliding door. Above this was a first-floor doorway with moulded dark orange brickwork forming its arched header and jambs. There was a hoist above, set below a gabled dormer. Further west, at ground-floor level, was a blocked single-storey wagon doorway providing access into the northern part of the Covered Yard. This was supported by an orange brick arch, which had been infilled and replaced by a sliding door. The aperture for the sliding door had been crudely broken through the brickwork wall (as had the internal access). Further to the west, a second, two-storey sliding door had been replaced in sheet metal. Its header was of dark red brick in contrast to the orange brick used over many other apertures (Plate 31).

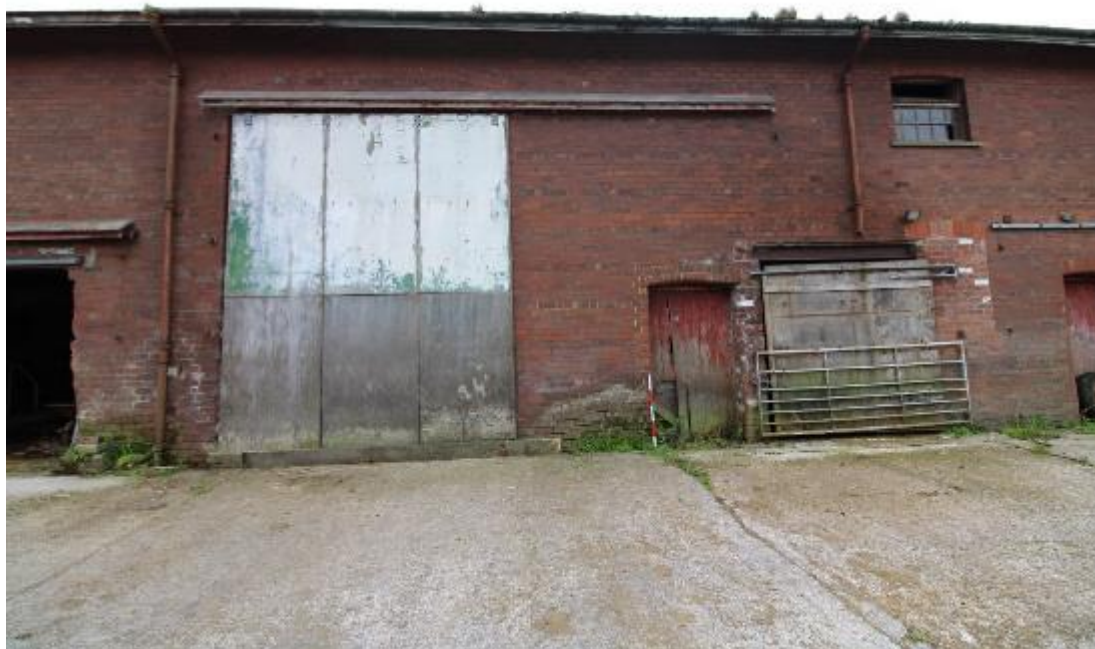
Plate 31: Two-storey sliding door at centre of the northern elevation

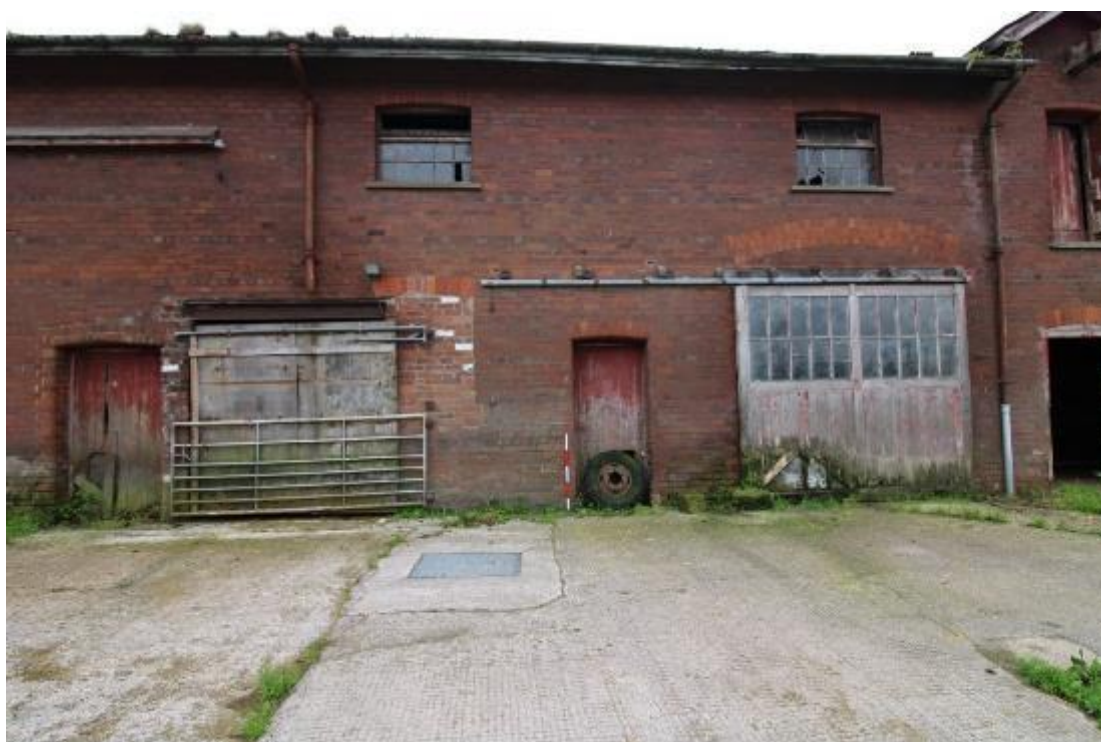
Plate 32: The central part of the northern elevation of the Central Block

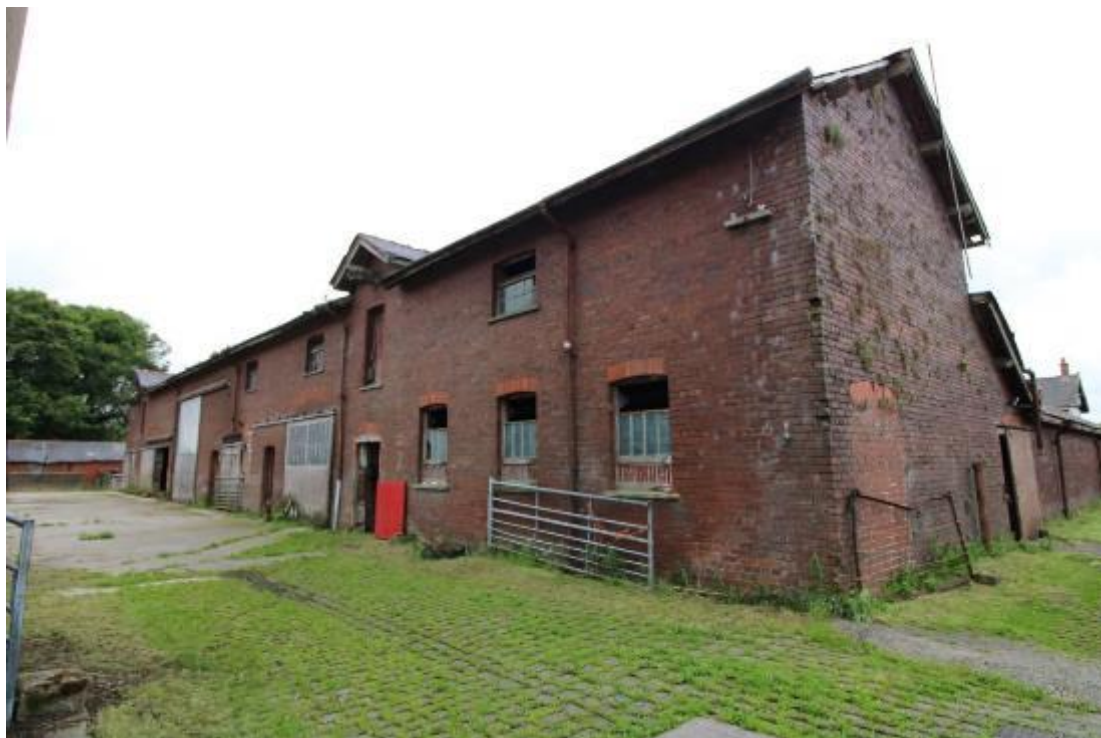
Plate 33: The northern elevation, facing south-east

A.3.2.12 The western half of the northern elevation had three identical ground-floor ventilated windows with arched headers in bright orange brickwork (Plate 33). There was one window at first-floor level above the central of the three ground floor examples. There was a single ground-floor doorway in this part of the range, with a first-floor example directly above, and, identical to that at the eastern end, a hoist set below a dormer gable.
