Brockhall Farm, Old Langho, Billington Archaeological Desk-based Assessment and Historic Building Survey

OA Reference No: 2020-21/2089

Archaeological Desk-based Assessment and Historic Building Survey

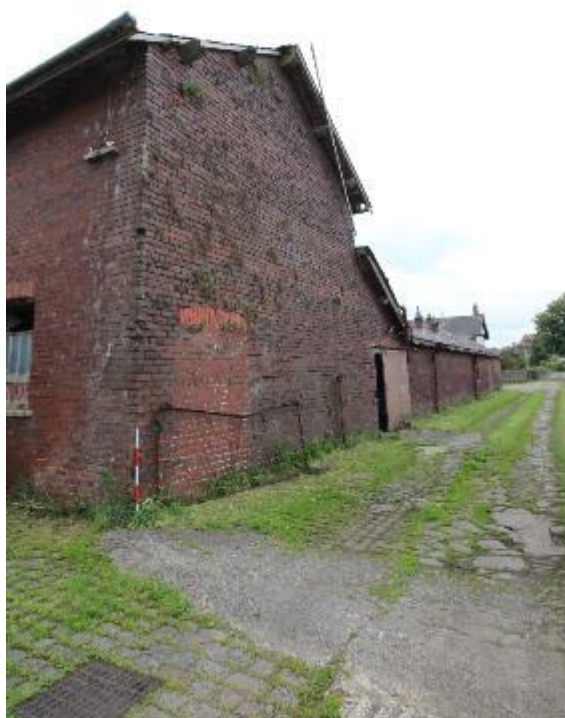
A.3.2.13 Western Elevation: The two-storey gable end of the western elevation of the Central Block had a blocked-in ground-floor doorway, with an orange brick arched header matching those on the north-facing elevation (Plate 34). No windows or other features were present. The brickwork, in poor condition, was characteristic of the remainder of the block, being formed of five stretcher courses to one header course. To the south of the main gable, and of the same build, was the gable of a catslide roof, its roofline providing continuity between the two-storey building and the remainder of the single-storey western range. An original single-width former doorway had been converted into a double-width doorway, with a sliding metal door inserted, giving access to the modern Dairy and Milking Parlour beyond (Plate 35). The former doorway had an orange-brick arched header.

Plate 34: Western gable end of northern range

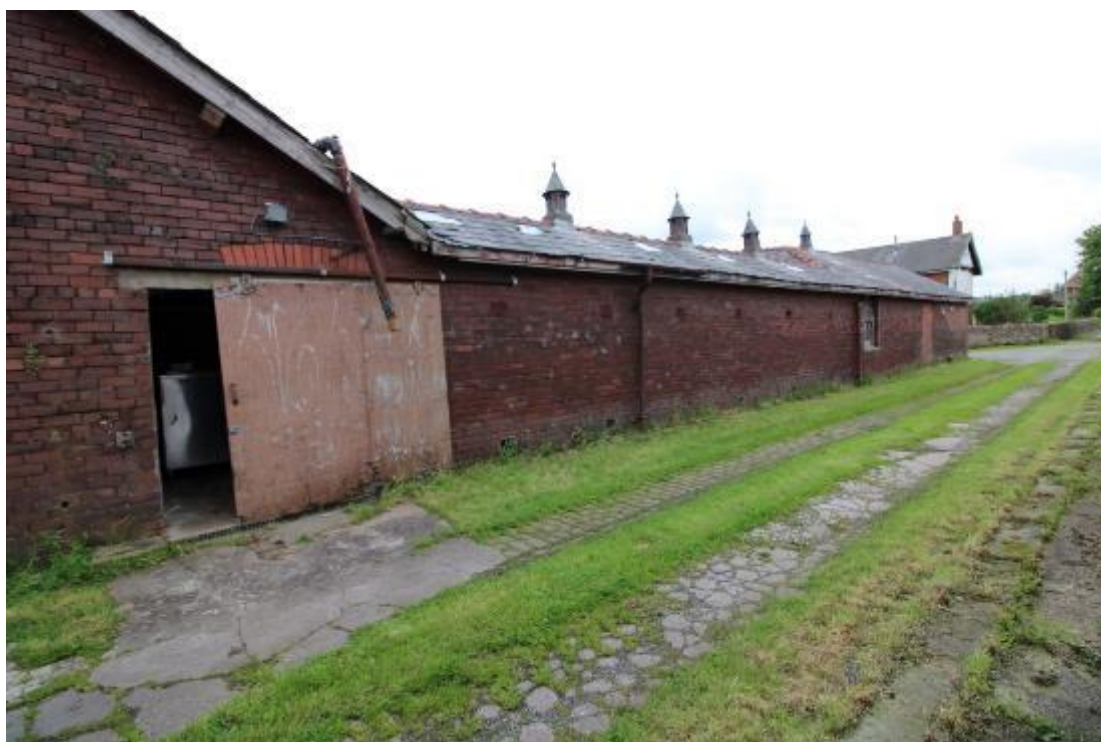
Plate 35: Modified entrance into Dairy, with rear wall of Pig Pens to right, facing south-east

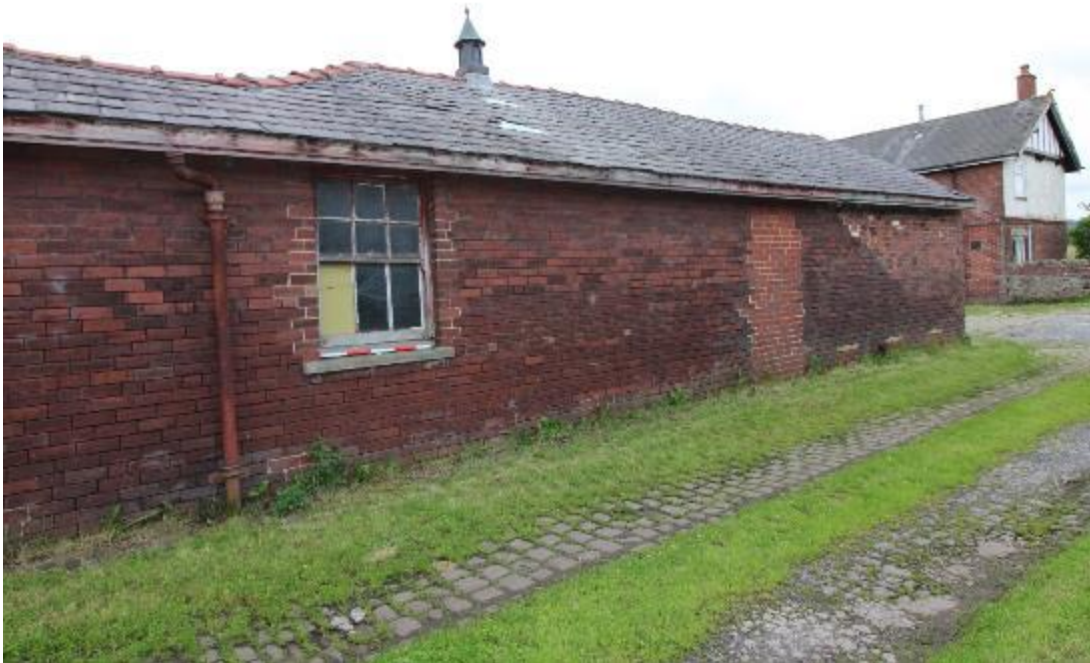
Plate 36: Inserted window, with blocked doorway to right, 1m scale

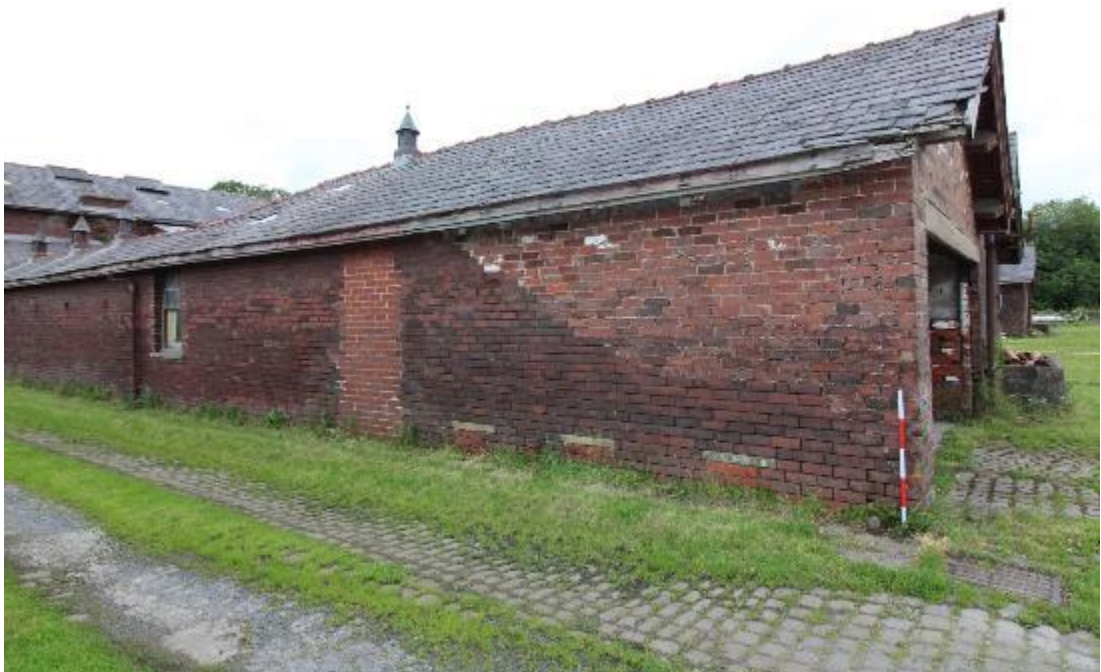
Plate 37: Southern end of western elevation, with 1m scale. Note the infilled apertures at the base of the wall (to the fowl houses labelled in Plate 7)

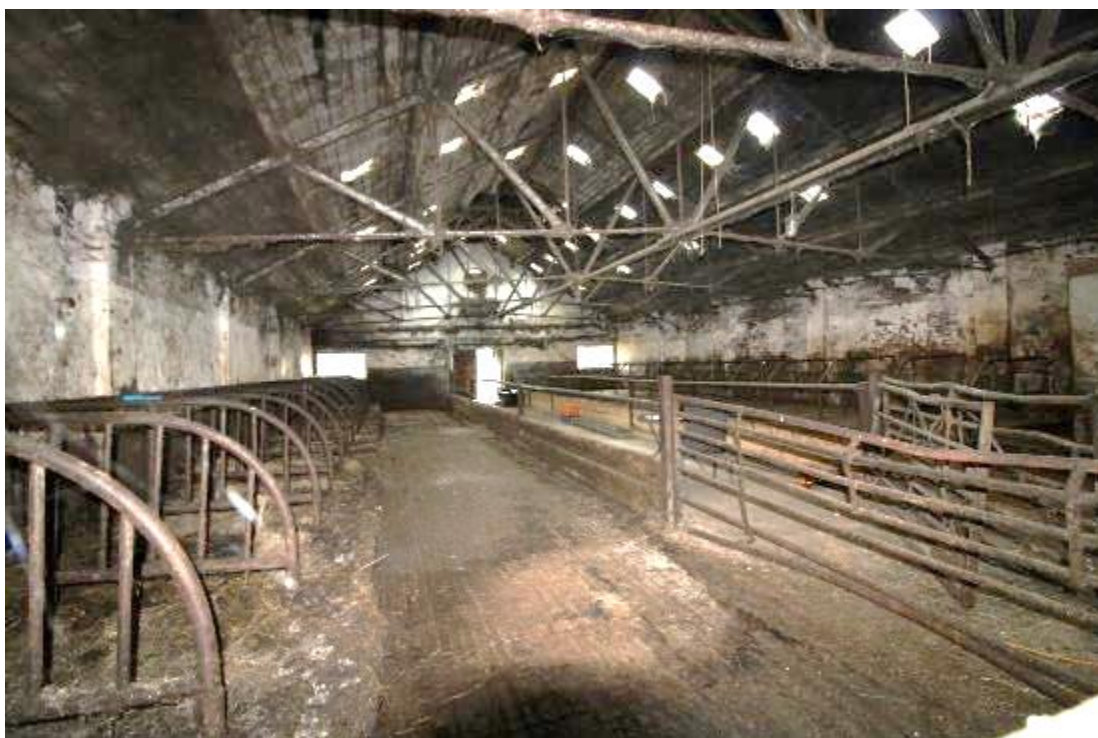
Plate 38: Shippon, facing south

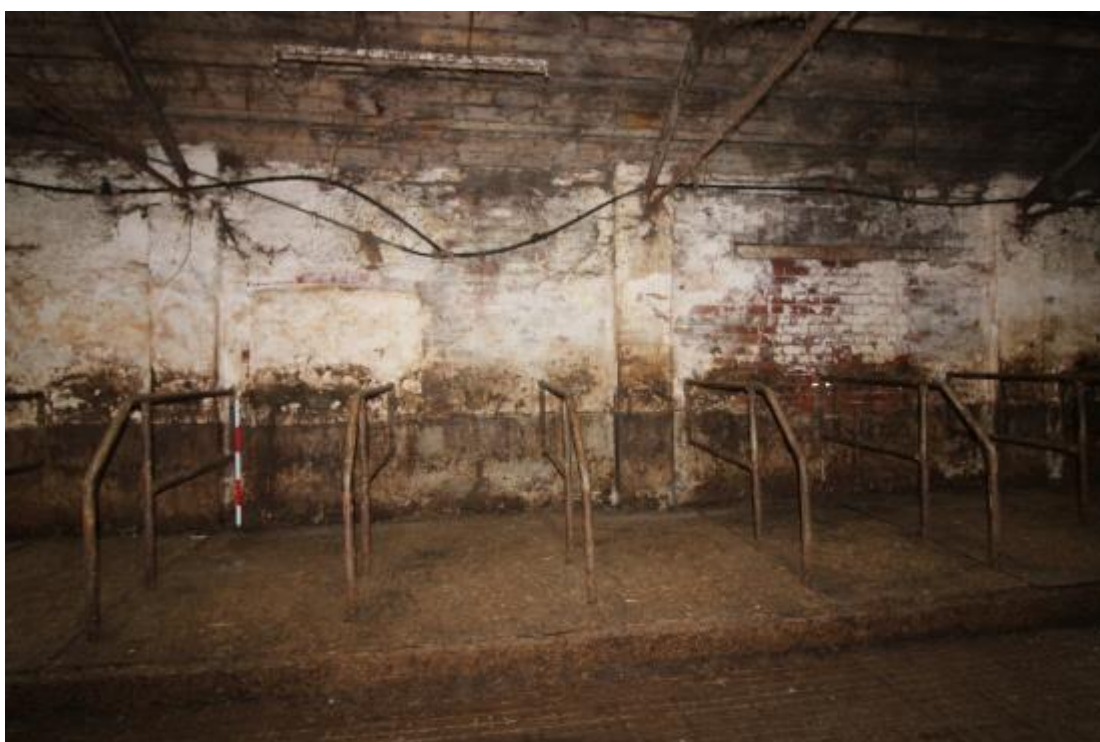
- A.3.3.3 The western wall carried the same arrangement of blocked doors and windows within the corresponding bays and would have provided light and access to the western Enclosed Courtyard (Plate 39). The northern end of the western wall had been cut away, with the insertion of a later Milking Parlour that protruded into the north-western corner of the Shippon as a plywood partition (Plate 40).

Plate 39: Blocked doorway at southern end of western wall, with 1m scale

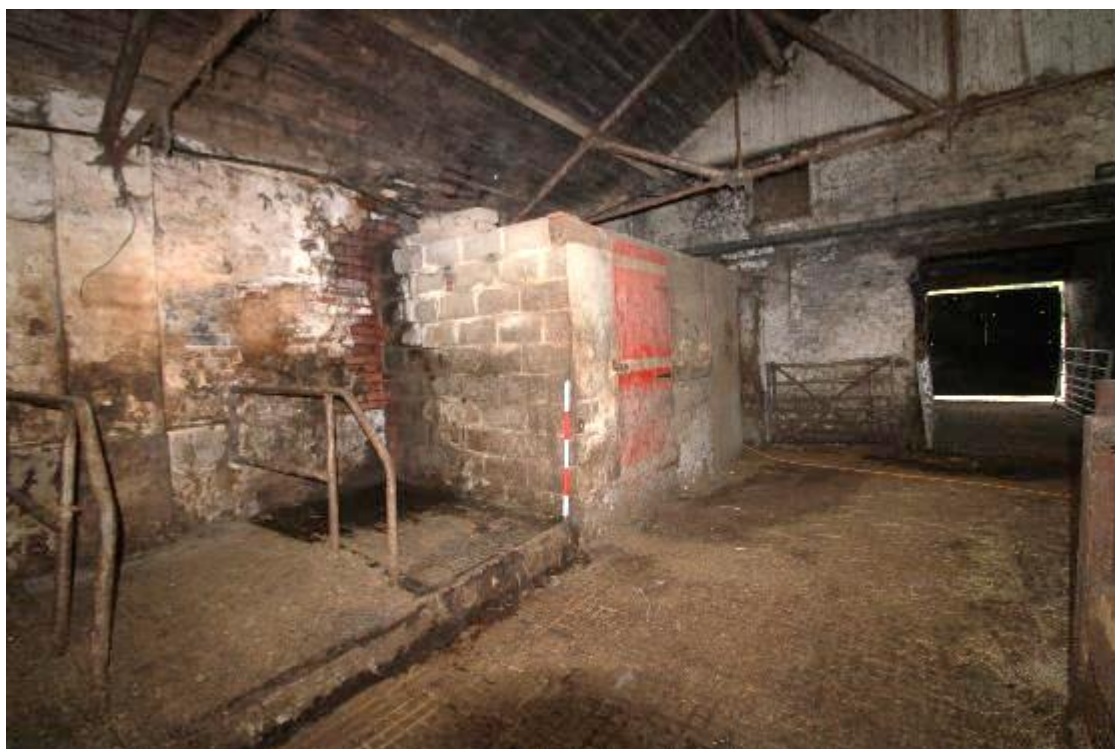
Plate 40: Milking Parlour intruding into north-western corner of Shippon, with 1m scale

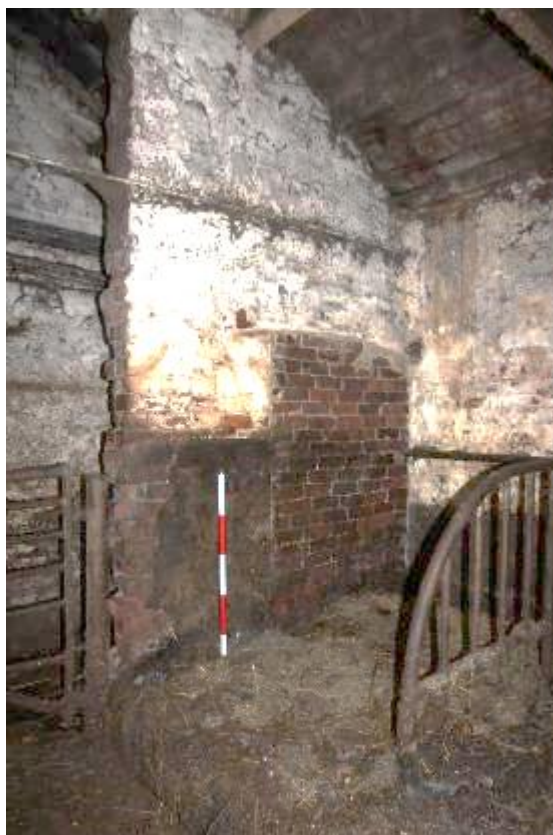
- A.3.3.4 The south end of the building exited through a set of double doors via the Lean-to in the central part of the southern yard. The northern wall had been largely dismantled, leaving just the eastern end which preserved the infilled remains of a pedestrian doorway (Plate 41). Prior to its removal, the wall formed the southern limits of a northern passage that ran across the full width of both the Shippon and Covered Yard, but a large hole had also been punched through the northern wall of this passage, supported by an RSJ to allow access for modern farming equipment via an opposing opening cut through the northern wall of the northern range (Plate 42).

Plate 41: Blocked doorway in north-eastern corner of Shippon, with 1m scale

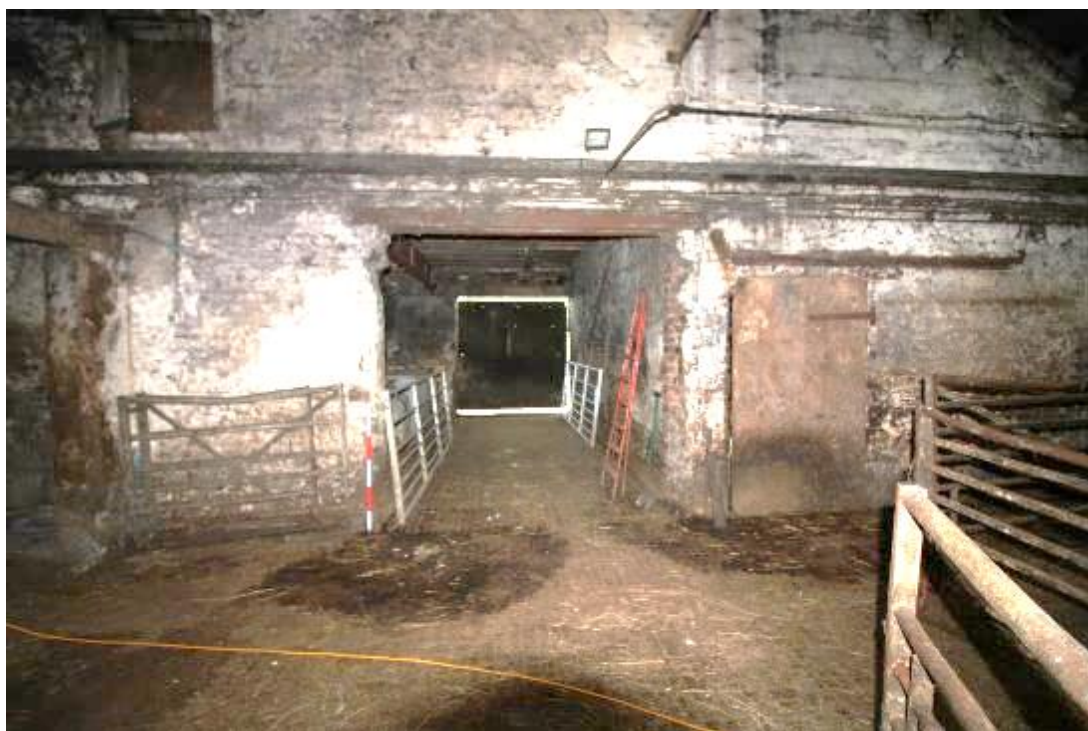
Plate 42: Shippon, facing north, showing knock-through into the northern range, with 1m scale

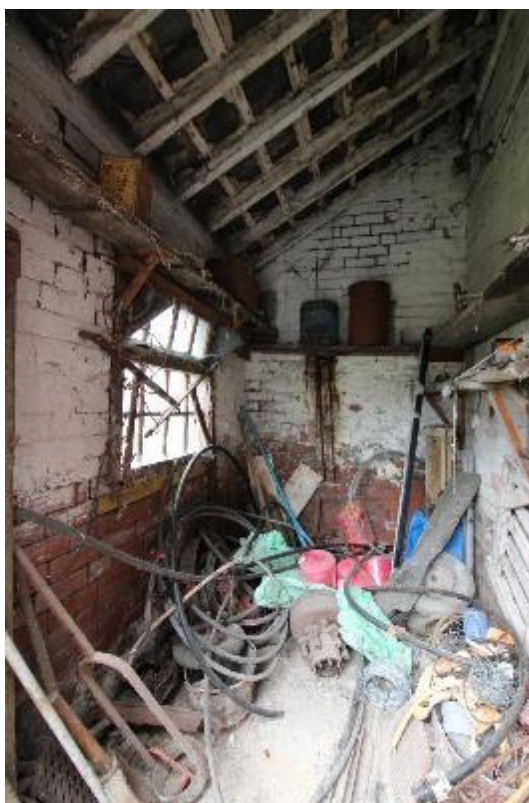
- A.3.3.5 The southern entrance to the Shippon was covered by a Lean-to that incorporated, on either side of the covered entrance, a small rectangular room (Fig 9). The eastern room was accessible from a doorway in its eastern wall and led into a cell with limewashed brick walls and common rafters (Plate 43). The floor was of concrete and the room was lit from the south by a fifteen-light window, with a continuous timber shelf carried across the northern, southern and western walls. The room at the western end of the lean-to was equipped as a small workshop, but here a timber ceiling had been fitted and a heater at the eastern end would have provided a degree of warmth (Plate 44).

Plate 43: Eastern cell of Lean-to structure

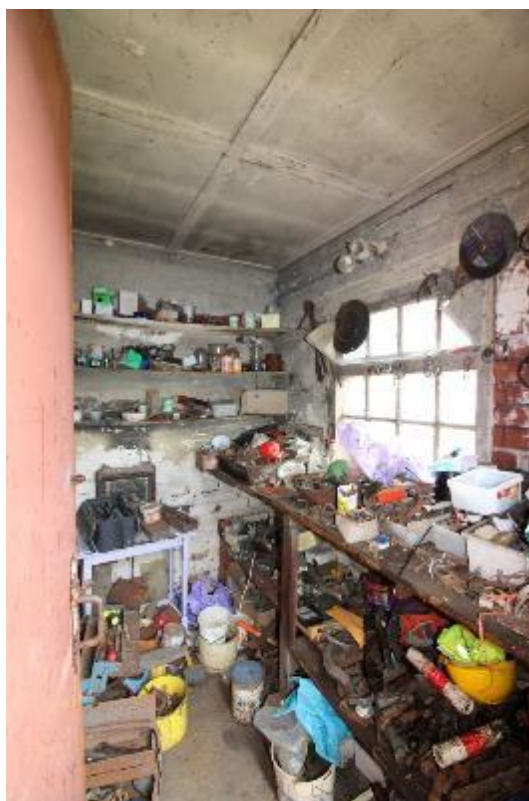
Plate 44: Interior of western cell of Lean-to, facing east

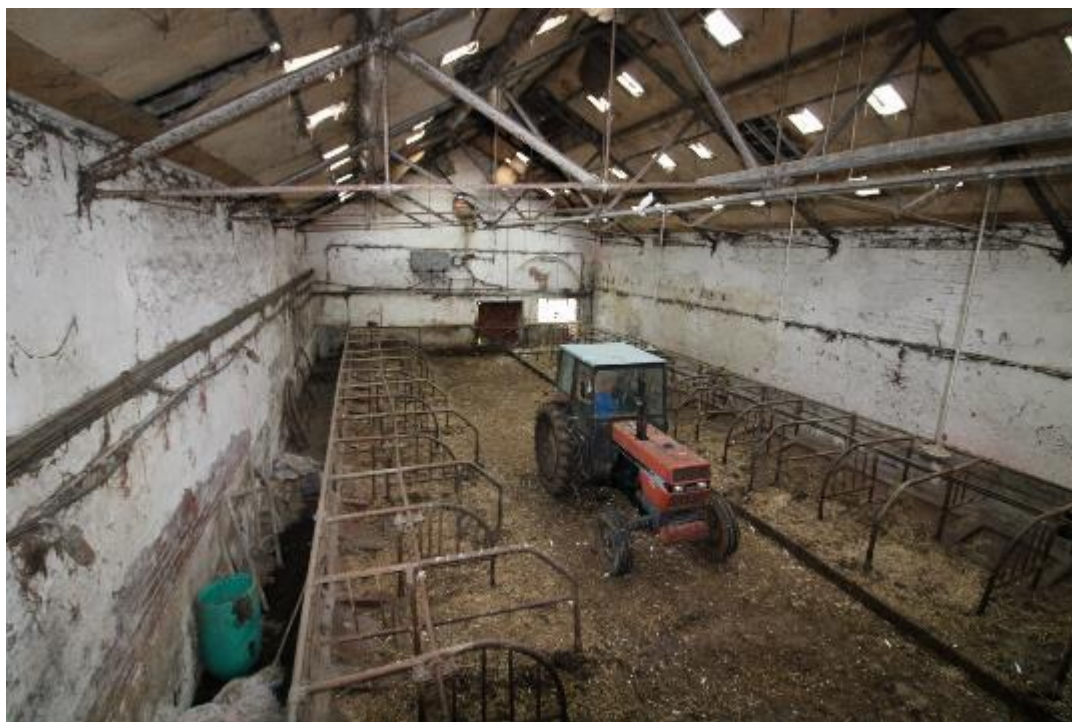
Plate 45: Covered Yard, facing south

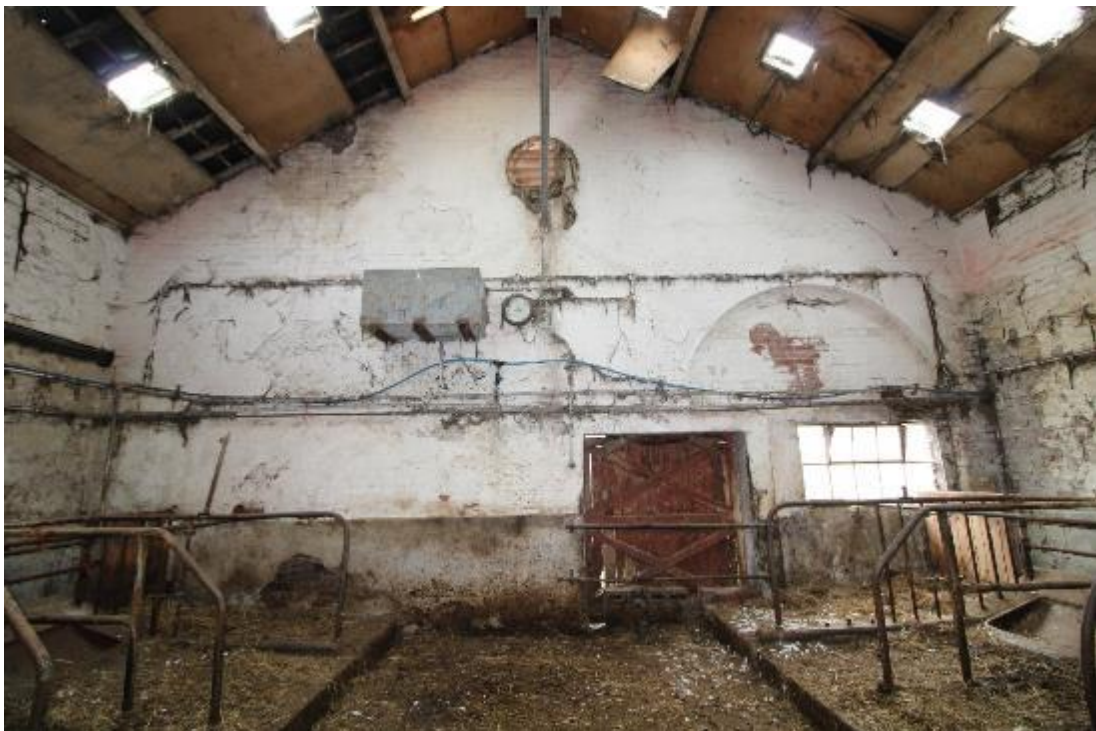
Plate 47: Southern wall, showing blocked entrance to right, facing south

- A.3.3.7 The walls of the yard were limewashed; the blocked former arched entrance (*Section A3.2.5*) was visible in the south wall where it had been replaced by a centrally-located modern sliding door when the yard was converted (Plate 47). Above this door and to the east lay a wall-mounted steel water tank with a clock to its west.

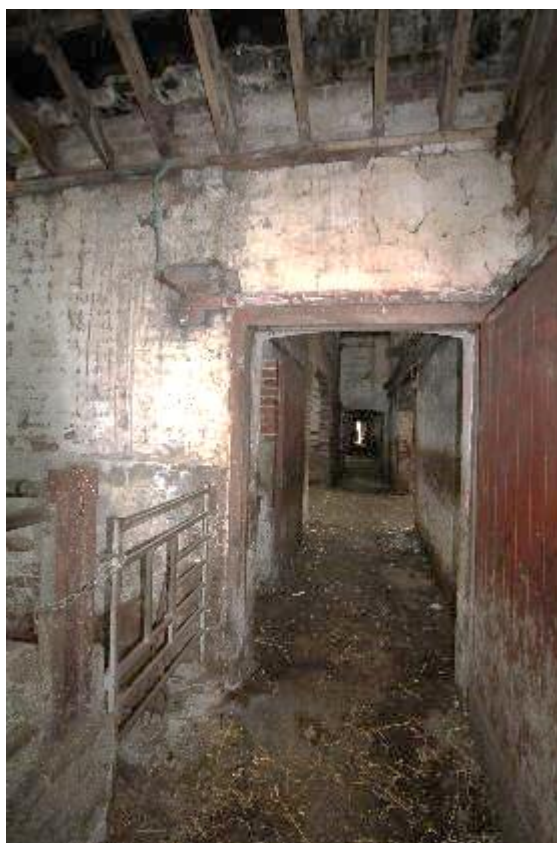
Plate 50: Entrance to Calving Shippon, facing west

- A.3.3.9 At the eastern end of the northern passage, a wide doorway (Plate 50) provided an entrance to the Calving Shippon, an elongated rectangular room with limewashed walls located within the single-storey eastern range (Figs 9 and 11). This room had a series of tubular steel stall partitions set upon a raised concrete plinth with a narrow front feeding passage to the west accessed, via a gate to the north (Plate 51). A manure passage occupied the eastern side of the building, with an external doorway at the southern end of the eastern wall as noted externally (*Section A.3.2.7*). At the north end, the lateral wall faces revealed the scar of a removed cross-wall that would have continued the northern feeding passage. A blocked doorway on the eastern external wall indicated where the passage would have exited the building (Plate 52).

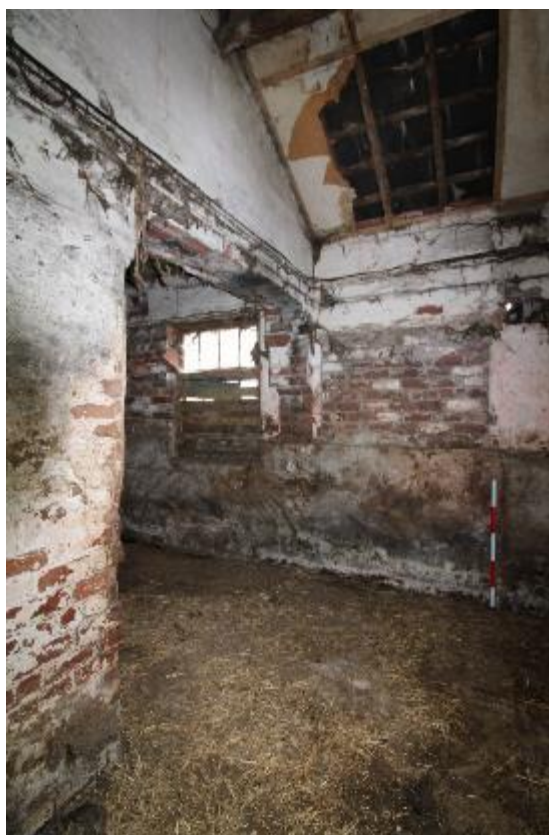
Plate 52: Blocked eastern doorway of northern passage, with widening doorway to left of frame

- A.3.3.10 At the eastern end of the northern wall of the feeding passage, a doorway appeared to have been widened to improve access to the eastern cell of the northern range (Plate 52). The single span pitched roof was supported by softwood limewashed King-post trusses. There were no windows but rooflights and a pair of ridge ventilators provided natural light and air flow.

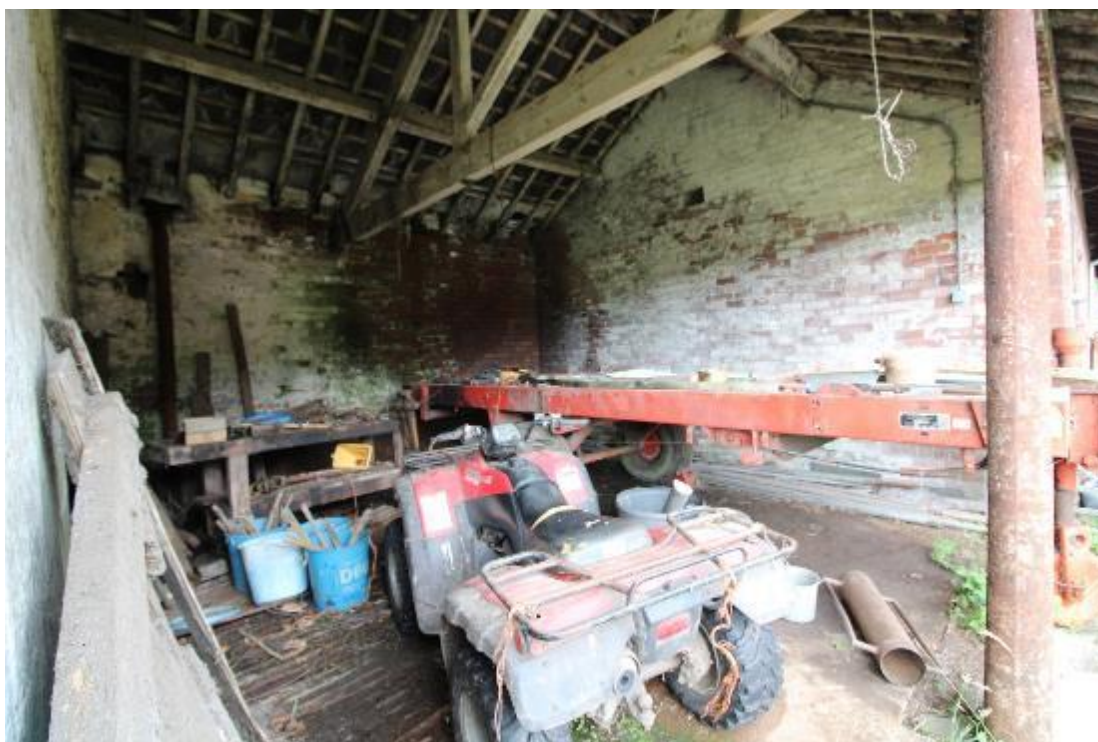
Plate 53: Northern cell of Cart and Implement Sheds, facing north-west

A.3.3.11 Adjoining the Calving Shippon to its south were two open-fronted sheds (Fig 9). The northern example was of two bays, divided to the east by a cast-iron column that supported the building's wall plate and the eastern end of a King-post roof truss (Plate 53). A ceiling-mounted crane hoist spanned both cells, with an operating handle located at the centre of the northern wall. The southern shed (Plate 54) was slightly larger but had been partitioned off at the southern end with a concrete block wall to form a narrow bay (Plate 55). This had access via an entrance at the centre of the partition wall, and from the pair of timber doors to the west (*Section A.3.2.7*). A series of steel sheets appeared to cover an opening in what was otherwise a concrete floor in the southern cell, and timber sheeting covered what may have been a similar aperture in that to the north: these features are likely to have been vehicle inspection pits. A roller shutter had been installed at the opening of the larger cell. The smaller cell accommodated a modern plastic tank and was evidently being used as a fuel store.

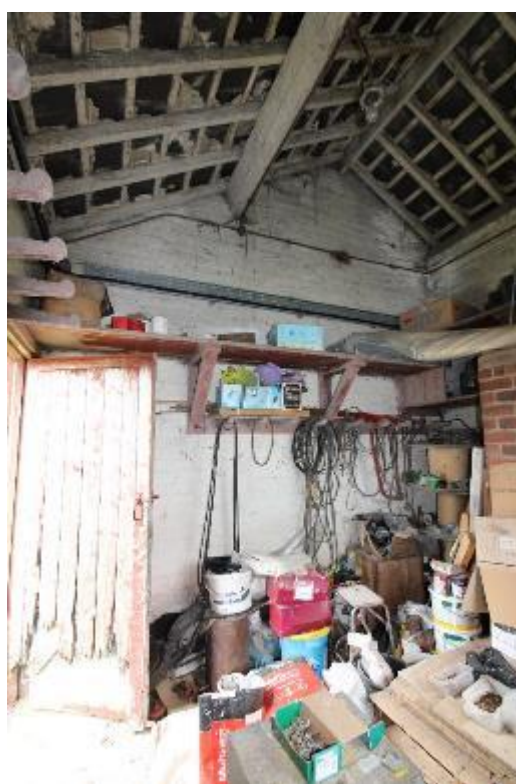
Plate 56: Tool House, facing north

- A.3.3.12 Adjoining the western side of the fuel store there lay a small square room accessible only from a doorway in its western elevation (Fig 9). Its exposed brick walls and roof timbers were coated in white paint, it had a concrete floor and was lit by a single three over six-light window on its southern gable (Plate 56). The room housed a modern tractor driven generator, lying beneath a row of timber pegs mounted on the western wall.
- A.3.3.13 The room's south-eastern corner had been annexed by the erection of a brick wall, creating a short corridor that led to a toilet in an adjacent cell and accessible from the only doorway in the southern gable wall (*Section A3.2.6*).

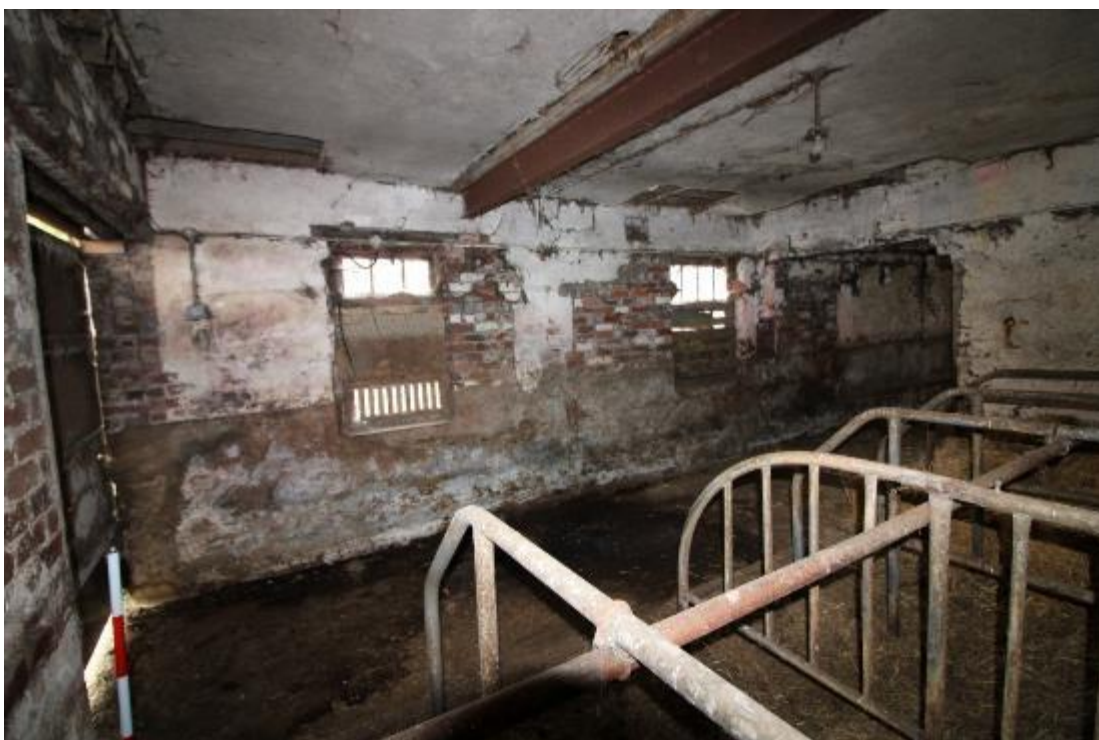
Plate 58: Cow stalls in the eastern end of the northern range

- A.3.3.15 The eastern cell of the northern range was a small square room, externally accessible from the sliding doorway at the eastern end of the building's northern elevation, and internally via the doorway that adjoined it to the Calving Shippon to the south (Fig 9). The room was lit by a pair of windows on the eastern wall. A raised platform to the west accommodated a series of tubular steel stall partitions (Plate 58).

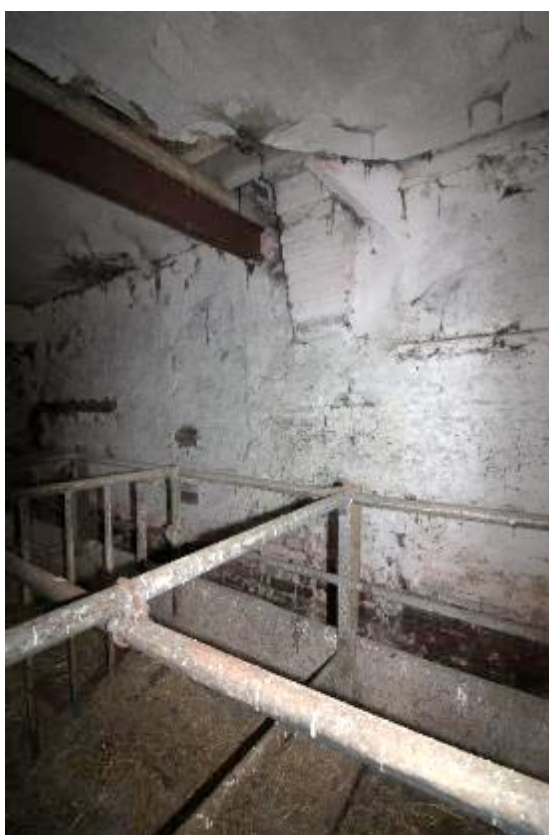
Plate 59: Corbelled brick flue on western wall of eastern cell

- A.3.3.16 A corbelled brick-built flue part way along the western wall with a blocked aperture at its base indicated the former position of a stove or fireplace (Plate 59). The room's walls had been coated in thick limeswash and the ceiling was of lath and lime plaster, suggesting a room of higher status than its present form. A scar within the ceiling indicated that the insertion of a steel beam across the width of the room had replaced a partition wall that had once divided the cell. This division coincided with the rebuilding work on the building's eastern wall which seems to have seen the blocking of a central doorway and insertion of the northern window (*Section A.3.2.8*).

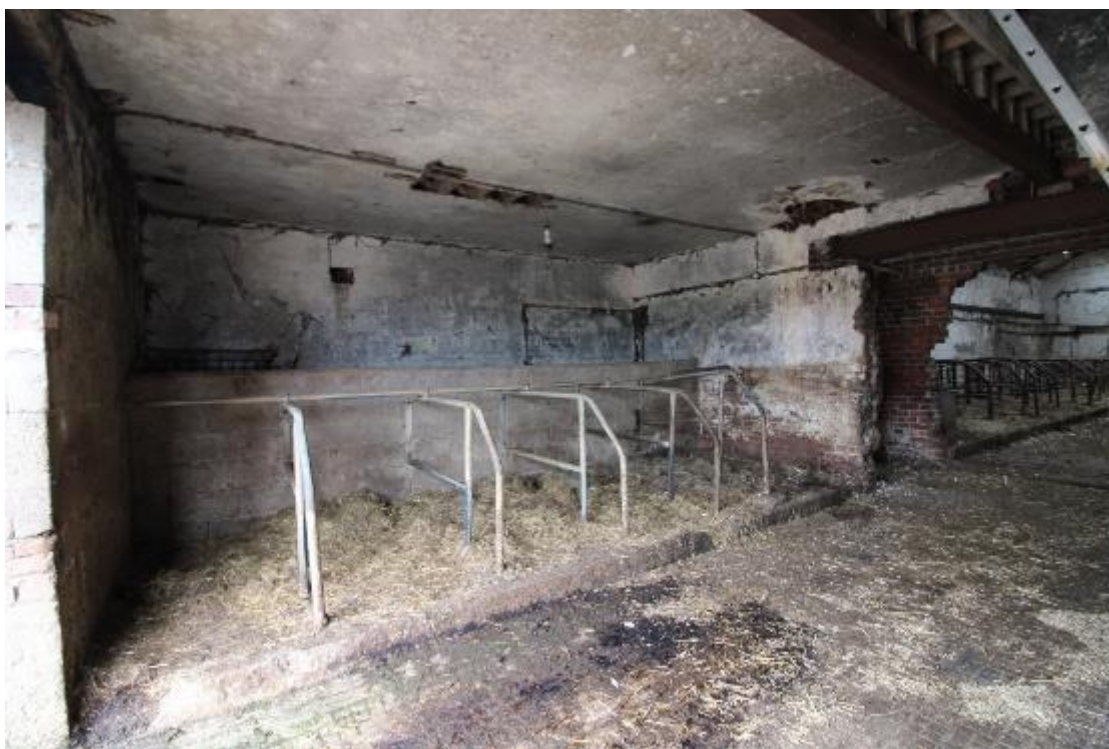
Plate 60: Former Gig House, facing south-east

- A.3.3.18 To the west of the eastern cell of the northern range was a small rectangular cell with a lath and lime plaster ceiling and limewashed brick walls that, according to architectural plans, had once served as a Gig House (Plates 10 and 60; Fig 9). A metal feeding rack had been bolted to the northern end of the eastern wall. The building's original northern entrance had been blocked and a half-height concrete blockwork cross-wall erected, which had rendered the eastern third of the cell inaccessible. A row of tubular steel stall partitions set upon a raised concrete plinth projected west from the face of this cross-wall, and the room's original western wall had been removed, effectively making the space an annex to the adjacent Barn.

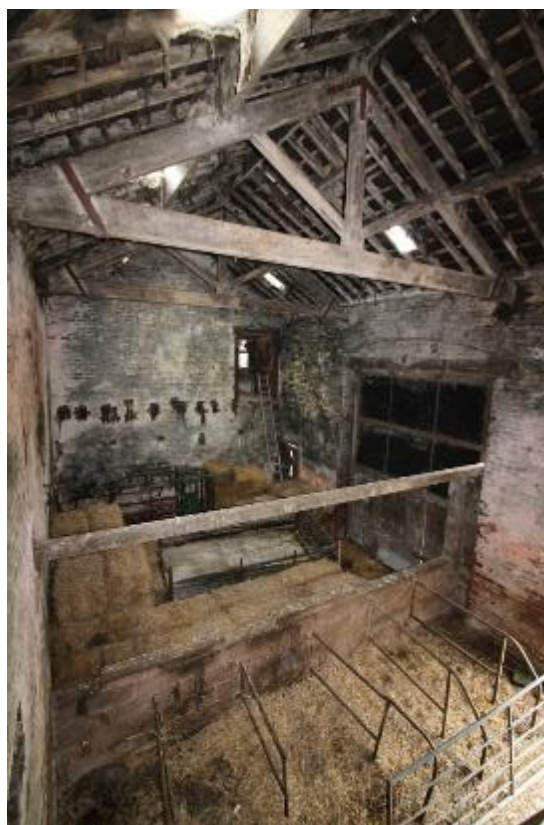
Plate 61: Barn, facing north-west

A.3.3.20 The Barn to the west of the Gig House was originally of three equal bays and open to its' full two storey height (Fig 9). External access was provided from the north by a pedestrian doorway in the western bay, and via a double-height cart entrance in the adjacent central bay (Plate 61). There was a third pedestrian entrance from the western end of the southern wall (Plate 62). There was another at first floor height at the northern end of the Barn's western gable wall. Below and to the south of this doorway a series of joists protruded through the face of the wall, with a further row of infilled sockets approximately 1m beneath, the latter indicating a former mezzanine floor (Plate 63). A low concrete blockwork wall had been erected immediately to the east of the double height entrance and spanned the width of the building, forming the western end of a row of tubular steel stall partitions. A timber cross beam had been installed above it (Plate 61).

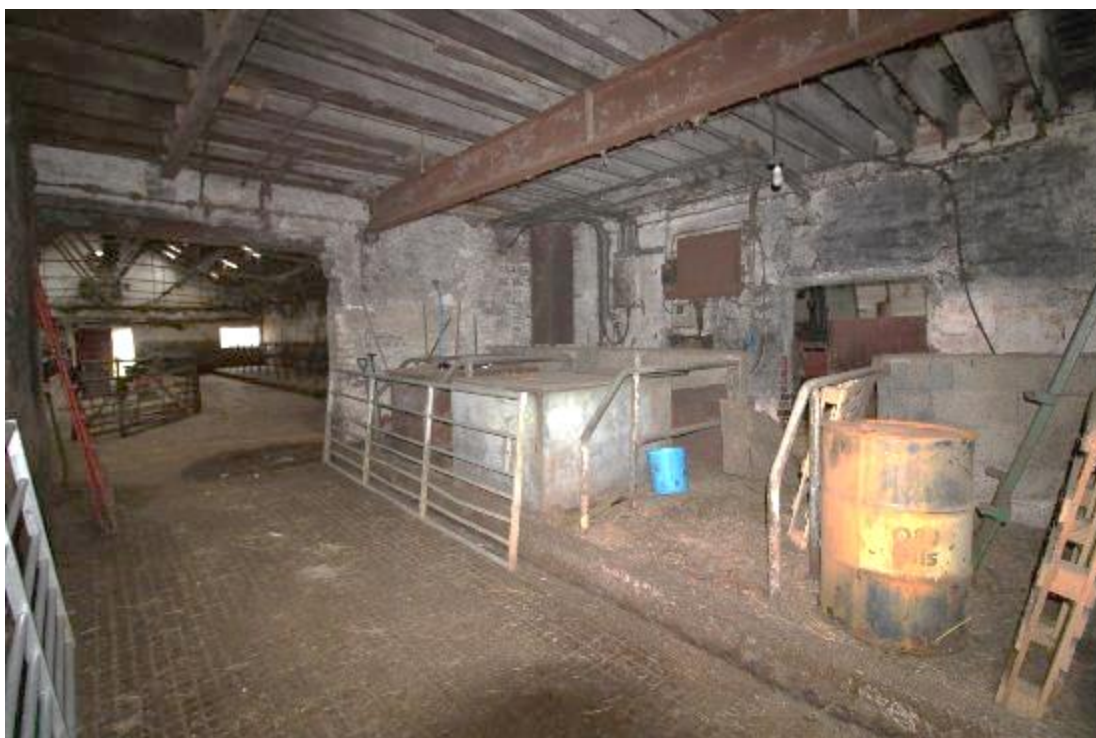
Plate 64: Root House, facing south-west

- A.3.3.23 Although the room's size and proximity to the Barn and the Shippon suggest it may have been a Root House, it had latterly been used as a cow house. A row of tubular steel stall partitions had been erected upon a raised concrete platform in the western half of the cell, facing onto a low cross-wall of concrete blockwork (Plate 64). The floor was laid in modern concrete, the brick walls were limewashed and with the exposed ceiling joists above were supported by an inserted RSJ.

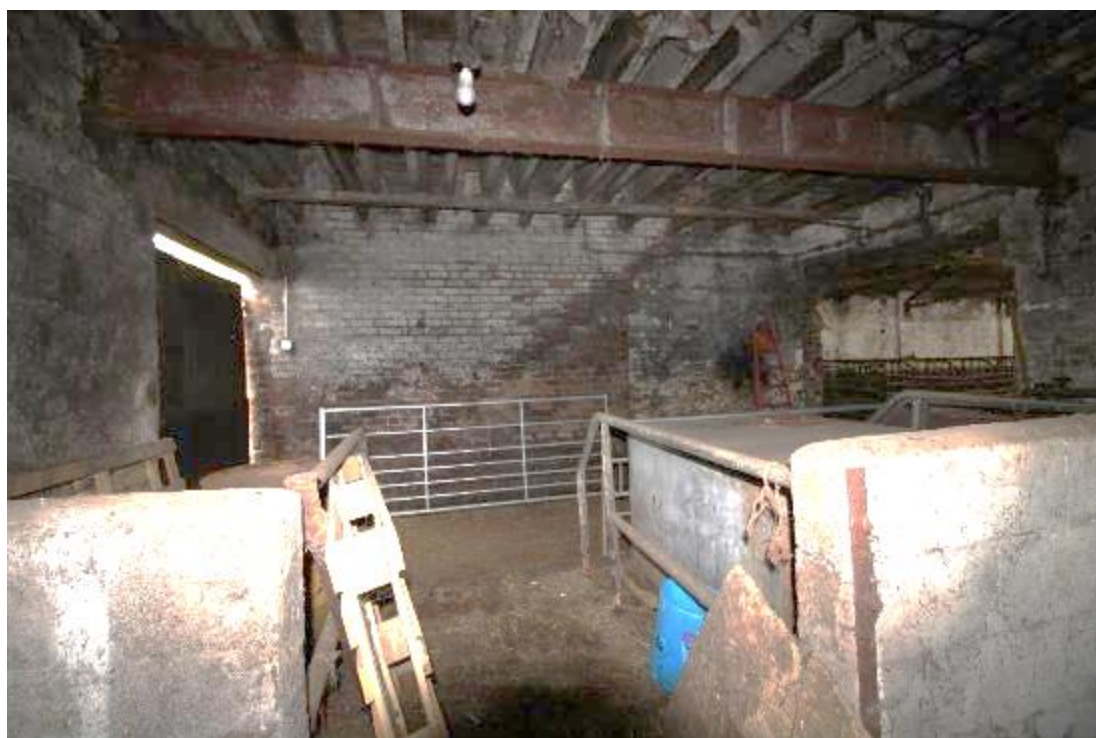
Plate 65: Root House, showing diagonal staircase scar on the eastern wall, facing east

- A.3.3.24 Examination of the eastern wall of the room revealed the distinctive diagonal scar of a staircase that had risen to first-floor height from the north to south (Plate 65). The removal of this staircase and the infilling of the stairwell on the floor above explained the timber stubs protruding from the eastern face of the western wall of the adjacent Barn (*Section A.3.3.19*).

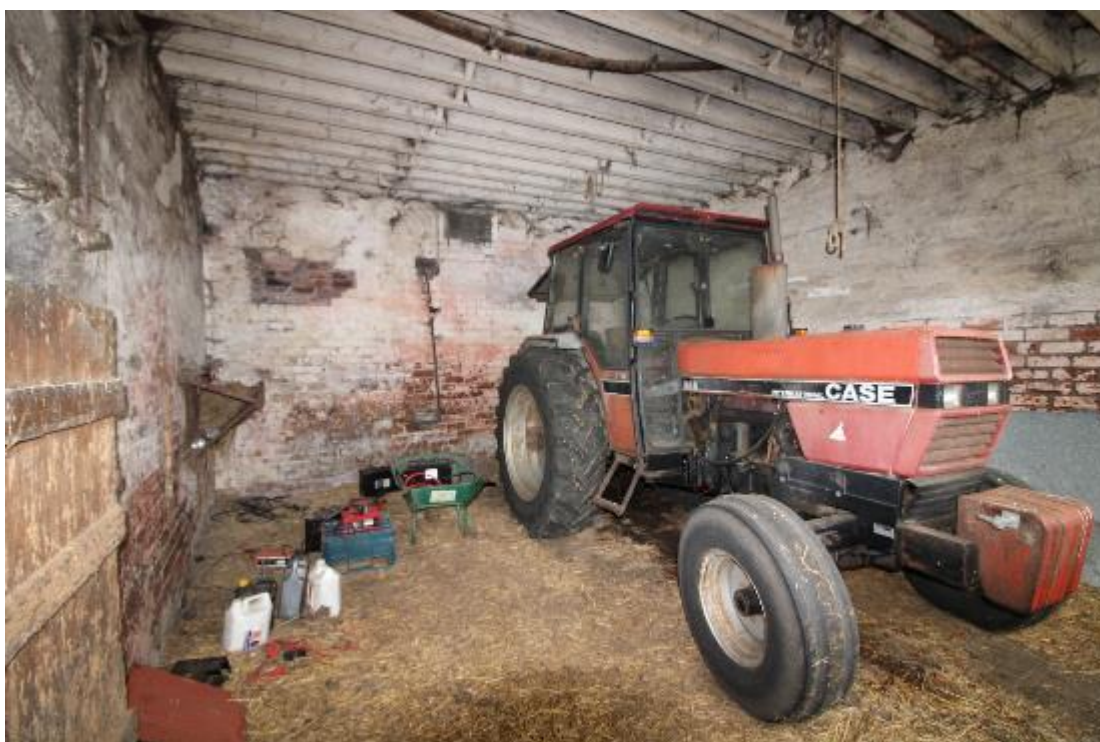
Plate 66: Mixing House, facing south

A.3.3.27 The floor was concreted and the brick walls were limewashed, as were the exposed joists of the first floor above (Plate 66). An iron hay rack bolted to the eastern wall and a water feeder at the centre of the southern wall indicated that the room had been used as a loose box (Plate 67). However, a narrow blocked vertical aperture to the north of the hay rack reminiscent of that used to transmit power via a belt and drive shaft system, suggested the room was once provided with mechanical power; along with its proximity to the Shippon, this suggested it was originally used as a Mixing House. A small square aperture near the head of the southern wall that may also have related to the transfer of power or perhaps provided ventilation.

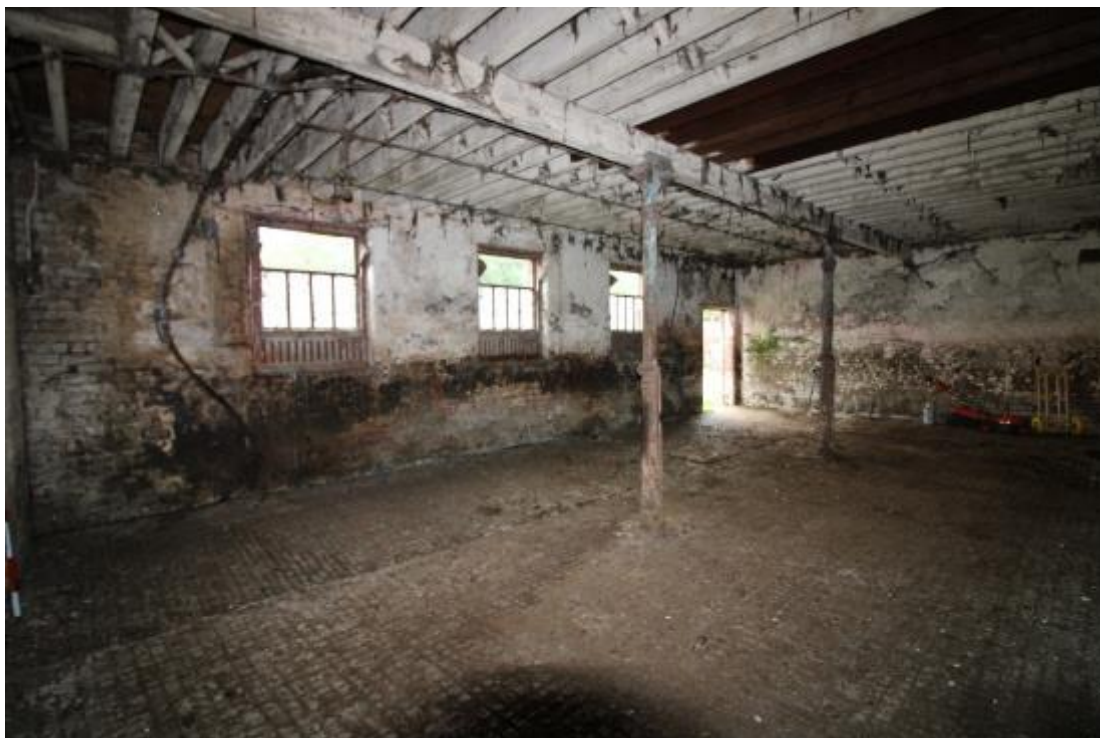
Plate 68: Western Loose Box, facing north-east

- A.3.3.28 At the eastern end of the northern range there was a large rectangular open-plan room of three bays as defined by a pair of cast-iron columns supporting a central axial timber floor beam (Plates 68 and 69; Figs 9 and 11). The walls and ceiling timbers were limewashed and the room was illuminated to the north by three ventilated windows. External access to the building was from a wide pedestrian doorway at the eastern end of the same northern wall. At the northern end of the western wall a pedestrian doorway of standard dimensions would once have provided a second entrance from the building's western gable end, but it had been infilled with brick (Plate 70). A narrow vertical channel set into the wall to the south of this blocked door was matched with the outline of a hatch in the first floor above, suggestive of chute.

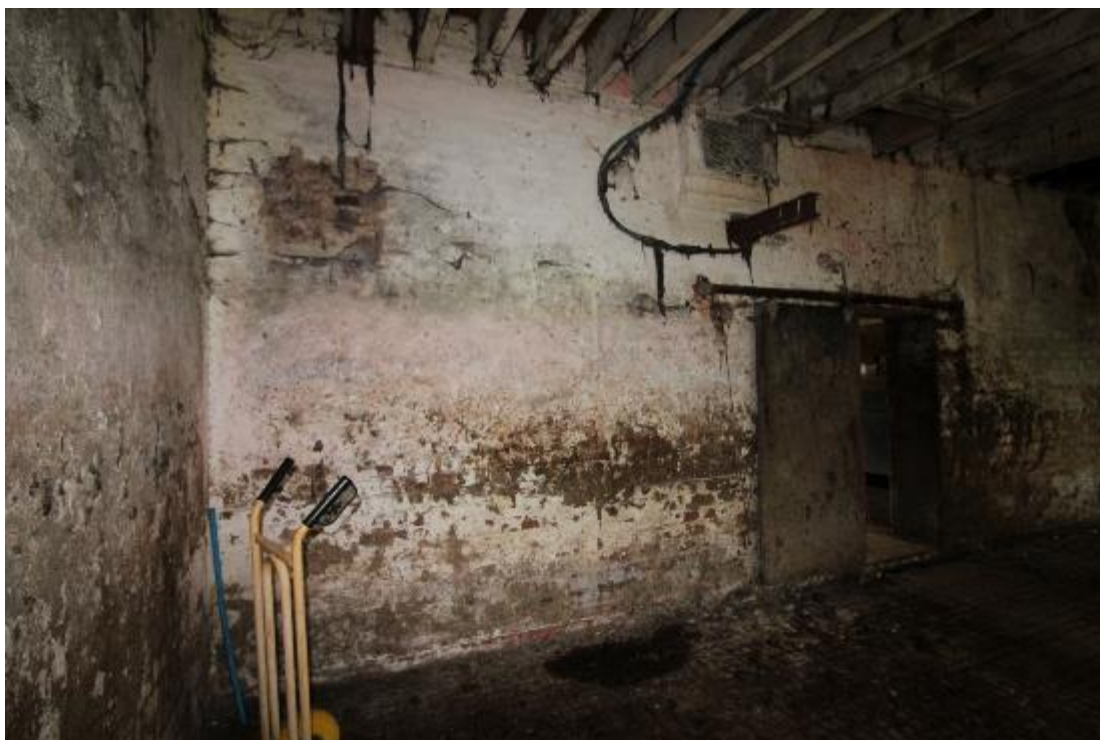
Plate 71: Southern entrance to the Milking Parlour with the ventilation aperture above and possible blocked bearing box to the left of frame

- A.3.3.29 At the eastern end of the southern wall a large opening with a sliding door connected the room with the Milking Parlour to the south. A corbelled square aperture with a wire mesh covering above this opening was possibly designed to provide ventilation (Plate 71). At the eastern end of the southern wall, a second square aperture had been blocked but was of a size reminiscent of a bearing box described in the detached Eastern Piggery (*Section A.3.6.8*).

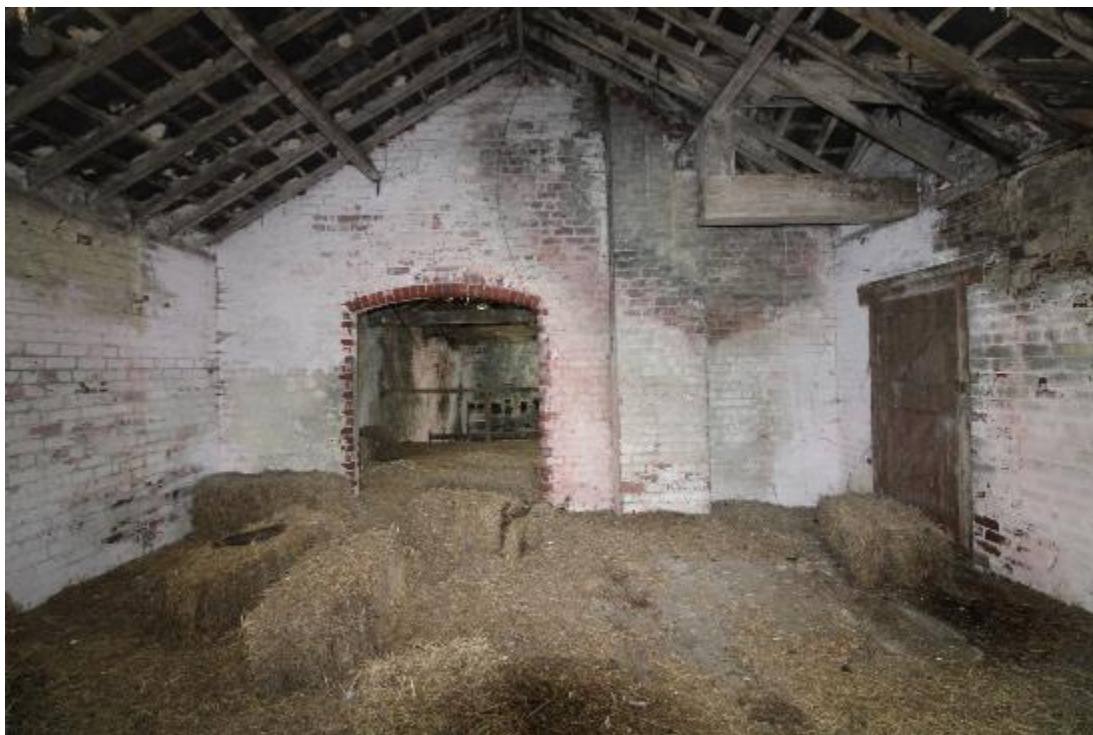
Plate 72: Easternmost room on first floor

- A.3.3.32 At the eastern end of the first floor, the eastern cell matched the footprint of the combined floor area of the Harness Room and Stable below. It was lit to the east by a central ten light window with a five-light hopper-style window above. Additional illumination came from a series of roof lights. At the western end of the northern wall, a taking-in door set into a gabled dormer provided access to the hoist at this end of the building (Plate 72). The substantial beam supporting the hoist projected into the room above the door. In the southern half of the western wall, a double-width doorway with a cambered brick arch connected the room to that to the west. On the same wall, a rectangular brick flue from the Harness Room projected from the face of the wall, continuing up through the roof.
