Brockhall Farm, Old Langho, Billington Archaeological Desk-based Assessment and Historic Building Survey

OA Reference No: 2020-21/2089

Archaeological Desk-based Assessment and Historic Building Survey

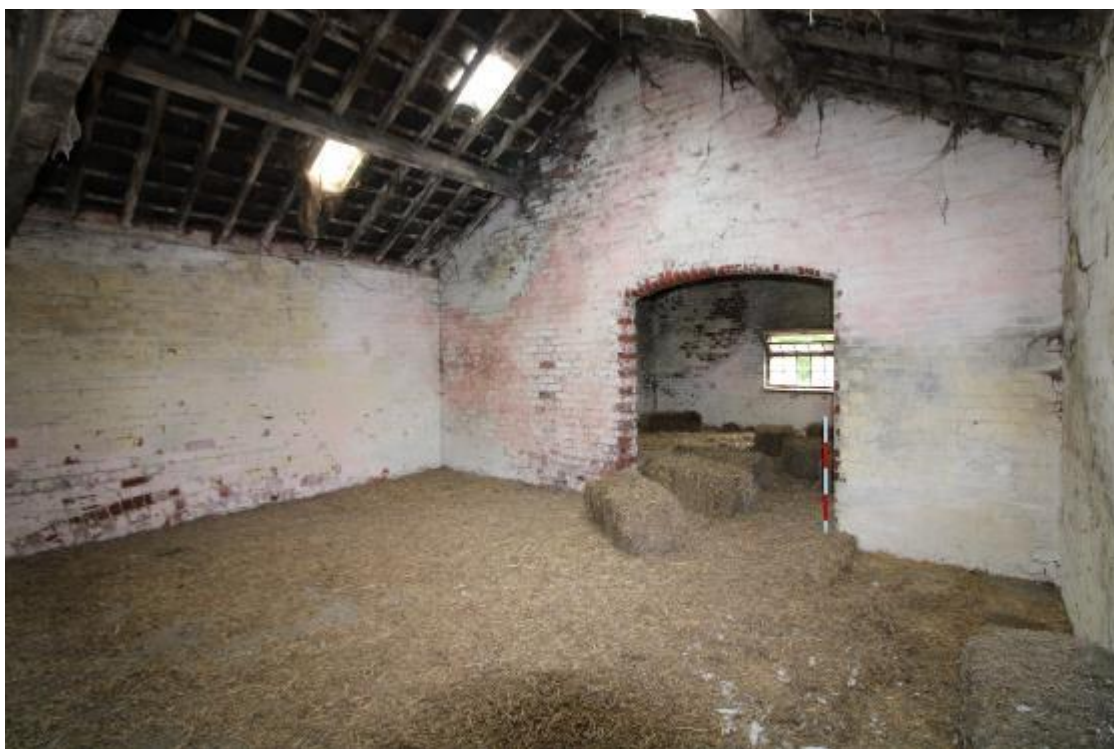
Plate 73: Penultimate eastern room on first floor, with 1m scale

- A.3.3.33 The adjacent room lay above the former Gig House and was of a similar size to the last, but it was open to the west, where it overlooked the Barn (Plate 73). Its only illumination came from the roof lights above and from this western side, where a King-post truss divided it from the remainder of the Barn. At the foot of the King-post, the letter 'B' had been inscribed as an assembly mark and the letters 'A' and 'X' could be seen in the same position on the Barn's remaining two trusses (Plate 74).

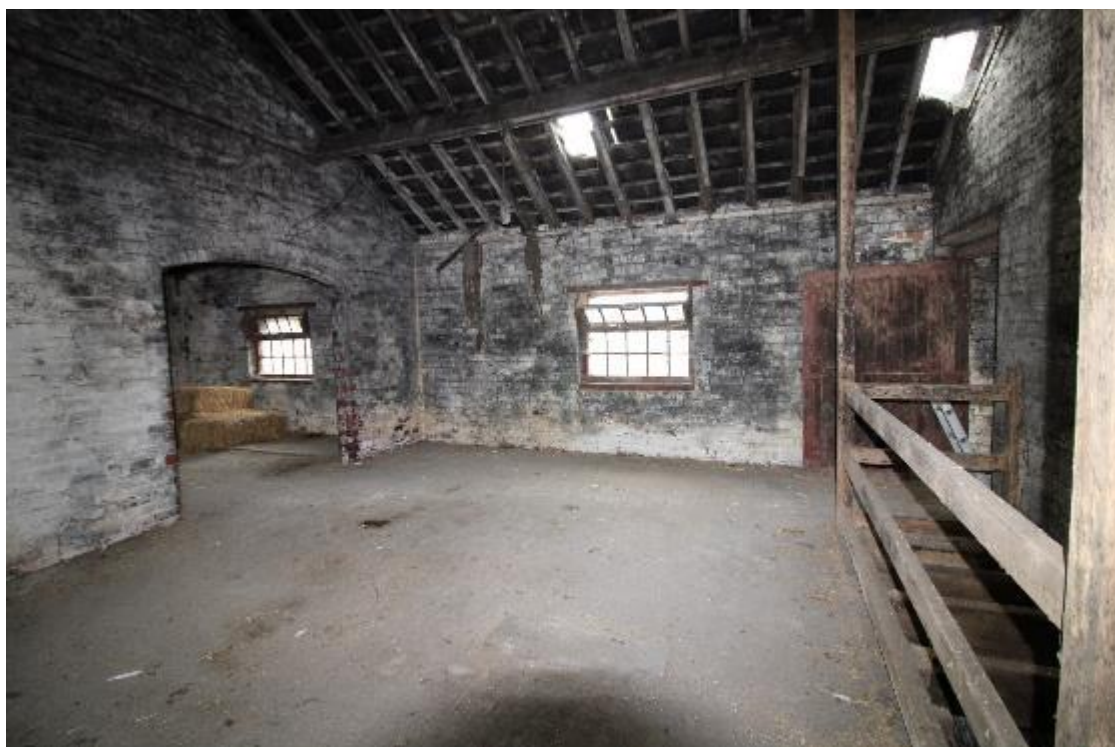
Plate 75: Infilled former stairwell to right of frame

- A.3.3.34 The only entry to the first floor above the western half of the northern range was via a ladder landing in the raised doorway on the western wall of the Barn. This doorway afforded entry to a square room with a 15-light window on the north wall, the upper third fitted with a five-light hopper (Plate 75). On the eastern wall, to the south of the doorway, a timber guard rail enclosed the former stairwell, which was infilled with floor joists. There was a double-width doorway beneath a shallow cambered arch to the north of centre on the western wall. In addition to the roof lights and window, the room had electric lighting.

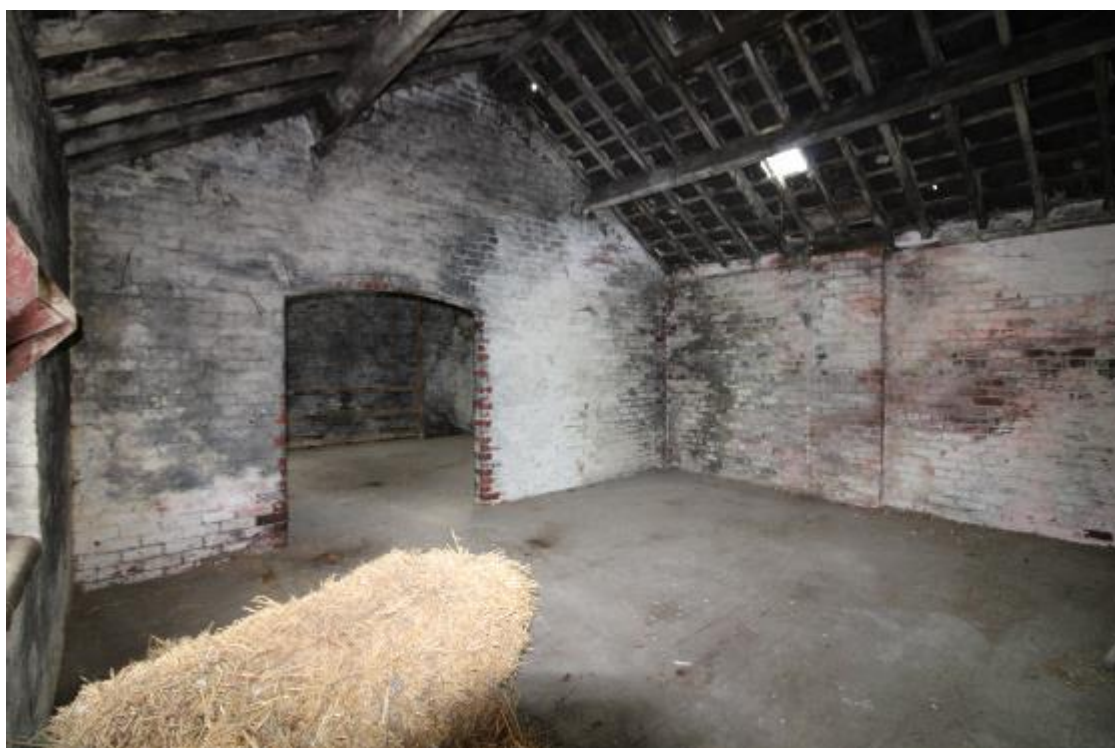
Plate 76: Penultimate western room on first floor, facing south-west

- A.3.3.35 The adjoining room was slightly smaller but had an identical window at the centre of the northern wall (Plate 76). On the opposing elevation, a shallow projection, perhaps the remnants of a flue, extended vertically up face of the wall. Another double-width doorway in the western wall led into the westernmost first-floor room.

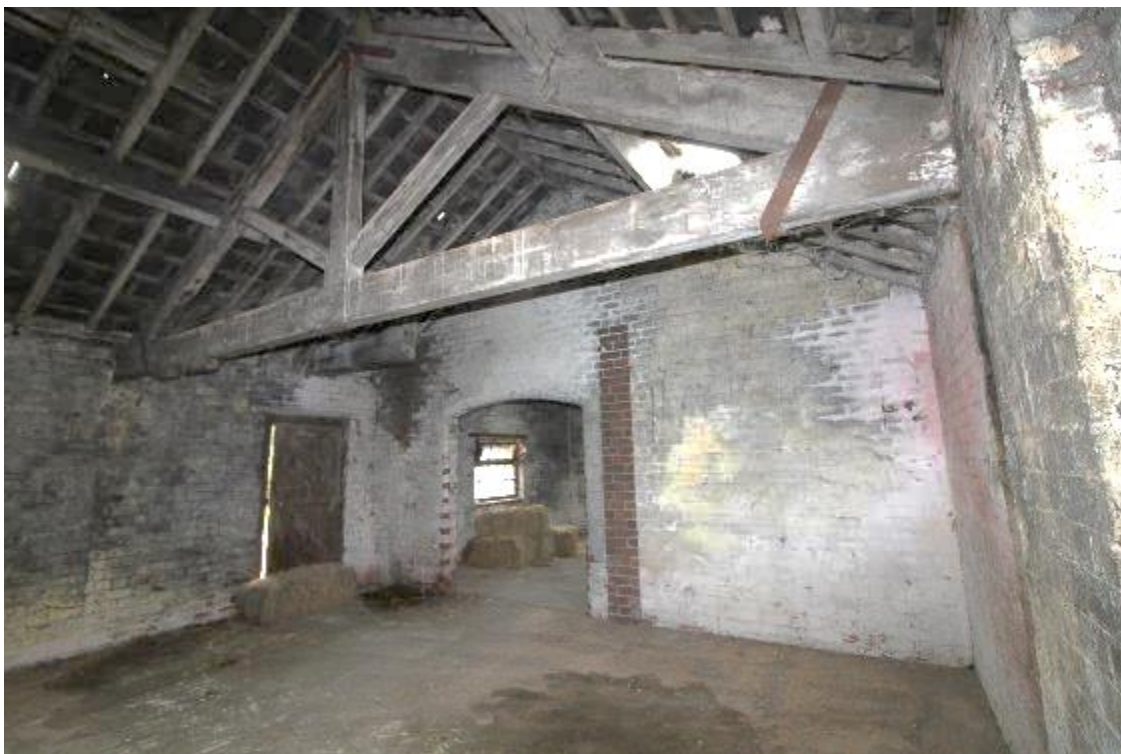
Plate 77: Western room, facing north-east

A.3.3.37 At the eastern end of the southern wall was another shallow vertical projection, identical to that described in the previous room. On the eastern wall, to the south of the entrance, the scar of what may have been a vertical partition was preserved by the absence of the white paint that covered the rest of the walls (Plate 77).

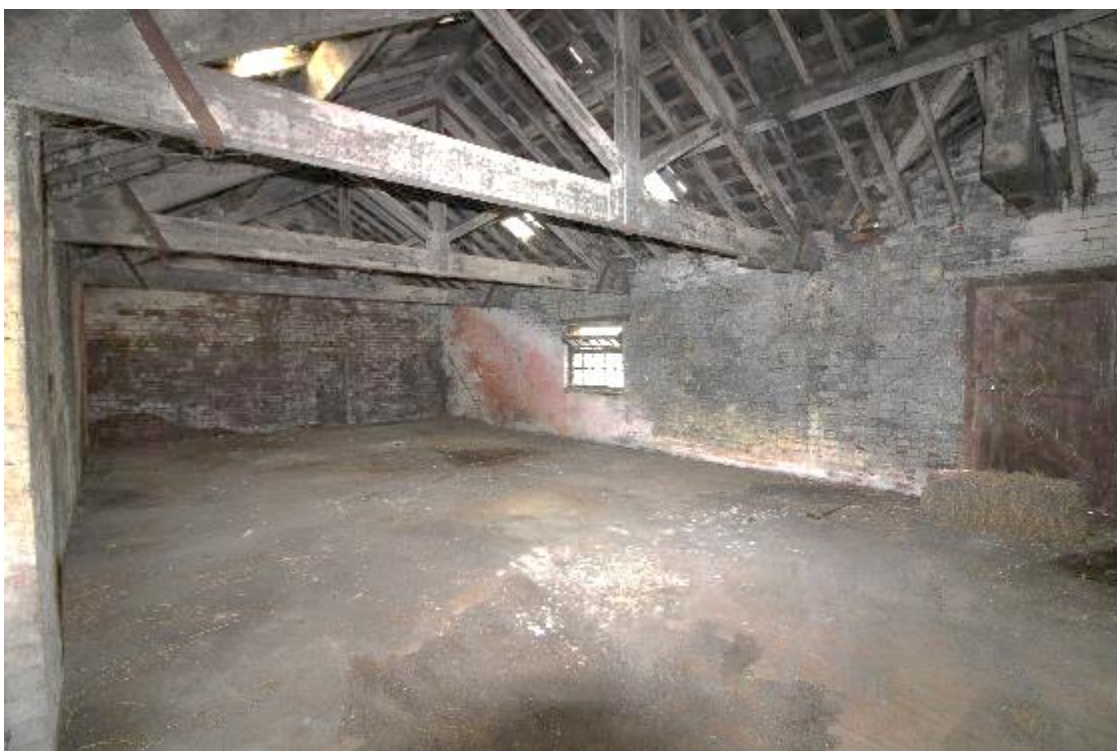
Plate 78: Western first-floor room, facing north-west

- A.3.3.36 This room was the largest on the upper floor and was divided into four bays by three King-post trusses, each inscribed with its own assembly letter from 'N', 'H', and 'I'. In the easternmost bay, there was another taking-in door beneath a gabled dormer as seen at the eastern end of the building, the rear of the hoisting arm again extending into the room above it (Plate 77). The room's only window lay to the west of centre on the same wall and was identical to that of the previous two rooms, roof lights providing additional illumination. On the western wall, a shallow vertical recess extended from the ground floor to approximately half height (Plate 78), corresponding to the feature identified on the ground floor of the same wall (*Section A.3.3.27*).

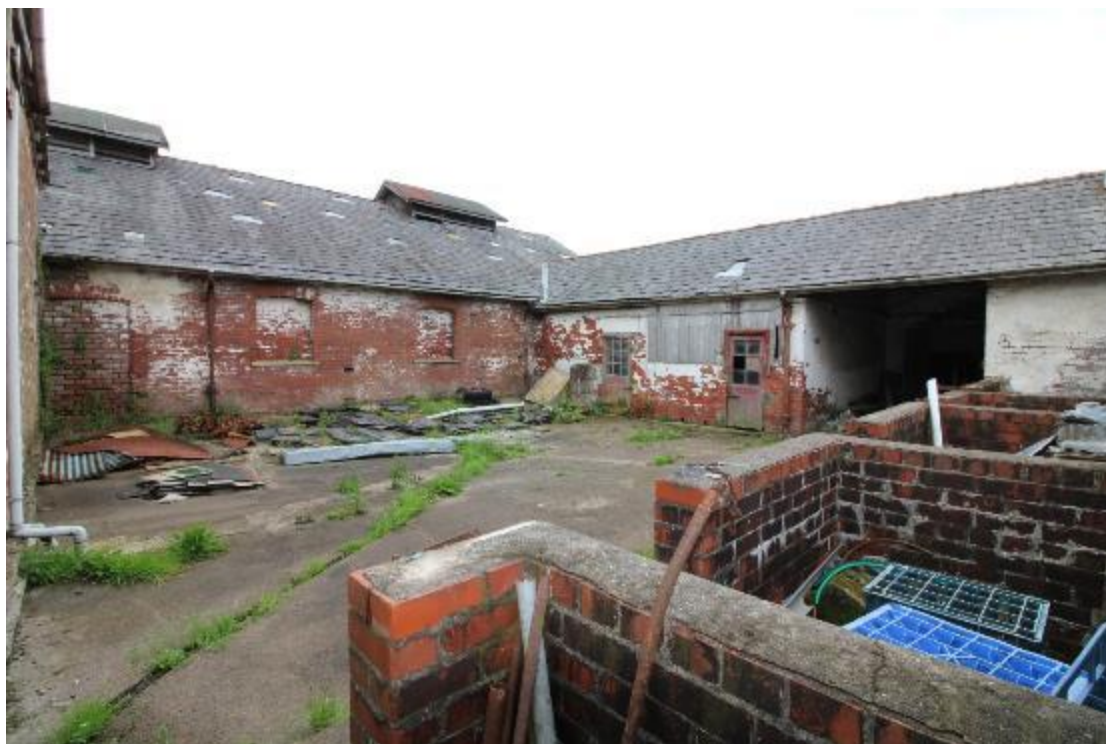
Plate 80: Courtyard, facing south-east

- A.3.4.3 The southern elevation of the yard had also been coated in thick limewash, and a half-glazed nine-light door at the eastern end was matched by a six-light door to the west, providing access to a pair of loose boxes (Plate 80). At the eastern end of this elevation a butt joint identified the loose boxes as belonging to a later phase than the Shippon. The western end the front wall of the western loose box was brick to half height and timber clad above.

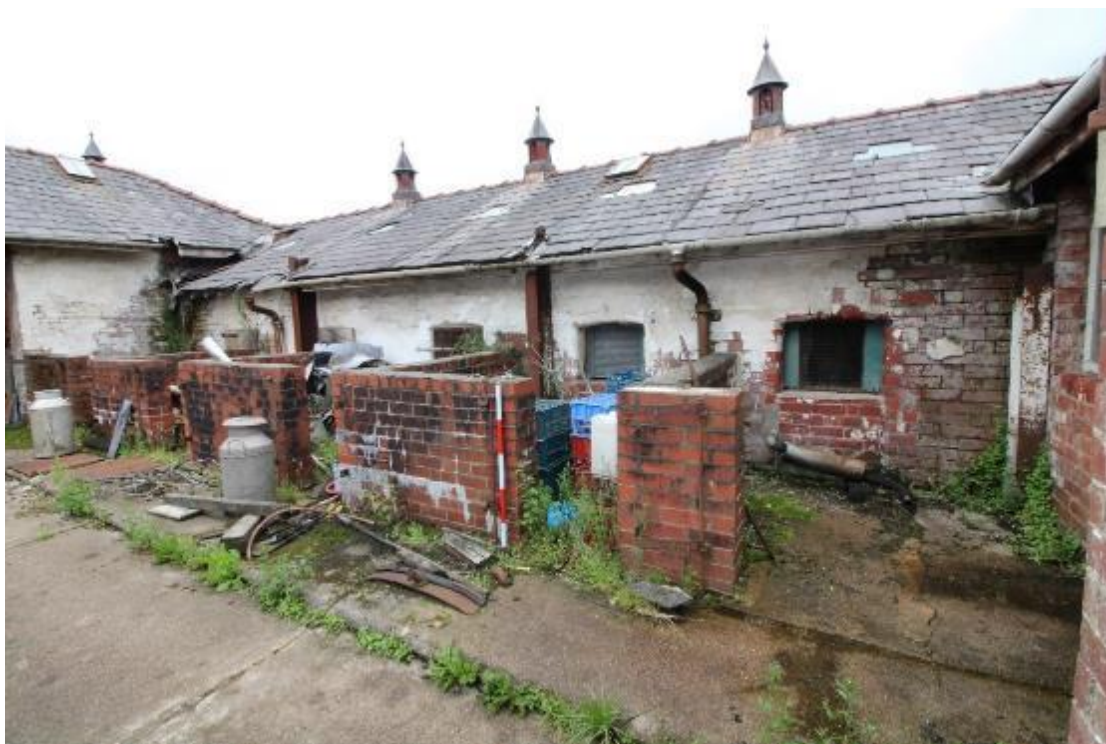
Plate 81: Pig Pens on western side of Courtyard, with 1m scale. Note change in roof height to left above Loose Boxes

- A.3.4.4 On the western side of the courtyard, each of the five Pig Pens had its own external yard enclosed by a half-height brick wall, with an entrance to the east and a low door beneath a shallow cambered arch beyond leading to an internal pen (Plate 81). The three northern doors had been part-blocked with brick to create small windows, while the remaining two had been fitted with modern plywood doors. Although subsequently truncated, it was evident there had been a vertical steel post erected at either end of the elevation, probably to support a roof. Two more posts spaced at thirds along its length survived in better condition.

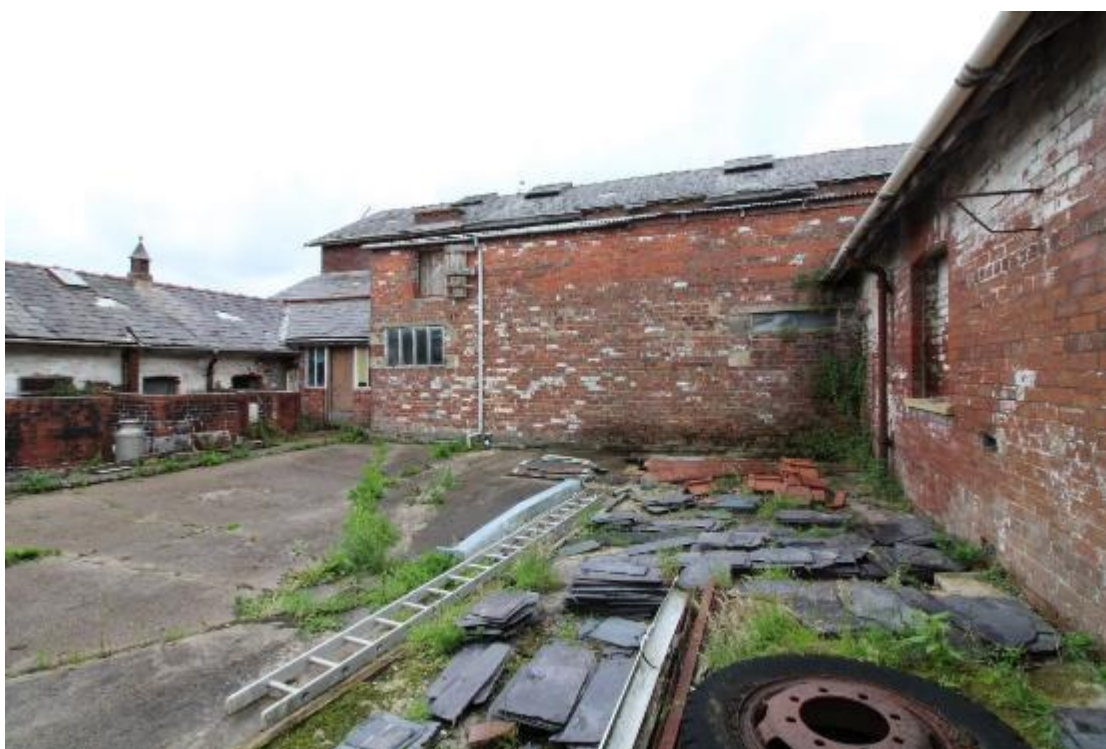
Plate 82: Milking Parlour on northern side of courtyard, facing north

- A.3.4.5 The Milking Shed on the northern elevation of the courtyard was of two storeys and the character of its brick clearly denoted it as a later structure (Plate 82). It had a corrugated sheet roof, a four-light window at the western end, and another narrow two-light window at the eastern end. The latter had been reduced in size by blocking its lower two-thirds. At the western end of the first floor, a low taking-in hatch with a timber shutter surviving on its eastern jamb had been blocked with plywood. The distribution of limewashed bricks indicated the materials had been reclaimed from an earlier structure. The western end of the elevation was of a single storey, narrower and structurally distinct from the Milking Shed (Plate 83). It formed a return to the western range, with a cat-slide slate roof (*Section A.3.2.13*) abutting a lean-to behind that accommodated the remainder of the Dairy. A pedestrian doorway (with a timber domestic door) at its centre was flanked on either side by mis-matched modern windows.

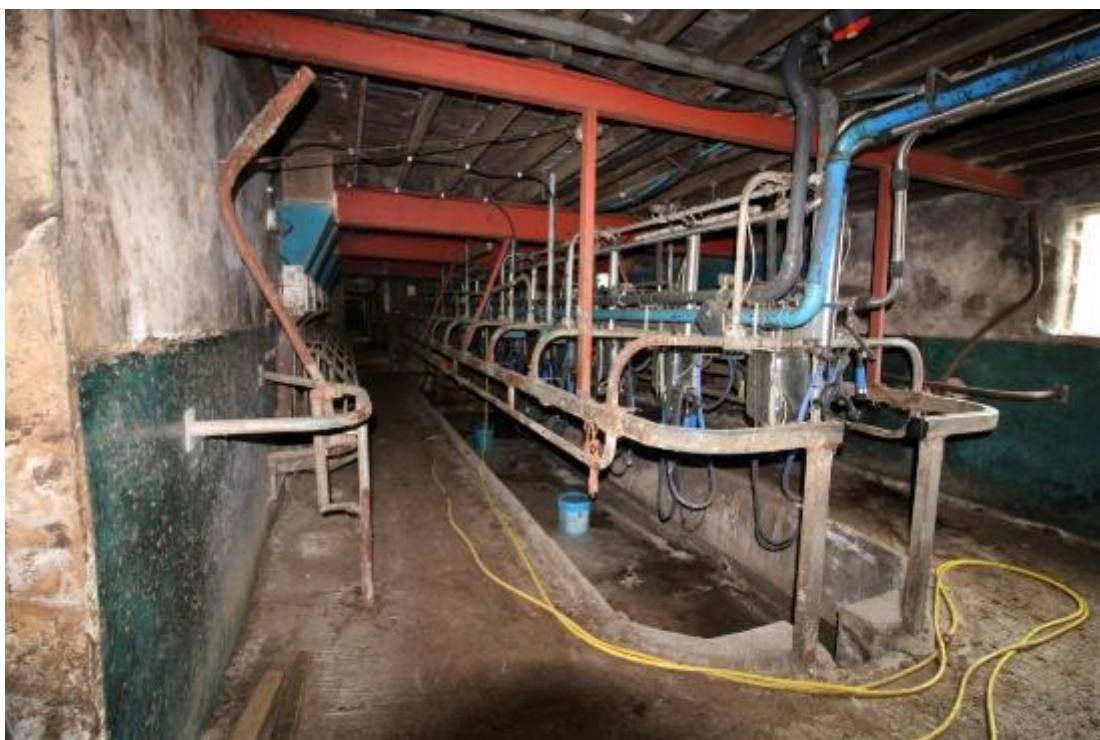
Plate 84: Milking Parlour, facing east

- A.3.5.1 The Milking Parlour was an elongated rectangular room adjoining the southern wall of the northern range, with a sunken access pit running along its centre, from which the cows were milked (Plate 84; Fig 9). The floor was of modern concrete, the walls were rendered and painted white and the first floor above was supported by RSJs. The northern and southern walls were fitted with modern tethering partitions, and doors at the northern end of the eastern and western walls connected the building to the central Shippon and Dairy respectively. A third door at the western end of the northern wall led into the Western Loose Box. The room was lit by a three-light window at the western end and a narrow two-light opening in the eastern end of the southern wall.

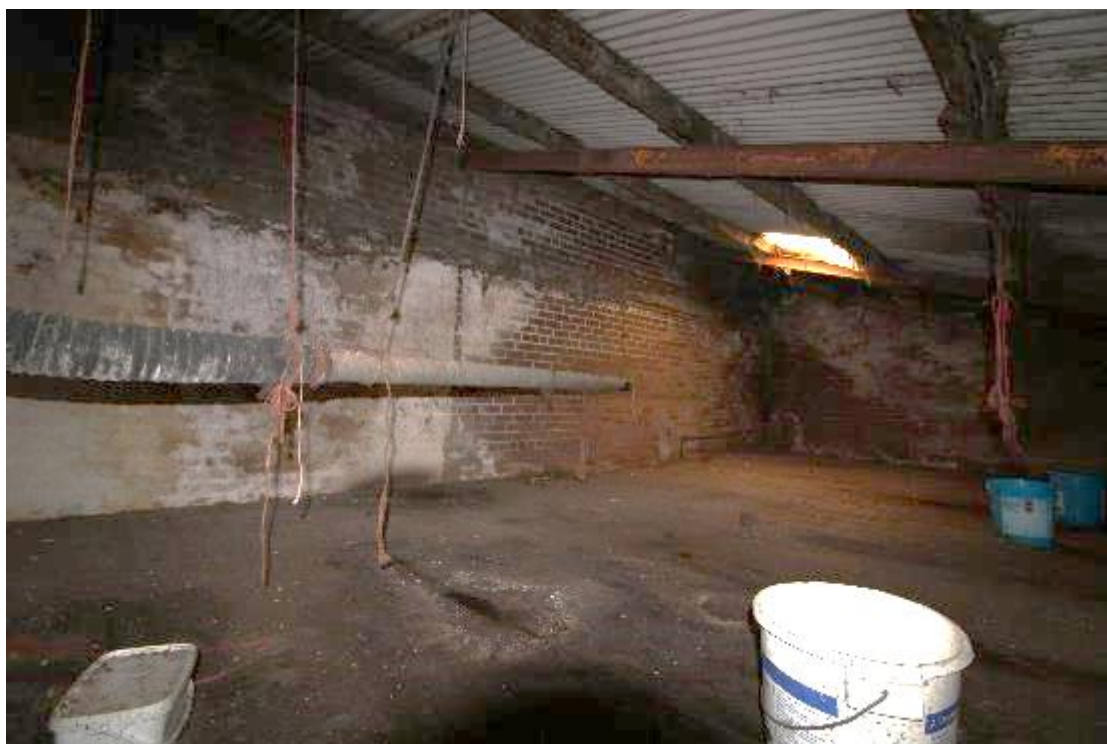
Plate 85: Roof Space above Milking Parlour, facing north-east

- A.3.5.2 Access to the first floor was via a hatch in the Milking Parlour's south-western corner. A ladder led up to a single undivided roof space with a timber floor and a low roof supported by steel rafters. The walls bore traces of white paint or limewash, and a half-height horizontal timber on the northern wall may have denoted the position of a former roof line (Plate 85).

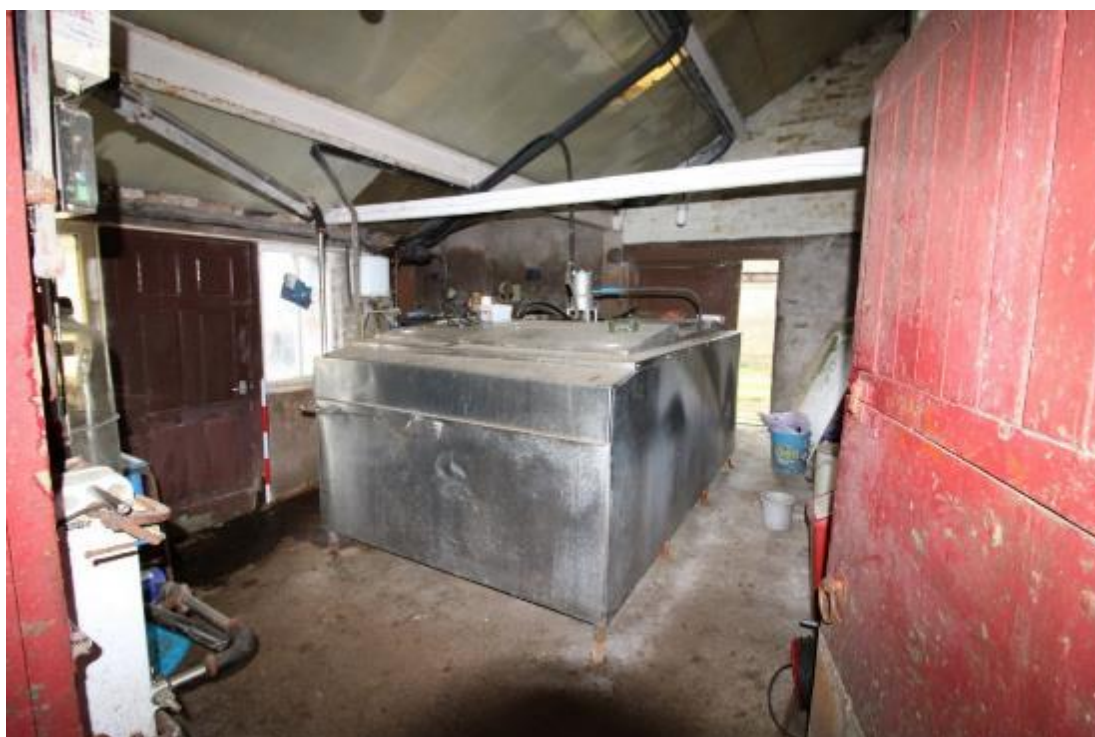
Plate 86: Dairy facing west, with 1m scale

- A.3.5.3 At the northern end of the western range, to the west of the Milking Parlour, was an L-shaped room which had been modified to accommodate the equipment necessary for a modern dairy and contained two large rectangular stainless steel tanks (Plate 86) (Figs 9 and 11). The floor was concreted, the lower 2.5m of the walls concrete-rendered, and sections of hard plastic sheet had been applied to the underside of the ceiling to conform to modern hygiene regulations. The roof was supported on a pair of white-painted steel purlins.

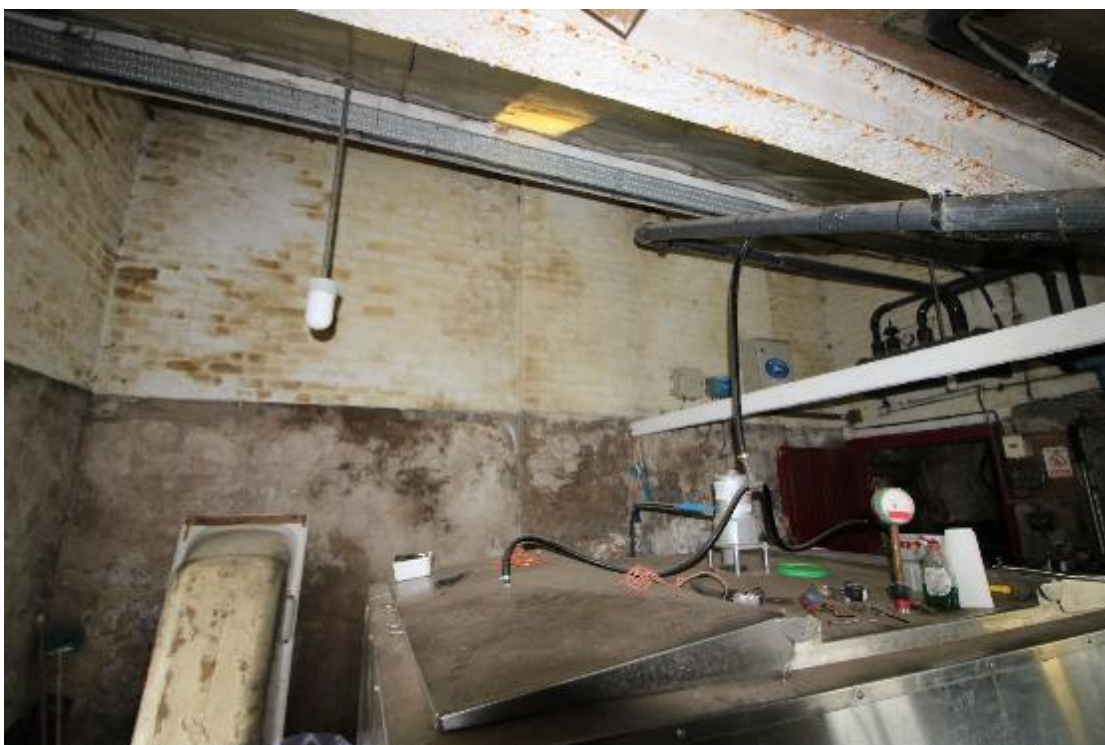
Plate 87: Dairy, facing north, with chimney breast to right of frame

- A.3.5.4 The Dairy was connected to the Milking Parlour via a split timber door at the northern end of its eastern wall. External exits were to the west through a sliding double-width door, and south into the Enclosed Courtyard. A shallow chimney flue projected from the face of the northern wall to the east of centre (Plate 87). At its southern end, the room had been extended by removing the partitions formerly associated with the northernmost pig pen and erecting a modern stud partition with a doorway at its centre giving access to a small Workshop. The room's proximity to the Pig Pens to its south and the presence of the chimney flue on its northern wall may indicate its former use as a Boiling House, used in the preparation of feed for the pigs.

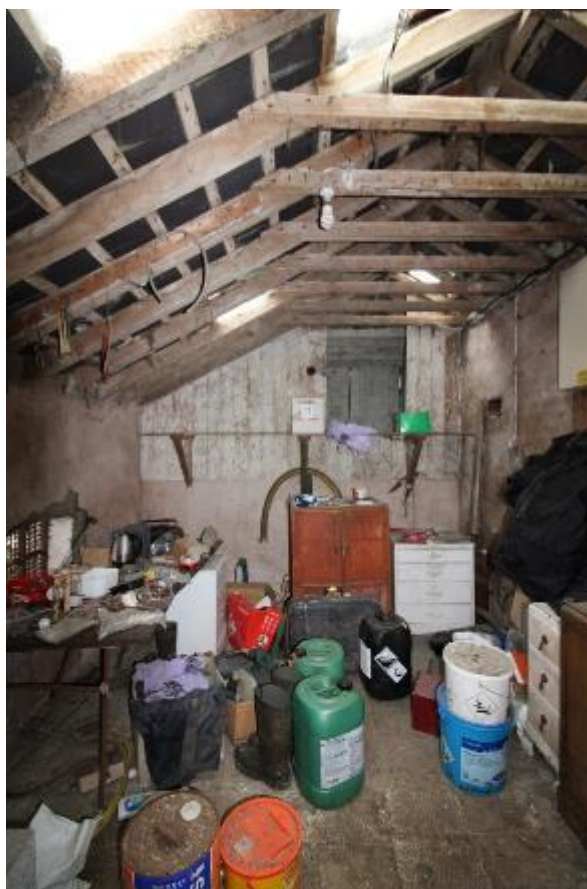
Plate 88: Workshop in former Pig Pens, facing south

- A.3.5.5 The Workshop was a small rectangular room created by amalgamating the two adjacent Pig Pens into a single space and converting one entrance into a ventilated window and fitting the other with an extractor fan (Plate 88; Figs 9-11). The eastern and western walls were rendered in modern plaster to full height, but the southern wall retained its original timber partition, rendered to half height. An inspection window in its upper half would have provided a view into the adjacent Pig Pen. The floor was laid in concrete tiles. The roof's common rafter structure was exposed, allowing natural light into the room via the intermittent rooflights. Additional ventilation was supplied by a pair of small rectangular vents set into the upper half of the western wall.

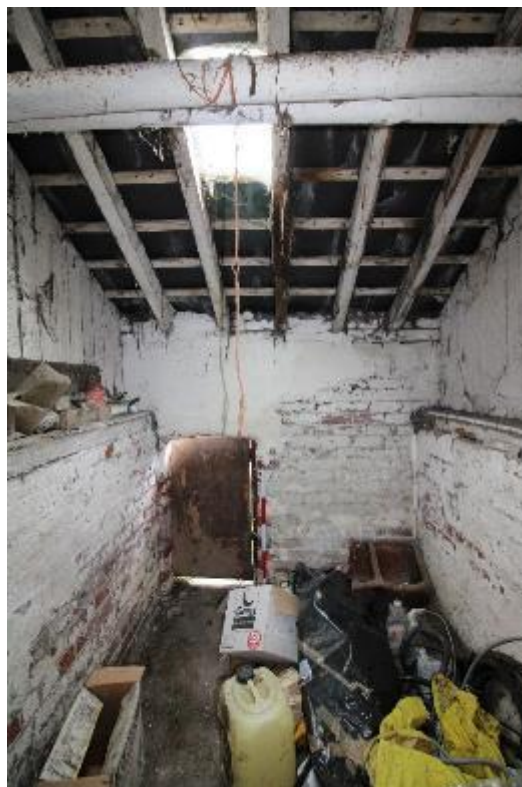
Plate 89: Northern surviving Pig Pen, facing east with 1m scale

- A.3.5.6 To the south of the Workshop lay the two surviving Pig Pens, both small rectangular spaces with concrete floors, exposed roof rafters and low entrances at the northern end of the eastern wall (Figs 9 and 11). The northern Pen was the smaller of the two, its northern and southern walls constructed in brick to half height with limewashed vertical timber cladding above (Plate 89). The northern Pen shared its southern wall with the southern example, and a pair of cast-iron heating pipes ran across the ceiling of both cells. The southern wall of the southern Pen was constructed entirely in red brick, but a vertical construction joint at the western end revealed what appeared to be a blocked doorway, above which the wall was left open (Plate 90). Both Pens were lit from above by roof lights. Both were also provided with small rectangular vents on their western walls and had ceramic feeding troughs at the base of the opposing wall.

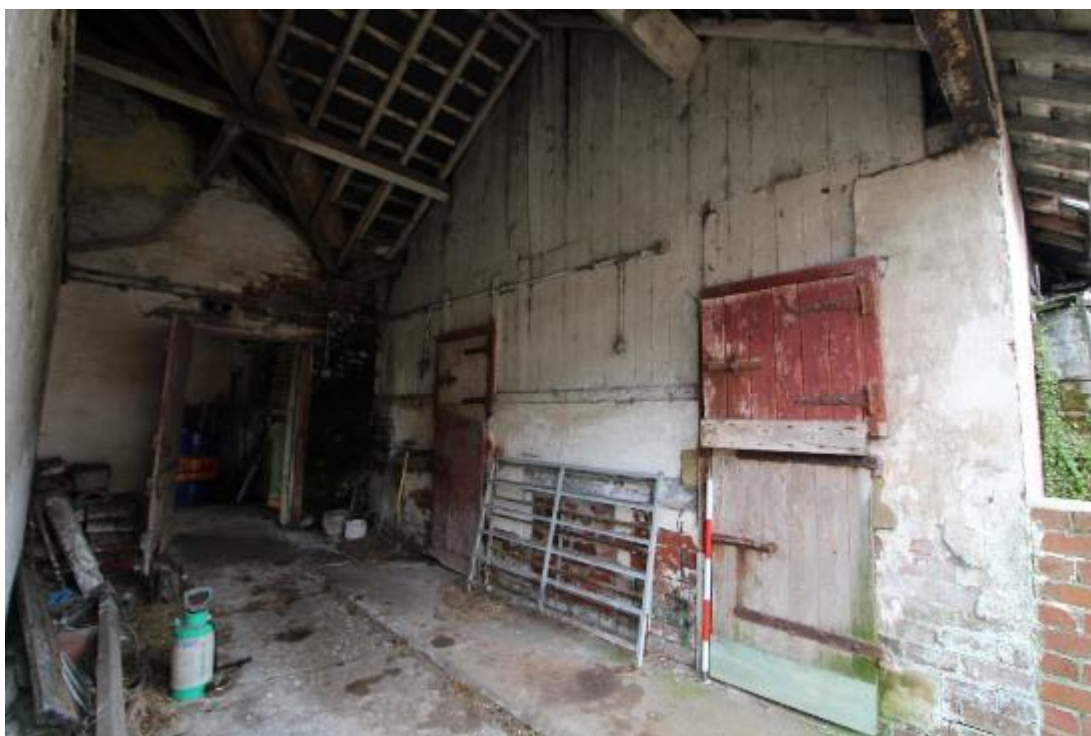
Plate 91: Western wall of cover entrance, facing south-west with 1m scale

- A.3.5.7 The western wall of the covered entrance to the Enclosed Courtyard was of more than one phase, with the lower metre constructed in red brick topped by a timber sill (Plate 91| Figs 9 and 11). The wall had then been raised by 0.5m in brick and rendered before a second timber sill had been laid to provide a base for the vertical timber panelling that continued to the apex. The wall incorporated a pair of awkward timber stable doors, each providing access to its own loose box.

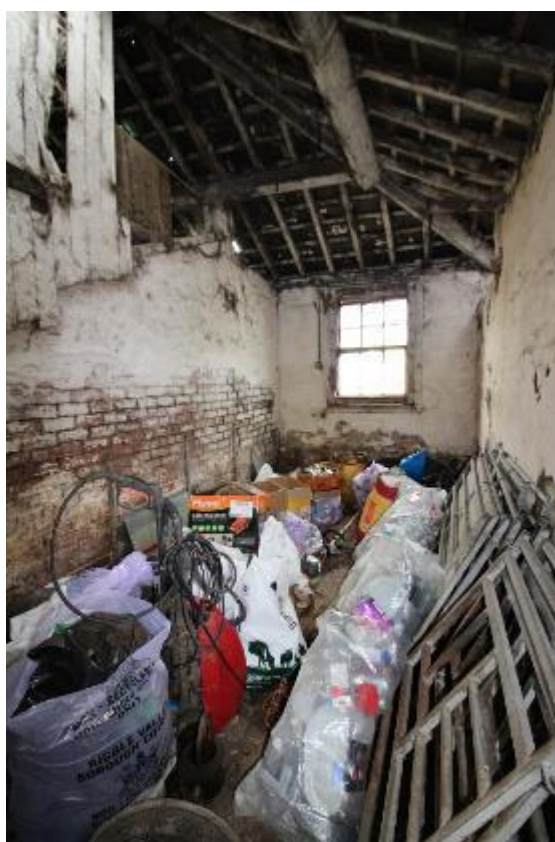
Plate 92: Northern loose box, facing west. Note the change in roof height from right to left

- A.3.5.8 The northernmost of the Loose Box cells was an elongated rectangular room, with a concrete floor, and brick walls and exposed limewashed rafters (Plate 92). The cell was lit to the west by a six over six sash window. The eastern end of its southern wall was pitched towards the east, with the partition above clad in vertical timber board. At the western end of this wall, just visible behind the limewash, was a blocked doorway corresponding to that on the opposite wall as observed in the southern Pig Pen. The architectural plans suggest the two may have provided a feeding passage along this side of the building (Plates 7 and 8). The cast-iron heating pipes from the Pig Pens to the north did not carry on across the ceiling, but their truncated stubs were visible near the head of the northern wall.

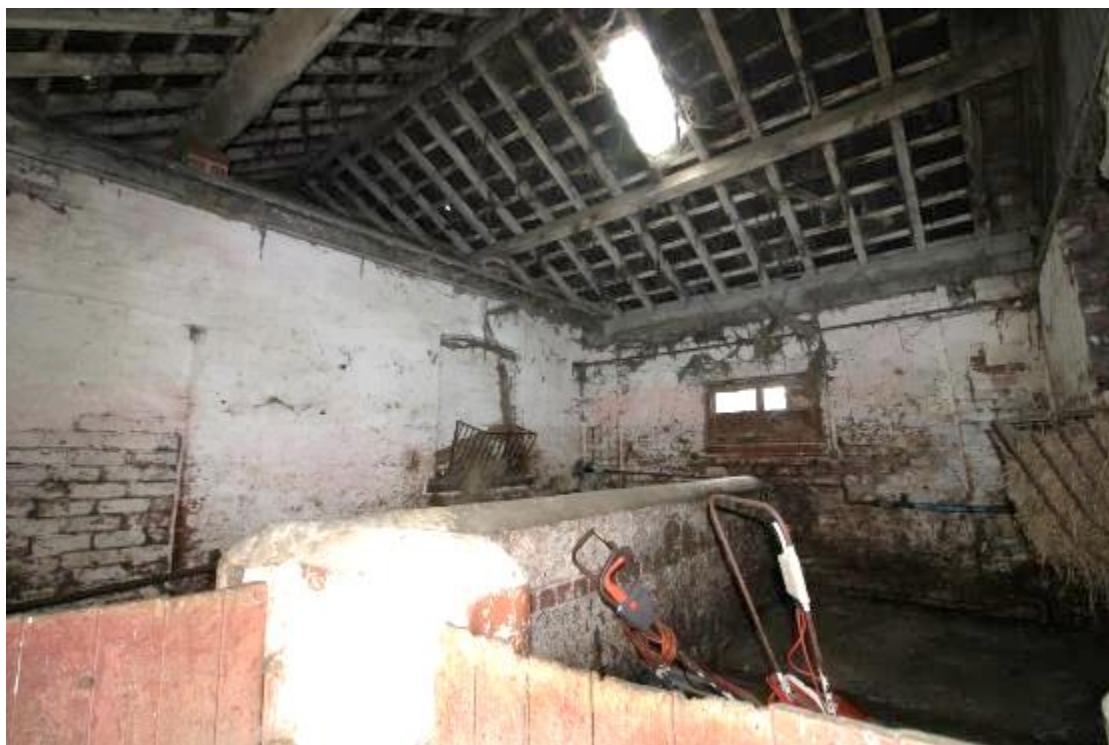
Plate 94: Eastern Loose Box, facing south

- A.3.5.11 East of the covered passage were two more Loose Boxes, each accessible via one of the half-glazed doors described externally (Fig 9). Both were rectangular, had concrete floors and limewashed brick walls. That to the east was larger and had been divided by a low L-shaped brick cross-wall and concrete blockwork that provided entrances at the northern end (Plate 94). A short rectangular window at the centre of the southern wall had been reduced in height with the infilling of its lower portion. This feature had been an insertion into a wider area of brick infill between two piers which represented the original entry to the courtyard.

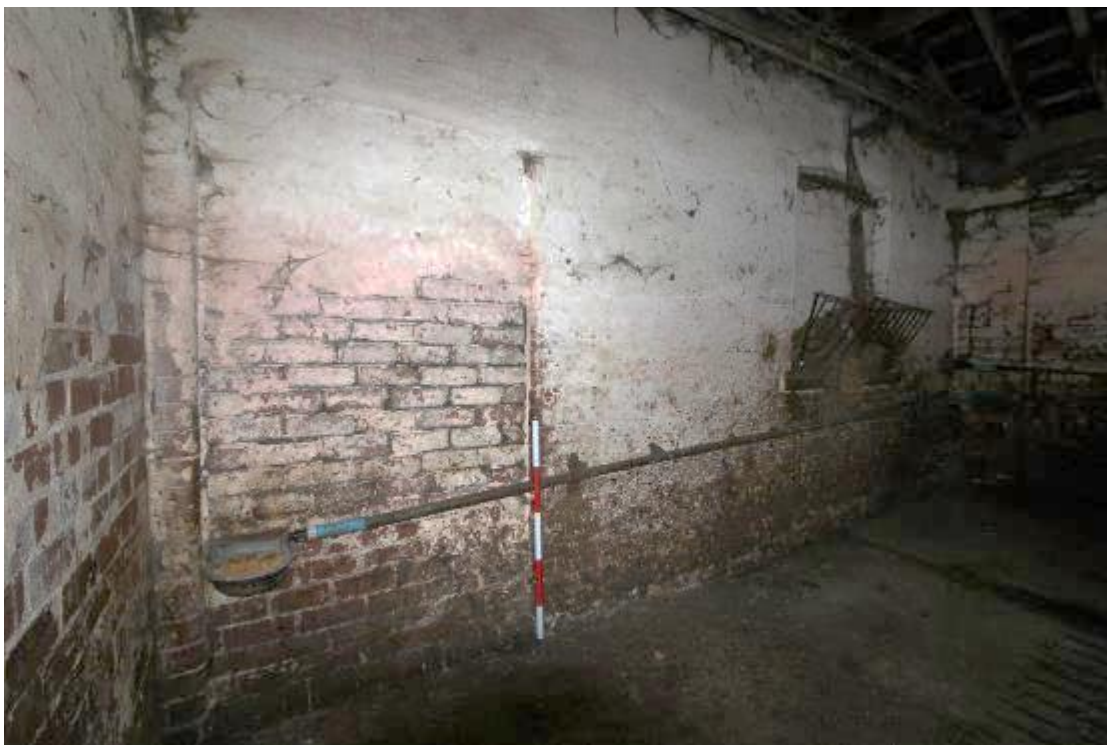
Plate 95: Blocked openings, formerly opening on to the Central Shippon, with 1m scale

- A.3.5.12 A blocked window on the east wall of the eastern loose box had been fitted with a hay rack but would once have provided light into the southern end of the Central Shippon. A blocked doorway on the same wall to the north would have provided an entrance to the same building (Plate 95). The pitch of the Shippon's roof survived above this wall, latterly enclosed by the present roof. An opening had been roughly cut through the centre of the room's western wall to provide a window into the adjacent loose box, but this too had been boarded up and fitted with a hay rack (Plate 96). Both cells were provided with water feeders and the eastern example also had a ceramic trough.

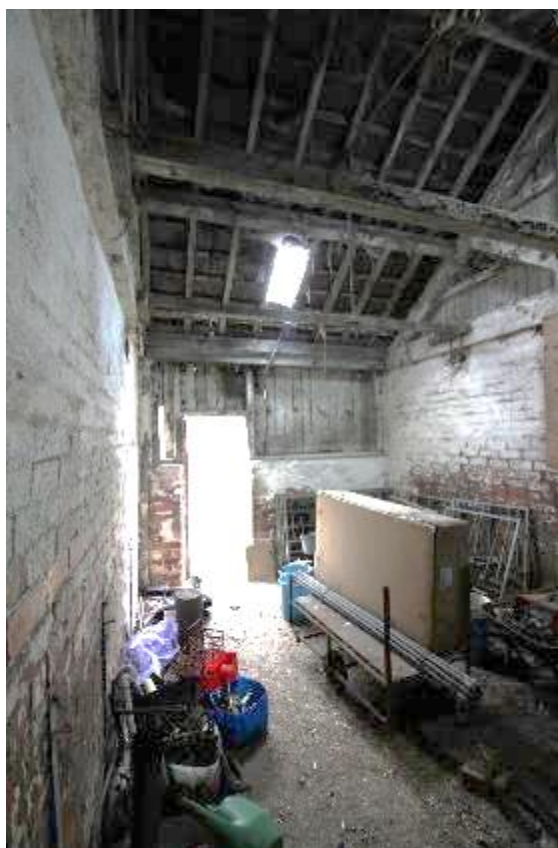
Plate 97: Western loose box, facing north

- A.3.5.13 The western Loose Box had no window of its own, although the half-timbered arrangement on the northern elevation may once have accommodated one (Plate 97).

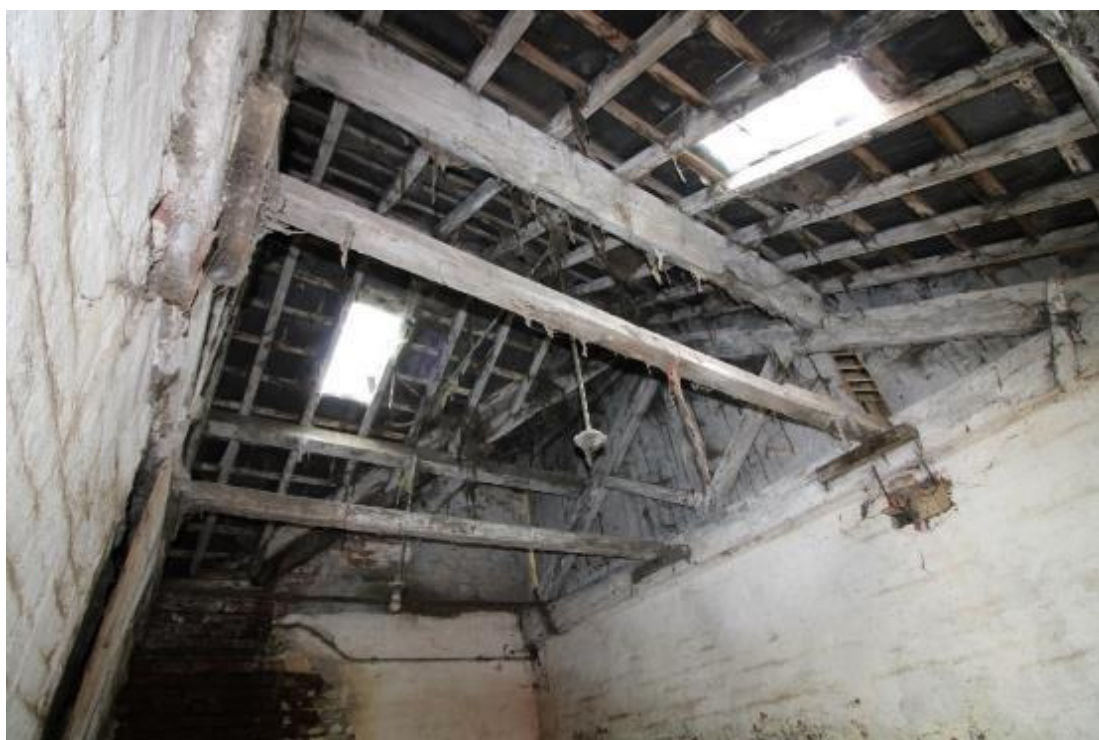
Plate 98: Roof structure in Western loose box

It was lit by two skylights and, prior to its boarding over, the borrowed light from the internal window on the cross-wall shared with the neighbouring Loose Box. The upper gable of the room's eastern and western walls was formed by a King-post truss, linked by four purlins, and clad in vertical timber boards. At its southern end, the structure incorporated one rafter of the intersecting perpendicular range to the south (Plate 98). The reverse face of the room's western wall formed the eastern side of the courtyard's entrance passage, from where the opposing rafter could be identified (Plate 99).

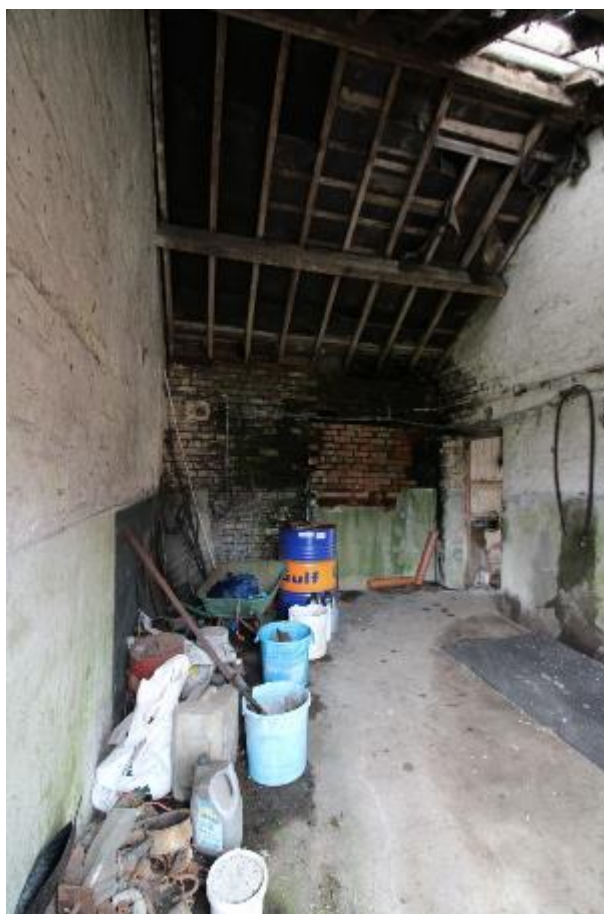
Plate 100: Through Passage Room, facing west

A.3.5.14 At the southern end of the entrance passage to the Enclosed Courtyard, a pedestrian doorway led into the north-western corner of a rectangular room (Fig 9). Following the erection of the two Loose Boxes, this room served as a through passage to the southern yard via a doorway at the southern end of its eastern wall (Plate 100). The floor was concreted, the lower third of the walls were cement-rendered and the upper areas limewashed. The failure of the roof above the western wall had resulted in damp ingress. At the northern end, a blocked doorway was visible above a section of cement render, the reverse of that observed in the Garage (*Section A.3.5.16*). The exposure of the rafters above allowed illumination via a skylight on the eastern pitch.

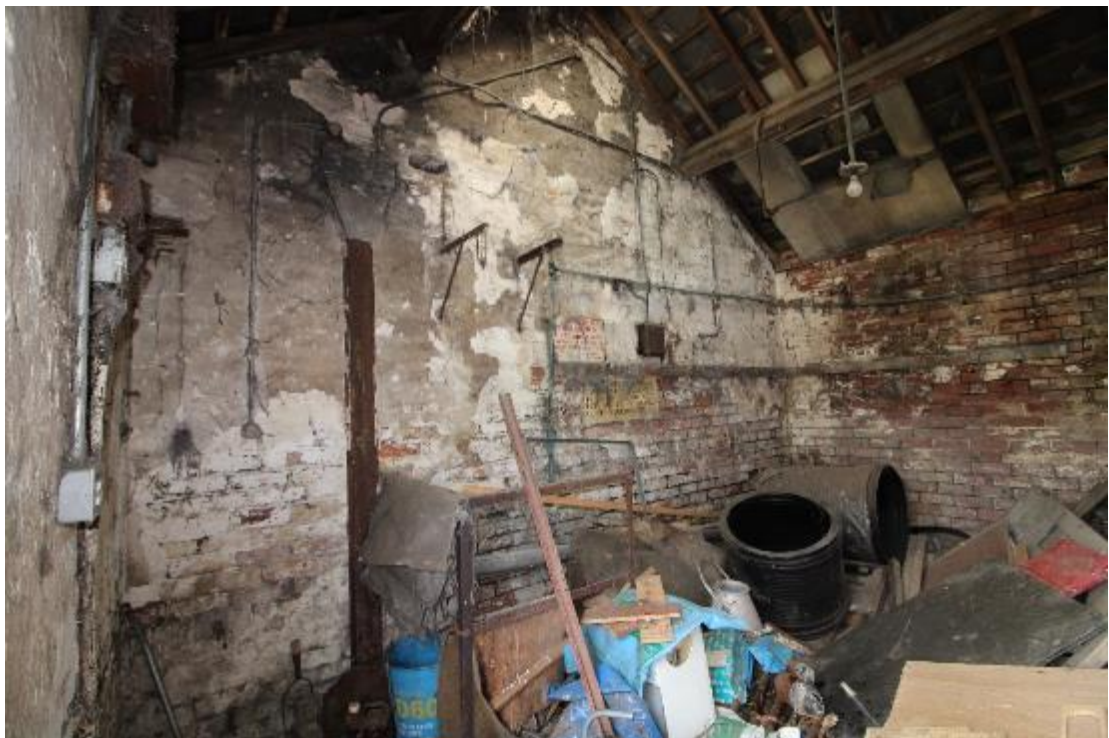
Plate 101: Boiler Room, facing south-west

A.3.5.15 The former Boiler Room was located to the south of the Through Passage and east of the Garage (Fig 9). It was accessed from the east, where a doorway opened into a rectangular space with its walls, floor and ceiling treated as in the Through Passage (Plate 101). It was lit by a pair of skylights on the eastern pitch of its gabled roof but had no additional openings. Although little remained of its fittings and fixtures, at the centre of the southern wall a hand painted metal sign indicated that the room had once been occupied by a coal-fired boiler, presumably associated with providing heat for the pigs (Plate 102). Above the sign, a pair of projecting angle iron brackets must once have supported a wall mounted water tank and in the south-eastern corner was a sunken drain set into the floor. At the northern end, an iron brace spanned the width of the room, projecting from the door lintel to the opposing wall, presumably to provide additional structural strength.

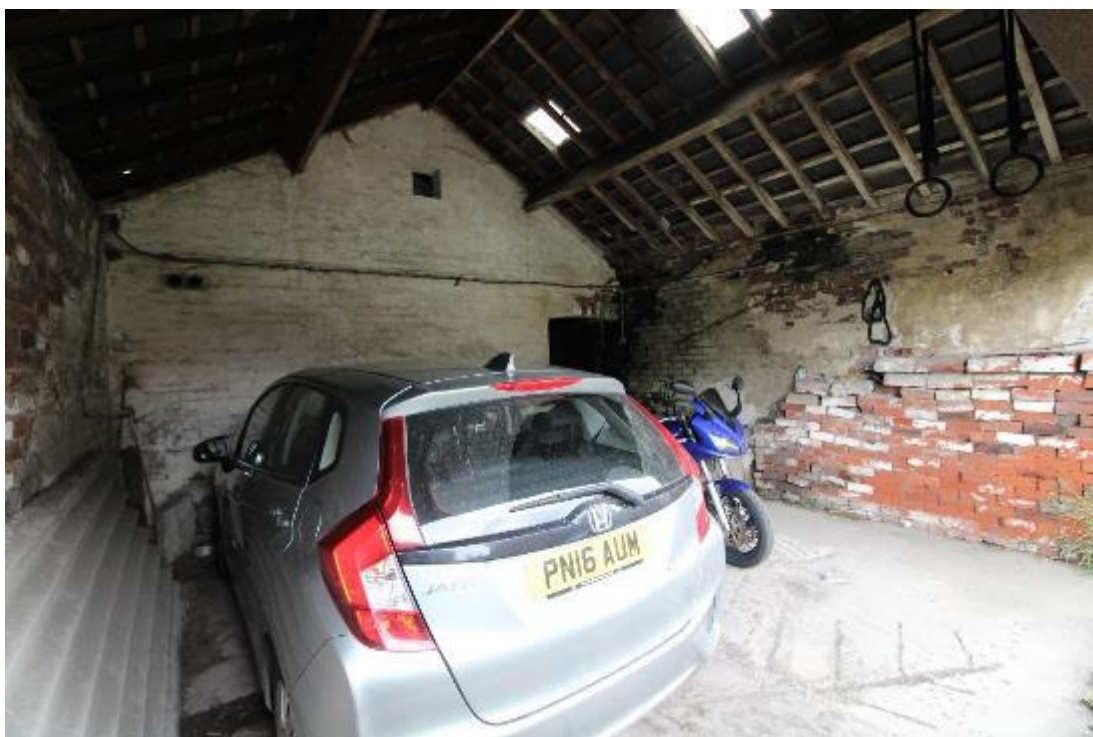
Plate 103: Garage, facing north-east

A.3.5.16 As demonstrated externally (*Section A.3.2.2*) the Garage had seen the considerable rebuilding of its southern and western walls, along with the re-laying of its floor in concrete to accommodate two or more vehicles (Plate 103; Figs 9 and 11). Its original eastern wall remained intact, and at its northern end, incorporated a blocked pedestrian doorway with a timber lintel which would once have led through into the Through Passage (Plate 104). At the northern end of the western wall, a second and opposing blocked door would have provided an exit into the western yard (*Section A.3.2.14*). A full height cross-wall with a door at the eastern end partitioned off the northern end of the Garage and formed a corridor linking the two doorways (Plate 103). At its eastern end, a low concrete blockwork wall projected across this corridor, leaving access only at the southern end (Plate 105). At the apex of the cross-wall was a small square aperture, perhaps for the access of poultry, and to the west were a pair of truncated cast-iron heating pipes set into the wall.

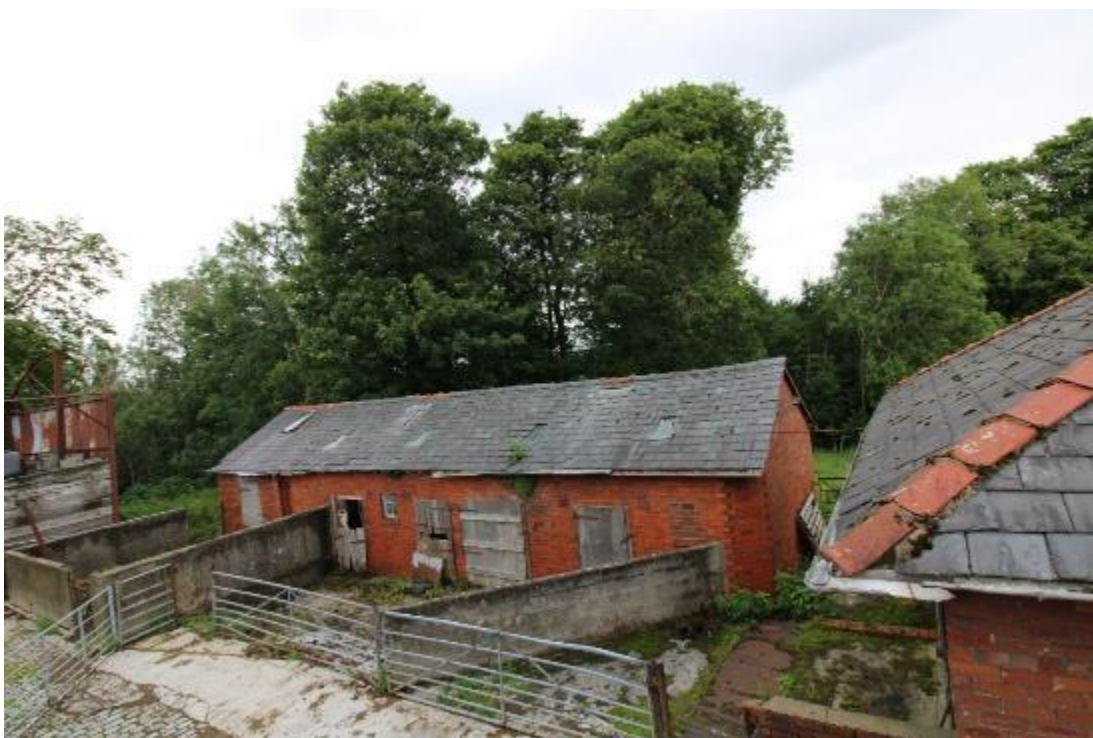
Plate 106: North-eastern Piggery, facing north- east

- A.3.6.2 The principal elevation lay to the west, where it faced onto its own small concrete yard. It incorporated a pair of doors at its centre, each flanked by its own small square window (Plate 106). Further doors lay at the northern and southern ends; these had each been accompanied by their own window, but the northern window and southern two windows had been blocked in brick. A row of small square vents were carried across the elevation at lintel height. At the northern end of the building, an extension had been added using mixed-coloured brick, and a single doorway beneath a concrete lintel provided entry into a separate cell via its own small, enclosed yard.
