Brockhall Farm, Old Langho, Billington Archaeological Desk-based Assessment and Historic Building Survey

OA Reference No: 2020-21/2089

Archaeological Desk-based Assessment and Historic Building Survey

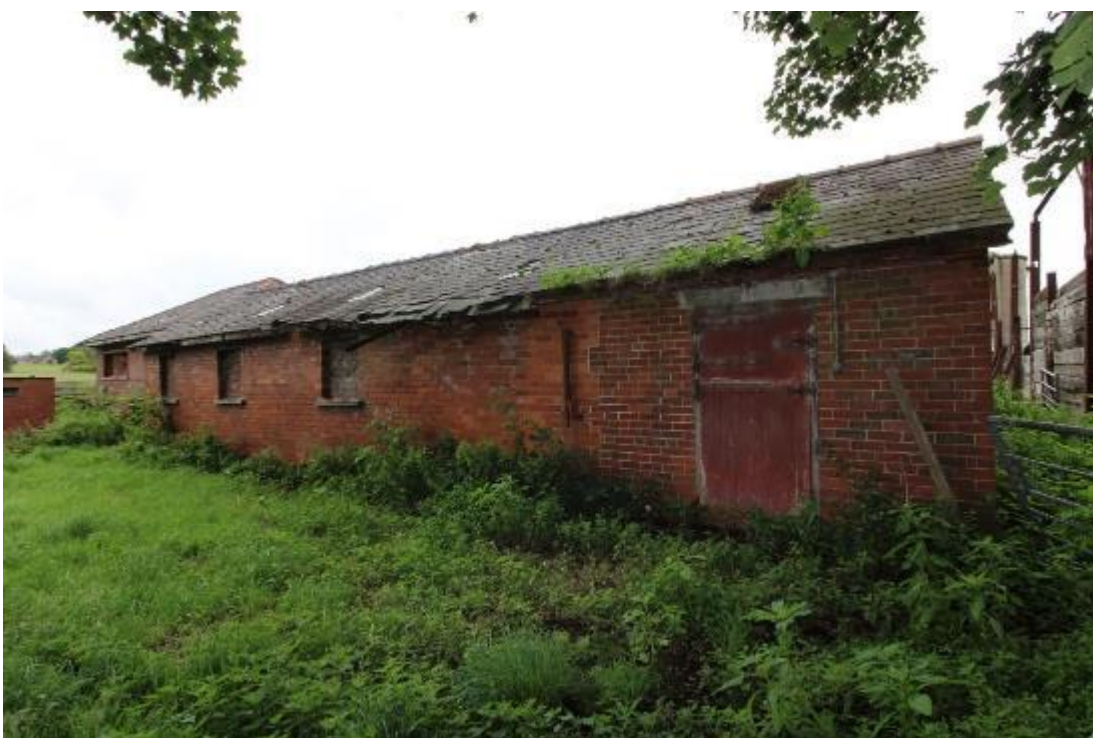
Plate 107: Eastern elevation, showing extension to right of frame

- A.3.6.3 The original building had been built with four large rectangular windows arranged at regular intervals along the eastern elevation, but these had been blocked in brick and the northern window had also had its sill removed (Plate 107). On this elevation there was a clearly defined vertical joint between the earlier phase and later extension. A split height timber door beneath a concrete lintel sat at the centre of the latter.

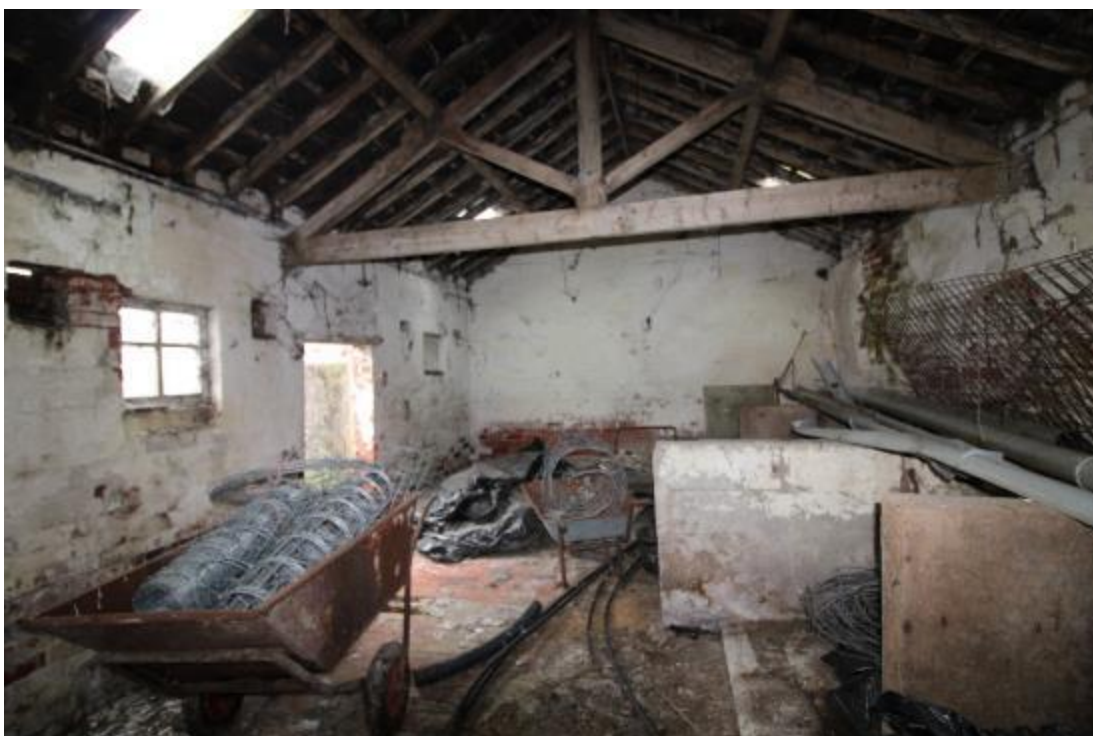
Plate 108: Interior, facing north

- A.3.6.4 Internally, the southern part of the building comprised a single open space with concrete stall partitions against the eastern wall (Plate 108). Each stall had a pair of metal water feeders, bearing the name 'Jackson Blackburn'. The floor was laid in brick and thick limewash on the walls may have obscured evidence for internal partitions. The roof rested upon a simple A-frame timber truss and a series of rooflights provided the only natural light source.
- A.3.6.5 The northern cell had no internal connection to the remainder of the building and had exposed brick walls and a concrete floor, into which had been set a pair of parallel tubular rails (Plate 109). The rails extended west from the doorway at the centre of the eastern wall and while presumably they once assisted in the management of the bulls, latterly they had provided stalling for up to three animals.

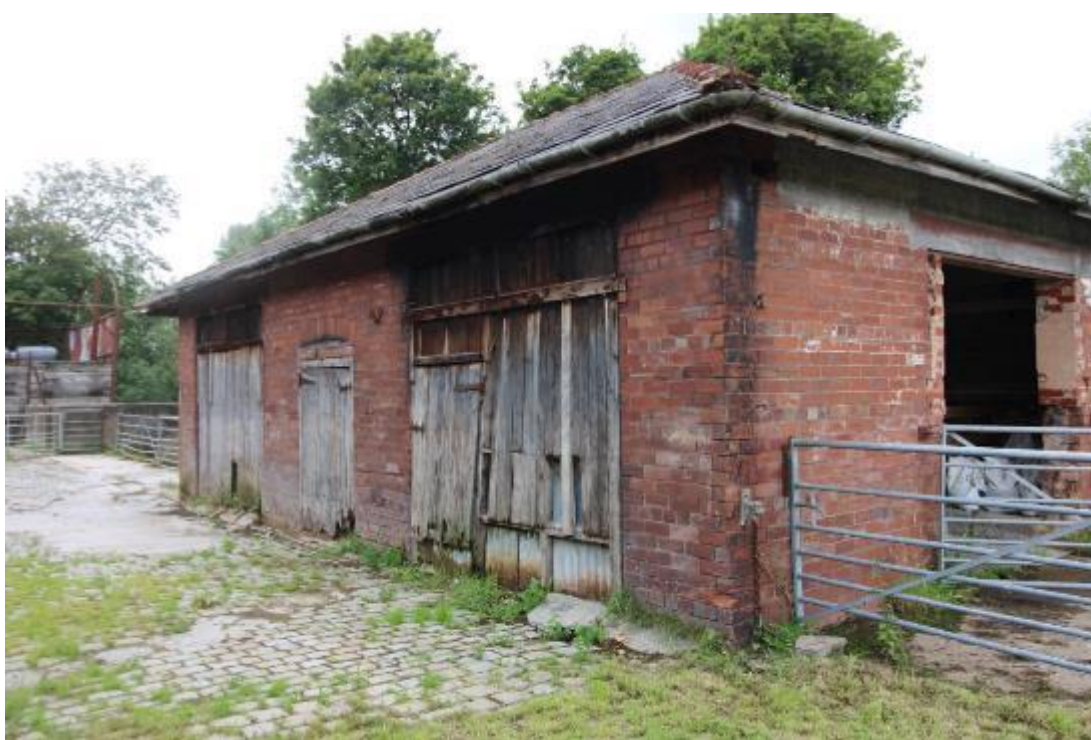
Plate 110: Western elevation, facing north-east

- A.3.6.7 The western elevation faced the Central Block across an access yard and comprised a central doorway, wide enough to accommodate livestock, beneath a segmental brick arch, flanked by a pair of large double-width openings topped by substantial timber lintels (Plate 110). The larger openings must once have been fitted with double doors and each preserved the frames of a pair of over-lighters above. A change in use had, however, necessitated the blocking of the openings with timber boarding, leaving just a single-width door in the northern half of the southern opening.

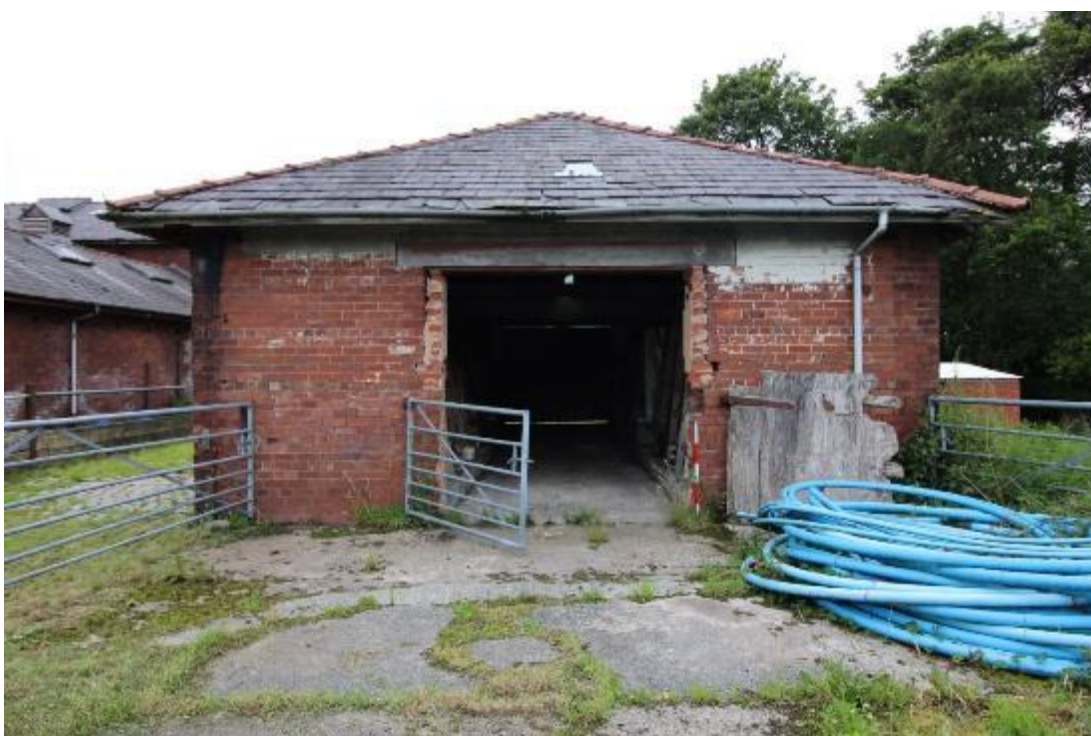
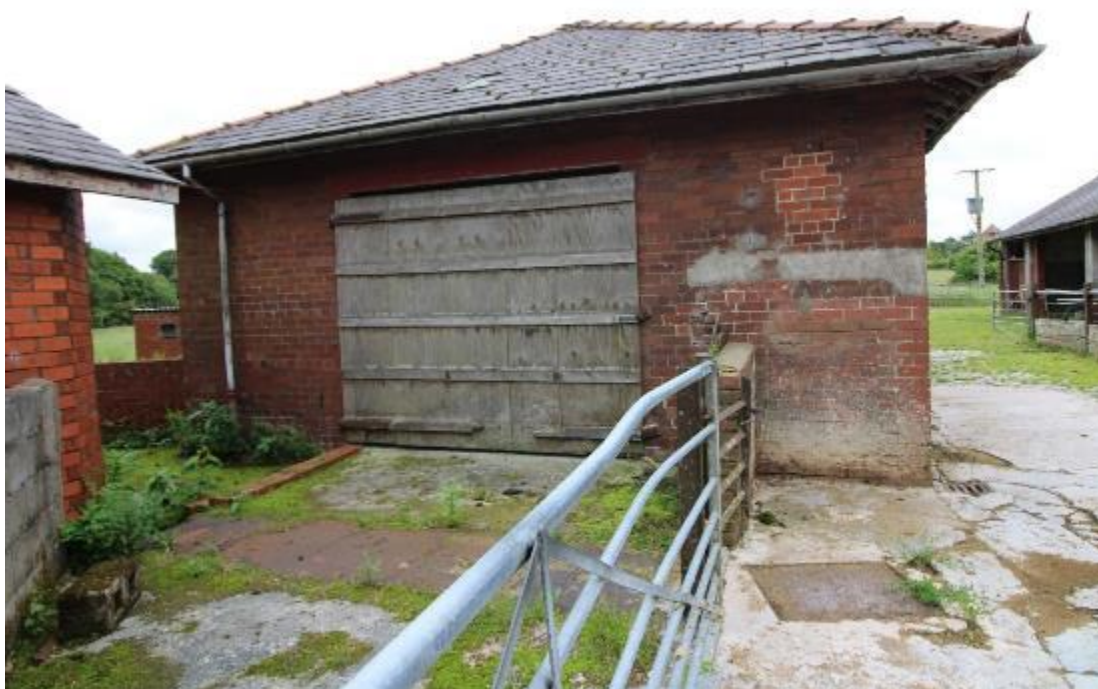
- A.3.6.8 Both the southern and northern elevations had a double-width door at their centres, beneath a timber lintel. The brickwork of the lower jambs indicated the apertures had originally been elongated, horizontal, rectangular windows (Plates 111 and 112). The southern elevation retained traces of the application of white paint across its upper half, while the northern included a small, blocked, vertical aperture to the west of the doorway, similar to that observed within the Mixing House (*Section A.3.3.26*).

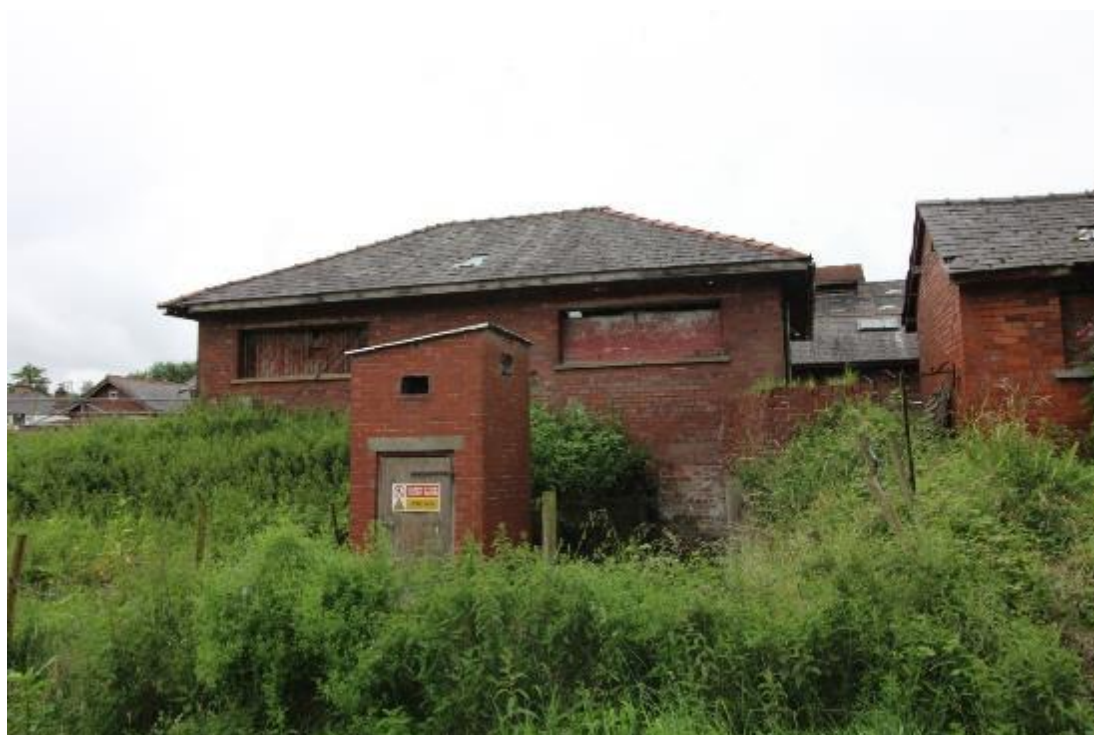
Plate 113: Eastern Piggery, facing west

- A.3.6.9 To the east of the Eastern Piggery, the ground dropped away sharply, and the wall was continued below yard height to retain the higher ground to the west. This elevation had a large, horizontal, rectangular window at each end, beneath a timber lintel, presumably of the form that once occupied the northern and southern elevations (Plate 113). Both windows were covered with timber shuttering on the internal face.

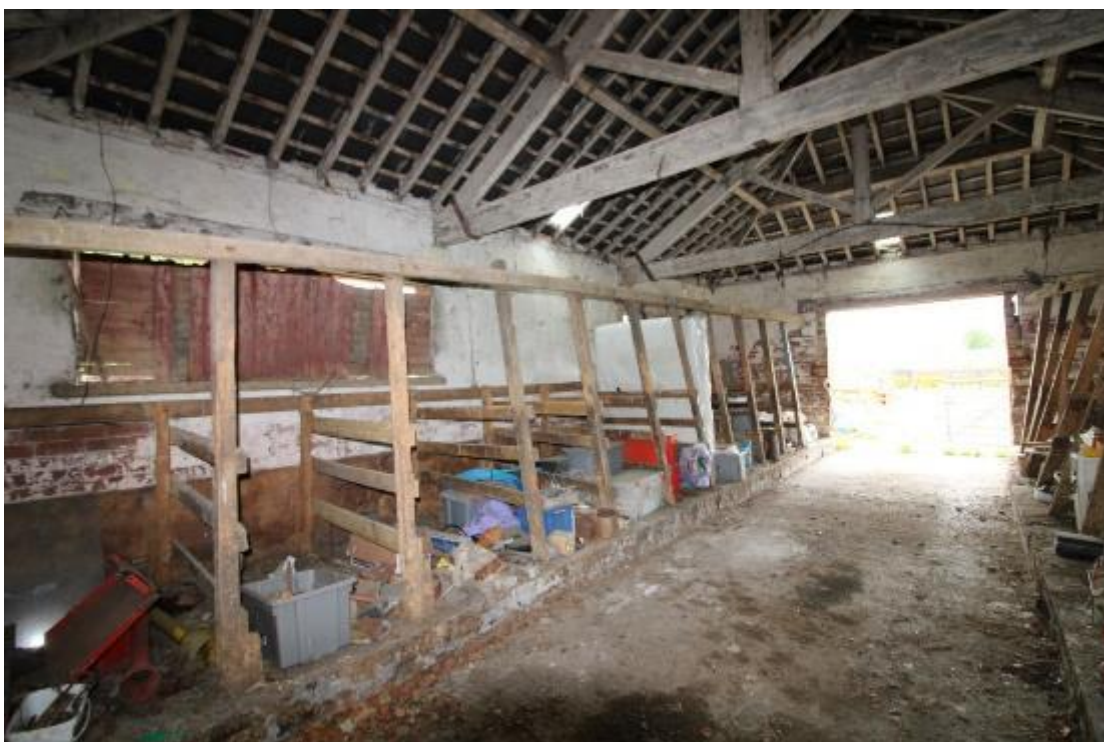
Plate 114: Interior, facing south

- A.3.6.10 The internal layout had been much modified, with timber stalling erected against the eastern and western walls, set upon a stepped concrete floor and central dung channel. A pair of King-post trusses supported the exposed roof structure (Plate 114). At the western end of the northern wall, the blocked narrow aperture identified externally lay adjacent to a cast-iron bearing box located at the northern end of the western wall (Plate 115). This arrangement clearly indicated that the building was once provided with motive power.

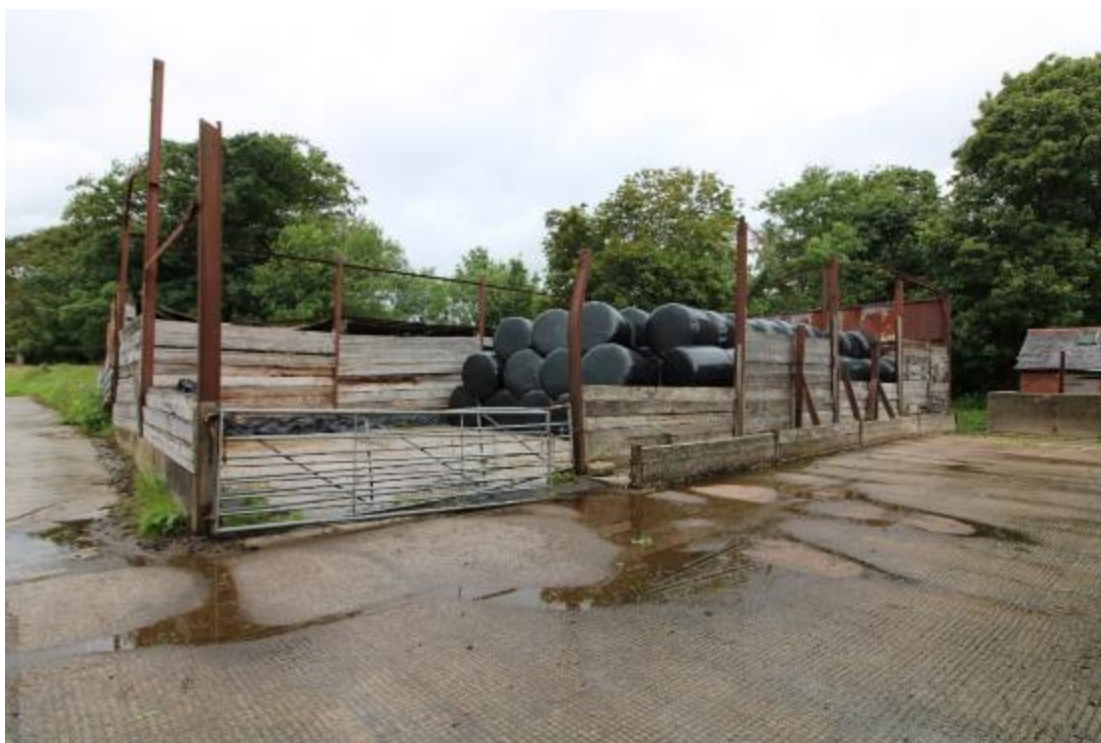
Plate 116: Eastern Dutch Barn, facing north-east

- A.3.6.11 In the north-eastern corner of the farm complex was the remnants of a Dutch-style barn, which was being used to store hay bales (Plate 116; Fig 13). The building was aligned east/west and was of five bays, constructed of a series of I-section steel posts set vertically into a concrete foundation. The lower halves of the walls were formed of horizontal timber planks, set one upon another and held in position by the flanges of each adjacent steel post. Only at the eastern gable did the building survive to full height, and here the upper half of the wall was clad in corrugated iron fastened to the building's steel frame (Plate 117). Although the roof had been lost, the remaining steelwork at the eastern gable end preserved the outline of the barrel-shaped roof that once covered the structure.

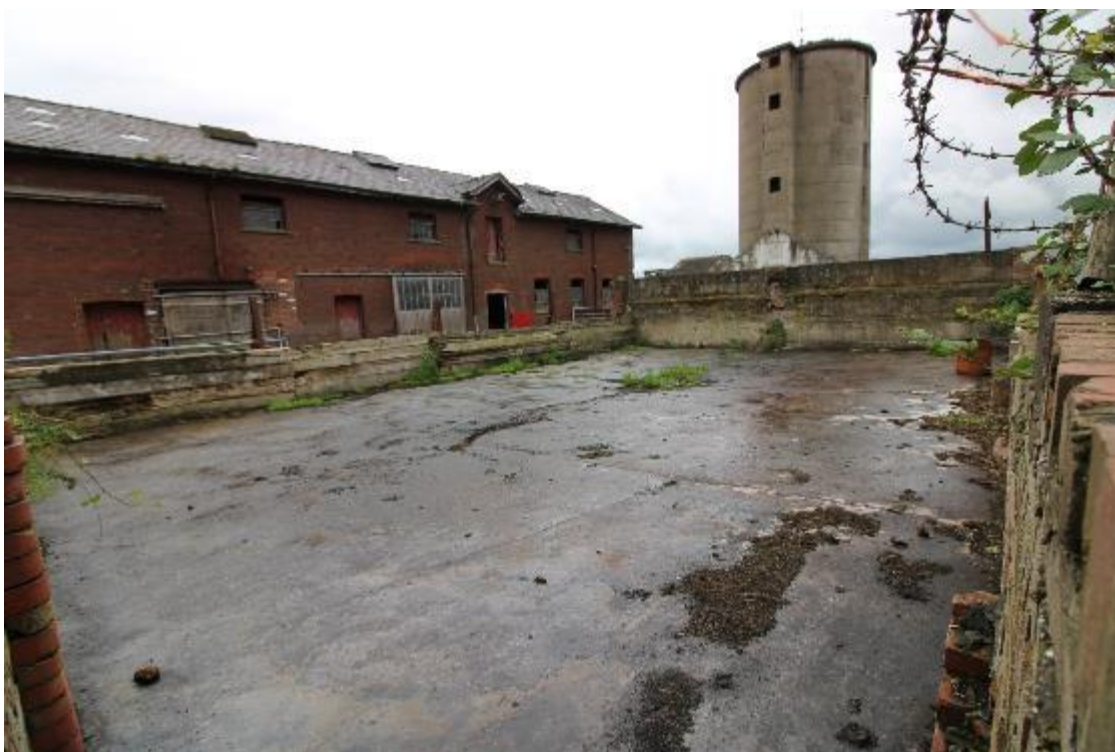
Plate 118: Middenstead, facing south-west

- A.3.6.13 At the northern end of the complex and lying across the access yard from the Central Block, lay a large unroofed raised concrete platform (the Middenstead) on an east/west alignment (Fig 13). To the west, the platform was defined by a half-height concrete block wall (Plate 118). Its slightly lower eastern wall was constructed in red brick and incorporated three shallow projecting internal piers (Plate 119). The southern wall was formed of stacked timber planks attached to braced, vertical steel posts that divided the building into four notional bays. To the north, the remnants of the corresponding posts were set on a retaining wall of predominantly brick construction. Except for the scar of a brick wall that must have extended at right-angles from the centre of the western wall, there were no internal features of note.

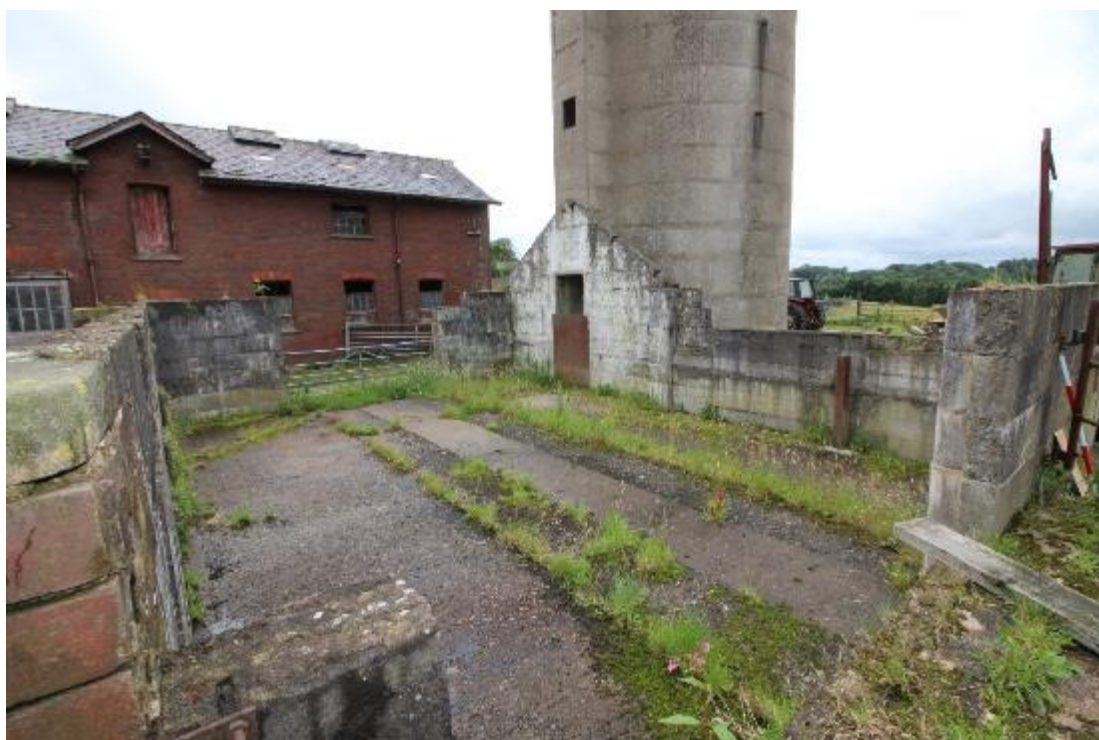
Plate 120: Interior of the Potato Shed, facing south

to the lower floor of the adjoining Silo. To the north of the door a single steel I-section post protruded from the building's concrete floor (Plate 120).

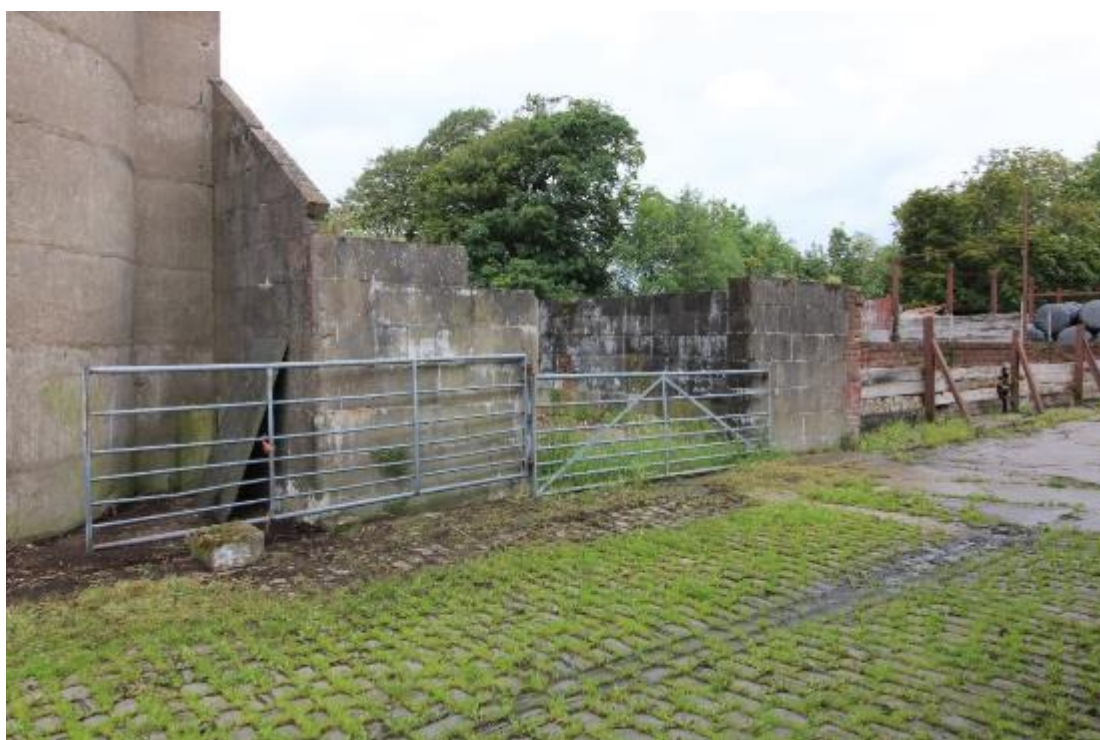
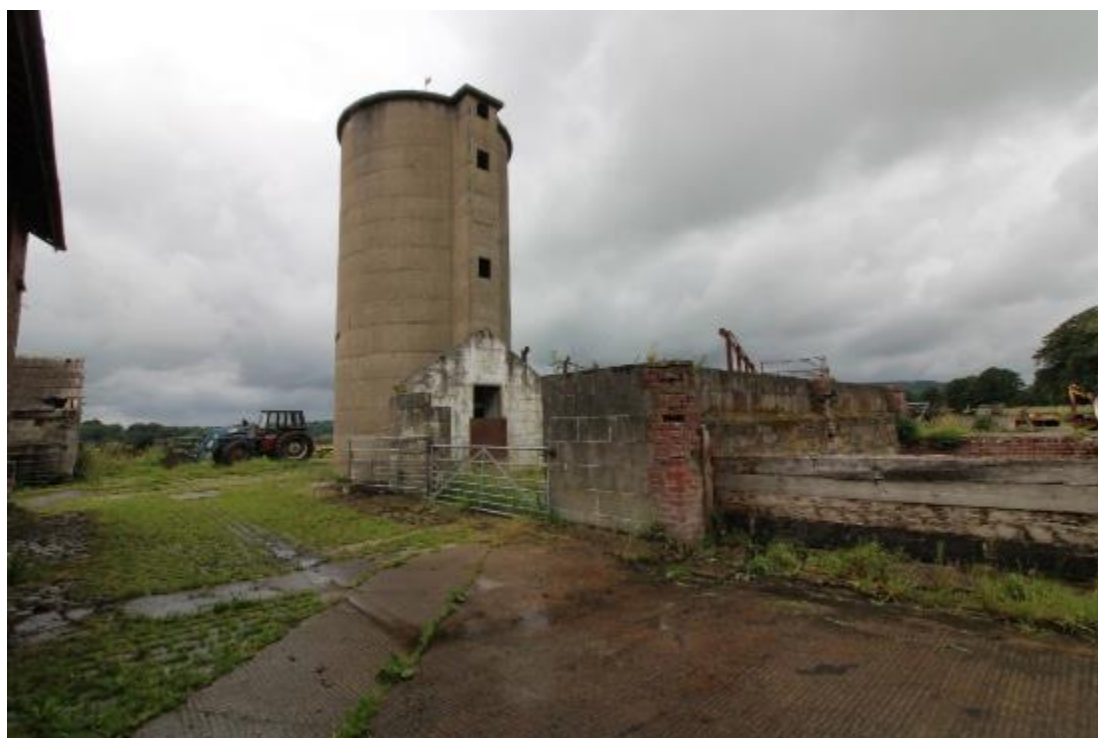
A.3.6.16 The Silo adjoined the gable wall of the Potato Shed to its west, the relationship of the structures suggesting the latter had been erected first, the gable end of the Potato shed being let into the Silo (Plates 14, 15, 121, 122). The Silo was a circular structure formed in what appeared to be mass concrete cast *in situ*, the individual lifts and subsequent repairs clearly visible. It had a low, conical roof, topped by a metal weathervane. A small rectangular projection on the eastern side of the silo presumably provided enclosed ladder access to the upper levels of the structure and was punctuated by three small window apertures, with a fourth aperture noted on its south-western side.

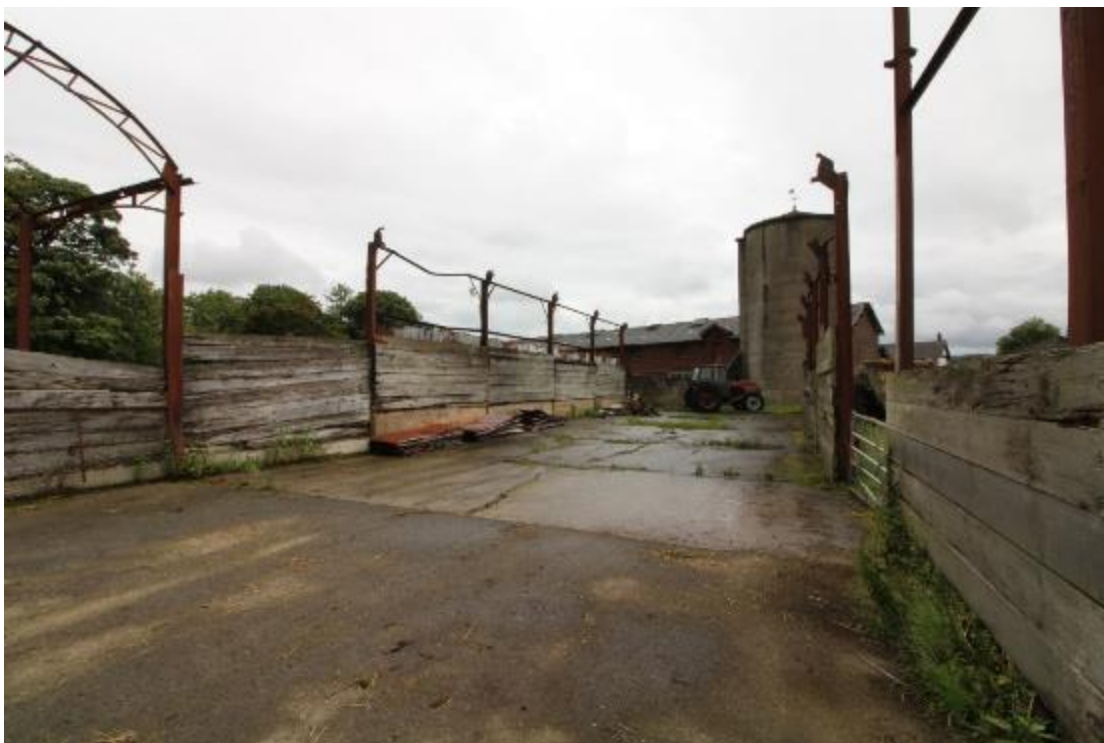
Plate 124: Interior of Northern Dutch Barn, facing south

- A.3.6.19 The walls were composed of timber planks which nowhere survived above mid-height (Plate 124). These were predominantly bolted to the upright posts. On the eastern wall of the larger building, the external elevation was clad in corrugated iron. The roof did not survive but the smaller structure preserved the framework of a barrel roof and the truncated stubs of the trusses on the larger building suggested the same.

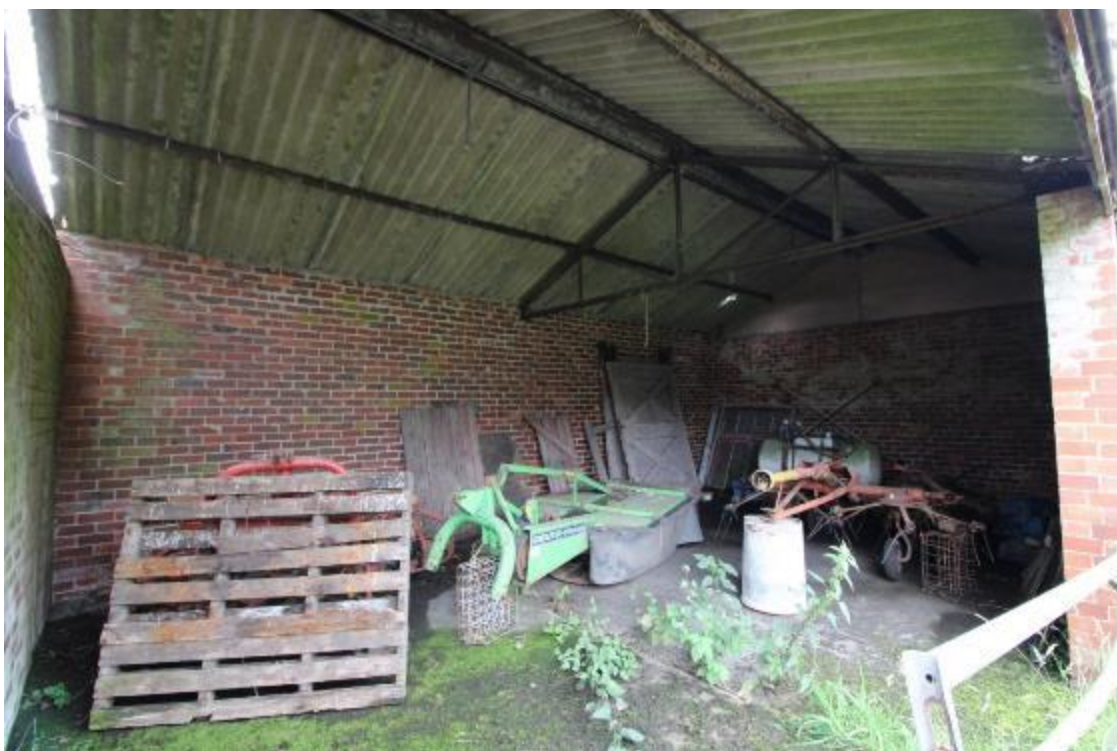
Plate 127: Interior of the southern cell, facing north-west

A.3.6.24 Internally, the larger southern cell was undivided, with brick walls and a concrete floor, beneath a single central truss of angle iron (Plate 127). From the interior it was evident that a truss of angle iron also formed the upper gable of the southern wall, hence the need for cladding in corrugated iron. The walls and floor of the northern cell were similarly treated, and the dividing wall between the two cells also had a truss of angle iron forming its upper gable (Plate 128). Despite the external cladding, the northern gable was a solid brick wall to its apex.

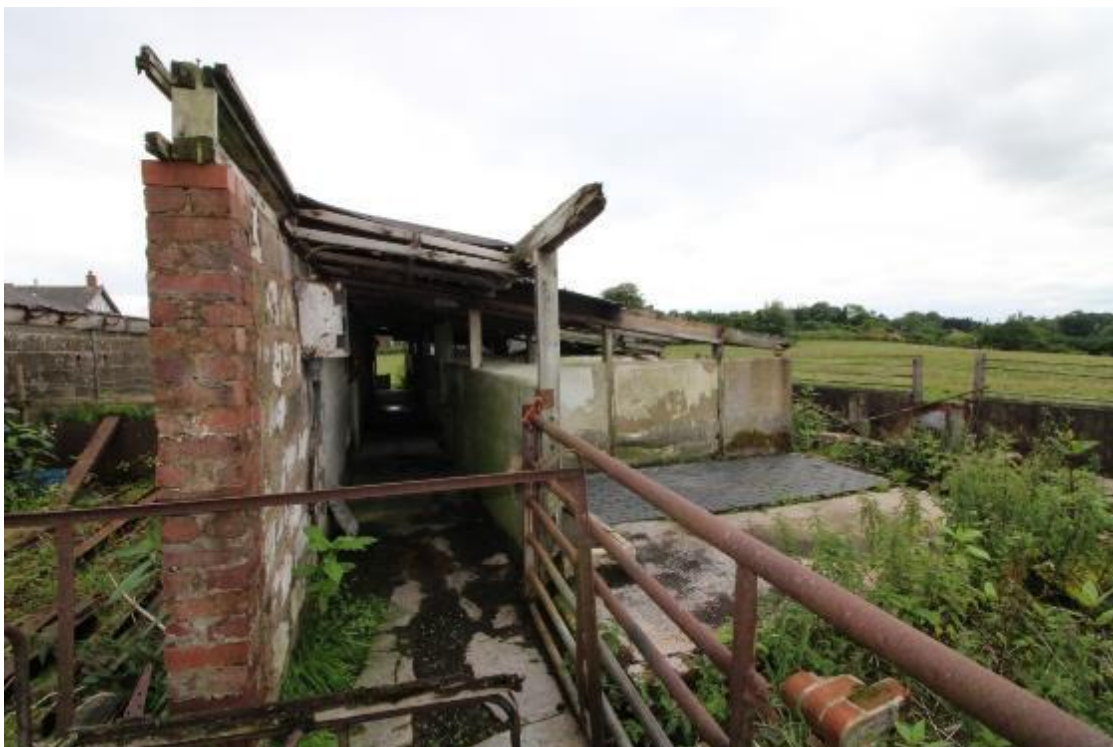
Plate 131: Remains of the Farrowing Pen, facing south

- A.3.6.27 To the west of the Western Piggery were the remnants of the Farrowing Pen, a smaller rectangular structure with which it shared its alignment (Plate 131). This building was also constructed of modern concrete blockwork and had a shallow, single-pitch roof of corrugated sheet material, draining to the west. It was in only marginally better condition than the adjacent Piggery. A passage running down the eastern side of the building provided access to the individually enclosed pens, with a series of enclosed yards on the western side also accessible from the west. As with the Western Piggery,

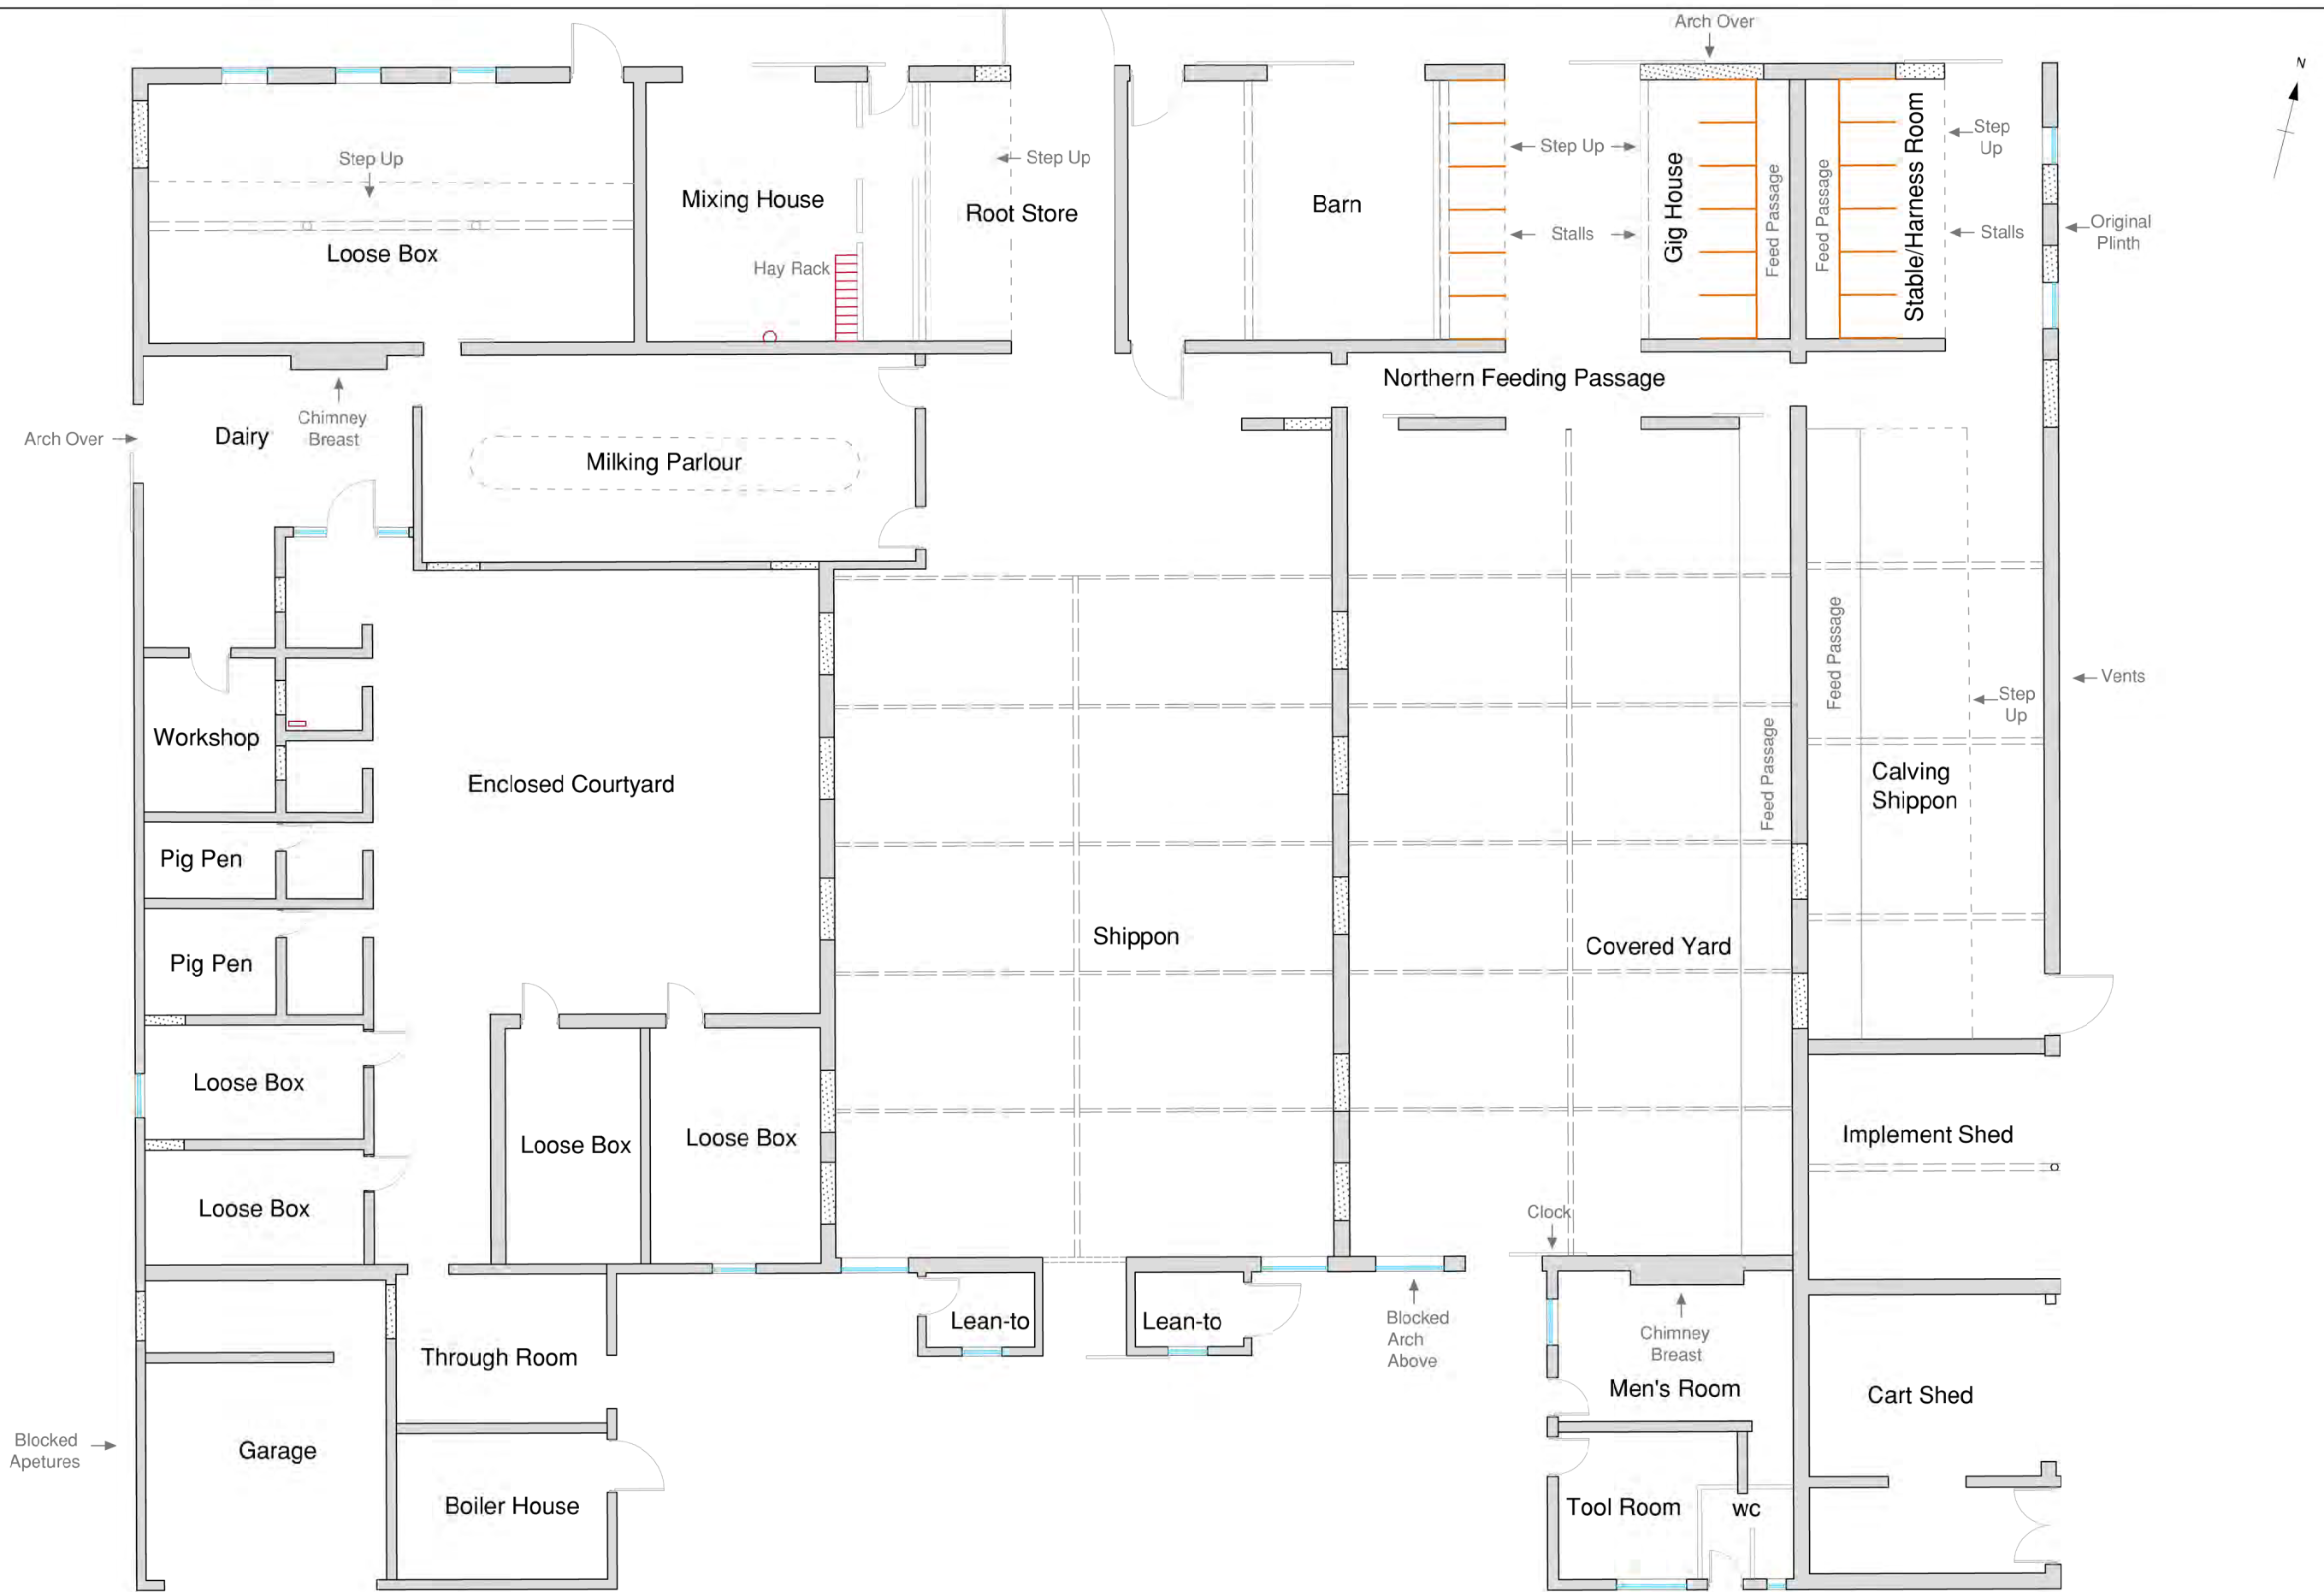
Figure 9: Ground-floor plan

A.3.5.14 At the southern end of the entrance passage to the Enclosed Courtyard, a pedestrian doorway led into the north-western corner of a rectangular room (Fig 9). Following the erection of the two Loose Boxes, this room served as a through passage to the southern yard via a doorway at the southern end of its eastern wall (Plate 100). The floor was concreted, the lower third of the walls were cement-rendered and the upper areas limewashed. The failure of the roof above the western wall had resulted in damp ingress. At the northern end, a blocked doorway was visible above a section of cement render, the reverse of that observed in the Garage (*Section A.3.5.16*). The exposure of the rafters above allowed illumination via a skylight on the eastern pitch.

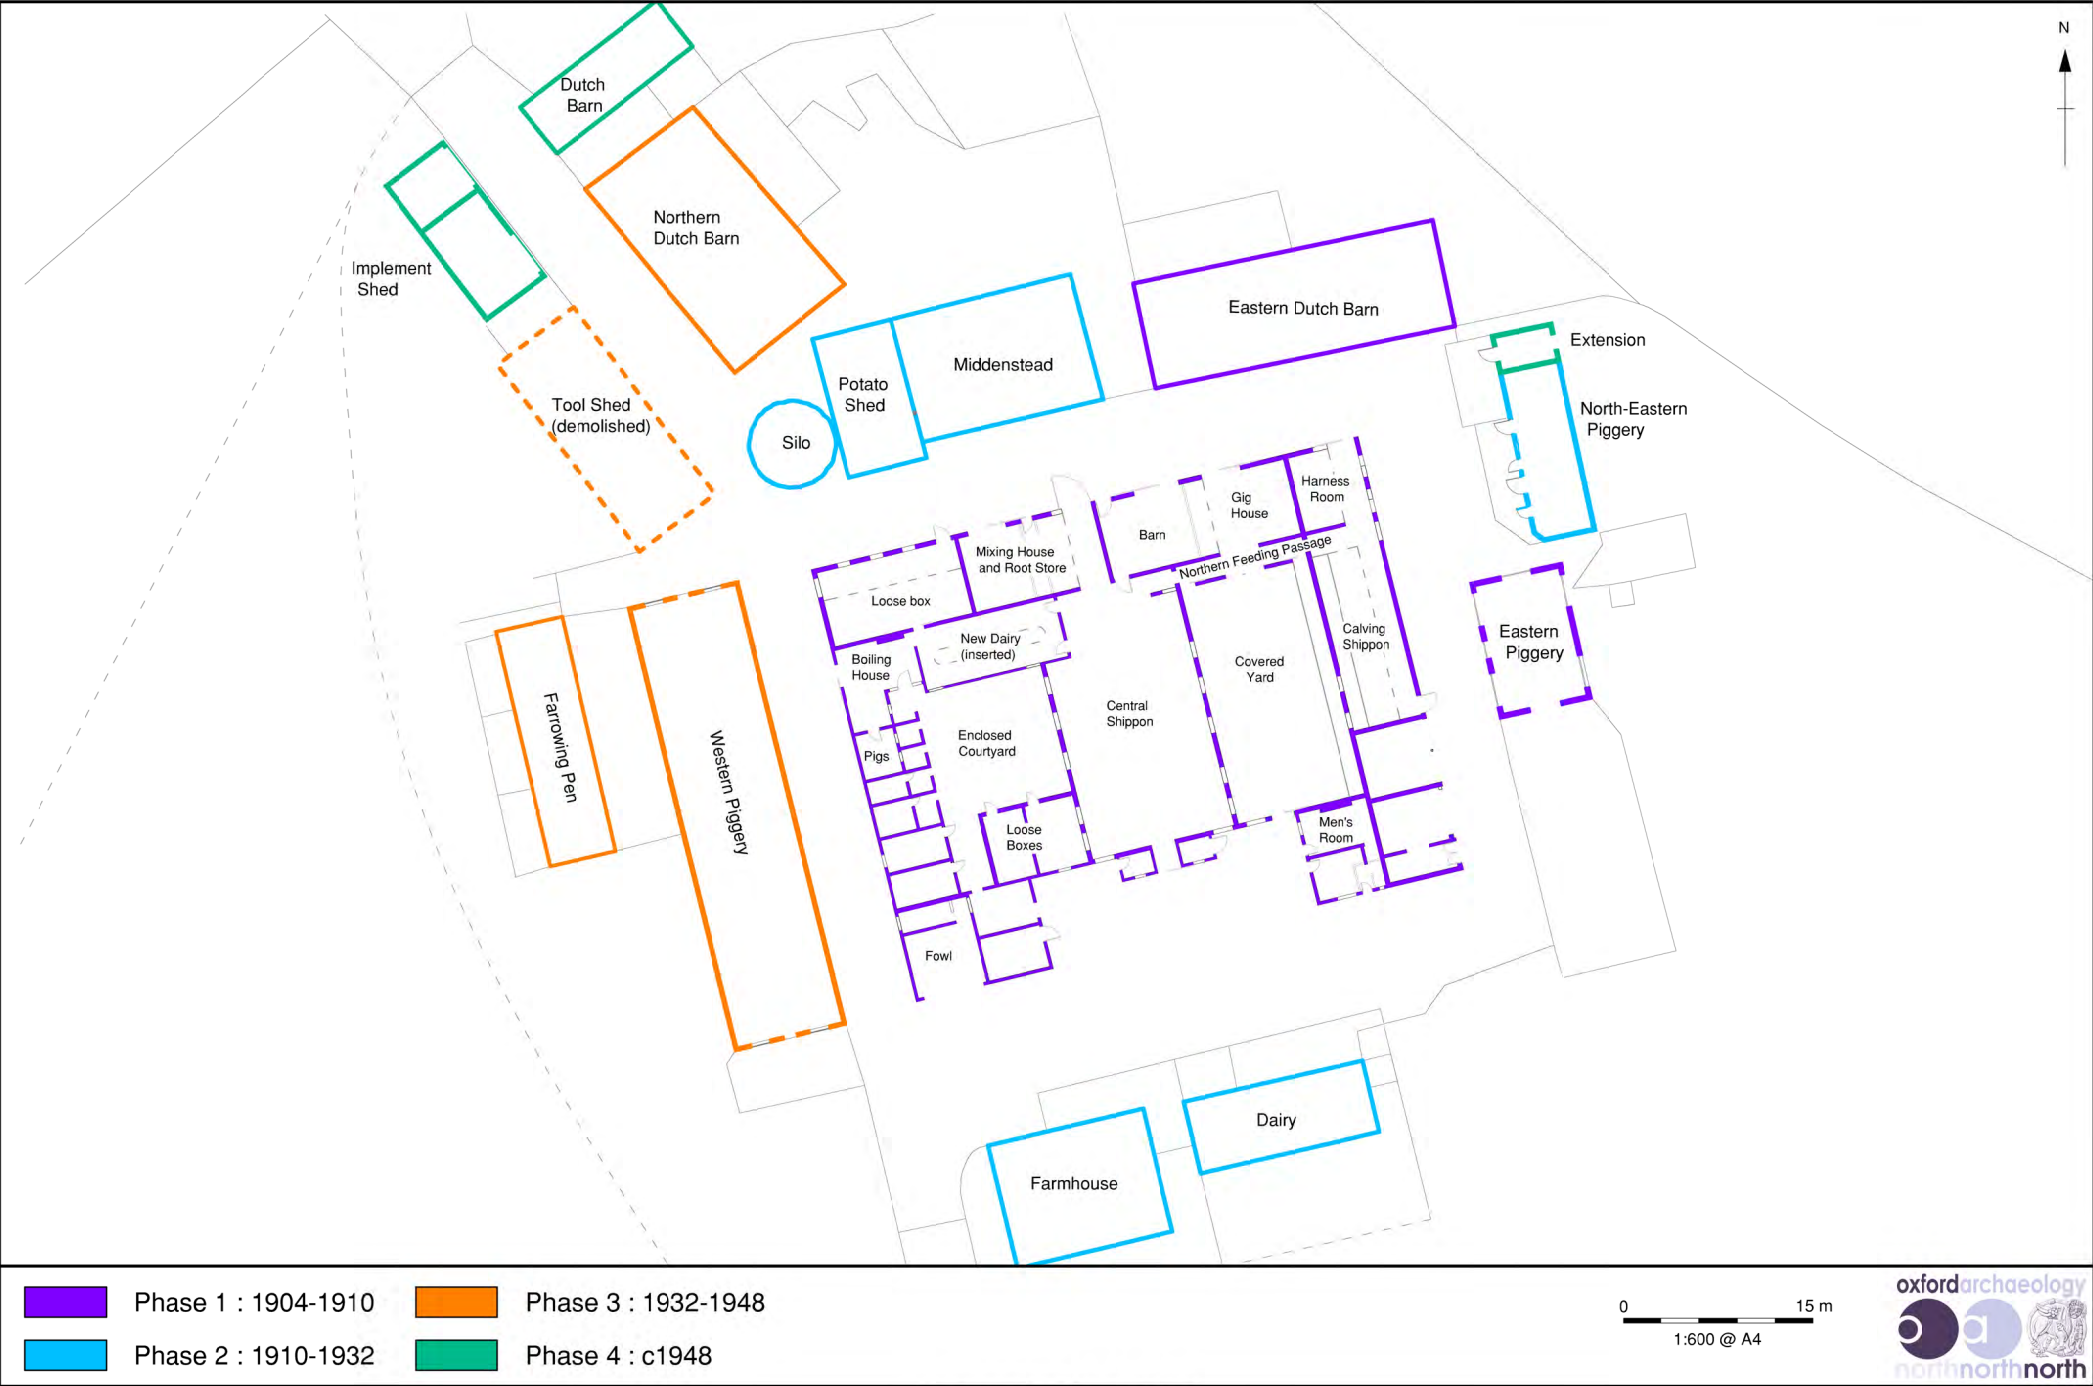
Figure 13: Ancilliary buildings photographic locations

- A.3.6.17 To the north of the Silo, and on the eastern side of the farm track leading to the fields north of the farm, lay the remnants of an L-Shaped range of Dutch Barns (Fig 13). The larger structure was an elongated rectangle, seven bays long and aligned north-west/south-east with an entrance at the southern end and another towards the northern end of the western wall (Plate 123). It was adjoined by a smaller single bay structure. The latter projected eastwards from the northern end of the barn's eastern wall and was accessible only from its southern side.

- A.3.6.21 The Implement Shed lay in the north-western corner of the complex, west of the track leading north towards the fields (Fig 13). The structure was aligned north-west/south-east and was rectangular in plan. It was three bays long and constructed of hard-fired red brick, beneath a gabled roof of corrugated sheet material. It was divided into two cells, the larger occupying the southern two bays accessed via a double width opening at the southern end of the eastern elevation (Plate 125). The smaller northern cell was accessed via a similar opening at the northern end of the same elevation. A metal rail at the head of the elevation suggested the former presence of top-mounted sliding doors.

- A.3.6.25 The Western Piggery was a large rectangular structure, aligned north/south and lying to the west of the Central Block (Plate 129; Fig 13). It was constructed of concrete blockwork with a timber roof structure clad in corrugated sheets. The farmer, Mr Willan, indicated that the building had not been used for some time after the collapse of the roof following a fire. The building could be entered from via a doorway at the centre of the northern gable wall, which was flanked by a pair of three part, six-light windows or from the opposing gable where a central door was accompanied to the east and west by additional entrances to the side passages.
