**Brockhall Farm, Old Langho, BB6 8BB**

**ECOLOGICAL SURVEY AND ASSESSMENT**  
**including a Licensed Bat and Bird Survey**

**Updated February 2021**

**[ERAP (Consultant Ecologists) Ltd ref: 2019-196]**

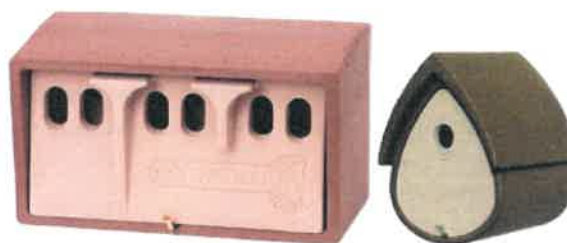
*Insert 2: Nest boxes suitable for installation on appropriate buildings to enhance the opportunities available for use by nesting birds, including Priority Species. Left to right: Schwegler 1SP house sparrow terrace and 1MR Avianex box*

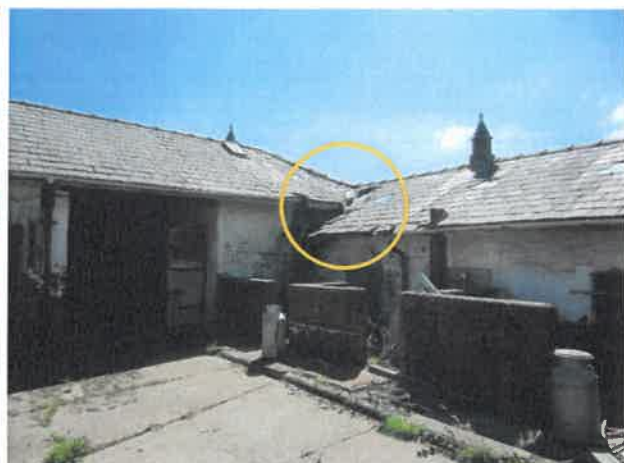
- 3.3.13 Refer to **Photo 21**. Section C is located along the western edge of the barn and comprises a lower, single storey area with a pitched slate covered roof. The roof is mostly unlined, although local areas are lined with plastic sheeting beneath the slates.
- 3.3.14 A hole in the roof formed by damage and water ingress is present at the point where Section C meets Section G, refer to **Photo 8**. No bats or bat droppings were found inside or around Section C.

**Photo 8:** Courtyard area (facing south-west) and damage to roof at Section C

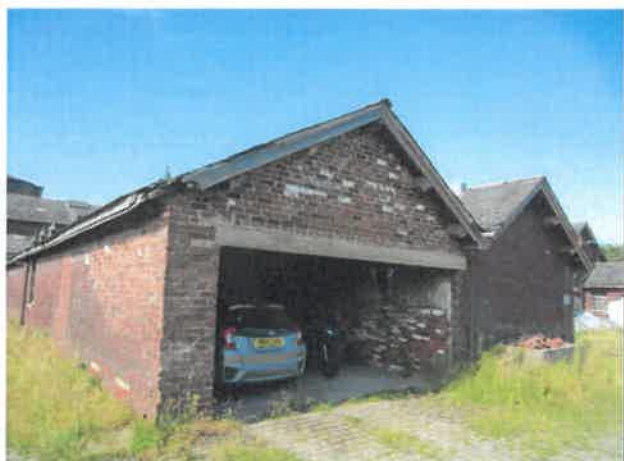
**Photo 9:** South-western corner (Section I) and damage to timber soffits and fascia

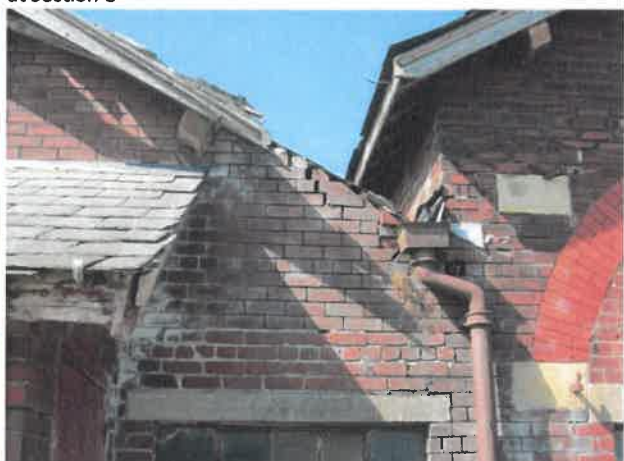
- Gaps in the brick elevation walls, particularly where there is damage (e.g. at the southern elevation, refer to **Photo 10**);
  - Between the slates and the wall tops at the roof verge on the gable ends, refer to **Photo 11**;

**Photo 10:** Gaps in brickwork at southern elevation

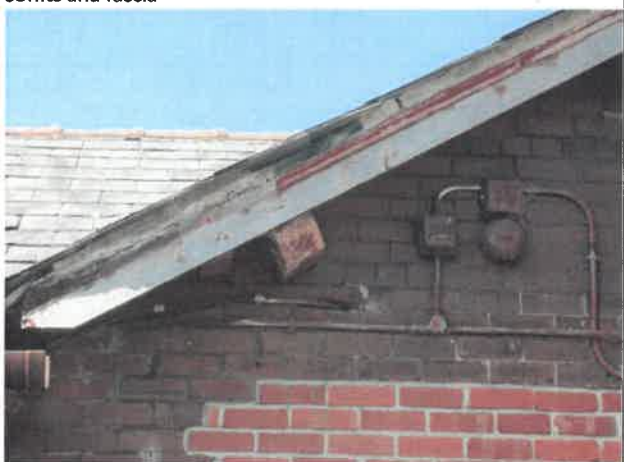
**Photo 11:** Gaps beneath the slates at the roof verge on southern elevation

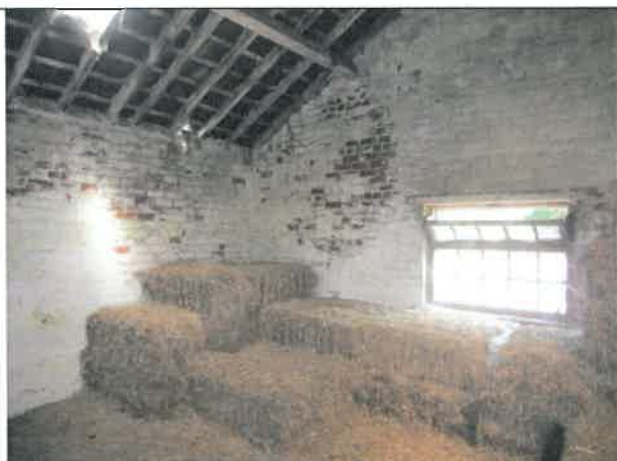
**Photo 13:** Interior of Section A showing mortared walls, underside of slates and skylights

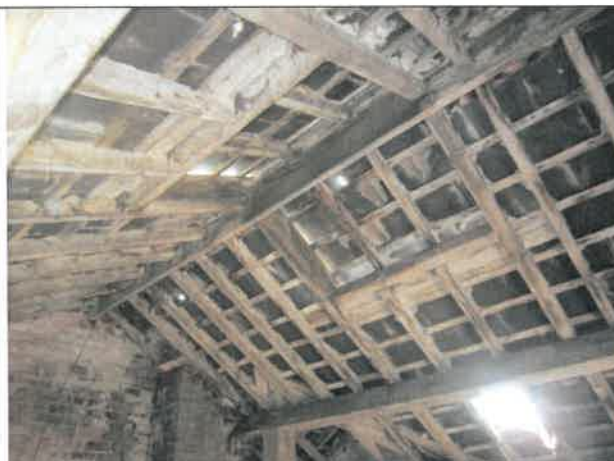
**Photo 14:** Underside of roof at Section A

- 3.3.8 Refer to **Photos 13 to 16**. Section A is located at the north-eastern corner of the barn and comprises of former livestock stalls on the ground floor with a timber floor to form a hayloft above. A large brick arched doorway aperture is present at the northern elevation. The roof is unlined and the underside of the slates are visible. The roof timbers comprise a traditional kingpost with purlin and rafter arrangement. The ridgeboards are covered with dense cobwebs.

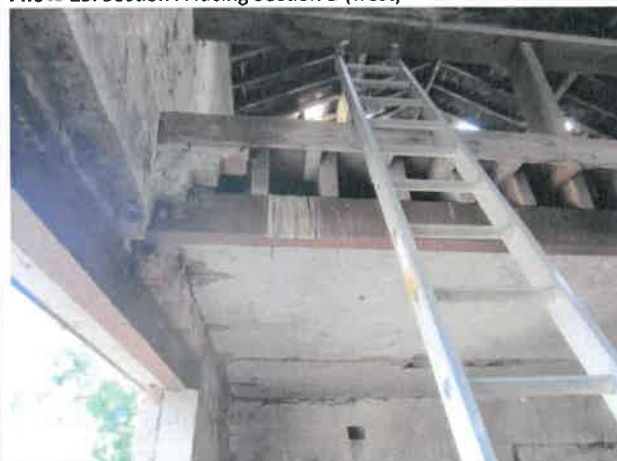
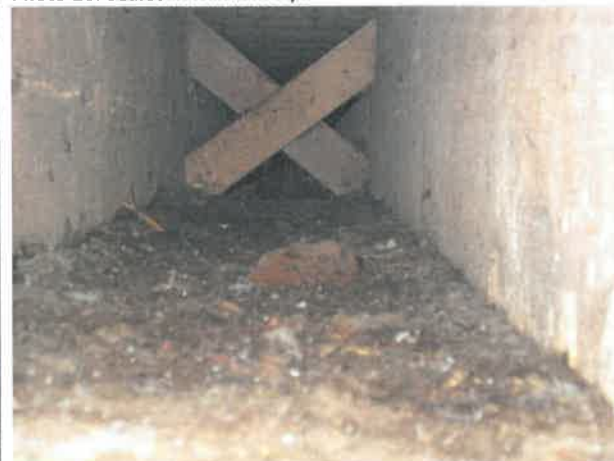
3.4.4 Use of Building 1 by nesting barn owl was confirmed by the presence of at least two nestlings in the void between the floor joists in the northern portion of the building on 23<sup>rd</sup> July 2019, refer to **Photos 17 and 18**. Adult barn owl were observed entering the barn carrying food during the dusk emergence survey on 29<sup>th</sup> July 2019 and the dawn survey on 20<sup>th</sup> August 2019. On the 20<sup>th</sup> August 2019 three barn owl fledglings were present in Section E of Building 1.

**Photo 17:** Concentration of barn owl faeces at Section A

**Photo 18:** Gap / void between floor joists used by nesting barn owl (chick present but difficult to photograph); Dead vole prey present.

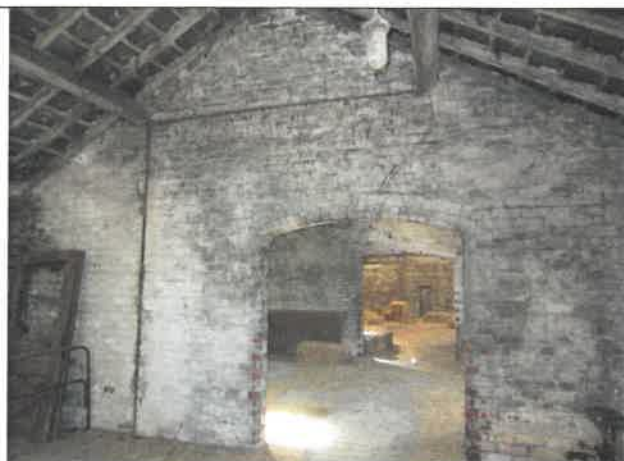
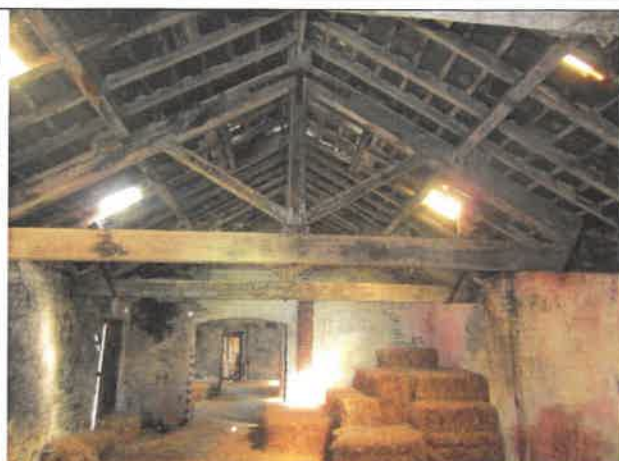
- 3.3.10 Refer to **Photos 19** and **20**. Section B is located at the north-western corner of the barn and is similar in construction to Section A with local areas of concrete rendered walls (internally).
- 3.3.11 No bats were found and closer inspection confirms that the eaves are well sealed, no gaps are present at the mortise joints at the roof timbers and the bricks at the arched doorways are tightly fitted.
- 3.3.12 Bat droppings were found scattered over the floor of the hayloft to indicate access by bats to the interior of the building.

**Photo 19:** Section B showing sealed brick walls

**Photo 20:** Roof timbers at Section B

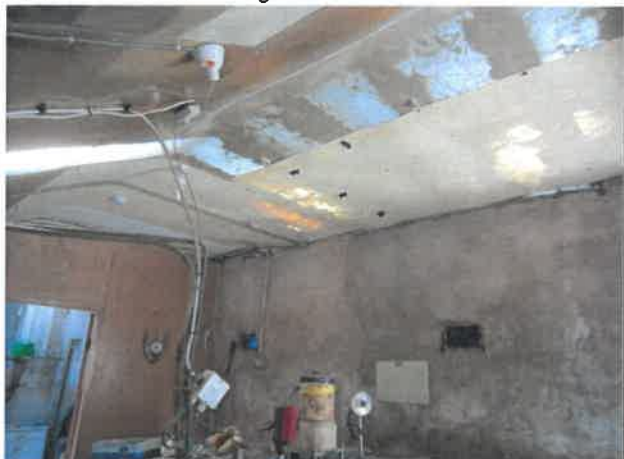
**Photo 21:** Section C

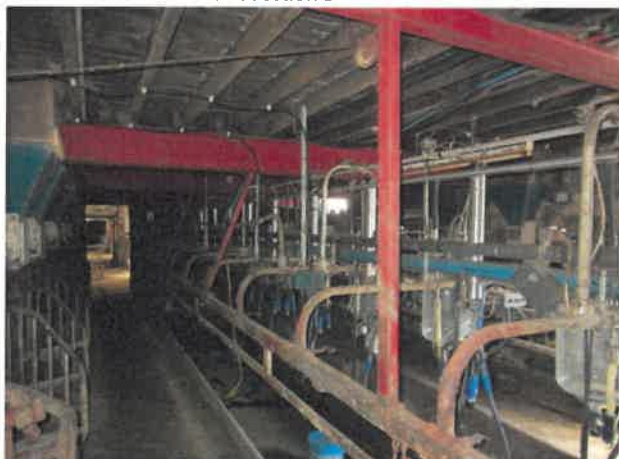
- 3.3.15 Refer to **Photo 22**. Section D forms the former milking area and supports a monopitch corrugated sheet covered roof. The walls are lined internally with render. No bats or bat droppings were found inside or around Section D.

**Photo 22:** Section D

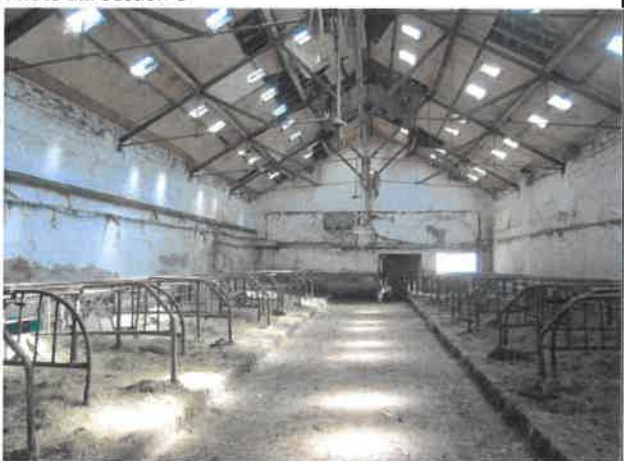
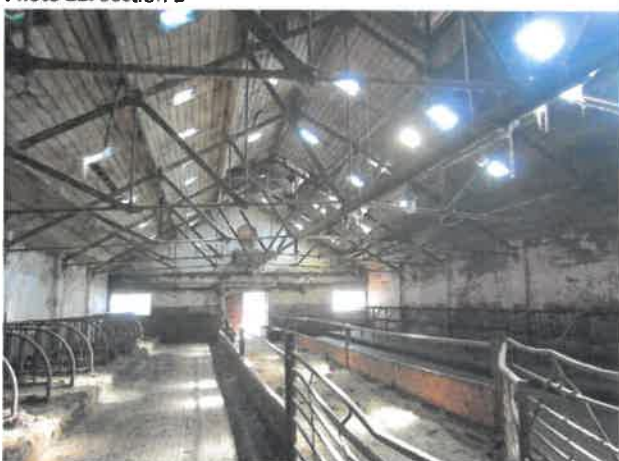
- 3.3.16 Refer to **Photos 23** and **24**. Section E comprises two cow sheds in the centre of the barn. The underside of the slates is lined with boards at the eastern shed and with timber sarking at the western shed. The large voids are light owing to the presence of skylights in the roof.
- 3.3.17 The eaves and wall-tops are sealed with timber planks and the internal walls are well pointed or sealed with a white wash and this limits opportunities for bat access to roosts internally. An old uncovered and water-filled tank was searched; no dead bats were found.
- 3.3.18 No bats or droppings were found inside the cow sheds, although it is accepted that the presence of straw on the floor limits the search.

**Photo 23:** Section E (east)

**Photo 24:** Section E (west)

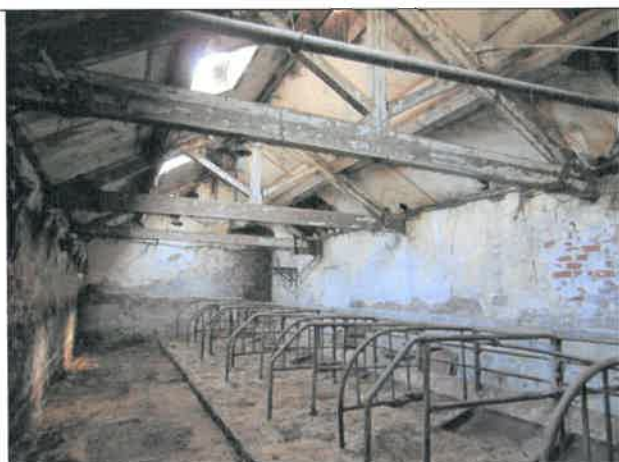
- 3.3.19 Refer to **Photo 25**. Section F is attached to the eastern elevation of Section E and comprises a single storey building with concrete render covered walls. The underside of the slates is mostly board lined. Skylights are present in the roof to create a light internal area. The eaves and wall-tops are sealed with timber planks; no gaps were noted at the roof timbers. No bats or bat droppings were found inside or around Section F.

**Photo 25:** Section F (facing south)

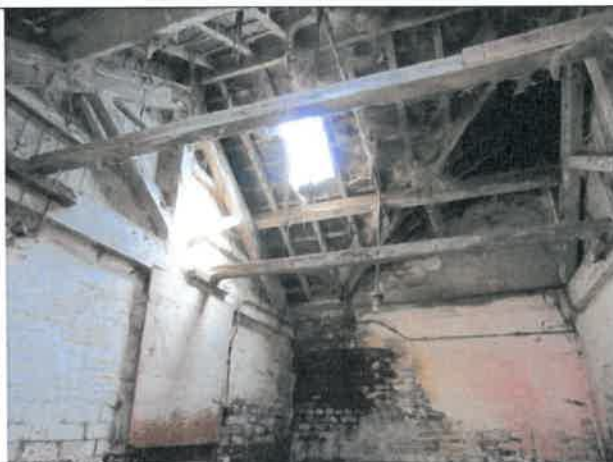
- 3.3.20 Refer to **Photo 26**. Section G comprises a former stable area in the south-western corner of the barn. The internal areas are in a similar condition to Sections A and B with rendered and painted / white washed walls. The underside of the slates is unlined. No bats or bat droppings were found.

**Photo 26:** Section G

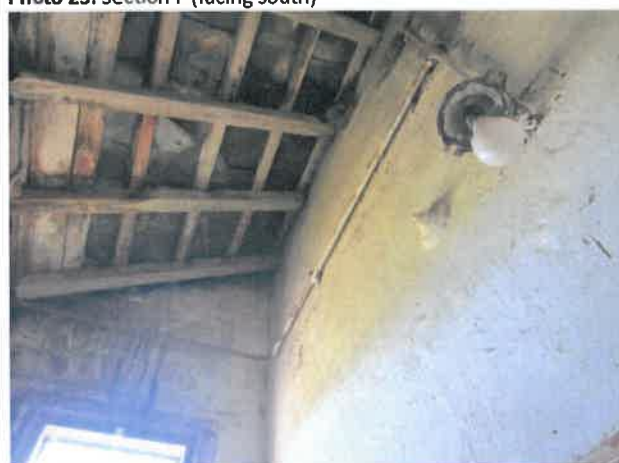
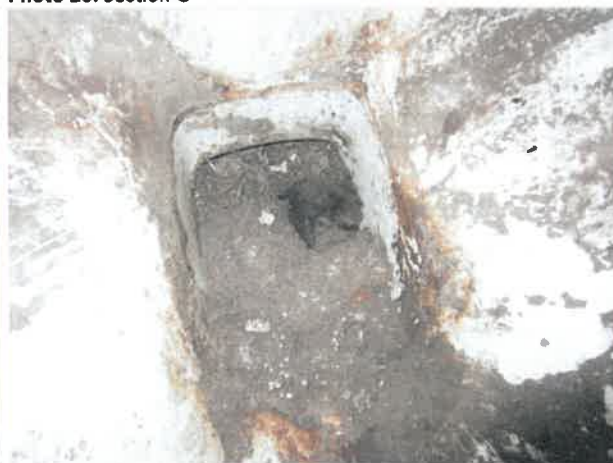
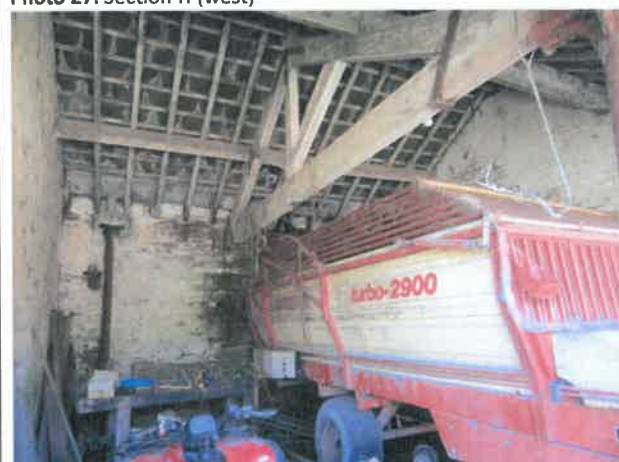
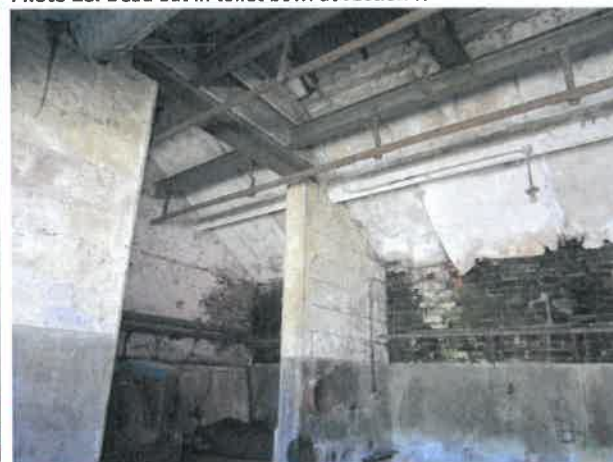
- 3.3.21 Refer to **Photos 27 to 30**. Section H is located at the south-eastern corner of the barn; the internal area is divided into two storage areas and a disused toilet by brick walls. The slates at the western part of Section H are unlined. At the eastern part over a garage / workshop area, the slates are board lined.
- 3.3.22 A dead bat (suspected pipistrelle species) was found in the dry toilet bowl, refer to **Photo 28** and **Figure 3**. No other bats or droppings were found in this section of the barn.

**Photo 28:** Dead bat in toilet bowl at Section H

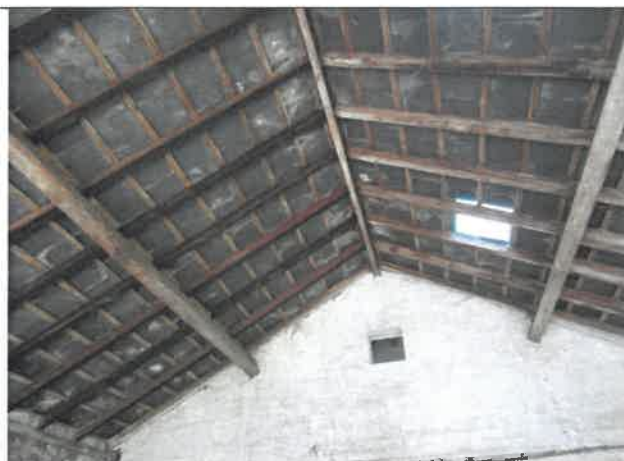
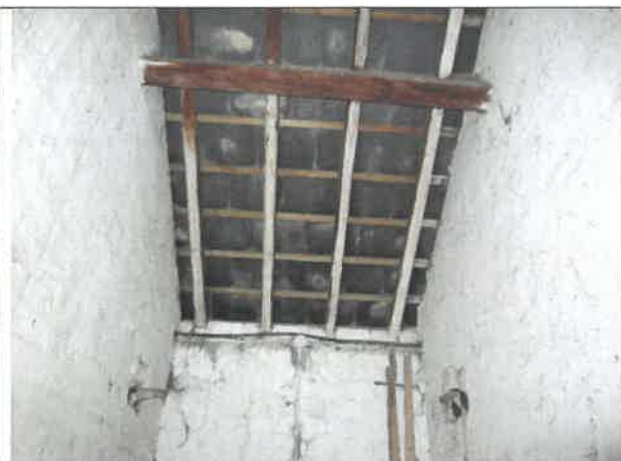
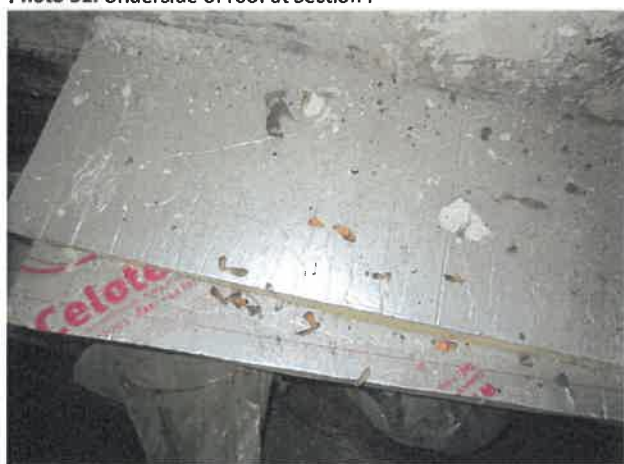
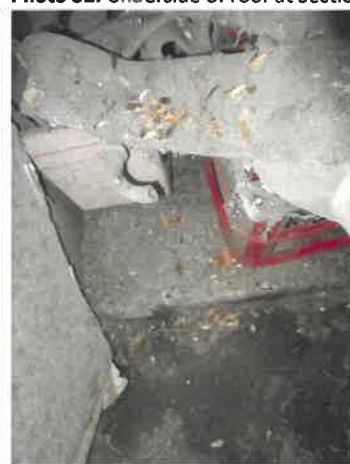
- 3.3.23 Refer to **Photos 31 to 34**. Section I is located at the south-western corner of the barn and comprises a garage area with a narrow store. The internal walls are painted white and the roof is not lined. No bats were found in this section of the building, however approximately 30 bat droppings and the remains of the large yellow underwing moth (*Noctua pronuba*) were found beneath the ridge board over the narrow store. The droppings and prey remains are indicative of a brown long-eared bat (*Plecotus auritus*) feeding / night / day roost [**Roost 1**].

**Photo 33:** Bat droppings and Yellow Underwing moth wings beneath Roost 1 at Section I

**Photo 34:** Bat droppings and Yellow Underwing moth wings beneath Roost 1 at Section I

- 5.4.9 The conversion works will involve the loss of Roosts 1 to 5 during works to re-roof the buildings.
- 5.4.10 The licensed ecologist must be present during the careful removal / soft strip of the roof coverings in the vicinity of Roosts 1 to 5 and all other features with suitability for use by roosting bats. Roof tiles / slates and ridge copings must be lifted (rather than slid) and the underside of the roof covering will be checked for bats prior to discard / stacking.
- 5.4.11 If a bat is present or found the licensed ecologist will carefully collect the bat (using a hand held static net or by direct handling), place the bat in an appropriate container and transfer the bat(s) to the bat box.

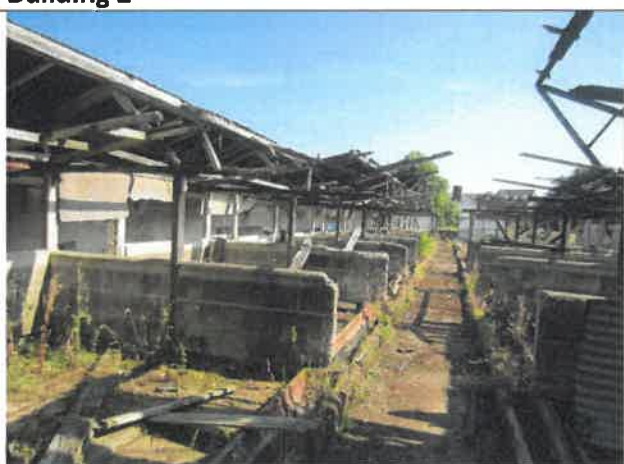
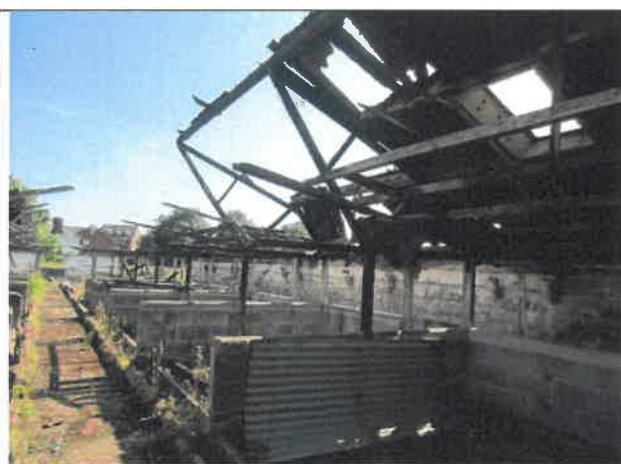
- 3.3.25 Refer to **Photos 35 and 36**. Building 2 is a concrete block structure with a timber frame. There is evidence of fire damage and no roof covering is present.
- 3.3.26 No bats or droppings were found. Owing to the absence of potential roost features and the exposed conditions present, Building 2 is assessed to be of negligible suitability for use by roosting bats.

**Photo 35:** Damaged roof and exposed conditions

**Photo 36:** Damaged roof and exposed conditions

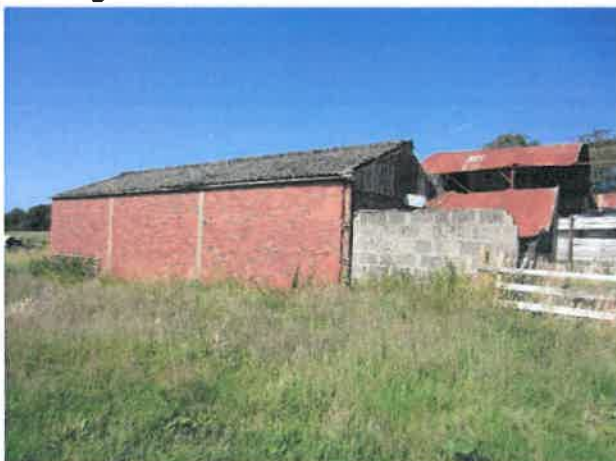
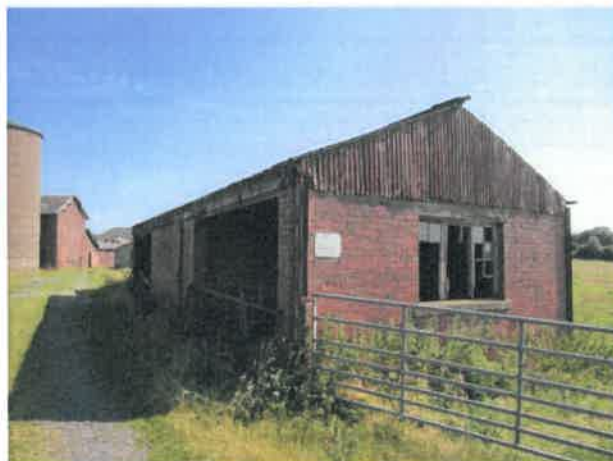
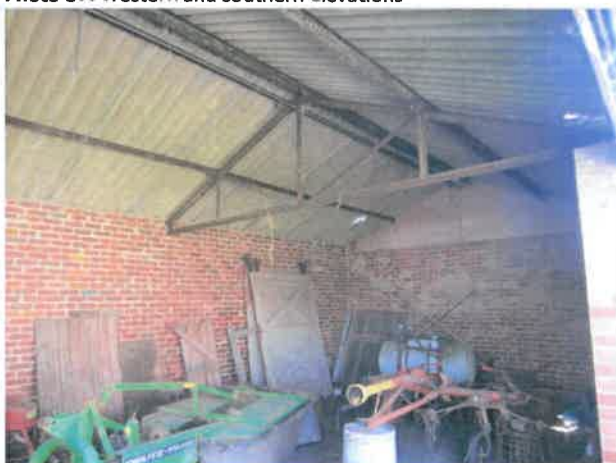
- 3.3.27 Refer to **Photos 37 to 39**. Building 3 is a single storey brick building with a pitched corrugated sheet covered roof. All elevation walls (exterior and interior) including the wall tops are well pointed; no gaps or opportunities for bat access into the walls were found.
- 3.3.28 No bats or droppings were found. Owing to the absence of potential roost features, Building 3 is assessed to be of negligible suitability for use by roosting bats.

**Photo 37:** Western and southern elevations

**Photo 38:** Eastern and northern elevations

**Photo 39:** Interior of Building 3

5.5.13 It is recommended that provisions for nesting swallow (i.e. protruding nails to provide an attachment point to enable swallow to construct their nests) are accommodated at the roof timbers of the converted 'Implement Shed' (Building 3). Access from the exterior will also need to be provided.

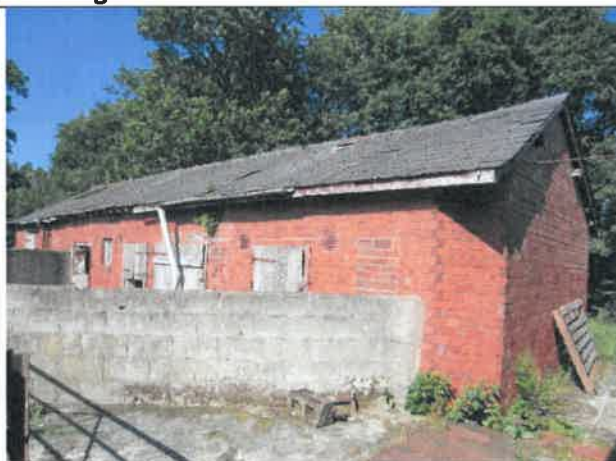
**Photo 40:** Western and southern elevations

- 3.3.29 Refer to **Photos 40 to 43**. Building 4 is a single storey brick structure of a pitched slate covered roof. The opportunities for bat access are similar to those described for Building 1.

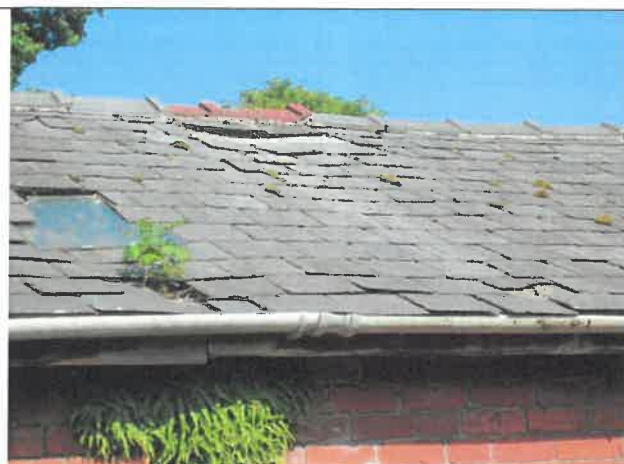
3.3.31 No bats or droppings were found. Owing to the presence of crevices suitable for bat access and the building's proximity to the woodland to the east, Building 4 is assessed to be of high suitability for use by roosting bats.

**Photo 42:** Gaps at the roof covering

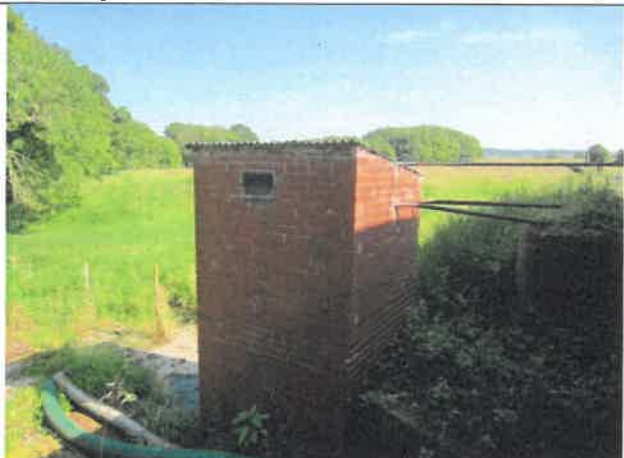
**Photo 44:** Building 5

3.3.32 Refer to **Photo 44**. Building 5 is a small (1 metre by 1 metre) brick structure with a monopitch corrugated sheeting covered roof; the building is assessed to be of negligible suitability for use by roosting bats.

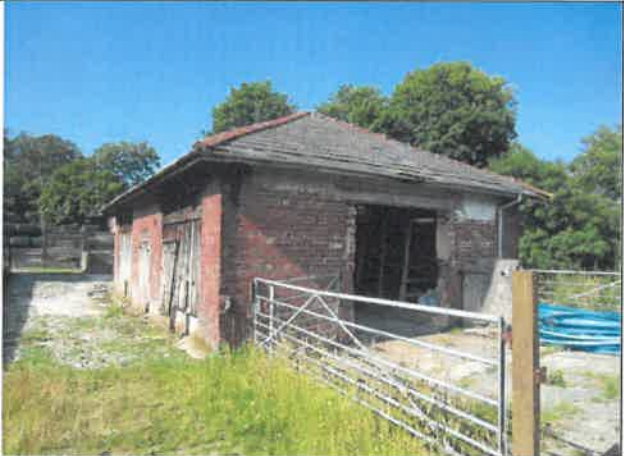
**Photo 45:** Western and southern elevations

3.3.33 Refer to **Photos 45 to 50**. Building 6 is a single storey brick building with a hipped slated covered roof and terracotta ridge copings. The timber eaves are overhanging and the roof is constructed from traditional timber trusses with rafters and purlins.

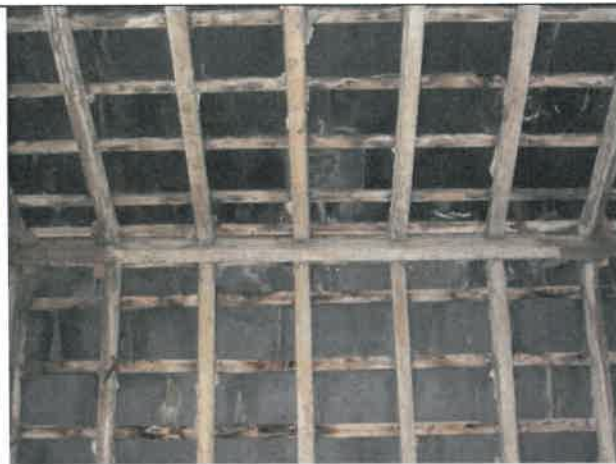
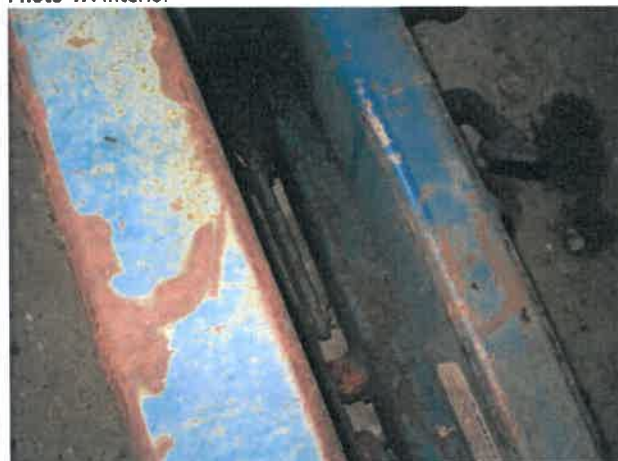
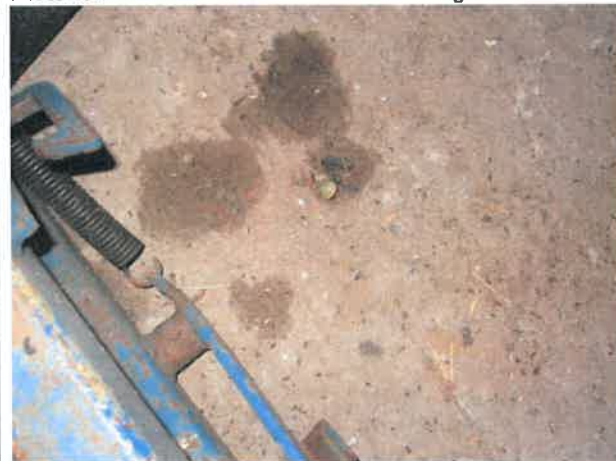
3.3.35 The ridgeboard is covered with dense cobwebs in the majority of the areas with the exception of the central and highest point. A cluster of 10 fresh bat droppings were found on the floor and tractor beneath the central area of the building in July. The number of droppings had increased to approximately 40 by September 2019 to indicate the presence of a bat roost [**Roost 2**].

**Photo 48:** Rafters and cobweb free section of ridgeboard

**Photo 49:** Bat droppings beneath the ridgeboard in the centre of the building [Roost 2]

**Photo 50:** Bat droppings beneath the ridgeboard in the centre of the building [Roost 2]

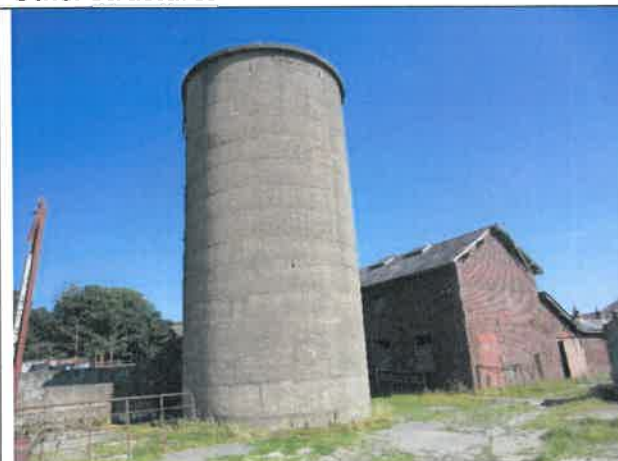
- 2.5.1 All areas of the site were accessed with the exception of the interior of the concrete silo (refer to **Figure 2**). Owing to the fabrication and condition of this structure, as described in **Section 3.3**, this is not a significant limitation and it is considered that the inaccessibility of the interior of the tower does not affect the assessment and conclusions.
- 2.5.2 Measurements within this report are approximate only, and have been either estimated whilst on site or calculated using mapping software (QGIS) or internet-based mapping services such as MAGiC and Google Earth.

**Photo 51:** Concrete silo to the north of the main barn

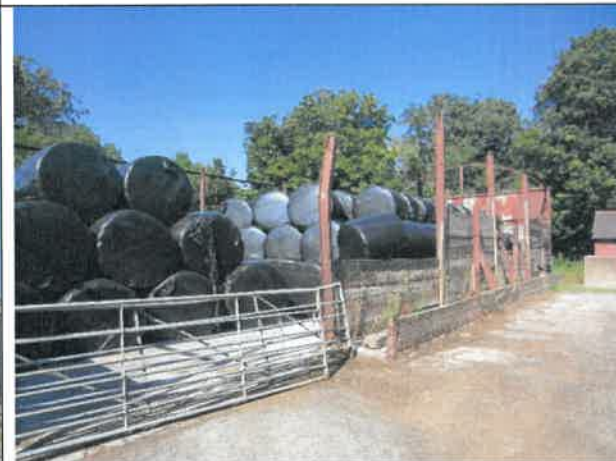
**Photo 52:** Remnant metal framed barn to the north of the main barn

3.3.37 Refer to **Photos 51 to 54**. North of the main barn is a concrete silo and the remnant metal frames of former Dutch barns; none of these structures have suitability for use by roosting bats.

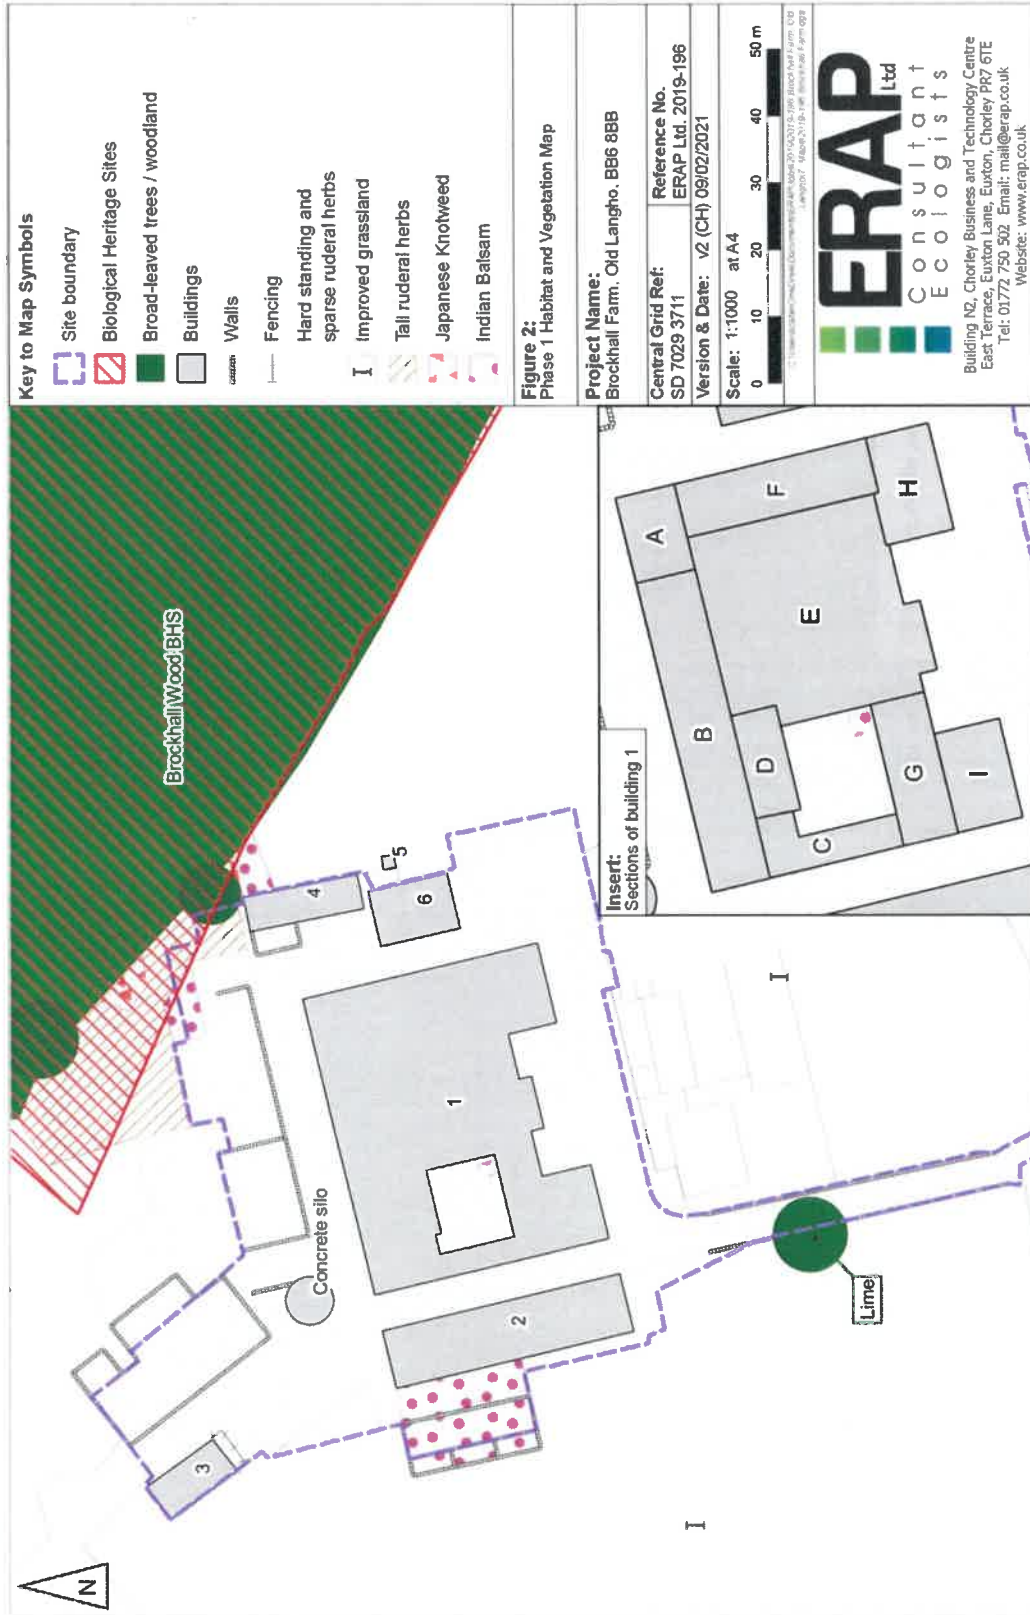
Figure 3: Plan to Show Surveyor Locations and Results of Surveys 2019

3.3.40 Five different roost locations were detected during the bat activity surveys as summarised at **Table 3.3** and annotated on **Figure 3**.

3.4.3 Refer to the annotations on **Figure 3**.
