**Re: Proposed development at 22 Ribchester Road, Wiltshire, BB1 9JH (central grid reference: SD 68630 32579)**

Thank you for your request for a biodiversity survey at the above site. I understand that the proposed development is for a rear single storey extension and a loft conversion including installation of a roof dormer to the existing dwelling house.

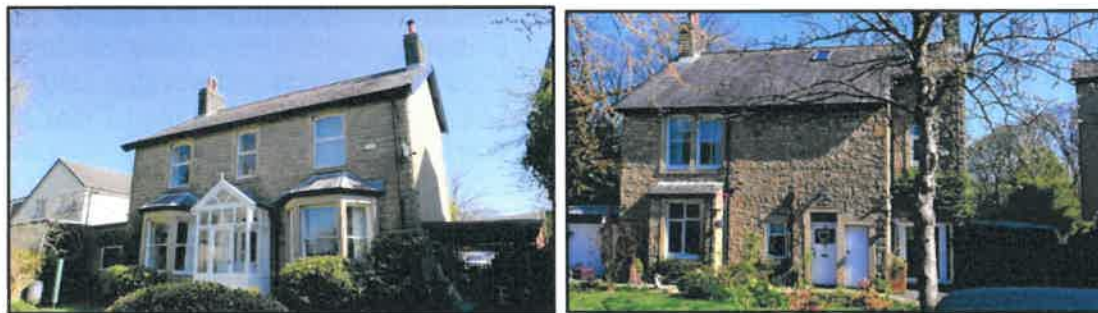
22 Ribchester Road comprises an occupied, detached dwelling house constructed of stone with a dual pitched slate roof and chimneys at the gables. There is an adjoining single storey, flat roof garage to the north and car port to the south, as well as front and rear gardens bordered by stone walls and established vegetation. There are mown lawns, hardstanding and planted trees and shrubs within both garden areas.

***View of 22 Ribchester Road front (west) elevation (lhs) and rear (east) elevation (rhs)***

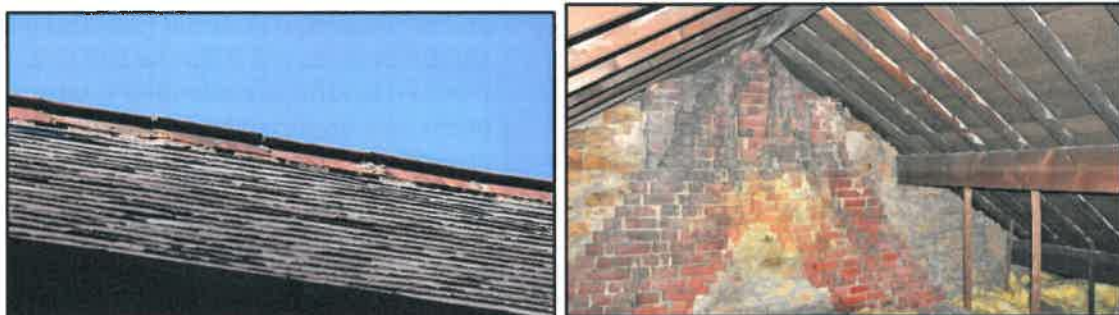
The exterior of the property is in good condition with occasional gaps, associated with natural fit of the slate roof coverings, missing mortar at the ridges and occasional small gaps along the roof edges. There is a single, large gap on the south east corner below the soffit which is suitable for use by nesting birds. Old signs of bird nesting are also present on the east elevation below the soffit, which has since been sealed tight. Old bird nesting material was also found within the roof void. There is also a fascia board on the rear of the single storey garage that has a gap suitable for access by roosting bats.

The southern half of the roof contains Velux windows and has been previously converted into living space. There are narrow voids (accessed via side hatches) along the eaves that connect with an enclosed roof void in the northern part of the property. All of the voids contain rock wool insulation, bitumastic roof liner and exposed timber roof supports. The main roof void (northern part of the roof) is currently unused, open and clutter free.

***View showing roof covering with occasional gaps present between slates and ridge(lhs) and internal roof void (rhs)***

| Protected Species | Impacts /Predicted Impacts | Action Required |
|---|---|---|
| Bats | <p>It is advised that there is no evidence to suggest that bats pose a constraint to the proposed development.</p> <p>It is advised that there are potential roost features (gaps) suitable for bats associated with roof coverings, roof edges and garage fascia. In this location and landscape setting, these features have low potential for bats to use throughout the year.</p> <p>All bat species are afforded full protection under The Conservation of Habitats and Species (Amendment) (EU Exit) Regulations 2019</p> | <p><b>Advice (mitigation):</b><br/>All personnel involved in proposed development works should be carefully advised about bats by a professional Ecologist, so that all works are undertaken with a clear understanding about legal aspects, precautions to be adopted and what to do if a bat is found. <b>Prior to development.</b></p> <p><b>Advice (mitigation):</b> As a precaution, it is advised that when removal or disturbance of potential roost features such roof coverings are to take place, this should be done carefully by hand. <b>At all times.</b></p> <p><b>Advice (mitigation):</b><br/>If bats are found at any time during the development, work must stop until advice has been sought from an appropriately experienced Ecologist. If the development will affect bats, a licence may be required and suitable mitigation put in place. <b>At all times.</b></p> |

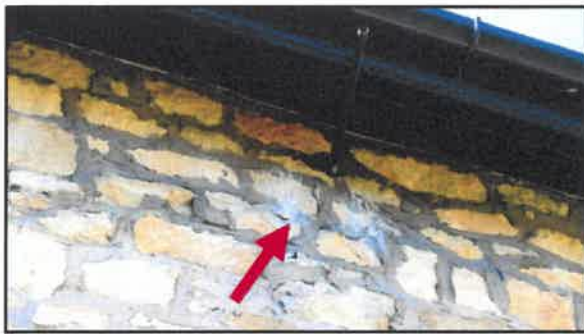
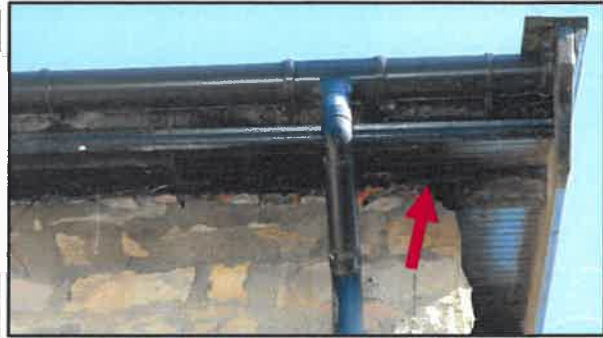
Old bird nesting signs were found associated with south east elevation in the roof void and below the soffit.

***Old signs of bird nesting below soffit (lhs) and gap on south east corner (rhs)***

| Protected species | Impacts /Predicted Impacts | Action Required |
|---|---|---|
| Nesting birds | <p>It is advised that there is high potential for birds to be nesting within roof edges during the bird nesting season (February to September).</p> <p>Under the Wildlife and Countryside Act 1981 (as amended), wild birds are protected from being killed, injured or captured, while their nests and eggs are protected from being damaged, destroyed or taken.</p> <p>There is no provision under the Wildlife and Countryside Act 1981 (as amended) for licensing the disturbance of nesting birds or the destruction of nests which are in use, for the purpose of development.</p> <p>If enforcement action were taken the developer would need to rely on the 'incidental result of an otherwise lawful operation' defence if it were not possible to avoid an offence being committed. This defence can only be tested in court and it is therefore important to ensure all possible mechanisms for avoiding an offence are considered.</p> | <p><b>Advice (mitigation):</b> It is advised that the most appropriate way to address the risk to nesting birds is:<br/>Avoid disturbance to the building and vegetation during the nesting season.<br/>Or<br/>If works cannot be delayed the proposed work area should be carefully checked, immediately prior to works commencing. Checks should be carried out by a suitably experienced ecologist. If the risk of nesting birds remains, then monitoring for nesting bird activity should continue for the duration of works. <b>Prior to any work commencing (checks) and throughout works in nesting season (monitoring).</b></p> <p><b>Advice (mitigation):</b><br/>If works are to be undertaken during the nesting season, all people working at the proposed development site should attend a toolbox talk delivered by an appropriately experienced person, to be made aware of the likelihood of encountering nesting birds and how to identify them, the legal protection of nesting birds and their own responsibilities as regards implementation of precautionary measures. <b>Prior to any work commencing.</b></p> |

| Protected species | Impacts /Predicted Impacts | Action Required |
|---|---|---|
| Nesting birds<br>Continued | | <b>Advice (mitigation):</b><br>If birds are found to be nesting within or in close proximity to the work area during proposed works, it will be necessary to stop and establish an exclusion area. The extent of the exclusion area, which should be determined by a suitably experienced ecologist, will depend on the bird species and the nature of the proposed works. <b>At all times.</b> |

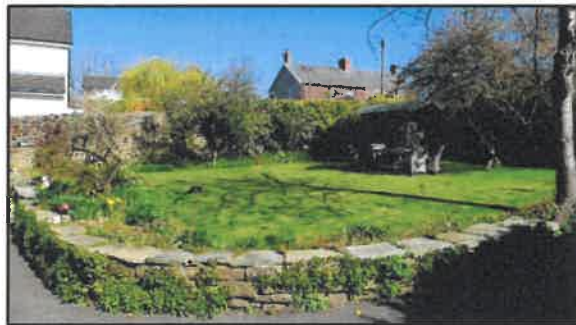
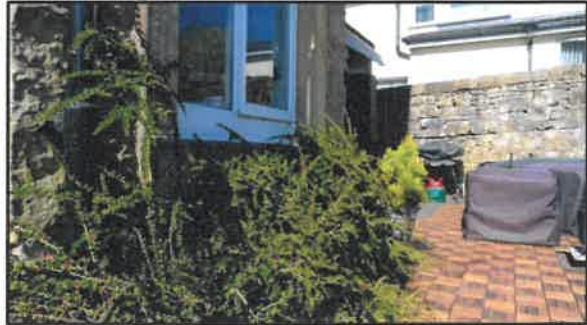
Growing on part of the east elevation wall and car port is a climbing vine plant; this has some potential for use by nesting birds. In addition, there are a range of trees and shrubs within the garden and close to the proposed development site that have high potential for use by birds during the nesting season (February to September). Amongst these shrubs are non-native invasive cotoneaster species.

***View of rear garden (lhs) and cotoneaster species growing below window (rhs)***

| Non-native invasive plant species | Impacts /Predicted Impacts | Action Required |
|---|---|---|
| Cotoneaster species confirmed within garden planting | <p>It is advised that the proposed development will have to take account of non-native invasive plant species.</p> <p>Proposed works to the building will involve an amount of disturbance which could result in the spread of non-native invasive plant species which are listed on Schedule 9 of the Wildlife and Countryside Act 1981 (as amended).</p> | <p><b>Advice (mitigation):</b> All personnel involved in the proposed development works should be made aware of the presence of non-native plant species and how to identify them, so that all works are undertaken with a clear understanding about legal aspects and working methods and precautions to be adopted. <b>Prior to any work.</b></p> <p><b>Advice (mitigation):</b> Where possible, leave all boundary and border plants in situ and avoid all activities that have the potential to disturb the ground/plants resulting in the further spread. If plants must be removed, they should be removed carefully by hand and all excavated material (soil and plants) should be removed from the site to a licensed landfill as controlled waste, or burnt on a bonfire where it will not cause nuisance to neighbours through excessive smoke or odour. <b>Prior to and during any work.</b></p> |
