# **Preliminary Bat Roost Assessment Report**

**1 Portfield Bar,  
Whalley,  
BB7 9DL**

**09.04.2021**

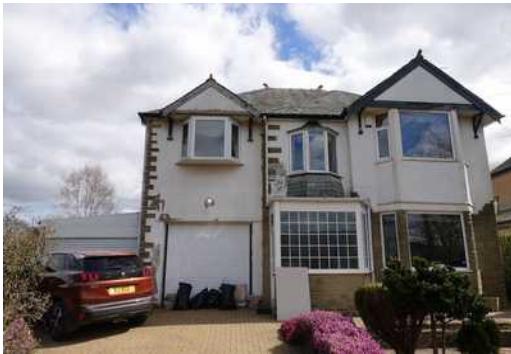
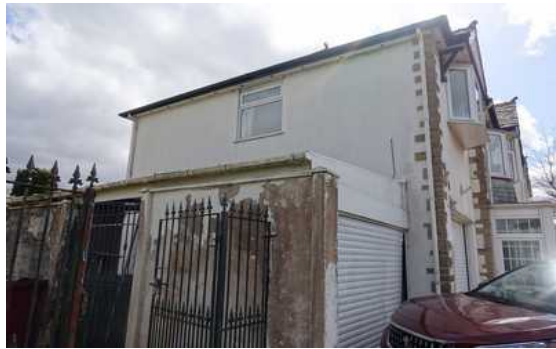
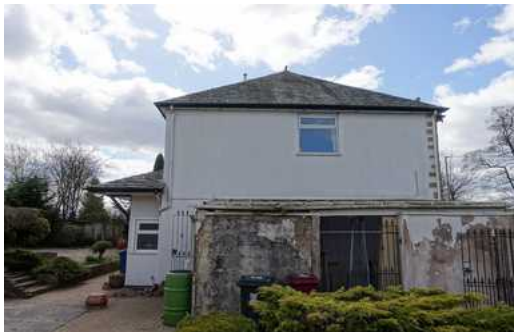
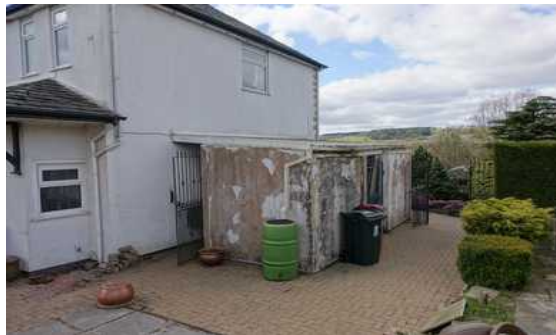
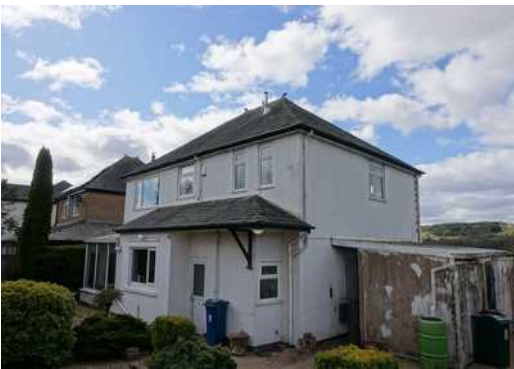
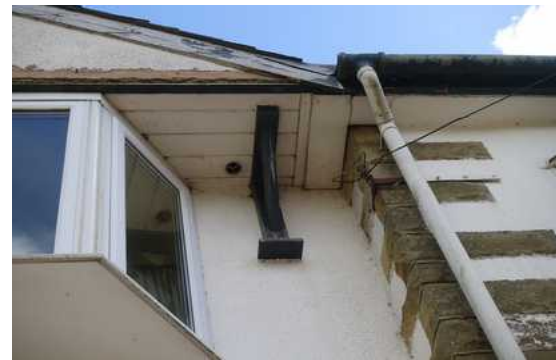
The property consists of a detached two storey house with hipped slate roof, a single storey single pitched roofed extension is present to the north side of the property.

External walls are rendered with no obvious cracks, gaps or crevices present. . Roof slates are close fitting with no slipped, lifted or missing tiles present. The ridge is pointed and well sealed. Timber soffits and fascia boarding is close fitting.

The single storey extension is flat roofed with well sealed and close fitting fascia boarding.

The building can be considered to offer negligible roosting bat potential.

The property is well maintained, well sealed and was assessed as offering negligible roosting potential with no obvious gaps or crevices suitable for roosting bats.
