HERITAGE STATEMENT

BLACK HOUSE FARM, DALE HEAD, LANCASHIRE

For Ms Anita King

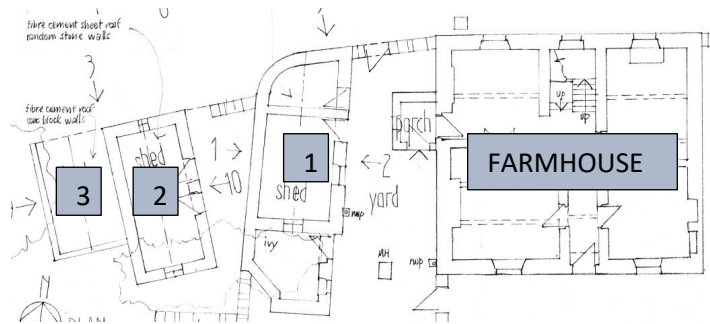
Linear Layout of house and outbuildings

KEY:

1: OUTBUILDING 1

2: OUTBUILDING 2

3: MODERN SHED

The introduction of the modern agricultural shed close to the North of the group has affected the farmstead and its setting detrimentally and prevents a clear view of the farmhouse and outbuildings from this viewpoint.

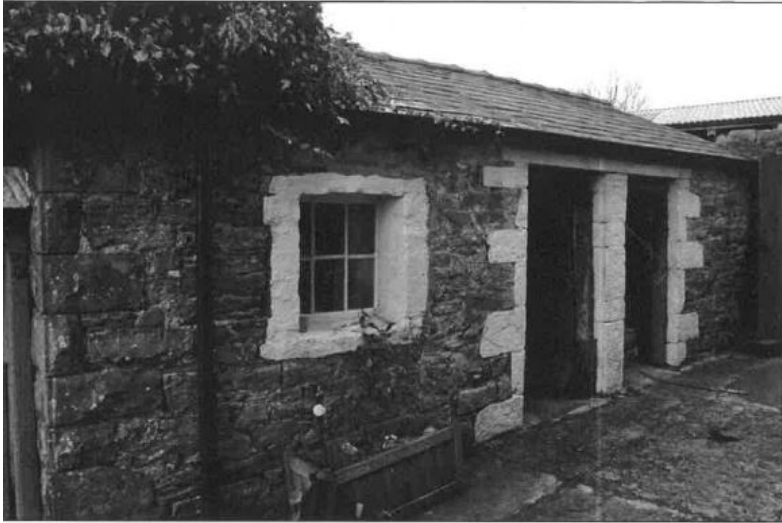
FIGURE 10: VIEW OF EXISTING OPENINGS IN OUTBUILDING 1, SHOWING OVERGROWN IVY

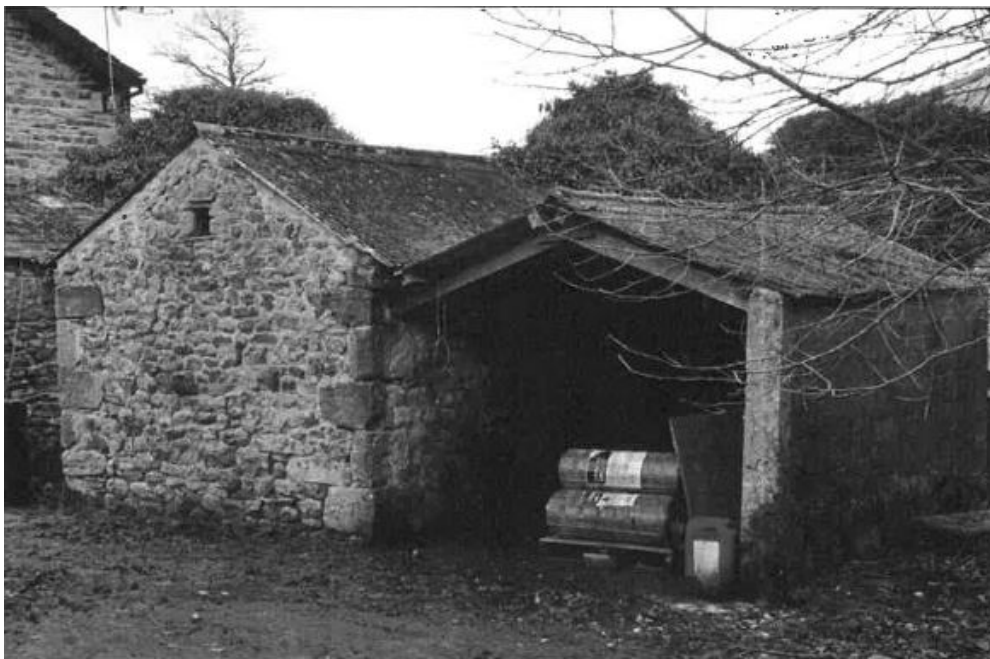
FIGURE 12: NORTH ELEVATION OF OUTBUILDING 2 & MODERN CONCRETE SHED WITH ASBESTOS CEMENT ROOFING

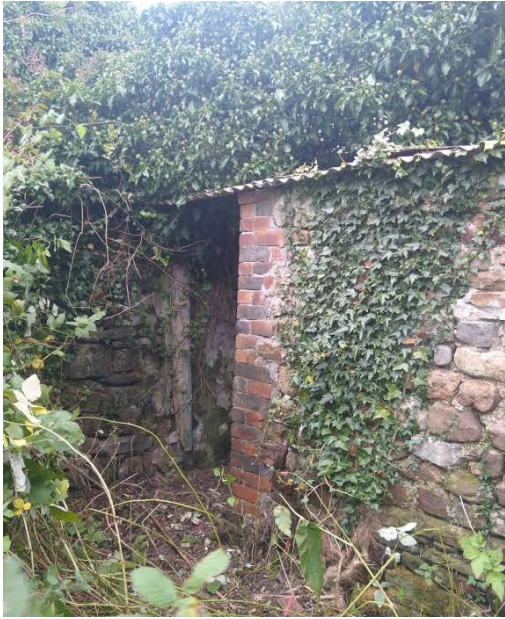
FIGURE 13: VIEW OF OUTBUILDING 1 SHOWING MODERN BRICKWORK & OVERGROWN IVY

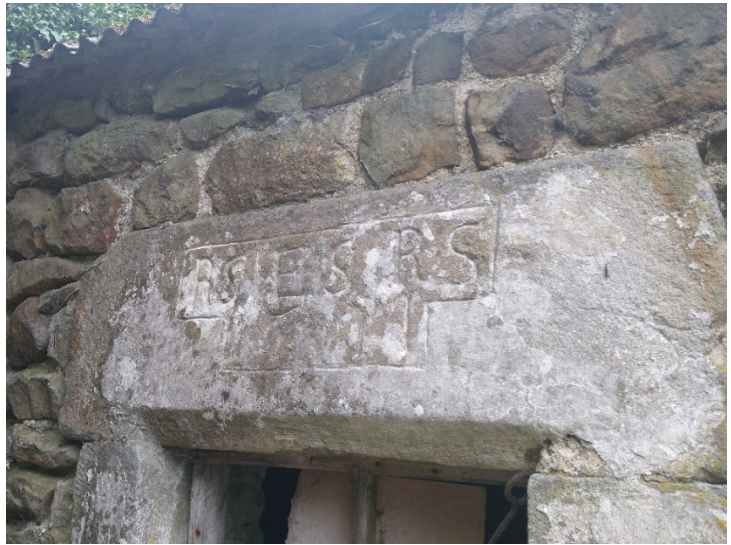
FIGURE 14: INSCRIBED STONE OVER HISTORIC DOOR OUTBUILDING 2 (pigsty)

- Existing door opening with inscribed historic lintel above is unaltered and forms a useful connection into the outbuilding. This use is now made permanent and therefore constitutes an enhancement that retains the original features.

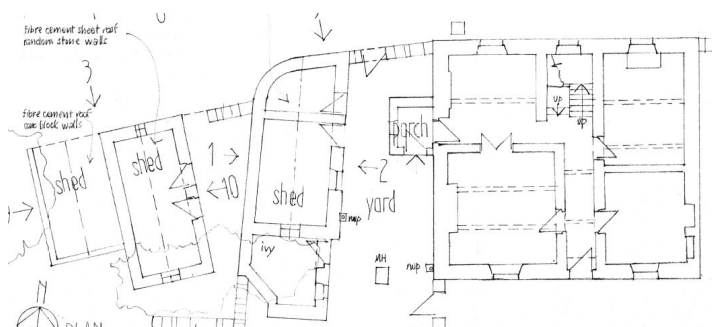
AS EXISTING FLOOR PLAN

As shown in the floor plans above, the footprint of the proposal does not project forward of primary elevations of the Listed property and retains specific heritage features and forms such as existing openings.

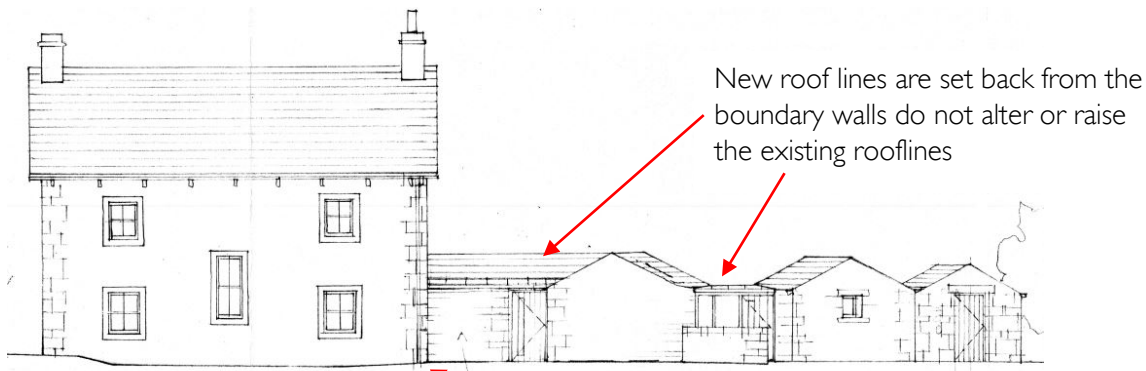
Proposed North Elevation

Existing boundary wall and door maintained and used as entrance to link. roof behind is set back

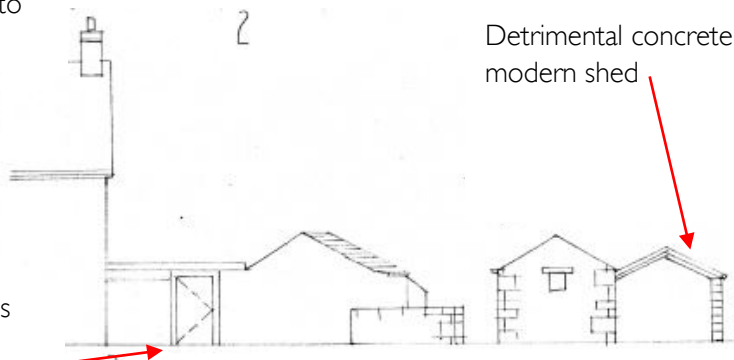
Existing North Elevation

Existing stone boundary wall forms visual barrier to East elevation of outbuilding and yard behind.

Detrimental concrete modern shed

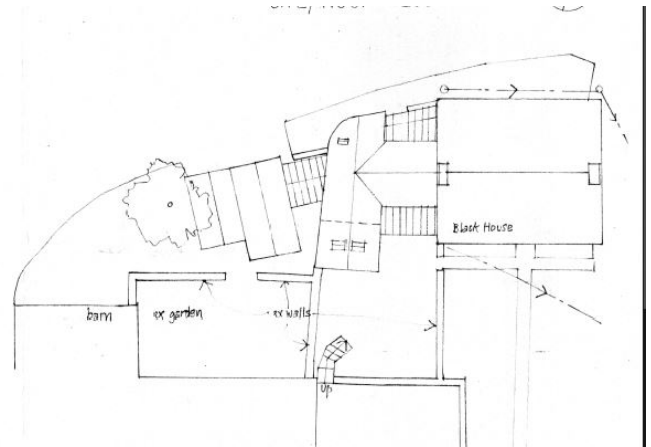
Proposed Site Plan

- The proposal is sensitive to the overall arrangement of the farmstead group, retaining the original form and scale of the buildings.
- The proposed development respects the principal elevations and building lines of the existing proposal.

- There is 'less than substantial harm' to the gable of the listed building caused by the new roof and glazed link however the primary features and overall form of the listed building and its setting have not been impacted.

- The overall form of the outbuildings has been respected and enhanced further by removal of unsightly elements such as the modern porch and replacement of the concrete shed.

- The garden walls and boundary features are all retained and given purpose thus maintaining the need for these elements.
- The setting will be improved from the South side due to the replacement of the brick-built and corrugated metal roof lean-to with a stone-built structure that is in keeping with the outbuilding nearest the listed building.

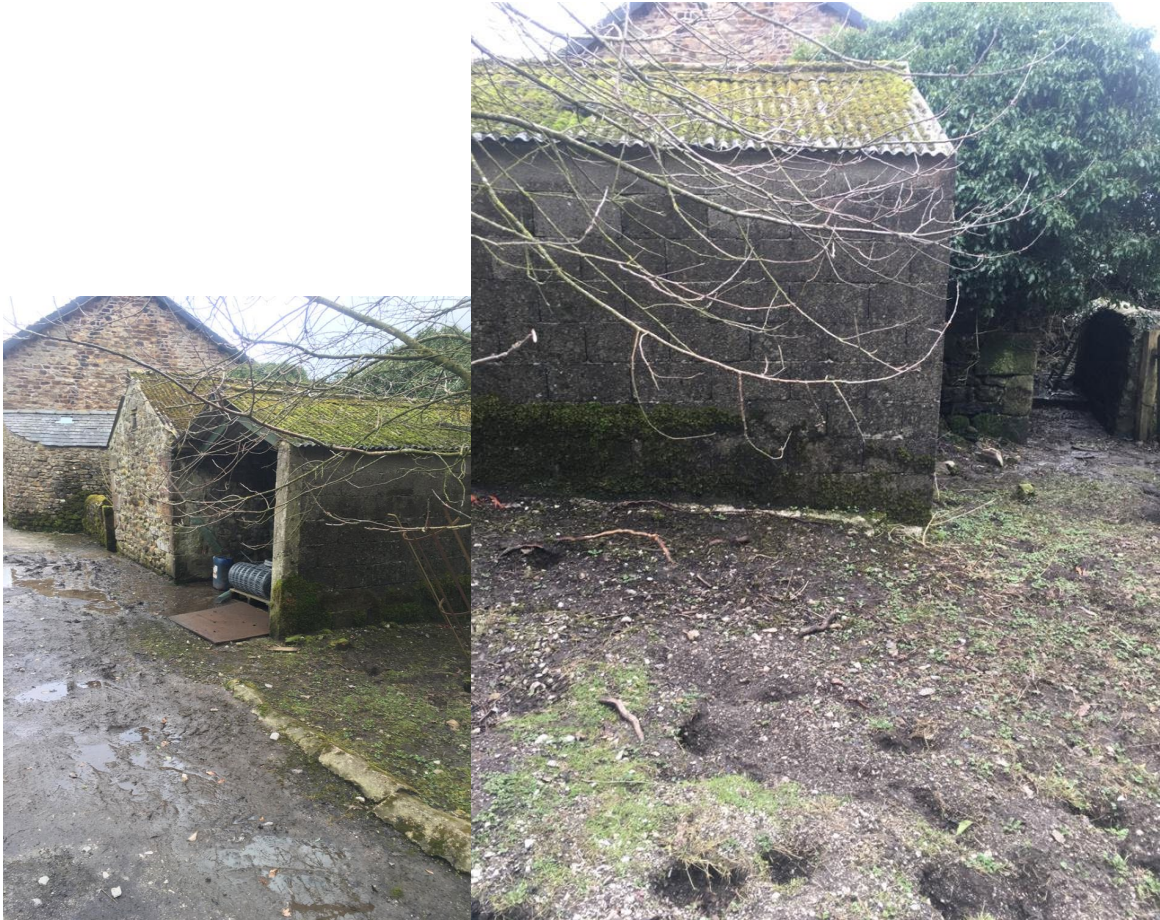
Small, dilapidated, stone building “1711” overgrown with ivy, asbestos roof and crumbling pointing. Not fit for use.

Building brought back in to use whilst maintaining original stone features.

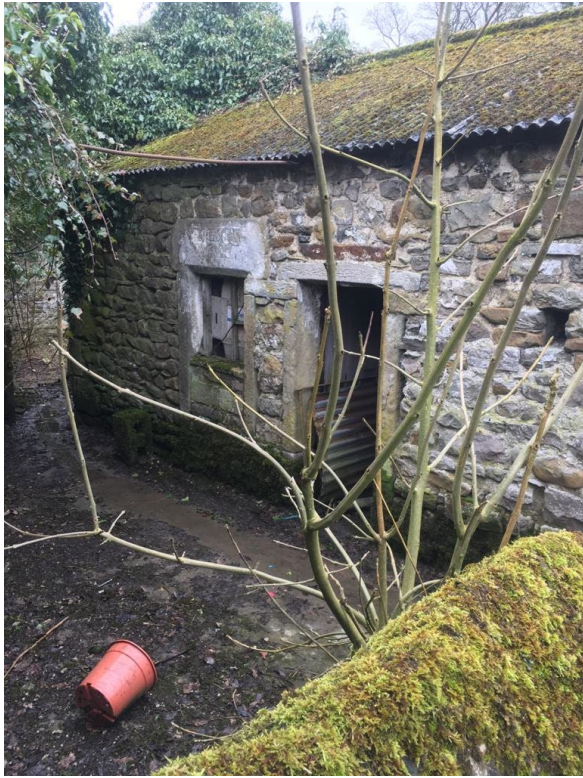
External wall between long set of outbuildings and "1711" collapsing.

Wall rebuilt using existing materials.
