# **Preliminary Bat Roost Assessment Report**

**Garage at Bashall Farm,  
Hothersall Lane,  
Hothersall,  
PR3 2XB**

**05.05.2021**

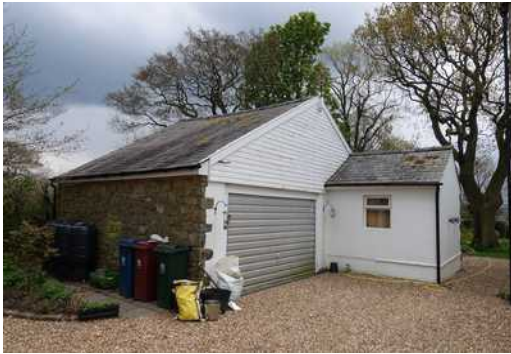
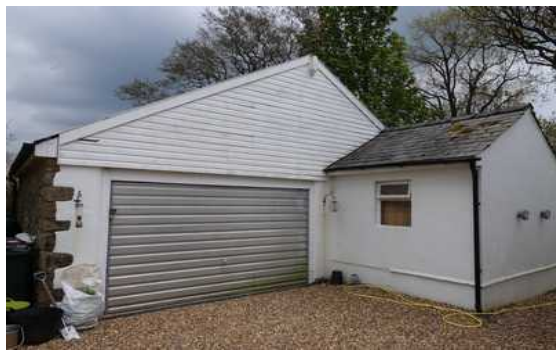
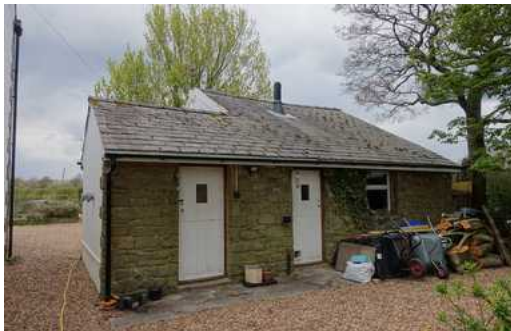
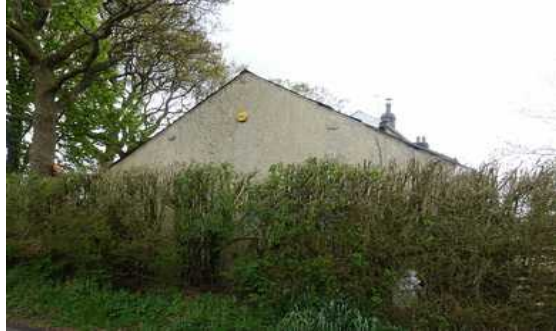
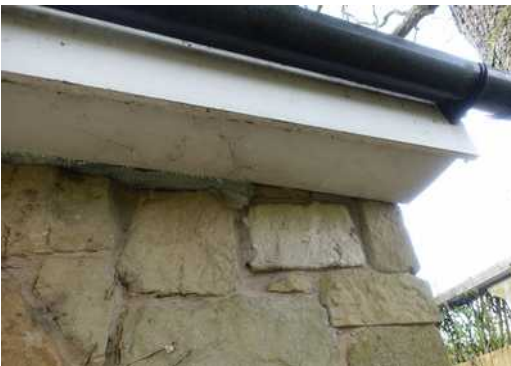
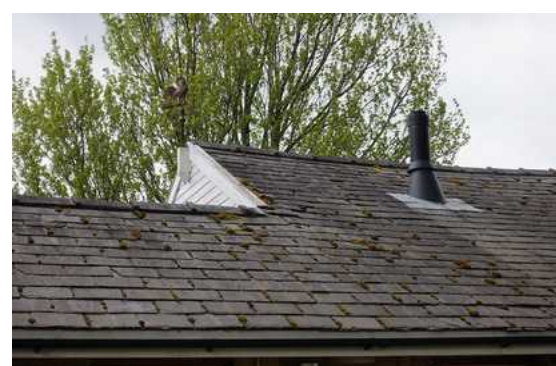
The property consists of a detached stone built garage with a double pitched slate roof. A single storey extension is present on the frontage.

External walls are well pointed and partially rendered and painted with no obvious cavities, cracks, gaps or crevices present. Gable ends are pointed and sealed. Roof slates are close fitting with some heavy moss growth present. The ridge tiles are pointed and well sealed. Timber cladding and soffits are generally close fitting.

The building can be considered to offer negligible roosting bat potential.

The property was assessed as offering negligible roosting potential with no obvious gaps or crevices suitable for roosting bats.

No physical evidence of bats grease marks or urine splashing was recorded on the building despite suitable horizontal surfaces being present and undisturbed.

No evidence of use by bats was recorded during the survey and the building were assessed as offering negligible roosting potential due to a lack of potential roosting features and the well maintained nature of the property.

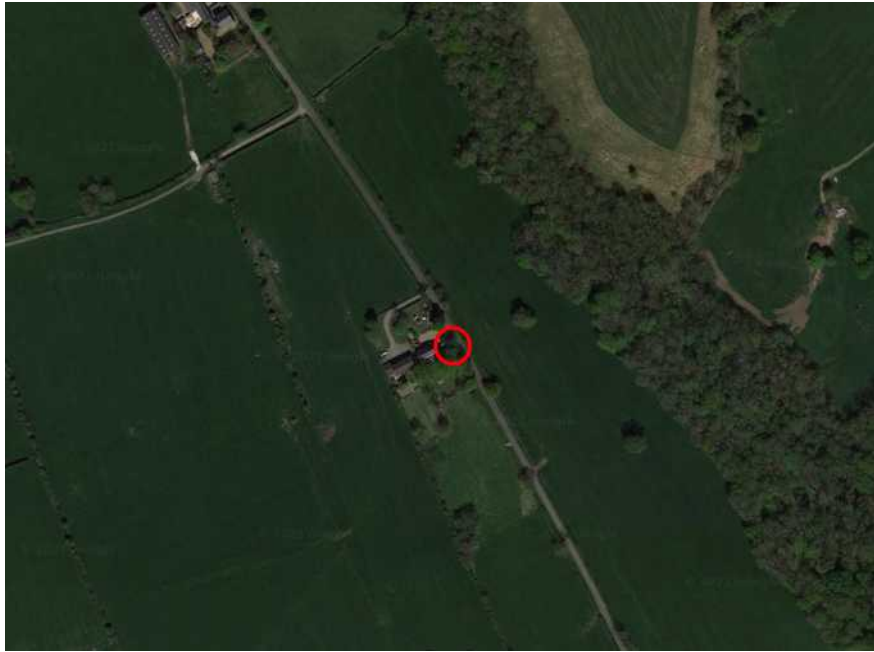
## Habitat

The property is located in a rural position with surrounding habitat a mosaic of mature ancient woodland, improved and semi improved grassland and remnant hedgerow on field boundaries. Connectivity to the wider landscape is moderate.

Bat foraging potential is moderate to high.
