**BAT SURVEY AT -
8 HAMMOND DRIVE
READ
CLITHEROE**

**DATE AND TIME OF VISIT
11th March 2021 9.30 pm**

REFERENCE NO. 6219

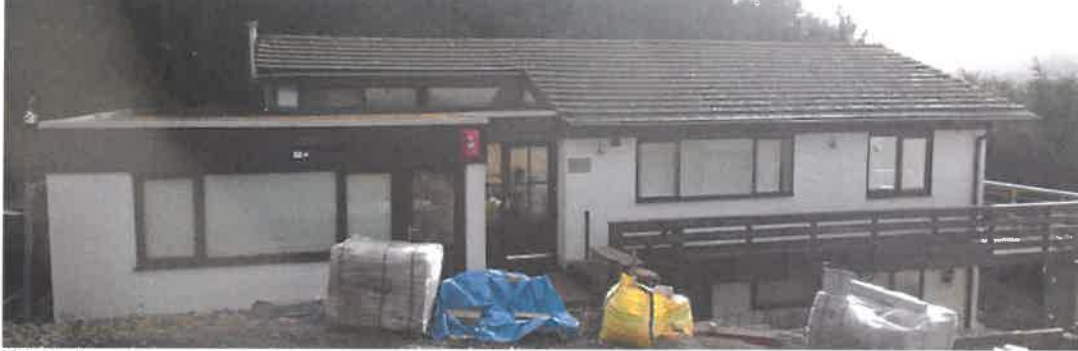
West Elevation

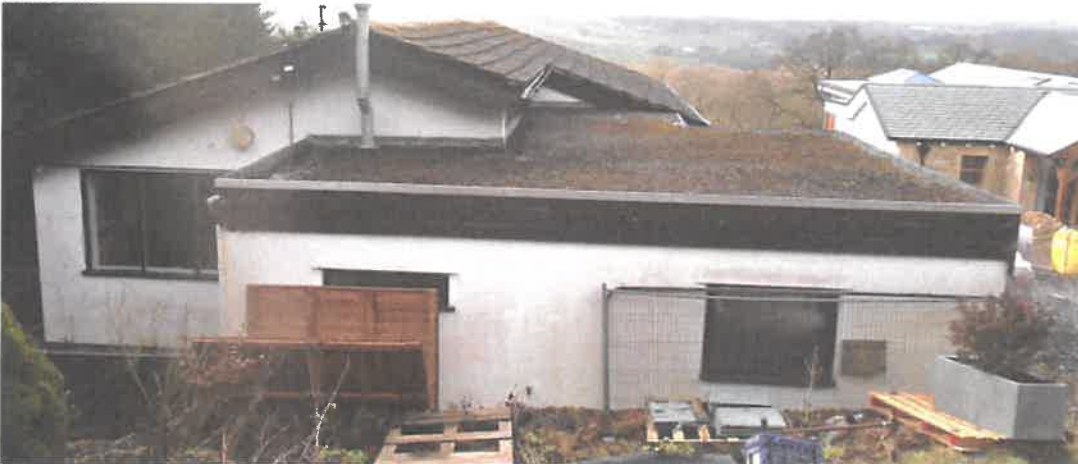
North Elevation

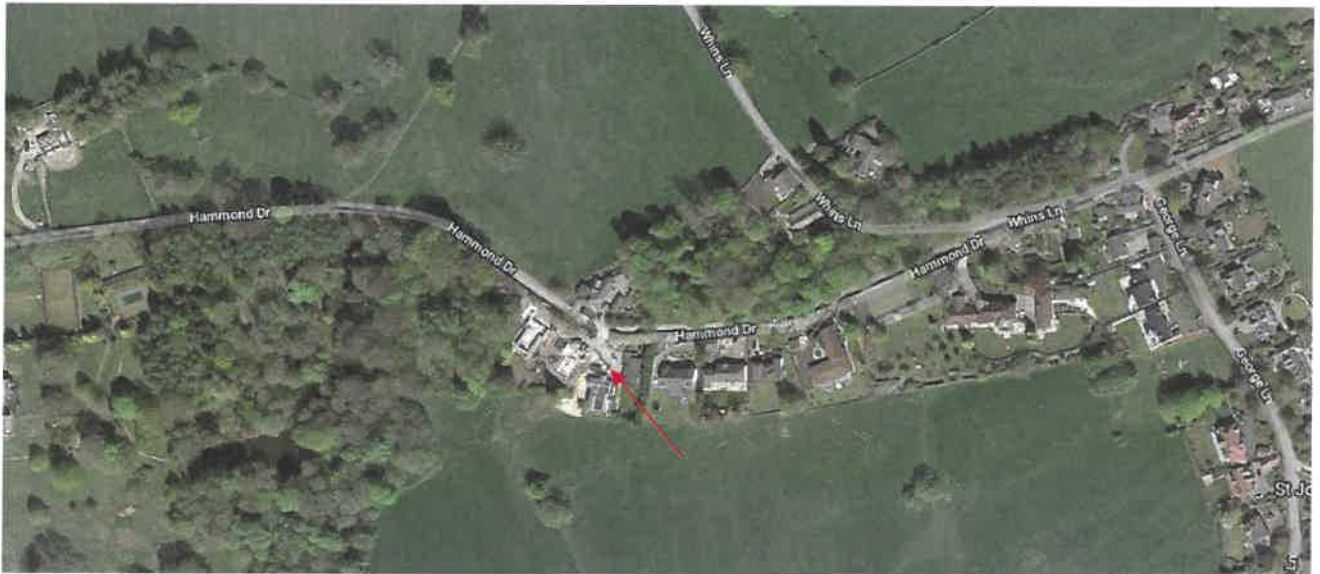
LOCATION SD 761348 120m elevation

The building is located approx 300m NW of the main settlement area of Read. On the south side of Hammond Drive.

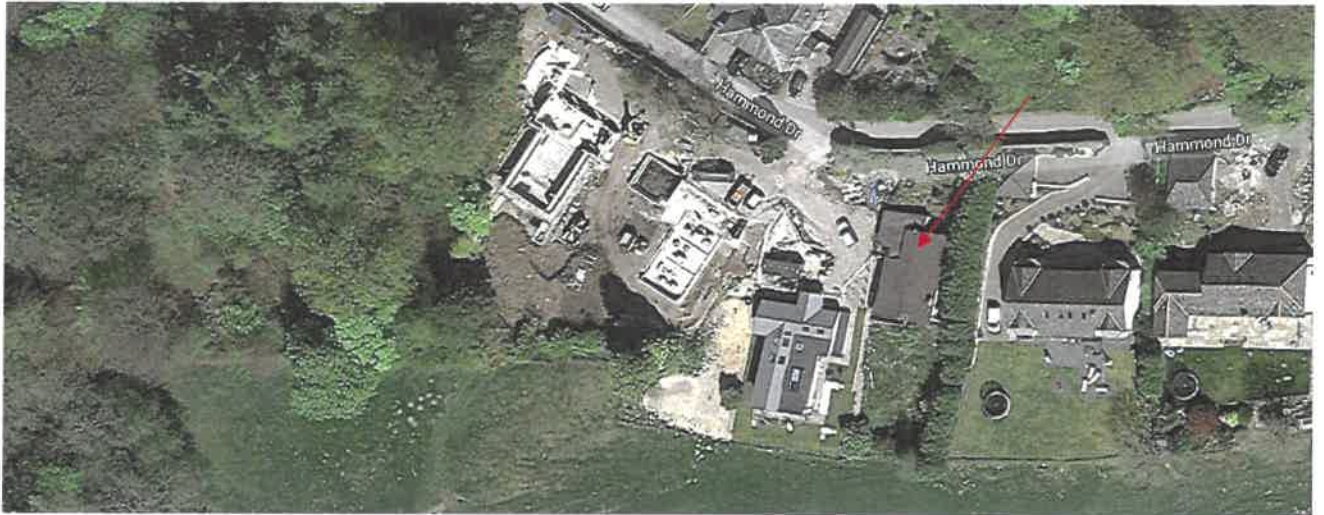
The house is adjacent to other residential properties along Hammond drive. the site is set within open countryside and can be classed as rural. There is broad leafed woodland providing a high value forage habitat 100m to the north and west.

The river Calder is the nearest significant water course 1km to the south

Previous bat surveys in this location have found Noctule bats present in the area and whiskered and Pipistrelle bats to be roosting in a property within 60m of the house.

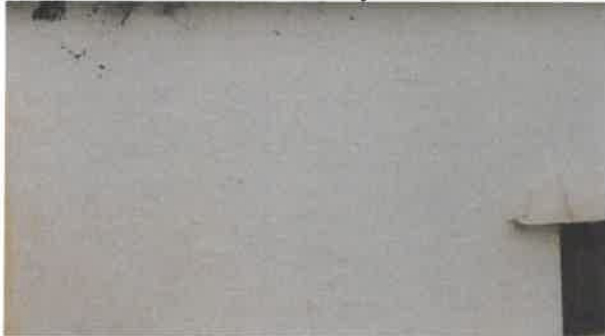
The walls are brick/block cavity construction with white render finish.

The render walls are in reasonable condition but do not have any cracks or crevices with the potential to provide any roost habitat. The walls do not provide any access points.

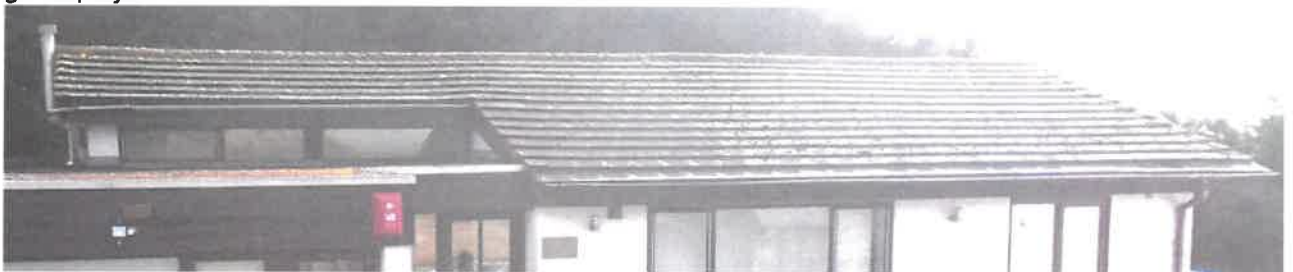
The roof is pitched with a tile finish, the eaves overhang has timber fascias and boarded soffits. The gable projections have timber boarded fascias and soffits.

West roof pitch

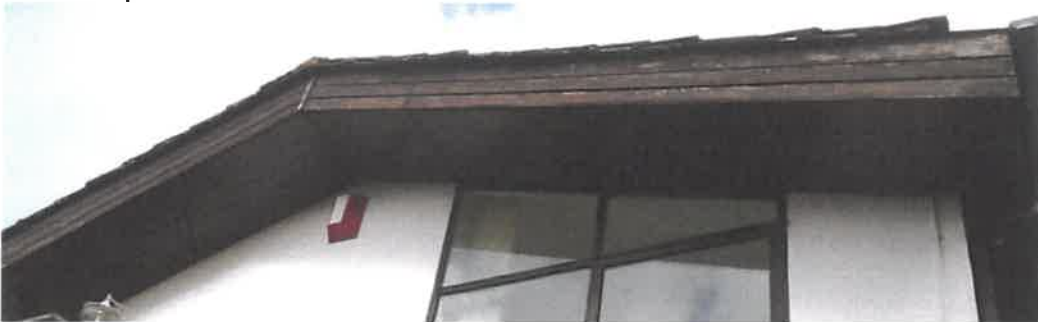
South gable of pitched roof

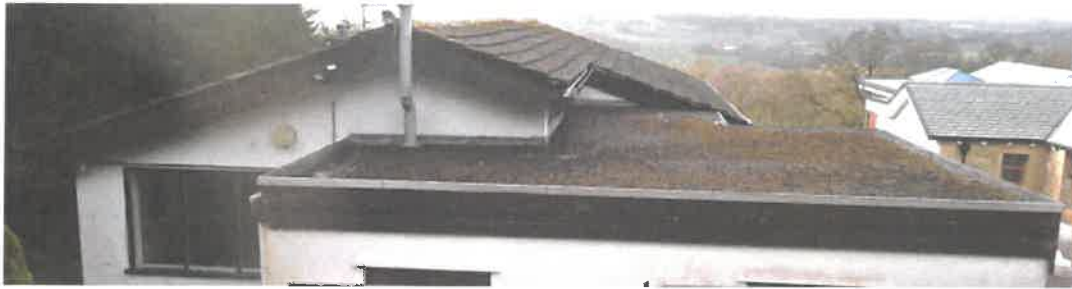
The flat roof has a bitumin felt with gravel finish with a timber boarded fascia detail fixed flush to the walls. Lead flashings at abutment with walls.

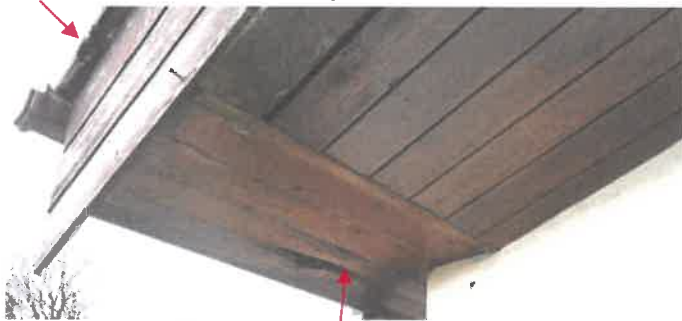
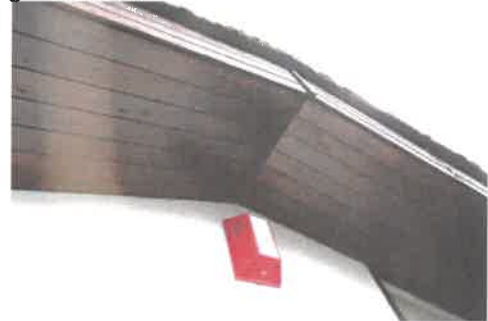
The tiles are in reasonable condition, no missing, broken or slipped tiles. The ridge tiles are well pointed however there are some sections of the verge pointing missing on the south elevation. The point indicated could be inspected with an endoscope and no signs of bat presence were evident however it was not possible to check sections at higher levels.

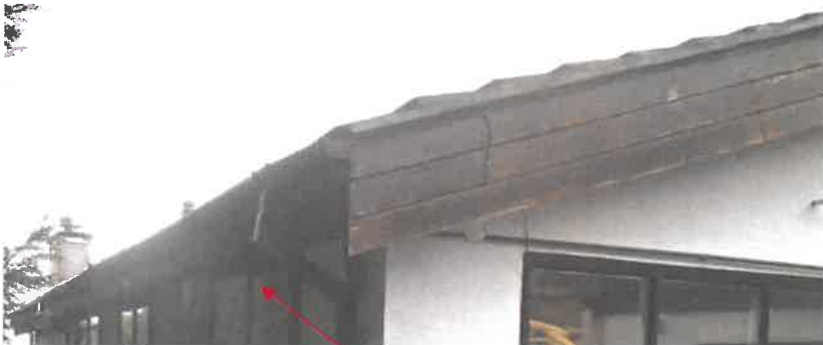
The timber soffits on the east elevation had numerous access points where the boards had rotted. It was not possible to examine these gaps due to the height.

West elevation soffit in poor

condition but not possible to closely examine

It is necessary for an emergence survey to be carried out during appropriate weather conditions during the activity period end of April - Sept

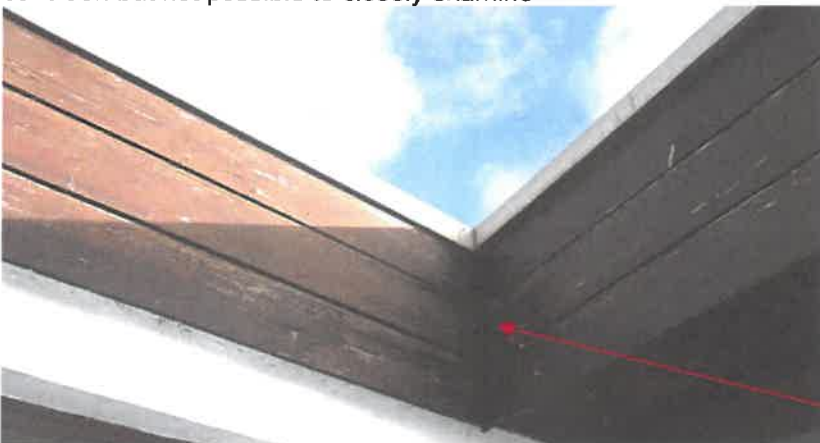
Crevice in rotted timber fascia.

Which was examined and found not to provide potential bat habitat.

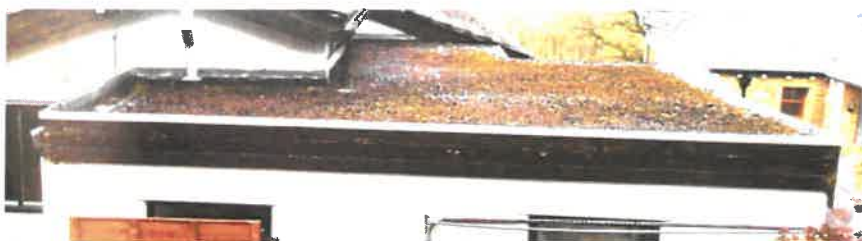
It was possible to closely examine the flat roof and its fascias. The surface has some moss coverage but is in reasonable condition with no raised laps or tears. The flashings at wall abutments to the house walls are tight fitting with no gaps. The fascias do not have any gaps behind. The roof does not provide any access points or potential bat roost habitat.

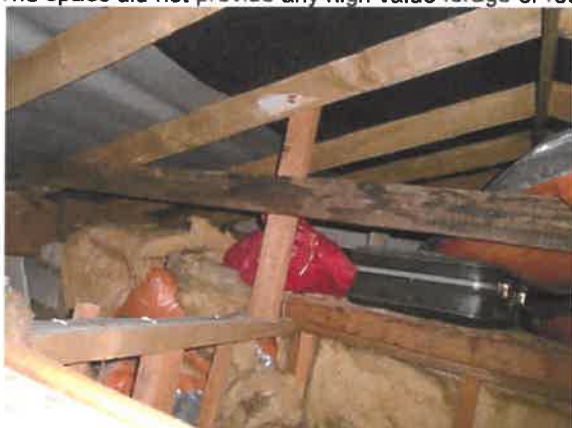
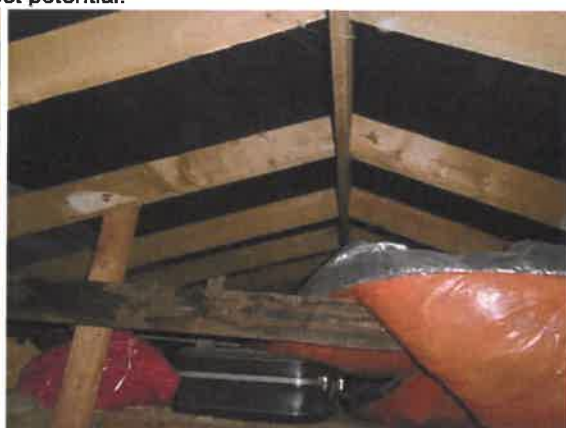
The roof void is height restricted and it was only possible to examine the space from the hatch. The timbers were in good condition with no areas of rot or significant cracks or crevices with the potential to provide roost habitat for bats. The felt was also in good condition.

As far as possible all the surfaces were inspected for dropping or feeding evidence the result was negative. No signs of any current hibernation or historic use by bats was evident.
