## BAT SURVEY AT

23 Queensway, Waddington

Author	Flora Whitehead	Date	10/5/21
Checked by	Andrew Gardner	Date	10/5/21
Report Version	1		
Field data entered	<input type="checkbox"/>		
Report Reference	7131

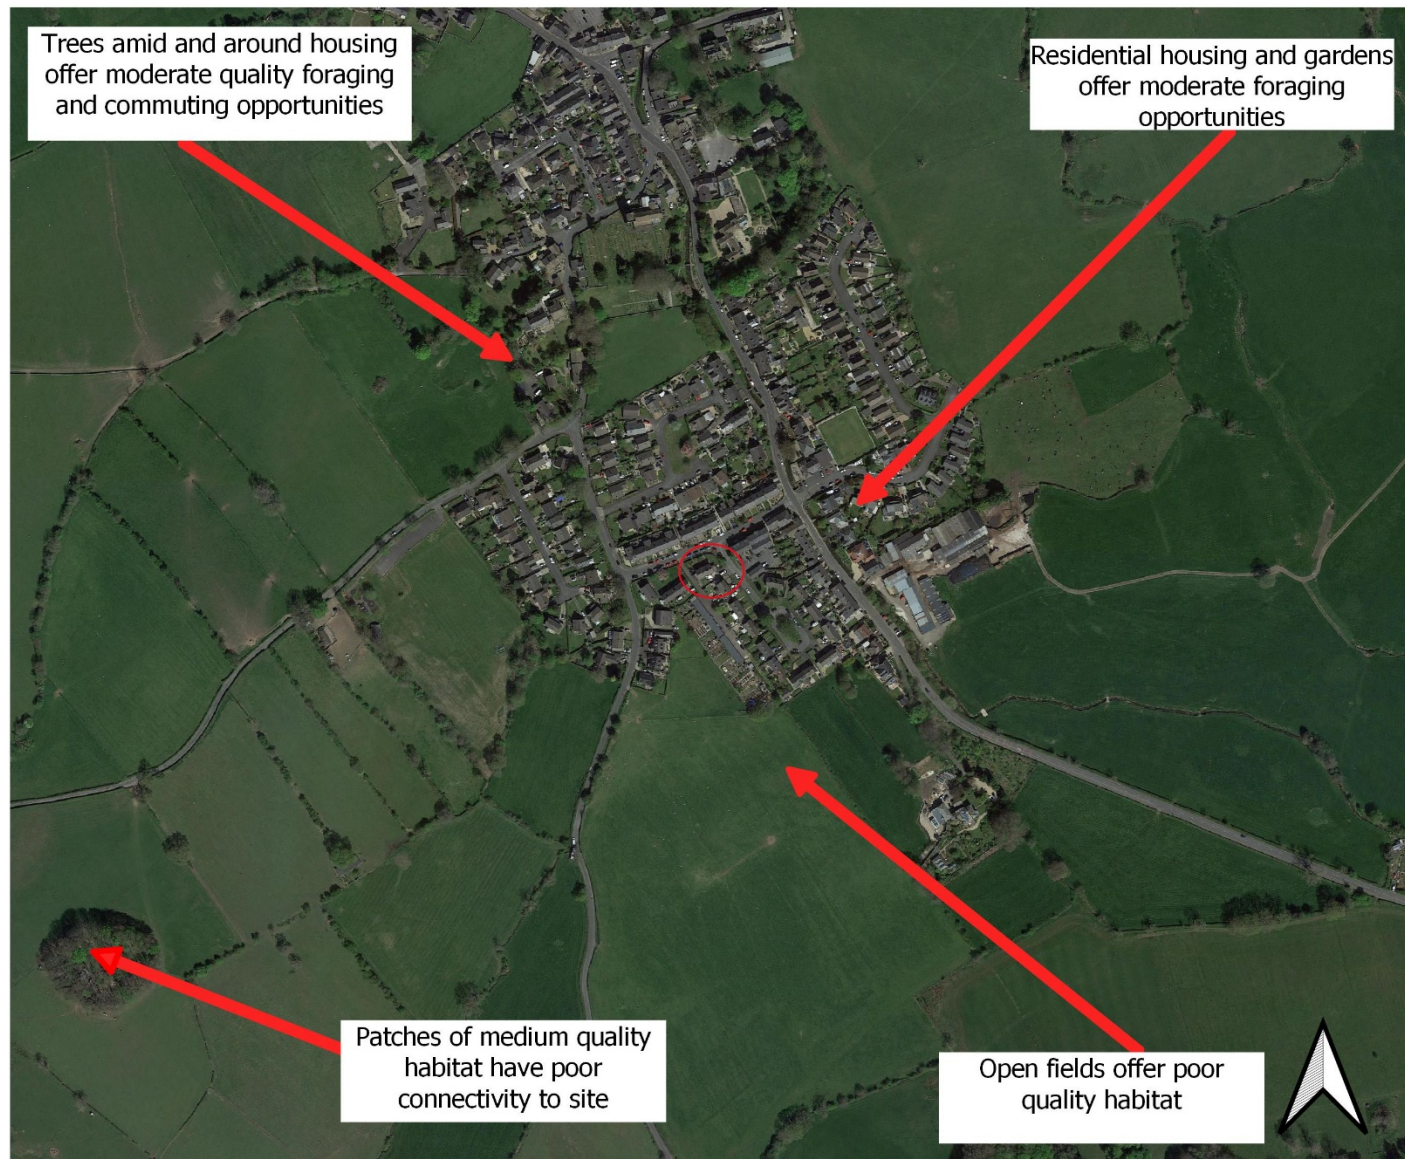
The habitat at and adjacent to the site was assessed from satellite imagery this was then ground truthed, Figure 5.

The habitat on and adjacent to the site identified from satellite images was ground truthed. Details of the habitats found on and adjacent to the site are detailed in Figure 5.

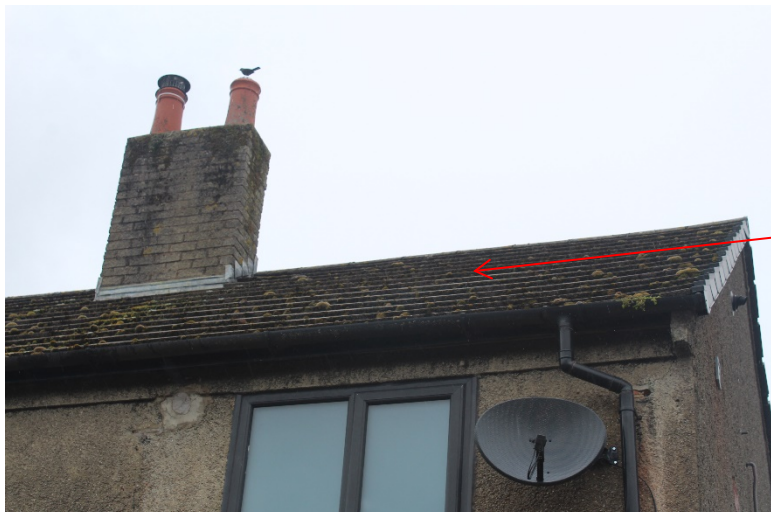
The roof of the building is made from concrete tiles. Tiles were all tightly fitted and in place, with patches of moss also present. There were no gaps in the ridgeline and the roof verges were capped and sealed. A small extension on the east elevation was roofed in bitumen felt and this did not provide favourable roosting opportunities for bats. The full extent of the roof could be seen from the ground with close focus binoculars and a 1,000,000 candle power torch. No indications of use by bats could be found.

Roof free from gaps

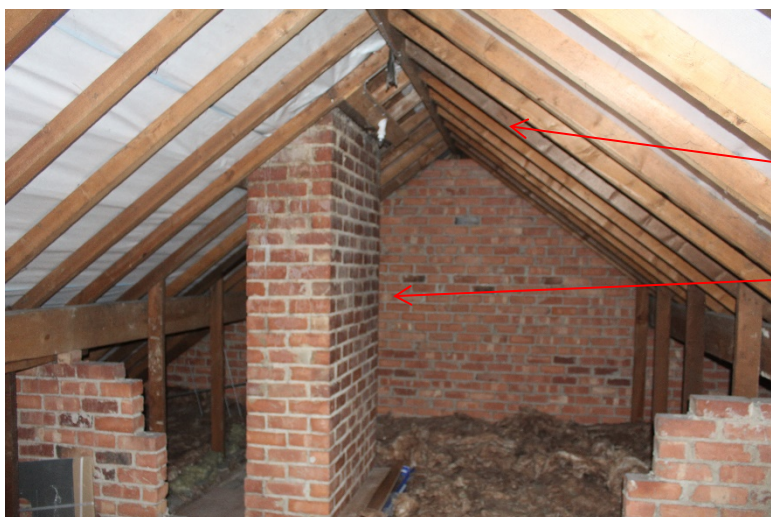
The roof lining and the timber beams in the roof were found to be in excellent condition with no rot, splits or gaps suitable for roosting or hibernating bats. Cobwebs spanned the roof apex. Insulation was present but there was a slight draught from small crevices at the eaves, below the level of the adjacent insulation. A single old bat dropping was found close to the eastern wall of the roof void. There were no other indications of bats and the no suitable access points identified. Exposed brick walls were free from droppings.

Roof timbers and lining in good condition

No indications of use by bats on walls

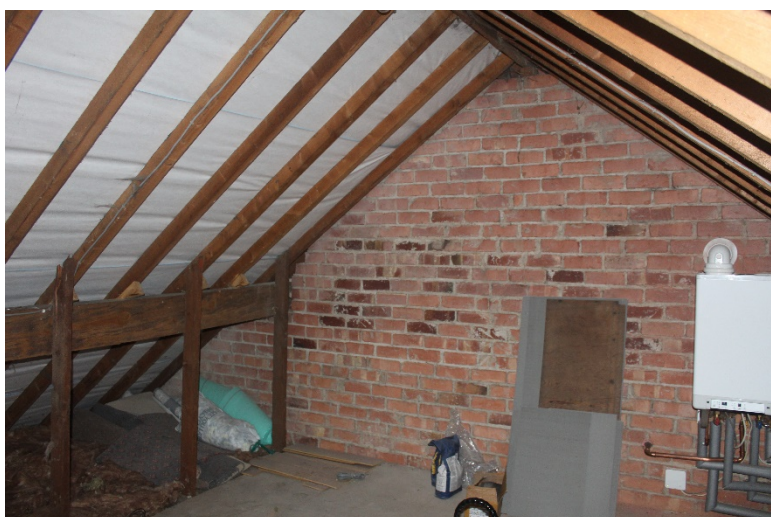
To summarise the building is of moderate size and the external walls are in excellent condition. The eaves lines have occasional narrow crevices. The roof void is lined and appears sealed from access by bats, although a single old dropping was found. The roof coverings are all closely fitted and intact. Overall this building has low potential for use by bats, our categorisation would be 3. Further details of our categorisation can be found in Table 1.

A single old bat dropping was found at the site. No current evidence of bats was found.

Single old bat dropping found close to east wall, but no current signs of bats.
