Re: Proposed development at Rose Cottage, Sandy Bank, Chipping, PR3 2GA

Thank you for your request for bat surveys regarding a proposed development at the above site. I understand that proposal is for a two-storey extension to the north east elevation.

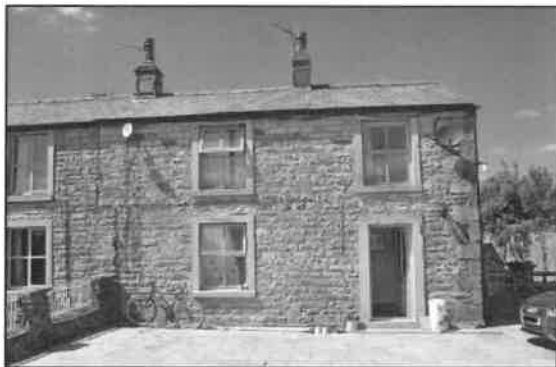
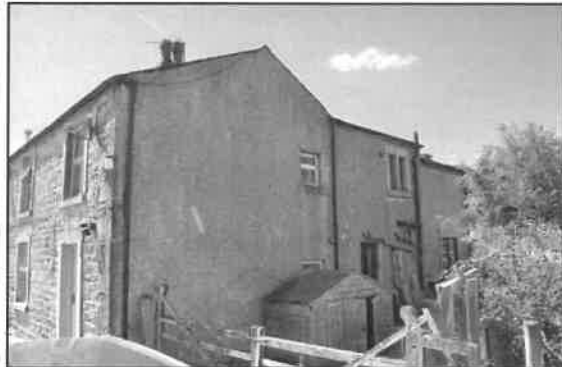
The original cottage has been re-roofed and the slate roof coverings associated with all the extensions are also in a good state of repair with very few visible gaps. There are, however a series of gaps at the roof edges, particularly at the gables on the north east, and on the middle roof section along the north east elevations. There are also gaps along the wall top behind a timber fascia on the front (south) elevation. These gaps are suitable for use by bats throughout the year and some of the gaps are also suitable for use by nesting birds throughout the nesting season (February to September). Signs of nesting birds (droppings) were found below the fascia on the front elevation. Timber fascias associated with building extensions to the rear of the property are tight fitting with no gaps present.

View of Rose Cottage south east (lhs) and north east (rhs) elevations

Protected Species	Impacts /Predicted Impacts	Action Required
Bats	<p>It is advised that there is no evidence to suggest that bats pose a constraint to the proposed development.</p> <p>It is advised that bats could utilise gaps associated with roof edges. There are open roof edges along the north east elevation where the work is proposed and bats were recorded in close proximity to the house during the emergence survey.</p> <p>It is our professional judgement that there <u>is</u> a reasonable likelihood of bats roosting at another time.</p> <p>All bat species are fully protected under the Wildlife and Countryside Act 1981 (as amended) and the Conservation of Habitats and Species Regulations 2017. This legislation has been amended by the Conservation of Habitats and Species Regulations (Amendment) (EU Exit) Regulations 2019 which continues the same provision for European protected species, licensing requirements, and protected areas continue after Brexit.</p>	<p>Advice (mitigation): A pre-commencement bat survey by a suitably qualified and experienced Ecologist should be carried out immediately prior to any proposed works. Depending on the time of year when the works are undertaken this should include:</p> <ol style="list-style-type: none"> 1. A single dusk emergence or dawn re-entry survey during the bat active season (April to October) Or 2. A close inspection of potential roost features e.g. from scaffolding or cherry picker. <p>This survey will help to avoid unlawful disturbance to bats and bat roosts before any development takes place- it is therefore specified to be used as a final precautionary approach once planning permission has been granted. Immediately prior to the roof works</p> <p>Advice (mitigation): All people working at Rose Cottage should be made aware of the likelihood of encountering bats and should be made aware of the legal protection of roosting bats and their own responsibilities as regards implementation of precautionary measures. Prior to the commencement of development.</p>

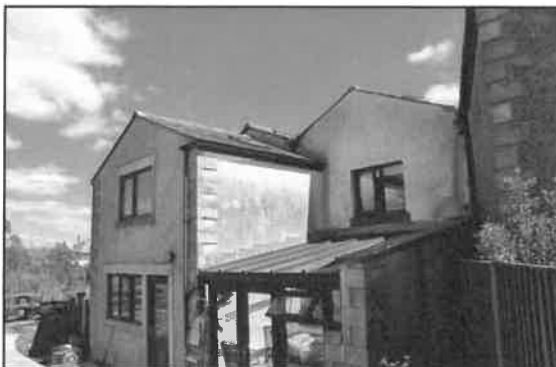
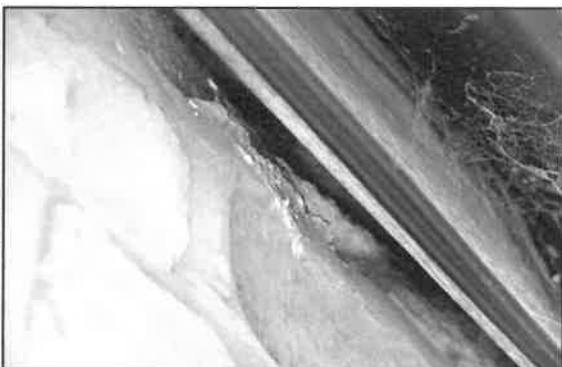
No nesting birds were found during the survey, birds signs were found below the fascia on the south east elevation.

Rear view of Rose Cottage, north west elevation (lhs) and bird droppings below south east fascia (rhs)

Protected species	Impacts /Predicted Impacts	Action Required
Nesting birds	<p>It is advised that signs of nesting birds (droppings) have been found along the south east elevation.</p> <p>It is our professional judgement that there is a reasonable likelihood of birds nesting in the building and garden boundary vegetation during the bird nesting season (March to August).</p> <p>Under the Wildlife and Countryside Act 1981 (as amended), wild birds are protected from being killed, injured or captured, while their nests and eggs are protected from being damaged, destroyed or taken.</p>	<p>Advice (mitigation): All people working at Rose Cottage should be made aware of the likelihood of encountering nesting birds and should be made aware of the legal protection of nesting birds and their own responsibilities as regards implementation of precautionary measures. Prior to any work commencing.</p>

Protected species	Impacts /Predicted Impacts	Action Required
Nesting birds		<p>Advice (mitigation): It is advised that the most appropriate way to address the risk to nesting birds is:</p> <ul style="list-style-type: none"> • Avoid disturbance to the building and/or boundary vegetation during the nesting season Or • If works cannot be delayed Rose Cottage should be carefully checked, immediately prior to works commencing. Checks should be carried out by a suitably experienced ecologist. If the risk of nesting birds remains, then monitoring for nesting bird activity should continue for the duration of works. <p>Prior to any work commencing (checks) and throughout works in nesting season (monitoring).</p> <p>Advice (mitigation): If nesting birds are found close enough to cause unlawful activities during development works, it will be necessary to delay works or seek advice as to whether or not any development can proceed lawfully at that time. Under these circumstances, work must stop until advice has been sought from an appropriately experienced Ecologist. Prior to and during works.</p>

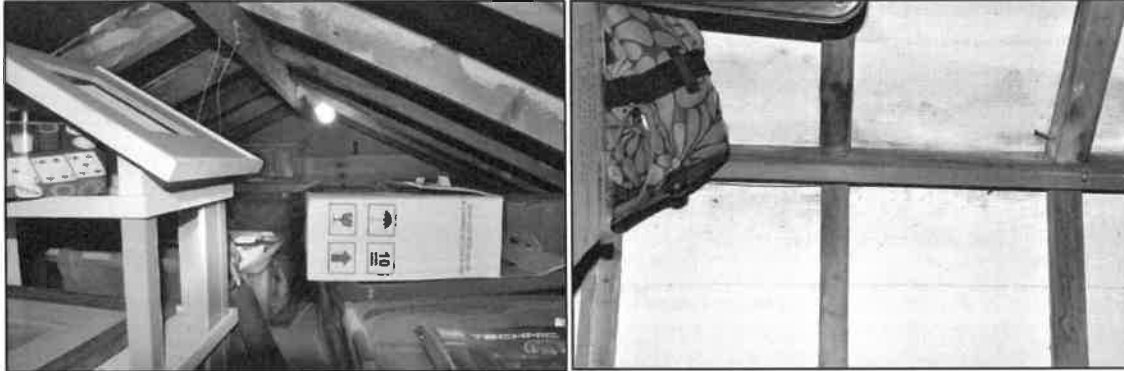
Two shallow roof voids associated with the original cottage were partly accessible for an internal inspection. Both roof voids are shallow, cluttered spaces constructed on timber roof supports, boarded floors and underlined with a modern roof membrane.

View of roof void showing shallow, cluttered space (lhs) and modern roof membrane (rhs)

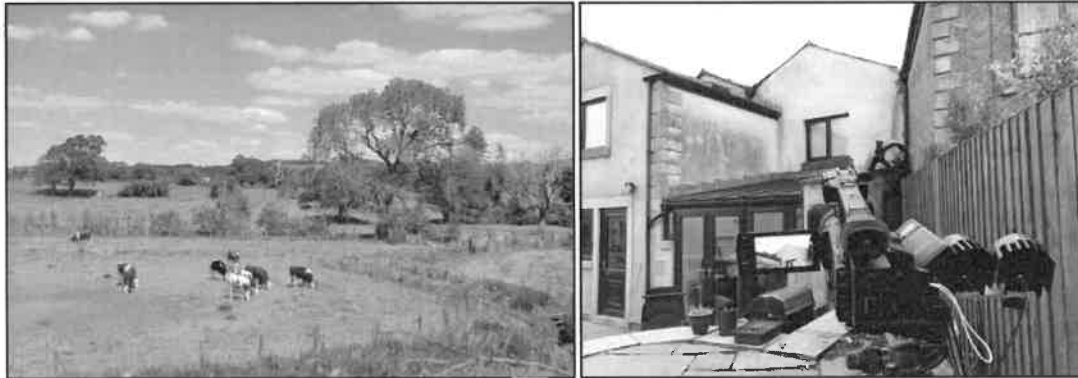
View of pasture field to the immediate east (rhs) and example of Infrared camera equipment used during emergence surveys (lhs)
