# **Preliminary Bat Roost Assessment Report**

**Outbuildings at Charnley Cottage,  
Preston Road,  
Longridge,  
PR3 3BD**

**17.06.2021**

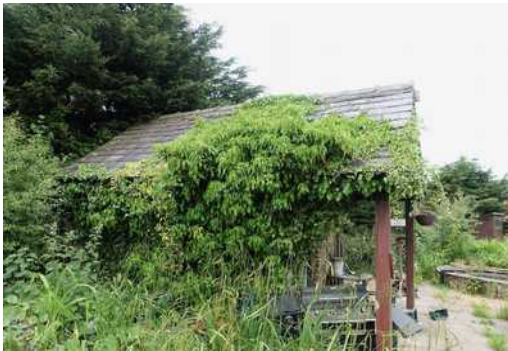
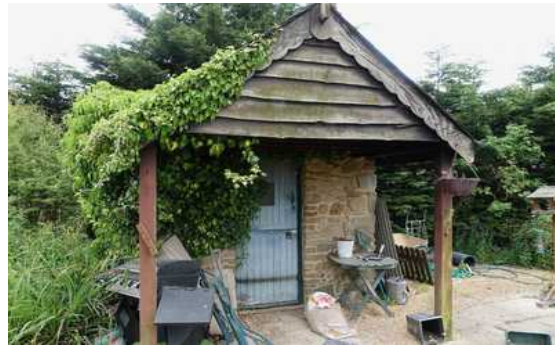
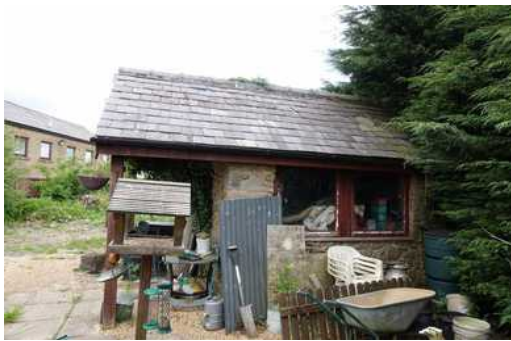
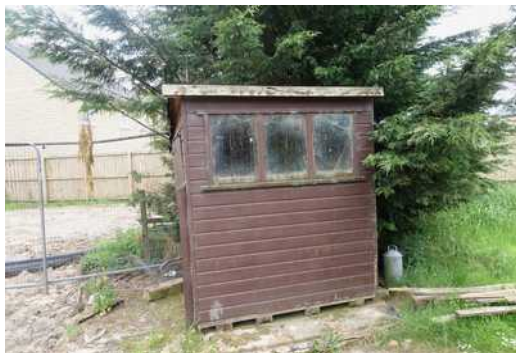
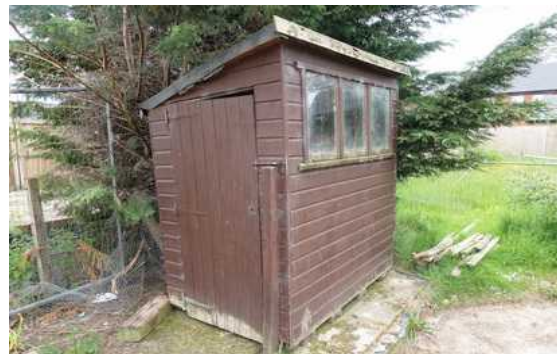
The outbuilding on the southern boundary is a single storey stone built shed with a double pitched slate roof. A porch extends from the front of the building with close fitting timber cladding. Roof slates are close fitting with no missing or lifted slates. The ridge is well pointed and sealed.

The roof interior is lined with a bituminous roofing felt, the ridge is heavily cobwebbed.

A single skin timber shed is present with a felted single pitch roof. The building has no crevices or gaps suitable for roosting bats.

The buildings can be considered to offer negligible roosting bat potential.

The buildings were assessed as offering negligible roosting potential with no obvious gaps or crevices suitable for roosting bats.

No evidence of use by bats was recorded during the survey and the buildings were assessed as offering negligible roosting potential due to a lack of potential roosting features and the general well maintained and well sealed nature of the property.
