# Preliminary Bat Roost Assessment Report

**17 Church Close,  
Waddington,  
BB7 3HX**

**26.04.2021**

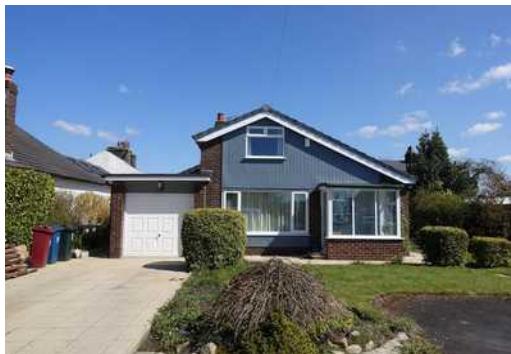
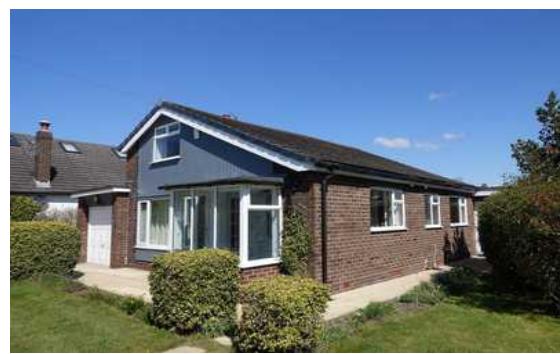
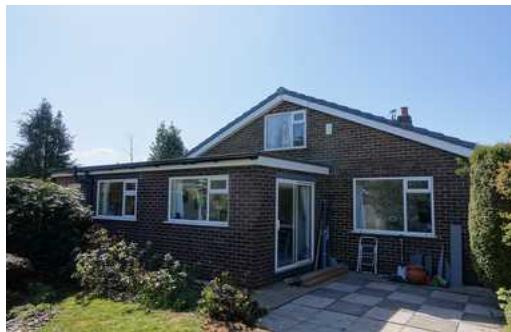
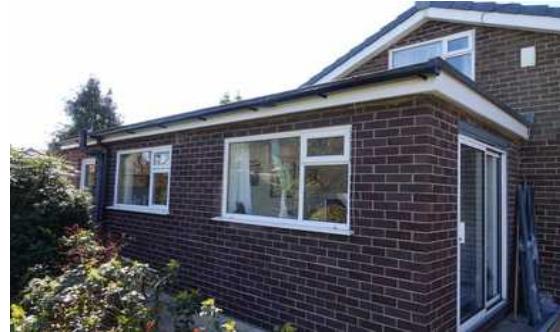
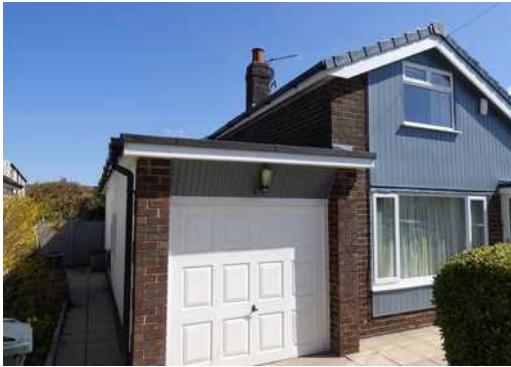
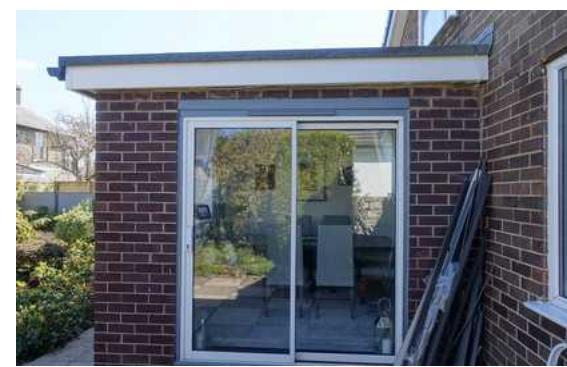
The property consists of a detached brick built bungalow with a double pitched tiled roof. A single storey adjoining garage is present to the northern facade, a single story flat roofed extension is present to the rear.

External walls are well pointed with no obvious cracks, gaps or crevices present. Roof tiles are close fitting with no lifted, slipped or missing tiles present. Ridge tiles are pointed and well sealed. The property has Upvc soffits and cladding which is well sealed.

The building can be considered to offer negligible roosting bat potential.
