Re: Proposed development at 21 Knowsley Road, Wilshire, BB1 9PX (central grid reference: SD 68607 31995)

Thank you for your request for a bat survey at the above site. I understand that the proposed development is for single and upper extensions to the existing dwelling house.

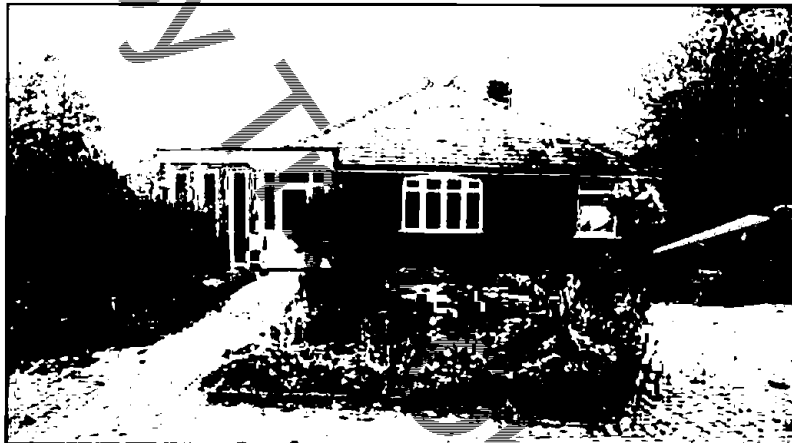
21 Knowsley Road comprises an unoccupied, detached bungalow, constructed of brick walls and hipped slate roof, with a single storey flat roof extension to the west and in-built, lower ground garages on the north elevation. There is a single chimney with lead flashing and a small overhang feature to the main roof. All roof coverings and lead flashing are in good condition with only a very small number of gaps visible. All roof edges are sealed apart from the north elevation, where small and larger gaps are present. These roof edge features offer very limited shelter for use by bats but some of the larger gaps do provide high potential for use by nesting birds. In addition, there are 2 nest boxes, one attached to the external walls on the east elevation of the building and one attached to the garden railings in the rear garden. The nest box attached to the east elevation wall was occupied by nesting house sparrows during the survey. On the flat roof extension are plastic fascia boards. There are some gaps behind these fascias that offer some limited potential for use by roosting bats.

View of 21 Knowlsey Road showing front (south) elevation

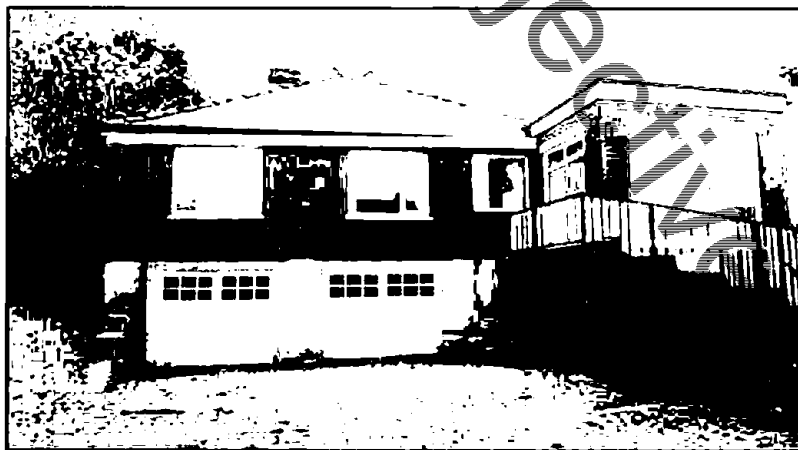
- Low potential – gaps associated with roof coverings, northern roof edge, and flat roof fascia boards
- Hibernation roosting - gaps associated with roof coverings and northern roof edge.

View of rear (north) elevation. Red line indicates gaps present along roof edge

Protected Species	Impacts /Predicted Impacts	Action Required
Bats	<p>It is advised that there is no evidence to suggest that bats pose a constraint to the proposed development.</p> <p>It is advised that there are potential roost features (gaps) suitable for bats associated with roof coverings, northern roof edges and flat roofed fascia boards. In this location and landscape setting, these features have low potential for bats to use throughout the year.</p> <p>All bat species are afforded full protection under The Conservation of Habitats and Species (Amendment) (EU Exit) Regulations 2019</p>	<p>Advice (mitigation): All personnel involved in proposed development works should be carefully advised about bats by a professional Ecologist, so that all works are undertaken with a clear understanding about legal aspects, precautions to be adopted and what to do if a bat is found. Prior to development.</p> <p>Advice (mitigation): As a precaution, it is advised that when removal or disturbance of potential roost features such roof coverings are to take place, this should be done carefully by hand. At all times.</p> <p>Advice (mitigation): If bats are found at any time during the development, work must stop until advice has been sought from an appropriately experienced Ecologist. If the development will affect bats, a licence may be required and suitable mitigation put in place. At all times.</p>

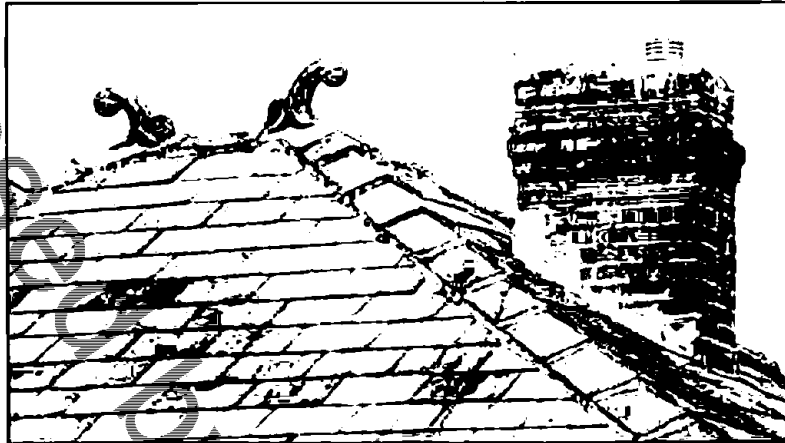
View of roof coverings and lead flashing on chimney, all good condition with few gaps visible.
