**HALL BARNS FARM**

**STONYHURST**

**HISTORIC BUILDING RECORDING**

HALL BARNS FARM  
STONYHURST  
LANCASHIRE

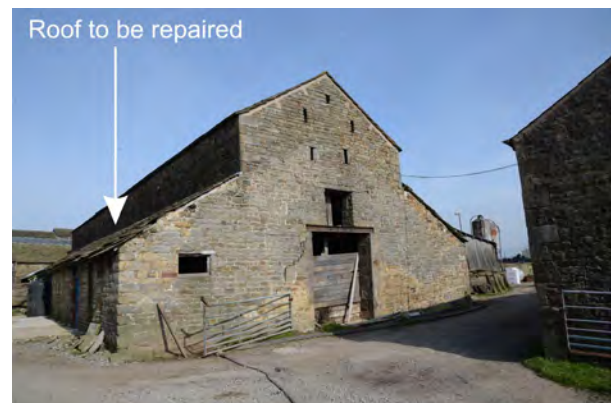
**Plate 3** Southeast elevation of the barn

The southwest outshut of the barn is in a deteriorating state of repair and requires re-roofing (Plate 3). Listed Building Consent has been granted (Ribbles Valley planning application reference 3/2020/0308), with the following condition:

The consented works would involve the removal of the existing roof covering, replacement of any rotten timber components with replacement equivalents, and then covering the roof with a breathable membrane, fitting new softwood battens and re-roofing with the roof tiles set aside. Any shortfall in roof tiles would be filled using tiles of matched colour, size and appearance salvaged from elsewhere on the estate.

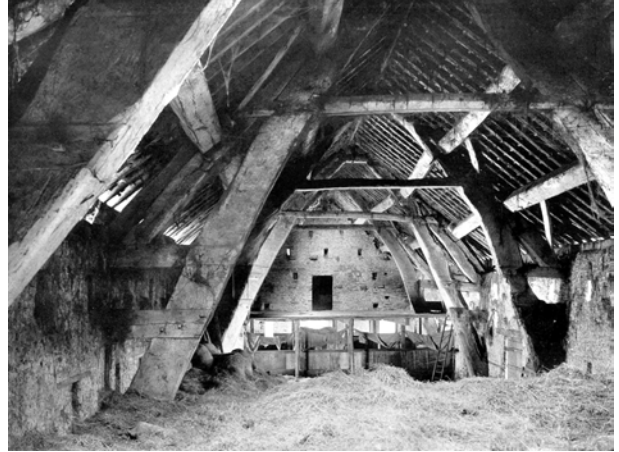
**Plate 6** Interior of the 'Shireburn Barn', 1927 (Stonyhurst Magazine)

The most northerly barn forming the Hall Barns Complex (not the barn that has been the subject of recording) is a cruck barn of possible 16th-century date, which would suggest that it functioned alongside the principal house constructed for the Shireburn family, long before the establishment of the college at the end of the 18th century. A photograph published in the *Stonyhurst Magazine*, shows the interior of the barn in 1927, then described as the 'Shireburn Barn' (Plate 6). A short description of the barn is also included, describing the 'massive and magnificent specimen' of a crook [sic] barn. It notes adze marks on the surviving timbers.

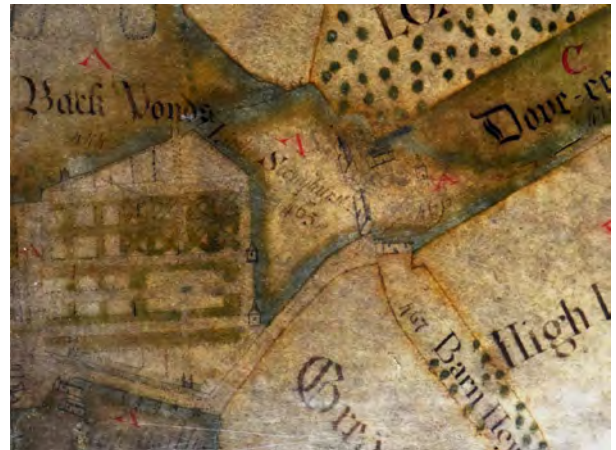
**Plate 7** Extract from 1733 Duchess's map, showing Hall Barns Farm (oriented with north to the left)

The 1733 plan shows the farm, with a series of stylistic buildings (Plate 7). The map shows the track that now leads past the farm, dividing these two fields; this splayed out at its northern end to form an irregular, roughly triangular, yard. Of particular note is a barn that stands at the eastern end of Barn Hey (Plate 8). When overlaid onto the Ordnance Survey mapping, this barn appears to be in the location of the barn forming the focus of this report and notably appears to be directly connected to the parcel of land labelled as Barn Hey.

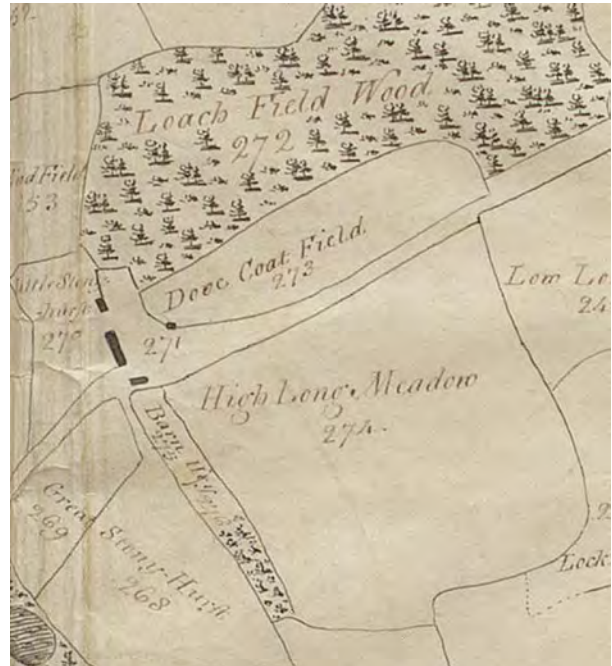
**Plate 9** Detail from 1774 Estate map showing Hall Barns Farm (oriented with north to the left)

The 1774 plan shows a similar arrangement, with perpendicular buildings, presumably the two Listed barns, and a small structure to the east (Plate 9). When overlaid onto Ordnance Survey the barn at the end of Barn Hey does appear to correspond with the location of the barn of interest (Plate 10).

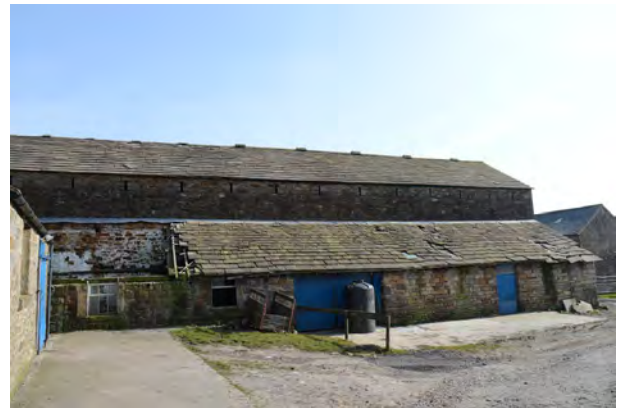
**Plate 14** The southwest side of the barn

The southwest elevation of the single-storey outshut centres on a large double door (Plate 14; SHB001, SHB002; SHB010). Evidence indicates that this double door, and the roof above, fill what would have been an open space between two separate outshuts, providing direct access to the main body of the barn through a large arched opening. This would have mirrored the current situation on the opposite side of the barn.

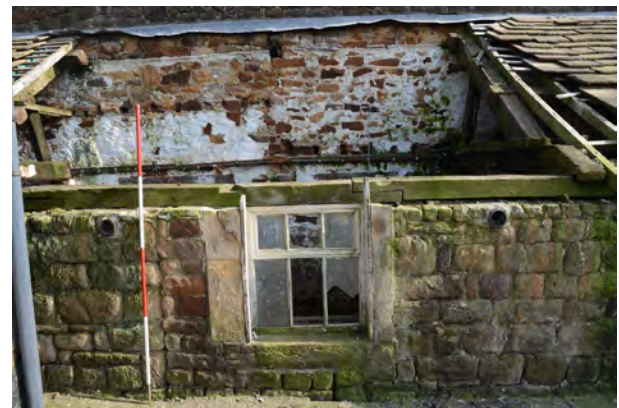
**Plate 15** Window inserted in doorway, southwest elevation

The window to the immediate north of double doors represents either an inserted window, or an opening that has been enlarged (SHB017). The next window has been inserted into a blocked door opening (the door opening appears to be an original feature)(SHB016, SHB024, SHB050; Plate 15). The two windows at the northern end are also either insertions or enlargements (SHB012-013; SHB014-015). The northernmost window is blocked. The remaining three windows contain timber transom frames; the two to the north are of the late 19th century, that to the south is of mid- to late 20th-century date. The former two frames provide a likely date for when the windows were inserted.

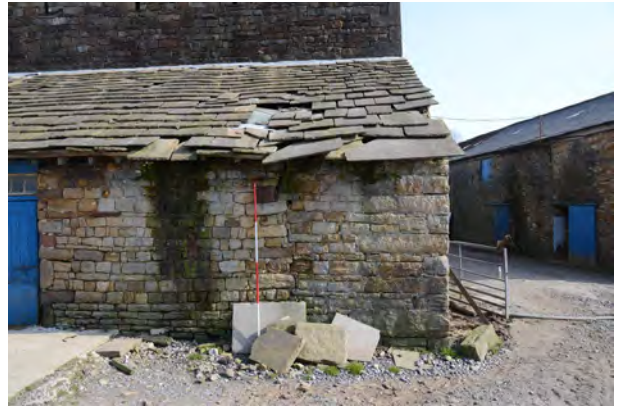
**Plate 16** Vertical break in the fabric of the southwest outshut

To the south of the double door the fabric consists of smaller sandstone blocks (SHB003-005; SHB022; Plate 16). These blocks are regularly coursed until close to the south end of the building where there is break in the fabric (SHB021). This break suggests that this end has been repaired or extended, or possibly indicates a much larger opening in this part of the elevation.

The main features of note are a blocked ventilator (SHB023), a door opening (SHB020) and a further blocked ventilator towards the south end (SHB022). The door opening contains a timber frame with overlight and a ledged and braced door. All openings in this part of the elevation appear to be primary to the fabric; the door itself is a later replacement. The break in the fabric towards the southern end of the elevation is near vertical (SHB021; Plate 16).

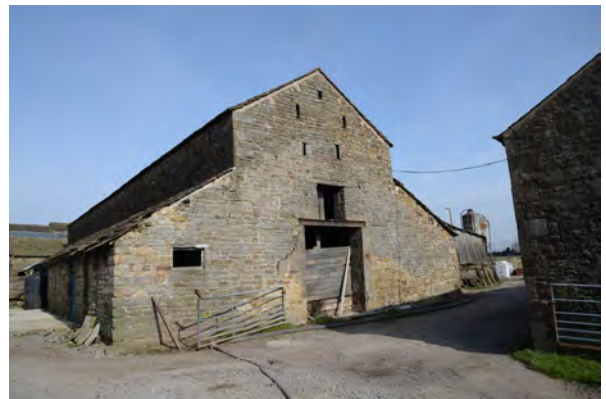
**Plate 17** Southeast elevation of the barn

The southeast elevation of the outshut forms part of the gable end of the barn as a whole (SHB001-003)(Plate 17). The fabric of the elevation is of coursed, roughly-squared sandstone blocks. A single window with timber lintel is located on the western side of the elevation which lights the interior of the southwest outshut; the window appears to be an insertion.

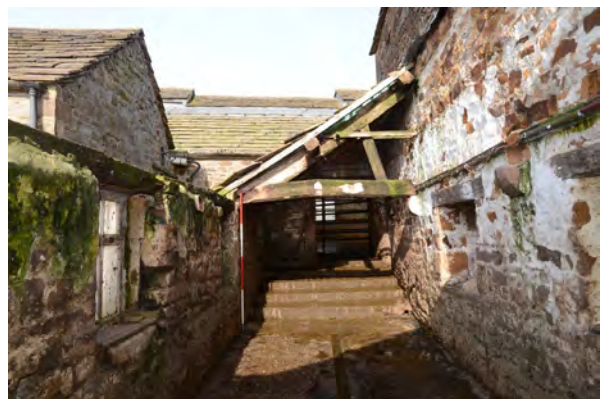
**Plate 18** Interior of the north end of the outshut on southwest side

The northern end of the northern compartment (SHB025) has steps upwards and connects through into the main barn area (Plate 18). This space is divided from the central area by a rubble wall (SHB032). The lower part of the fabric courses through into the main part of the barn fabric, suggesting it is contemporary, while the upper part of the stonework does not, suggesting this is infill. It is possible that the upper part of the wall replaced an earlier area of timber framing.

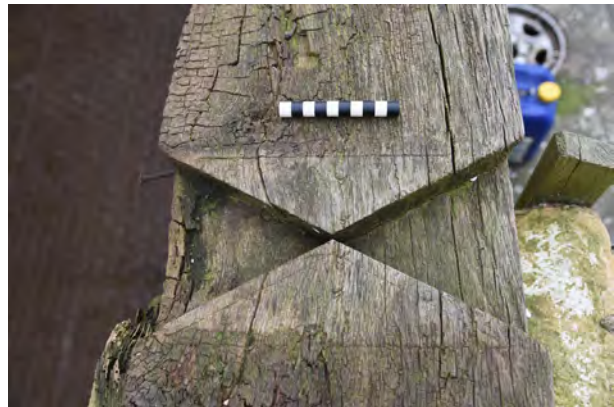
**Plate 19** Upper part of wall plate showing notches for tie beam

The recorded elements on the removed timbers include detailing of the joints that would have secured the tie beams on the wall plate (SHB140), corresponding to those observed in the exposed wall plate (see Plate 19).

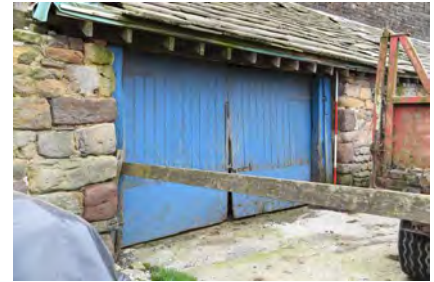
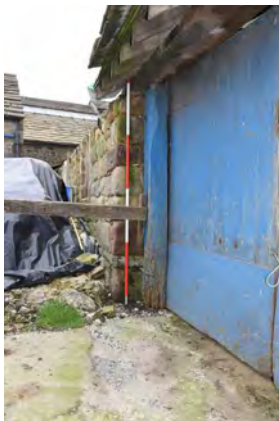
The double door is a replacement door of likely 20th-century date, inserted into what was probably an open area accessing the main arched opening (SHB018-019). Opposed doorways suggest that this was originally a threshing barn.

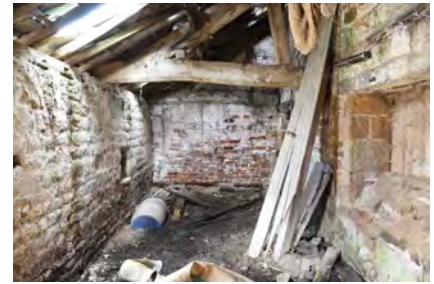
SHB051

The central space is divided from the southern compartment by a wall of mixed construction (SHB051-052, SHB055). Courses of stonework are visible at the bottom, with an area of brickwork above. Again, this can be interpreted as replacement of timber framing with masonry.
