## Preliminary Bat Roost Assessment Report

**11 Southfield Drive,  
West Bradford,  
Clitheroe,  
BB7 4TU**

**02.06.2021**

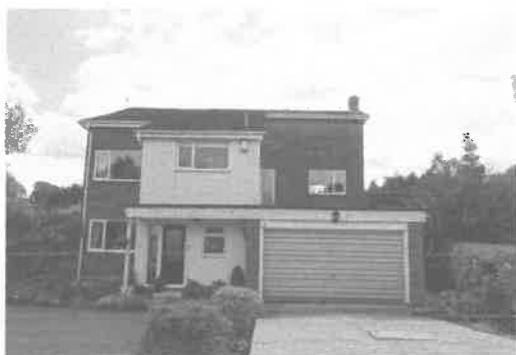
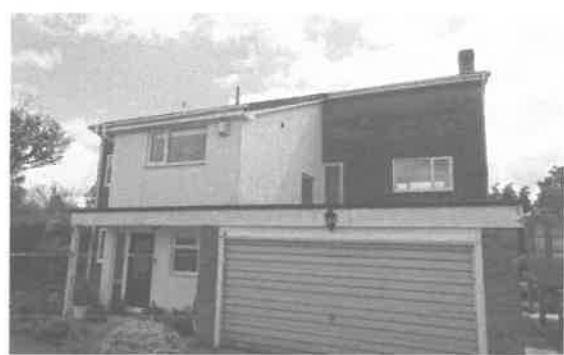
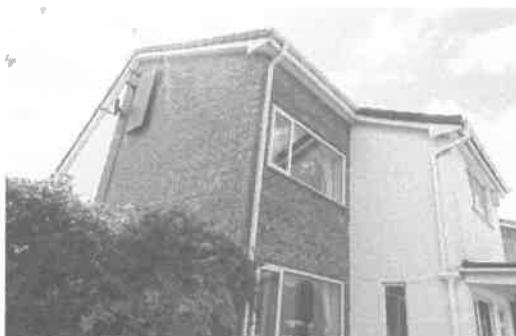
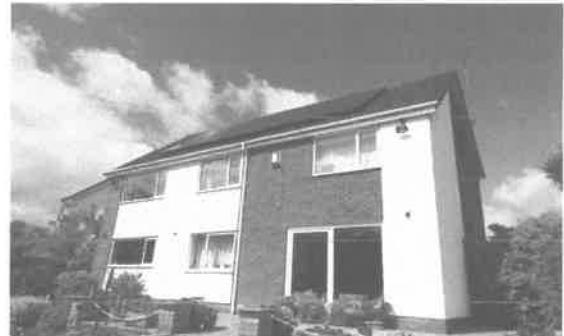
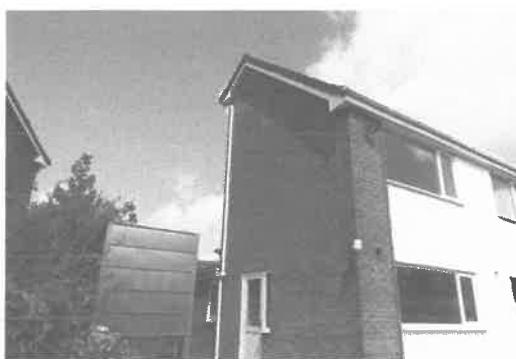
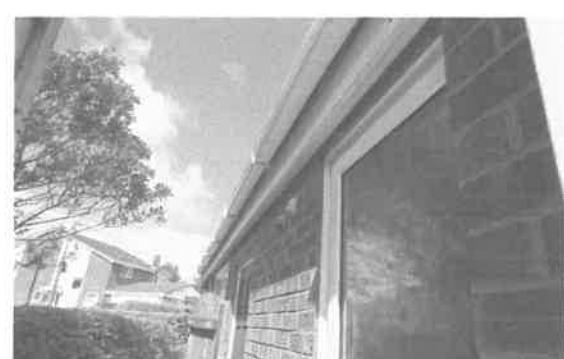
The property consists of a brick built detached two storey house with a double pitched tiled roof. A single storey flat roofed garage is present on the frontage.

External walls are well pointed and partially rendered with no obvious cavities, cracks, gaps or crevices present. The gables are well sealed. Upvc soffits and fascia boards are close fitting.

Roof tiles are close fitting with no slipped, missing or lifted slates present. Some moss growth is present on roof tiles. The ridge tiles are pointed and well sealed. Roof tiles are heavily moss covered to the front of the property, a solar array is present on the rear roof aspect.

The building can be considered to offer negligible roosting bat potential.
