# Preliminary Bat Roost Assessment Report

49 Edisford Road,  
Clitheroe,  
BB7 3LA

02.06.2021

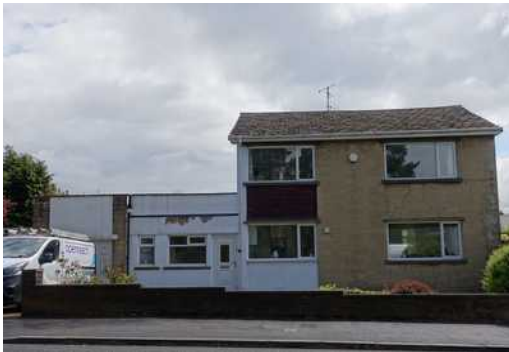
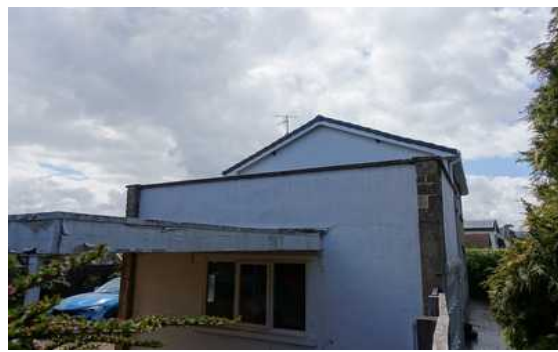
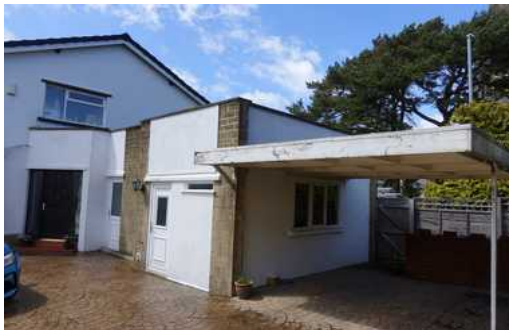
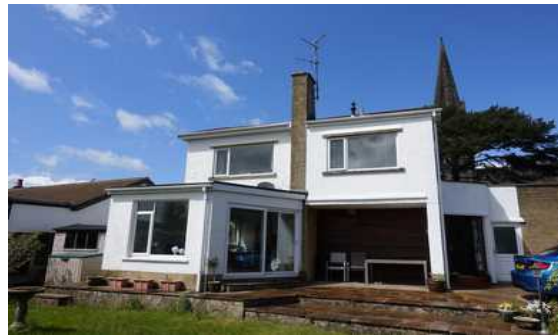
The property consists of a stone built detached two storey house with a double pitched tiled roof. A single storey single pitched roofed extension and garage is present on the eastern gable. A single storey flat roofed extension is present on the rear facade.

External walls are well pointed and partially rendered with no obvious cavities, cracks, gaps or crevices present. The gables are well sealed. Upvc soffits and fascia boards are close fitting.

Roof tiles are close fitting with no slipped, missing or lifted slates present. Some moss growth is present on roof tiles. The ridge tiles are pointed and well sealed.

The building can be considered to offer negligible roosting bat potential.

The property was assessed as offering negligible roosting potential with no obvious gaps or crevices suitable for roosting bats.

No evidence of use by bats was recorded during the survey and the building were assessed as offering negligible roosting potential due to a lack of potential roosting features and the well maintained and well sealed nature of the property.
