# **Preliminary Bat Roost Assessment Report**

**20 Shireburn Avenue,  
Clitheroe,  
BB7 2PN**

**08.06.2021**

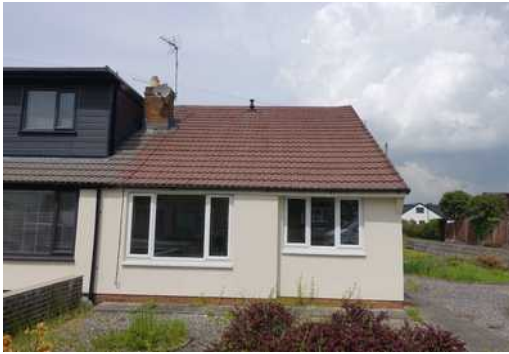
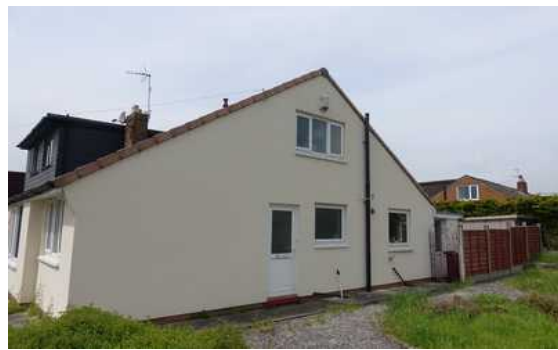
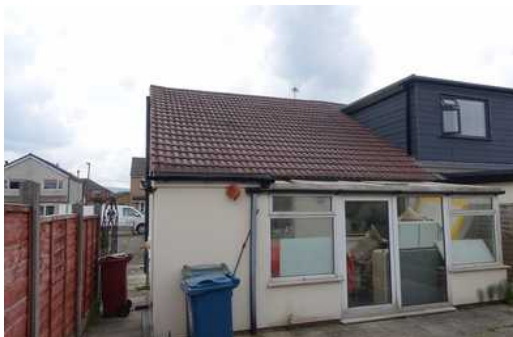
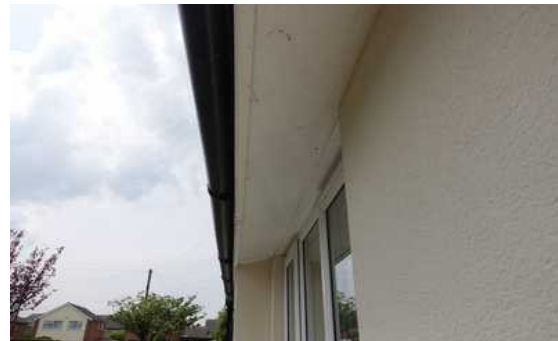
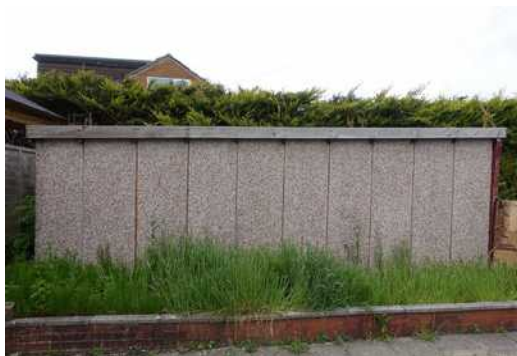
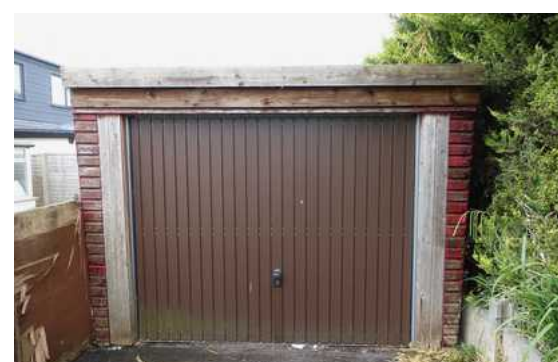
The property consists of a brick built semi detached bungalow with a double pitched tiled roof. A single storey flat roofed prefabricated garage is present to the west of the property. External walls are well pointed and rendered with no obvious cavities, cracks, gaps or crevices present. The gable is well sealed. Upvc soffits are close fitting.

Roof tiles are close fitting with no slipped, missing or lifted slates present. The ridge tiles are pointed and well sealed.

The building can be considered to offer negligible roosting bat potential.

The property was assessed as offering negligible roosting potential with no obvious gaps or crevices suitable for roosting bats. The building is well sealed and well maintained.

No physical evidence of bats grease marks or urine splashing was recorded on or around the building despite suitable horizontal surfaces being present and undisturbed.

No evidence of roosting bats was observed on the exterior of the building.
