**BAT SURVEY AT -
38 MITTON ROAD
WHALLEY**

DATE AND TIME OF VISIT
12th May 2021 2.00pm

REFERENCE NO. 6254

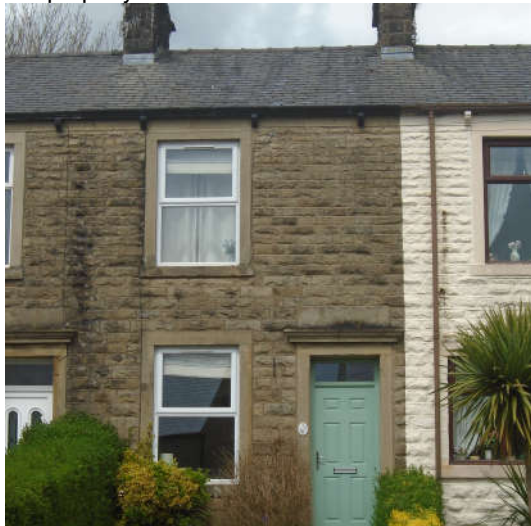
Front South elevation

The property is the middle house in a terraced row of three.

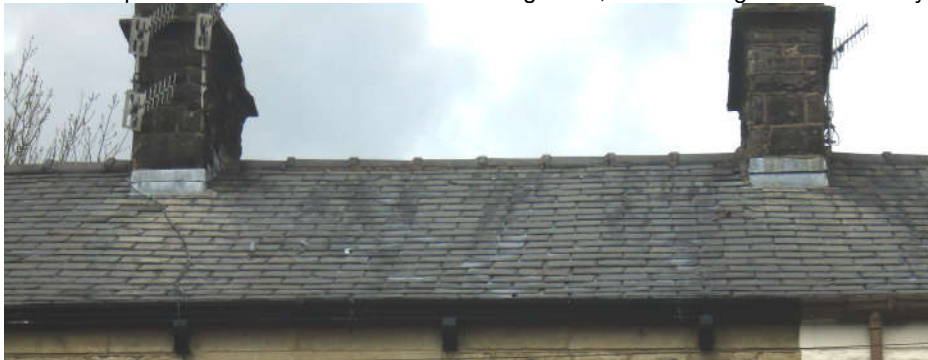
Front roof pitch

The roof is pitched with a blue slate finish and ridge tiles, lead flashings to two chimneys.

The roof was examined from ground level with the aid of binoculars. The slates are tight fitting and the ridge tiles are in good condition and well pointed. The lead flashings to the chimneys are in good condition and tight fitting. The eaves behind the gutters on did appear to have any gaps suitable for bat ingress.

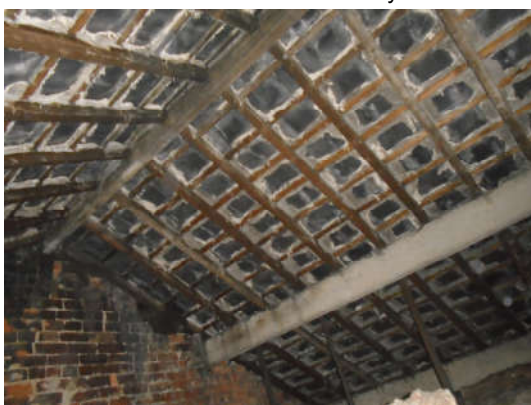
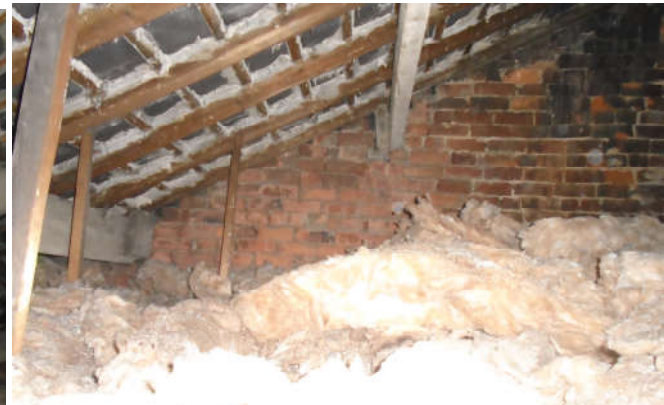
The roof space was accessed via a ceiling hatch, the structure was timber purlins rafters and battens. There is no underlay, the slates are pointed to the battens. The timbers are in reasonable condition with no rot, cracks or crevices. The insulation quilt over the ceiling joists is clean and free from any dropping, or insect remains. Evidence of current or historic use by bats was not found.
