# **Preliminary Bat Roost Assessment Report**

**24 Hillside Drive,  
West Bradford,  
BB7 4TG**

**15.07.2021**

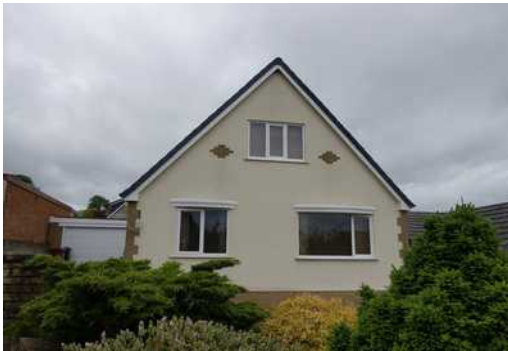
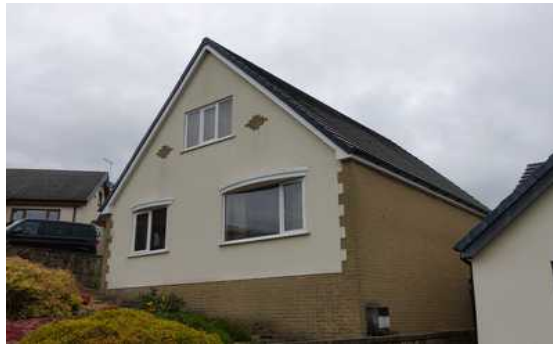
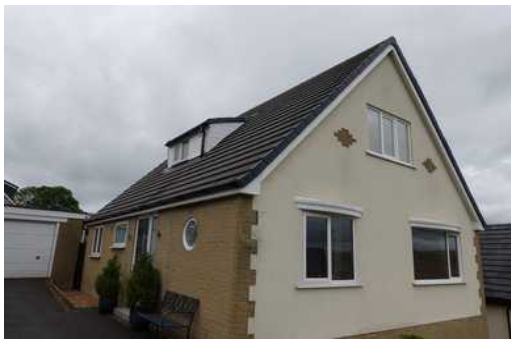
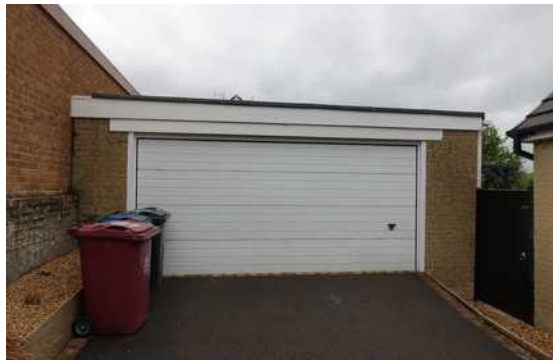
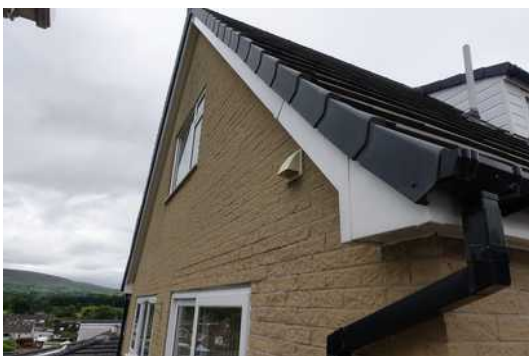
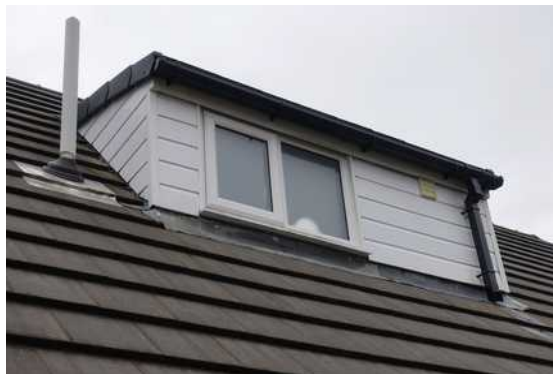
The property consists of a detached dormer bungalow with a double pitched tile roof. A single storey flat roofed garage is present on the northern side of the property.

External walls are well pointed and partially rendered with no obvious cavities, cracks, gaps or crevices present. The gables are well sealed. Upvc soffits and fascia boards are close fitting with no obvious gaps present.

Roof tiles are close fitting with no slipped, missing or lifted tiles present. The ridge tiles are pointed and well sealed.

The building can be considered to offer negligible roosting bat potential.
