Listers Farm, Clitheroe

Bat Activity Survey

Project Title :	Listers Farm, Clitheroe
Report Type:	Bat Activity Survey
Report Date:	10/06/2021
Author:	A. Gould
Client:	Mrs. S. Wright
PBA Ref:	PC20043/BatAct/1.0

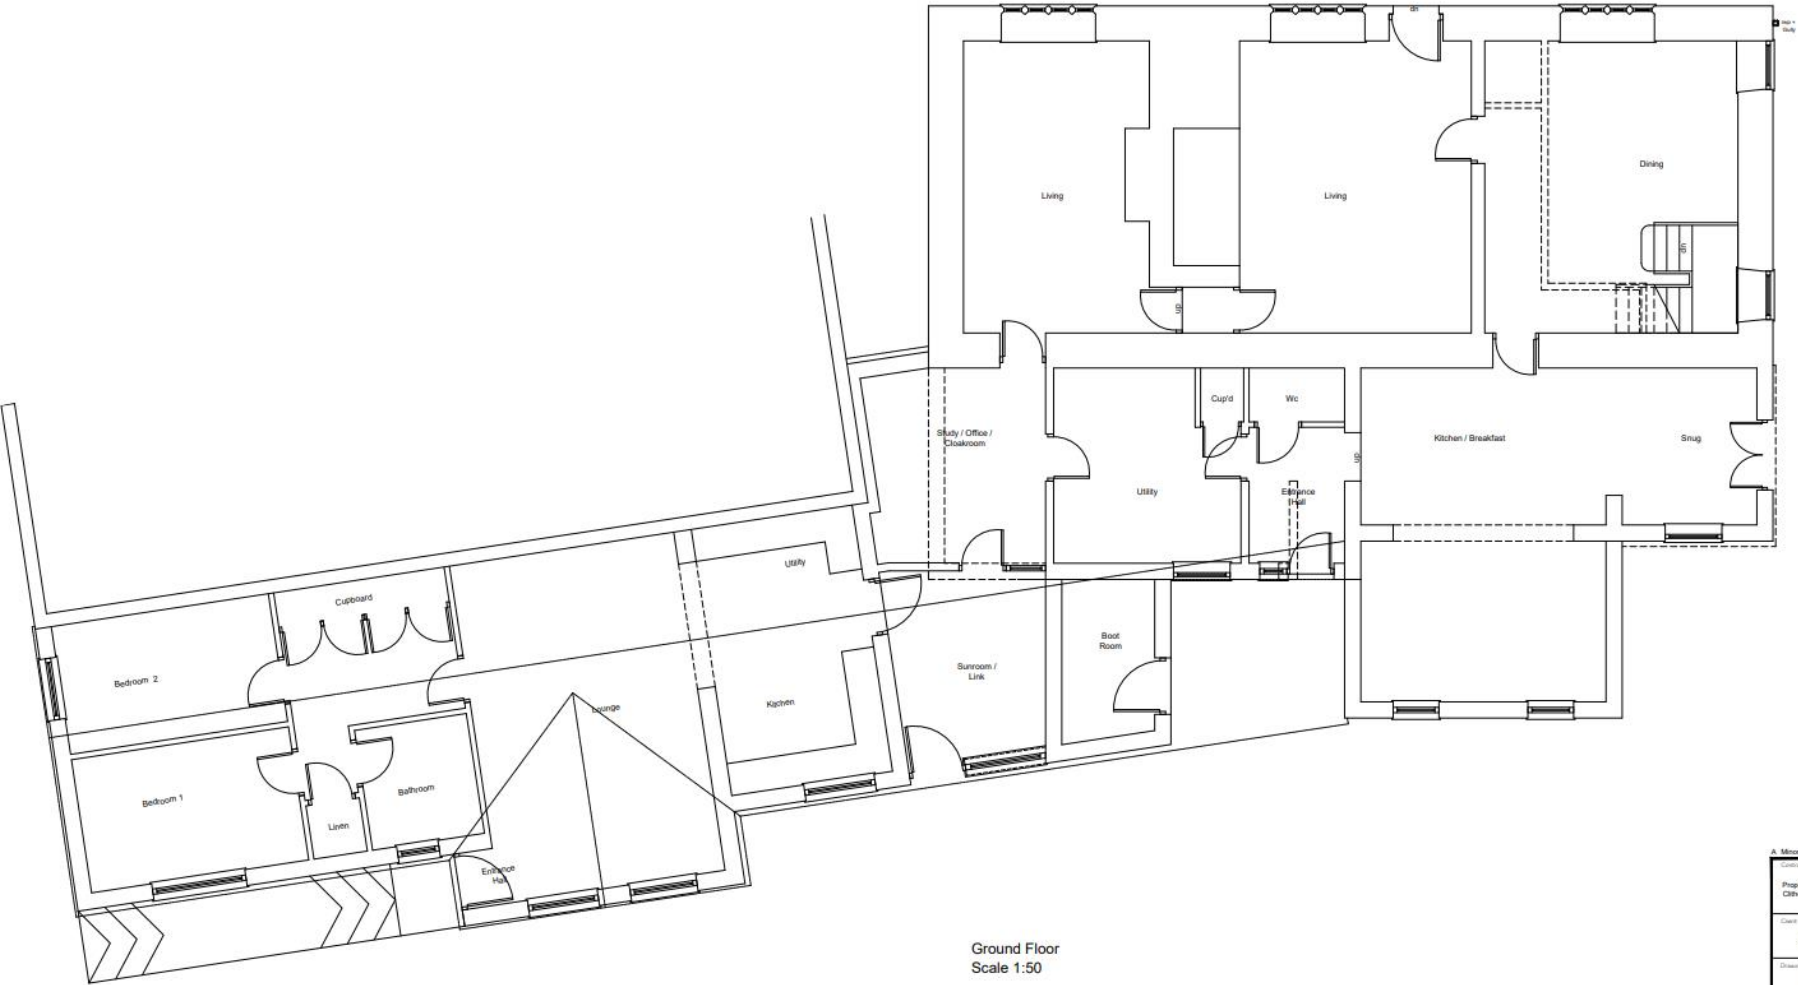
Site plan as proposed.

The proposed works are expected to include the construction of an extension on the rear of the farmhouse, with internal remodelling. This will involve the demolition of the rear part of the outbuilding. Plans for the proposed works can be found in Appendix B.

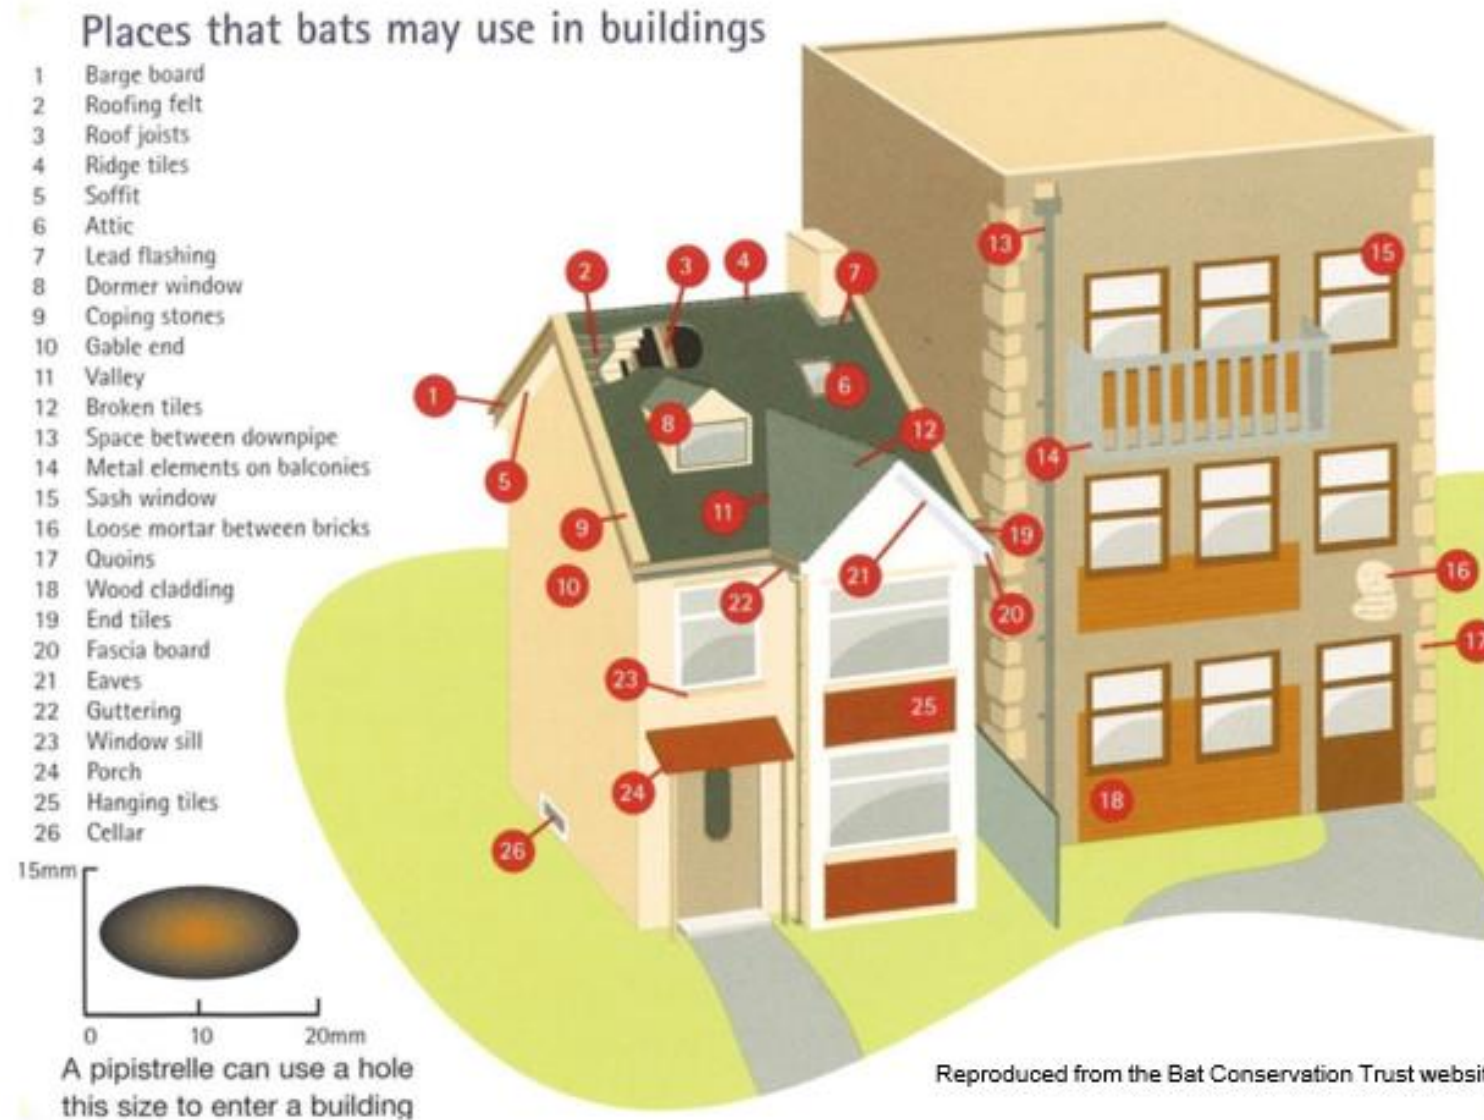
Appendix D - Possible roosting sites and access points for bats in buildings

Of the UK's 17 resident bat species, the majority will utilise the built environment at some point during their lifecycle and some species are particularly linked to buildings. Appendix D provides a diagram showing possible roost sites within buildings. Some species roost in building crevices, such as common and soprano pipistrelle (*Pipistrellus pipistrellus* and *P. pygmaeus*); others prefer large cavities, such as brown long-eared (*Plecotus auritus*) and Natterer's bats (*Myotis nattereri*). Bats are most likely to be present and seen for the duration of the summer months, but may be present within buildings throughout the year.
