Document Title	Biodiversity Net Gain Assessment	Ref: RVBC-BO-APP-008_01
Prepared for	United Utilities	
Prepared by	TEP - Warrington	
Document Ref	7478.04.005

DRAWINGS
Drawing 1 – G7478.04.13 Ribble Valley District Compound Overview
Drawing 2 – G7478.04.14 Ribble Valley District Baseline Habitats
Drawing 3 – G7478.04.15 Ribble Valley District Post Development Habitats

1. TEP was commissioned by United Utilities to undertake a Biodiversity Net Gain (BNG) assessment of the Haweswater Aqueduct Resilience Programme. This report covers the BNG assessment of land within the boundary of Ribble Valley Borough Council only.

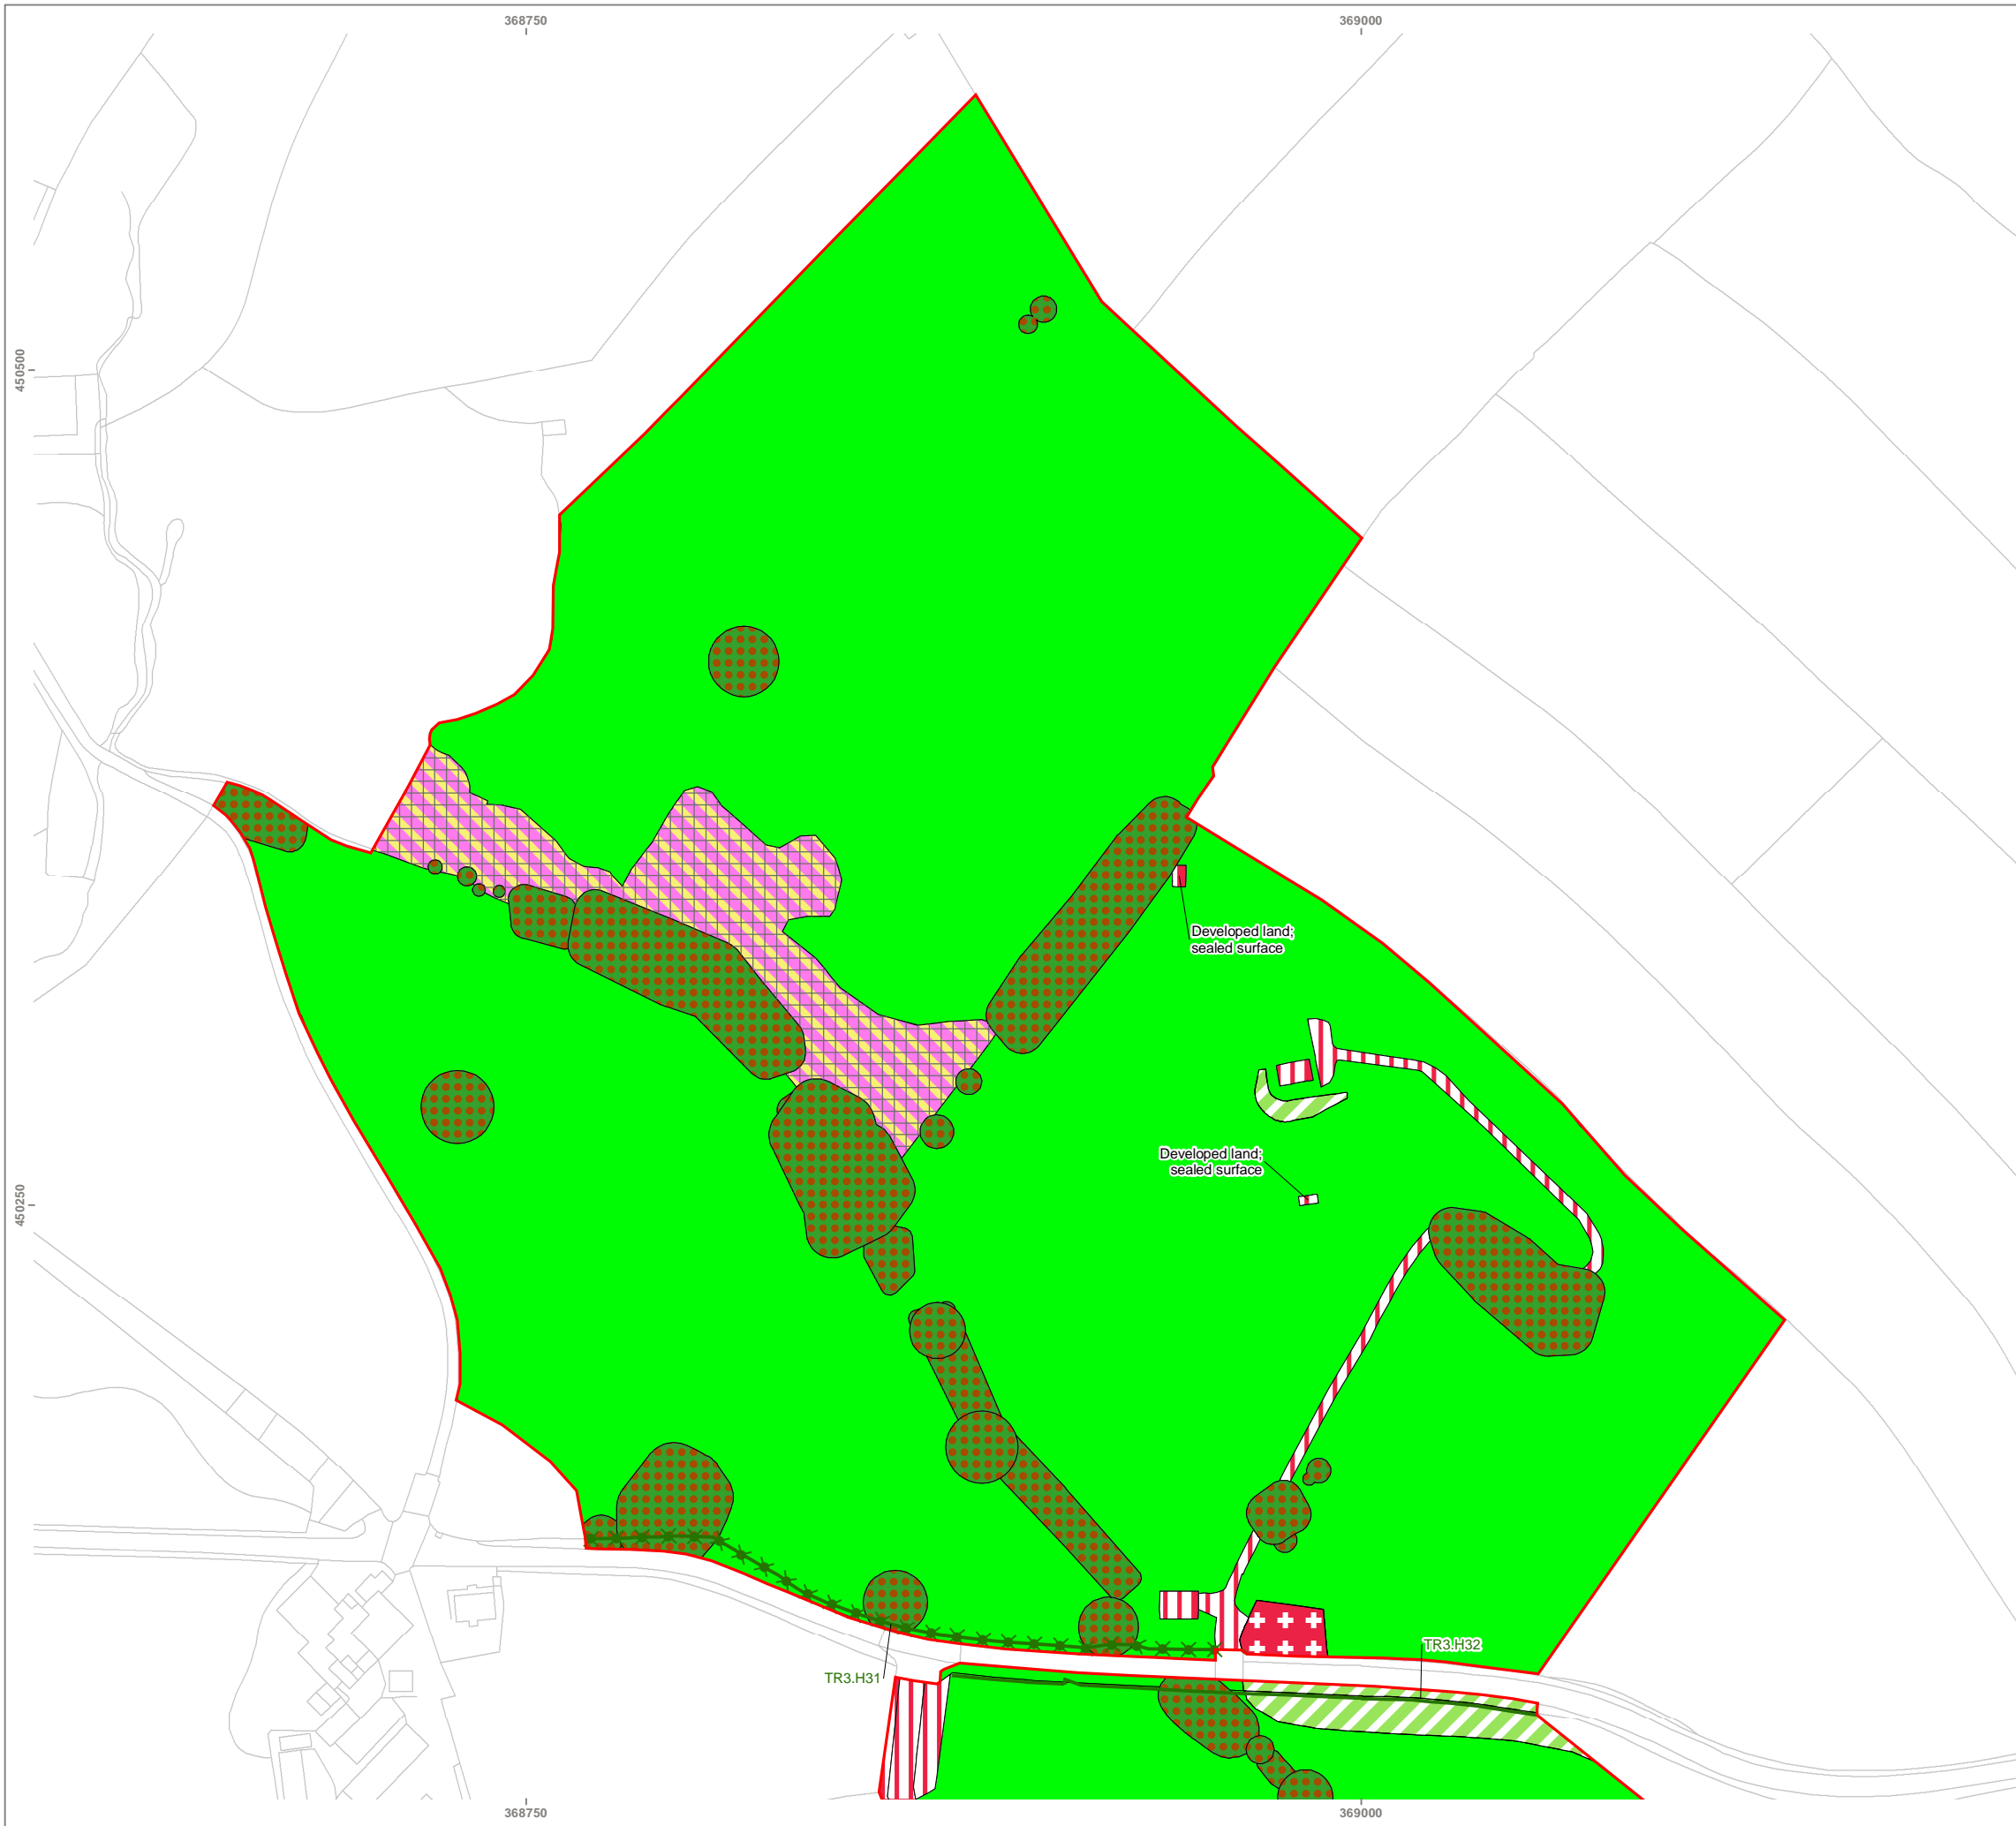
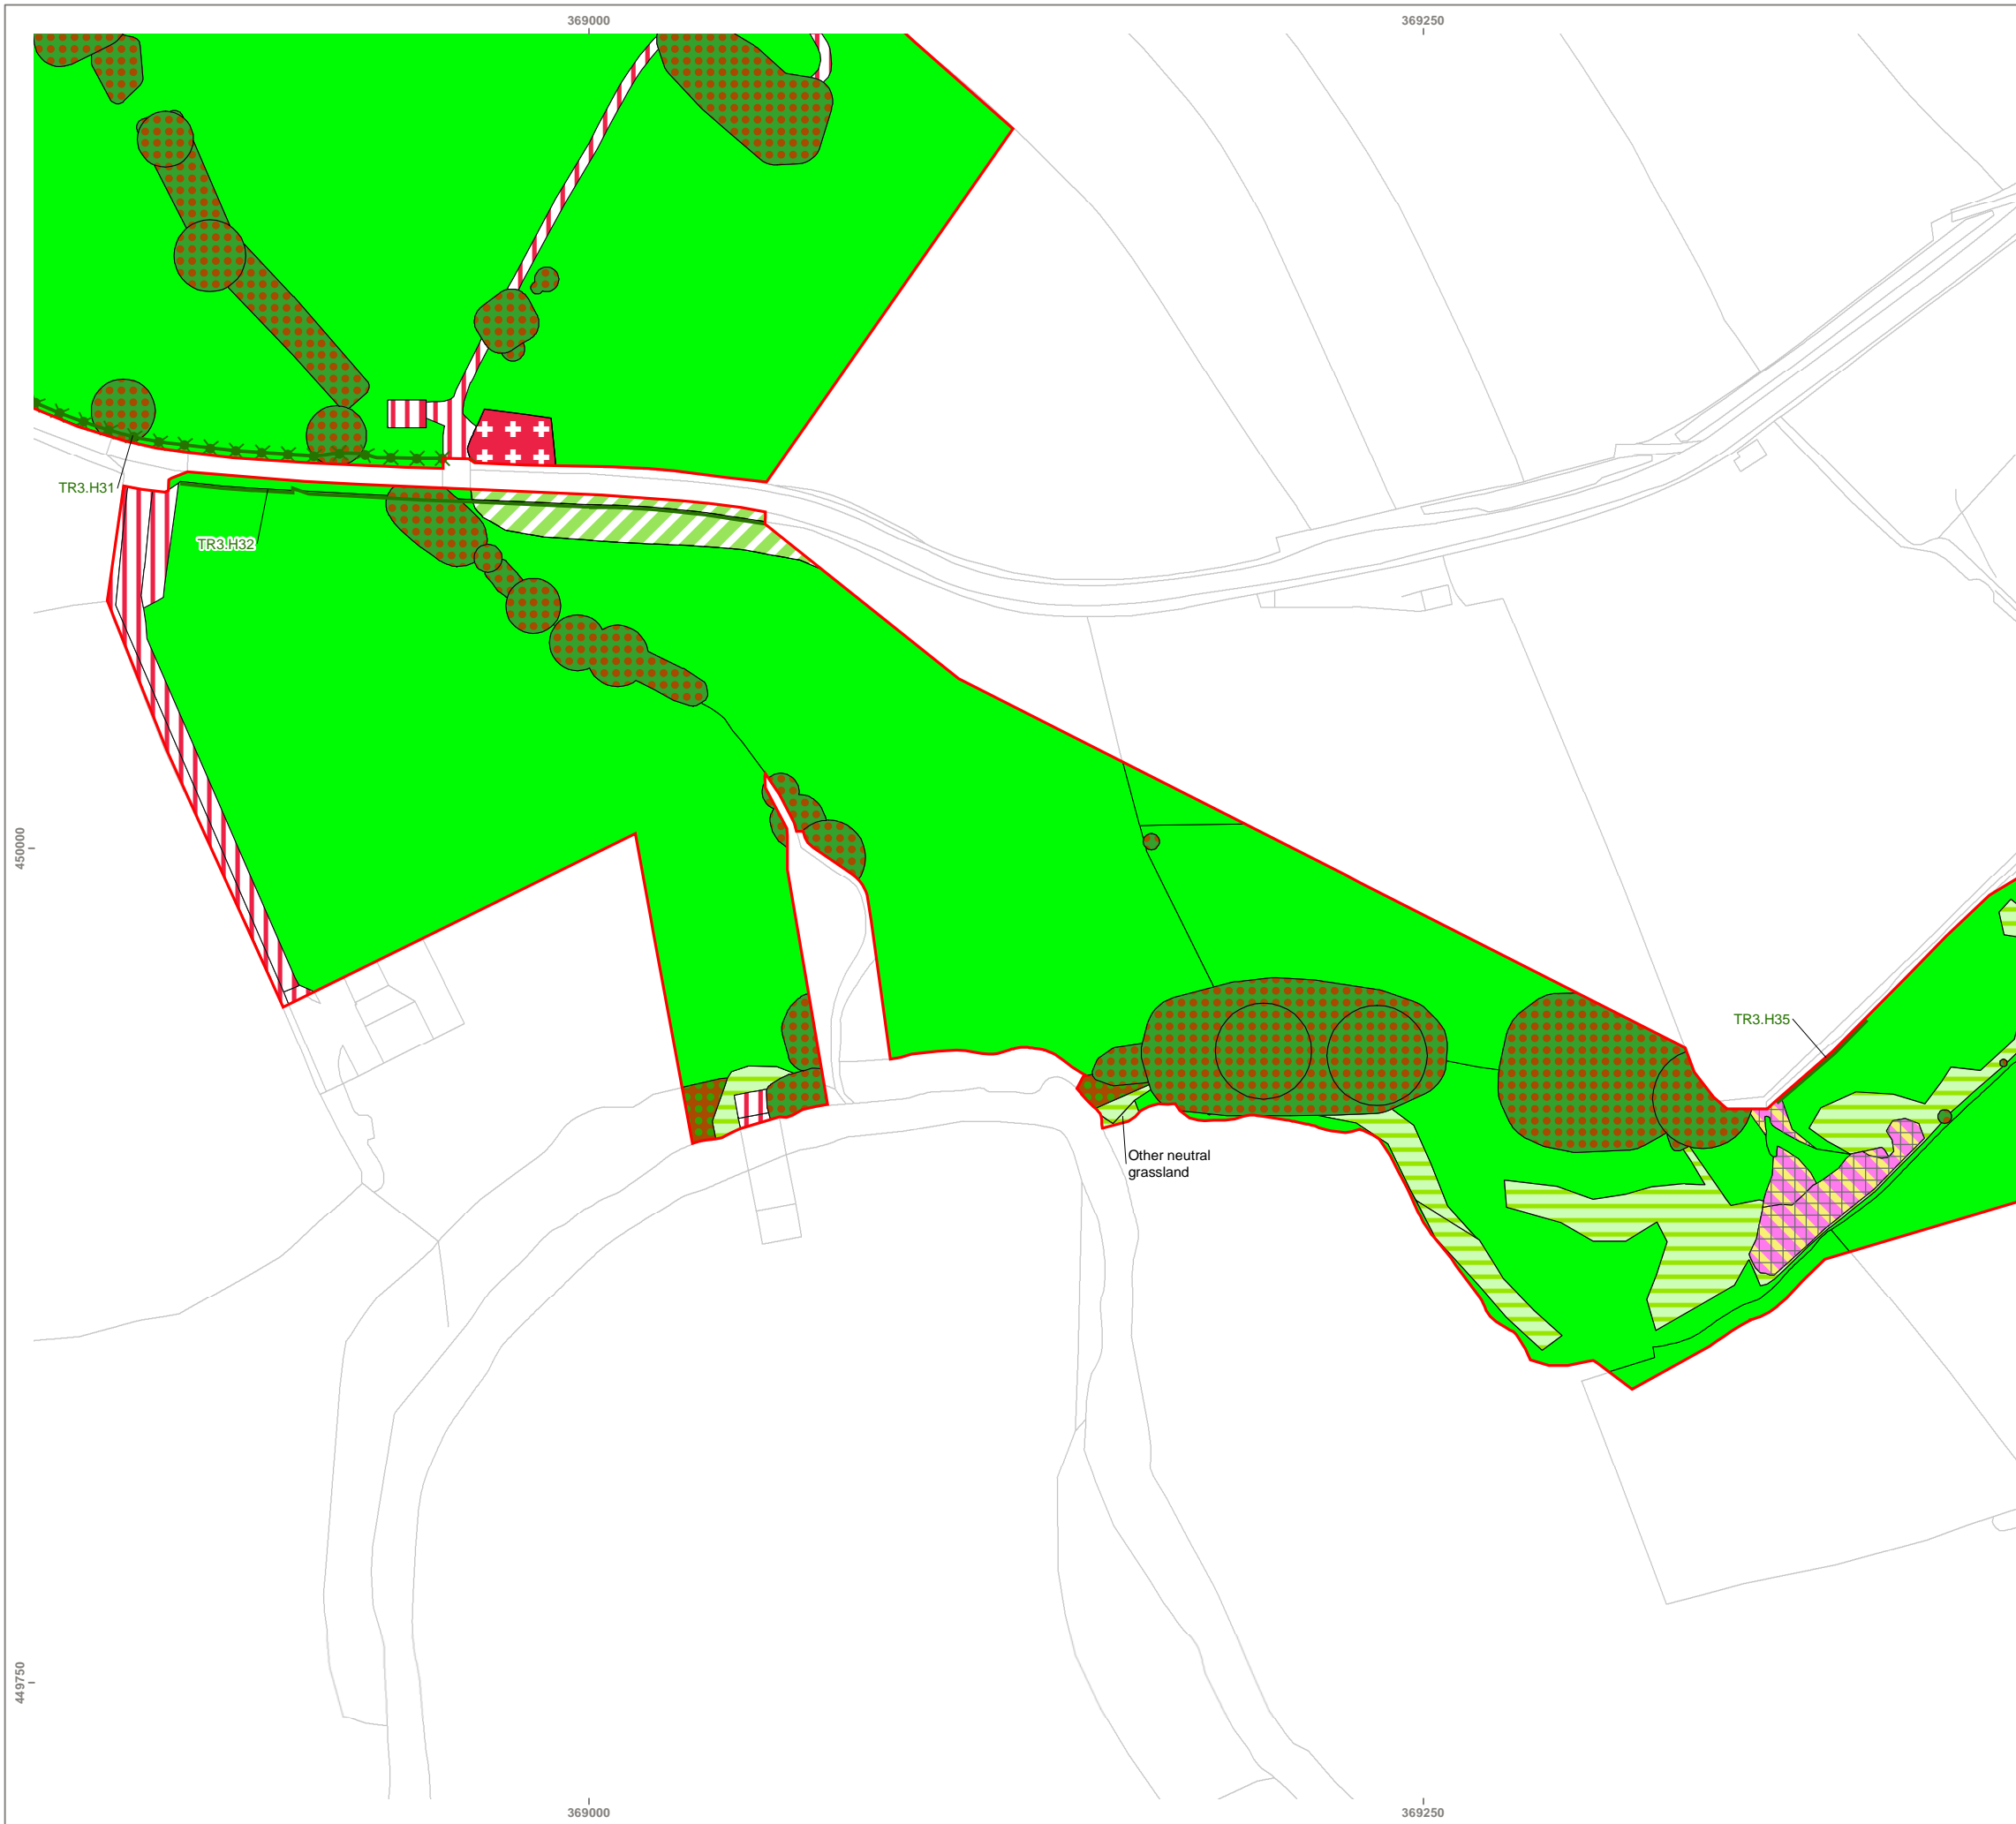
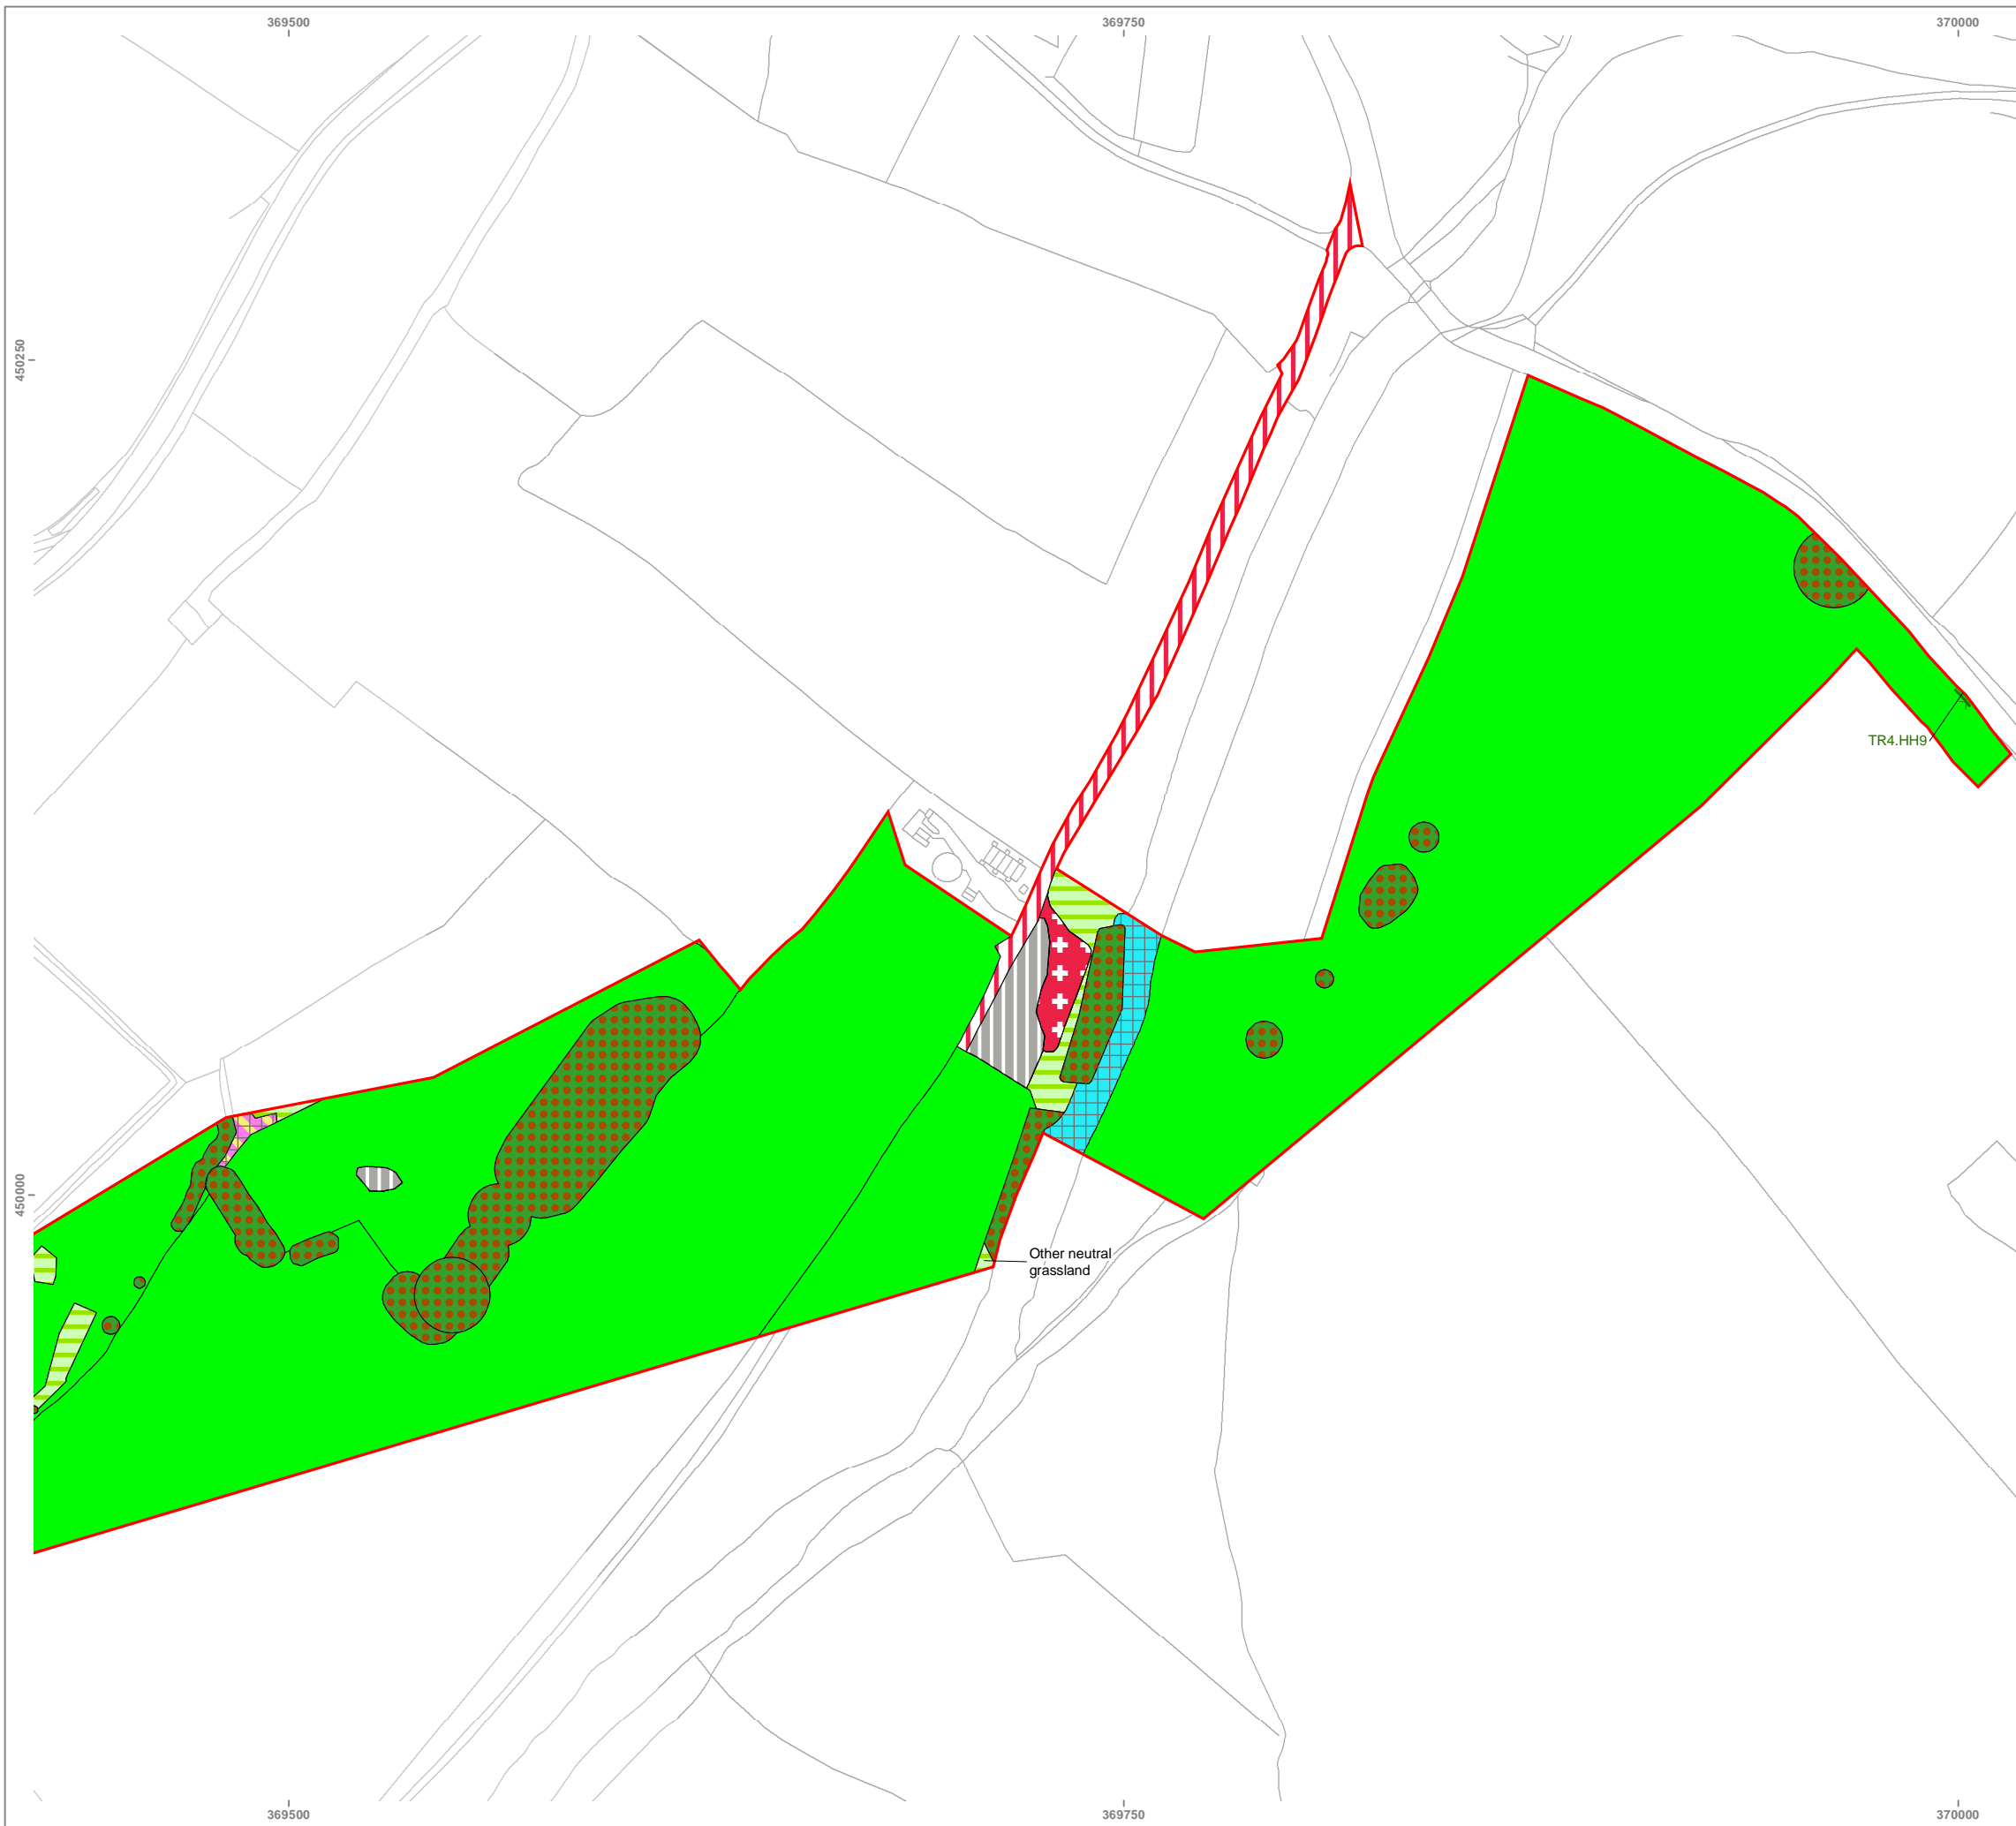
Drawing 2 – G7478.04.14 Ribble Valley District Baseline Habitats

- Compound boundary
- Habitat excluded from calculations
- UK Habitat Classification**
 - Native hedgerow
 - Native species rich hedgerow
 - Native species rich hedgerow with trees
 - Lowland fens
 - Other lowland acid grassland
 - Other neutral grassland
 - Modified grassland
 - River
 - Ruderal/Ephemeral
 - Developed land/sealed surface
 - Vacant/derelict land/bare ground
 - Other woodland - broadleaved
 - Other woodland - mixed

Note:
The locations of habitats and habitat features are indicative.

- 3.2 The baseline habitats drawing (TEP Ref: G7478.004.014) illustrates the habitats present across the site. Tables 1 lists the habitats present, their Phase 1 habitat code and reclassified UK Habitat classification (UK Hab) code with their associated conditions and also provides a summary of how this assessment was derived.

- 3.4 Drawing TEP Ref: G7478.004.014 also illustrates the location of the hedgerows. Table 2 lists the hedgerows present within the application area, their Phase 1 habitat code and reclassified UK Habitat classification code with their associated conditions and provides a summary of how this assessment was derived.

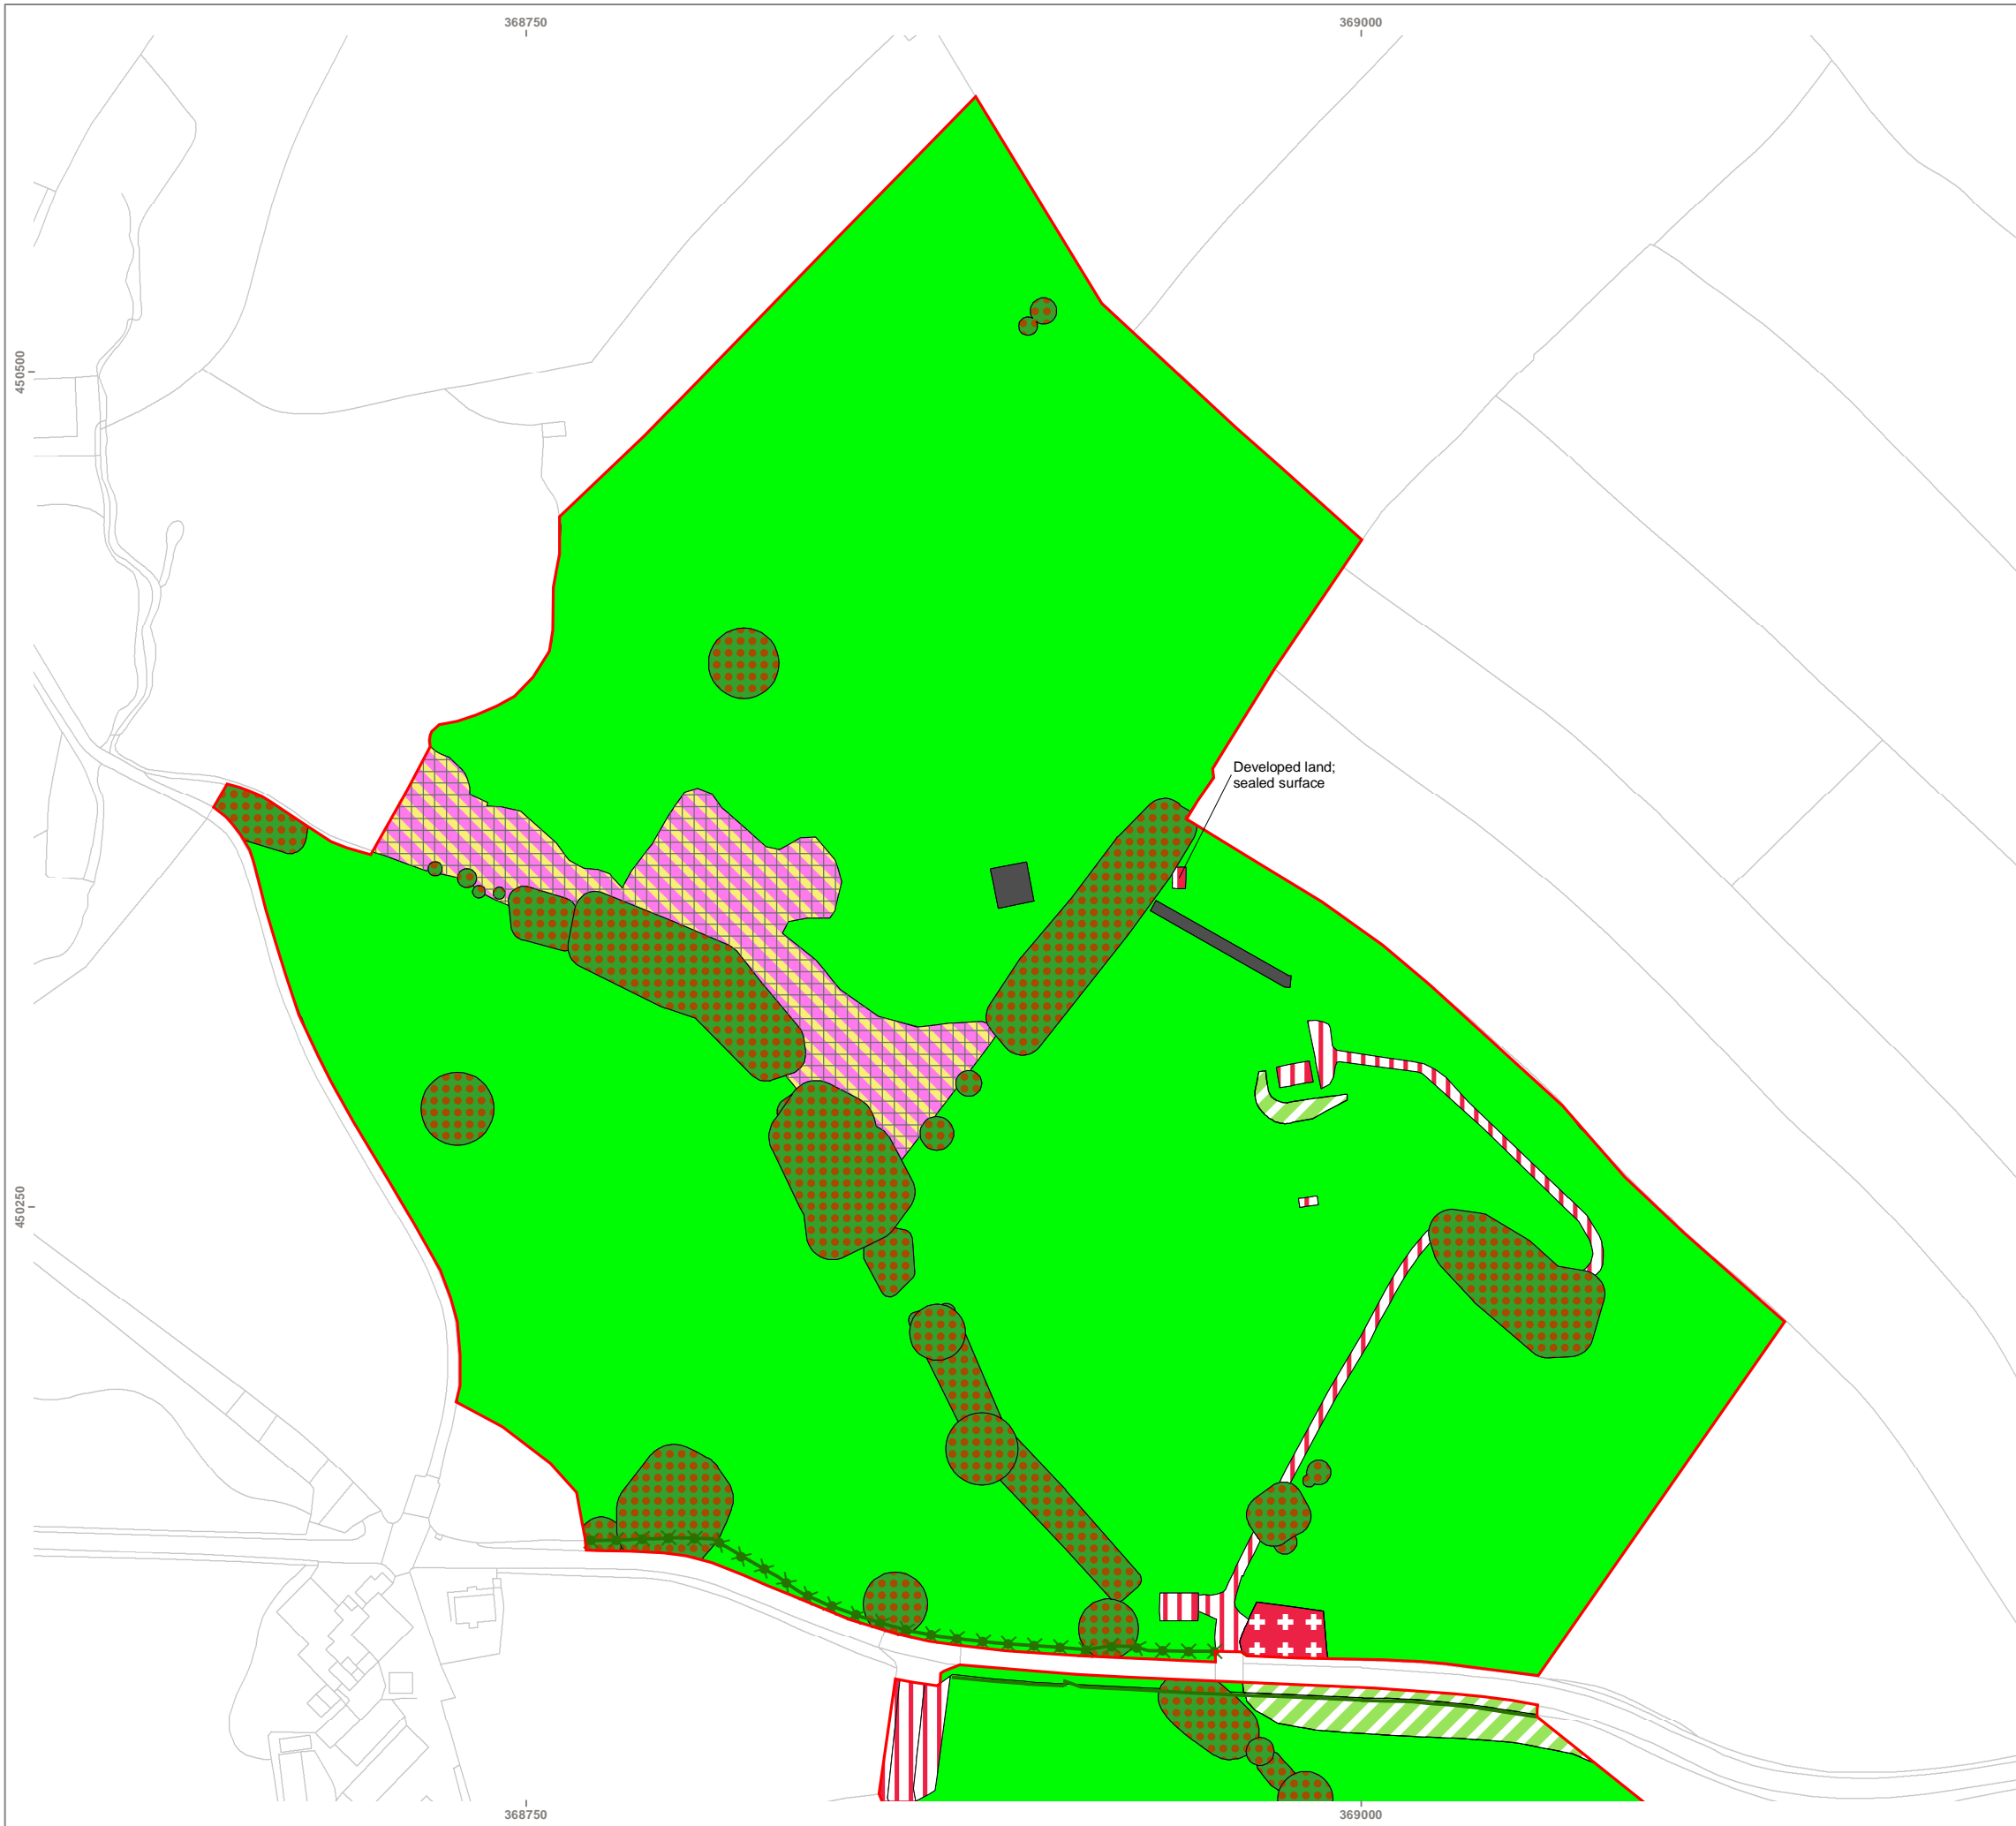
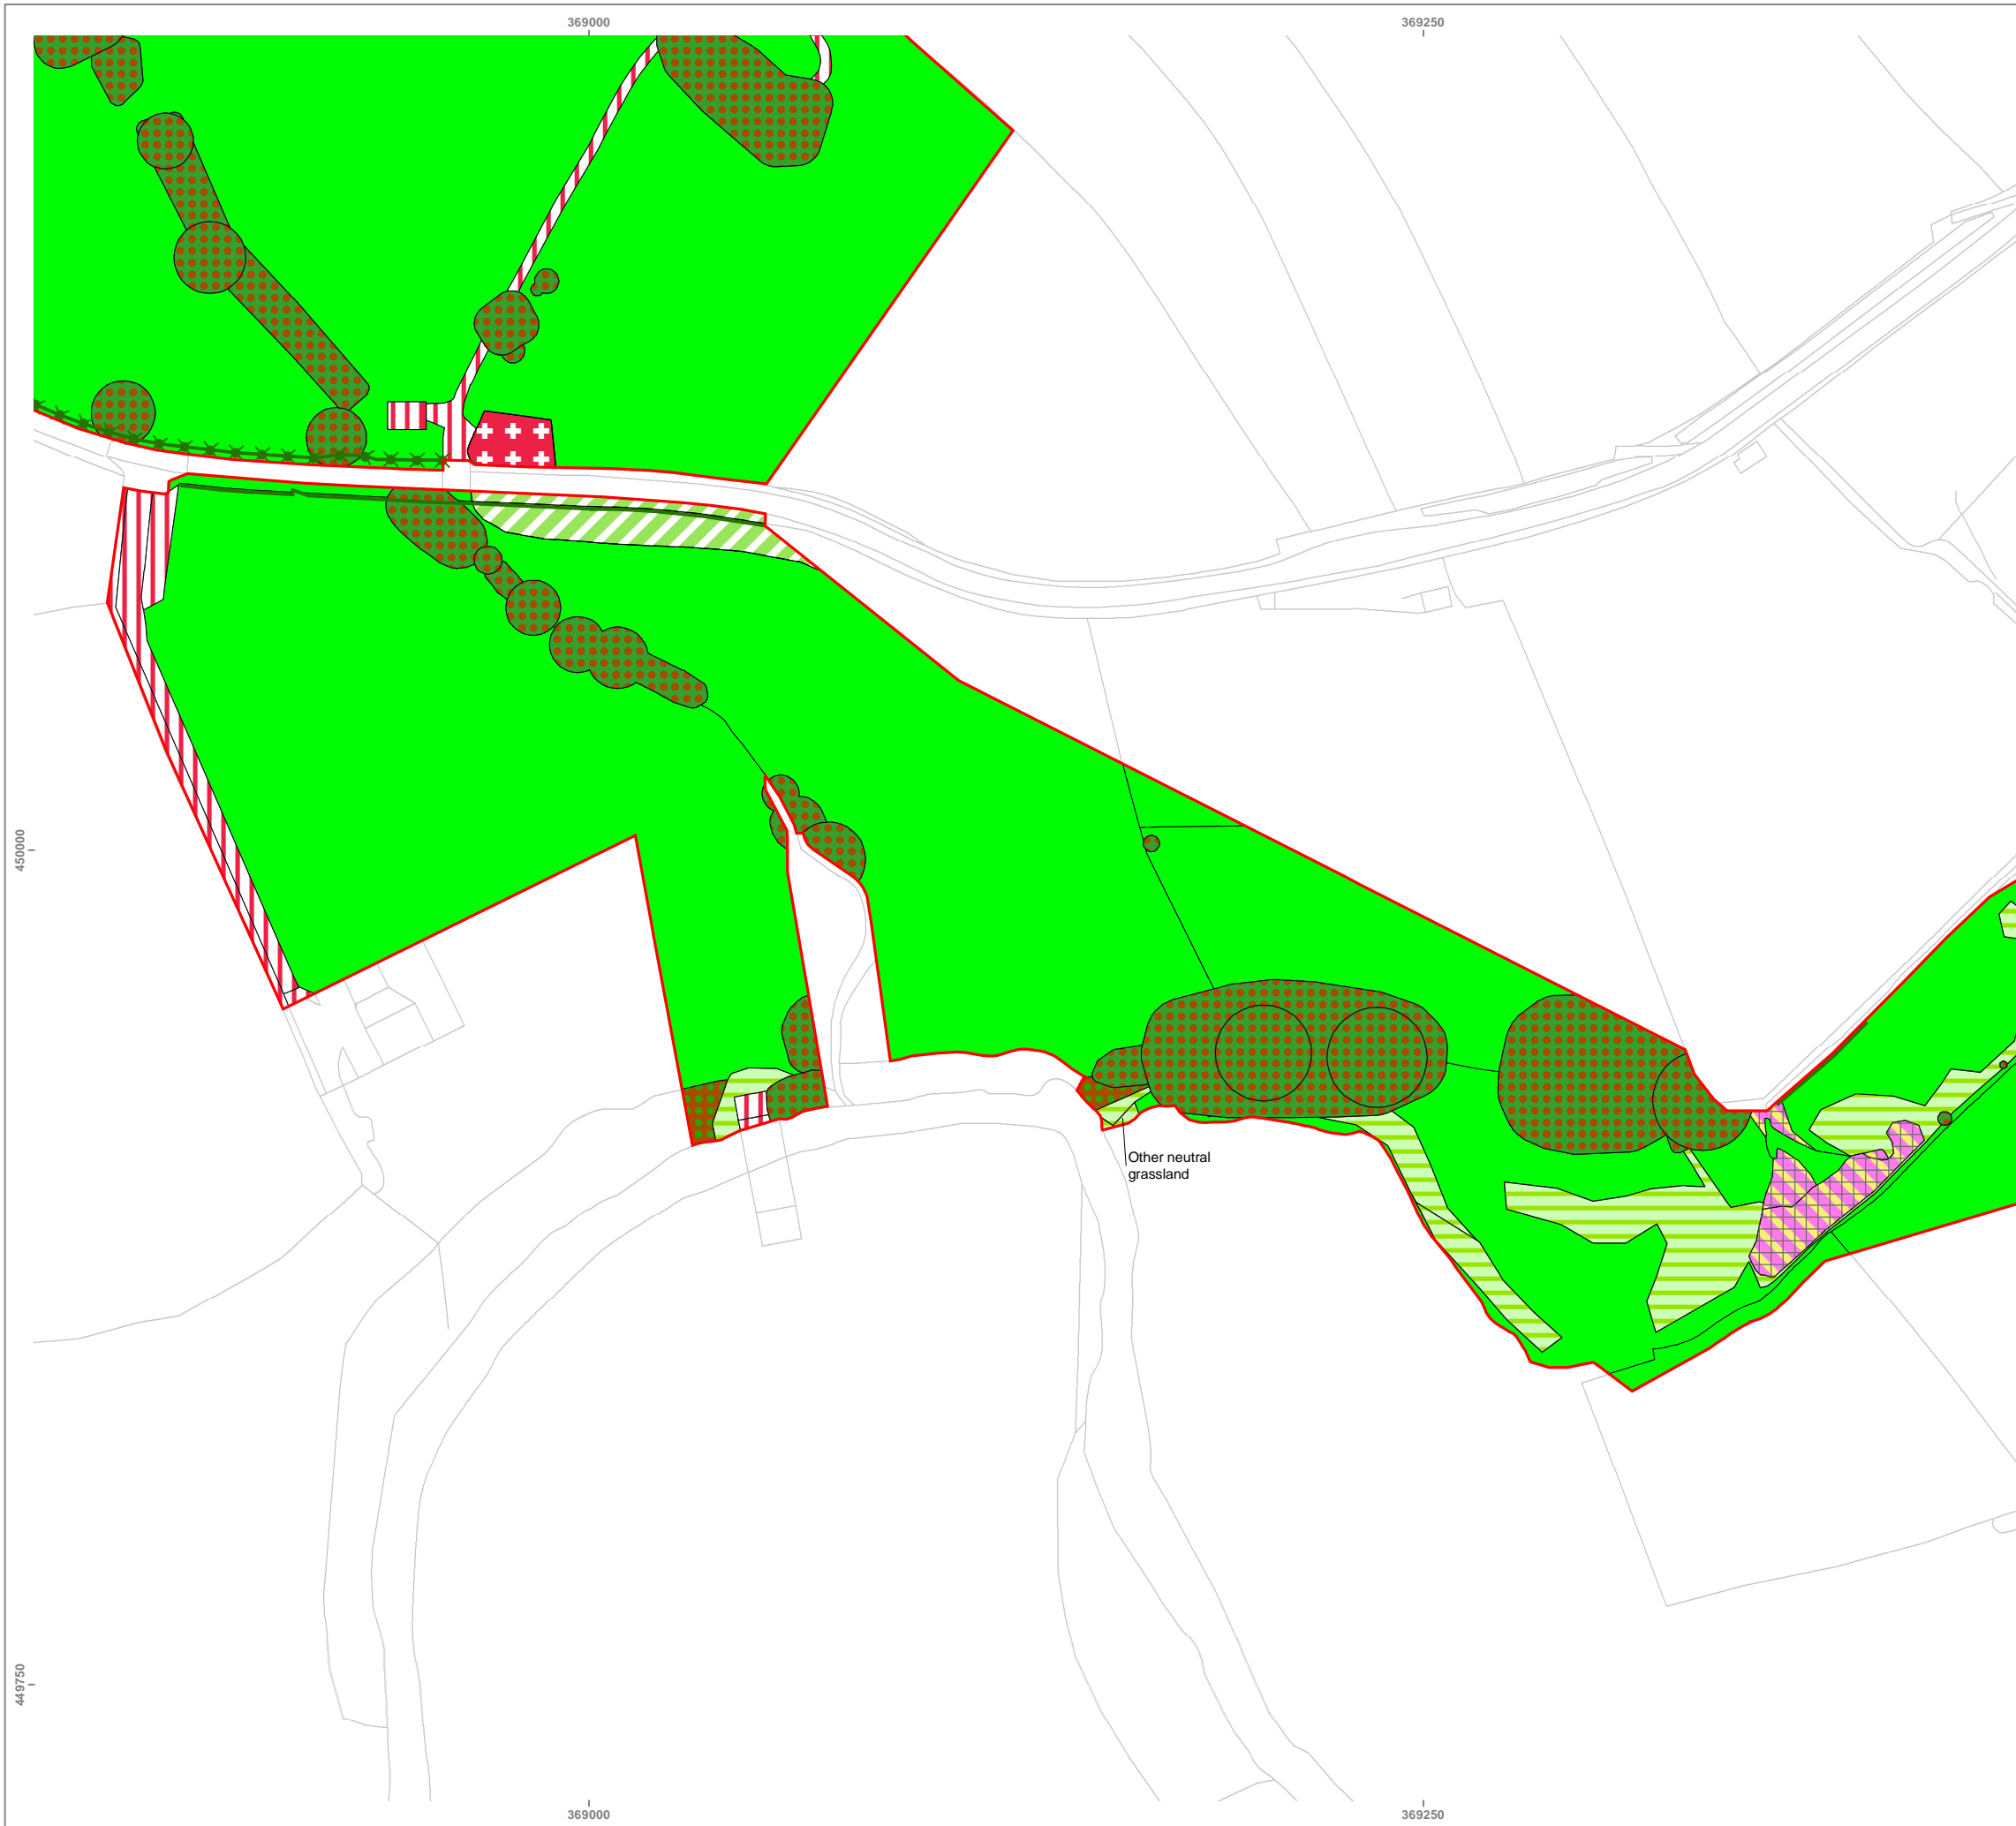
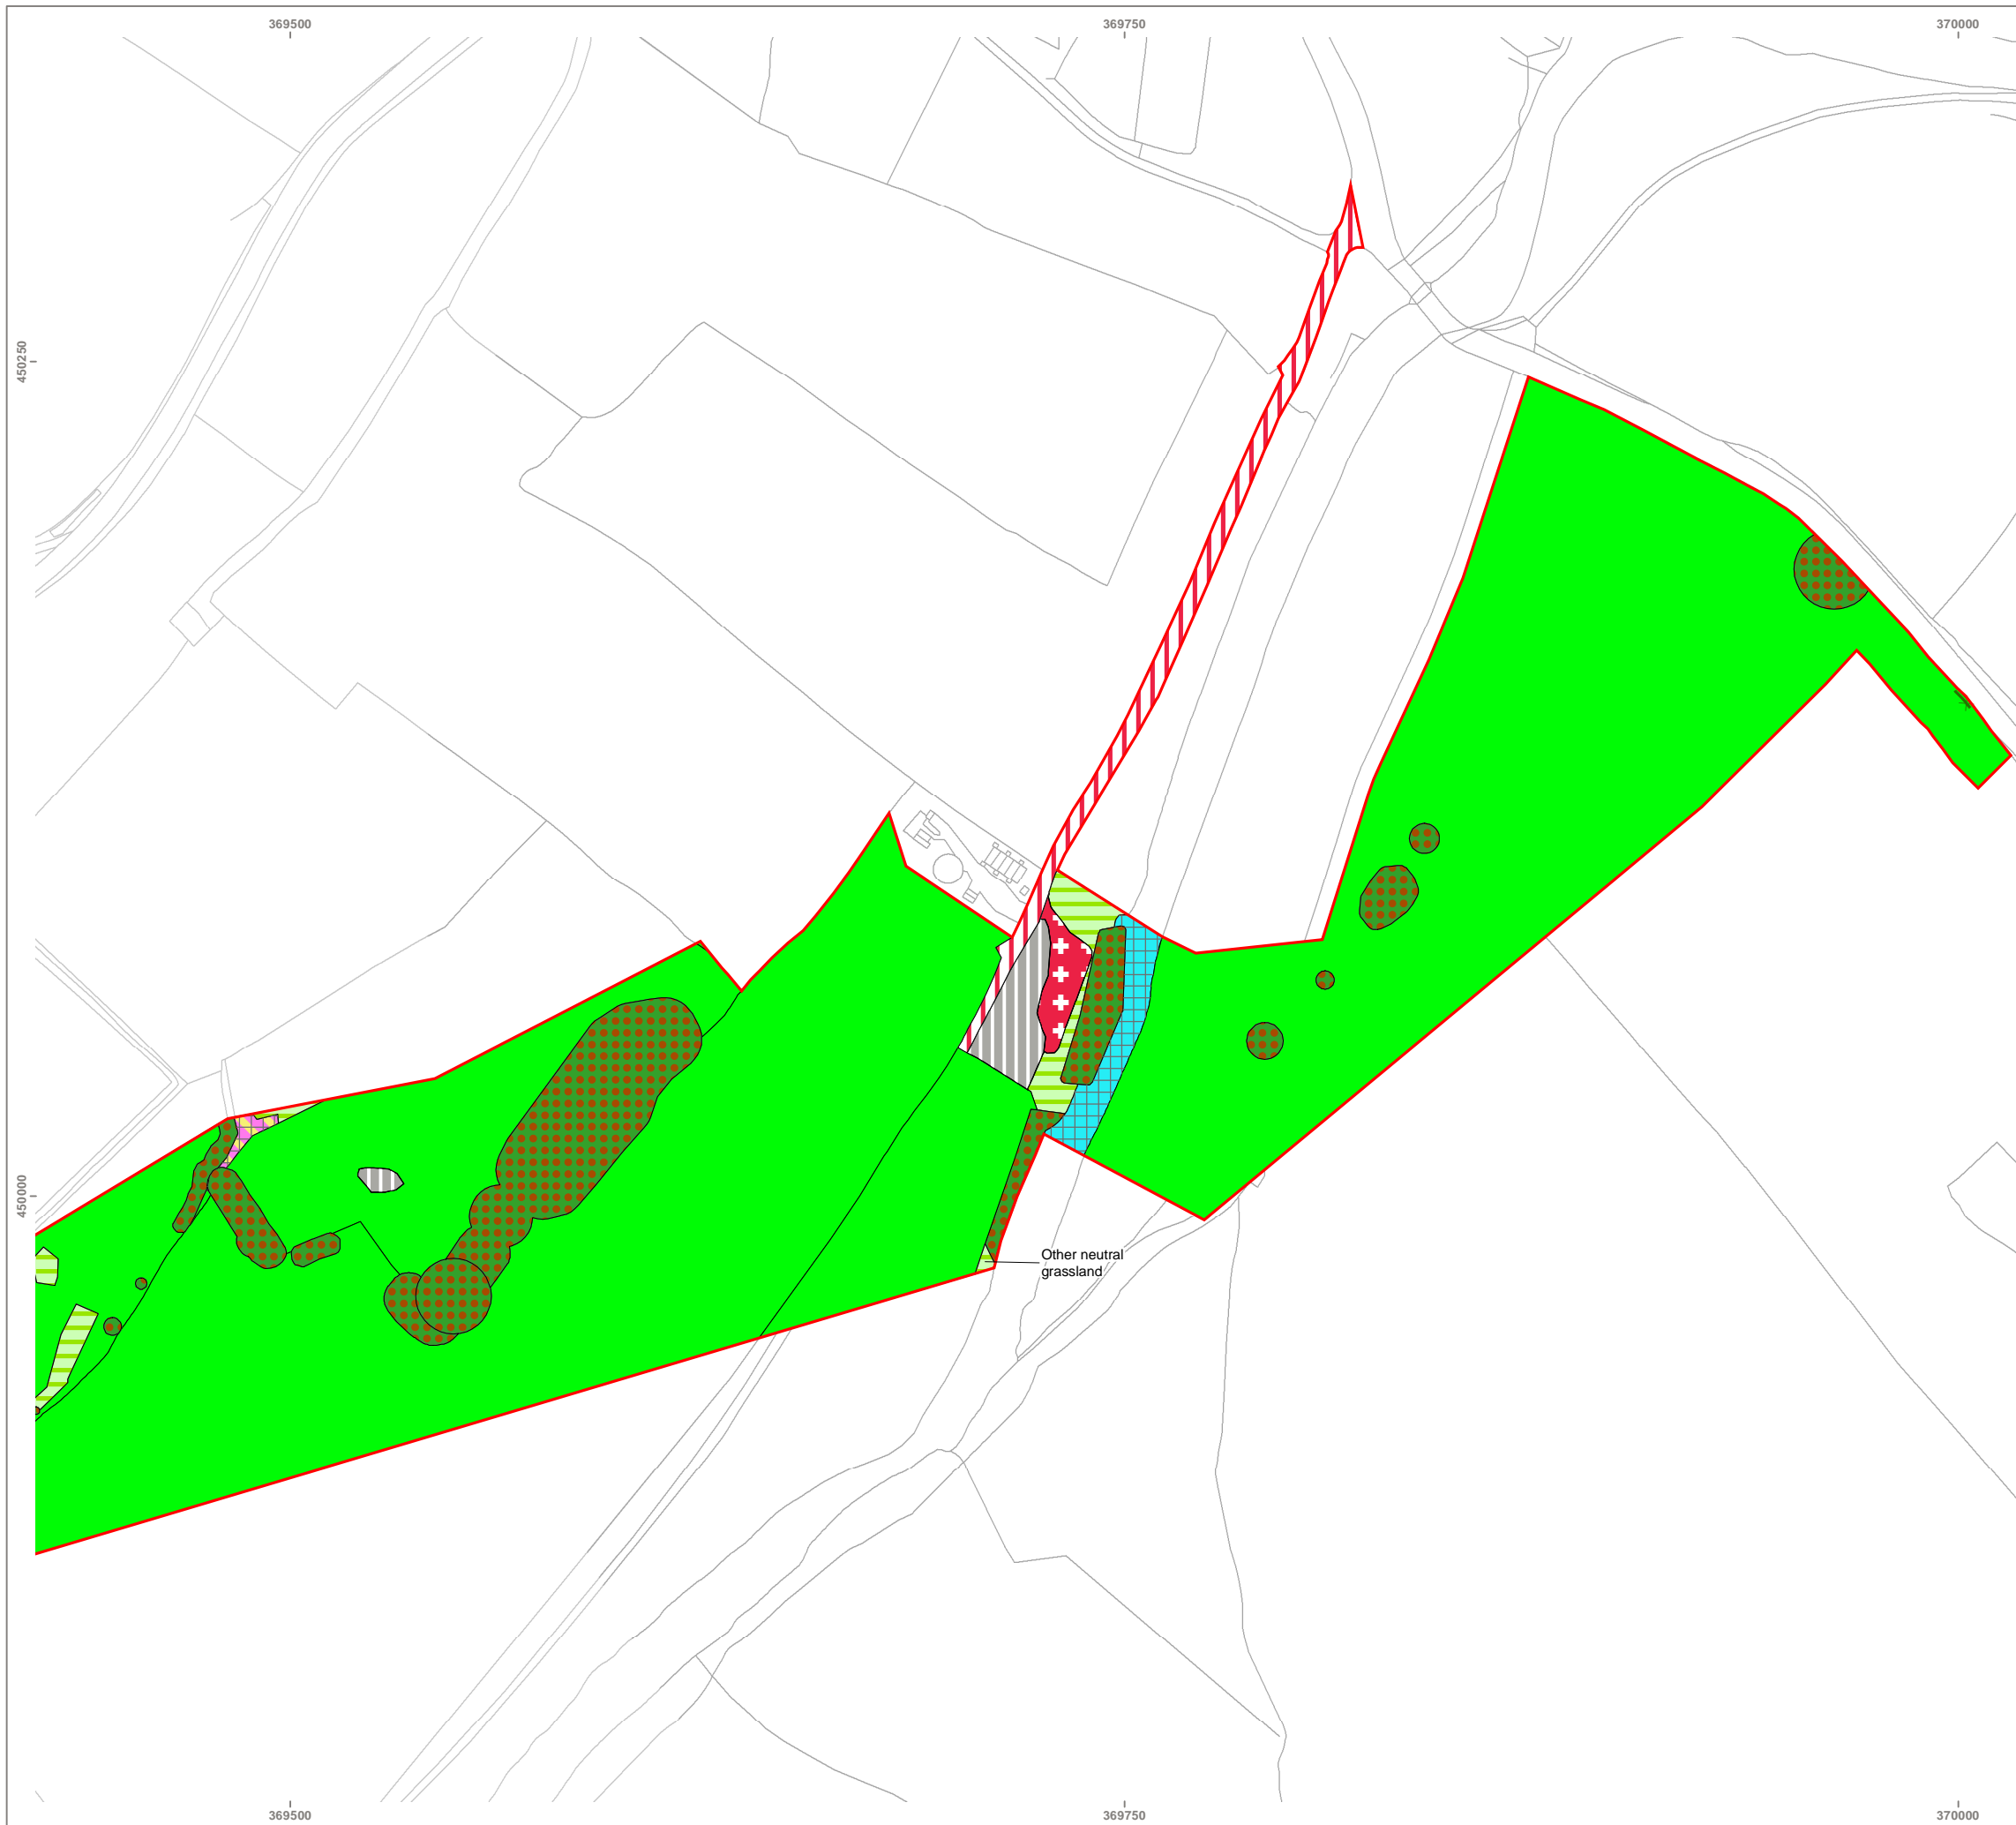
Title
**Ribble Valley District Post Development Habitats - Bowland
Section, Newton-in-Bowland Compound**

- Compound boundary
- Habitat excluded from calculations
- Permanent loss of habitat
