## Haweswater Aqueduct Resilience Programme

Chapter 9A - Appendix 9A.3

Environmental Statement

## Appendix A. Bowland Ecology Hedgerow Assessment Report

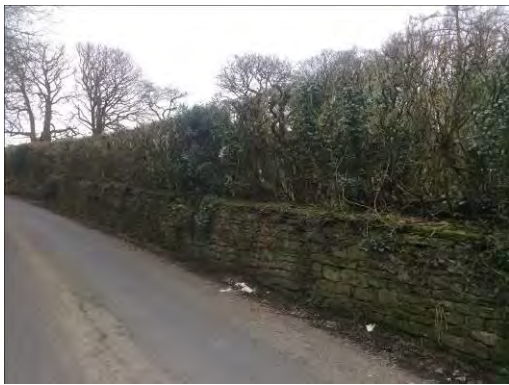
<p>This hedgerow is 55 m in length and 1 m wide and located along a public road. The northern end of the hedgerow is located on top of a stone wall and appears to form the boundary of a residential dwelling - the height of the hedgerow above the top of the wall is approximately 1.5 m. The southern end of the hedgerow is located on a bank. There are no connections with other hedgerows. It is fenced from the adjacent field and appears to have been recently trimmed/flailed. The hedgerow is established and mature and therefore obviously more than 30 years in age.</p> <p>The hedgerow has one associated sycamore mature tree (<i>Acer pseudoplatanus</i>), and no gaps. There is no associated ditch. The canopy comprises frequent hazel (<i>Corylus avellana</i>) and hawthorn (<i>Crataegus monogyna</i>) with occasional holly (<i>Ilex aquifolium</i>) and more rarely yew (<i>Taxus baccata</i>) (four canopy species). There are several notable (Schedule 2) ground flora species as follows: lords-and-ladies (<i>Arum maculatum</i>), dog's mercury (<i>Mercurialis perennis</i>), hart's tongue (<i>Asplenium scolopendrium</i>) and polypody (<i>Polypodium vulgare</i>). Other ground flora noted includes ivy (<i>Hedera helix</i>), cleavers (<i>Galium aparine</i>), red campion (<i>Silene dioica</i>), common chickweed (<i>Stellaria media</i>), common nettle (<i>Urtica dioica</i>), lesser celandine (<i>Ranunculus ficaria</i>), hedge mustard (<i>Alliaria petiolata</i>) and bramble (<i>Rubus fruticosus</i> agg.). No Wildlife &amp; Countryside Act protected species have been identified to be present.</p> <p><b>The hedgerow classifies under ecological criteria as 'Important' under The Hedgerow Regulations 1997, however, as it appears to form the boundary of a residential dwelling the Regulations may not apply in this case.</b></p>

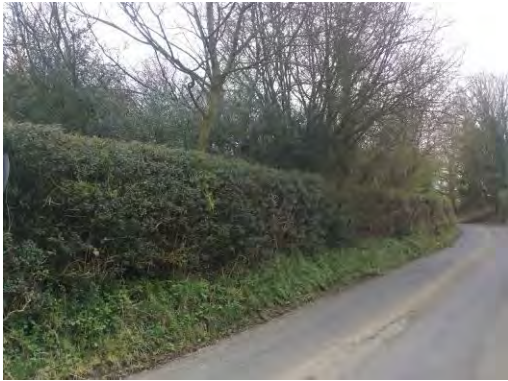
TR3.H2

<p>This roadside hedgerow is 30 m in length and 1 m in height. It is 1.5 m wide and has one associated mature tree (sycamore). There is no associated ditch and no gaps but one connection to another hedgerow. There is an associated hedge bank. The hedgerow is of significant age (not less than 30 years).</p> <p>The canopy comprises holly, hazel, hawthorn and elder (four canopy species). Notable (Schedule 2) ground flora species are frequent and comprise: lords-and-ladies, broad buckler fern (<i>Dryopteris dilatata</i>), male-fern (<i>Dryopteris filix-mas</i>), herb Robert (<i>Geranium robertianum</i>), dog's mercury, hart's tongue, barren strawberry (<i>Potentilla sterilis</i>) and primrose (<i>Primula vulgaris</i>). Other ground flora present includes ivy, cleavers, red campion, common chickweed, common nettle, lesser celandine, hedge mustard, bramble, meadowsweet (<i>Filipendula ulmaria</i>), greater stitchwort (<i>Stellaria holostea</i>), bush vetch (<i>Vicia sepium</i>) and cow parsley (<i>Anthriscus sylvestris</i>). No Wildlife &amp; Countryside Act protected species have been identified to be present.</p> <p><b>This hedgerow classifies under ecological criteria as 'Important' under The Hedgerow Regulations 1997.</b></p>

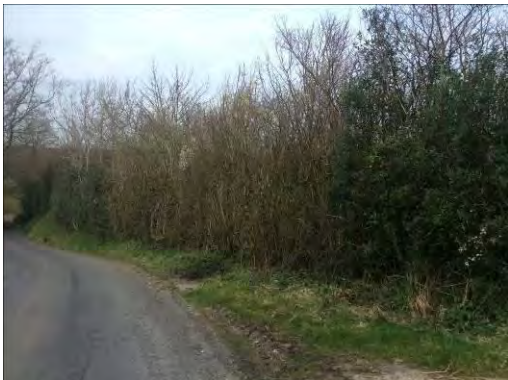
TR3.H3

<p>This roadside hedgerow is 90 m in length, 1.5 m wide and 2.5 m in height. It is a roadside hedgerow with no gaps and one associated mature tree (sycamore). There is no associated ditch but an associated hedge bank. There is a connection to one other hedgerow. The hedgerow is mature and established has been historically laid and is over 30 years in age.</p> <p>The canopy is dominated by holly with hazel, ash (<i>Fraxinus excelsior</i>) and rose (<i>Rosa</i> sp.), with smaller amounts of blackthorn (<i>Prunus spinosa</i>) (five canopy species). Notable (Schedule 2) ground flora species are lords-and-ladies, dog's mercury and barren strawberry. Other ground flora present at the time of survey was ivy, foxglove (<i>Digitalis purpurea</i>), cow parsley, meadowsweet, cleavers, dock (<i>Rumex</i> sp.), creeping buttercup (<i>Ranunculus repens</i>), soft rush (<i>Juncus effusus</i>), hogweed (<i>Heracleum sphondylium</i>) and dandelion (<i>Taraxacum officinale</i> agg.). No Wildlife &amp; Countryside Act protected species have been identified to be present.</p> <p><b>This hedgerow classifies under ecological criteria as 'Important' under The Hedgerow Regulations 1997.</b></p>

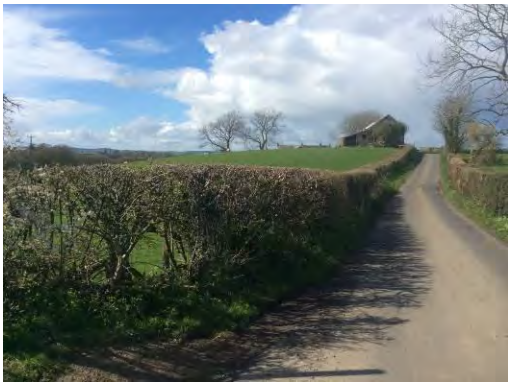
TR3.H7

<p>A roadside hedgerow which is 170 m in length, 1.5 m in height and 1.5 m wide. There are a small number of gaps totalling around 2% of the total length of the hedgerow, and no associated mature trees or ditches. The hedgerow has been historically laid in some sections and is more than 30 years old. It has been recently flailed/trimmed. There are no connected hedgerows but it connects to a block of broadleaved woodland.</p> <p>The canopy is composed of dominant hazel and abundant hawthorn and ash with smaller amounts of holly, blackthorn and gooseberry (<i>Ribes uva-crispa</i>; six canopy species). Notable (Schedule 2) ground flora species are relatively few and comprise lords-and-ladies and dog's mercury. Additional ground flora species are red campion, cleavers, common nettle, bramble, cow parsley, ivy, honeysuckle and garlic mustard. No Wildlife &amp; Countryside Act protected species have been identified to be present.</p> <p>This hedgerow does not classify under ecological criteria as 'Important' under The Hedgerow Regulations 1997.</p>

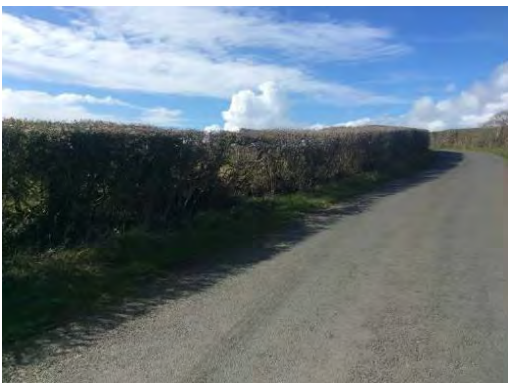
TR3.H8

<p>This roadside hedgerow is 450 m in length, 2 m in height and 1.5 m wide. There is one gap of approximately 10 m which is less than 5% of the overall length of the hedgerow. There are three associated mature trees (sycamore). There is no associated ditch but the hedgerow has a bank of approximately 1 m for much of its length. There is one connection to another hedgerow. It is fenced from the adjacent sheep grazed field and has been historically laid (more than 30 years old).</p> <p>The canopy is mixed and has no clear dominant with the following species noted: hazel, hawthorn, ash, holly, blackthorn, rose species, elder, rowan and gorse (nine canopy species). Notable (Schedule 2) ground flora species are abundant and comprise lords-and-ladies, broad buckler fern, male-fern, wood avens (<i>Geum urbanum</i>), wild strawberry (<i>Fragaria vesca</i>), herb Robert, polypody and primrose. Other climber and ground flora species noted include greater stitchwort, honeysuckle (abundant), foxglove, bush vetch, cleavers and dock species. No Wildlife &amp; Countryside Act protected species have been identified to be present.</p> <p><b>This hedgerow classifies under ecological criteria as 'Important' under The Hedgerow Regulations 1997.</b></p>

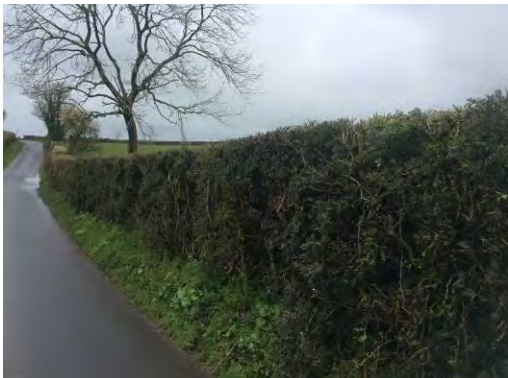
TR3.H9

<p>This roadside hedgerow is 380 m in length, 1.5 m in height and 2 m wide. There is only one small gap which is less than 1% of the total length of the hedgerow. There is no associated ditch or hedge bank. There are nine associated mature trees (predominantly oak (<i>Quercus</i> sp.)). It has been recently trimmed/flailed and is more than 30 years old.</p> <p>The canopy is extremely mixed and comprises abundant holly and hawthorn with hazel, ash, blackthorn, pedunculate oak (<i>Quercus robur</i>), rose species, gooseberry, elder (<i>Sambucus nigra</i>), and rowan (<i>Sorbus aucuparia</i>) (ten canopy species). Notable (Schedule 2) ground flora species are also abundant and diverse and comprise lords-and-ladies, male-fern, wild strawberry, wood avens, dog's mercury, hart's tongue, polypody, barren strawberry, wood sage (<i>Teucrium scorodonia</i>) and common dog violet (<i>Viola riviniana</i>). Other climbers and ground flora are honeysuckle, cleavers, garlic mustard, ivy, common nettle, cow parsley, greater stitchwort, herb Robert, lesser celandine, meadowsweet, bush vetch, red campion and creeping buttercup. No Wildlife &amp; Countryside Act protected species have been identified to be present.</p> <p><b>This hedgerow classifies under ecological criteria as 'Important' under The Hedgerow Regulations 1997.</b></p>

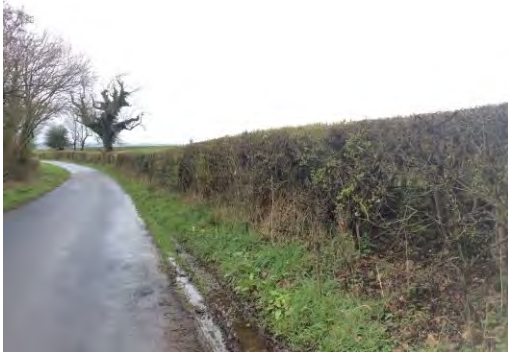
TR3.H10

<p>A roadside hedgerow 800 m in length, 1.5 in height and 1.5 wide. It has recently been flailed/trimmed and is a mature established hedgerow more than 30 years old. There are four gaps, totalling no more than 1% of the overall hedgerow length. There is one associated mature tree (sycamore), no ditches and no hedge bank. There is a connection to one other hedgerow (across a road gap).</p> <p>The canopy is extremely diverse with no clear dominant species with abundant holly and hawthorn and additional hazel, ash, blackthorn, rose species, willow (<i>Salix</i> sp.), elder and rowan (nine canopy species). Notable (Schedule 2) ground flora species are as follows: ramsons (<i>Allium ursinum</i>), broad buckler fern, male-fern, wood avens, barren strawberry, primrose and wood sage. Other climbers and ground flora species noted include greater stitchwort, lesser celandine, ground elder, bush vetch, common bird's-foot trefoil (<i>Lotus corniculatus</i>), snowdrop (<i>Galanthus nivalis</i>), common knapweed (<i>Centaurea nigra</i>), red campion, yarrow (<i>achillea millefolium</i>) and hedge woundwort (<i>Stachys sylvatica</i>). No Wildlife &amp; Countryside Act protected species have been identified to be present.</p> <p><b>This hedgerow classifies under ecological criteria as 'Important' under The Hedgerow Regulations 1997.</b></p>

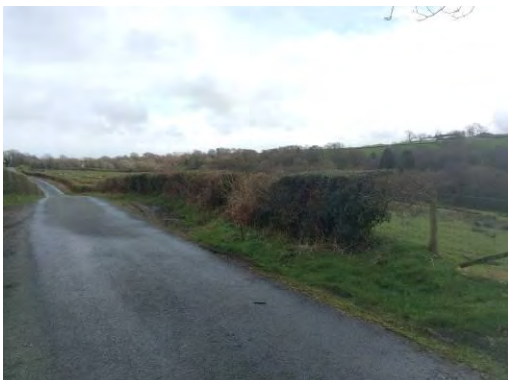
TR3.H11

<p>A roadside hedgerow 700 m in length, 1.5 m in height and 1.5 m wide. There is one associated mature tree (ash), no associated ditch or hedge bank. There are three connections with other hedgerows. The hedgerow has been recently trimmed/flailed and is more than 30 years old.</p> <p>The canopy is diverse and mixed with dominant holly. Other canopy species are: hazel, hawthorn, ash, blackthorn, rose species, willow species, elder, rowan and gorse (<i>Ulex europaeus</i>; ten canopy species). Notable (Schedule 2) ground flora species are lords-and-ladies, broad buckler fern, male-fern and wood avens. Additional climbers and ground flora species are black bryony (<i>Tamus communis</i>), greater stitchwort, honeysuckle, hedge woundwort with significant bracken cover. No Wildlife &amp; Countryside Act protected species have been identified to be present.</p> <p><b>This hedgerow classifies under ecological criteria as 'Important' under The Hedgerow Regulations 1997.</b></p>

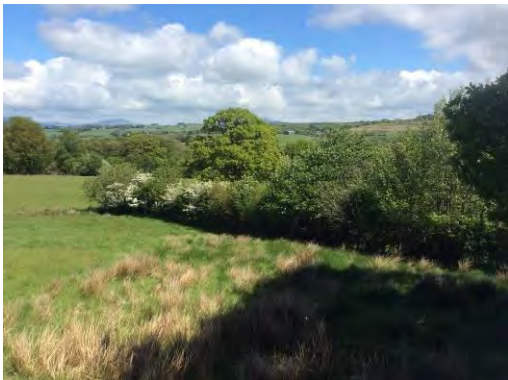
TR3.H12

<p>This hedgerow is 80 m in length, average 3 m in height and 1.5 m wide. There are five associated mature trees (oak), a marshy ditch to the east of the hedgerow and no hedge bank or connections to other hedgerows. There is no evidence of recent management and the hedgerow is overgrown. The central section has additional plantings which still have tree guards present but the majority of the hedgerow is mature and established and more than 30 years in age. The base of the hedgerow is marshy.</p> <p>The canopy comprises abundant hawthorn with smaller amounts of alder (<i>Alnus glutinosa</i>), blackthorn and willow species (four canopy species). Notable (Schedule 2) ground flora is limited to broad buckler fern and wood sorrel (<i>Oxalis acetosella</i>). Other ground flora noted includes meadowsweet, greater stitchwort, cleavers, field horsetail (<i>Equisetum arvense</i>) and reed canary grass (<i>Phalaris arundinacea</i>). No Wildlife &amp; Countryside Act protected species have been identified to be present.</p> <p><b>This hedgerow does not classify under ecological criteria as 'Important' under The Hedgerow Regulations 1997.</b></p>

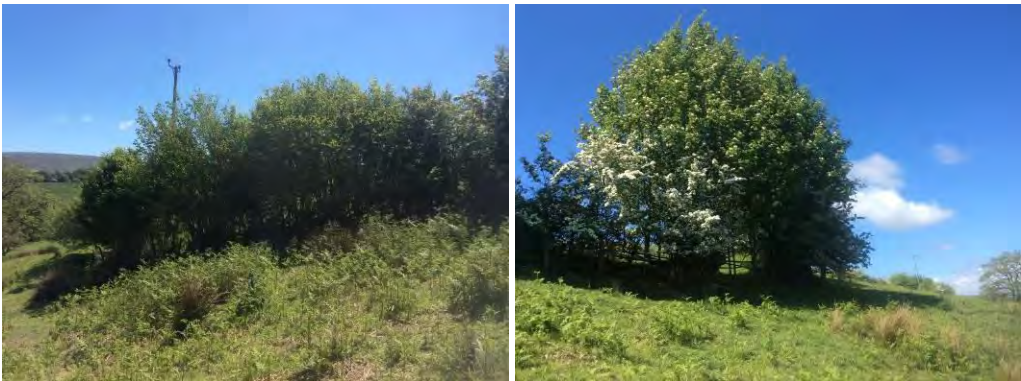
TR3.H13

<p>This hedgerow is 250 m in length, and approximately 1.5 m high and 2 m wide. There is no associated ditch or hedge bank, and five associated mature trees. The hedgerow is more than 30 years old has been previously laid, and there are some areas of newly planted whips with tree guards still present.</p> <p>The canopy comprises dominant hawthorn with small amounts of hazel, blackthorn and rowan (four canopy species). The only notable (Schedule 2) ground flora species was English bluebell (<i>Hyacinthoides non-scripta</i>). Other ground flora comprises abundant foxglove, with bracken, bramble, common nettle, cleavers, hogweed, reed canary grass and small amounts of greater stitchwort. Bluebell is a species present which is listed on the Wildlife &amp; Countryside Act.</p> <p><b>This hedgerow classifies under ecological criteria as 'Important' under The Hedgerow Regulations 1997.</b></p>

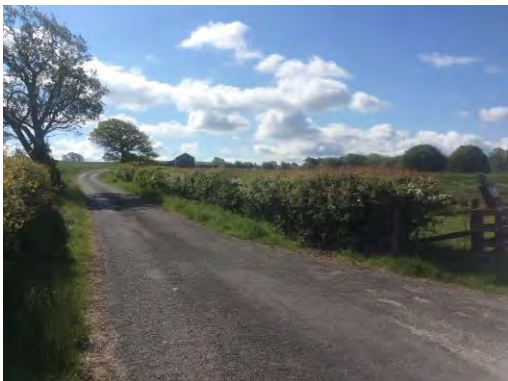
TR3.H14

<p>A roadside hedgerow which is 80 m long, 1.5 m wide and 1.5 m in height. It has one associated mature tree (oak) and no associated ditches or hedge banks. There are no gaps and the hedgerow is mature and established and is more than 30 years old. This is a small section of existing hedgerow which has recently been extended with new plantings (assessed separately as TR3.H15).</p> <p>The canopy is mixed, comprising hawthorn, ash, holly, rose species and rowan (five canopy species). The only notable (Schedule 2) ground flora species is broad buckler fern. Other climber and ground flora species noted include abundant honeysuckle, common nettle, cleavers, field horsetail, cow parsley, bush vetch, common hogweed, soft rush, cuckooflower (<i>Cardamine pratensis</i>) and greater stitchwort. No Wildlife &amp; Countryside Act protected species have been identified to be present.</p> <p>This hedgerow does not classify under ecological criteria as 'Important' under The Hedgerow Regulations 1997.</p>

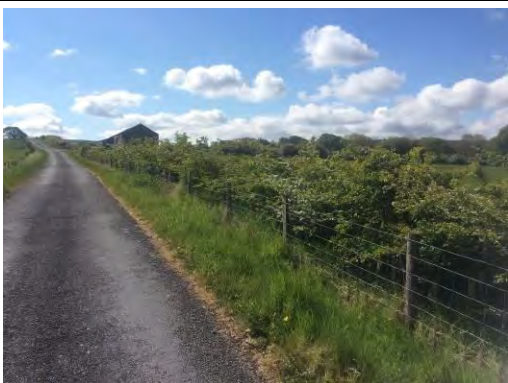
TR3.H15

A roadside hedgerow 100 m in length and forming a recently planted extension to the more established hedgerow at TR3.H14. It is approximately 1.5 m in height and 1 m wide. It is fenced to both sides, and has no associated mature trees, ditches or hedge banks. There are no gaps.

The canopy is species-poor, comprising hawthorn, blackthorn and rarely, an apple species (three canopy species). The only notable ground flora species is herb Robert. The remaining species comprise ruderal species and coarse grasses (tufted hair grass (*Deschampsia cespitosa*), meadow fescue (*Festuca pratensis*)), cow parsley, broad leaved dock, common hogweed, common sorrel (*Rumex acetosa*) and ribwort plantain (*Plantago lanceolata*). No Wildlife & Countryside Act protected species have been identified to be present.

This hedgerow does not classify under ecological criteria as 'Important' under The Hedgerow Regulations 1997.

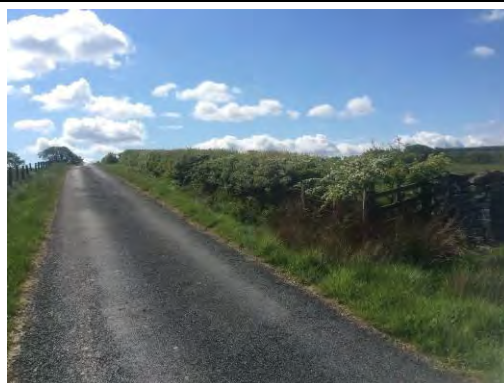
TR3.H16

A roadside hedgerow 150 m in length, 1.5 m in height and 2 m in width. There are no associated mature trees, ditches or hedge banks and no gaps. The hedgerow appears to be subject to some management in the form of trimming/flailing. It is dense and stock proof to ground level. It is an established hedgerow over 30 years in age and is fenced to both sides.

The canopy comprises a mixture of species, dominated by hawthorn with additional downy birch (*Betula pubescens*), hazel, holly, willow species and rowan (six canopy species). Notable (Schedule 2) ground flora is limited to broad buckler fern and bluebell (native), with other ground flora noted to include bramble, honeysuckle, broad-leaved dock, bracken, soft rush, cleavers and common nettle. Bluebell is a species present which is listed on the Wildlife & Countryside Act.

**This hedgerow classifies under ecological criteria as 'Important' under The Hedgerow Regulations 1997.**

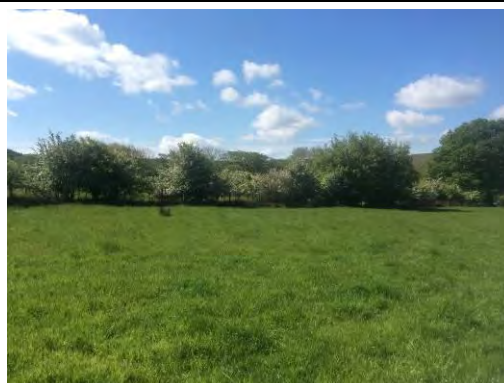
TR3.H17

A hedgerow 90 m in length, tall (3-4 m in height) and 1.5 m wide. There are three associated mature trees (willow, oak), but no ditches or hedge banks. The hedgerow is overgrown and shows no signs of recent management. It is fenced to both sides and tree guards are still present despite the hawthorn being in excess of 3 m. This appears to be supplementary planting as some of the more mature hawthorn have been laid and therefore are older than 30 years. The hedgerow is connected to another hedgerow and to a block of woodland.

The canopy comprises dominant hawthorn with blackthorn, rose and willow species (four canopy species). Notable (Schedule 2) ground flora is limited to male-fern and wood sage. Other ground flora noted is as follows: cleavers, foxglove, Yorkshire fog (*Holcus lanatus*), soft rush, common sorrel, broad-leaved dock and wood horsetail (*Equisetum sylvaticum*). No Wildlife & Countryside Act protected species have been identified to be present.

This hedgerow does not classify under ecological criteria as 'Important' under The Hedgerow Regulations 1997.

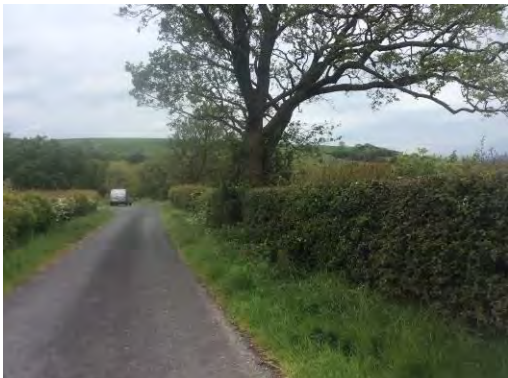
TR3.H18

<p>A roadside hedgerow which is 235 m long, 3 m in height and 2 m wide. It has 19 associated mature trees (alder, ash, holly, silver birch, hawthorn, hazel), and gaps that constitute less than 1% of the overall hedgerow length. There is no associated ditch but there is a small hedge bank.</p> <p>The canopy comprises dominant holly and hawthorn with additional alder, ash, blackthorn and rose species (six canopy species). Notable (Schedule 2) ground flora includes bugle, pignut, tormentil (<i>Potentilla erecta</i>), broad buckler fern, herb Robert, bluebell (native), wood sorrel and common dog violet. Other climber and ground flora species include Yorkshire fog, common nettle, hogweed, cleavers, bush vetch, bramble, honeysuckle, cow parsley, greater stitchwort, creeping thistle (<i>Cirsium arvense</i>), horsetail species, broad-leaved dock, garlic mustard, ribwort plantain, ivy, foxglove, creeping buttercup, germander speedwell (<i>Veronica chamaedrys</i>) and Bluebell is a species present which is listed on the Wildlife &amp; Countryside Act.</p> <p><b>This hedgerow classifies under ecological criteria as 'Important' under The Hedgerow Regulations 1997.</b></p>

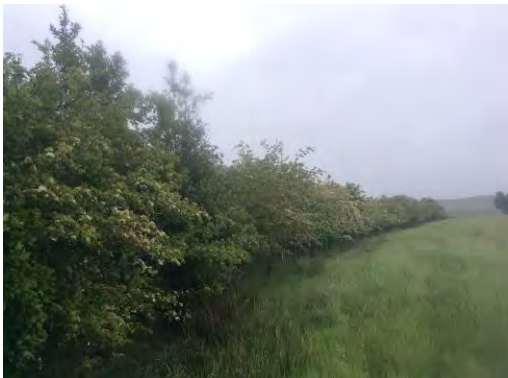
TR3.H19

<p>A hedgerow 100 m in length, 1.5 m in height and 1 m wide, with no gaps and no associated ditch or hedge bank. This is a relatively new section of hedgerow (less than 30 years old) and forms an extension to TR3.H14.</p> <p>The canopy is relatively species-poor, comprising hawthorn, blackthorn and rarely an apple species (three canopy species). No notable (Schedule 2) ground floras was noted. The ground flora is grassy (tufted hair grass, meadow fescue and sweet vernal-grass (<i>Anthoxanthum odoratum</i>)), with additional cow parsley, broad-leaved dock, common hogweed, bush vetch and common sorrel. No Wildlife &amp; Countryside Act protected species have been identified to be present.</p> <p><b>This hedgerow does not classify under ecological criteria as 'Important' under The Hedgerow Regulations 1997.</b></p>

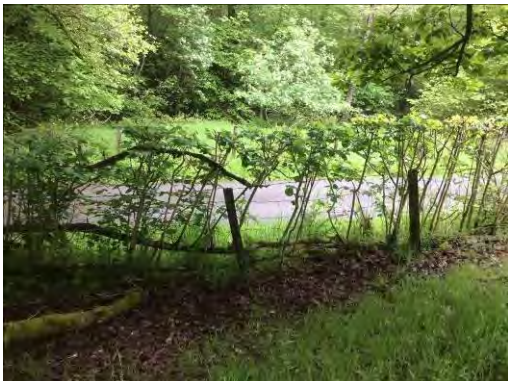
TR3.H20

<p>A roadside hedgerow 20 m in length, 1 m high and 0.5 m wide. This is a young sparse hedgerow, with tree guards still present, but older sections are evident and have been laid. There are no associated mature trees, ditches or hedge bank. It is a small section of hedgerow at the entrance to a private property.</p> <p>The canopy is species poor, comprising hawthorn and hazel (two canopy species). Notable (Schedule 2) ground flora is restricted to broad buckler fern and herb Robert. Also noted within the ground flora is common nettle, cleavers, ivy, bush vetch, meadow buttercup (<i>Ranunculus acris</i>), greater stitchwort and Yorkshire fog. No Wildlife &amp; Countryside Act protected species have been identified to be present.</p> <p>This hedgerow does not classify under ecological criteria as 'Important' under The Hedgerow Regulations 1997.</p>
TR3.H21

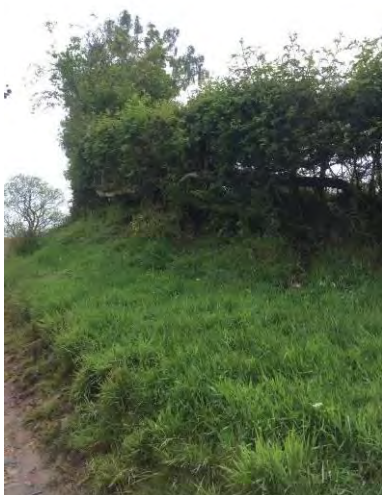
<p>A hedgerow bordering the access road of a private property with an associated grassy hedge bank. The hedgerow is 40 m long, 2 m high and 2 m wide. There are three associated mature trees and five gaps totalling approximately 30 % of the overall length.</p> <p>The canopy comprises guelder rose with hawthorn, holly and more rarely hazel and rowan (five canopy species). Notable (Schedule 2) ground flora is as follows: pignut, broad buckler fern and herb Robert. Other ground flora species include bracken, foxglove, Yorkshire fog, cleavers, soft rush, sheep's fescue (<i>Festuca rubra</i>), greater stitchwort, sweet vernal-grass, garlic mustard, bramble, common sorrel, meadow buttercup, cock's-foot (<i>Dactylis glomerata</i>) and creeping buttercup. No Wildlife &amp; Countryside Act protected species have been identified to be present.</p> <p><b>The hedgerow classifies under ecological criteria as 'Important' under The Hedgerow Regulations 1997, however, as it appears to form the boundary of a residential dwelling the Regulations may not apply in this case.</b></p>

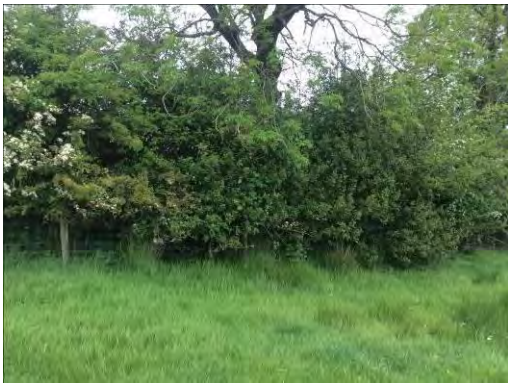
TR3.H22

<p>A 50 m long hedgerow, which is up to 4 m in height and 3 m wide. It has two associated mature trees (ash), but no ditches or hedge bank. It is a mature overgrown hedgerow bordering the garden of a private residential property. There are no gaps.</p> <p>The canopy comprises dominant hawthorn, holly, blackthorn and guelder rose (<i>Viburnum opulus</i>) (four canopy species). Notable (Schedule 2) ground flora is restricted to herb Robert. Other ground flora noted includes creeping buttercup, cleavers, soft rush, Yorkshire fog, honeysuckle, cock's-foot and germander speedwell. No Wildlife &amp; Countryside Act protected species have been identified to be present.</p> <p>This hedgerow does not classify under ecological criteria as 'Important' under The Hedgerow Regulations 1997.</p>
TR3.H23

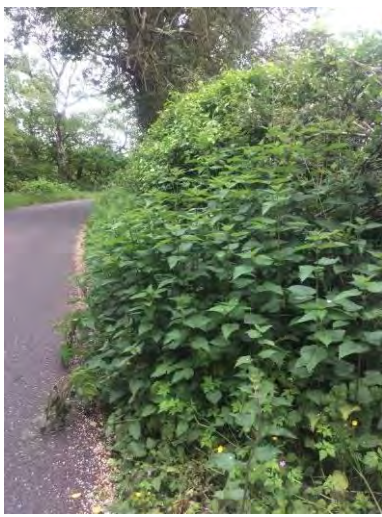
<p>A 50 m long hedgerow which is 2.5 m in height and 2 m in width. It is a roadside hedgerow with three associated mature trees, one gap totalling 10% of the overall hedgerow length and no associated ditch. There is a small hedge bank. The growth in the hedgerow is uneven, with some areas of dense growth and some areas which are very sparse. There are no connections to other hedgerows.</p> <p>The canopy is fairly species poor comprising dominant holly with small amounts of hawthorn and rose species (three canopy species). Two notable (Schedule 2) ground flora species were recorded; male-fern and herb Robert. Other ground flora species noted include meadow buttercup, common nettle, broadleaved dock, germander speedwell, cleavers, cock's-foot, garlic mustard, ivy, bush vetch and bramble. No Wildlife &amp; Countryside Act protected species have been identified to be present.</p> <p>This hedgerow does not classify under ecological criteria as 'Important' under The Hedgerow Regulations 1997.</p>

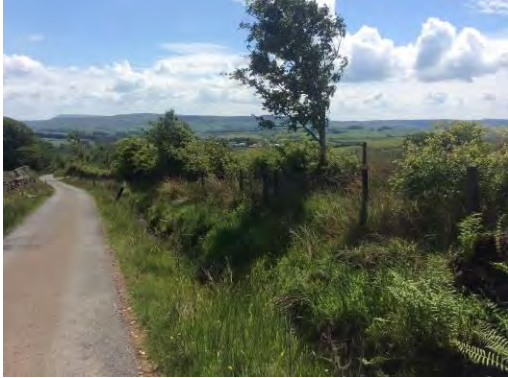
TR3.H24

<p>A roadside hedgerow which is in excess of 100 m long, 2.5 m in height and 1 m wide. It is fenced to both sides. It has three associated mature trees (alder, ash) (other trees are immature and less than 20 cm at chest height) and an associated ditch to the east which is fast flowing and well vegetated. This hedgerow is fenced to both sides and relatively recent in origin, with timber stakes and tree guards still in place. This is an established hedgerow of greater than 30 years age which has been subject to some supplementary planting. A section of the hedgerow has been recently laid. There is a small hedge bank and gaps, but they do not total more than 10% of the hedgerow.</p> <p>The canopy is mixed, with dominant hawthorn throughout but with additional ash and blackthorn and occasionally hazel, holly and rowan (six canopy species). No notable (Schedule 2) ground flora species were noted, as the ground flora is dominated by cleavers, marsh thistle (<i>Cirsium palustre</i>), curled dock (<i>Rumex crispus</i>), cock's-foot and Yorkshire fog. No Wildlife &amp; Countryside Act protected species have been identified to be present.</p> <p><b>This hedgerow classifies under ecological criteria as 'Important' under The Hedgerow Regulations 1997.</b></p>

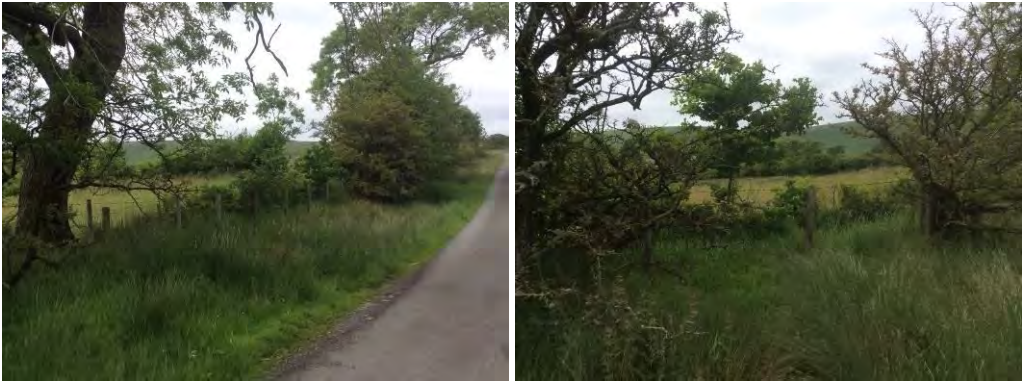
TR3.H25

<p>A roadside hedgerow 150 m in length, 1 m in height and less than 1 m wide. It has nine associated mature trees (ash, sycamore), two gaps which total approximately 10% of the overall length and a wet ditch to the east. There is no associated hedge bank. New planting (tree guards still present) appears to supplement an existing hedgerow which is more than 30 years old. There has also been some trimming of the associated mature trees. It has connections to two other hedgerows.</p> <p>The canopy is dominated by hawthorn, with all other species occurring rarely including hazel, ash, holly, blackthorn and pedunculate oak (six canopy species). Only one notable (Schedule 2) ground flora species was noted; pignut (<i>Conopodium majus</i>). No Wildlife &amp; Countryside Act protected species have been identified to be present.</p> <p><b>This hedgerow classifies under ecological criteria as 'Important' under The Hedgerow Regulations 1997.</b></p>

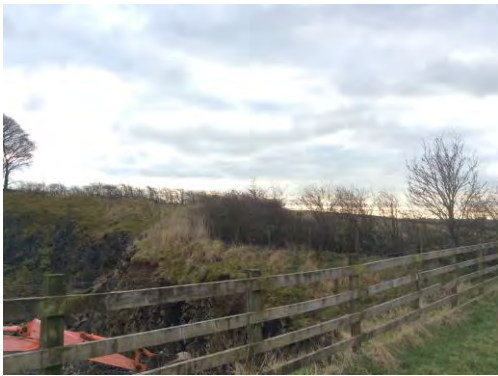
TR3.H28

<p>A roadside hedgerow 168 m in length, 2.5 m in height and 2 m wide. It does not have any gaps or an associated hedge bank or ditch. There are no mature trees within the hedgerow. The hedgerow is more than 30 years old.</p> <p>The canopy comprises dominant hawthorn, frequent blackthorn and rose species and, rare or occasional holly, rowan and hazel (six woody species). Schedule 2 species present within the ground flora includes broad buckler fern. Other climber and ground flora species include; common nettle, foxglove, creeping thistle, cock's foot and holly saplings. The hedgerow has previously been laid and is fenced on both sides. No other Wildlife &amp; Countryside Act protected species have been identified to be present.</p> <p>This hedgerow does not classify under ecological criteria as 'Important' under The Hedgerow Regulations 1997.</p>
TR3.H29

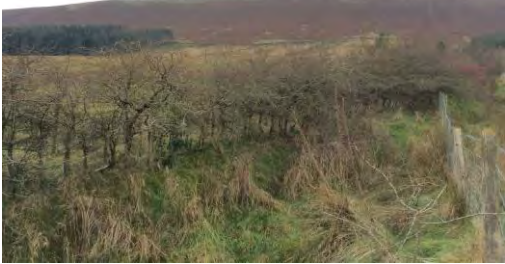
<p>A hedgerow 87 m in length, 2 m in height and 3 m wide. It is located on an east facing bank and has an associated wet ditch on the eastern side. There are no associated mature trees. The hedgerow is less than 30 years old; it has recently been planted with tree guards present and is fenced on both sides.</p> <p>The canopy comprises dominant hawthorn, with all other species occurring rarely (hazel, blackthorn, holly, rose species and rowan) (six canopy species). There are no Schedule 2 species associated with the hedgerow. Tufted-hair grass dominates the ground flora. No Wildlife &amp; Countryside Act protected species have been identified to be present.</p> <p>This hedgerow does not classify under ecological criteria as 'Important' under The Hedgerow Regulations 1997.</p>

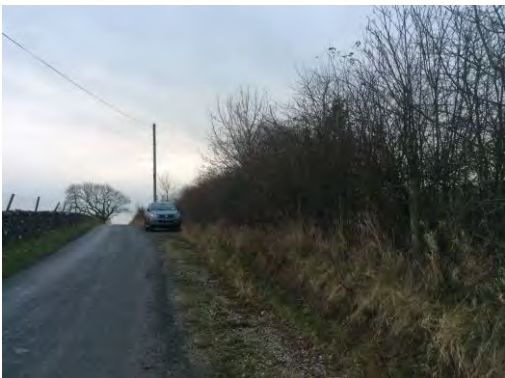
TR3.H30

<p>A roadside hedgerow 160 m in length, 3 m in height and 1.5 m wide with no gaps or connections. It has a wide grassy verge adjacent and an associated hedge bank or ditch. There are eight associated mature trees (ash, rowan). The hedgerow is more than 30 years old and has been previously laid.</p>

The canopy comprises dominant hawthorn and hazel, with all other species occurring occasionally or rarely (ash, holly, blackthorn, rose species and rowan (seven woody species)). No Schedule 2 species were recorded in the ground flora. Other climber and ground flora species include; yarrow, cleavers, germander speedwell and tufted hair grass. Japanese rose, a Schedule 9 is present. The hedgerow has previously been laid and it is fenced on both sides. No Wildlife & Countryside Act protected species have been identified to be present.

This hedgerow does not classify under ecological criteria as 'Important' under The Hedgerow Regulations 1997.

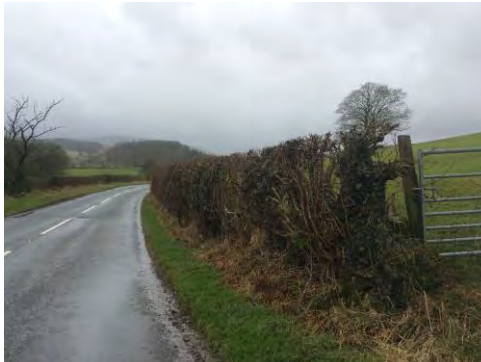
TR3.H31

A roadside hedgerow 500 m in length, 2 m in height and on average 2 m wide. It has a narrow grassy verge adjacent and a supporting hedge bank or wall along at least half of its length. There is no associated ditch. There are five associated mature trees (ash, sycamore). The hedgerow is more than 30 years old and has been previously laid. The hedgerow has 2 gaps that make up 5% of the total length.

The canopy comprises dominant hawthorn and frequent hazel, with all other species occurring rarely (rose and sycamore (three qualifying woody species)). Schedule 2 species present within the ground flora include; lords-and-ladies, broad buckler fern, English bluebell, Hart's tongue fern and common dog violet. Other climber and ground flora species include; ivy, common nettle, cleavers, abundant mosses and lichens, herb Bennett, bracken, common daisy, foxglove, red campion, lesser celandine and cow parsley. The hedgerow has previously been laid and is now cut each year.

**This hedgerow classifies under ecological criteria as 'Important' under The Hedgerow Regulations 1997.**

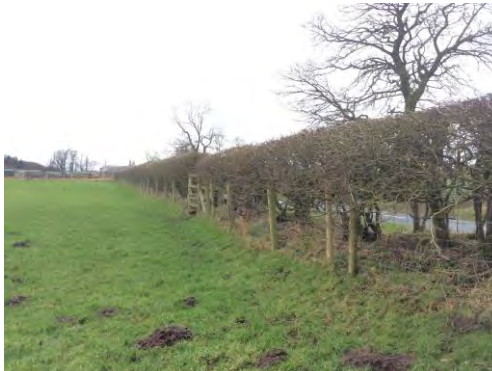
TR3.H32

A roadside hedgerow 476 m in length, 2 m in height and 2 m wide. It has an associated hedge bank but no ditch. There are no associated mature trees. The hedgerow is considered to be less than 30 years old.

The canopy comprises dominant hawthorn, with no other species (one canopy species). Three Schedule 2 species are present in the ground flora including; barren strawberry, Lord's-and-ladies and wild strawberry. Other climber and ground flora species include; cow parsley, willowherb sp., tufted hair grass, cleavers, cock's foot, herb Bennett, bracken, common nettle, creeping thistle, vetch species, lesser celandine, yarrow, meadow grass and creeping cinquefoil. No other Wildlife & Countryside Act protected species have been identified to be present.

This hedgerow does not classify under ecological criteria as 'Important' under The Hedgerow Regulations 1997.

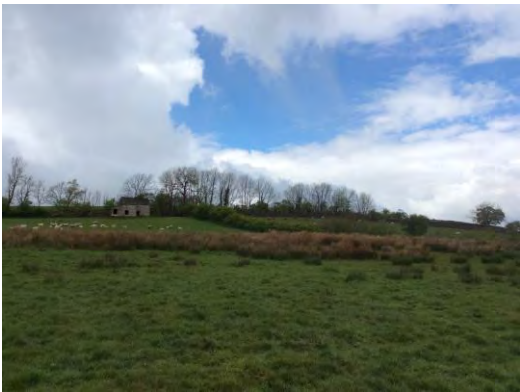
TR3.H33

<p>A roadside hedgerow 313 m in length, 2.5 m in height and 2 m wide. It has an associated wet ditch along the northern bank. There are 2 associated mature trees (willow and birch). The hedgerow is more than 30 years old but recent re-planting has been carried out to fill up gaps.</p> <p>The canopy comprises a mix of species, with willow being dominant in sections, crab apple abundant and hawthorn being frequent or occasional. Blackthorn, rose sp. and elder occur rarely (six canopy species). Schedule 2 species present within the ground flora include; bugle, Lord's-and-ladies, pignut, herb Robert, wood avens, dog's mercury and primrose. Other climber and ground flora species include; meadowsweet, tufted hair grass, hedge woundwort, cleavers, lesser celandine, ground elder, germander speedwell, bramble, vetch sp., common nettle, creeping thistle, Yorkshire fog, foxtail and speedwell. No other Wildlife &amp; Countryside Act protected species have been identified to be present.</p> <p>This hedgerow does not classify under ecological criteria as 'Important' under The Hedgerow Regulations 1997.</p>

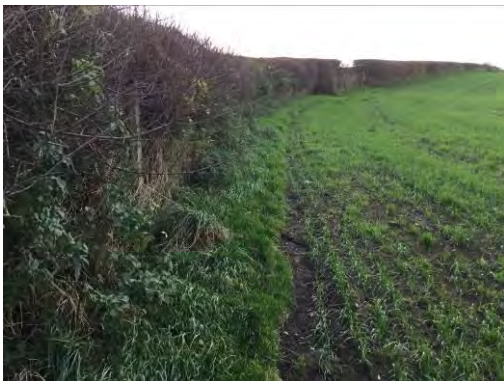
<p>This roadside hedge is approximately 500 m in length, 2 m wide and 2-3 m tall. There are no associated trees or ditch, and the hedgerow is situated on a bank. There is one gap in the hedgerow which accounts for &lt;5% of the total length. Outside the survey area there are connections with two other hedgerows (scoring two connection points), and there are two parallel hedgerows (TR3.WH3 and TR3.WH4) within 15 m.</p> <p>The canopy is overall species-rich and includes dominant blackthorn (<i>Prunus spinosa</i>), with additional hazel (<i>Corylus avellana</i>), hawthorn (<i>Crataegus monogyna</i>), ash (<i>Fraxinus excelsior</i>), elder (<i>Sambucus nigra</i>) and sessile oak (<i>Quercus petraea</i>) (total six woody species). Schedule 2 ground flora recorded along the length of the hedgerow includes lady fern (<i>Athyrium filix-femina</i>), dog's mercury (<i>Mercurialis perennis</i>) and wood avens (<i>Geum urbanum</i>). Other ground flora recorded includes; cleavers (<i>Galium aparine</i>), perennial rye grass (<i>Lolium perenne</i>), Yorkshire fog (<i>Holcus lanatus</i>), garlic mustard (<i>Alliaria petiolata</i>), red campion (<i>Silene dioica</i>), bramble (<i>Rubus fruticosus agg.</i>), ivy (<i>Hedera helix</i>) and cock's foot grass (<i>Dactylis glomerata</i>). The hedgerow is established and mature and therefore obviously more than 30 years in age. It has previously been laid and recently cut / maintained.</p> <p>No Wildlife &amp; Countryside Act protected species have been identified to be present.</p> <p>The hedgerow does not classify under ecological criteria as 'Important' under The Hedgerow Regulations 1997.</p>

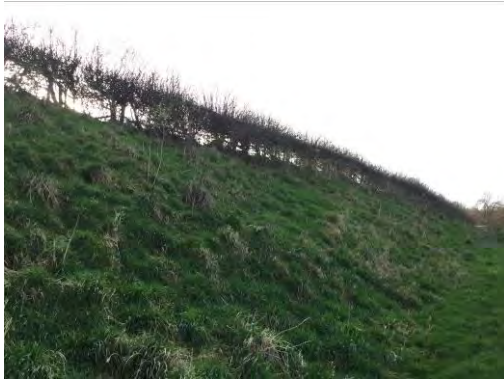
TR3.WH2

<p>This hedgerow is along a field boundary, is approximately 60 m in length, 3 m tall and 2 m wide. There are no associated trees or ditch, and the hedgerow is situated on a tall bank which slopes steeply down towards the north. There are no gaps along the hedgerow length. There are no connections to other hedgerows, ponds or woodland, and there are no parallel hedgerows within 15 m.</p> <p>The canopy comprises dominant blackthorn and rare hawthorn (total two woody species). Schedule 2 ground flora species recorded include dog's mercury and lady fern. Additional ground flora species recorded include; red campion, common hogweed (<i>Heracleum sphondylium</i>), cock's foot grass, common nettle (<i>Urtica dioica</i>) and meadow grass (<i>Poa sp.</i>). There were signs of use of the hedgerow by nesting birds and rabbit (<i>Oryctolagus cuniculus</i>). The hedgerow is established and mature and therefore obviously more than 30 years in age. Some parts of the hedgerow are growing out and becoming "leggy".</p> <p>No Wildlife &amp; Countryside Act protected species have been identified to be present.</p> <p>This hedgerow does not classify under ecological criteria as 'Important' under The Hedgerow Regulations 1997.</p>

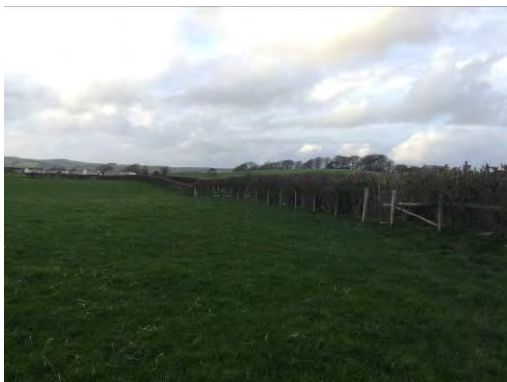
TR3.WH4

<p>This roadside hedgerow is approximately 526 m in length, 3 m in height and 2 to 3 m wide. There are two gaps within the hedgerow accounting for &lt;5% of the length. There are no associated trees or ditch, and the hedgerow is situated on a bank. There are connections to two other hedgerows (TR3.WH6 and TR3.WH7), and it is also parallel within 15 m to two hedgerows (TR3.WH1 and TR3.WH3).</p> <p>The canopy is dominated by blackthorn, with additional species recorded including hazel, hawthorn, rose species and elder (total five woody species). Schedule 2 ground flora species recorded include dog's mercury, herb Robert (<i>Geranium robertianum</i>), male fern, lady fern and wood avens. Additional ground flora species include; common nettle, ivy, garlic mustard, creeping thistle, common mouse ear (<i>Cerastium fontanum</i>), common hogweed, yarrow (<i>Achillea millefolium</i>), cleavers, red campion, bracken and cock's foot. Sections of the hedge have become out grown and "leggy". It has been previously laid, is fenced on one side and has also been recently cut / maintained. The hedgerow is established and mature and therefore obviously more than 30 years in age.</p> <p>No Wildlife &amp; Countryside Act protected species have been identified to be present.</p> <p><b>This hedgerow classifies under ecological criteria as 'Important' under The Hedgerow Regulations 1997.</b></p>

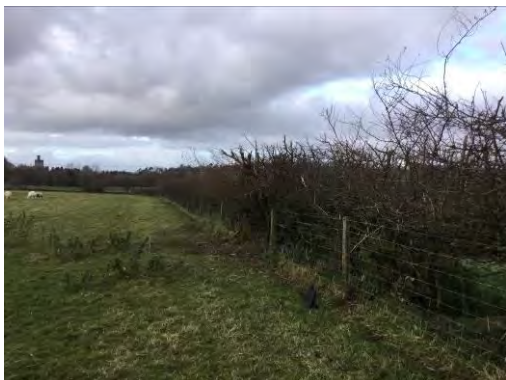
TR3.WH5

<p>This hedgerow delineates a field boundary and is approximately 100 m in length, 3 m in height and 2 m wide. There are no gaps along the length of the hedgerow. There are no associated trees or a ditch, and the hedgerow is not situated on a bank. This hedgerow does not connect to and is not parallel to any other hedgerows.</p> <p>The canopy is dominated by blackthorn, with additional species recorded including hazel, hawthorn, ash and willow (<i>Salix</i> sp.) (total five woody species). Schedule 2 ground flora species were absent. Other ground flora species recorded include cock's foot grass, common nettle, meadow grass and foxglove. The hedgerow has been previously laid, and recently flailed. It is established and mature and therefore obviously more than 30 years in age.</p> <p>No Wildlife &amp; Countryside Act protected species have been identified to be present.</p> <p>This hedgerow does not classify under ecological criteria as 'Important' under The Hedgerow Regulations 1997, however, it is possible that additional Schedule 2 ground flora species may be present during the optimal time period and this may incur a change in classification to 'Important'.</p>

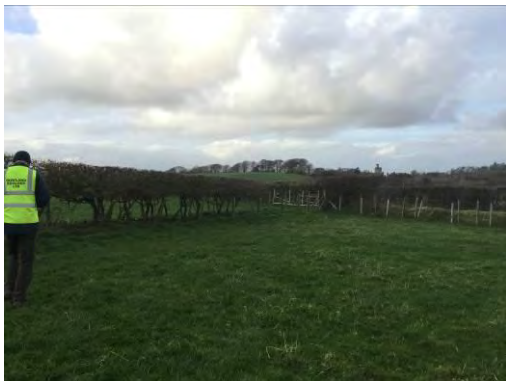
TR3.WH6

<p>This hedgerow delineates a field boundary and is approximately 110 m in length, 2 m in height and 2 m wide. There are two gaps along the length of the hedgerow, accounting for approximately 10% of the length. There are no associated trees or a ditch, and the hedgerow is not situated on a bank. This hedgerow connects to one other hedgerow (TR3.WH4).</p> <p>The canopy is dominated by hawthorn, with additional species recorded including blackthorn (total two woody species). Schedule 2 ground flora species were absent. Other ground flora species recorded include; cock's foot grass, common nettle, meadow grass, bittercress species (<i>Cardamine</i> sp.) and common mouse ear. The hedgerow is tall and "leggy" and is fenced on both sides. There are signs of use by nesting birds. It appears to be less than 30 years old.</p> <p>No Wildlife &amp; Countryside Act protected species have been identified to be present.</p> <p>This hedgerow does not classify under ecological criteria as 'Important' under The Hedgerow Regulations 1997.</p>

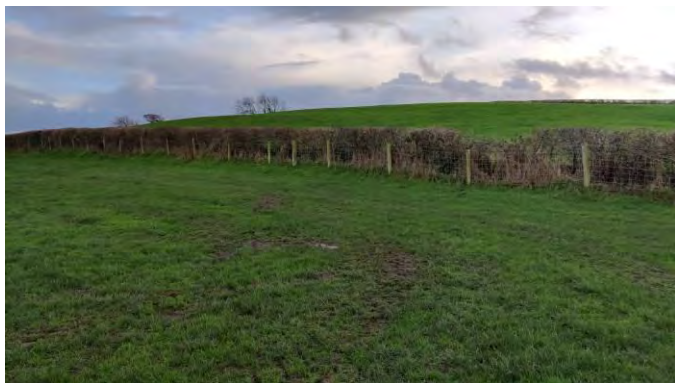
TR3.WH7

<p>This hedgerow follows a field boundary and is approximately 140 m in length, 2 m in height and 2 m wide. There are two gaps along the length of the hedgerow, accounting for approximately 10% of the length. There are no associated trees or a ditch. The hedgerow is situated on a bank. This hedgerow connects to one other hedgerow (TR3.WH4).</p> <p>The canopy is dominated by elder, with additional species recorded including blackthorn, rose species and hazel (total four woody species). Schedule 2 ground flora species present include lady fern and male fern. Other ground flora species recorded include; bramble, common nettle, meadow grass, red campion, cock's foot grass, cleavers and foxglove. The hedgerow has previously been laid, has recently been cut and is fenced. It is established and mature and therefore obviously more than 30 years in age.</p> <p>No Wildlife &amp; Countryside Act protected species have been identified to be present.</p> <p>This hedgerow does not classify under ecological criteria as 'Important' under The Hedgerow Regulations 1997.</p>
