Haweswater Aqueduct Resilience Programme

Bowland Environmental Statement

Technical Appendix 9B.1:

Aquatic Ecology Baseline

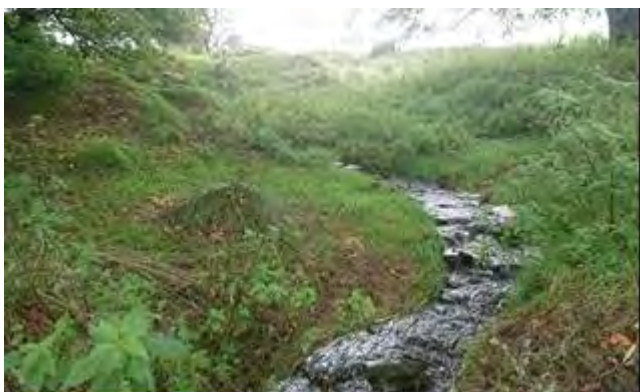
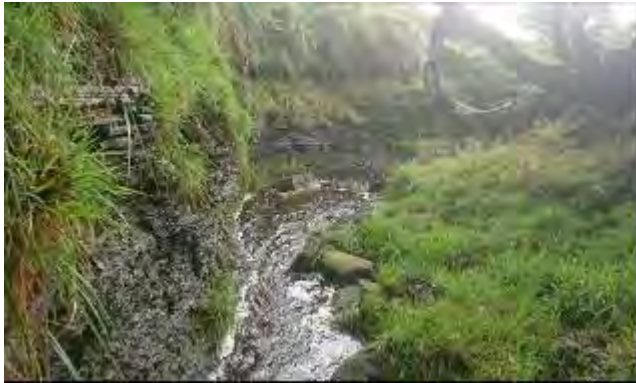
<p>Upstream: SD63236554</p> <p>Downstream: SD63746579</p> <p>No evidence of white-clawed crayfish or non-native crayfish species was found. This watercourse is considered to be sub-optimal for crayfish, with only short sections of the watercourse with suitable refugia.</p> <p>Number of refugia searched: 201 (3 sections, all suitable refugia searched)</p> <p>A watercourse with a max depth of approximately 0.25 m and low turbidity, but with some brown colouration to the water.</p>

The refuges present comprised mainly cobbles with boulders, woody debris, other debris and moss also present. Potential refuges in the bank were present in the form of cobbles/boulder and vertical/undercut banks. The main substrate beneath was gravel, with sections of bedrock and silt also present. Shading was in excess of 30% of the watercourse and comprised overhanging vegetation and shading from trees.

The flow is moderate to fast and the watercourse has an approximate mean width of 1 m. The bankside vegetation comprises coarse grassed, soft rush (*Juncus effusus*) and common nettle (*Urtica dioica*). The banks are poached by livestock in places.

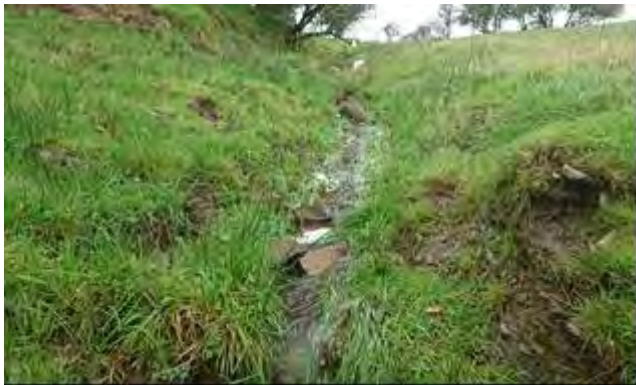
TR3.WC12

Upstream: SD63826557

Downstream: SD63966569

The refuges present comprised mainly cobbles with boulders, woody debris and other debris (broken pipes). There were no potential refuges in the bank identified. The main substrate beneath was gravel, with sections of bedrock and silt also present. Shading was in excess of 30% of the watercourse from bankside oak (*Quercus* sp.) and hawthorn (*Crataegus monogyna*).

The flow is moderate to fast with some slow flowing sections and the watercourse has an approximate mean width of 0.4 m. It flows through sheep grazed pasture. The bankside vegetation comprises coarse grassed, creeping buttercup (*Ranunculus repens*), creeping thistle (*Cirsium arvense*) and soft rush (*Juncus effusus*). The banks are poached by livestock in places as the watercourse is unfenced.

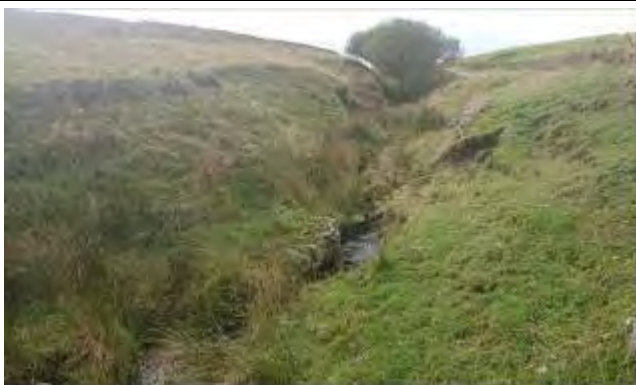
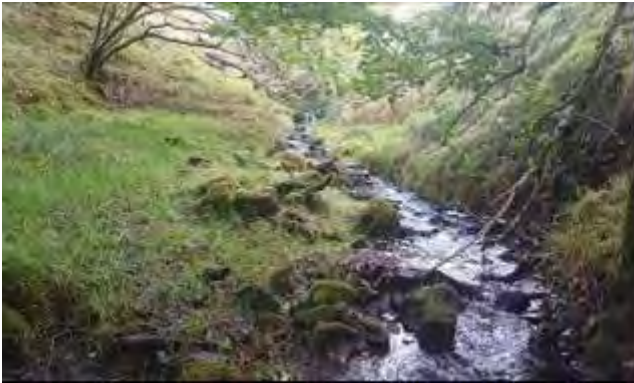
TR3.WC31

Upstream: SD64056389

Downstream: SD64186389

No evidence of white-clawed crayfish or non-native crayfish species. This watercourse is considered to be suitable for crayfish, particularly downstream of the survey area but number of suitable refugia within the survey area is considered to be a limiting factor.

A watercourse with a max depth of approximately 0.4 m (with some deeper pools) and low turbidity, but with strong

brown colouration to the water.

The refuges present comprised mainly cobbles with boulders, fine tree roots, moss, woody debris. There were potential refuges in the bank in the form of cobbles/boulder, large tree roots and vertical/undercut banks. The main substrate beneath was cobbles, with sections of gravel also present. Shading was in excess of 30% of the watercourse from bankside trees.
