# Haweswater Aqueduct Resilience Programme - Proposed Bowland Section

#### Appendix 6.6: Arboricultural Assessment

Project No: B27070CT  
Document Title: Proposed Bowland Section ES, Volume 4  
Appendix 6.6: Arboricultural Assessment  
Document Ref.: LCC\_RVBC-BO-TA-006-006  
Revision: 0  
Date: June 2021  
Client Name: United Utilities Water Ltd

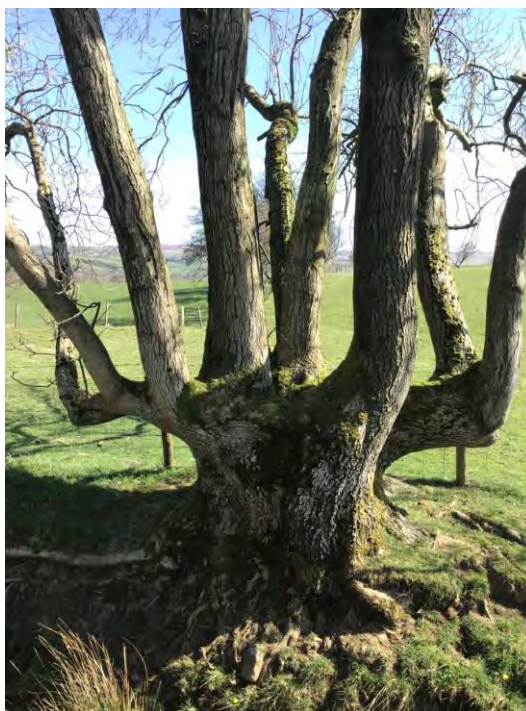
- 30) The proposed location of the Lower Houses Compound is situated in flat open agricultural grassland containing limited tree cover of mixed age class and comprises predominantly of B and C grade trees.
- 31) The assessment area is intermittently covered with scattered individual trees and intermittent boundary vegetation concentrated at field margins or watercourses. Approximately 20 % of the Proposed Bowland Section's surveyed trees are located at this compound. The compound's assessment area contains one A grade feature (Illustration 1).

**Illustration 1: Part of A grade group feature historically managed as a low pollard**

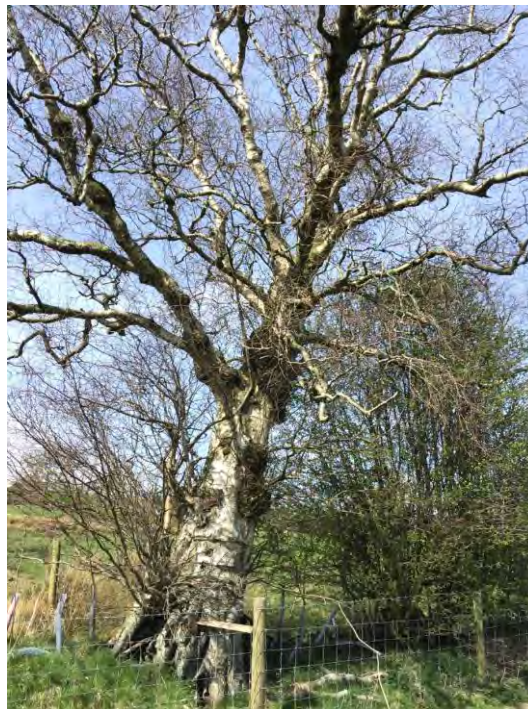
- 34) The treescape to the north of Dunsop Road contains a mixture of B and C grade trees scattered within fields or located at roadside and field margins. The treescape to the south of Dunsop Road predominantly contains B grade broadleaf trees concentrated at roadside, field margins and the River Hodder.
- 35) Approximately 80 % of the Proposed Bowland Section's surveyed trees are located at this compound with around 60 % of all surveyed tree stock being of at least of mature age class.
- 36) All 16 A grade features are concentrated between the River Hodder and Dunsop Road including one potential veteran tree (Illustration 2).

**Illustration 2: Potential veteran silver birch tree**

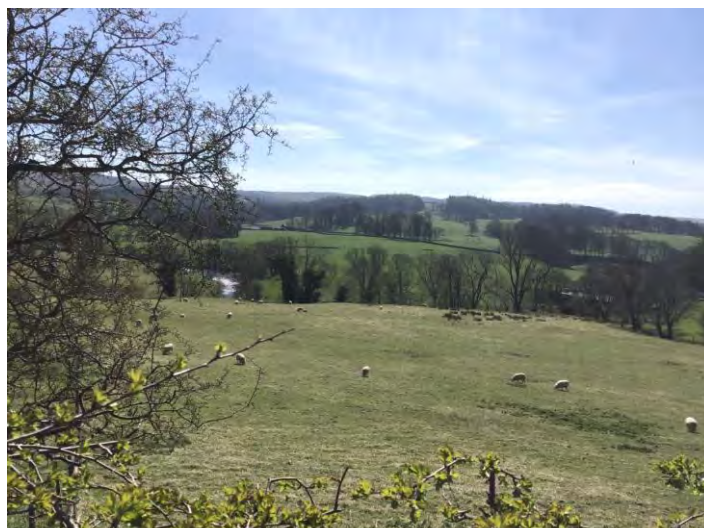
- 37) The treescape to the south of Dunsop Road includes prominent linear tree groups of mature trees (Illustration 3) or scattered A grade individual trees (Illustration 4).

**Illustration 3: The red boxed area contains linear groups of mature ash, sycamore or alder of moderate and high quality. As viewed south from Dunsop road towards the River Hodder**

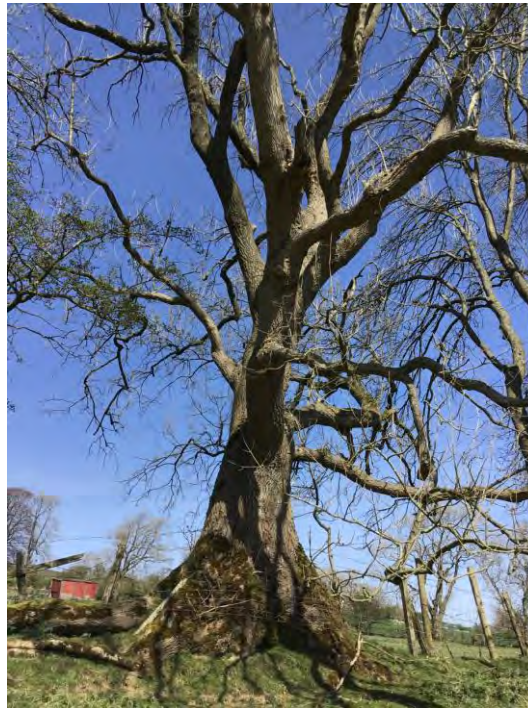
**Illustration 4: Typical example of A grade ash tree contained within field margin of assessment area**

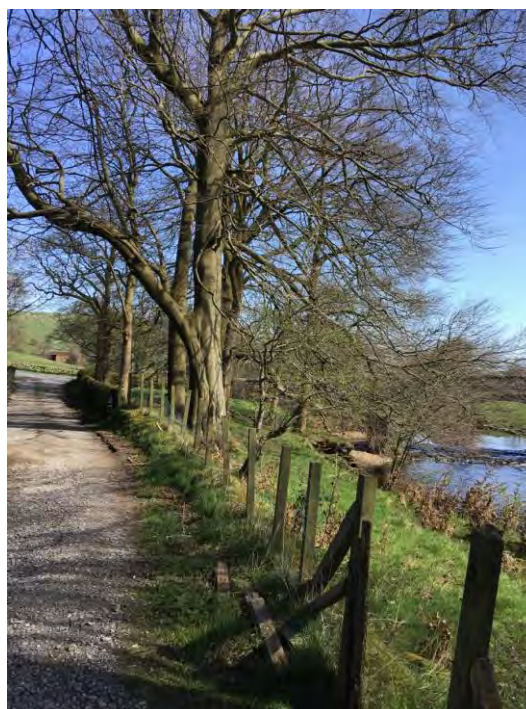
- 38) The assessment area contains a tree avenue flanking an existing access track situated immediately west of the existing road bridge crossing the River Hodder. The access track appears in shared vehicular use to residential property, adjacent agricultural land and the operational Wastewater Treatment Works. Surveyed trees within the avenue are assessed to be of mixed quality and appear to be contained within 'Newton Conservation Area' as shown in Appendix G. Illustration 5 highlights a specific riverside tree group identified as 'Important Trees' within the CA.

**Illustration 5: Part of existing tree avenue within the assessment area highlighted as 'Important Trees' within CA plan**

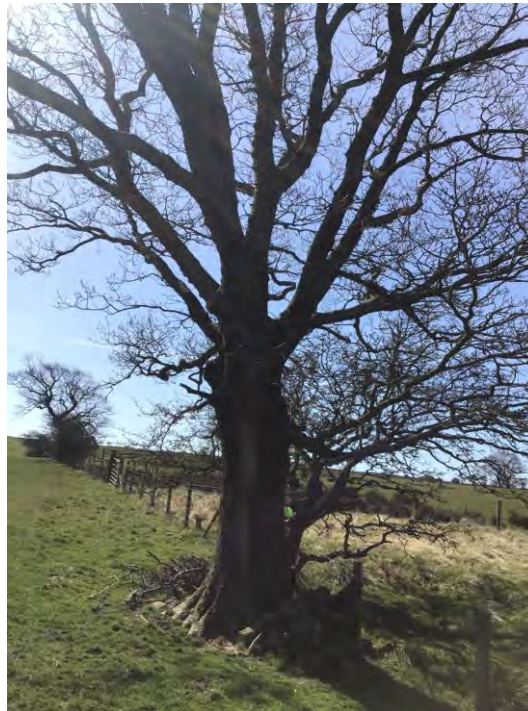
**Illustration 6: Mature B grade oak tree at risk**

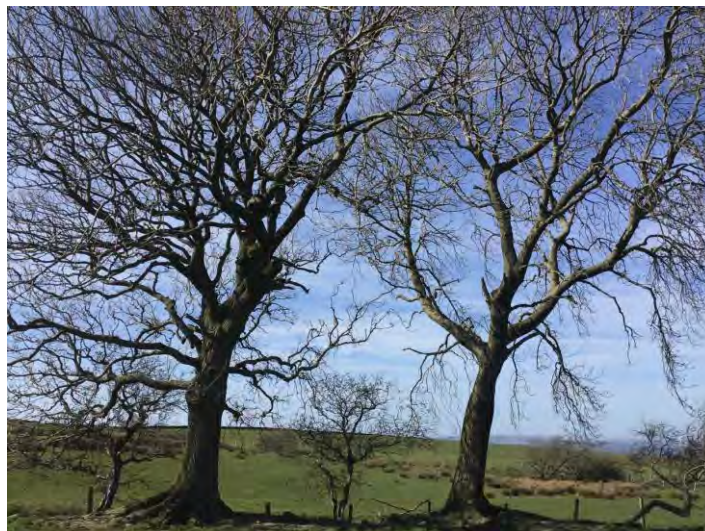
**Illustration 7: Mature B grade tree group at risk**

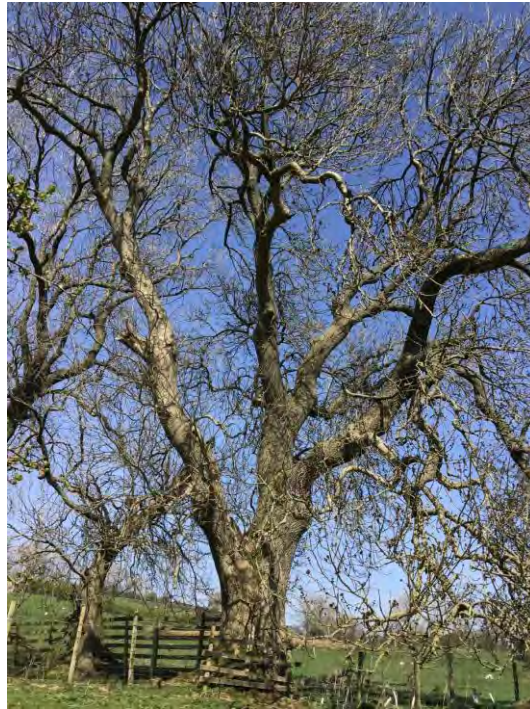
**Illustration 8: A grade ash tree at risk due to proposed road alignment**

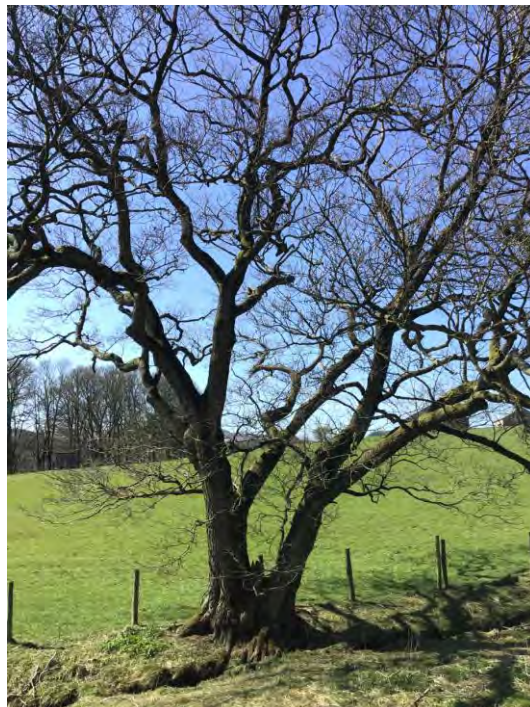
**Illustration 9: A grade alder tree at risk due to encroachment to works around an existing well house adjacent to the River Hodder.**

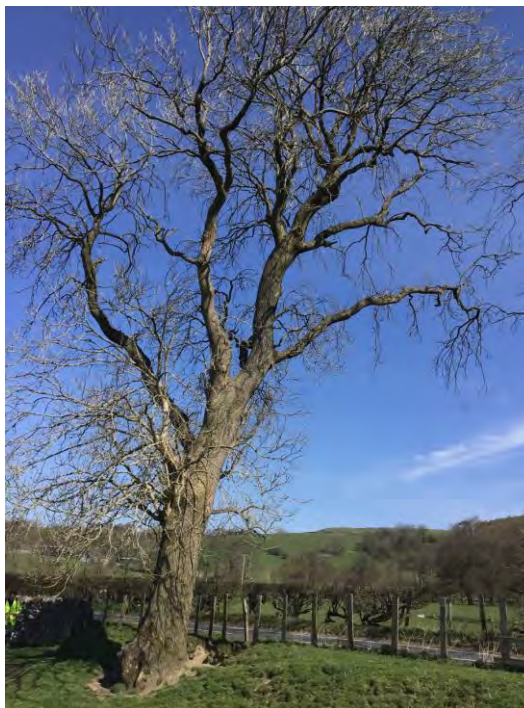
- 59) One A grade feature is located adjacent to the proposed new road junction alignment onto existing Hallgate Hill (Illustration 10).

**Illustration 10: Roadside A grade ash tree to be removed due to proposed road junction alignment**

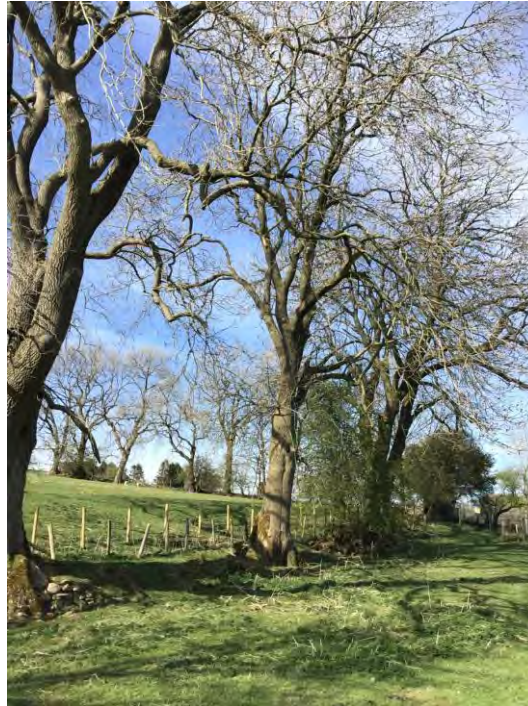
**Illustration 11: A grade ash group located on field boundary to be retained**
