**Haweswater Aqueduct Resilience Programme – Proposed  
Bowland Section  
Volume 6**

**Proposed Ribble Crossing**

**Technical Appendix 9A.2: Habitats**

June 2021

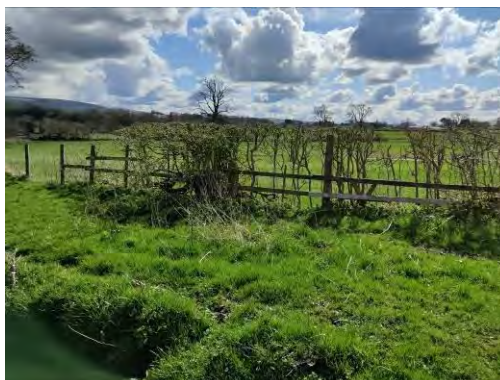
RC.H3

This hedgerow is approximately 118 m in length, on average is 1 m tall and 1 m wide. There are four gaps along the hedgerow which account for approximately 10% of the length. There is one associated mature tree along with a dry ditch on the southern elevation (which extends along less than half the hedgerow length). There is no supporting bank or wall. There are no connections to woodland, ponds or other hedgerows, and there are no parallel hedgerows. The hedgerow is well established and greater than 30 years in age.

The dominant woody species is blackthorn with additional hazel, hawthorn, rose species and elm species (total five woody species). Schedule 2 ground flora species recorded include; lady fern (*Athyrium filix-femina*), primrose (*Primula vulgaris*) and lords and ladies. Additional ground flora species recorded include; stitchwort (*Stellaria* sp.), reed canary grass (*Phalaris arundinacea*), red campion (*Silene dioica*), cleavers, soft rush (*Juncus effusus*), bittercress species (*Cardamine* sp.), Yorkshire fog, tufted hair grass, Himalayan balsam (*Impatiens glandulifera*), common nettle, self-heal (*Prunella vulgaris*), hedge woundwort (*Stachys sylvatica*), broadleaved dock (*Rumex obtusifolius*), lesser celandine, creeping buttercup (*Ranunculus repens*), willowherb species (*Epilobium* sp.), bramble (*Rubus fruticosus* agg.), meadowsweet and foxglove (*Digitalis purpurea*).

Himalayan balsam is listed as an invasive species on Schedule 9 of the Wildlife and Countryside Act 1981 (as amended).

A disused birds nest (unidentified species) was noted within the hedgerow.

The hedgerow does not classify under ecological criteria as 'Important' under The Hedgerow Regulations 1997.

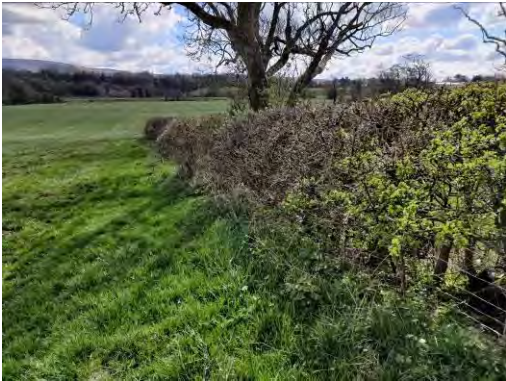
RC.H11

<p>This hedgerow is approximate 81 m in length, on average is 1 m tall and 1 m wide. There are three gaps accounting for approximately 5% of the hedgerow length. There are four associated mature trees along with a dry ditch on the northern elevation. There is no bank or supporting wall, and there are no connections to ponds, woodland or other hedgerows, nor any parallel hedgerow. The hedgerow is well established and greater than 30 years in age. The hedgerow is well maintained and has previously been laid.</p> <p>The dominant woody species is hawthorn with additional blackthorn and elder (total three woody species). Schedule 2 ground flora recorded include; lords and ladies, herb Robert, and dog's mercury. Additional ground flora recorded include; red campion, bramble, lesser celandine, burdock (<i>Arctium lappa</i>), creeping bent, ivy, cleavers, common nettle, common hogweed, Yorkshire fog, garlic mustard, broadleaved dock, creeping buttercup and cow parsley.</p> <p>No Wildlife &amp; Countryside Act protected species have been identified to be present.</p> <p>The hedgerow does not classify under ecological criteria as 'Important' under The Hedgerow Regulations 1997.</p>

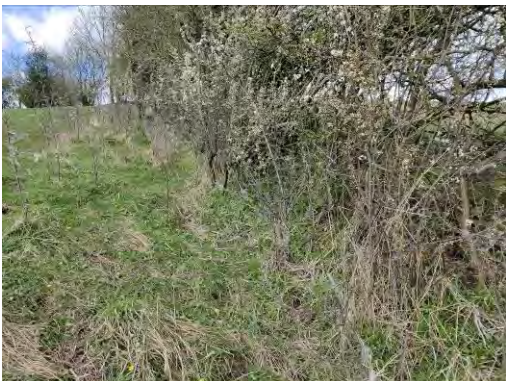
RC.H20

<p>This hedgerow is approximately 187 m in length, on average is 3.5 m tall and 1.5 m wide. There are three gaps accounting for approximately 5% of the length of the hedgerow. There are six mature trees and a wet ditch is present on the northern elevation. There is a supporting bank or wall. The hedgerow connects to a small area of woodland at the western edge. There are no parallel hedgerows. The hedgerow is well established and greater than 30 years in age.</p> <p>The dominant woody species is blackthorn with additional willow species (<i>Salix</i> sp.), rose species, holly, ash (<i>Fraxinus excelsior</i>), and hazel (total six woody species). Schedule 2 ground flora species recorded include; wood anemone (<i>Anemone nemorosa</i>), lords and ladies, lady fern, pignut, male fern (<i>Dryopteris filix-mas</i>), wood avens, English bluebell (<i>Hyacinthoides non-scripta</i>), dog's mercury, hart's tongue fern (<i>Phyllitis scolopendrium</i>) and early dog violet (<i>Viola reichenbachiana</i>). Additional ground flora recorded include; common nettle, tufted hair grass, cock's foot grass, Himalayan balsam, opposite-leaved golden saxifrage (<i>Chrysosplenium oppositifolium</i>), bramble, red campion, lesser celandine, creeping thistle (<i>Cirsium arvense</i>), cleavers, willowherb species, self-heal and wild thyme (<i>Thymus polytrichus</i>).</p> <p>Himalayan balsam is listed as an invasive species on Schedule 9 of the Wildlife and Countryside Act 1981 (as amended).</p> <p><b>This hedgerow classifies under ecological criteria as 'Important' under The Hedgerow Regulations 1997.</b></p>

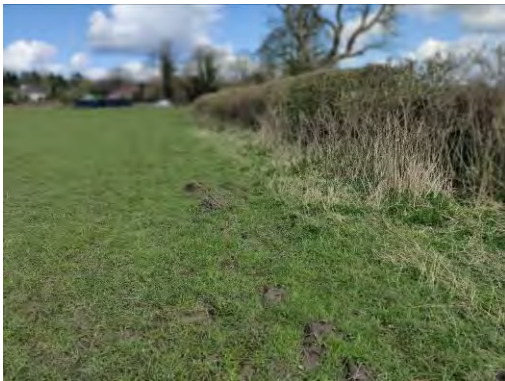
RC.H27

<p>This roadside hedgerow is approximately 38 m in length, on average is 1.5 m tall and 1.5 m wide. There are no gaps, mature trees or ditches associated with the hedgerow. There is a supporting bank or wall. There are no connections to woodlands, ponds or other hedgerows. There are no parallel hedgerows within 15m. The hedgerow is well established and greater than 30 years in age.</p> <p>The dominant woody species is blackthorn, with additional hazel, hawthorn, ash and elm species (total five woody species). Schedule 2 ground flora species recorded include lords and ladies, lady fern, dog's mercury, moschatel (<i>Admoxa moschatellina</i>), ramsons (<i>Allium ursinum</i>) and primrose. Additional groundflora species recorded include common nettle, ivy, lesser celandine, creeping buttercup, broadleaved willowherb (<i>Epilobium montanum</i>), cleavers, wild daffodil (<i>Narcissus pseudonarcissus</i>), Himalayan balsam, hedge woundwort and garlic mustard.</p> <p>A disused birds nest (unidentified species) was noted within the hedgerow.</p> <p>Himalayan balsam is listed as an invasive species on Schedule 9 of the Wildlife and Countryside Act 1981 (as amended).</p> <p><b>This hedgerow classifies under ecological criteria as 'Important' under The Hedgerow Regulations 1997.</b></p>
