# Haweswater Aqueduct Resilience Programme – Proposed Bowland Section

Proposed Ribble Crossing

Technical Appendix 9A.5: Amphibians

June 2021

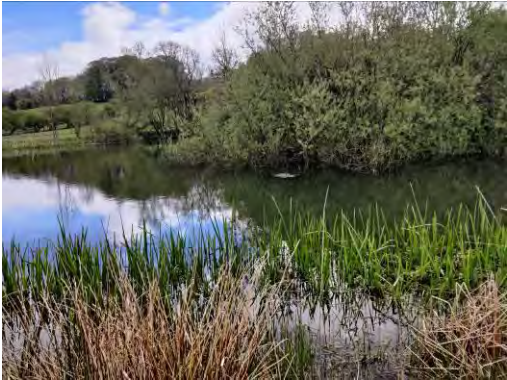
| 1 Project Details | | | |
|---|--|--|--|
| <b>Pond 2:</b> | | | |

| 1 Project Details | | | |
|---|--|--|--|
| | | <p>Large 'U' shaped pond which is fenced off from the surrounding sheep-grazed fields, and surrounded by amenity grassland and woodland providing approximately 70% shade. Woodland species include alder (<i>Alnus glutinosa</i>), hornbeam (<i>Carpinus betulus</i>), willow species (<i>Salix</i> sp.) and cherry species (<i>Prunus</i> sp.). Some gaps in the canopy are present around the pond edges and here the vegetation is dominated by grasses.</p> <p>Emergent vegetation includes flag iris (<i>Iris pseudacorus</i>), bulrush (<i>Typha latifolia</i>), water mint (<i>Mentha aquatica</i>) and willowherb species (<i>Epilobium</i> sp.) and this covers approximately 10% of the pond surface at the edges. Bankside vegetation includes cuckoo flower (<i>Cardamine pratensis</i>), meadowsweet (<i>Filipendula ulmaria</i>), lesser celandine (<i>Ranunculus ficaria</i>), common hogweed (<i>Heracleum sphondylium</i>), Himalayan balsam (<i>Impatiens glandulifera</i>) and lords and ladies (<i>Arum maculatum</i>).</p> <p>The banks are steep on the south-eastern side and more gradual to the north-west.</p> <p>Water fowl have a minor impact. Grey heron (<i>Ardea cinerea</i>) and moorhen (<i>Gallinula chloropus</i>) were observed using the pond. An abundance of tadpoles (not identified to species) were also observed around shallow edges of the pond on the northern side. The water quality appears to be good as there were several invertebrate species identified at the pond edges during sampling including whirligig beetles (Gyrinidae) and pond skaters (Gerridae). Fish presence is possible and the pond likely doesn't dry out at all.</p> | |

| 5 eDNA survey results | | |
|---|---|--|
| Pond 2 | Negative | Access limited on the south-eastern edge where the pond embankments were very steep. |

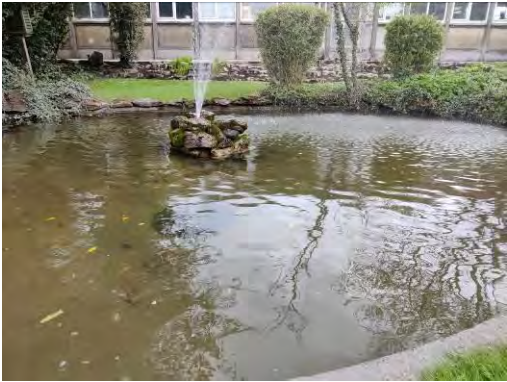
| 5 eDNA survey results | | |
|---|---|--|
| <b>Pond 1:</b><br> <p>Small ornamental pond close to the entrance of Hanson Cement, set within an area of amenity grassland and close to ornamental tree and shrub planting. The pond is stone lined and has a central rocky island with a working fountain. The base of the pond is visible and the pond is shallow. There is no aquatic vegetation present. Nearby ornamental tree planting shades the pond by approximately 40%. There is the possibility of fish being present and negligible waterfowl impacts. The pond does not dry.</p> | | |

| 5 eDNA survey results | | |
|---|---|--|
| Pond 1 | Negative | N/A |

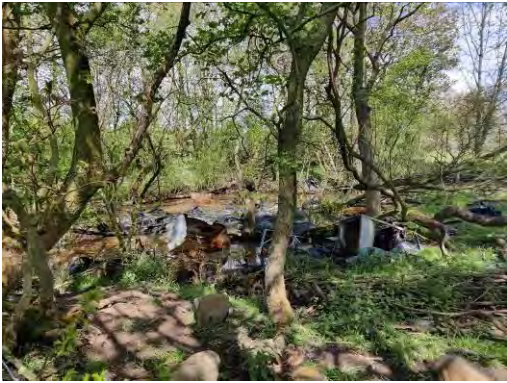
| 5 eDNA survey results | | |
|---|---|--|
| <b>Pond 3:</b><br> <p>Small woodland pond which has been filled with litter and farm waste including machinery and filled bin bags. The small pockets of water present are discoloured to a rusty red and there is no observed aquatic vegetation or aquatic invertebrates. The surrounding woodland includes ash (<i>Fraxinus excelsior</i>), sycamore (<i>Acer pseudoplatanus</i>), willow species and oak species (<i>Quercus</i> sp.). There is a negligible impact from waterfowl and fish. The pond may dry yearly due to being infilled with waste.</p> <p><b>Pond not sampled due to being unsuitable and filled with litter.</b></p> | | |

| 5 eDNA survey results | | |
|---|---|--|
| Pond 3 | N/A | Filled in with litter and drying out, not sampled. |

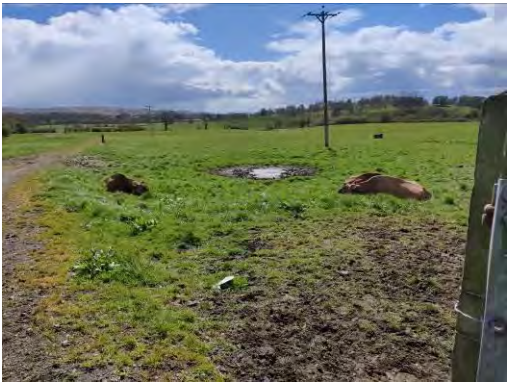
| 5 eDNA survey results | | |
|---|---|--|
| <b>Pond 4:</b><br> <p>Small, circular and dry pond within cattle grazed species-poor semi-improved grassland. The area is cattle poached and there is no observed aquatic vegetation. The pond likely dries out yearly, filling with water rarely and there is poor water quality (no observed invertebrates). There is no shading to the pond.</p> <p><b>Pond not sampled due to being dry.</b></p> | | |

| 5 eDNA survey results | | |
|---|---|--|
| Pond 4 | N/A | Dry, not sampled. |
