Haweswater Aqueduct Resilience Programme

Chapter 9A - Appendix 9A.7

Environmental Statement

Appendix A. Bowland Ecology eDNA Survey Report

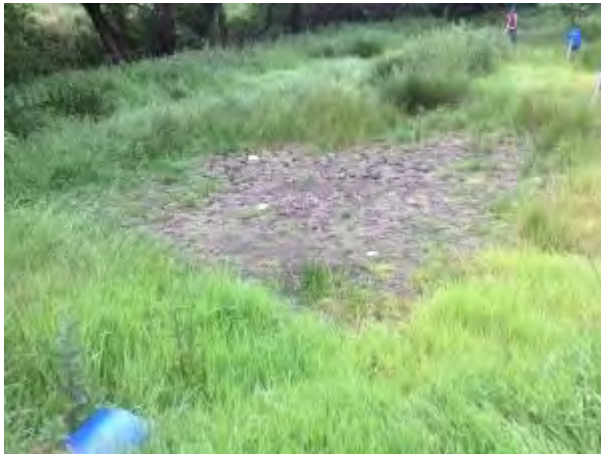
Dry pond which is approximately circular and appears to dry out annually, surrounded by species-poor semi-improved grassland and deciduous woodland at the base of a sloping sheep-grazed field.

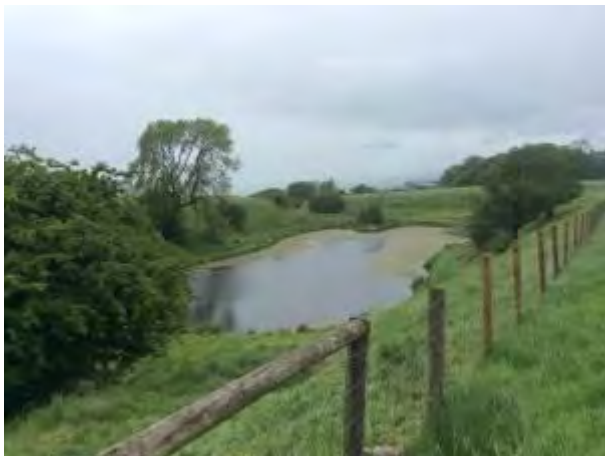
TR3 Pond 2:

Large, roughly oval pond approximately 4500m². A timber fishing / dipping platform is present at the southern end which suggests the pond is likely to be fish stocked. In the centre of the pond is a small island with some dead trees along with willow (*Salix* sp.) and alder (*Alnus glutinosa*) scrub and some tall ruderal vegetation. Pond margins are fringed with canary grass (*Phalaris canariensis*), yellow flag iris (*Iris pseudacorus*), soft rush (*Juncus effusus*), sedges (*Carex* spp.), foxglove (*Digitalis purpurea*), and horse tail (*Equisetum* sp.). On the eastern bank there is a large stand of bulrush (*Typha latifolia*). The pond surface contains a large expanse of pondweed (*Potamogeton* sp.), water mint (*Mentha aquatica*), water horsetail (*Equisetum fluvatile*), and common water starwort (*Callitriche stagnalis*). Many tadpoles were present throughout the margins of the pond (not identified to species). There is evidence of sheep-grazing to the vegetation at the pond edges, and the pond is immediately surrounded by rough grassland and scattered scrub. The margins of the pond are shallow (<50cm), however it appears to reach considerable depths towards the centre. The bank profile is variable; steep vertical grassy banks and shallow water-logged slopes.

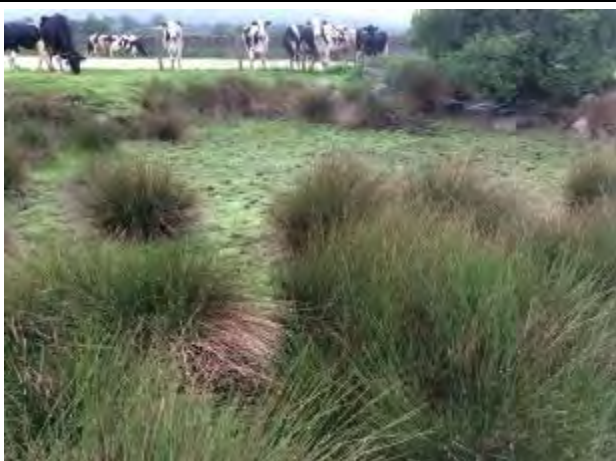
TR3 Pond 3:

Small dry pond within an agricultural field grazed by cattle. Appears to be permanently dry, with soft rush encroaching to, and choking the centre.

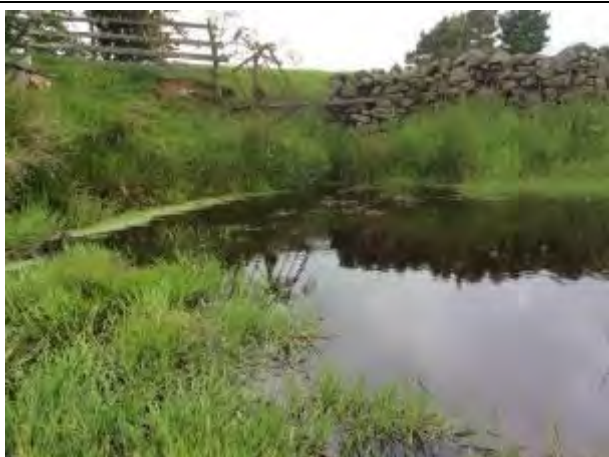
TR3 Pond 5c:

Small circular pond approximately 24m² located next to a farm building at the bottom of a sloping field and surrounded by grassland. Floating aquatic vegetation includes common water starwort, pondweed (*Potamogeton* sp.), ivy-leaved crowfoot (*Ranunculus hederaceus*), floating sweet grass (*Glyceria fluitans*) and water mint, with banks dominated by foxglove (*Digitalis*), soft rush, broadleaved dock (*Rumex obtusifolius*) and cuckoo flower (*Cardamine pratensis*). There is an inflow from the north and outflow to the south, close by is a dry-stone wall and scrub line.

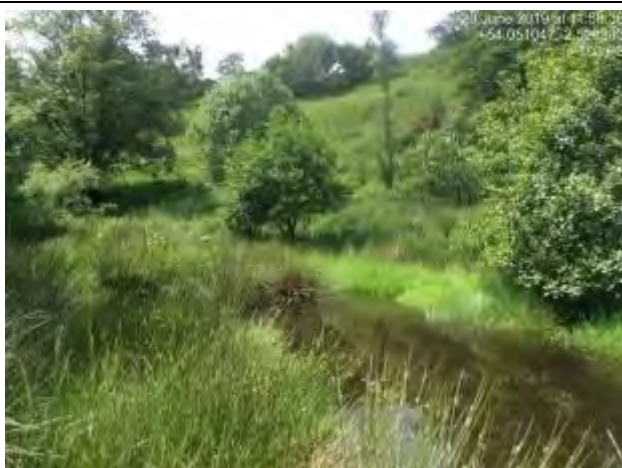
TR3 Pond 8:

Large pond approximately 120m², the depth is shallow at the margins (<5cm) but gets gradually deeper towards the centre. Located within a steep valley, the surrounding area is wet woodland with an alder dominated canopy, there is no understory and ground flora is dominated by Yorkshire fog (*Holcus lanatus*) and soft rush. There is a central island vegetated with soft rush, foxglove and broadleaved dock. Macrophyte cover comprises of floating sweet grass, duckweed sp., and common water starwort. There is dense organic plant matter which carpets the bottom of the pond. The pond has both inflow (northwest) and outflow (south east). Pond skaters, water spiders (*Argyroneta* sp.), whirligig beetle (*Gyrinidae* sp.), water boatman (*Corixidae* sp.), tadpoles (not identified to species) and water beetles (*Adephaga* Sp.) were identified, along with abundant damselflies (*Zygoptera* Sp.).

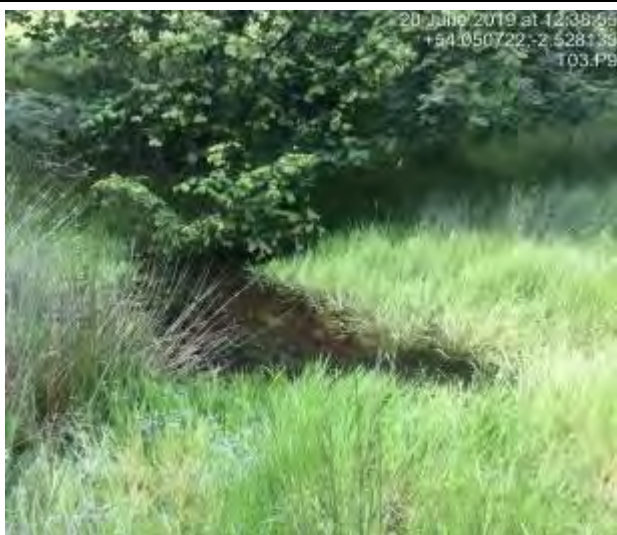
TR3 Pond 9:

Small, shallow pond approximately 30m² surrounded by wet, alder dominated woodland with no understory present. Marshy grassland ground flora dominates with species such as Yorkshire fog and soft rush. The pond is choked with macrophyte species including water forget me not (*Myosotis scorpioides*), floating sweet grass and common water starwort. The pond was rich in invertebrates such as water spider and diving beetle (*Dytiscidae* Sp.). The water is ochreous with a small area of duckweed sp. cover. There is a pond inflow (north-west) which may run from TR3 Pond 8.

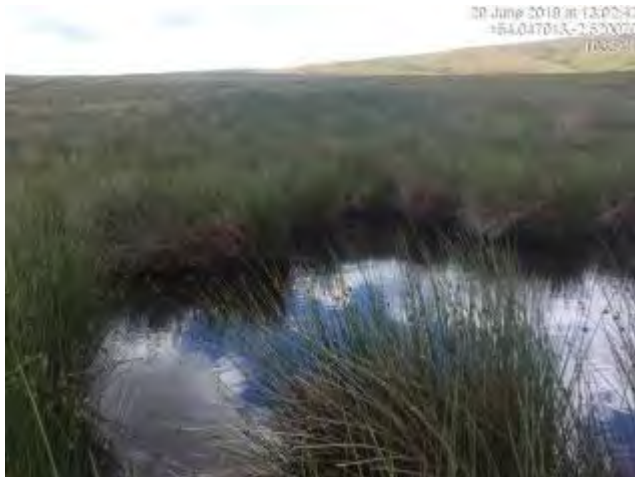
<p>Small roughly circular pond approximately 70m². Very turbid water of an unknown depth, with obvious waterfowl impacts. There are vertical earth banks. The pond is surrounded by dense marshy grassland, dominated by soft rush. It holds a relatively exposed position within the landscape with some nearby dry-stone walls. The water surface has some small areas of duckweed sp. (approximately 10%). Surrounding land use is a mixture of species-poor semi-improved sheep grazing pasture and upland moorland.</p>
TR3 Pond 11a

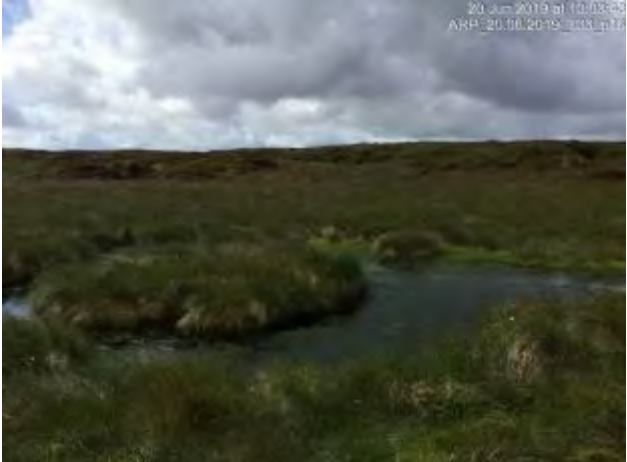
<p>Small pond approximately 21m², filled with sphagnum mosses and contains a central island which is dominated by grasses including tufted hair grass. The pond is situated in open heathland with species present including tufted hair grass, sheep's fescue, common heather, cross-leaved heath and bilberry. Sphagnum and polytrichum mosses also carpet the surrounding area. The water is clear and a deep orange/brown in colour suggesting a water inflows from peaty ground.</p>

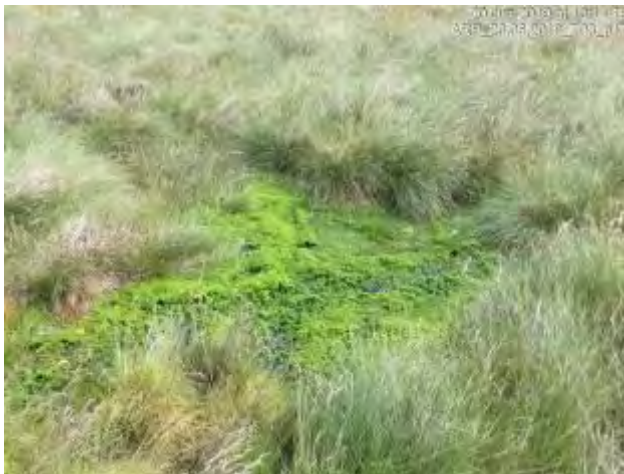
TR3 Pond 17

Dry pond; a small depression within the open heather moorland which is choked with sphagnum mosses and surrounding by tufted hair grass.

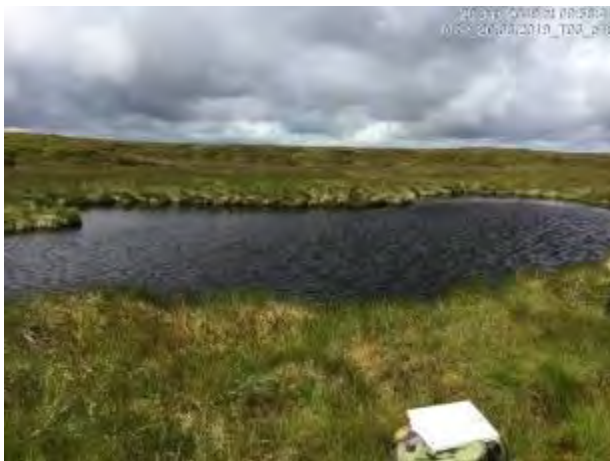
TR3 Pond 18

Large oval pond approximately 600m² situated in an open heath moorland, at the summit of 'White Hill'. The pond is exposed to strong winds from all directions, creating a strong, persistent ripple over across the surface. The pond margins are short, vertical earth/peat banks. Species present at the water edge include sphagnum mosses, polytrichum moss, tufted hair grass, common cotton grass, sheep's fescue, common heather and bilberry. The water is clear and a deep orange/brown in colour suggesting a water inflows from peaty ground.

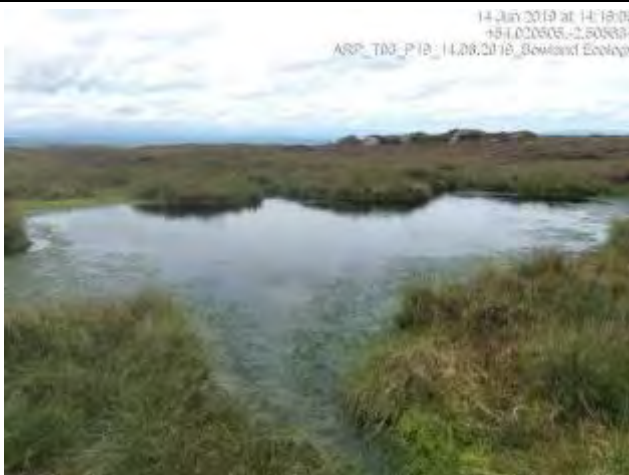
TR3 Pond 19

Irregular shaped pond approximately 80m² is situated in upland heath moorland. The water is clear and orange in colour suggesting water inflows from peaty ground. The pond is shallow and dominated by submerged moss species. The banks are shallow and boggy and vegetated by tufted hair grass, hare's tail cotton grass, sphagnum moss, polytrichum moss, bilberry and common heather.

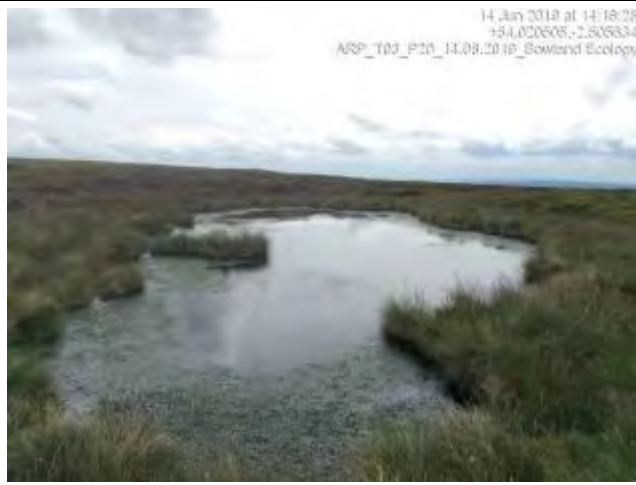
<p>14 Jun 2018 at 14:18:28 +54.020605,-2.505634 ASP_TR3_P20_14.06.2018_Bowland Ecology</p>	<p>Pond approximately 200m² situated in upland heath moorland. The water is clear and orange in colour suggesting water inflows from peaty ground. The pond is very deep in the centre and has shallow but vertical earth banks. Submerged sphagnum mosses species dominate the margins. The banks are boggy and vegetated by purple moor grass, tufted hair grass, hare's tail cotton grass, sphagnum mosses, polytrichum moss, bilberry and common heather.</p>
<p>TR3 Pond 21</p>

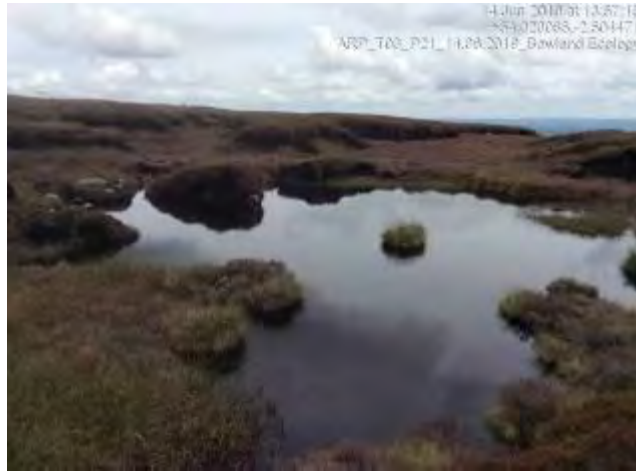
<p>14 Jun 2018 at 13:57:18 +54.020605,-2.504471 ASP_TR3_P21_14.06.2018_Bowland Ecology</p>	<p>Medium sized pond (15m x 15m) situated in upland heath moorland. The surrounding land contains undulating peat mounds. The pond margins are shallow sloping. The water is clear and orange in colour suggesting a high peat content. The banks are boggy and vegetated by purple moor grass, tufted hair grass, hare's-tail cotton grass, sphagnum mosses, polytrichum moss, bilberry and common heather.</p>

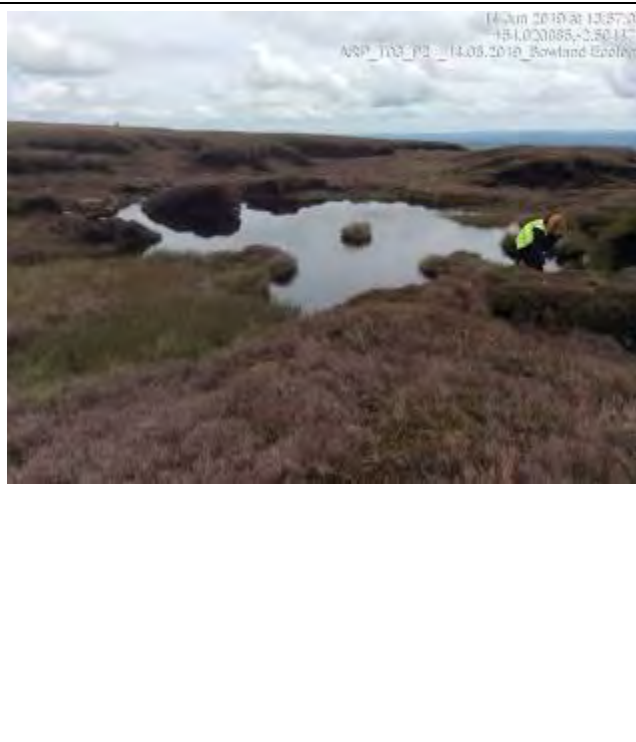
<p>TR3 Pond 22</p>

<p>14 Jun 2018 at 13:57:08 +54.020605,-2.504471 ASP_TR3_P22_14.06.2018_Bowland Ecology</p>	<p>Moderately sized (15m x 10m) oval pond, situated in upland heath moorland. The water is clear and orange in colour suggesting water inflows from peaty ground. The pond is rich in submerged mosses and shallow. The banks are boggy and vegetated by tufted hair grass, purple moor grass, sphagnum moss, bilberry, crowberry (<i>Empetrum nigrum</i>) and common heather.</p>
<p>TR3 Pond 23</p>

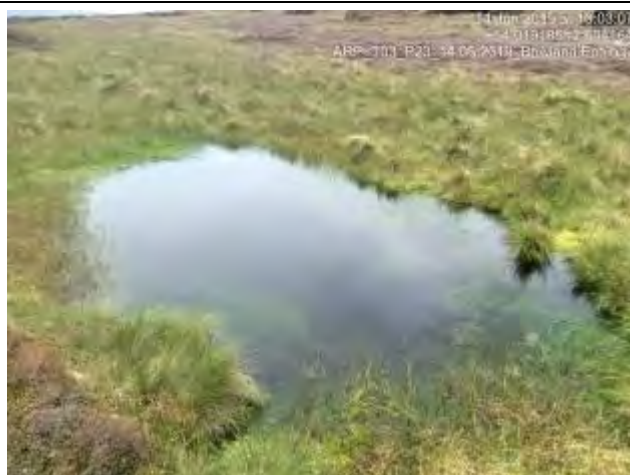
Small (4m x 3m), oval pond on upland heath moorland. The pond is shallow, no more than 12cm deep. Surrounding banks are boggy and vegetated by sphagnum mosses, polytrichum moss, tufted hair grass, purple moor grass, hare's-tail cotton grass, bilberry and cross-leaved heath. Water is clear and orange in colour suggesting a high peat content. There is a good diversity of invertebrates within the pond. Polytrichum moss is present within the pond and dominates.

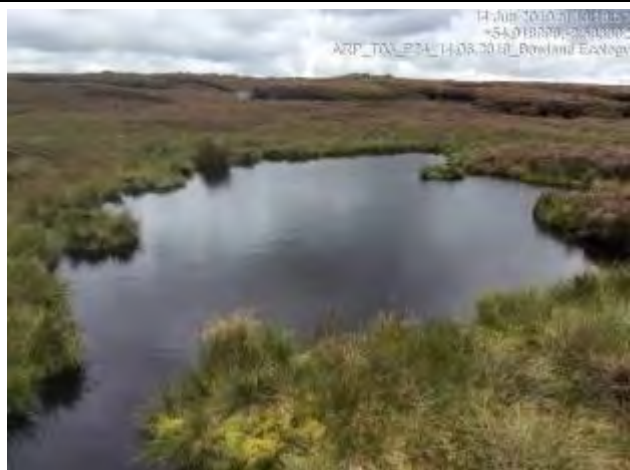
TR3 Pond 24

Oval pond (15m x 8m), with deep, turbid water that appears black in colour, suggesting water inflows from peaty ground. The pond is situated on an upland heath moorland. The banks are boggy and vegetated by tufted hair grass, polytrichum moss, bilberry and common heather. There is some evidence of waterfowl impacts to the banks. There is no shading or visible submerged macrophytes.

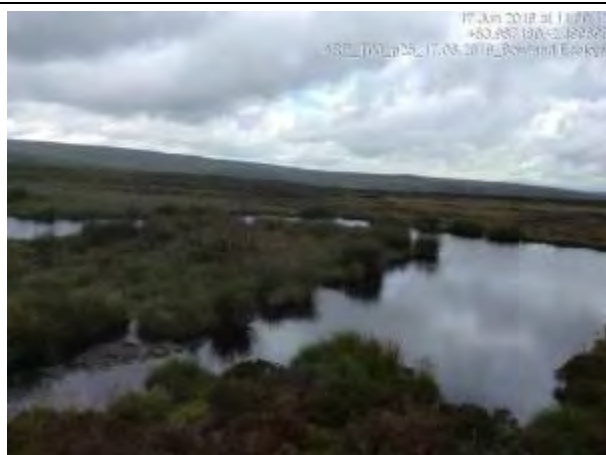
TR3 Pond 25

Large irregularly shaped pond approximately 30m x 15m. There is a small central island dominated by soft rush. This pond connects to TR3 Pond 27 via a small channel to the south. The pond is situated in an open heath moorland, with species recorded including soft rush, common heather, tufted hair grass, purple moor grass, sheep's fescue, heath rush (*Juncus squarrosus*) sphagnum mosses and soft rush. The water is deep, >1m, clear and an orange/brown colour indicating water inflows from peaty ground. The banks are a mixture of shallow, sloping and vertical earth / peat.

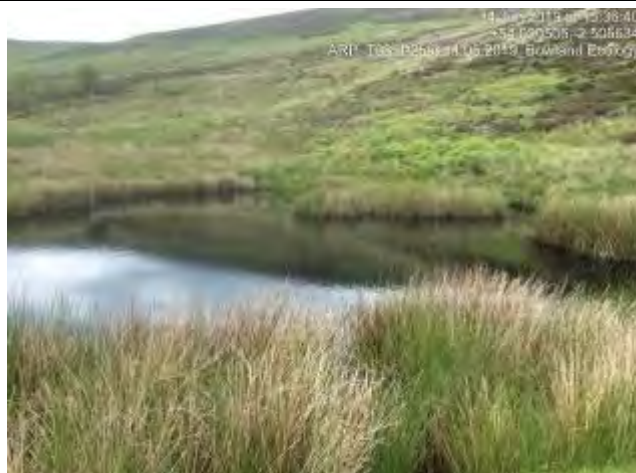
TR3 Pond 25a

<p>Medium sized pond (approximately 20m x 20m) in an upland valley, surrounded by upland heath moorland. The water is deep and clear with a small stream inflow at the north bank. Soft rush vegetates the banks and two small central islands in the centre. The surrounding vegetation has a high water table and includes marsh pennywort (<i>Hydrocotyle vulgaris</i>), bilberry, common heather, purple moor grass, tormentil (<i>Potentilla erecta</i>), sphagnum mosses and polytrichum moss. There is some evidence of waterfowl impacts along the pond banks.</p>

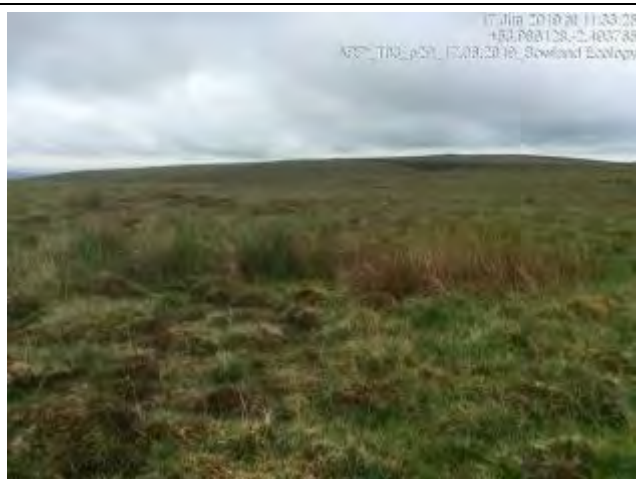
TR3 Pond 29

Dry; the area is a small depression within open heathland which is dominated by soft rush.

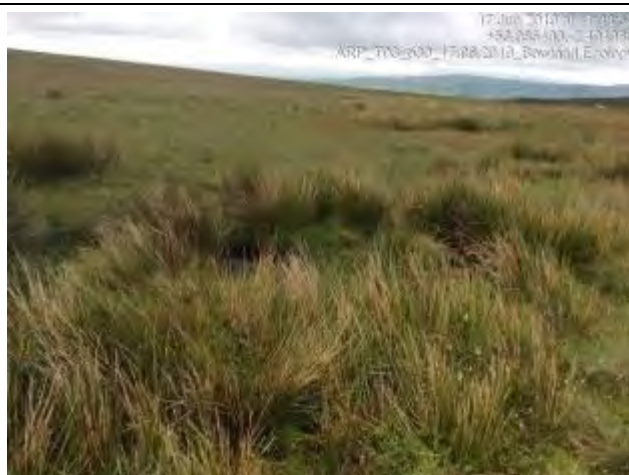
TR3 Pond 30

Small circular pond (approximately 7m in diameter), surrounded and shaded by dense soft rush. Sphagnum moss carpets the edges and encroaches into the pond. The water is shallow, yet clear with a rich orange colour suggesting water inflows from peaty ground. The pond is situated in open heath moor, with species recorded including tufted hair grass, purple moor grass, soft rush and common cotton grass.

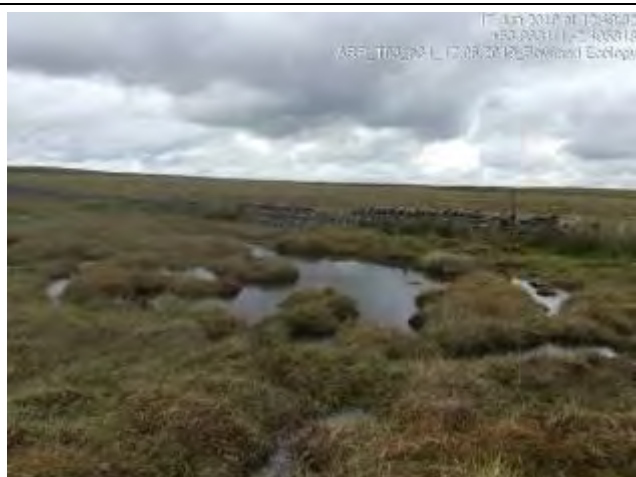
<p>TR3 Pond 34</p>

Medium sized (approximately 20m x 20m), deep, irregular-shaped pond. The water is clear with scattered peat/moss hummocks throughout the centre of the pond. The pond is situated in an open heathland with dominant species recorded including soft rush, tufted hair grass, polytrichum and sphagnum mosses. This pond is one of a cluster of four ponds located close together.

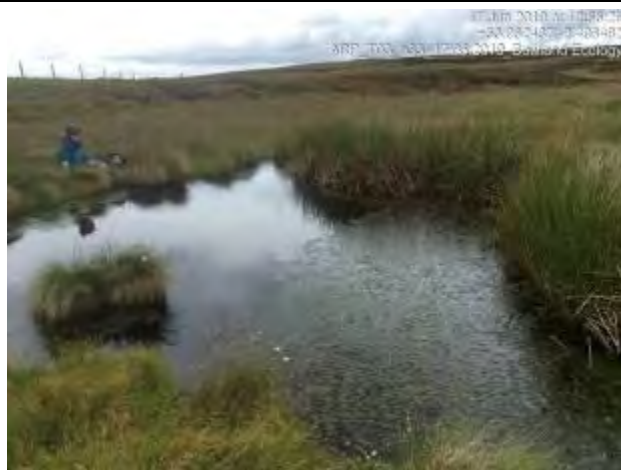
TR3 Pond 35

Small circular pond (approximately 7m diameter) in an open heathland, surrounding habitat is bog with polytrichum and Sphagnum moss forming dense carpets in and around the pond. Soft rush, tufted hair grass and common cotton grass also present around pond. The water is very deep and a dark brown/orange in colour suggesting high organic matter content (peat rich). This pond is one of a cluster of four ponds located close together.

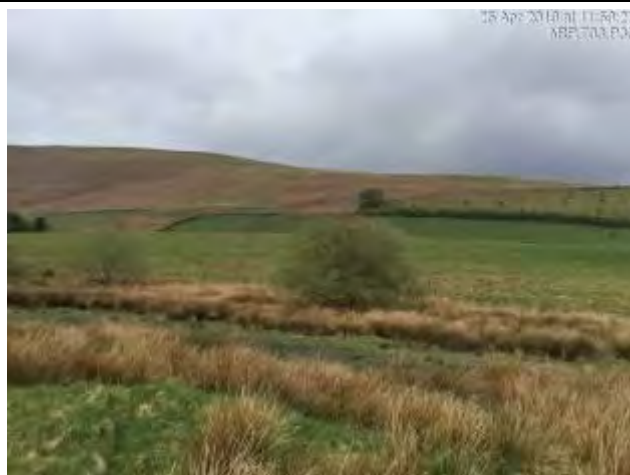
TR3 Pond 36

Dry pond; large and flat expanse of short-sward species poor semi-improved grassland surrounded by soft rush along the margins.

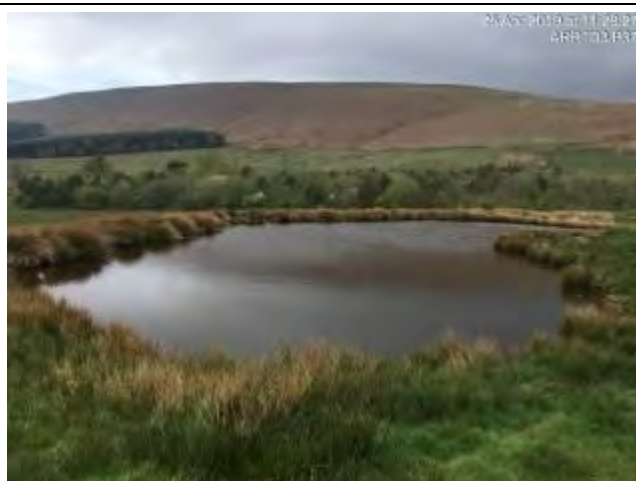
TR3 Pond 37

Large roughly oval-shaped pond (approximately 35m x 18m) surrounded by heathland / moorland habitats, with a hedgerow and large expanse of mixed woodland nearby. The immediate surrounding area is classified as a 'wildlife area' by the farm. The pond perimeter is dominated by soft rush. Mallards (*Anas platyrhynchos*) were recorded nesting at the pond edge. The pond banks are steep, vertical earth banks. The water is highly turbid, with an abundance of organic matter.

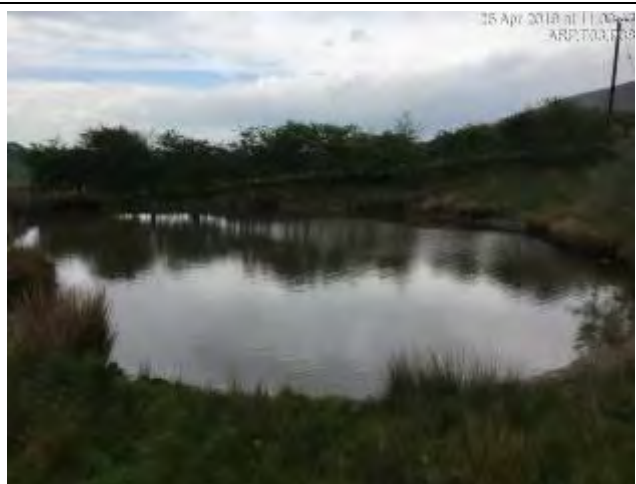
TR3 Pond 38

Moderately sized, approximately oval pond (24m x 16m) located within a grazed sheep pasture. A nearby hedgerow is present to the north and comprises silver birch (*Betula pendula*), hawthorn and holly (*Ilex aquifolium*). The pond is sectioned off from grazing animals via timber fencing. There is some minor evidence of waterfowl use at the pond edges. The pond is shallow and approximately 40cm in the centre. The pond edges are shallow, mud / earth with some exposed rock. Surrounding vegetation includes willow (*Salix* sp.) scrub, soft rush and rosebay willowherb (*Chamaenerion angustifolium*). Dense clumps of tadpoles (not identified to species) were noted throughout the pond.

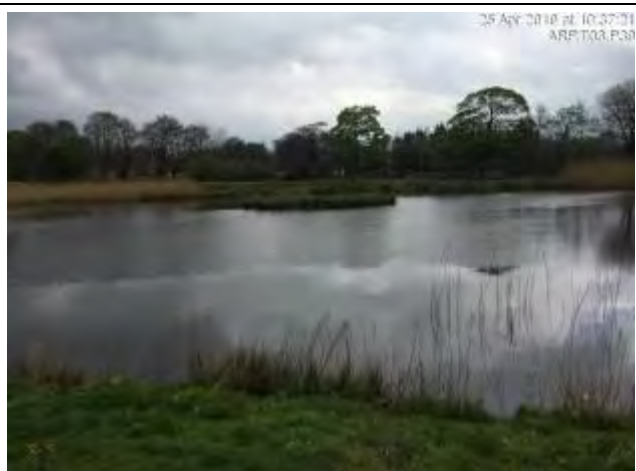
TR3 Pond 39

Large, approximately rectangular pond (65m x 60m) which is situated within grazed semi-improved grassland. Species recorded include meadow grass sp., lesser celandine (*Ranunculus ficaria*), cuckooflower (*Cardamine pratensis*), yellow rattle (*Rhinanthus minor*) and marsh marigold (*Caltha palustris*). A farm track is adjacent to the east. There is a small central island which is dominated by soft rush at the edges and grasses in the centre. Common reed (*Phragmites australis*) dominates the northern pond edge. A group of mature sycamore (*Acer pseudoplatanus*) and alder trees are present at the southern edge of the pond. Nesting mute swans (*Cygnus olor*), mallard and tufted duck (*Aythya fuligula*) are present. The pond edges are a mixture of shallow sloping and vertical earth banks. Scattered alder scrub is present around the edges. A small inflow channel is present in the south-western corner.

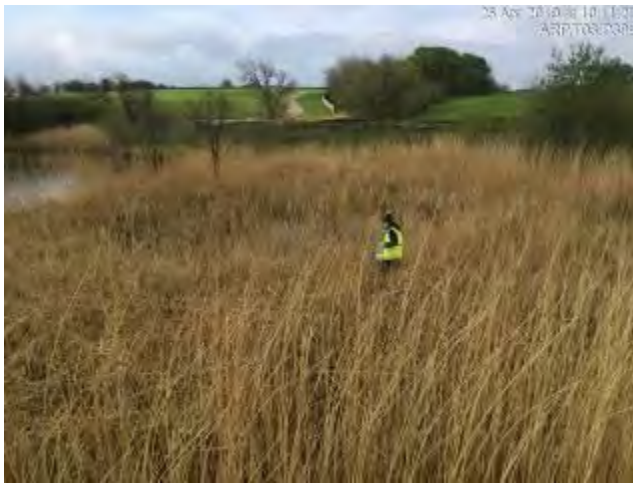
TR3 Pond 39a

Small, roughly circular pond (approximately 8m diameter) which is dominated by common reed which is present both within the pond and along the edges. This pond is situated south-east of TR3 Pond 39b and in heavy rain they are likely to join together. The pond may also connect to the much larger TR3 Pond 39 (to the east) during heavy rainfall. It is likely that historically the two ponds were one. The surrounding habitat consists of semi-improved grassland with some scattered willow scrub. A tree line is present to the east.

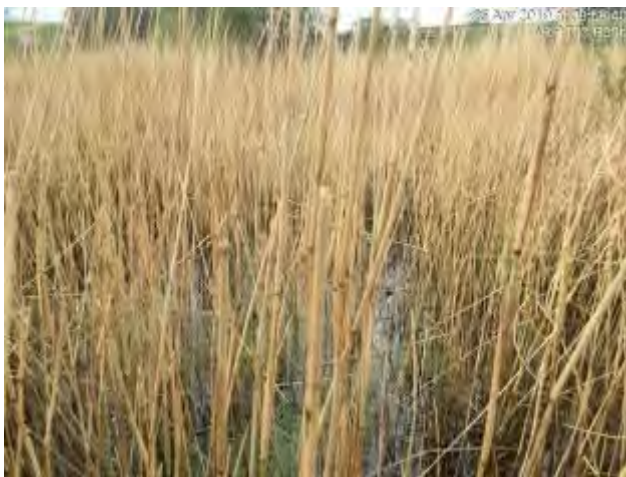
TR3 Pond 39b

Small, roughly circular pond (approximately 6m diameter) which is completely choked with common reed. The tall vegetation shades the pond. This pond is situated north-west of TR3 Pond 39a and in heavy rain is likely to join together. Pondweed sp. and common water starwort are present within the pond. The surrounding habitat consists of semi-improved grassland with some scattered willow scrub.

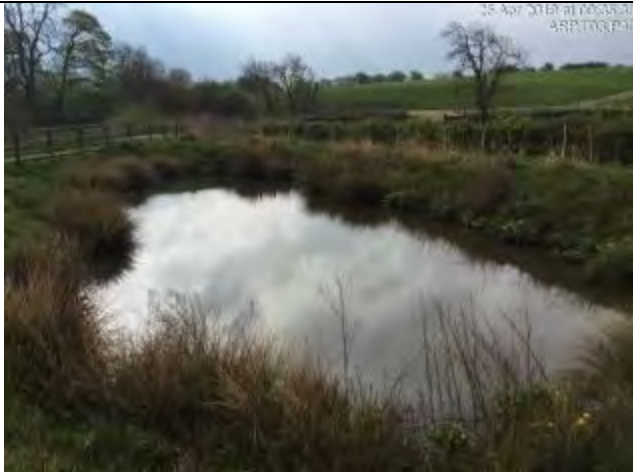
TR3 Pond 40

Small, roughly rectangular pond (approximately 16m x 10m) which is fed by a brook to the south-east. The pond is fenced off to the north and south and there is a laid hedgerow along the southern boundary. The pond perimeter consists of dense tussocks of soft rush with scattered rosebay willowherb and marsh marigold. The water was highly turbid during the survey; however, this could be due to the recent heavy rain. Pond edges are steep grassy banks.

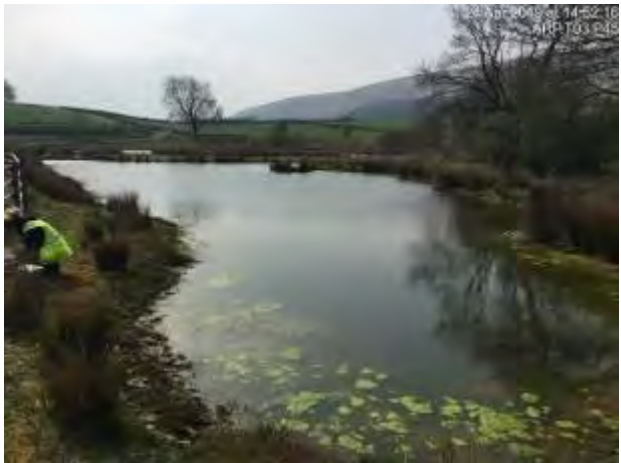
<p>Moderately sized (40m x 20m) irregular shaped pond situated within grazed pasture. A farm track runs along the southern boundary. The pond perimeter is scattered with soft rush. Algae is present within the pond along with dense numbers of tadpoles (not identified to species). Pond edges are gently sloping. The pond is partially fenced off and also immediately adjacent to another pond on the west. A line of trees and scrub are present along the northern boundary.</p>

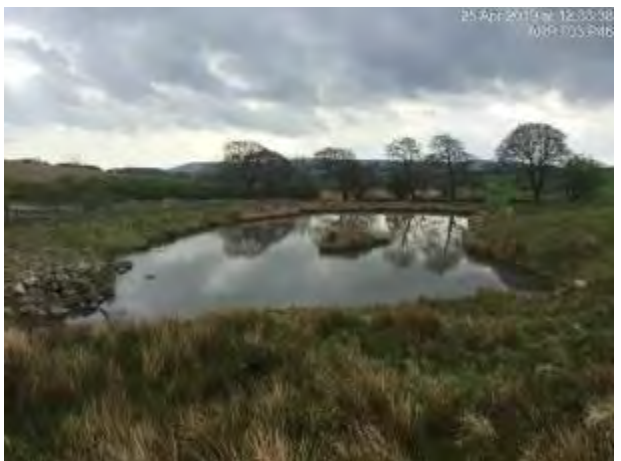
<p>TR3 Pond 46</p>

<p>Moderately sized (40m x 22m) approximately rectangular pond situated within grazed pasture adjacent to a farm track. A small island is present within the pond centre and is vegetated with soft rush. A small inflow of water is present at the northern edge of the pond from TR3 Pond 47. The banks are gently sloping and there is a section of rocks at the north corner. There is some evidence of poaching of the water edges by livestock. A tree line is present along the south and a hedgerow to the east between the pond and the farm track. Low numbers of tadpoles (not identified to species) were noted within the pond.</p>

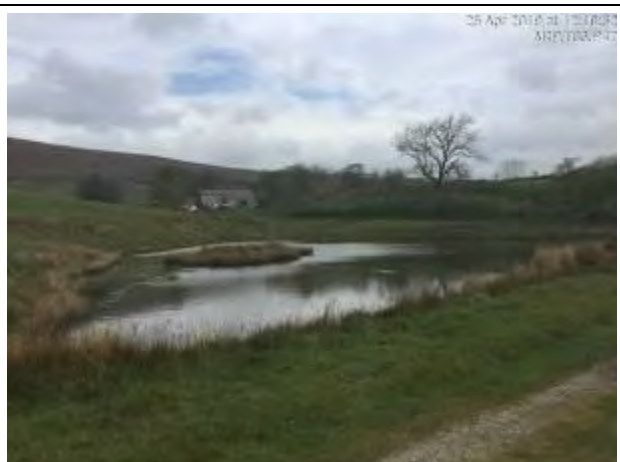
<p>TR3 Pond 47</p>

<p>Large, irregular shaped pond (approximately 52m x 34m) surrounded by grazed pasture at the base of a slope. A small inflow of water is present at the northern edge of the pond. There is a small outflow of water at the southern edge of the pond which flows into TR3 Pond 46. A small central island is present within the pond and is vegetated with soft rush. Soft rush is also scattered around the pond perimeter. Water horsetail is present within the pond. A hedgerow is present to the east between the pond and a farm track. There is evidence of livestock access to the pond edges. A small number of tadpoles (not identified to species) were observed within the pond.</p>
<p>TR3 Pond 48</p>

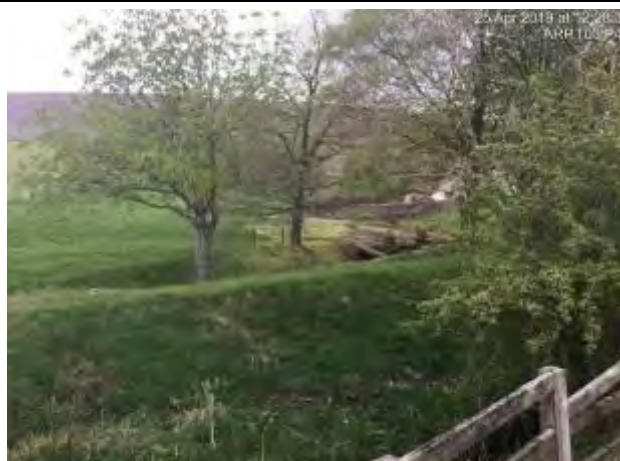
<p>Dry pond; a steep depression within the field surrounded by broadleaved woodland which is connected to a drain/ditch and likely to fill with water during heavy rain.</p>
<p>TR3 Pond 49</p>

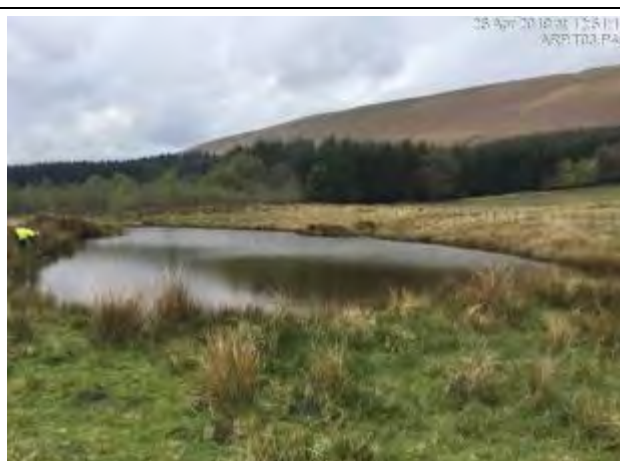
<p>A large (58m x 16m) roughly rectangular pond situated adjacent to a farm track and surrounded by grazed pasture. Nearby habitats include immature broadleaved plantation and a large expanse of coniferous plantation. The pond edges are a mixture of steep, marshy grassland banks and gentle sloping earth / exposed stone. A small number of tadpoles (not identified to species) were observed within the water. Tufted ducks and mallards were noted during the survey. There are two small islands at the western end of the pond which are vegetated with soft rush and scattered willow scrub. The pond is fenced off along the north-western elevation. The water was particularly turbid during the survey.</p>

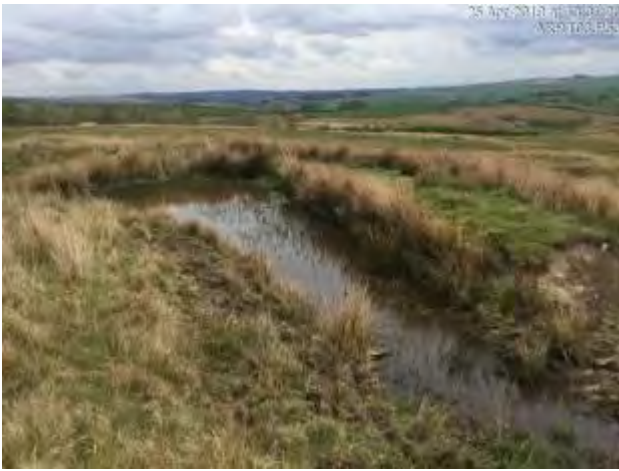
<p>TR3 Pond 53</p>

<p>A small (12m x 6m) pond situated within grazed pasture and located within a network of drainage ditches and series of ponds (TR3 Ponds 50 to 56). There is slow outflow from the pond to the south-west, which extends towards a large expanse of coniferous plantation woodland. Evidence of livestock poaching is present throughout the pond perimeter. A small number of tadpoles (not identified to species) were present. The water at the time of the survey was moderately turbid.</p>
<p>TR3 Pond 54</p>

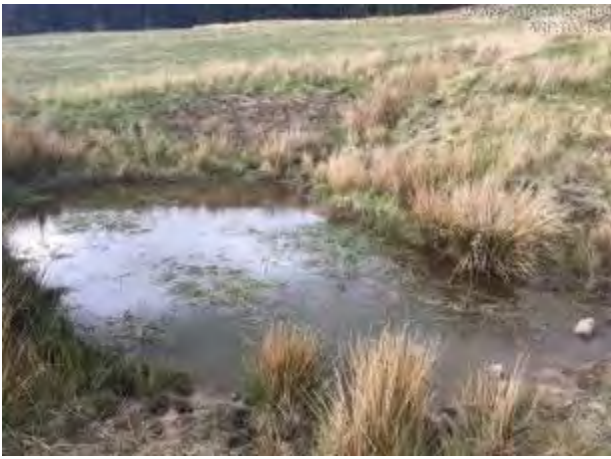
<p>A small (12m x 6m) pond situated within grazed pasture and located within a network of drainage ditches and series of ponds (TR3 Ponds 50 to 56). Evidence of livestock poaching is present throughout the pond perimeter. The water at the time of the survey was moderately turbid. Surrounding vegetation is dominated by soft rush. The pond edges are gently sloping. Floating sweet grass is present within the pond.</p>

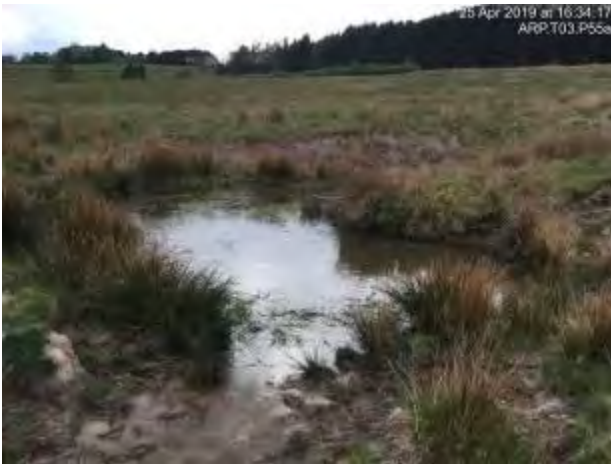
<p>TR3 Pond 55</p>

<p>A small (6m x 6m) irregular shaped pond situated within grazed pasture and located within a network of drainage ditches and series of ponds (TR3 Ponds 50 to 56). A ditch overflow is present along the south-eastern edge. Evidence of livestock poaching is present throughout the pond perimeter. The water at the time of the survey was moderately turbid. Surrounding vegetation is dominated by soft rush. The pond edges are a mixture of gently sloping and steep grassy banks. Floating sweet grass is present within the pond.</p>

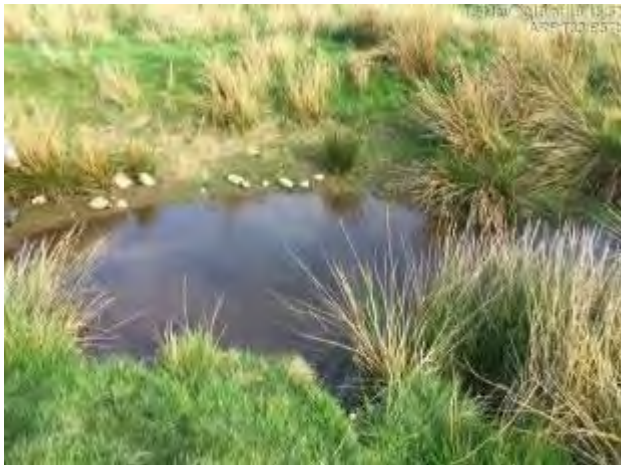
<p>TR3 Pond 57b</p>

<p>Small (5m x 2m) and shallow (up to 20cm) pond, third in a succession of interconnected ponds along a drainage ditch (TR3 Ponds 57-57f) leading to a plantation woodland. The surrounding habitat comprises dense, soft rush dominated marshy grassland. The habitat is lightly grazed by cattle. There is a high silt content within the pond. A small area (approximately 10%) of floating sweet grass is present along the south-eastern edge. The banks are gently sloping with some areas of exposed bare earth / rocks.</p>
<p>TR3 Pond 57c</p>

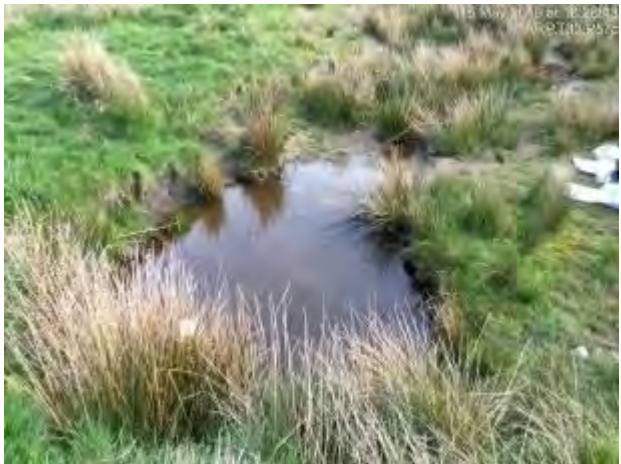
<p>A small pond (3m x 10m), fourth in a succession of interconnected ponds along a drainage ditch (TR3 Ponds 57-57f) leading to a plantation woodland. The surrounding habitat comprises dense, soft rush dominated marshy grassland. The habitat is lightly grazed by cattle. The pond has dried and reduced in size (approximately one quarter of the full size). The pond is shaded partially by the steep earth bank and tall rushes. The pond is up to 40cm at the deepest point. A small area of floating sweet grass is present within the pond; approximately 10% of the surface.</p>

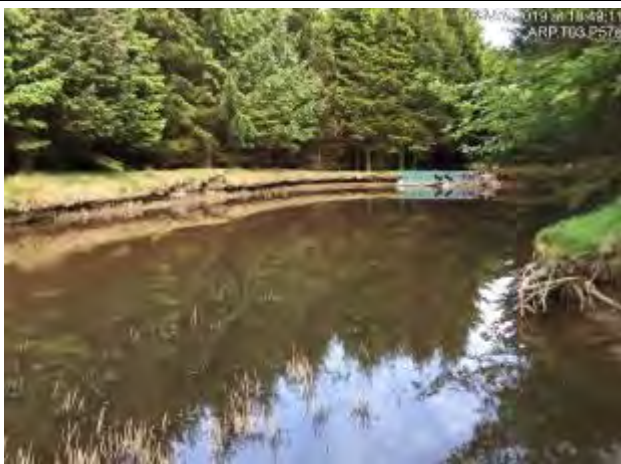
<p>TR3 Pond 57d</p>

<p>Large pond (30m x 20m) within plantation woodland and fifth in a succession of interconnected ponds along a drainage ditch (TR3 Ponds 57-57f). There is evidence of use by waterfowl and a mallard nest was identified at the north-western edge. The pond banks are steep bare earth and undercut. The water level was particularly low at the time of survey evidenced by the exposed banks. The pond is shaded by the adjacent mature trees. The water was highly turbid at the time of the survey. There are small areas of scattered emergent soft rush but otherwise the banks are bare.</p>

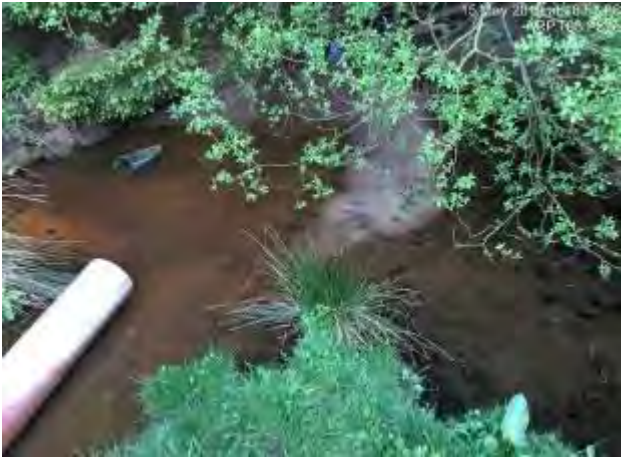
<p>TR3 Pond 57e</p>

<p>Small (5m x 5m) pond within plantation woodland and sixth in a succession of interconnected ponds along a drainage ditch (TR3 Ponds 57-57f). The pond is essentially a pooled area of stagnant water at the southern edge of a ditch and is almost entirely beneath an overhanging willow tree. There are large expanses of surface algae and no emergent vegetation. Nearby vegetation comprises coarse, marshy grassland and sheep-grazed pasture. The pond is shallow, up to 30cm, and the water is tinted bright orange / brown in places suggesting iron oxide content.</p>
<p>TR3 Pond 57f</p>

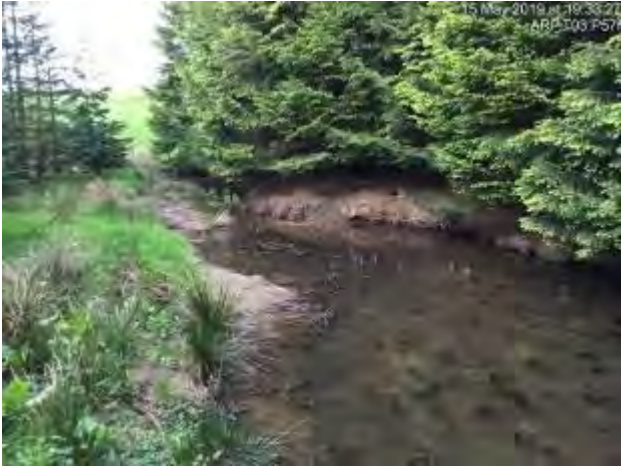
<p>Large pond (39m x 10m), seventh/last in a succession of interconnected ponds along a drainage ditch (TR3 Ponds 57-57f). The pond is densely bordered by coniferous trees on the eastern side where the banks are steep, bare earth and undercut. The pond is heavily shaded by the nearby trees, although there is an open section to the west which is bordered by an area of grassland and gentle sloping banks. The pond is approximately 50cm deep. There is a small area of water mint along the western pond edge. Surface algae is frequent throughout the pond. Rabbit holes are frequent along the eastern bank. There is evidence of waterfowl use around the perimeter.</p>

*Inconclusive result indicates degradation or inhibition of the sample, therefore lack of detection of GCN DNA is not conclusive evidence for determining the absence of the species in the sample provided. T03.P12 and T03.P24 showed sample inhibition and degradation. T03.P57f showed sample degradation.

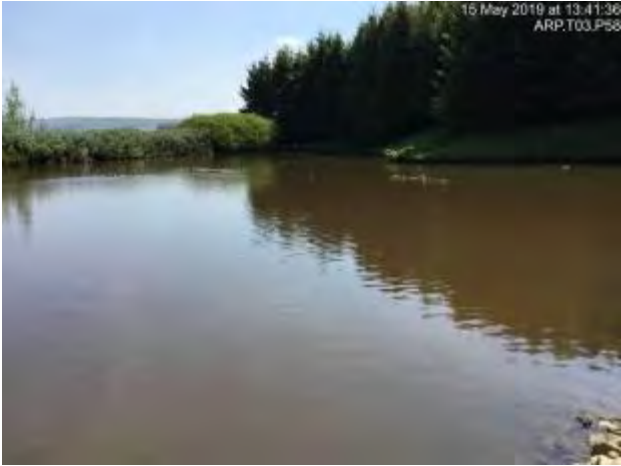
<p>TR3 Pond 58</p>

<p>Large lake/pond (50m x 25m) adjacent to a residential property and fourth/last in a succession of ponds along a drainage ditch (TR3 Ponds 60 to 58, not including 58a and 58b). The pond is maintained for use by waterfowl, with approximately 30 mallard ducks present at the time of survey and lots of evidence around the perimeter. The water is turbid and there is an inflow of water from the north-west, and outflow to the south-east. The pond edges are a mixture of stone boulders and steeply sloping grassy, undercut banks. The immediately surrounding habitat includes coniferous woodland (south), introduced shrub (east), marshy grassland and sheep-grazed pasture (north and west). There is no emergent vegetation, bankside species recorded include soft rush, common nettle, creeping thistle (<i>Cirsium arvense</i>) and broadleaved dock.</p>

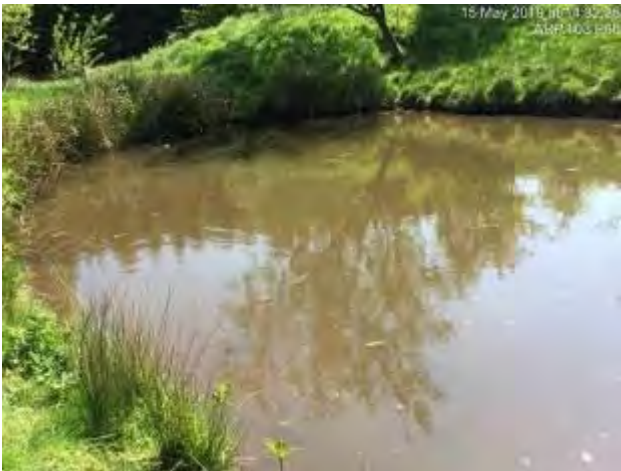
<p>TR3 Pond 60</p>

<p>Small (5m x 10m), roughly circular pond with very slow inflow from the north-west and outflow to the south-east. This pond is second in a succession of interconnected ponds along a drainage ditch (TR3 Ponds 60 to 58, not including 58a and 58b). There is nearby immature willow scrub, semi-improved grassland and coniferous woodland. The water was turbid at the time of survey and the pond is an unknown depth. There is a small amount of soft rush along the pond perimeter but otherwise the edges comprise various grass species and scattered willow saplings. The pond edges are steep, partially undercut earth banks which shade the pond partially. A thin film of oil pollution is present on the surface in stagnant areas of the pond edges.</p>
<p>TR3 Pond 61</p>

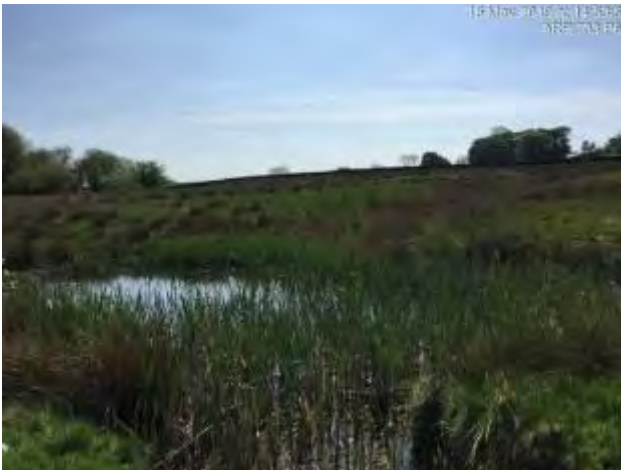
<p>Moderately sized (15m x 10m) roughly oval shaped pond which is first in a succession of interconnected ponds along a drainage ditch (TR3 Ponds 60 to 58, not including 58a and 58b). Bulrush dominates the pond edges and provides some shading below. There is also a small amount of water horsetail. The pond is immediately surrounded by marshy grassland and sheep-grazed pasture and is situated at the base of a shallow slope. The pond edges are a mixture of gently sloping and vertical earth banks.</p>

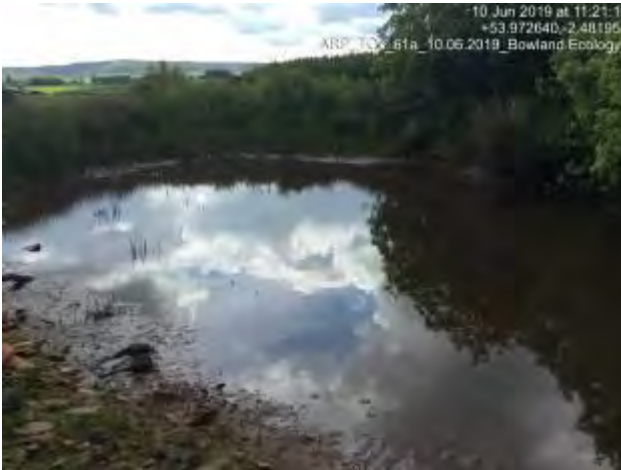
<p>TR3 Pond 61a</p>

<p>Small (140m²) shallow pond situated within a silage field, 100m from conifer plantation. The pond is fenced. The water is clear, and the substrate is silty. There are no macrophytes and very few invertebrates. Horsetail sp. and soft rush are present at the pond edges. There are willow trees on the banks. There is a small outflow to the south. This pond is last / fifth in a succession of interconnected ponds along a drainage channel (TR3 Ponds 61e to 61a).</p>

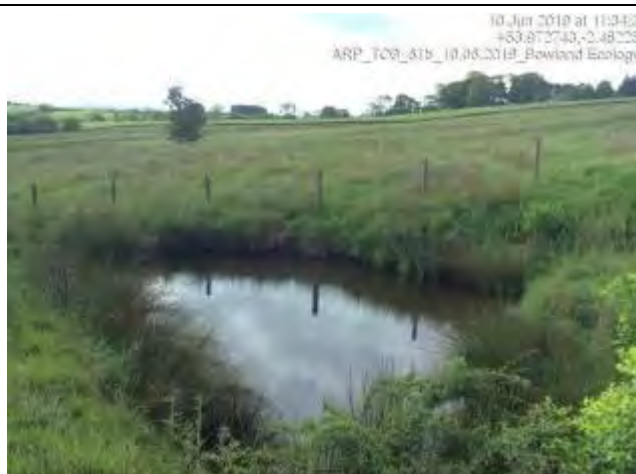
<p>TR3 Pond 61b</p>

<p>Small (50m²) and shallow pond (approximately 20cm deep) situated within a silage field and fenced off. The water is clear, and a silty substrate is visible. The banks are steep and vegetated with soft rush, meadowsweet (<i>Filipendula ulmaria</i>), ribwort plantain (<i>Plantago lanceolata</i>), yarrow (<i>Achillea millefolium</i>) and various grasses. Willow and hawthorn scrub surround the pond which is fourth in a succession of interconnected ponds along a drainage channel (TR3 Ponds 61e to 61a).</p>
<p>TR3 Pond 61c</p>

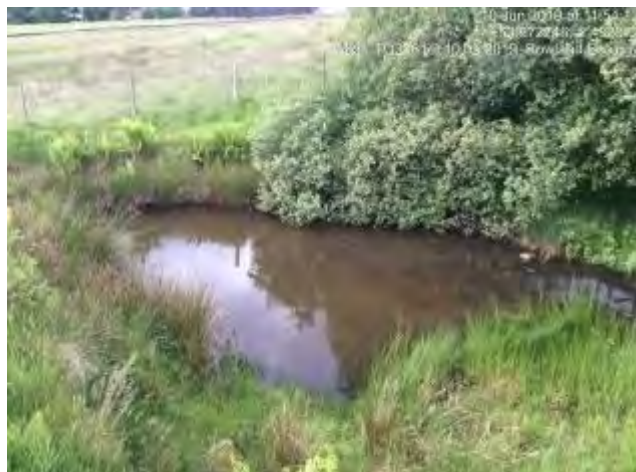
<p>Small (80m²) shallow pond, situated within a hay/silage field. The water is clear with a silty substrate. There is a large willow tree on north-western bank. Surrounding vegetation comprises soft rush, horsetail, marsh thistle, meadow sweet, bracken and grass species. This pond is third in a succession of interconnected ponds along a drainage channel (TR3 Ponds 61e to 61a).</p>

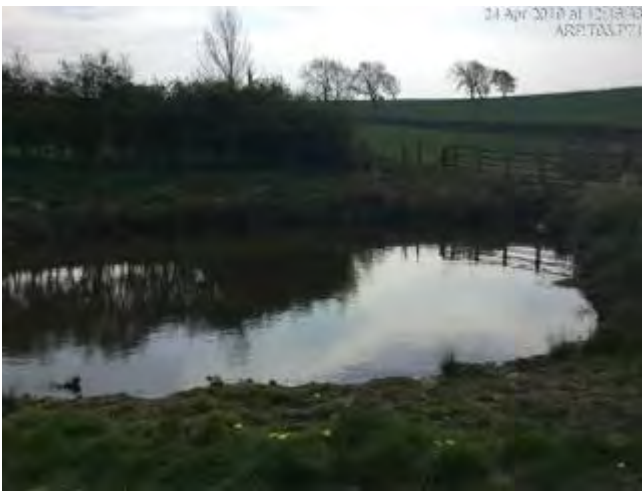
<p>Moderately sized (18m x 18m) roughly circular pond which is partially fenced off. A hedgerow is present to the east. A nearby public footpath is present to the west. Dog footprints were observed at the pond perimeter. Nesting mallards were observed on the pond. Soft rush is scattered around the pond. The banks are shallow sloping. There is no emergent vegetation.</p>
<p>TR3 Pond 72</p>

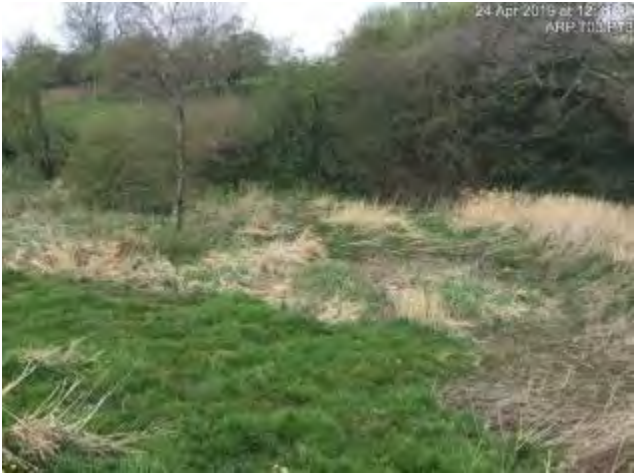
<p>Dry pond; small depression within grassland north of TR3 Pond 72. This area is likely to hold water during periods of heavy rainfall.</p>
