Haweswater Aqueduct Resilience Programme

Chapter 9A - Appendix 9A.7

Environmental Statement

Appendix A. Bowland Ecology eDNA Survey Report

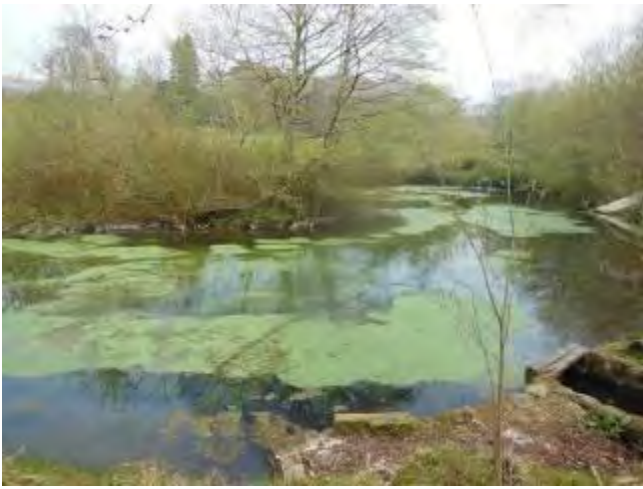
Large (500m ²) circular pond with a central island within residential garden. This pond connects to TR3 Pond 88 via a small inflow at the eastern edge and TR3 Pond 89a via a small inflow along the south-eastern edge. The banks are surrounded by immature tree species include ash, beech, willow and alder. The pond surface is heavily vegetated with common water starwort and there is a small scattering of common reed along the southern edge. Nesting birds were observed on the water including domestic geese and mallards. The pond is an unknown depth and has gently sloping banks with some exposed earth and rocks.
TR3 Pond 89a
