Document reference: LCC-RVBC-BO-SEI Appendix B7

**Haweswater Aqueduct Resilience Programme -  
Proposed Bowland Section**

**Appendix B7: Ecology Assessment - Off-Site Highways Works**

February 2022

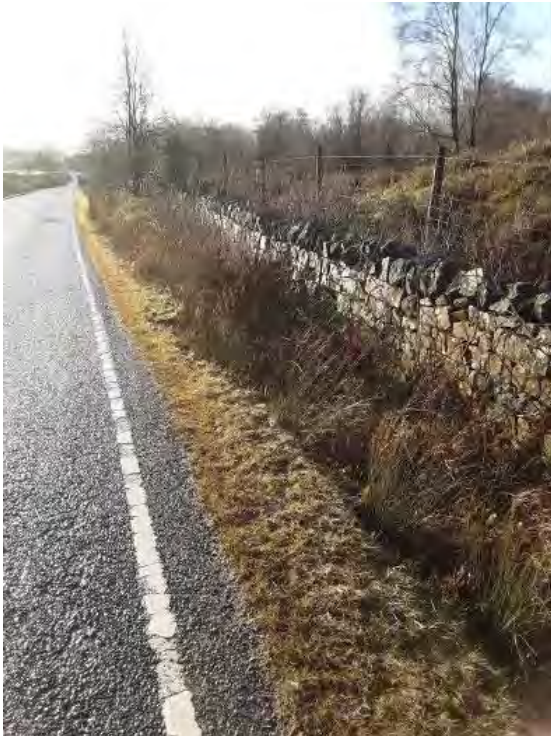
TR4.HTN41

<b>Protected Species Assessment</b>			<b>Summary of Constraints</b>		
<ul style="list-style-type: none"> <li>The adjacent habitats have ground nesting bird potential.</li> <li>The mix of habitats on and adjacent to the site could support a range of foraging and commuting species (e.g. reptiles, bats, badger, brown hare, invertebrates).</li> <li>Amphibians are unlikely to be present due to lack of potential breeding ponds (&gt; 500m).</li> </ul>			<ul style="list-style-type: none"> <li>Habitats will be not reinstated on completion of the works.</li> <li>Works appear to be limited to the SI grassland road verge. No significant impacts anticipated.</li> <li>It is assumed the adjacent dry stone wall will remain in-situ, thus protecting the adjacent habitats.</li> <li>Works should avoid the nesting bird season or be subject to nesting bird checks (including adjacent fields).</li> <li>Waddington Fell and Browsholme Moor BHS lies adjacent to the site on the opposite side of the road.</li> </ul>

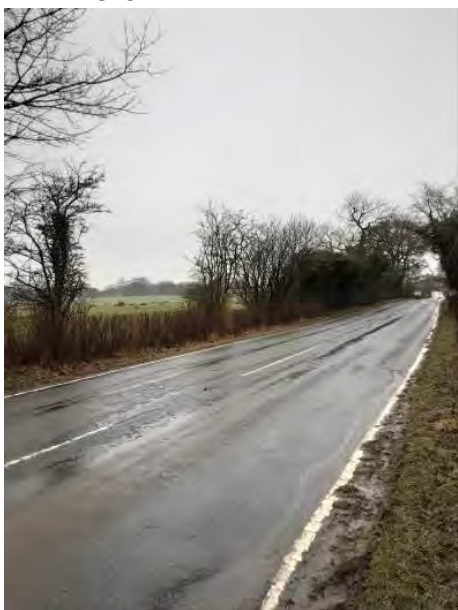
TR4.HBG19

Protected Species Assessment			Summary of Constraints		
<ul style="list-style-type: none"><li>Group of trees approx. 20m from the site have moderate potential to support roosting bats (TR4.HBG19). This tree will not be removed to facilitate works but there is a risk overhanging branches may require removal.</li><li>The hedgerow has nesting bird potential. The adjacent SI grassland has ground nesting bird potential.</li><li>The mix of habitats on and adjacent to the site could support a range of foraging and commuting species (e.g. reptiles, bats, badger, brown hare, hedgehog, invertebrates).</li><li>Amphibians are unlikely to be present due to lack of potential breeding ponds (&gt; 500m).</li></ul>			<ul style="list-style-type: none"><li>Habitats will be not reinstated on completion of the works.</li><li>Works appear to be limited to the road verge, therefore it is assumed the adjacent hedgerow will not be impacted by the proposals.</li><li>Works should avoid the nesting bird season or be subject to nesting bird checks (including hedgerows and adjacent fields).</li><li>Works should avoid any impacts to trees with bat potential in proximity of the site. If any branch removal is required to facilitate works, further surveys will be required in relation to roosting bats before works can commence.</li></ul>

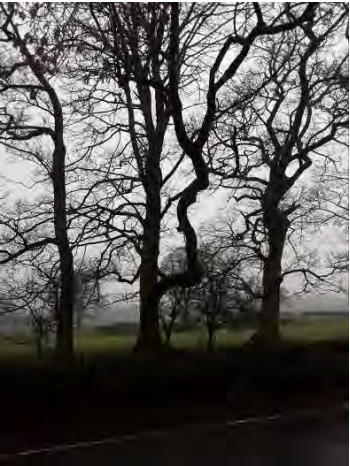
TR4.HBG16

<b>Protected Species Assessment</b>			<b>Summary of Constraints</b>		
<ul style="list-style-type: none"> <li>Several trees adjacent to the site have moderate potential to support roosting bats (TR4.HBG16, TR4.HBG15, TR4.HBG14). Two other trees adjacent to the site have moderate potential to support roosting bats (TR4.HBG17, TR4.HBT26). These trees will not be removed to facilitate works but there is a risk overhanging branches may require removal.</li> <li>The woodland at TR4.HTN59 has potential for nesting birds and foraging and commuting habitat for bats.</li> <li>The hedgerow has nesting bird potential. The adjacent SI grassland has ground nesting bird potential.</li> <li>The mix of habitats on and adjacent to the site could support a range of foraging and commuting species (e.g. reptiles, bats, badger, brown hare, hedgehog, invertebrates).</li> <li>Amphibians are unlikely to be present due to lack of potential breeding ponds (&gt; 500m).</li> </ul>			<ul style="list-style-type: none"> <li>Habitats will be not reinstated on completion of the works.</li> <li>Current proposals will require removal of approximately 60 m of species-rich intact hedgerow and trees as well as associated SI verge habitat.</li> <li>Hedgerow could be classed as important under the Hedgerow Regulations 1997.</li> <li>Mitigation for hedgerow loss will be required which needs agreeing with the LPA, either as part of the reinstatement proposals or improvement of adjacent areas of hedgerow.</li> <li>Works should avoid the nesting bird season or be subject to nesting bird checks.</li> <li>Works should avoid any impacts to trees with bat potential in proximity of the site. If any branch removal is required to facilitate works, further surveys will be required in relation to roosting bats before works can commence.</li> </ul>

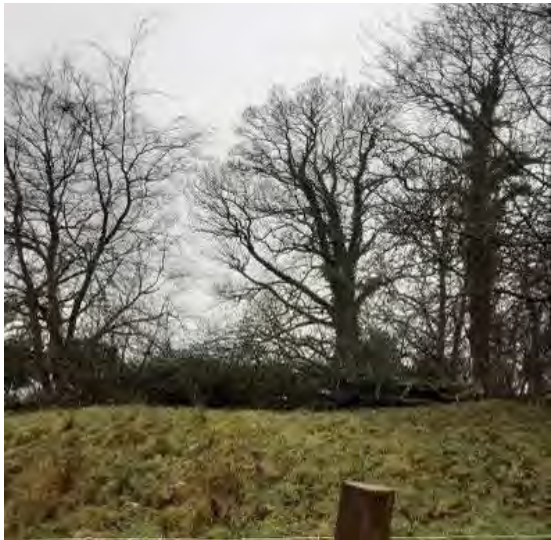
TR4.HTN56

<b>Protected Species Assessment</b>			<b>Summary of Constraints</b>		
<ul style="list-style-type: none"> <li>Brash pile adjacent to scrub and scattered trees. This habitat is a suitable refuge for amphibians as well as having potential for nesting birds and small mammals (including hedgehog) (TR4.HTN56).</li> <li>The adjacent woodland has potential for large mammals (including badger setts), nesting birds, roosting, commuting and foraging bats, small mammals and terrestrial habitats for amphibians (TR4.HTN57).</li> <li>Variegated yellow archangel within the understory of the woodland. This is listed as an invasive species on Schedule 9 of the Wildlife and Countryside Act 1981 (as amended) (TR4.HTN58).</li> <li>The mix of habitats on and adjacent to the site could support a range of foraging and commuting species (e.g. reptiles, bats, badger, brown hare, hedgehog, invertebrates).</li> <li>Amphibians are unlikely to be present due to lack of potential breeding ponds (&gt; 500m).</li> </ul>			<ul style="list-style-type: none"> <li>Habitats will be not reinstated on completion of the works.</li> <li>Works appear to be limited to the road verge, therefore it is assumed the adjacent woodland and scrub will not be impacted by the proposals.</li> <li>Works should avoid the nesting bird season or be subject to nesting bird checks (including adjacent habitats).</li> <li>Works should avoid any impacts to trees with bat potential in proximity of the site. If any branch removal is required to facilitate works, further surveys will be required in relation to roosting bats before works can commence.</li> </ul>

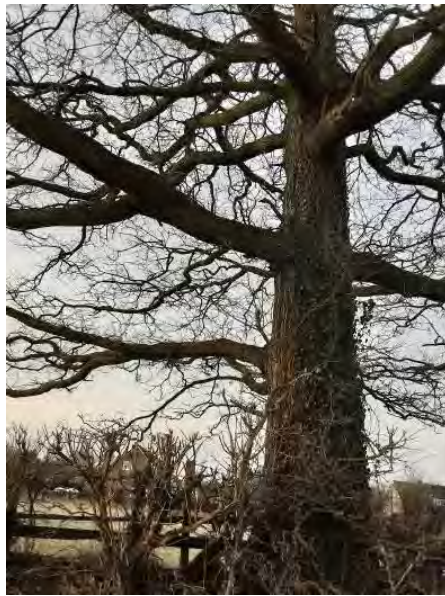
TR4.HBT27

Protected Species Assessment			Summary of Constraints		
<ul style="list-style-type: none"><li>One tree in the local area has low potential to support roosting bats (TR4.HBT27), but is located sufficient distance from the works to assume no impacts to these tress will occur.</li><li>The scrub and adjacent SI grassland have nesting bird potential.</li><li>The limited mix of habitats on and adjacent to the site could support a range of limited foraging and commuting species (e.g. reptiles, bats, badger, brown hare, hedgehog, invertebrates).</li><li>Amphibians are unlikely to be present due to lack of potential breeding ponds (&gt; 500m).</li></ul>			<ul style="list-style-type: none"><li>Habitats will be not reinstated on completion of the works.</li><li>Works appear to be limited to the road verge with a small loss of scrub and SI field.</li><li>Works should avoid the nesting bird season or be subject to nesting bird checks (including hedgerows and adjacent fields).</li></ul>

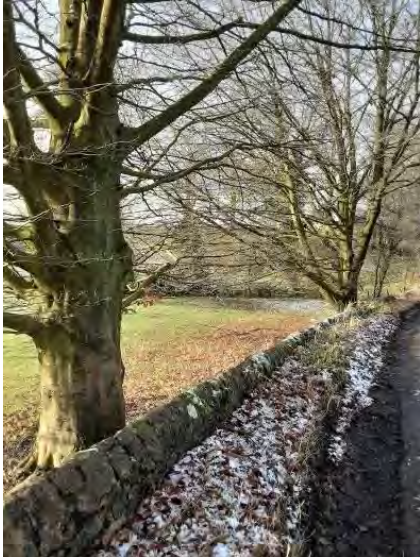
TR4.HBG23

<b>Protected Species Assessment</b>			<b>Summary of Constraints</b>		
<ul style="list-style-type: none"> <li>Multiple trees adjacent to the site have moderate potential to support roosting bats (TR4.HBG25, TR4.HBG24). Multiple trees adjacent to the site have low potential to support roosting bats (TR4.HBG23). These trees will not be removed to facilitate works but there is a risk overhanging branches may require removal.</li> <li>The hedgerow, wall and adjacent SI grassland have nesting bird potential.</li> <li>The mix of habitats on and adjacent to the site could support a range of foraging and commuting species (e.g. reptiles, bats, badger, brown hare, invertebrates).</li> <li>Amphibians are unlikely to be present due to lack of potential breeding ponds (&gt; 500m).</li> </ul>			<ul style="list-style-type: none"> <li>Habitats will be not reinstated on completion of the works.</li> <li>Current proposals will require removal of approximately 30 m of species-rich intact hedgerow and associated verge habitat.</li> <li>Hedgerow could be classed as important under the Hedgerow Regulations 1997.</li> <li>Mitigation for hedgerow loss will be required which needs agreeing with the LPA, either as part of the reinstatement proposals or improvement of adjacent areas of hedgerow.</li> <li>Loss of a small area of adjacent semi-improved grassland is unlikely to have a significant adverse effect but there could be disturbance to ground nesting species using the wider field.</li> <li>Works should avoid the nesting bird season or be subject to nesting bird checks.</li> </ul>

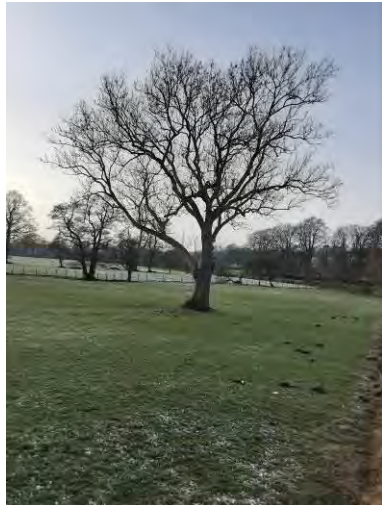
<div>TR4.HBT30</div>

Protected Species Assessment			Summary of Constraints				
<ul style="list-style-type: none"><li>Two trees adjacent to the site have moderate potential to support roosting bats (TR4.HBG28, TR4.HBT30). These trees will not be removed to facilitate works but there is a risk overhanging branches may require removal.</li><li>Four trees in proximity to the site adjacent to the river have moderate potential to support roosting bats (TR4.HBG29). These trees appear to be located a sufficient distance from the works to assume no impacts to these tress will occur.</li><li>The mix of habitats on and adjacent to the site could support a range of foraging and commuting species (e.g. reptiles, bats, badger, brown hare, hedgehog, invertebrates, and amphibians).</li><li>The River Ribble lies immediately to the north of the works. The watercourse could be suitable to support commuting and foraging otter and water vole, as well as water vole burrows, however no impacts to bankside habitat are anticipated. This section of watercourse does not provide enough cover to support otter holts. There will be no direct impacts associated with these species.</li></ul>			<ul style="list-style-type: none"><li>Habitats will not be reinstated on completion of the works</li><li>Works appear to be limited to an area of SI grassland habitat.</li><li>Works should avoid the nesting bird season or be subject to nesting bird checks (including wall, adjacent fields and river).</li><li>Works should avoid any impacts to trees with bat potential in proximity of the site. If any branch removal is required to facilitate works, further surveys will be required in relation to roosting bats before works can commence.</li><li>River Ribble from London Road Bridge Preston, in West, to County Boundary, in East BHS encompasses the River Ribble and lies adjacent to the site (north)</li></ul>

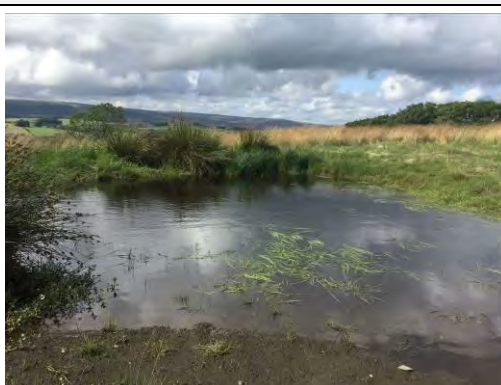
<p>Approximately five scrapes within semi-improved neutral grassland, which have been purposefully excavated for lapwing (<i>Vanellus vanellus</i>) breeding. The scrapes are shallow (approx. 20 to 40cm) and periodically dry throughout the summer. Water enters the scrapes from the adjacent access road, filling the eastern pool first, then soaking westwards. There is some flow between the scrapes and an oily film on the water surface. The land occupier confirms common toad (<i>Bufo bufo</i>) and common frog (<i>Rana temporaria</i>) are frequently observed along the roadside. Plant species present include brooklime (<i>Veronica beccabunga</i>), floating sweet grass (<i>Glyceria fluitans</i>), soft rush (<i>Juncus effusus</i>), water mint (<i>Mentha aquatica</i>), lesser spearwort (<i>Ranunculus flammula</i>), water starwort species (<i>Callitriche</i> sp.), bulbous rush (<i>Juncus bulbosus</i>), jointed rush (<i>Juncus articulatus</i>) and horsetail species (<i>Equisetum</i> sp.).</p> <p>Habitat Condition (provisional): Good (Score 3)</p>

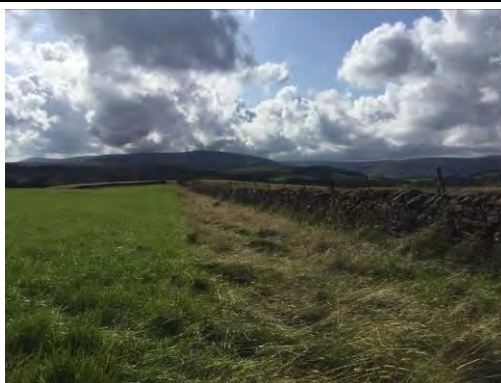
TR4.TN16

<p>A traditional hay meadow which has been restored. The meadow is cut once per year, after 15<sup>th</sup> July, with no fertiliser added and it is lightly sheep grazed. Species include yellow rattle (<i>Rhinanthus minor</i>), common mouse ear (<i>Cerastium fontanum</i>), creeping thistle (<i>Cirsium arvense</i>), bird’s-foot trefoil (<i>Lotus corniculatus</i>), meadow buttercup (<i>Ranunculus acris</i>), common sorrel (<i>Rumex acetosa</i>), eyebright species (<i>Euphrasia</i> sp.), ribwort plantain (<i>Plantago lanceolata</i>), sweet vernal grass (<i>Anthoxanthum odoratum</i>), meadow foxtail (<i>Alopecurus pratensis</i>), Yorkshire fog (<i>Holcus lanatus</i>), crested dog’s-tail (<i>Cynosurus cristatus</i>), common yellow sedge (<i>Carex demissa</i>), meadow vetchling (<i>Lathyrus pratensis</i>), common bent (<i>Agrostis capillaris</i>), Timothy (<i>Phleum pratense</i>), creeping bent (<i>Agrostis stolonifera</i>), meadow grass species (<i>Poa</i> sp.), meadowsweet (<i>Filipendula ulmaris</i>), horsetail species, heath bedstraw (<i>Galium saxatile</i>), lesser stitchwort (<i>Stellaria graminea</i>), marsh thistle (<i>Cirsium palustre</i>), lesser celandine (<i>Ranunculus ficaria</i>), autumn hawkbit (<i>Scorzoneroide</i></p>

*autumnalis*) and sneezewort (*Achillea ptarmica*). Potential for ground nesting birds, and small mammals at the edges which are left uncut.

Habitat Condition (provisional): Good (Score 3)

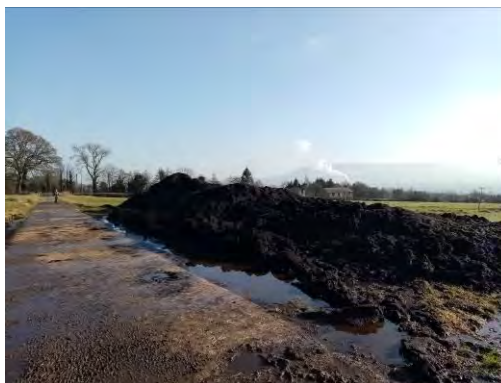
TR4.TN49

Large pile of spoil and manure which is adjacent to the access track and is leeching pollutants into the surrounding grassland.

Habitat Condition (provisional): Not applicable (no assessment required)

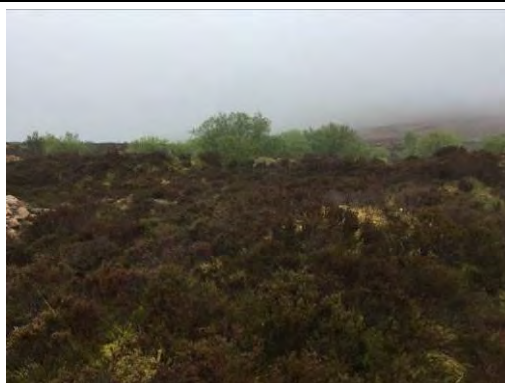
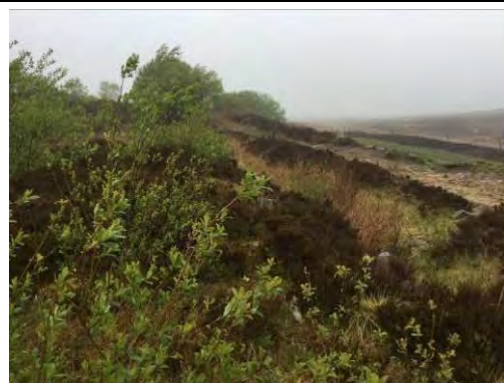
TR4.TN50

Dry dwarf shrub heath surrounding ponds (TR4.P16 and TR4.P17) and is the dominant habitat in the area. The area is unmanaged (the heather is not burnt or maintained), and on relatively flat ground surrounding the ponds, although it slopes upwards to the west, and downwards to the east. Dominant species is ling (*Calluna vulgaris*), with abundant bilberry (*Vaccinium myrtillus*), and a carpet of mosses (rarely *Sphagnum*s), several sedge species, mat grass (*Nardus stricta*), crowberry (*Empetrum nigrum*), willowherb species (*Epilobium* sp.), foxglove (*Digitalis purpurea*), broadleaved dock (*Rumex obtusifolius*), bracken (*Pteridium aquilinum*), some immature self-seeded rowan (*Sorbus aucuparia*) and willow (*Salix* sp.), red fescue (*Festuca rubra*), heath woodrush (*Luzula multiflora*) and wavy hair grass (*Deschampsia flexuosa*). The heather shrub is mature and all of a similar age. Potential for nesting birds, foraging bats, small mammals, amphibians, reptiles and otter (*Lutra lutra*) lay-up sites. An abundance of predated common frogs and toads were note at the water edge and hundreds of tadpoles are present within the ponds.

Habitat Condition (provisional): Moderate (Score 2)

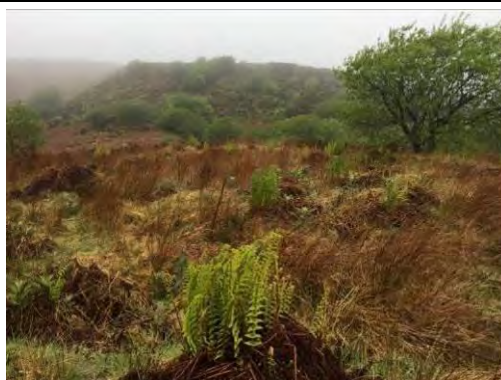
TR4.TN51

<p>Unmanaged habitat mosaic including semi-improved grassland, marshy grassland and scattered dry dwarf shrub heath. Dominant species include soft rush, foxglove, Yorkshire fog with additional male fern (<i>Dryopteris filix-mas</i>), hard fern (<i>Blechnum spicant</i>), red fescue, marsh thistle, ling, <i>Polytrichum</i> mosses, heath woodrush, heath bedstraw and compact rush (<i>Juncus conglomeratus</i>). Potential habitat for nesting birds, small mammals, foraging bats, amphibians, reptiles and otter lay-up sites.</p> <p>Habitat Condition (provisional): Moderate (Score 2)</p>		
TR4.TN52

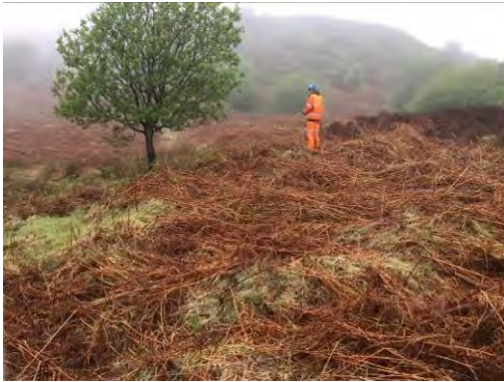
<p>Unmanaged, dense and continuous bracken which extends down the slope (facing south-east). Potential for nesting birds, small mammals, amphibians, reptiles and otter lay-up sites. There are scattered willow scrub trees within the bracken along with grass species and scattered heather.</p> <p>Habitat Condition (provisional): Moderate (Score 2)</p>

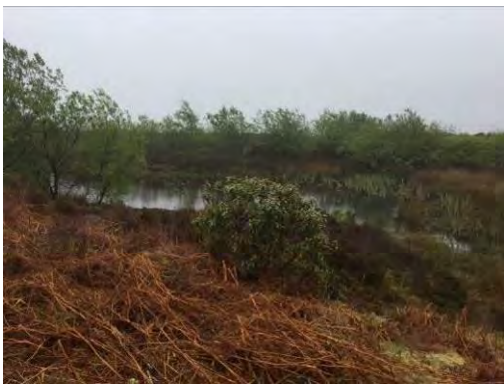
TR4.TN53

<p>Rhododendron (<i>Rhododendron ponticum</i>) (Schedule 9 Wildlife and Countryside Act 1981, as amended) shrub at the pond edge.</p> <p>Habitat Condition (provisional): Poor (Score 1)</p>		
TR4.TN59

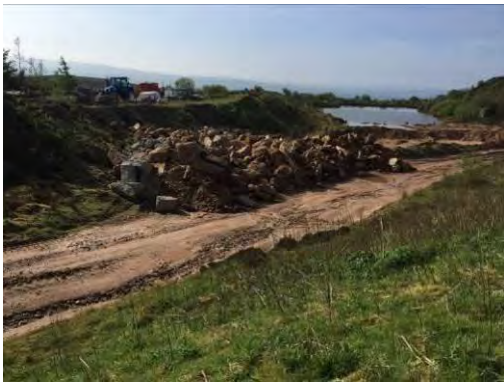
<p>Large rock pile at the side of an access trackway which provides suitable refugia for reptiles.</p> <p>Habitat Condition (provisional): Not applicable (no assessment required)</p>

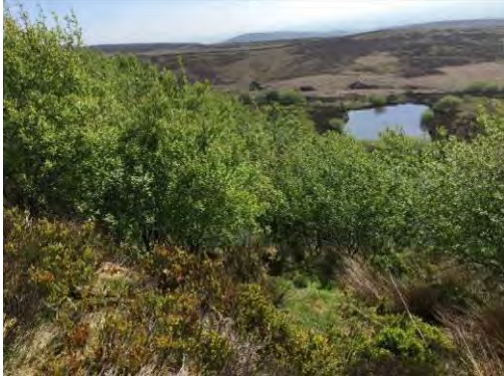
TR4.TN66

<p>Mature willow scrub with a ground layer of dry dwarf shrub heath and scattered soft rush. Potential for small mammals, nesting birds, foraging bats, amphibians and reptiles.</p> <p>Habitat Condition (provisional): Moderate (Score 2)</p>	
TR4.TN69

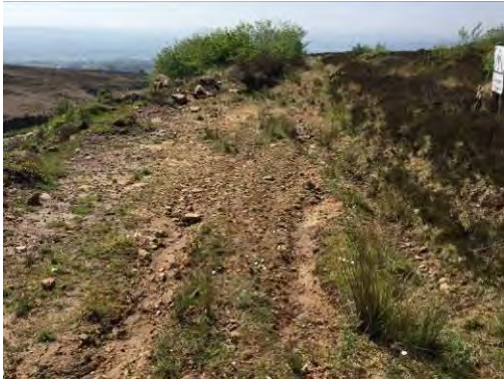
<p>Ephemeral / short perennial vegetated pathway with spoil bunds either side. The track appears unused but once provided access around the site. Species include common daisy (<i>Bellis perennis</i>), ling, willow scrub, wavy hair grass, ribwort plantain, brooklime, broadleaved dock, bird's-foot trefoil, marsh thistle, soft rush, sweet vernal grass, common ragwort (<i>Jacobaea vulgaris</i>), lady's mantle (<i>Alchemilla vulgaris</i>), crowberry, square stalked St. John's wort (<i>Hypericum tetrapterum</i>), creeping cinquefoil (<i>Potentilla reptans</i>), silverweed (<i>Argentina anserina</i>), soft rush and yarrow (<i>Achillea millefolium</i>). This habitat is suitable for nesting birds, small mammals, invertebrates and foraging bats.</p> <p>Habitat Condition (provisional): Moderate (Score 2)</p>

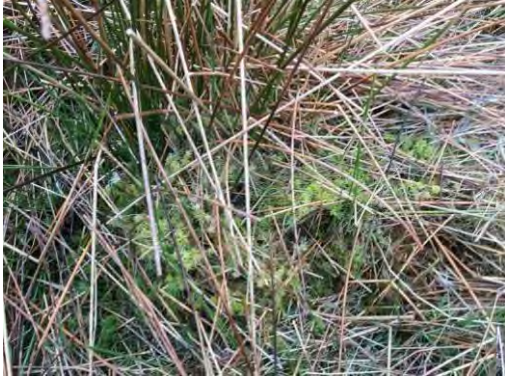
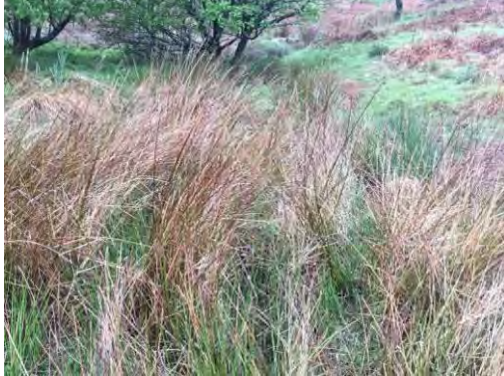
TR4.TN70

<p>Small area of flush surrounding a slow through flow of water between TR4.P16 and TR4.P17. The habitat is dominated by soft rush with scattered <i>Sphagnum</i> mosses, hemp agrimony (<i>Eupatorium cannabinum</i>) and bulrush (<i>Typha latifolia</i>). Suitable for reptiles, amphibians and nesting birds. Further south of the flush there is a lack of <i>Sphagnum</i>s and the habitat grades into marshy grassland.</p> <p>Habitat Condition (provisional): Good (Score 3)</p>

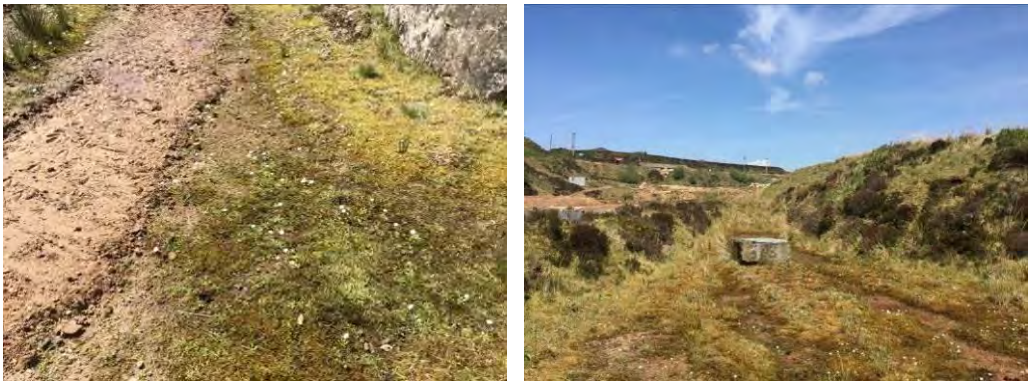
TR4.TN71

<p>Ephemeral / short perennial vegetation surrounding lagoon. Sections of the habitat are located on steep west facing slopes, with patches of bare earth. Species include common daisy, common sedge (<i>Carex nigra</i>), marsh thistle, soft rush, willow, ling, sheep's fescue (<i>Festuca ovina</i>), common mouse ear, common ragwort, rosebay willowherb (<i>Chamerion angustifolium</i>) and bird's foot trefoil. Vegetation is short and transitions at the lagoon edge to marshy grassland. Suitable for ground nesting birds, reptiles and invertebrates.</p> <p>Habitat Condition (provisional): Moderate (Score 2)</p>	
TR4.TN72

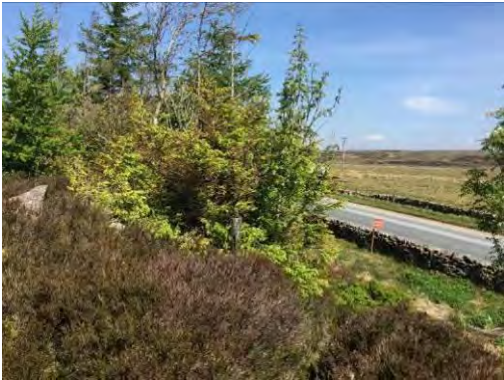
<p>Mixed plantation woodland on an eastern facing slope at the edge of the boundary. Canopy species include rowan, larch (<i>Larix decidua</i>) and alder (<i>Alnus glutinosa</i>). The trees have been planted over dry dwarf shrub heath, dominated by ling. Suitable for nesting birds, small mammals, reptiles, foraging bats and terrestrial amphibian habitat.</p> <p>Habitat Condition (provisional): Moderate (Score 2)</p>

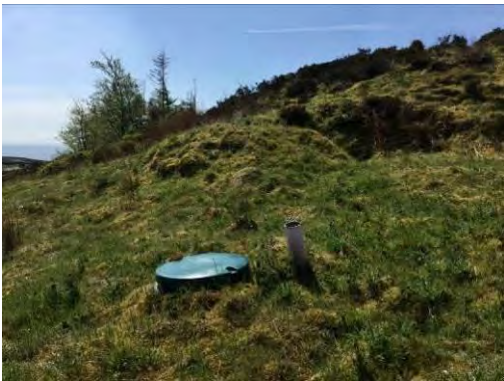
TR4.TN73

<p>Herb-rich semi-improved neutral grassland verge at the entrance to the quarry with some acidic indicator species. Some areas are recently disturbed as evidenced by locally dominant patches of common nettle (<i>Urtica dioica</i>). Species include Yorkshire fog, meadow vetchling, creeping thistle, common nettle, red fescue, cuckoo flower (<i>Cardamine pratensis</i>), creeping buttercup (<i>Ranunculus repens</i>), marsh thistle, dandelion sp. (<i>Taraxacum</i> agg.), common sorrel, ribwort plantain, heath bedstraw, field woodrush (<i>Luzula campestris</i>), common mouse ear and common ragwort. Evidence of use by rabbits (<i>Oryctolagus cuniculus</i>) is present. An orchid species was also identified on the northern verge, close to the access track. Suitable habitat for nesting birds and small mammals.</p> <p>Habitat Condition (provisional): Moderate (Score 2)</p>

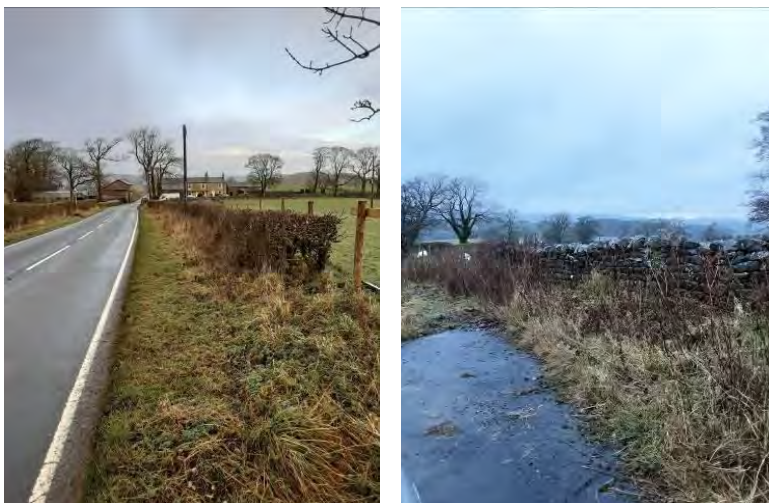
TR4.HTN1

Semi-improved neutral grassland road verge. This is the dominant habitat lining the road throughout TR4, and is approximately 0.5 m - 2 m wide. Mostly infrequently managed, with a sward height approximately 0.5 m. Located adjacent to hedgerows, dry stone walls and wire fences. Mostly species-rich, including: Yorkshire fog, fescue species (*Festuca* sp.), cock's foot grass (*Dactylis glomerata*), tufted hair grass (*Deschampsia cespitosa*), common sorrel (*Rumex acetosa*), several umbellifer species (likely wild carrot (*Daucus carota*)), cow parsley (*Anthriscus sylvestris*), wild angelica (*Angelica sylvestris*), common sow thistle (*Sonchus oleraceus*), ground ivy (*Glechoma hederacea*), common mallow (*Malva sylvestris*), lady's mantle (*Alchemilla vulgaris*), dogs mercury (*Mercurialis perennis*), cinquefoil species (*Potentilla* sp.), vetch species (*Vicia* sp.), greater plantain (*Plantago major*), ribwort plantain, herb Robert (*Geranium robertianum*), wood avens (*Geum urbanum*), lesser celandine, barren strawberry (*Waldsteinia fragarioides*), creeping buttercup, bittercress species (*Cardamine* sp.), garlic mustard (*Alliaria petiolata*), coltsfoot (*Tussilago farfara*), common ragwort, spear thistle (*Cirsium vulgare*), white clover (*Trifolium repens*), variegated yellow archangel (*Lamium galeobdolon*), primrose (*Primula vulgaris*), creeping thistle, crosswort (*Cruciata laevipes*), common nettle (*Urtica dioica*), sedge species (*Carex* sp.), soft rush, meadowsweet, common mouse ear, male fern and broadbuckler fern (*Dryopteris dilatata*). Moss species include: springy turf moss (*Rhytidiadelphus squarrosus*), feather moss species (*Ptilium* sp.).

Tall ruderal vegetation is also abundant within the verge adjacent to the layby at TN1, comprising great willowherb (*Epilobium hirsutum*), broadleaved dock, common hogweed (*Heracleum sphondylium*), creeping thistle, common knapweed (*Centaurea nigra*), dog rose (*Rosa canina*) and common nettle. Towards the northern end of the survey area at TN1, the verge on both sides of the road is steep and mown to under 10 cm.

Habitat condition (provisional): Moderate (Score 2)

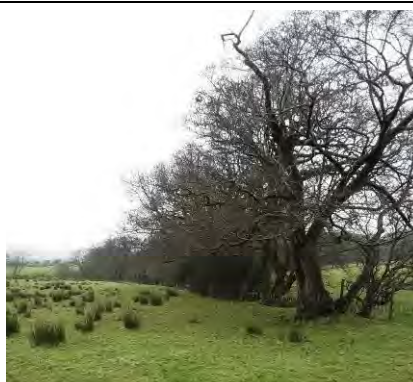
TR4.HTN2

A narrow strip of relic semi-natural deciduous woodland. Located between grazed species-poor semi-improved fields with WC39 cutting through the centre. The canopy comprises mature and semi mature alder, oak species (*Quercus* sp.), sycamore (*Acer pseudoplatanus*) and ash (*Fraxinus excelsior*). Species recorded in the understory include holly (*Ilex europaeus*) and hawthorn (*Crataegus monogyna*). The ground flora is limited to grazed grassland species, which has a sward height of less than 10 cm. Common nettle was also recorded in the ground flora. Signs of management comprise a large brash pile within the woodland. The canopy is fairly open, when in full leaf the woodland will have a canopy cover of approximately 40%. Occasional brash piles and leaf litter are present.

The habitat provide opportunities for nesting birds and commuting and foraging bats. Brash piles provide habitat for small mammals including hedgehog (*Erinaceus europaeus*), as well as providing terrestrial habitat for amphibians.

Habitat condition (provisional): Moderate (Score 2)

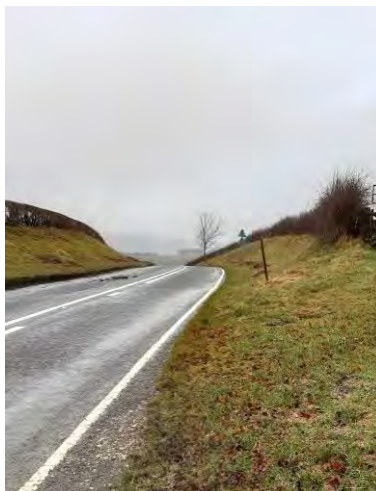
TR4.HTN3

Semi-improved neutral grassland road verges on steep banks which are approximately 2 m tall on both sides of road. Recently mown and cuttings piled up on verge. Species present include those recorded in TR4.HTN1.

The verge provides suitable habitat for small mammals, nesting birds, amphibians, reptiles as well as foraging and commuting habitat for bats.

Habitat condition (provisional): Moderate (Score 2)

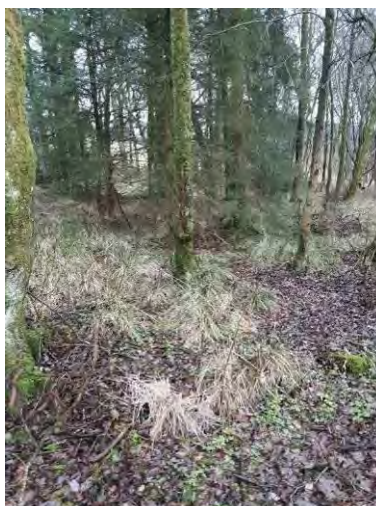
TR4.HTN4

Mixed woodland (~15% conifer species). The woodland is semi-natural in character with mostly semi-mature species. The age of the canopy is uniform in structure. Canopy species include ash, sycamore, horse chestnut (*Aesculus hippocastanum*), oak species, lime species (*Tilia x europaea*), larch and other conifer species. Saplings of varying maturity including coniferous and broadleaved species are present in the understory. The understory includes holly, hawthorn, conifer saplings, ash saplings and sycamore saplings. Species recorded in the ground flora include harts tongue fern (*Asplenium scolopendrium*), common polypody fern (*Polypodium vulgare*), tufted hairgrass, broadbuckler fern, creeping buttercup, common nettle, wood avens and moss species. There is abundant leaf litter, brash and deadwood, including standing and fallen deadwood, some of which is the result of management (chainsaw cuts in logs are evident). A dry

stone wall surrounds the wood and there is a watercourse running through the centre (TR4.HWC3).

Habitat condition (provisional): Moderate (Score 2)

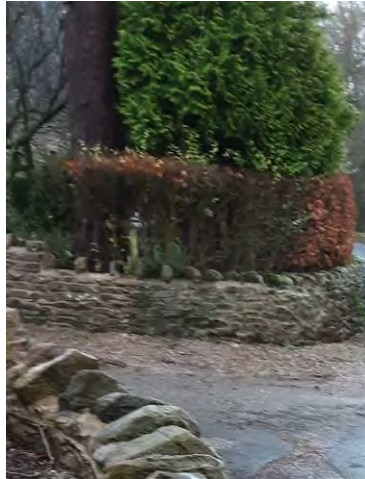
TR4.HTN5

Snowberry (*Symphoricarpos albus laevigatus*) present within a residential ornamental hedge. The hedge is approximately 8 m in length and therefore not subject to a full hedgerow regulations assessment. It comprises predominantly beech (*Fagus sylvatica*), with ivy (*Hedera helix*) and locally dominant areas of snowberry. The snowberry has extended from the residential garden and spread along the roadside.

Habitat condition (provisional): Poor (Score 1)

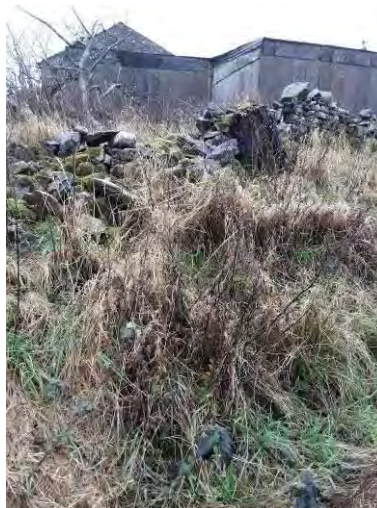
TR4.HTN6

Collapsed stone wall next to the road and on a bank of semi-improved neutral grassland, adjacent and within the wall are tree stumps. The fallen wall has good moss coverage and has likely been historically present for a long time. The wall provides good potential habitat for reptiles, amphibians and small mammals, as well as invertebrates due to the presence of tree stumps.

Habitat condition (provisional): N/A (assessment not applicable)

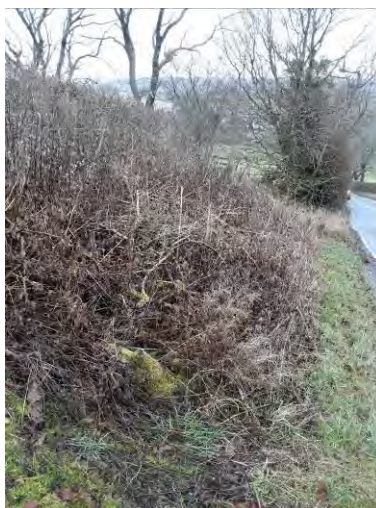
TR4.HTN10

Deadwood and brash pile on the western road verge. Tall ruderal vegetation is growing within it, dominated by rosebay willowherb and common nettle, with other species present including common hogweed, cow parsley and creeping thistle. This area provides opportunities for small mammals including hedgehog, amphibians, nesting birds and reptiles.

Habitat condition (provisional): N/A (assessment not applicable)

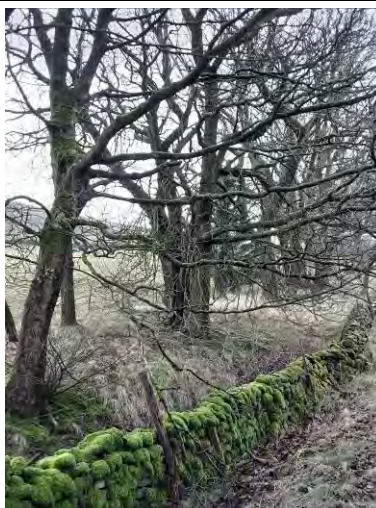
TR4.HTN11

Strip of semi-natural broadleaved woodland lining the road, and situated opposite a large patch of woodland at TR4.HTN4. A dry stone wall lines the woodland feature, and there is an abundance of moss present on and at the foot of this. The woodland is semi-mature with some good bat potential roosting features present within the trees (TR4.HBG7). The wood lacks an understory and is quite open under the canopy. The woodland strip is narrow so light can penetrate easily through woodland edge. Some saplings are present indicating regeneration, and there is no management evident. Canopy species include sycamore, sessile oak (*Quercus petraea*), ash, horse chestnut, sweet chestnut (*Castanea sativa*) and beech. Ground flora comprises tufted hair grass (dominant species), with frequent creeping buttercup and feather moss, and an even mixture of occasional barren strawberry, broadbuckler fern, male fern and *Polytrichum commune*.

The woodland provides suitable habitat for small mammals, large mammals (including badger), nesting birds, amphibians and roosting/foraging/commuting bats.

Habitat condition (provisional): Moderate (Score 2)

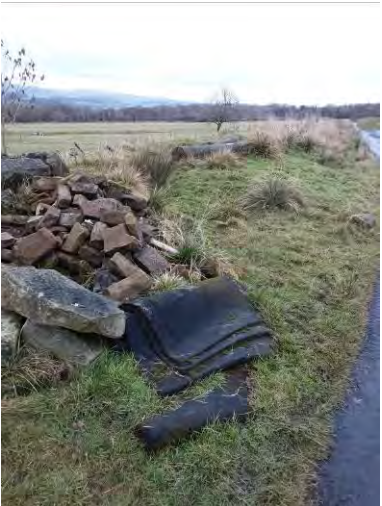
TR4.HTN13

<p>Spoil and rubble piles on a grassy mound running along a small track which appear well established with abundant moss coverage. The spoil and rubble is suitable for reptiles, amphibians and nesting birds.</p> <p>Habitat condition (provisional): N/A (assessment not applicable)</p>

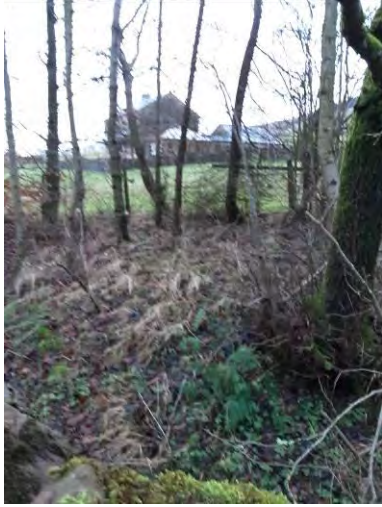
TR4.HTN14

<p>Small area of broadleaved plantation woodland within private property, situated behind a stone wall and adjacent to scattered semi-mature ash trees on the road verge. All trees within the woodland are young to semi-mature in age. Canopy species comprise beech, alder, fir species (<i>Abies</i> sp.) and ash. Understory species include laurel (<i>Laurus nobilis</i>) and hawthorn. Ground flora species recorded include those described in TR4.HTN11. Shade is approximately 90%, no signs of management present. Sapling presence indicates natural regeneration.</p> <p>The woodland provides suitable habitat for small mammals, large mammals (including badger), amphibians, nesting birds and foraging / roosting / commuting bats.</p> <p>Habitat condition (provisional): Poor (Score 1)</p>
TR4.HTN15

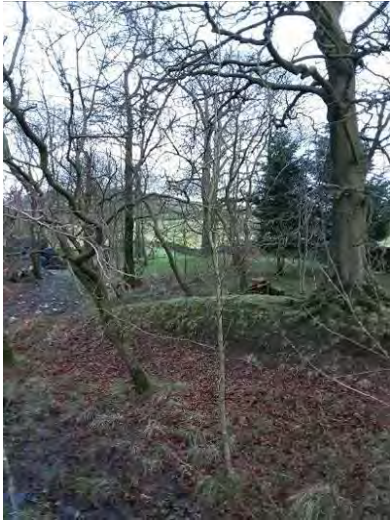
<p>Semi-natural broadleaved woodland comprised of mature trees. Canopy species include beech, alder, ash and chestnut species. A stream is present within the woodland (TR4.HWC2). The woodland lacks management evidence and the ground flora is as described in TR4.HTN11. There are saplings present and the coverage of shade is high (approximately 90%). Sapling presence indicates natural regeneration.</p> <p>The woodland provides suitable habitat for small mammals, large mammals (including badger), amphibians, nesting birds and foraging / roosting / commuting bats.</p> <p>Habitat condition (provisional): Moderate (Score 2)</p>

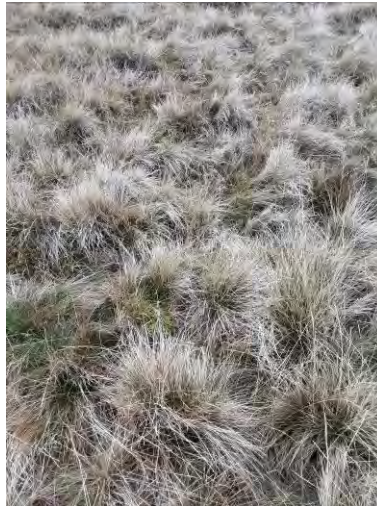
TR4.HTN19

Semi-improved acid grassland on a south facing bank within the moorland. The slope is approximately 45 degree. The area is lightly sheep grazed with small tussocks which have potential for reptiles. Dominated by rough meadowgrass (*Poa trivialis*) and mat grass with frequent purple moor grass (*Molinia caerulea*), low lying bilberry (*Vaccinium myrtillus*) (up to 2 cm tall) and heath bedstraw. There is occasional heath rush (*Juncus squarrosus*), crowberry (*Empetrum nigrum*), lichens, feather moss, *Polytrichum* moss, and rarely *Sphagnum* moss, marsh cinquefoil (*Comarum palustre*) and wavy hairgrass (*Deschampsia flexuosa*).

This area has potential for reptiles, small mammals, amphibians and nesting birds.

Habitat condition (provisional): Moderate (Score 2)

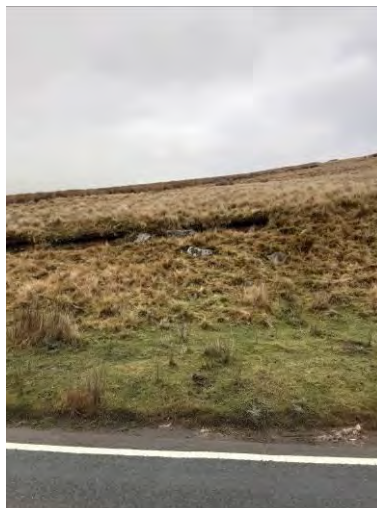
TR4.HTN20

Species-poor semi-improved grassland directly adjacent to the road and approximately 1.5 m wide. The grassland is a shorter sward height (less than 2 cm) than surrounding habitats and on flat ground adjacent to the road. Species recorded include meadow grass species, common daisy, clover species, dandelion species (*Taraxacum officinale* agg.), spear thistle and creeping buttercup present along the flattened roadside. Exposed rocks and a small exposed bare earth / peat overhang is also present within the surrounding acid grassland.

Habitat condition (provisional): Poor (Score 1)

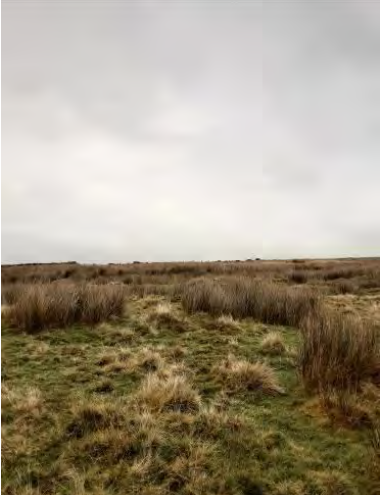
TR4.HTN21

<p>A mosaic of marshy grassland and semi-improved acid grassland. The area is mostly dry with some small boggy areas which hold water. Marshy grassland areas are dominated by soft rush, with species listed in TR4.HTN18 less frequently occurring, with additional foxglove , bittercress and willowherb species (<i>Epilobium</i> sp.). The acid grassland species comprise those listed in TR4.HTN19.</p> <p>This area is suitable for nesting birds, amphibians, small mammals and reptiles.</p> <p>Habitat condition (provisional): Moderate (Score 2)</p>	
TR4.HTN22

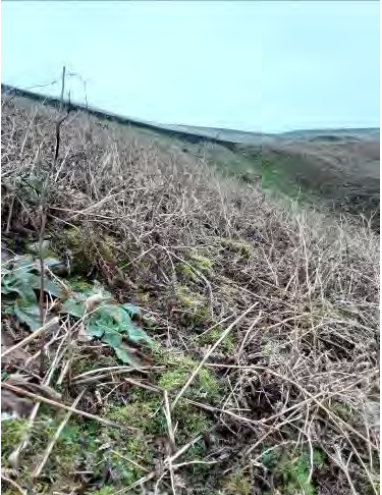
<p>Continuous bracken with occasional foxglove, frequent feather moss, occasional heath bedstraw and <i>Polytrichum</i> moss. This habitat is on steep sided bank, approximately 45 to 80 degrees.</p> <p>This area provides suitable habitat for small mammals, reptiles, nesting birds and amphibians.</p> <p>Habitat condition (provisional): Moderate (Score 2)</p>

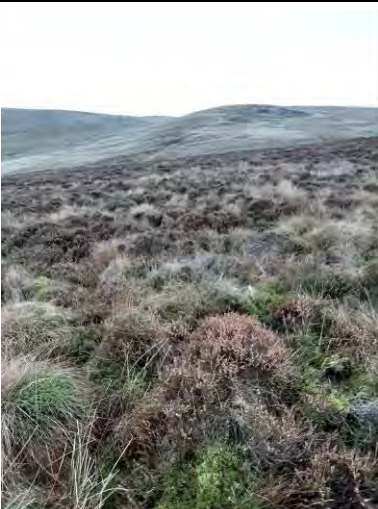
<p>Wet dwarf shrub heath with ling dominant over 50%. Species recorded include sheep's fescue abundant, purple moor grass, feathermoss, <i>Polytrichum</i> moss abundant, frequent crowberry, cross leaved heath (<i>Erica tetralix</i>), <i>Sphagnum</i> mosses, occasional bilberry, cranberry (<i>Vaccinium oxycoccos</i>), tormentil (<i>Potentilla erecta</i>) and sedge species. Rare broadbuckler fern, golden scaled male fern (<i>Dryopteris affinis</i>), bog rosemary (<i>Andromeda polifolia</i>) and bog asphodel (<i>Narthecium ossifragum</i>). The area is unmanaged other than light sheep grazing. The shrubs are up to 60 cm tall and tussocky. At the edge of the habitat acid grassland and marshy grassland are present. There are lots of small mammal tracks and runs, and a field vole (<i>Microtus agrestis</i>) was identified.</p> <p>This habitat is suitable for reptiles, small mammals, nesting birds and amphibians.</p>

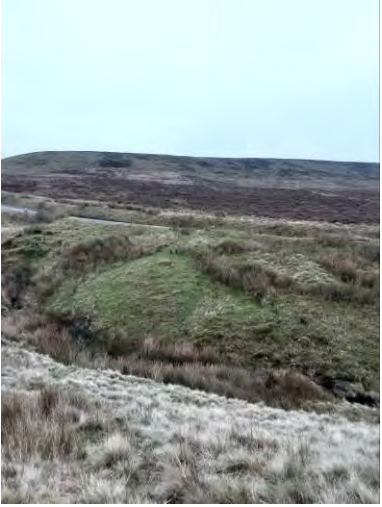
TR4.HTN26

<p>Marshy grassland and acid grassland mosaic verge along both sides of road. The banks are north facing on both sides of road. The south bank is approximately 1.5 m high and 10 m high on the north of road. The verges are damp with abundant mosses, bittercress and lichens present. Abundant grasses and rushes with small tussocks. The area is unmanaged except for sheep grazing.</p> <p>This habitat is suitable for nesting birds, small mammals, amphibians and reptiles.</p>	
TR4.HTN27

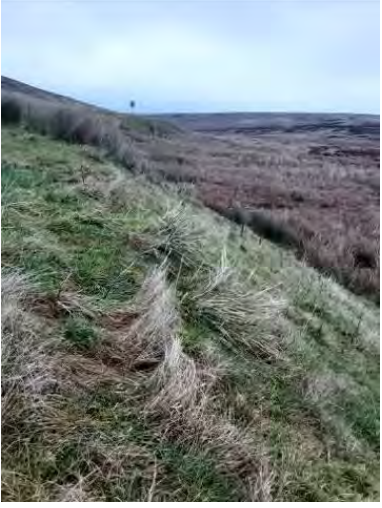
<p>Steep north-east facing bank adjacent to road, characterised as semi-improved acid grassland and grazed by sheep. The bank is on a 45 degree slope and transitions into a mosaic of acid grassland, wet dwarf shrub heath and marshy grassland towards the east.</p> <p>This area is suitable for reptiles, amphibians, small mammals and nesting birds.</p> <p>Habitat condition (provisional): Moderate (Score 2)</p>

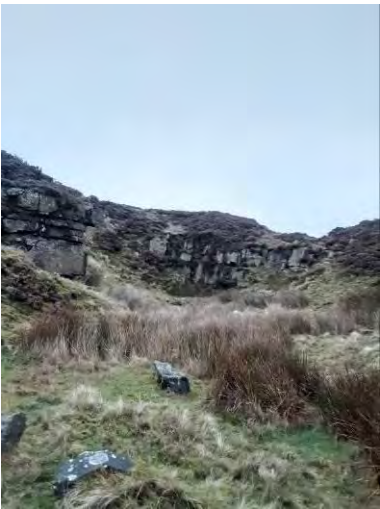
TR4.HTN29

<p>Old quarry workings, ground depressions and spoil mounds which are now vegetated with dry dwarf shrub heath and acid grassland. Some rubble piles still present which are partly moss covered. This area provides a sheltered refuge from the exposed moorland. They provide suitable habitat for reptiles, common amphibians and nesting birds. There are areas of bare rock exposed in places, up to 10 m tall rock face. The surrounding habitats include acid grassland, marshy grassland, and heathland on banks 45 degree slope.</p> <p>Habitat condition (provisional): Not applicable (no assessment required)</p>	
TR4.HTN30

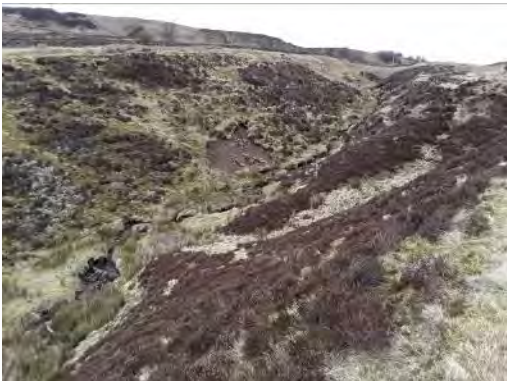
<p>Dry heath/acid grassland mosaic, covering a steep sided watercourse valley which is approximately 15 m tall. Ling is present as immature and mature shrubs. The acid grassland component is composed of wavy hairgrass, mat grass, springy turf moss, bilberry, heath bedstraw, hard fern, foxglove, soft rush, sedge sp. and health rush. The valley is lightly sheep grazed, but is otherwise unmanaged.</p> <p>The area provides suitable habitat for reptiles, amphibians, small mammals and ground nesting birds.</p> <p>Habitat condition (provisional): Moderate (Score 2)</p>

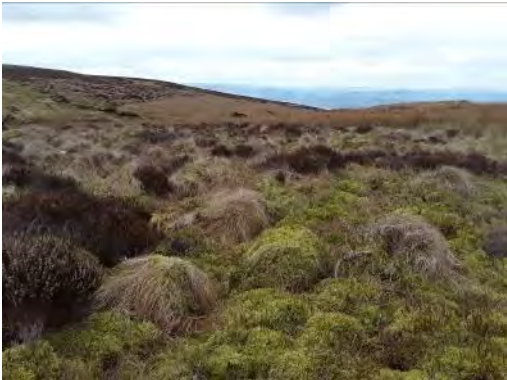
TR4.HTN31

Wet heath / acid grassland mosaic, located on an east facing, gently sloping hillside. Species recorded include ling, hare's tail cottongrass (*Eriophorum vaginatum*), bilberry, *Hypnum jutlandicum*, *Polytrichum* sp., waved silk moss (*Plagiothecium undulatum*), *Sphagnum compactum* and *S. capillifolium*, cranberry, crowberry and cowberry (*Vaccinium vitis-idaea*). The area is lightly grazed by sheep and game birds (pheasant (*Phasianus colchicus*) and red grouse (*Lagopus lagopus*)) are also present. The heather is mature shrubs.

The habitat is suitable for nesting birds, reptiles, amphibians and small mammals. Also a suitable area for foraging bats and foraging birds of prey.

Habitat condition (provisional): Moderate (Score 2)

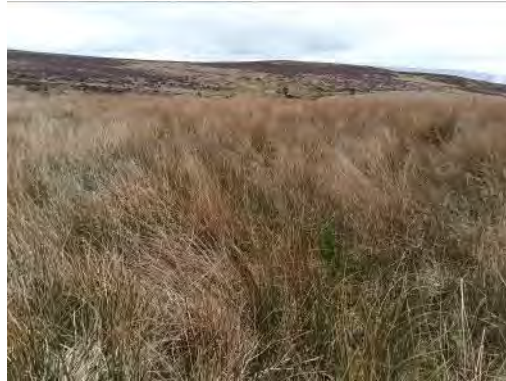
TR4.HTN32

Marshy grassland located on an east facing, gently sloping hillside. The area is dominated by soft rush, with marsh thistle, marsh willowherb, bittercress sp., *Sphagnum fallax* occasionally present, *Polytrichum* sp., Yorkshire fog, *Rhytiadelphus squarrosus*, heath bedstraw, hard rush and tufted hairgrass.

The habitat is suitable for nesting birds, amphibians, reptiles and small mammals.

Habitat condition (provisional): Moderate (Score 2)

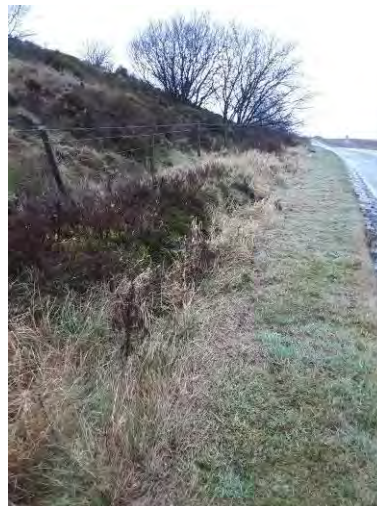
TR4.HTN33

Dry heath and acid grassland mosaic dominates the verge, species comprising those listed in TR4.HTN19 with additional ling and bilberry frequent. The verge is approximately 3 m wide. There are a few young hawthorn shrubs and the verge is tussocky. Further north and south, part of the verge is marshy grassland dominated and up to 1.5m wide.

The verge is suitable for amphibians, reptiles, small mammals and nesting birds.

Habitat condition (provisional): Moderate (Score 2)

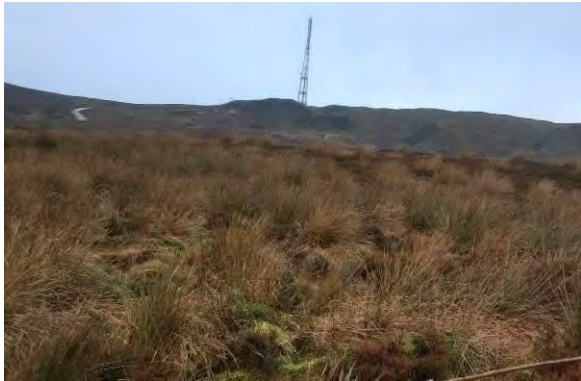
TR4.HTN34

<p>Mosaic of dry heath, wet heath and marshy grassland, located on a gentle south-facing slope. Dry heath comprised of ling, cowberry and a layer of mosses including <i>Hypnum jutlandicum</i>. Overall in the dry heath area, the ericoid shrubs are over mature with some areas showing signs of burning. Wet heath is comprised of ling, common cotton grass (<i>Eriophorum angustifolium</i>), <i>Hypnum jutlandicum</i>, cranberry, heath rush, hare's tail cottongrass, <i>Polytrichum</i>, <i>Sphagnum palustre</i>, hard fern and sedge species. There are some areas of exposed peat due to damage or disturbance of unknown source. Marshy grassland areas are dominated by soft rush, with <i>Hypnum jutlandicum</i>, <i>Polytrichum</i> sp., <i>Sphagnum fallax</i>, health bedstraw, liverwort species, bracken, foxglove, and common polypody fern.</p> <p>The area provides suitable habitat for nesting birds, foraging bats, small mammals, amphibians and reptiles.</p> <p>Habitat condition (provisional): Moderate (Score 2)</p>

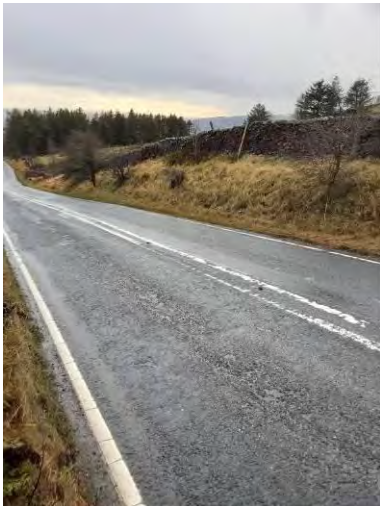
TR4.HTN35

<p>Semi-improved acid grassland roadside verge on a bank next to a drystone wall with some areas of scattered bracken, marshy grassland and heathland. Species present are similar to those listed in TR4.HTN1, however, on the western side of the road, scattered bracken, bilberry, heather and soft rush are also occasionally present. The verge is approximately 0.5 – 3 m wide, height approximately road level to 2 m high. The verge on the eastern side of the road is much narrower, up to 0.5 m wide.</p> <p>The habitat is suitable for nesting birds, amphibians, reptiles and small mammals.</p> <p>Habitat condition (provisional): Moderate (Score 2)</p>

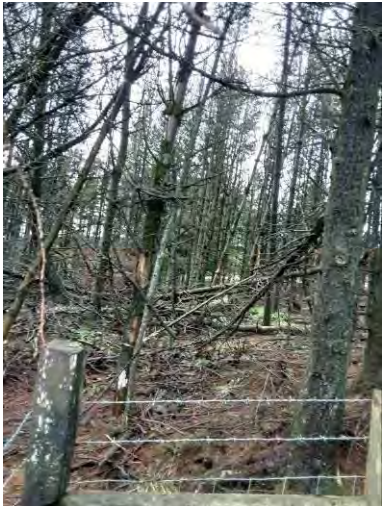
TR4.HTN36

<p>Small coniferous plantation comprised of young to semi-mature Scot's pine (<i>Pinus sylvestris</i>) and spruce (<i>Pinus</i> sp.), with occasional mature trees. Approximately 90% canopy cover. The ground flora is sparse and predominantly covered by pine needles. There are frequent mosses and short grasses, frequent foxglove and occasional soft rush. There are several standing deadwood trees, accounting for less than 10% and an abundance of deadwood on the woodland floor. No signs of management. There are no signs of sapling or regeneration within the wooded, open understorey. Negligible bat potential.</p> <p>The woodland has potential for nesting birds, foraging and commuting bats, small mammals, large mammals and amphibians.</p> <p>Habitat condition (provisional): Poor (Score 1)</p>
TR4.HTN37	No photo.
	<p>Dry stone wall that has collapsed in places, leaving rubble piles along semi-improved acid grassland field boundary.</p> <p>Potential habitat for reptiles, nesting birds and small mammals.</p> <p>Habitat condition (provisional): Not applicable</p>

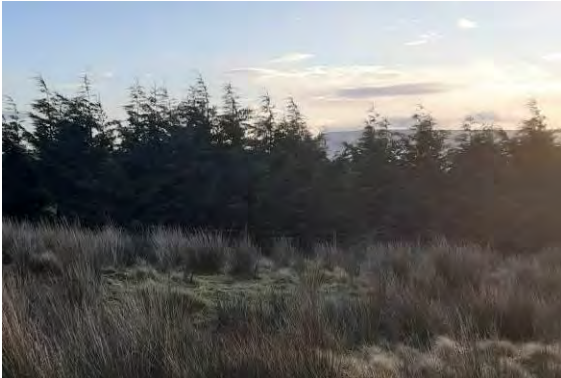
TR4.HTN38

<p>Row of young recently planting cypress trees (<i>Cupressus</i> sp.) within marshy grassland field. The area has limited ecological value but is suitable for nesting birds.</p> <p>Habitat condition (provisional): Poor (Score 1)</p>

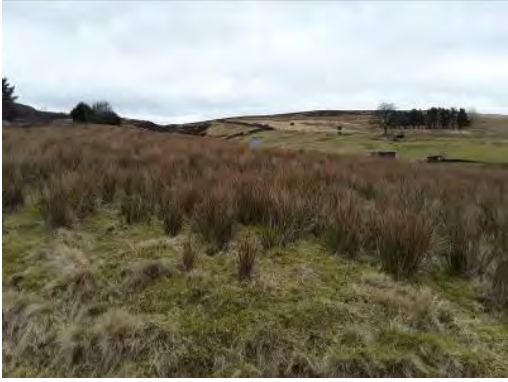
TR4.HTN39

<p>Marshy grassland interspersed with small areas of semi-improved acid grassland. Marshy grassland is dominated by soft rush with springy turf moss, tufted hairgrass, marsh thistle, bittercress sp. heath bedstraw, willowherb sp., compact rush, buttercup sp. and common sorrel. The acid grassland is composed of sheep's fescue, tufted hairgrass, Yorkshire fog, sedge sp. and has a layer of moss dominating beneath the grasses. The field slopes gently towards the south, and steeply to the east, towards TR4.HWC20. The field is lightly sheep grazed. There is also scattered gorse (<i>Ulex europeaus</i>) and hawthorn scrub.</p> <p>The area provides habitat for nesting birds, amphibians, reptiles and small mammals.</p> <p>Habitat condition (provisional): Moderate (Score 2)</p>
TR4.HTN40

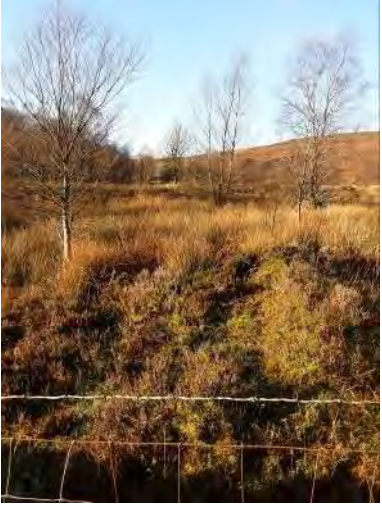
<p>Marshy grassland within a small depression at the base of a sloping field. Soft rush dominates the sward with occasional foxglove, mat grass and bracken. A layer of moss is present beneath the rushes and includes <i>Hypnum jutlandicum</i>, <i>Polytrichum</i> sp. and rare <i>Sphagnum fallax</i>.</p> <p>The area is suitable for nesting birds, amphibians, reptiles and small mammals as well as foraging bats.</p> <p>Habitat condition (provisional): Moderate (Score 2)</p>
