Document reference: LCC-RVBC-BO-SEI Appendix B7

**Haweswater Aqueduct Resilience Programme -  
Proposed Bowland Section**

**Appendix B7: Ecology Assessment - Off-Site Highways Works**

February 2022

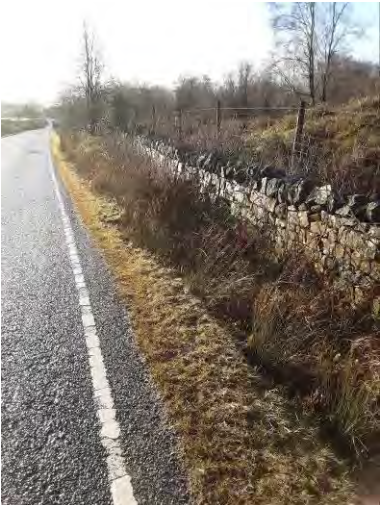
TR4.HTN41

<p>Roadside verge which is classified as semi-improved acid grassland and comprises wavy hair grass, mat grass, meadow grass species, cock's foot, Yorkshire fog, mosses, rushes, scattered bracken, raspberry (<i>Rubus idaeus</i>), hawthorn, ericoid species, and fern species. A small watercourse (TR4.HWC11) is present approximately 1m from the road within the grassland habitats. Further north the verge becomes narrower and flat, with willowherb species also present.</p> <p>The verge provides habitat for nesting birds, small mammals and amphibians.</p> <p>Habitat condition (provisional): Moderate (Score 2)</p>	
TR4.HTN42

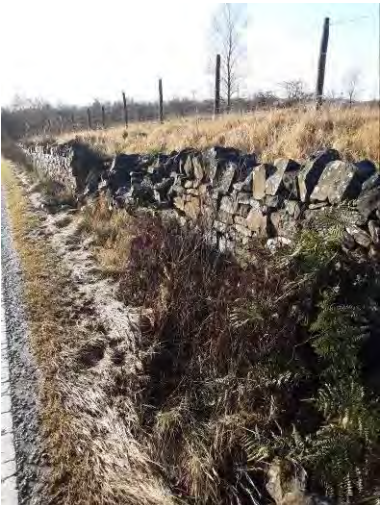
<p>Semi-improved acid grassland dominated verge on bank, with collapsing drystone wall halfway up the bank. Species recorded are largely acid-grassland indicators with some neutral herbs. Species include bracken, red campion (<i>Silene dioica</i>), common hogweed, cock's foot grass, tufted hair grass, mat grass, meadowsweet, creeping buttercup, cow parsley, dandelion sp., hard fern, common ragwort, willowherb species, sow thistle (<i>Sonchus</i> sp.), soft rush, common nettle, bilberry, ling, red stemmed feather moss (<i>Pleurozium schreberi</i>), springy turf moss and heath bedstraw. The bank is east facing.</p> <p>This area is suitable for nesting birds, small mammals, reptiles and amphibians.</p> <p>Habitat condition (provisional): Moderate (Score 2)</p>

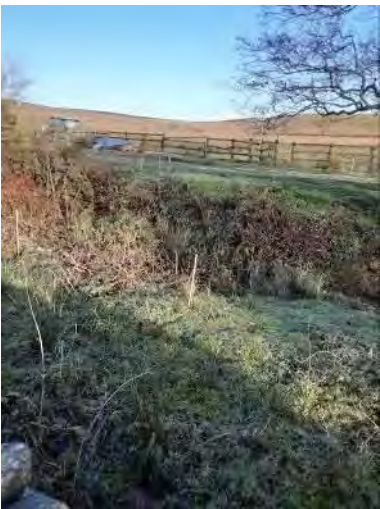
<p>Small area of species-poor semi-improved grassland along the banks of a stream (TR4.HWC13). The sward is a short height and there are frequent stands of soft rush. Scattered trees and scrub are present. The trees are immature and have guards present. Some areas of the bank are bramble dominated with occasional gorse and foxglove. On the western side of the stream are broadleaved trees including beech and willow, along with shrubs including laurel.</p> <p>This area is suitable for nesting birds and small mammals.</p> <p>Habitat condition (provisional): Poor (Score 1)</p>

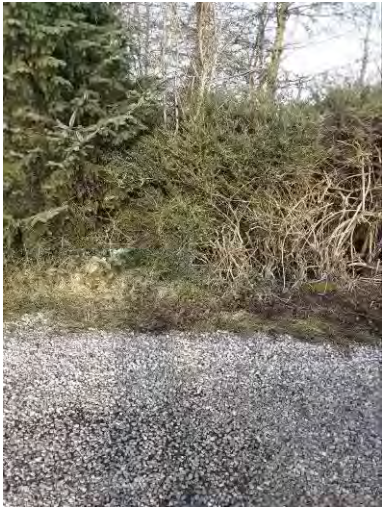
TR4.HTN46

<p>Cotoneaster species (<i>Cotoneaster</i> sp.) present at the entrance to the horse paddock measuring approximately 5 m in total length. Several cotoneaster species are listed as invasive on Schedule 9 of the Wildlife and Countryside Act 1981 (as amended).</p> <p>Habitat condition (provisional): Poor (Score 1)</p>	
TR4.HTN47

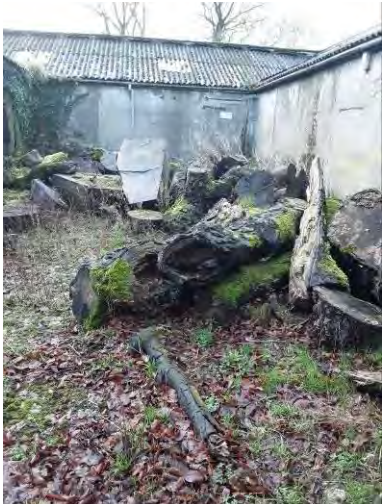
<p>Large pile of wood within a yard of abandoned farm building.</p> <p>This area is suitable refugia for nesting birds, small mammals and amphibians.</p> <p>Habitat condition (provisional): Not applicable (no assessment required)</p>		
TR4.HTN49

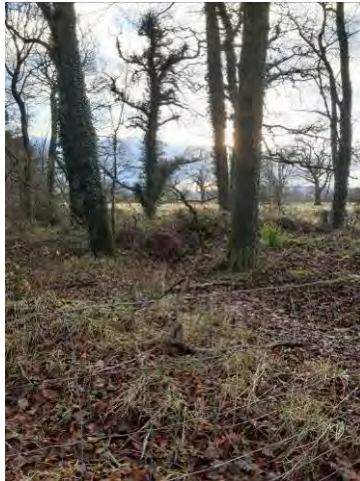
<p>Broadleaved semi-natural woodland between the road and a sheep-grazed field. A watercourse (TR4.HWC17) flows within the woodland. The trees are semi-mature to mature trees and include the species beech, oak species, alder, conifer species, Scot's pine, sycamore, sweet chestnut, and silver birch (<i>Betula pendula</i>). There is some scattered standing deadwood. There is an understory of hazel saplings and holly. There are also piles of fallen deadwood. In general the understory is sparse with some minor tree regeneration. The canopy is 80% covered. The ground flora is dominated by ivy, with wood avens, mosses, herb Robert, cock's foot grasses, willowherb species, tufted hair grass, rose species (<i>Rosa</i> sp.), frequent bramble and ferns. There are no signs of management. The composition is approximately 70% mature and 30% semi mature trees.</p> <p>The woodland provides suitable habitat for nesting birds, roosting/foraging/commuting bats, small mammals, large mammals and amphibians.</p> <p>Habitat condition (provisional): Moderate (Score 2)</p>

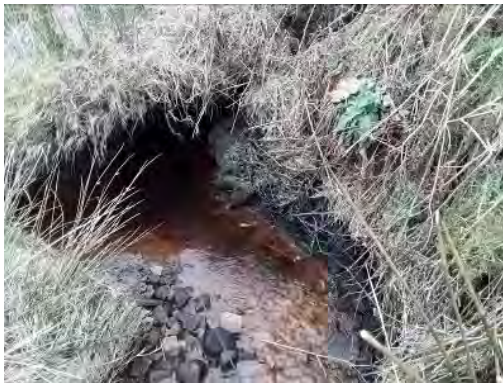
TR4.HTN50

<p>Mammal burrow adjacent to TR4.HWC9, located atop the western bank within an area of collapsed bank. The entrance is approximately 20 cm wide and 30 cm deep and the internal tunnel continues to be approximately this size. No evidence of a particular species but <b>potentially suitable for use by otter as a holt</b>.</p> <p>Habitat condition (provisional): N/A (not applicable)</p>

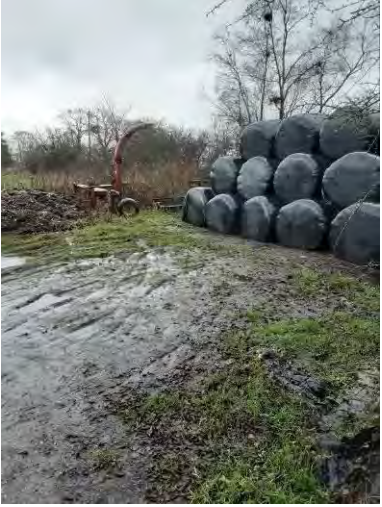
TR4.HTN51

<p>Storage of hay bales and compost heaps in small area of bare ground surrounded by an approximately 1 m wide strip of tall ruderal vegetation dominated by common nettle and rosebay willowherb.</p> <p>This area is suitable for amphibian refuge.</p> <p>Habitat condition (provisional): Poor (Score 1)</p>	
TR4.HTN52

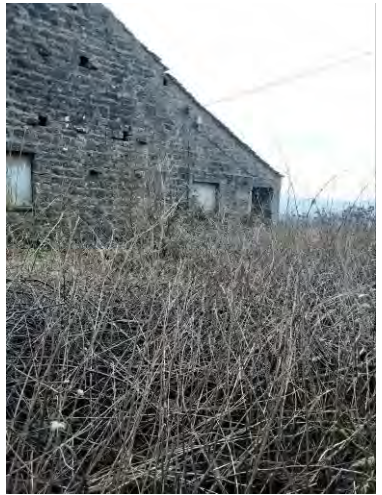
<p>Area in front of a barn and wooden/stone outhouse. The area is approximately 10 m x 7 m, and is filled with brash piles. There is also tall ruderal vegetation comprising common nettle, common hogweed and greater burdock (<i>Arctium lappa</i>) grown through the brash. Close to the barn, bramble and tree saplings locally dominate forming an area of scrub approximately 5m x 2m. There is a large tree stump south of outhouse which provides good opportunities for invertebrates. The area is separated from the road by dry stone wall.</p> <p>This provides suitable habitat for small mammals (including hedgehog), amphibians, reptiles, nesting birds and foraging bats.</p> <p>Habitat condition (provisional): Not applicable (no assessment required)</p>

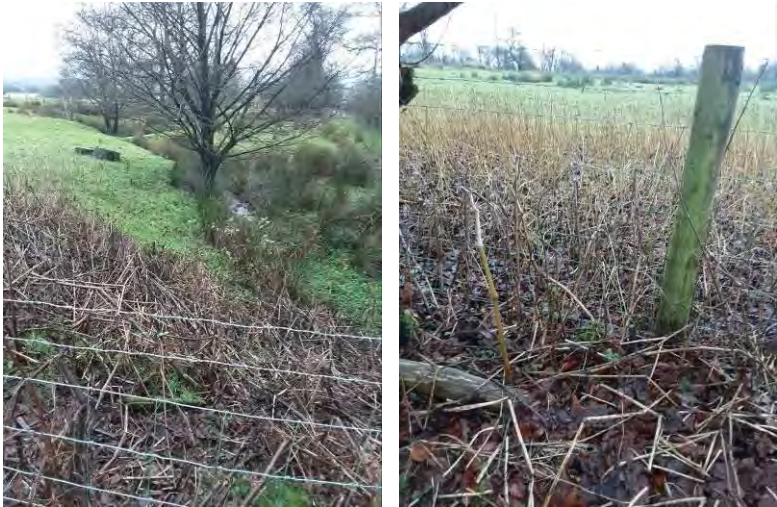
TR4.HTN53

<p>Patches of Himalayan balsam (<i>Impatiens glandulifera</i>) between and adjacent to roadside hedgerows, including a dense stand to the south of hedgerow TR4.HH14 and on the northern bank of watercourse TR4.HWC18. Himalayan balsam is an invasive species listed on Schedule 9 of the Wildlife and Countryside Act 1981 (as amended).</p> <p>Habitat condition (provisional): Poor (Score 1)</p>	
TR4.HTN54

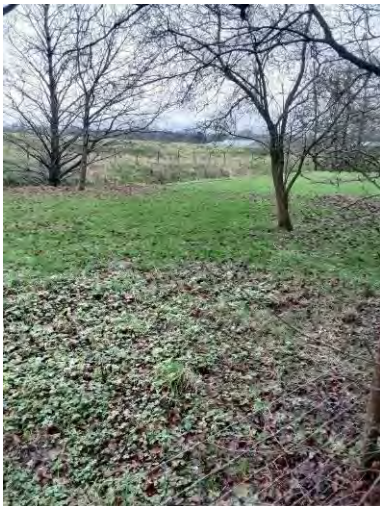
<p>Residential garden with an orchard of apple trees (<i>Malus</i> sp.). There are scattered trees lining a small stream (TR4.HWC18) within the garden. The surrounding area is classified as amenity grassland. There is a small section of fallen drystone wall to the north of the garden boundary, with stacked paving flags leaning against it.</p> <p>The garden provides habitat for nesting birds, small mammals, foraging bat habitat and terrestrial habitat for common amphibians.</p> <p>Habitat condition (provisional): Moderate (Score 2)</p>

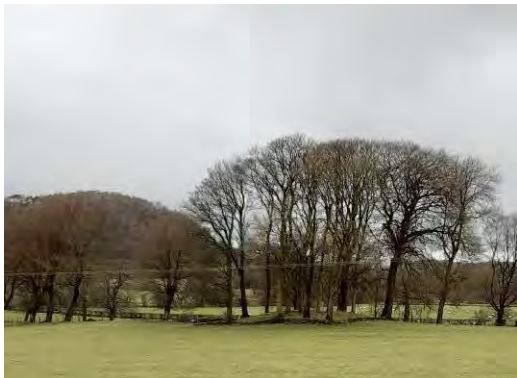
TR4.HTN55

Group of mature and semi-mature ash, beech and sycamore trees as a small woodland block, which are enclosed by a fallen down dry stone wall on an earth mound. The ground flora comprises grazed species-poor semi-improved grassland and moss-covered stones. Assessed as a relic of semi-natural deciduous woodland. No shrub layer present.

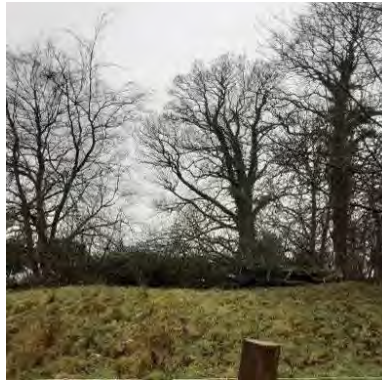
TR4.HTN56

Brash pile adjacent to scrub and scattered trees. This habitat is a suitable refuge for amphibians as well as having potential for nesting birds and small mammals (including hedgehog).

Habitat condition (provisional): N/A (assessment not applicable)

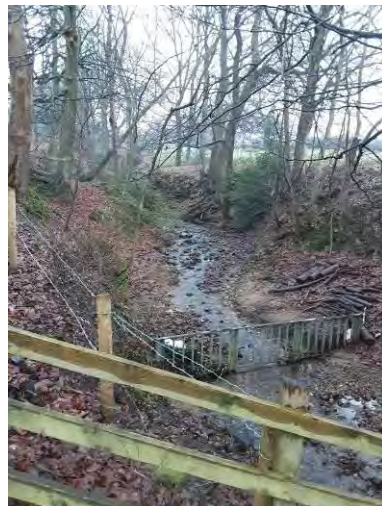
TR4.HTN57

Semi-natural broadleaved woodland located on both sides of the road. The canopy is composed of ash, oak species, beech, alder and birch species (*Betula* sp.). There is an understorey of snowberry, holly, hawthorn and rose species. The ground flora consists of creeping buttercup, variegated yellow archangel (a Schedule 9 species of the Wildlife and Countryside Act 1981 (as amended)), wood avens, pendulous sedge (*Carex pendula*), lords-and-ladies (*Arum maculatum*), ivy, bramble, dog's mercury (*Mercurialis perennis*), hart's tongue fern and common polypody fern. The trees are mature and semi mature, with immature saplings also present in the understorey. Some of the more mature trees have ivy cladding. There is evidence of previous management due to the presence of felled deadwood on the ground. Some dead limbs are also present on trees, along with fallen deadwood. A stream (TR4.HWC19) runs through the woodland and the woodland slopes fairly steeply towards the watercourse, creating a small valley.

The woodland has potential for large mammals (including badger setts), nesting birds, roosting, commuting and foraging bats, small mammals and terrestrial habitats for amphibians.

Habitat condition (provisional): Moderate (Score 2)

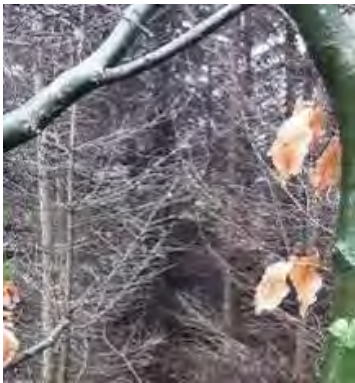
TR4.HTN59

<p>Coniferous plantation woodland with a dense canopy. There is no understorey or ground flora layer and there is also an absence of deadwood.</p> <p>The woodland has potential for nesting birds and foraging and commuting habitat for bats.</p> <p>Habitat condition (provisional): Poor (Score 1)</p>
TR4.HTN60

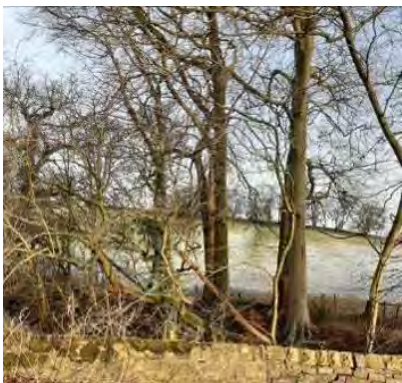
<p>Narrow strip of semi-natural broadleaved woodland which encompasses TR4.HWC22. The canopy is composed of alder, ash, horse chestnut and beech. Trees are all mature and semi mature and there is an understorey of holly and immature beech. The ground flora includes tufted hairgrass, fern species and bramble. Tree sapling regrowth is present, along with standing and fallen deadwood.</p> <p>The woodland has potential for nesting birds, commuting/ foraging / roosting bats, small mammals and terrestrial habitat for amphibians.</p> <p>Habitat condition (provisional): Moderate (Score 2)</p>

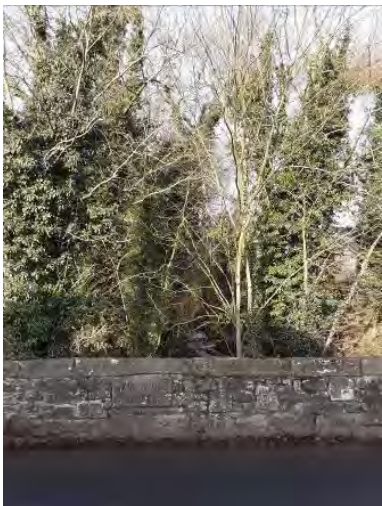
TR4.HTN61

Narrow strip of semi-natural broadleaved woodland which encompasses TR4.HWC23. The canopy is composed of oak species, ash, conifer spies and willow. Trees are all mature and semi mature, some of which are clad with ivy. There is an understorey of willow and holly. The ground flora includes ivy with bare earth/leaf litter also present. Succession is evident due to presence of young tree saplings. Standing and fallen deadwood are also present. The woodland sits within a small valley, with the watercourse running through the centre. Old bird nests were noted.

The woodland has potential for nesting birds, commuting/ foraging / roosting bats, small mammals and terrestrial habitat for amphibians.

Habitat condition (provisional): Moderate (Score 2)

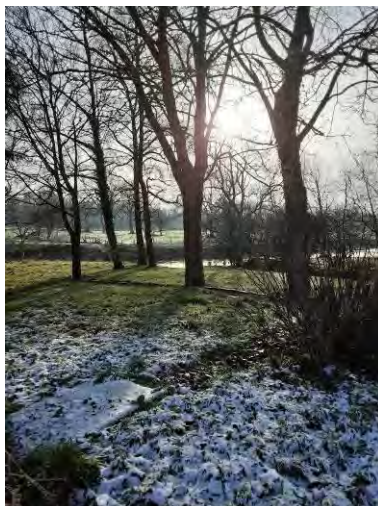
TR4.HTN63

Group of approximately ten scattered silver birch and sycamore trees within a residential garden. The trees are all mature and semi-mature and there is no understorey layer. The ground flora comprises amenity grassland present beneath, along with Grindleton brook TR4.HWC23.

The trees have potential for nesting birds, commuting/ foraging / roosting bats, small mammals and terrestrial habitat for amphibians.

Habitat condition (provisional): Poor (Score 1)

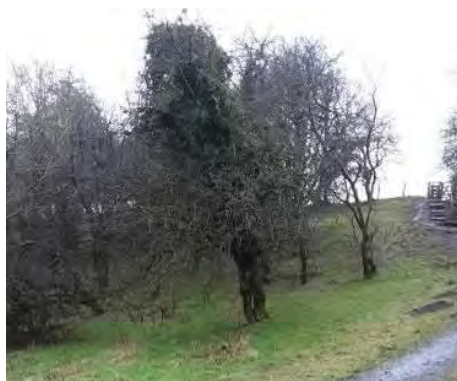
TR4.HTN64

Semi-natural broadleaved woodland with a canopy of semi-mature ash, oak species and mature blackthorn (*Prunus spinosa*). Some of the trees are clad with ivy. There is no understorey layer. The ground flora is composed of grazed species-poor semi-improved grassland. The woodland lacks standing or fallen deadwood and there is no succession evident. The woodland is located on a northern facing slope.

The woodland has potential for nesting birds, commuting/ foraging / roosting bats, small mammals and terrestrial habitat for amphibians.

Habitat condition (provisional): Moderate (Score 2)

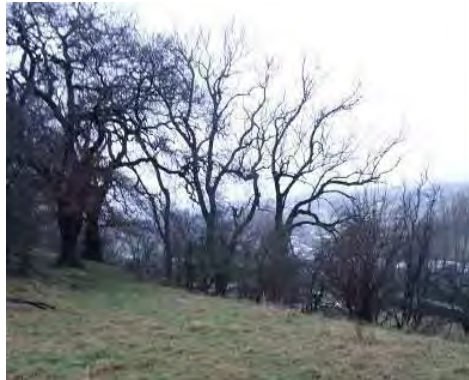
TR4.HTN65

Semi-natural broadleaved woodland with a canopy of mature sycamore. The canopy is quite open with gaps between mature trees. The understorey includes hawthorn and the ground flora is grazed species-poor semi-improved grassland. The canopy and understorey have an open structure with lots of internal light. There are some small narrow pieces of fallen and standing deadwood. The woodland is situated on a north-eastern facing slope.

The woodland has potential for nesting birds, commuting/ foraging / roosting bats, small mammals and terrestrial habitat for amphibians.

Habitat condition (provisional): Moderate (Score 2)

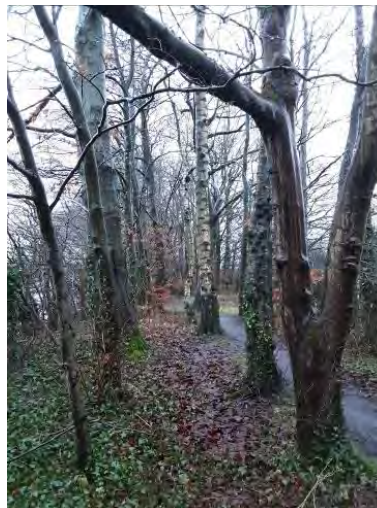
TR4.HTN67

Narrow strip of semi-natural broadleaved woodland which sits behind hedgerow TR4.HH31. The canopy consists of semi-mature silver birch, beech, sycamore and mature hawthorn and is dense. The understorey includes beech saplings, hawthorn, rose species and willow. Leaf litter covers the majority of the ground, however, ivy, bramble, wood avens, dog's mercury and lesser celandine were also noted. There is some fallen narrow pieces of deadwood present, however standing deadwood is absent.

The woodland has potential for nesting birds, commuting/ foraging / roosting bats, small mammals and terrestrial habitat for amphibians.

Habitat condition (provisional): Moderate (Score 2)

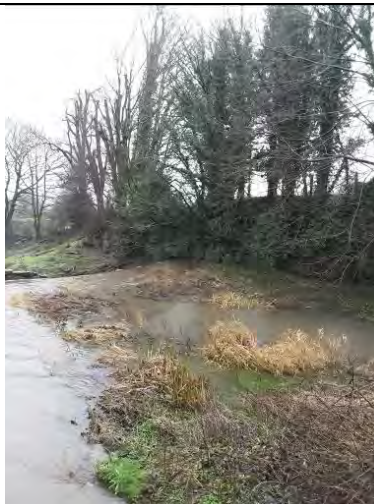
TR4.HTN68

Semi-natural broadleaved woodland located along the eastern bank of TR4.HWC25. The canopy consists of willow, sycamore and ash. The trees are all semi mature and immature, some of which are clad with ivy. There is an understorey of immature willow and hawthorn. The ground flora is dominated by dense ivy. The woodland is located on a stone bank which borders the watercourse. There is some standing and fallen deadwood present, as well as some narrow pieces of fallen deadwood which appear to have been carried downstream by the watercourse. Old disused bird nests were noted.

The woodland has potential for nesting birds, commuting/ foraging / roosting bats, small mammals and terrestrial habitat for amphibians.

Habitat condition (provisional): Moderate (Score 2)

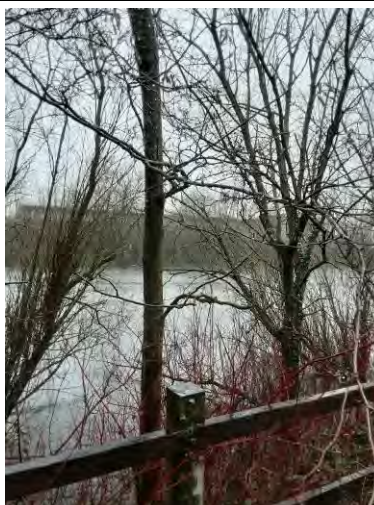
TR4.HTN69

Large area of standing water which is surrounded by semi-natural broadleaved woodland. The standing water has no associated aquatic vegetation. There were no waterfowl present at time of survey, however it is suitable for those species. The water appears to be moderately turbid, although the survey was undertaken during heavy rain. Fish are possibly present within the waterbody. It is shaded by approximately 5%. The water quality was assessed to be moderate and the surrounding terrestrial habitat good, in line with Habitat Suitability Index (HSI) assessment. Waterbodies have potential to support breeding amphibians (including great crested newts (*Triturus cristatus*)), as well as being important habitats for a range of other fauna including foraging bats, small mammals, nesting birds and large mammals.

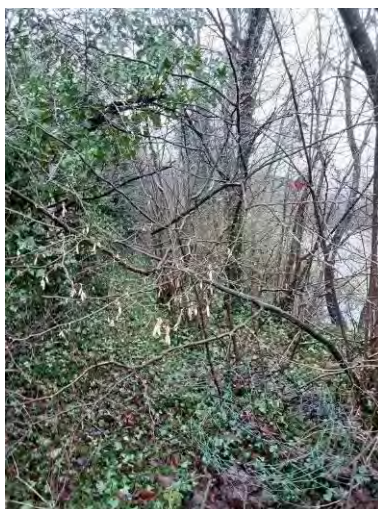
TR4.HTN70

Semi-natural broadleaved woodland which surrounds TR4.HTN69. There is a canopy of willow, oak, hazel and ash. Semi mature and immature trees were noted, some of which appear to have been previously coppiced, and some of which are clad with ivy. The understorey includes hawthorn, snowberry, dogwood (*Cornus sanguinea*), rose species and bramble. The ground flora consists of dense ivy. The canopy and understorey are both dense and a lack of deadwood was noted.

The woodland provides suitable habitat for nesting birds, large mammals, small mammals, commuting/foraging/roosting bats and terrestrial habitat for amphibians.

Habitat condition (provisional): Moderate (Score 2)

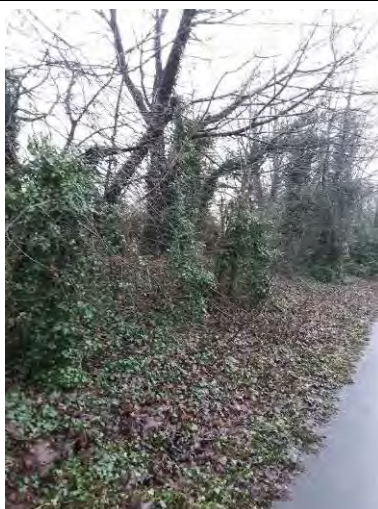
TR4.HTN71

Narrow strip of semi-natural broadleaved woodland located adjacent to the road. The canopy consists of sycamore and ash. Mature and semi mature trees noted, some of which are clad with ivy. The understorey consists of hawthorn and immature sycamore. The ground flora is dense ivy, with moss species, fern species and yarrow. There are numerous narrow pieces of fallen deadwood on the ground which are covered by moss and ivy. There is no standing deadwood.

The woodland provides suitable habitat for nesting birds, large mammals, small mammals, commuting/foraging/roosting bats and terrestrial habitat for amphibians.

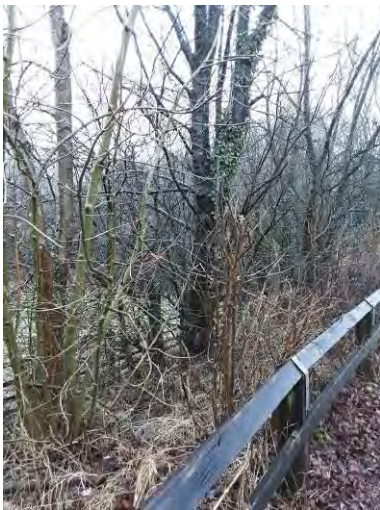
<p>Semi-natural broadleaved woodland with a canopy of semi-mature ash and sycamore. The understorey consists of hawthorn and immature oak and ash. The ground flora includes dense ivy, with wood avens, rose, bramble, creeping cinquefoil and cock's foot grass. There are some narrow pieces of fallen deadwood present and no standing deadwood. The woodland slopes downwards towards the south-west and towards TR4.HWC26.</p> <p>The woodland provides suitable habitat for nesting birds, large mammals, small mammals, commuting/foraging/roosting bats and terrestrial habitat for amphibians.</p> <p>Habitat condition (provisional): Moderate (Score 2)</p>	
TR4.HTN73

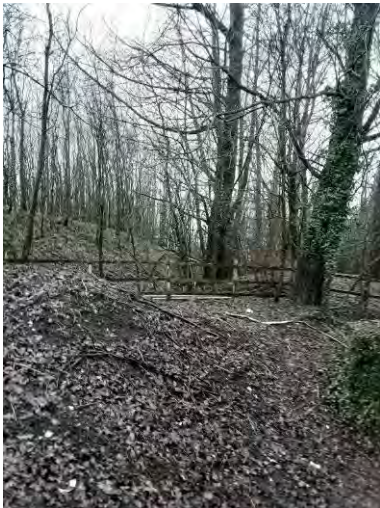
<p>Semi-natural broadleaved woodland with a canopy of willow, ash and sycamore. The trees are mostly immature with scattered mature trees, these are clad with ivy. The understorey consists of privet (<i>Ligustrum vulgare</i>), elm species (<i>Ulmus</i> sp.) , ash saplings, beech saplings and hawthorn. The ground flora is mostly covered with leaf litter, also present are ivy and bramble. No deadwood noted. The woodland is situated on a steep bank or bund. Multiple mammal paths are identified in the ground flora. The woodland joins on to a railway to the west and steeply slopes at this edge. A layer of dust is present on the ground flora from roadside pollution.</p> <p>The woodland provides suitable habitat for nesting birds, large mammals, small mammals, commuting/foraging/roosting bats and terrestrial habitat for amphibians.</p> <p>Habitat condition (provisional): Poor (Score 1)</p>

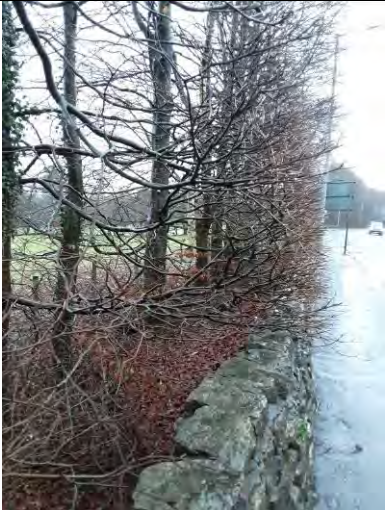
TR4.HTN74

<p>Narrow strip of planted trees which runs parallel to the road. The canopy is composed of semi-mature beech and the understorey layer is absent. The ground flora is composed of dense ivy and leaf litter. There is no deadwood present.</p> <p>The woodland provides suitable habitat for nesting birds, large mammals, small mammals, commuting/foraging/roosting bats and terrestrial habitat for amphibians.</p> <p>Habitat condition (provisional): Poor (Score 1)</p>
TR4.HTN75

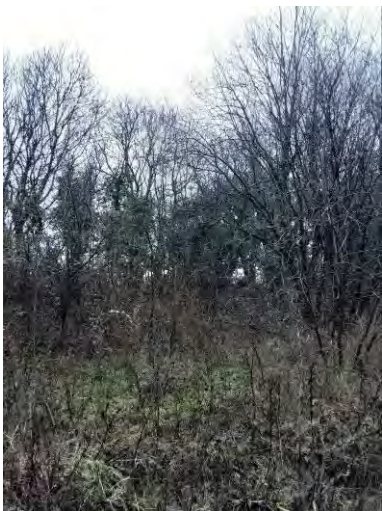
<p>Semi-natural broadleaved woodland with a canopy dominated by willow. Additional canopy species include ash, sycamore and beech. The trees are all semi-mature and immature adjacent to the road, and further away from the road the trees are semi-mature to mature. Some trees are clad with ivy. The understorey is composed of immature willow, hawthorn and beech saplings. The ground flora is dominated by ivy, with common knapweed, bramble and umbellifer species also present. The canopy and understorey are both dense. No deadwood was noted. Old birds' nests were identified.</p> <p>The woodland provides suitable habitat for nesting birds, large mammals, small mammals, commuting/foraging/roosting bats and terrestrial habitat for amphibians.</p> <p>Habitat condition (provisional): Moderate (Score 2)</p>

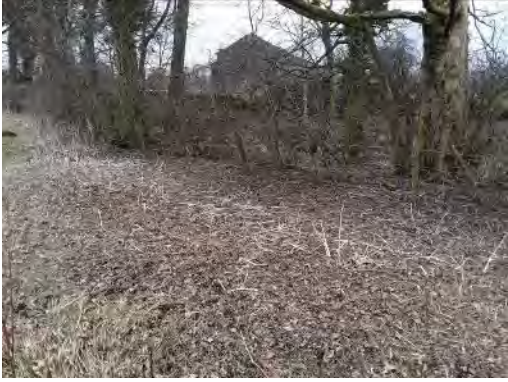
<p>Area of Himalayan balsam at the edge of the woodland which extends out into the field by approximately 40 m by 4 m. Himalayan balsam is an invasive species listed on Schedule 9 of the Wildlife and Countryside Act 1981 (as amended).</p> <p>Habitat condition (provisional): Poor (Score 1)</p>	
TR4.HTN77

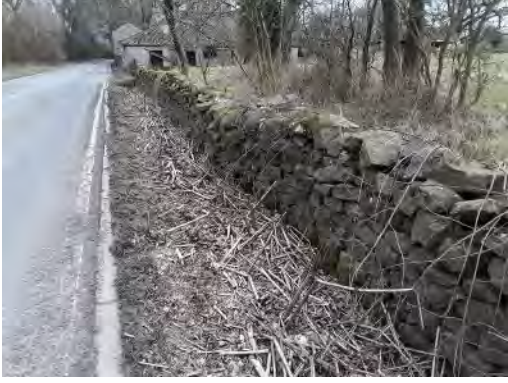
<p>Himalayan balsam dominated the roadside verge in this area for approximately 40 -50 m in length. Himalayan balsam is an invasive species listed on Schedule 9 of the Wildlife and Countryside Act 1981 (as amended).</p> <p>Habitat condition (provisional): Poor (Score 1)</p>	
TR4.HTN78	No photo.
<p>Himalayan balsam stand within field adjacent to trees and scrub along a field boundary. The area is approximately 5 m by 3 m. Himalayan balsam is an invasive species listed on Schedule 9 of the Wildlife and Countryside Act 1981 (as amended).</p> <p>Habitat condition (provisional): Poor (Score 1)</p>

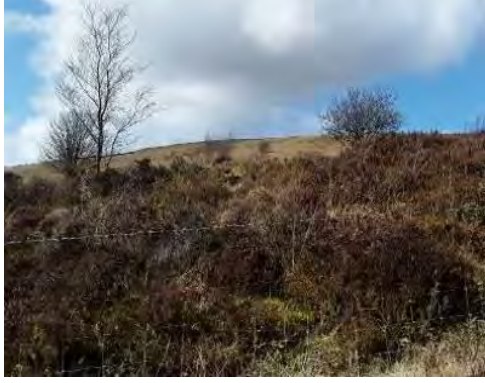
TR4.HTN79

<p>Dry heath acid grassland mosaic within an area of undulating ground which generally slopes towards the south. Dominated by mature ling with bilberry, <i>Hypnum jutlandicum</i>, springy turf moss, hard fern, soft rush, purple moor grass, foxglove, bracken, compact rush, tufted hair grass, cock's foot, tormentil and scattered birch and hawthorn scrub. The area grades into continuous bracken at the break of the slope towards the west.</p> <p>Suitable for nesting birds, reptiles, amphibians, small mammals.</p>

Habitat condition (provisional): Moderate (Score 2)		
TR4.HTN80

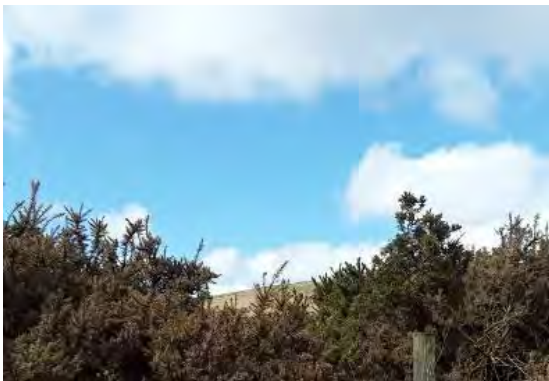
<p>Area of dense gorse scrub which is adjacent to a dry stone wall. There is scattered bramble between the gorse. Towards the west is a sheep-grazed species-poor semi-improved grassland field.</p> <p>The scrub is suitable for small mammals, foraging and commuting bats and nesting birds.</p> <p>Habitat condition (provisional): Poor (Score 1)</p>		
TR4.HTN81

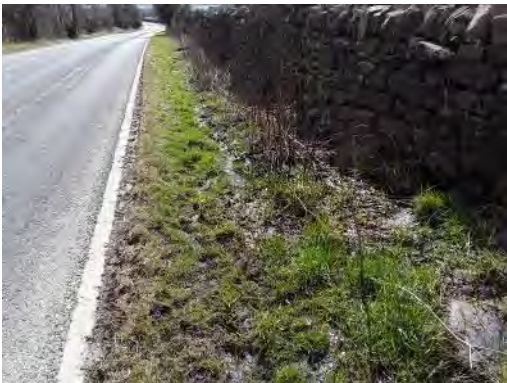
<p>The verge habitats at this location is damp and there is a very small area of flowing water which eventually becomes indistinct further downstream in the verge. Species recorded include common sorrel, mat grass, meadowsweet, lesser celandine, common hogweed, common nettle, broadleaved dock, cock's foot, cleavers, Yorkshire fog and bracken.</p> <p>Habitat condition (provisional): Moderate (Score 2)</p>		
TR4.HTN82

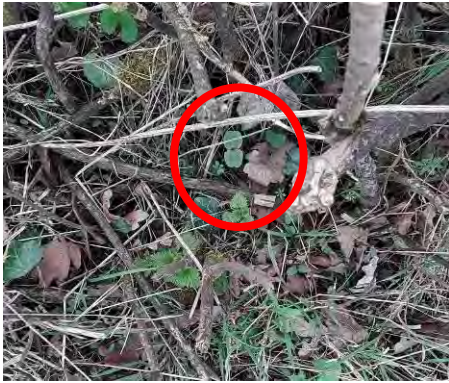
<p>Immature Himalayan balsam seedlings within TR4.HH22. Himalayan balsam is an invasive species listed on Schedule 9 of the Wildlife and Countryside Act 1981 (as amended).</p> <p>Habitat condition (provisional): Poor (Score 1)</p>

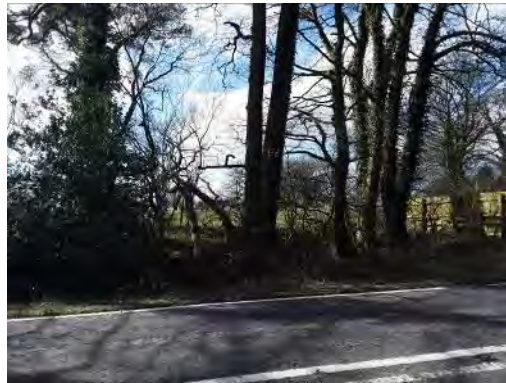
TR4.HTN84

Small triangle of semi-natural broadleaved woodland with a small watercourse running through (TR4.HWC18). Canopy species are mature and include alder, ash and beech. There is an understory layer of rowan, holly and alder. Ground flora is ivy dominated with some bramble, cow parsley, honeysuckle (*Lonicera periclymenum*), pendulous sedge, dog's mercury and meadow grass. Steeply slopes down to the watercourse. The woodland joins into a larger area of woodland to the north beyond a wooden fence. Some immature Himalayan balsam seedlings are present. Himalayan balsam is an invasive species listed on Schedule 9 of the Wildlife and Countryside Act 1981 (as amended).

Habitat condition (provisional): Moderate (Score 2)

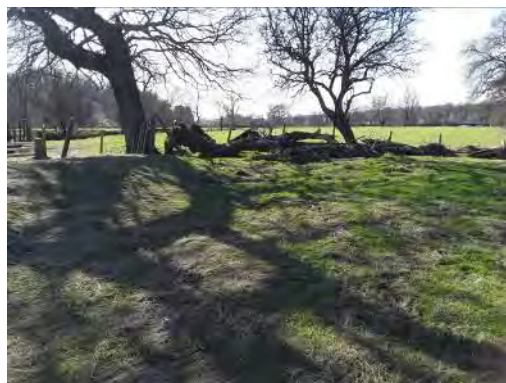
TR4.HTN85

Piles of brash and deadwood from previously fallen tree. This creates good habitat for small mammals (including hedgehog), amphibians and nesting birds.

Habitat condition (provisional): N/A (not applicable)

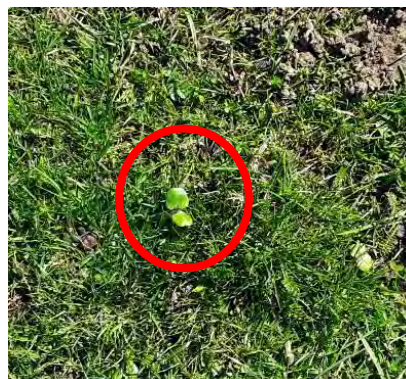
TR4.HTN86

Himalayan balsam seedlings alongside the riverbank close to the road bridge. Approximate area is 1 m by 3 m. There are no signs of the plant there from the previous year (i.e. no dead stems) which possibly indicates it was either grazed or has spread along the riverbanks. Himalayan balsam is an invasive species listed on Schedule 9 of the Wildlife and Countryside Act 1981 (as amended).

Habitat condition (provisional): Poor (Score 1)

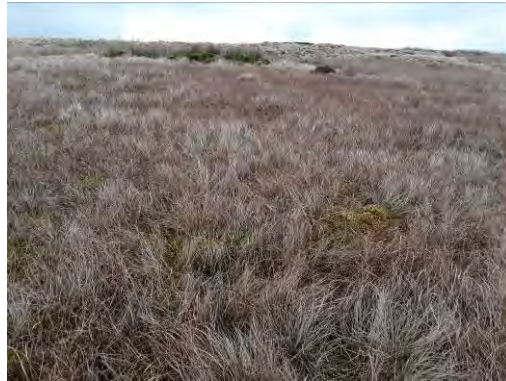
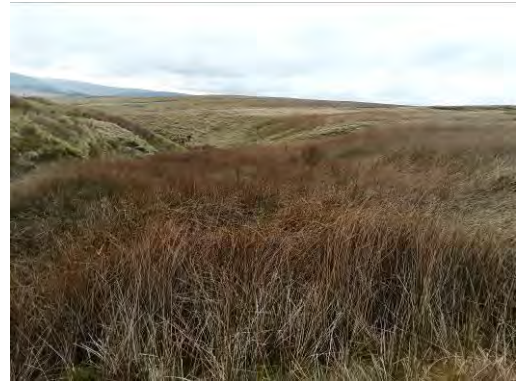
TR4.HTN87

An area of mire and flush between two watercourses (TR4.HWC5 and TR4.HWC6). The mire is dominated by a continuous layer of hare's tail cotton grass and common cottongrass, over a thick carpet of *Sphagnum* mosses, including *S.fallax*, *S.palustre* and *S.papilosum*. The flush is a dense sward of soft rush with a dense carpet of *Sphagnum* mosses beneath (same species). Additional moss species present within the flush area include *Hypnum jutlandicum* and *Polytrichum commune*. This area is sensitive to pollution and provides habitat for amphibians, reptiles, small mammals, nesting birds and foraging bats.

Habitat condition (provisional): Moderate (Score 2)

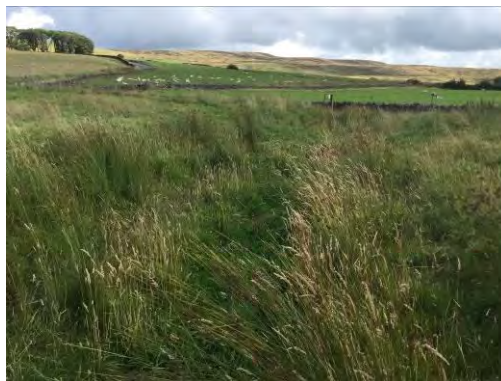
TR4.WC4

A slow flowing drainage ditch with shallow earth banks. The channel is approximately 1 m wide with a few centimetres of water at time of survey. The channel is well vegetated with brooklime and the margins are vegetated with silverweed (*Potentilla anserina*), bittercress, water mint, compact rush and soft rush. The earth banks are rush dominated with water mint, heath bedstraw, tufted hair grass and Yorkshire fog. There is negligible protected species potential because the ditch is very shallow, not densely vegetated and there is no connectivity to other watercourses.

Habitat Condition (provisional): Moderate (Score 2)

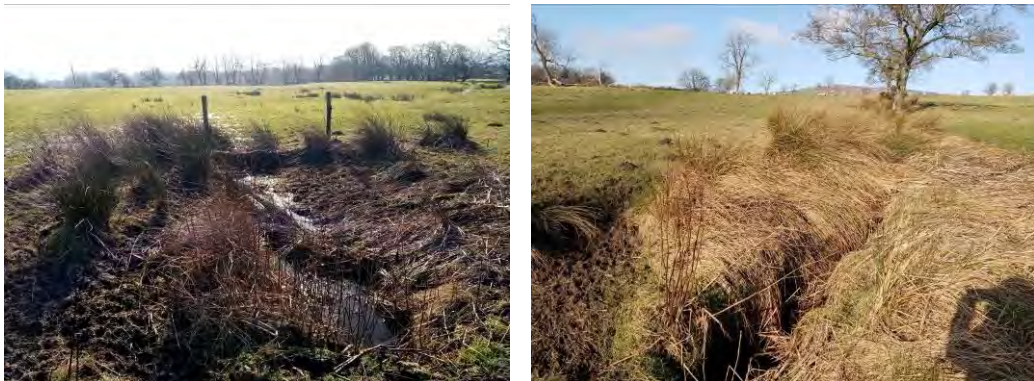
<p>Narrow, fast flowing stream, with flows north to south and culverted underneath the access track. The stream sinks to beneath the ground south of the access track. The width is approximately 0.3 m and depth 0.2 m. The substrate is earth with pebbles and boulders. The banks are steep and dominated by dense rush growth.</p> <p>Habitat condition (provisional): Moderate (Score 2)</p>	
TR4.WC22	 
<p>Very slow flowing outfall from pond which flows approximately south-west between two small hillocks. The channel is indistinct and dry in places. The depth is up to 4 cm. The channel is fringed by soft rush with shade provided by willow scrub. Negligible protected species potential but suitable for amphibians in stagnant areas.</p> <p>Habitat condition (provisional): Moderate (Score 2)</p>	
TR4.WC23	 
<p>A very narrow overflow channel running between ponds/lagoons. Vertical earth banks are up to 30 cm tall and the channel is approximately 10 cm wide. In some areas the channel is indistinguishable beneath the rushes / flush. Fringed by soft rush and continuous bracken in the wider area. Negligible protected species potential.</p> <p>Habitat condition (provisional): Moderate (Score 2)</p>

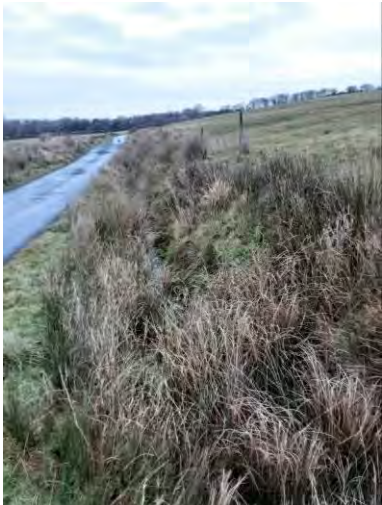
TR4.HWC1

<p>Narrow ditch containing a small stream within a marshy grassland strip along the edge of a semi-improved grassland field. The flow is slow and stagnant in places and the watercourse flows roughly east to west. The channel width ranges from 0.5 -0.1 m, and the bank width is approximately 1 m. The substrate is mostly bare earth with scattered stones. The embankment is steep on the southern side and more gradual to the north. The bankside vegetation is characterised as marshy grassland, with the species outlined in TR4.HTN12. Emergent in-channel vegetation includes brooklime , willowherb and bittercress species. The watercourse has negligible potential for protected species. It culverts beneath the track and road in several locations. The channel is heavily choked with vegetation and narrow in places.</p> <p>Habitat condition (provisional): Poor (Score 1)</p>	
TR4.HWC2

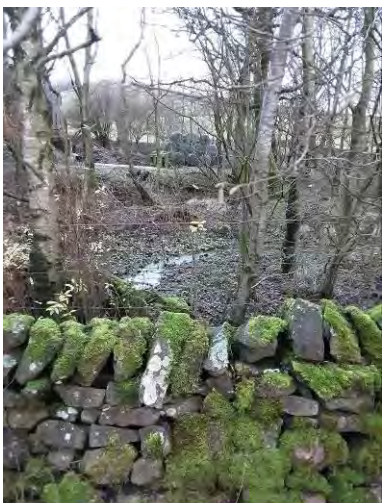
<p>Small stream flowing east to west within a broadleaved woodland. The watercourse emerges from a culverted pipe in the woodland and culverts again under the main road and opposite field. The watercourse reappears downstream to the west within a semi-improved grassland field (renamed TR4.HWC30 here). The flow is slow and the banks are flat, enabling water to overflow which has created boggy ground within the woodland. There is some fallen deadwood in the stream. The embankment flora is broadleaved woodland with ground flora including creeping buttercup, common nettle, fern species and is largely dominated by leaf litter. The channel substrate is bare earth. The watercourse has negligible protected species potential. The channel width is approximately 0.4 m at the widest point. The watercourse has the potential to overflow in places with flat banks. Sections of the banks are steeper although overall are gradually sloped.</p> <p>Habitat condition (provisional): Poor (Score 1)</p>

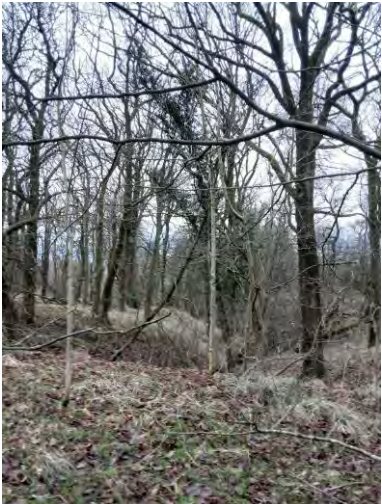
TR3.HWC3

<p>Small watercourse flowing within mixed woodland. The channel is cut deeply into the ground and is 100 % shaded by woodland. the channel is 1 m wide, with a variable water depth of less than 20 cm. There is a moderate flow, from south-east to north west. the substrate is earth with stones, cobbles and boulders. The banks are earth and stone with exposed tree roots. Marginal vegetation includes tufted hair grass, common nettle and mosses. There is abundant leaf litter, brash piles and dead wood. Potential for forging otter and holts in dead wood. Watercourse source within the woodland is from a culvert.</p> <p>Habitat condition (provisional): Moderate (Score 2)</p>	
TR4.HWC4

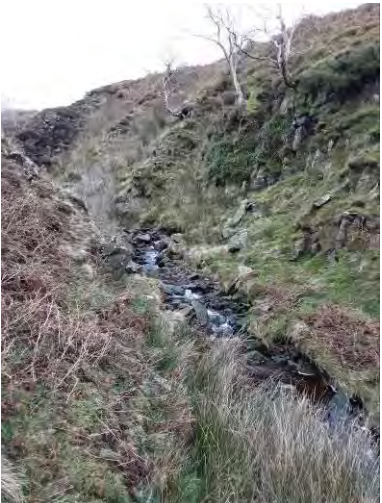
<p>Fast-flowing stream through scattered bracken and acid grassland in a steep sided valley gorge. The watercourse is 1.5 m wide, approximately 30 cm deep, with deeper pools in sections. The banks of the stream are dominated by bracken with areas of mature dry heath, acid grassland, soft rush, fern species, bittercress species and mosses on the banks directly adjacent. The substrate is rocky and the stream bed is stepped, flowing over exposed bedrock. There are overhanging exposed peat banks which are undercut, and sections which are boulder/pebble dominated. The channel is shaded due to the overhanging sections of the bank and the steep valley the watercourse is within. The water appeared to be clear. There is negligible potential for protected species.</p> <p>Habitat condition (provisional): Moderate (Score 2)</p>

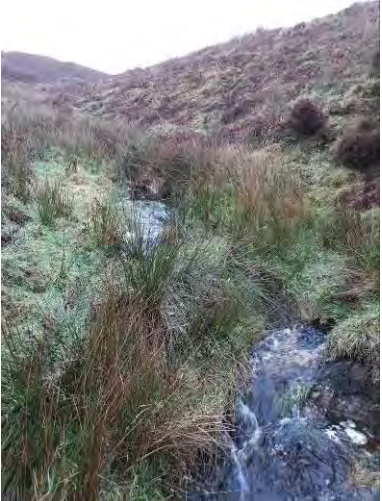
TR4.HWC9

<p>Moderate to fast flowing stream through a steep sided gully which is dominated by heathland and acid grassland. The channel flows roughly north the south. At the northern end of the survey area, the watercourse has steep-sided banks which are approximately 2 m tall and are near vertical. Some banks have collapsed resulting in some shallower areas of the banks. The channel is approximately 30 cm wide and ranges from 5 cm to 20 cm deep, with some deeper pooling in parts. The channel bed is composed of boulders and gravel. Through the central area of the watercourse within the survey area, the stream has a moderate to fast flow through a steep-sided gully. The habitat within the gully is dry heath and acid grassland mosaic. There is a band of soft rush bordering the channel. The stream bed is stepped in places and pools in places. Towards the southern end of the watercourse within the survey area, the channel is approximately 50 cm wide and ranges from 10 cm to 30 cm deep. There are small cascades in places within the channel. The banks are steep earth and range from 0.5 m to 5 m deep. There is in general a lack of aquatic vegetation with a scattering of mosses and liverworts on exposed boulders. The watercourse is suitable for commuting otter.</p> <p>Habitat condition (provisional): Moderate (Score 2)</p>

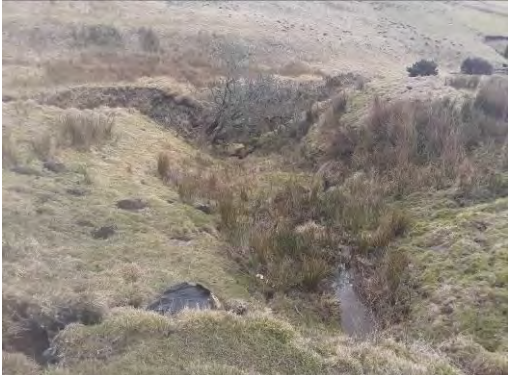
TR4.HWC10

<p>Tributary stream to TR4.HWC9. A small stream flowing from beneath the road and through semi-improved acid grassland towards TR4.HWC9. The watercourse has an indistinct channel and flows over the grassland before flowing down a short and steep rocky valley where it joins TR4.WC9. The channel consists of sand, gravel and boulders. The banks range from very shallow to approximately 0.5 m tall and vertical. The watercourse is approximately 2 cm to 10 cm deep and width approximately 15 cm with some wider pools in places. The watercourse has negligible protected species potential.</p> <p>Habitat condition (provisional): Poor (Score 1)</p>

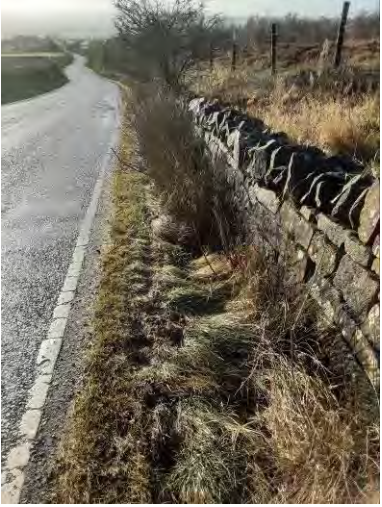
TR4.HWC11

<p>This watercourse is similar to TR4.HWC8 and is a small, narrow stream / seepage adjacent to the road. The embankments are dominated by grassland, with rushes (including soft rush and jointed rush ). The watercourse is up to 1 cm deep and 20 cm wide. The substrate is bare earth and sections of the watercourse are choked with mud. There are emergent mosses within the channel as well as grasses and rushes. There is negligible protected species potential.</p> <p>Habitat condition (provisional): Poor (Score 1)</p>	
TR4.HWC12

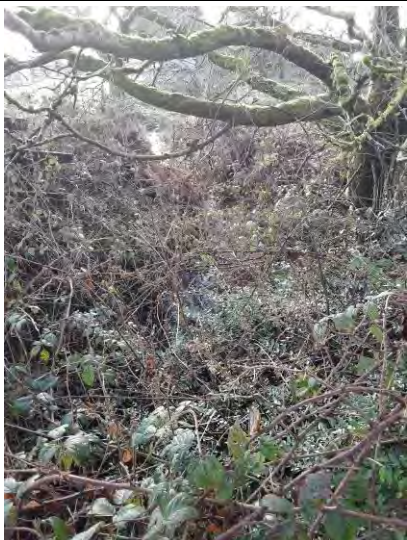
<p>Stream flowing parallel to the road, situated within dense scrub, then emerging into a marshy grassland field further south. There is a moderate flow and the channel is approximately 50 cm wide and 5 cm deep. The substrate is stones. The embankments are steep and heavily vegetated. Species include foxglove, gorse, bramble, bracken, fern species and hawthorn scrub. Tree saplings are also present on the banks and overhanging the stream. Sections of the banks are shallow and grassy and other sections are steep but with bare patches of ground and mosses. Further south the watercourse is culverted through a marshy grassland field, and here there are gorse, young trees and saplings on the bank. Continuing further south the watercourse has steep banks and the stream flows through a steep valley. A small tributary (not separately described) flows into the main stream, coming from under the road. The tributary is approximately 20 cm wide, 2-3 cm deep with no obvious banks present and a bare earth and gravel substrate. Here there is overhanging marshy grassland, submerged grasses and gorse scrub.</p> <p>Habitat condition (provisional): Moderate (Score 2)</p>

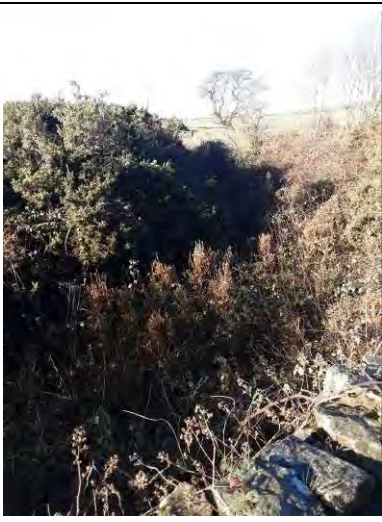
TR4.HWC14

<p>Stream flowing adjacent to the road in a steep sided gully. Towards the south of the survey area the watercourse is culverted beneath the road. The watercourse has a moderate flow and is approximately 0.5 m wide and up to 10 cm deep. The banks are steep and heavily vegetated with an abundance of overhanging vegetation. The watercourse is hidden beneath dense vegetation in places. There is approximately 3 m of vegetated banks on both sides of the watercourse. Species include bramble, gorse, bracken, umbellifer species, willowherb, common nettle, common hogweed, umbellifers and tree saplings. The substrate is sand, pebble and bare earth. In channel vegetation includes marsh pennywort (<i>Hydrocotyle vulgaris</i>). There is negligible potential for protected species.</p> <p>Habitat condition (provisional): Moderate (Score 2)</p>

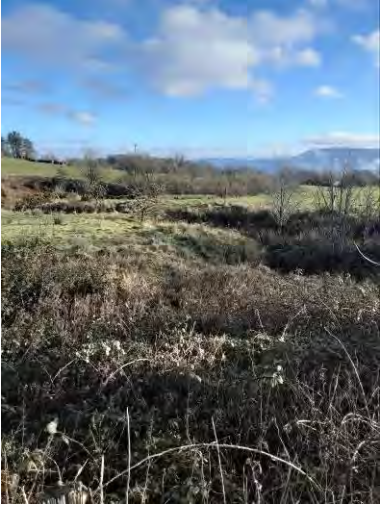
TR4.HWC15

<p>Stream flowing through a marshy grassland strip at the edge of a field which culverts beneath the road further downstream, before emerging within dense scrub. The watercourse has a slow flow which is stagnant in places. It is approximately 0.5 m wide and 2 cm deep. There are shallow grassland-dominated banks which are approximately 60 cm tall. Soft rush immediately surrounds the banks. The channel has a bare earth, muddy substrate. The channel flows through a winding gully in between semi-improved fields. Young tree saplings, gorse, bramble, tall ruderals, marshy grassland and dense scrub (including dog rose) are present on the banks. There is negligible potential for protected species.</p> <p>Habitat condition (provisional): Moderate (Score 2)</p>	
TR4.HWC16

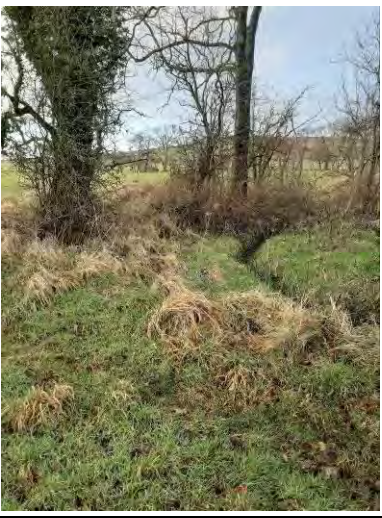
<p>This stream emerges from a culvert from a semi-improved grassland field and culverts beneath the road. There is only a small section visible above the ground. The channel is 15 to 30 cm wide and 2 cm deep. The substrate is bare earth and muddy. The banks are up to 30 cm tall and dominated by grasses. Tall ruderals also present on banks as well as willowherb species, umbellifer species, and bramble. The watercourse has a slow flow with occasional submerged grasses within the channel. There is negligible potential for protected species.</p> <p>Habitat condition (provisional): Poor (Score 1)</p>

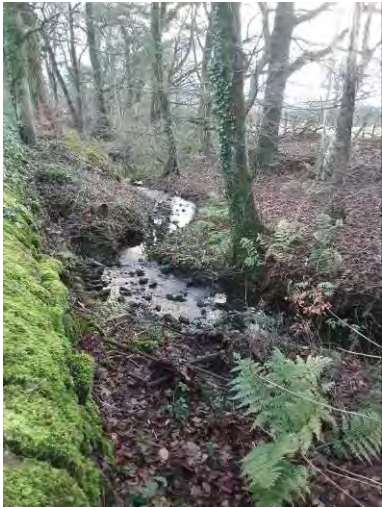
TR4.HWC17

<p>Stream running through broadleaved woodland (TR4.HTN49). The substrate is stone and sand and the watercourse has a slow to moderate flow. The banks are flat in sections and up to 2 m deep in other sections. There are some overhanging tree roots within the channel. The adjacent woodland ground flora is dominated by leaf litter with bittercress species and speedwell (<i>Veronica</i> sp.) noted along with overhanging ferns and trees. The channel is up to 1 m wide and approximately 3 cm deep. The watercourse has negligible protected species potential. Himalayan balsam is present within this woodland, this is an invasive species listed on Schedule 9 of the Wildlife and Countryside Act 1981 (as amended).</p> <p>Habitat condition (provisional): Moderate (Score 2)</p>	
TR4.HWC18

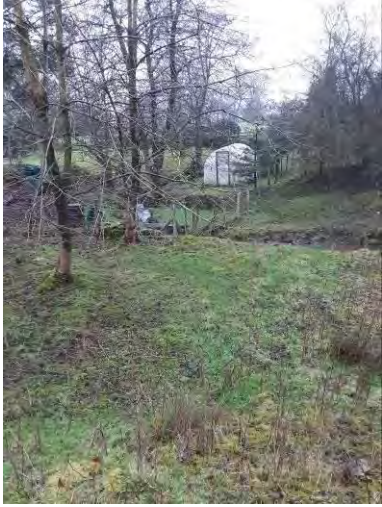
TR4.HWC19

<p>Narrow stream which is a continuation of TR4.HWC18, flowing roughly from north to south. The watercourse ranges from approximately 1 - 1.5m wide and 5 – 10 cm deep. The watercourse has a substrate of rock, pebbles, gravel and silt. There is a moderate flow although the survey was undertaken during rainfall. The banks are bare earth and consist of near vertical to near horizontal slopes along the length. The watercourse is approximately 30 cm deep. There is no aquatic vegetation recorded. The bankside vegetation includes soft rush, lesser celandine, hawthorn and bramble. There is potential for commuting otter but otherwise negligible protected species potential. The watercourse flows through species-poor semi-improved grassland, woodland and scrub habitats.</p> <p>Habitat condition (provisional): Moderate (Score 2)</p>	
TR4.HWC20

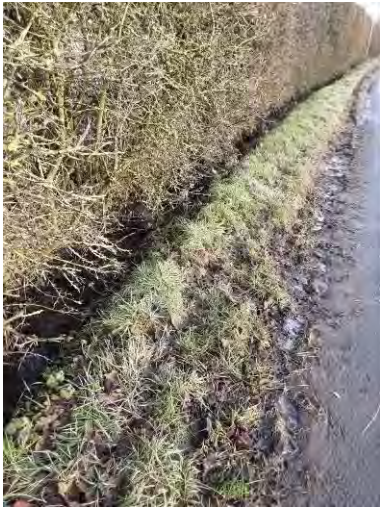
TR4.HWC21

<p>Small stream running parallel to the road. The watercourse is approximately 10 cm deep, 20 cm wide, with a slow to moderate flow. The substrate is silt and stone. The watercourse roughly runs from northeast to southwest and is culverted at the southwestern end. There is no aquatic vegetation and the majority of the channel is shaded by TR4.HH25. The banks are bare earth and are approximately 5 cm tall and horizontal. There is negligible protected species potential.</p> <p>Habitat condition (provisional): Poor (Score 1)</p>	
TR4.HWC22

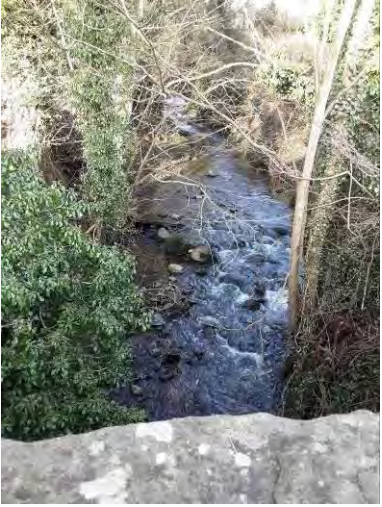
TR4.HWC23

<p>Grindleton Brook flows roughly from north to south and is surrounded by broadleaved woodland to the north of the road. The brook is culverted beneath the road and to the south of the road, emerges south of houses. It is a tributary of the River Ribble (TR4.HWC24)/ The watercourse is approximately 2 - 4 m wide, 10 - 30 cm deep with a moderate flow. The watercourse has a bed of rock and shingles. The banks are bare earth and are approximately 3 m deep and a 45 degree slope. There is no aquatic vegetation. TR4.HTN61 describes the surrounding vegetation. The watercourse has commuting otter potential along with crayfish and salmonid fish potential.</p> <p>Habitat condition (provisional): Moderate (Score 2)</p>	
TR4.HWC24

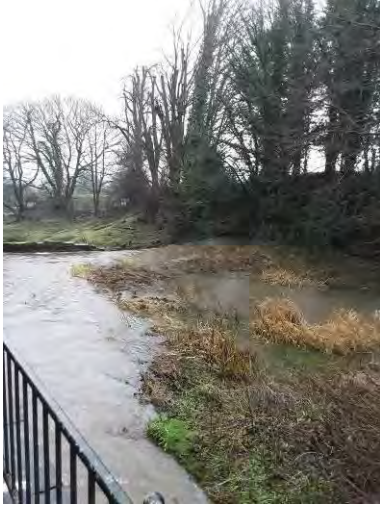
TR4.HWC25

<p>Watercourse flowing roughly from south to north located to the east of residential houses. The watercourse ranges from approximately 2 m to 10 m wide, with vegetated islands present within the channel. The vegetated islands include the species iris, pendulous sedge, buddleia, reed canary grass, common hogweed and broadleaved dock. The channel is mostly man made, with stone brick banks which reach approximately 3 m high. Small areas of the bank are composed of natural stone and earth, here the bank is shallower (approximately 45 degree slope). The watercourse bed was not visible due to highly turbid water and recent heavy rain immediately before and during survey. A weir is present within the survey area. A woodland (TR4.HTN68) is present on the eastern bank and the remaining banks are unvegetated or clad with ivy. This watercourse is a tributary to the River Ribble (TR4.HWC24). There is potential for commuting otter, crayfish and salmonid fish.</p> <p>Habitat condition (provisional): Moderate (Score 2)</p>
