Document reference: LCC-RVBC-BO-SEI Appendix B7

**Haweswater Aqueduct Resilience Programme -  
Proposed Bowland Section**

**Appendix B7: Ecology Assessment - Off-Site Highways Works**

February 2022

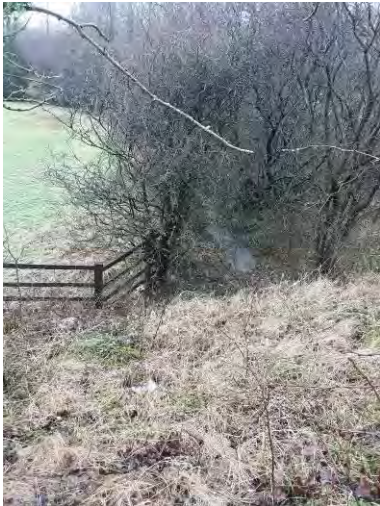
TR4.HWC26

<p>A narrow stream which flows through an area of broadleaved woodland, roughly from southeast to northwest. The watercourse is approximately 0.75 m wide of an unknown depth with a moderate flow. There is no aquatic vegetation. The channel is culverted at the south-eastern end. The channel is heavily shaded by the surrounding woodland. There are shallow earth banks which are approximately 20 cm deep. TR4.HTN72 contains a description of the surrounding vegetation. There is negligible protected species potential.</p> <p>Habitat condition (provisional): Moderate (Score 2)</p>	
TR4.HWC27	No photo.
<p>Wet ditch along a hedgerow (TR4.HH8). Channel is 0.5 m wide and less than 10 cm deep. The ditch becomes dry close to the road (western section of the ditch). The banks are earth and pebbles and the substrate is earth. The southern bank features the hedge in a raised bund, the northern bank is more gently sloped. Aquatic and marginal vegetation includes brooklime, soft rush and grass species; Yorkshire fog and cock's foot. Negligible protected species potential.</p> <p>Habitat condition (provisional): Poor (Score 1)</p>

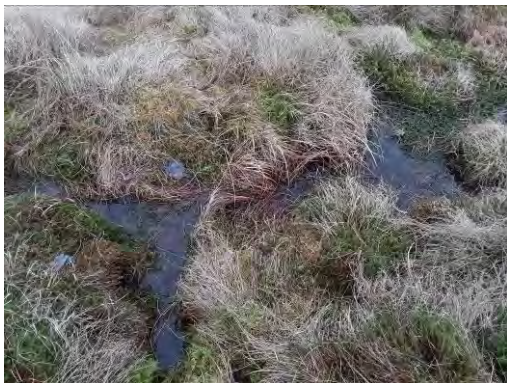
TR4.HWC32

Very short section of watercourse flowing emerging in an area of soft rush in a corner of land close to the road. This watercourse is likely fed by TR4.WC22 underground. The channel is approximately 1 m wide and pooling and is approximately 10 cm deep. The channel flows roughly eastwards where it becomes indistinct within the rushes and is choked with *Sphagnum* mosses, *Polytrichum* moss and scattered hare's tail cottongrass. There are sections of exposed peat visible. There is negligible potential for protected species.

Habitat condition (provisional): Moderate (Score 2)

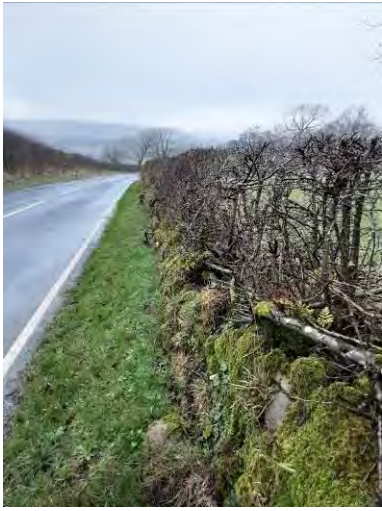
<p>This roadside hedge is approximately 65 m in length, 1.2 m tall and 0.6 m wide. There are no associated gaps, mature trees or ditches. The dominant woody species is hawthorn (<i>Crataegus monogyna</i>), with additional ash (<i>Fraxinus excelsior</i>), blackthorn (<i>Prunus spinosa</i>) and rose species (<i>Rosa</i> sp.; total four woody species). Schedule 2 ground flora species recorded include lady fern (<i>Athyrium filix-femina</i>), dog's mercury (<i>Mercurialis perennis</i>) and barren strawberry (<i>Potentilla sterilis</i>). Additional ground flora species recorded include crosswort (<i>Cruciata laevipes</i>), cinquefoil (<i>Potentilla simplex</i>), thistle species (<i>Cirsium</i> sp), ground ivy (<i>Glechoma hederacea</i>) and honeysuckle (<i>Lonicera periclymenum</i>). The hedgerow is neatly managed and there is evidence of previous laying. The hedgerow is supported by a bank or wall along at least half of the length. There is a parallel hedgerow within 15 m (TR4.HH2).</p> <p>No Wildlife &amp; Countryside Act protected species have been identified to be present.</p> <p><b>This hedgerow classifies under ecological criteria as 'Important' under The Hedgerow Regulations 1997.</b></p>

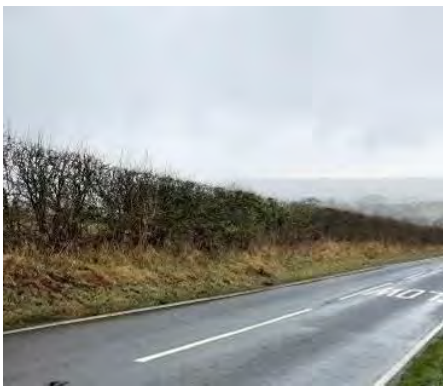
<p>TR4.HH2</p>

This roadside hedgerow is approximately 400 m long, 1.5 to 2 m tall and 0.5 to 1m wide. There are three associated gaps which account for 5% of the length of the hedgerow. There are eight associated mature trees and there is no associated ditch. The dominant woody species is hawthorn, with additional blackthorn and rose species (total three woody species). Schedule 2 ground flora recorded include lady fern, broad buckler fern (*Dryopteris dilata*), herb Robert (*Geranium robertianum*) and dog's mercury. Additional ground flora recorded includes ivy (*Hedera helix*), lesser celandine (*Ranunculus ficaria*), vetch species (*Vicia* sp.), common nettle (*Urtica dioica*), Yorkshire fog (*Holcus lanatus*), common burdock (*Arctium lappa*), cow parsley (*Anthriscus sylvestris*) and cleavers (*Galium aparine*). The hedgerow is lichen-rich and there is evidence of previous laying. There are two parallel hedgerows within 15 m (TR4.HH1 and TR4.HH3) and it has one connecting hedgerow (TR4.HH12).

No Wildlife & Countryside Act protected species have been identified to be present.

The hedgerow does not classify under ecological criteria as 'Important' under The Hedgerow Regulations 1997.

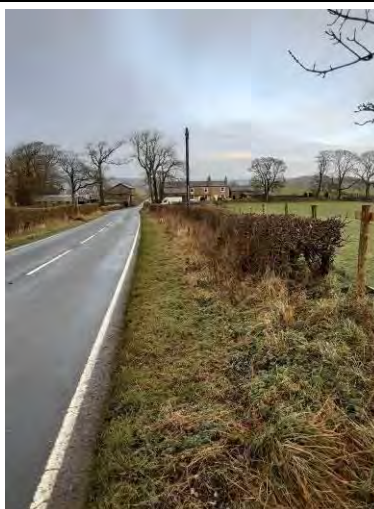
TR4.HH3

This hedgerow is approximately 120 m long, 1 m tall and 0.5 m wide. There is one associated mature tree. Associated gaps account for 5% of the total length and there is no associated ditch. The dominant species is hawthorn with additional blackthorn and rose species. Schedule 2 groundflora recorded include male fern (*Dryopteris filix-mas*) and dog's mercury. Additional ground flora species include; ribwort plantain (*Plantago lanceolata*), greater plantain (*Plantago major*), ivy, cow parsley, vetch species, common nettle, feather moss species (*Ptilium* spp.), stitchwort species (*Stellaria* sp.) and creeping buttercup (*Ranunculus repens*). A parallel hedgerow is present within 15 m (TR4.HH2). This hedgerow does not connect to other hedgerows.

No Wildlife & Countryside Act protected species have been identified to be present.

The hedgerow does not classify under ecological criteria as 'Important' under The Hedgerow Regulations 1997.

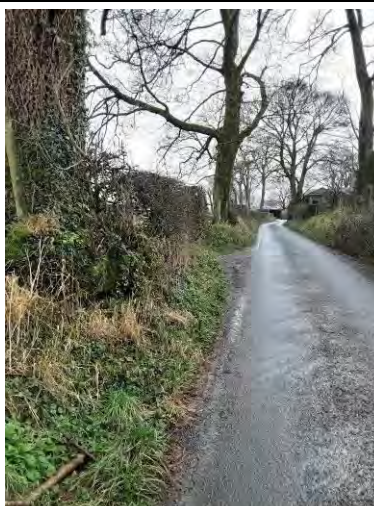
TR4.HH4

This hedgerow is approximately 100 m in length, 1.5 m tall and 0.5-1 m wide. There are three associated gaps accounting for approximately 10% of the hedgerow length. There are three associated mature trees and no associated ditch. The dominant woody species is hawthorn with additional hazel (*Corylus avellana*), ash, blackthorn, rose species and sycamore (*Acer pseudoplatanus*; total five woody species not including sycamore). Schedule 2 ground flora recorded include male fern, wild strawberry (*Fragaria vesca*), herb Robert and dog's mercury. Additional ground flora includes ground ivy, cleavers, cow parsley, feather moss, germander speedwell (*Veronica chamaedrys*), ivy, vetch species and red campion (*Silene dioica*). A parallel hedgerow is present within 15 m (TR4.HH5) and there is one other connecting hedgerow (TR4.HH6).

No Wildlife & Countryside Act protected species have been identified to be present.

**This hedgerow classifies under ecological criteria as 'Important' under The Hedgerow Regulations 1997.**

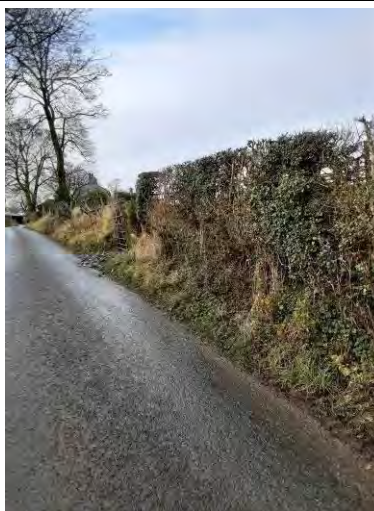
TR4.HH5

This hedgerow is approximately 25 m long (within the survey boundary), 1.5 to 2 m tall and 0.6 m wide. There are three gaps which account for approximately 15% of the hedgerow length. There are four associated mature trees and no ditch. The dominant species is hazel with additional hawthorn, ash and rose (total four woody species). Schedule 2 ground flora recorded include male fern, sweet woodruff (*Galium odoratum*), herb Robert and dog's mercury. Additional ground flora includes ground ivy, creeping buttercup, vetch species, Yorkshire fog and broadleaved dock (*Rumex obtusifolius*). A parallel hedgerow is present within 15 m (TR4.HH4).

No Wildlife & Countryside Act protected species have been identified to be present.

**This hedgerow classifies under ecological criteria as 'Important' under The Hedgerow Regulations 1997.**

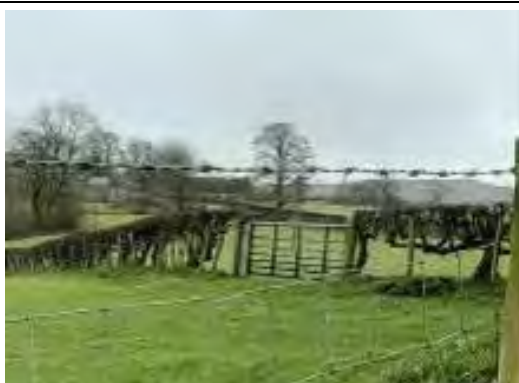
TR4.HH6

This hedgerow is approximately 60 m long, 1.5 to 2 m tall and 0.5 m wide. There are three associated gaps accounting for approximately 15% of the length of the hedgerow. There are no associated mature trees or ditch. The dominant woody species is hawthorn with additional blackthorn (total two woody species). Schedule 2 ground flora were not recorded. Additional ground flora species include meadow grass species (*Poa* sp.), perennial rye grass (*Lolium perenne*) and common nettle. There are no connection points or other parallel hedgerows.

No Wildlife & Countryside Act protected species have been identified to be present.

The hedgerow does not classify under ecological criteria as 'Important' under The Hedgerow Regulations 1997.

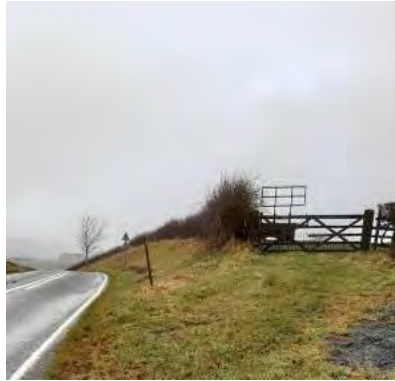
TR4.HH7

This hedgerow is approximately 490 m in length, 1.5 to 2 m tall and 1 m wide. There are 13 associated mature trees and no associated gaps or ditches. The dominant woody species is hawthorn with additional alder (*Alnus glutinosa*), hazel, ash, blackthorn, rose species and sycamore (total six woody species excluding sycamore). Schedule 2 ground flora recorded include male fern, wood avens (*Geum urbanum*) and dog's mercury. Additional ground flora includes common hogweed (*Heracleum sphondylium*), lesser celandine, common sorrel (*Rumex acetosa*), dog rose (*Rosa canina*), cow parsley, meadowsweet (*Filipendula ulmaris*), crosswort, feather moss, germander speedwell, ground ivy, Yorkshire fog, red campion, colt's foot (*Tuffilago farfara*), lady's mantle (*Alchemilla vulgaris*), ribwort plantain, creeping thistle (*Cirsium arvense*), common knapweed (*Centaurea nigra*) and silverweed (*Argentina anserina*). There is a parallel hedgerow within 15 m (TR4.HH9 and TR4.HH10) and this hedgerow connects to one other (TR4.HH8). A rabbit (*Oryctolagus cuniculus*) burrow was noted within the hedgerow.

No Wildlife & Countryside Act protected species have been identified to be present.

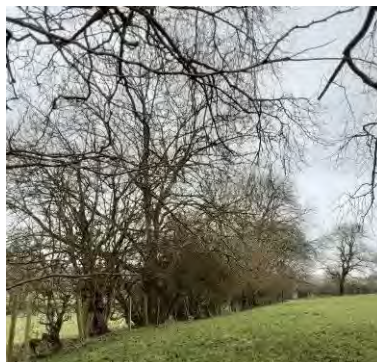
TR4.HH8

This hedgerow is approximately 45 m long, 4-5 m tall and 3 m wide. There are no associated gaps and there are three associated mature trees. A ditch is present on the northern elevation (TR4.HWC27). The dominant species is hawthorn with additional alder noted (total two woody species). Schedule 2 ground flora species present include lady fern. Additional ground flora species include creeping buttercup, soft rush, common nettle and brooklime (*Veronica beccabunga*). There is one connecting hedgerow (TR4.HH7).

No Wildlife & Countryside Act protected species have been identified to be present.

The hedgerow does not classify under ecological criteria as 'Important' under The Hedgerow Regulations 1997.

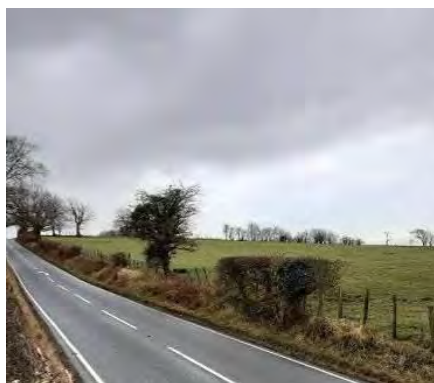
TR4.HH9

This hedgerow is approximately 200 m long, 1.5-2 m tall and 1 m wide. There are eight associated gaps which account for 25% of the hedgerow length. There are three mature associated trees and no ditch. The dominant woody species is hawthorn with additional alder, hazel, ash and blackthorn (total five woody species). Schedule 2 ground flora recorded include dog's mercury and wood avens. Additional ground flora includes common sorrel. There is a parallel hedgerow within 15 m (TR4.HH7) and an additional hedgerow is directly connected (TR4.HH10).

No Wildlife & Countryside Act protected species have been identified to be present.

The hedgerow does not classify under ecological criteria as 'Important' under The Hedgerow Regulations 1997.

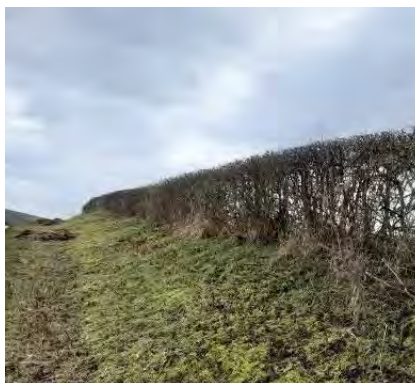
TR4.HH10

This hedgerow is approximately 250 m long, 1 to 1.5 m tall and 1 m wide. There are no associated gaps, trees or ditches. The dominant woody species is hawthorn with additional ash and blackthorn (total three woody species). Schedule 2 ground flora recorded include broad buckler fern, male fern, sweet woodruff, wood avens and dog's mercury. Additional ground flora includes feather moss species, bramble (*Rubus fruticosus agg.*), common nettle, creeping thistle, red campion, crosswort, black knapweed, common daisy (*Bellis perennis*), ground ivy, ivy, lesser celandine, coltsfoot, and spear thistle (*Cirsium vulgare*).

No Wildlife & Countryside Act protected species have been identified to be present.

The hedgerow does not classify under ecological criteria as 'Important' under The Hedgerow Regulations 1997.

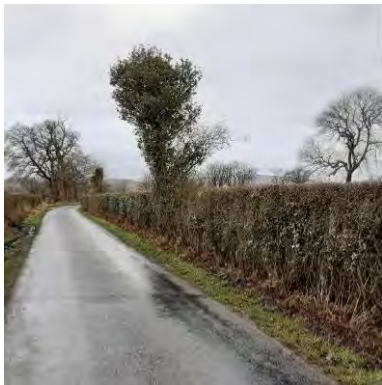
TR4.HH11

<p>This hedgerow is approximately 80 m long, 1.5 m tall and 1 m wide. There are no associated gaps or ditches. There is one associated mature tree. The dominant woody species is hawthorn, with additional beech (<i>Fagus sylvatica</i>), ash, holly, blackthorn, pedunculate oak (<i>Quercus robur</i>), rose species and sycamore (total woody species excluding sycamore is seven). Schedule 2 ground flora species include lady fern and dog's mercury. Additional ground flora species include common nettle, creeping buttercup, meadowsweet, cow parsley and ivy. There is a parallel hedgerow within 15 m and there are two connecting hedgerows. An disused birds nest was observed within the hedgerow.</p> <p>No Wildlife &amp; Countryside Act protected species have been identified to be present.</p> <p><b>This hedgerow classifies under ecological criteria as 'Important' under The Hedgerow Regulations 1997.</b></p>

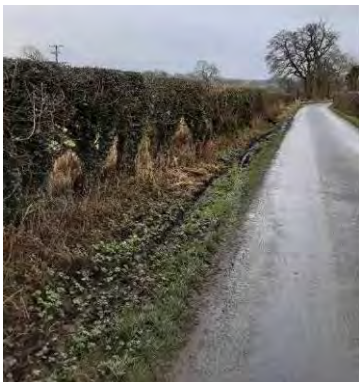
TR4.HH12

<p>This hedgerow is approximately 80 m long, 1.5 m tall and 0.5 – 1 m wide. There are no associated gaps, mature trees or ditches. The dominant woody species is hawthorn with additional hazel, blackthorn and rose species (total woody species is four). Schedule 2 ground flora species include broadbuckler fern and dog's mercury. Additional ground flora species include ivy, creeping buttercup and meadowsweet. There is a parallel hedgerow within 15 m and there is a connection to one other hedgerow.</p> <p>No Wildlife &amp; Countryside Act protected species have been identified to be present.</p> <p><b>This hedgerow classifies under ecological criteria as 'Important' under The Hedgerow Regulations 1997.</b></p>
TR4.HH13	No photo.
	<p>This hedgerow is approximately 300 m long, 1.6 m tall and 1.5 m wide. There are two gaps which account for approximately 5% of the hedgerow length and there are 13 associated mature trees. There is no associated ditch. The dominant woody species is hawthorn with additional alder, hazel, ash, holly, rose and sycamore (total woody species excluding sycamore is six). Schedule 2 ground flora recorded include male fern and dog's mercury. Additional ground flora species include reed canary grass (<i>Phalaris arundinacea</i>), ivy, vetch species, common hogweed and cow parsley. The hedgerow connects to one other hedgerow and a woodland.</p> <p>No Wildlife &amp; Countryside Act protected species have been identified to be present.</p> <p><b>This hedgerow classifies under ecological criteria as 'Important' under The Hedgerow Regulations 1997.</b></p>

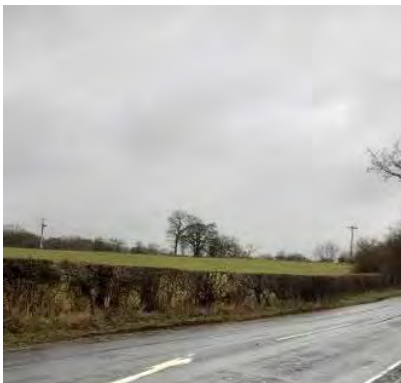
TR4.HH16

This hedgerow is approximately 320 m in length, 1 to 2 m tall and 1 to 2 m wide. Gaps account for approximately 2% of the hedgerow length and there are two associated mature trees. There is no associated ditch. The dominant woody species is hawthorn with additional hazel, beech, ash, holly, wild privet (*Ligustrum vulgare*), blackthorn, pedunculate oak, rose species, elder (*Sambucus nigra*), elm and sycamore (total eleven woody species excluding sycamore). Schedule 2 ground flora species include broad buckler fern, male fern, sweet woodruff, wood avens, herb Robert, lords-and-ladies (*Arum maculatum*), wild garlic (*Allium ursinum*) and dog's mercury. Additional ground flora species include red campion, snowberry and ground ivy. The is parallel to two other hedgerows (TR4.HH15 and TR4.HH14).

No Wildlife & Countryside Act protected species have been identified to be present.

**This hedgerow classifies under ecological criteria as 'Important' under The Hedgerow Regulations 1997.**

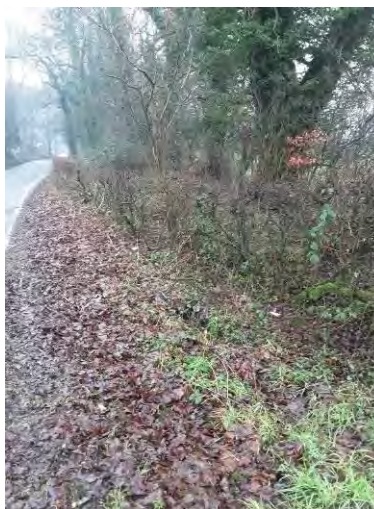
TR4.HH17

This hedgerow is approximately 44 m in length, 1 m tall and 0.5 m wide. There are no gaps, associated mature trees or a ditch. The dominant woody species is hawthorn with additional hazel, rose species, sycamore and oak species (total four woody species, excluding sycamore). Schedule 2 ground flora species include lords and ladies, wood avens and dog's mercury. Additional ground flora species include ivy and bramble. This hedgerow connects to a broadleaved woodland and is parallel to one other hedgerow (TR4.HH18). This hedgerow is well established and show signs of being previously laid. The hedgerow is supported by a bank or wall along at least half of its length.

No Wildlife & Countryside Act protected species have been identified to be present.

**This hedgerow classifies under ecological criteria as 'Important' under The Hedgerow Regulations 1997.**

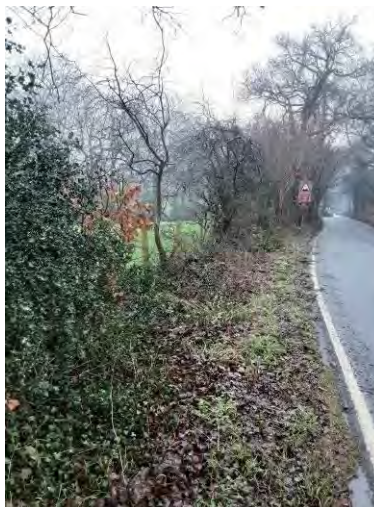
TR4.HH18

This hedgerow is approximately 230 m in length, 2.5 m tall and 0.75 m wide. There are no associated gaps or ditches and four associated mature trees. The dominant woody species is hawthorn, additional species include beech, ash and holly (total four woody species). Schedule 2 ground flora species include wood avens and dog's mercury. Additional ground flora species include creeping buttercup, ivy, Yorkshire fog, lesser celandine and common hogweed. This hedgerow connects to a coniferous plantation woodland (TN4.HTN59) and is parallel to one other hedgerow (TN4.HH17). A disused bird nest was observed within the hedgerow.

No Wildlife & Countryside Act protected species have been identified to be present.

**This hedgerow classifies under ecological criteria as 'Important' under The Hedgerow Regulations 1997.**

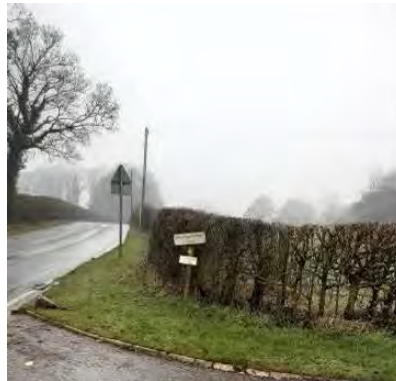
TR4.HH19

This hedgerow is approximately 120 m in length, 1.5 m tall and 1.5 m wide. There are no associated gaps, mature trees or ditches. The dominant woody species is hawthorn, additional species include ash, elder, lime sp. (*Tilia* sp.) and sycamore (total of four woody species excluding sycamore). Schedule 2 ground flora species includes dog's mercury. Additional ground flora species include creeping buttercup, ivy and lesser celandine. This hedgerow connects to a broadleaved woodland and one other hedgerow (TR4.HH21), and is parallel to one other hedgerow (TR4.HH20).

No Wildlife & Countryside Act protected species have been identified to be present.

The hedgerow does not classify under ecological criteria as 'Important' under The Hedgerow Regulations 1997.

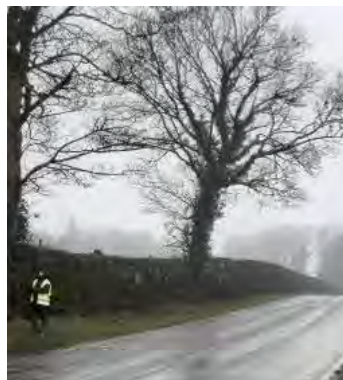
TR4.HH20

This hedgerow is approximately 75 m in length, 2 m tall and 1.5 m wide. There are no associated gaps or ditches and two associated mature trees. The dominant woody species is lime sp., additional species include hawthorn, holly, wild privet, rose sp. and sycamore (total of five woody species excluding sycamore). Schedule 2 ground flora species include lady fern, wood avens and dog's mercury. Additional ground flora species include fern sp., cleavers, ivy, common nettle, hedge mustard (*Sisymbrium officinale*), bramble and cock's foot (*Dactylus glomerata*). This hedgerow connects to a broadleaved woodland and there is a parallel hedgerow within 15 m (TR4.HH19).

No Wildlife & Countryside Act protected species have been identified to be present.

**This hedgerow classifies under ecological criteria as 'Important' under The Hedgerow Regulations 1997.**

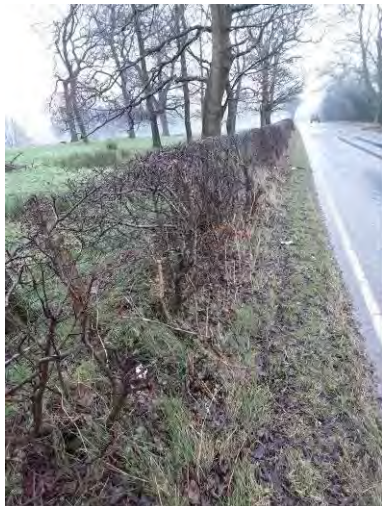
TR4.HH21

<p>This Hedgerow is approximately 245 m in length, 1 m tall and 0.5 m wide. Gaps account for approximately 2% of the hedgerow length and there is one associated mature tree. There is no associated ditch. The dominant woody species is hawthorn, additional species include beech, rose sp., elm sp., and lime sp. (total five woody species). Schedule 2 ground flora species include wood avens, dog's mercury and wood anemone (<i>Anemone nemorosa</i>). Additional ground flora species include ivy, tufted hairgrass (<i>Deschampsia cespitosa</i>), yarrow, lesser celandine, common hogweed, bramble and creeping buttercup. The hedgerow connects to one other hedgerow (TR4.HH19) and there is a parallel hedgerow within 15 m (TR4.HH22).</p> <p>No Wildlife &amp; Countryside Act protected species have been identified to be present.</p> <p>The hedgerow does not classify under ecological criteria as 'Important' under The Hedgerow Regulations 1997.</p>

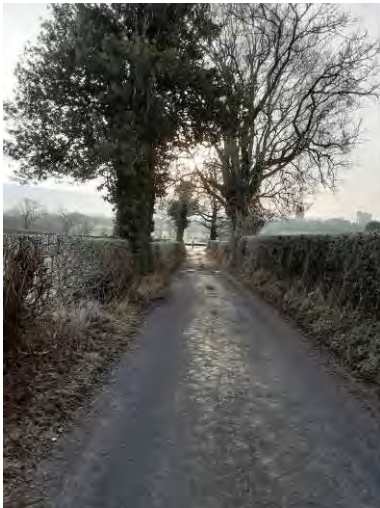
<p>This hedgerow is approximately 100 m in length, 1.5 m tall and 0.75 m wide. There are no associated gaps or ditches and three associated mature trees. There is no dominant woody species; hawthorn and blackthorn are both abundant. Additional woody species include holly, rose sp., elder, elm sp., lime sp. and sycamore (total of seven species excluding sycamore). Schedule 2 ground flora species include lady fern, wood avens and dog's mercury. Additional ground flora species include ivy, bramble and cock's foot. The hedgerow connects to two other hedgerows and there is a parallel hedgerow within 15 m (TR4.HH23). No Wildlife &amp; Countryside Act protected species have been identified to be present.</p> <p>No Wildlife &amp; Countryside Act protected species have been identified to be present.</p> <p><b>This hedgerow classifies under ecological criteria as 'Important' under The Hedgerow Regulations 1997.</b></p>

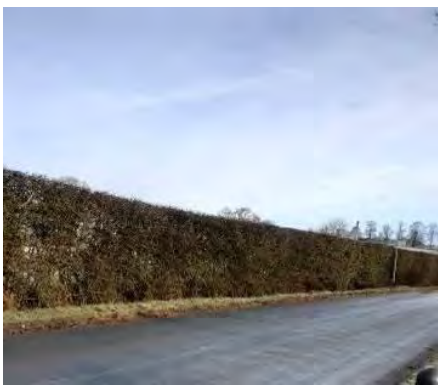
TR4.HH25

<p>This hedgerow is approximately 82 m in length, 2 m tall and 0.75 m wide. There are no associated gaps or trees. A wet ditch runs along the eastern elevation. The dominant woody species is blackthorn, additional species include hazel, holly, elder and sycamore (total of four species excluding sycamore). Schedule 2 ground flora species include lord-and-ladies, wood avens and dog's mercury. Additional ground flora species include ivy, common nettle and daffodil (<i>Narcissus pseudonarcissus</i>). The hedgerow connects to two other hedgerows.</p> <p>No Wildlife &amp; Countryside Act protected species have been identified to be present.</p> <p><b>This hedgerow classifies under ecological criteria as 'Important' under The Hedgerow Regulations 1997.</b></p>

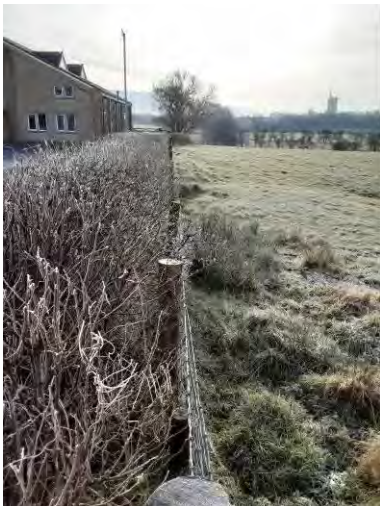
TR4.HH26

<p>This hedgerow is approximately 108 m in length, 0.75 m tall and 1 m wide. There are no associated gaps or ditches and one associated mature tree. The dominant woody species is hawthorn, additional species include hornbeam and lime sp. (total of three species). Schedule 2 ground flora species include primrose (<i>Primula vulgaris</i>) and wood avens. Additional ground flora species include creeping buttercup, ivy and herb Robert. The hedgerow connects to an area of broadleaved woodland.</p> <p>No Wildlife &amp; Countryside Act protected species have been identified to be present.</p> <p>The hedgerow does not classify under ecological criteria as 'Important' under The Hedgerow Regulations 1997.</p>
TR4.HH27

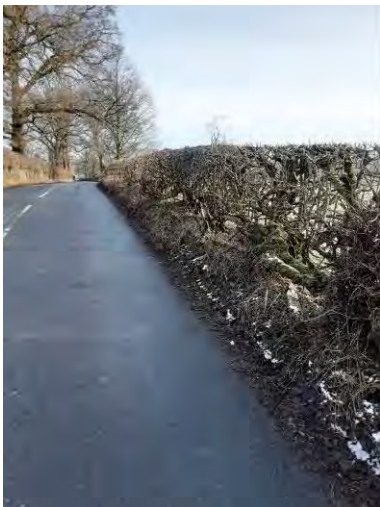
<p>This hedgerow is approximately 53 m in length, 1.5 m tall and 0.75 m wide. There are no associated gaps, ditches or mature trees. The dominant woody species is blackthorn, additional species include hawthorn, holly, elder and elm sp. (total five species). Schedule 2 ground flora species include wood avens and dog's mercury. Additional ground flora species includes ivy. There is a parallel hedgerow within 15 m (TR4.HH28).</p> <p>No Wildlife &amp; Countryside Act protected species have been identified to be present.</p> <p>The hedgerow does not classify under ecological criteria as 'Important' under The Hedgerow Regulations 1997.</p>

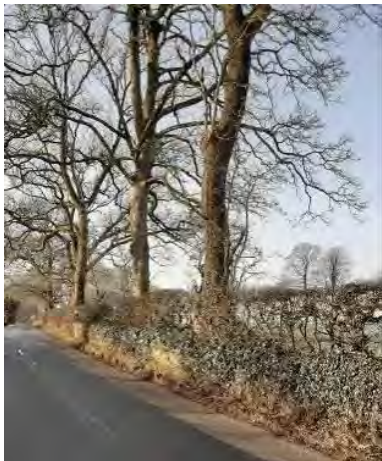
TR4.HH28

<p>This hedgerow is approximately 195 m in length, 2 m tall and 0.75 m wide. There are no associated gaps or ditches and seven associated mature trees. The dominant woody species is hawthorn, additional species include beech, ash, blackthorn, elder, elm sp., oak sp. and sycamore (total of seven species excluding sycamore). Schedule 2 ground flora species include lord-and-ladies, wood avens and dog's mercury. Additional ground flora species include ivy and bramble. The hedgerow connects to a broadleaved woodland (TN4.HTN60). There is a parallel hedgerow within 15 m (TR4.HH27).</p> <p>No Wildlife &amp; Countryside Act protected species have been identified to be present.</p> <p><b>This hedgerow classifies under ecological criteria as 'Important' under The Hedgerow Regulations 1997.</b></p>
TR4.HH29

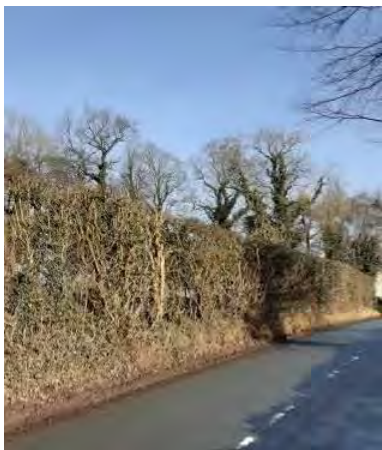
<p>This hedgerow is approximately 65 m in length, 2 m tall and 1 m wide. There are no associated gaps, ditches or trees. A wall supports the hedgerow along at least half its length. The dominant woody species is hawthorn, additional species include holly, rose sp., elder, elm sp. and sycamore (total of five species excluding sycamore). Schedule 2 ground flora species includes dog's mercury. Additional ground flora species include ivy, bramble and ground elder (<i>Aegopodium podagraria</i>). The hedgerow connects to a broadleaved woodland (TR4.HTN61) and one other hedgerow.</p> <p>No Wildlife &amp; Countryside Act protected species have been identified to be present.</p> <p><b>This hedgerow classifies under ecological criteria as 'Important' under The Hedgerow Regulations 1997.</b></p>

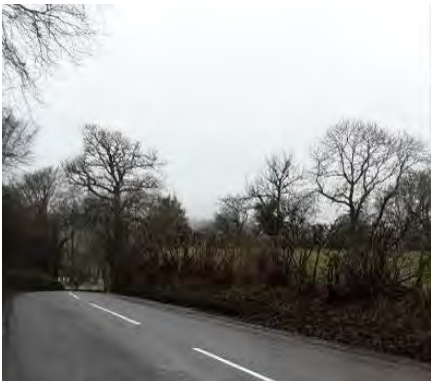
TR4.HH30

<p>This hedgerow is approximately 102 m in length, 2 m tall and 1.5 m wide. There are no associated gaps or ditches and two associated mature trees. A bank supports the hedgerow along at least half of its length. There is no dominant woody species; hawthorn, blackthorn and sycamore are all frequent. Additional species include ash, rose sp., elder and elm sp. (total of six species excluding sycamore). Schedule 2 ground flora species include lords-and-ladies, wood avens and dog's mercury. Additional ground flora species include ivy and bramble. The hedgerow connects to a broadleaved woodland (TR4.HTN64) and there is a parallel hedgerow within 15 m (TR4.HH31).</p> <p>No Wildlife &amp; Countryside Act protected species have been identified to be present.</p> <p><b>This hedgerow classifies under ecological criteria as 'Important' under The Hedgerow Regulations 1997.</b></p>	
TR4.HH31

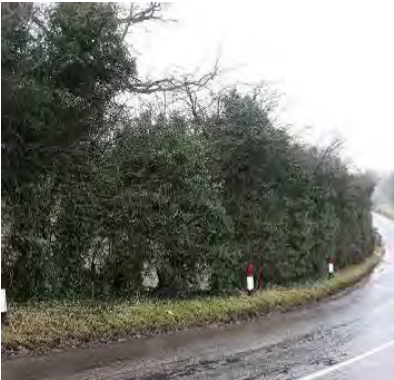
<p>This hedgerow is approximately 107 m in length, 5 m tall and 2 m wide. There are no associated gaps, ditches or mature trees. A bank supports the hedgerow along at least half of its length. The dominant woody species is hawthorn, additional species include beech, ash, blackthorn, willow species (<i>Salix</i> sp.), elder, elm sp. and sycamore (total of seven species excluding sycamore). Schedule 2 ground flora species include lady fern, wood avens and dog's mercury. Additional ground flora species include coltsfoot, creeping buttercup, ivy and bramble. The hedgerow connects to two broadleaved woodlands (TR4.HTN65 and TR4.HTN67) and one other hedgerow. There is a parallel hedgerow within 15 m (TR4.HH30).</p> <p>No Wildlife &amp; Countryside Act protected species have been identified to be present.</p> <p><b>This hedgerow classifies under ecological criteria as 'Important' under The Hedgerow Regulations 1997.</b></p>

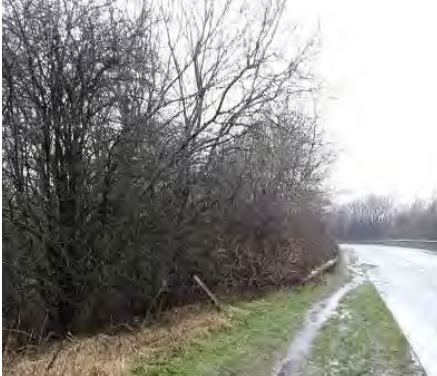
TR4.HH32

This hedgerow is approximately 36 m in length, 3 m tall and 1 m wide. Gaps account for approximately 40% of the hedgerow length. There are no associated ditches or mature trees. The dominant woody species is hawthorn, additional species include hazel, ash and blackthorn (total of three species). Schedule 2 ground flora species include harts tongue fern. Additional ground flora species include ivy, bramble and common nettle. The hedgerow connects to a broadleaved woodland (TR4.HTN72) and there is a parallel hedgerow within 15 m (TR4.HH33).

No Wildlife & Countryside Act protected species have been identified to be present.

The hedgerow does not classify under ecological criteria as 'Important' under The Hedgerow Regulations 1997.

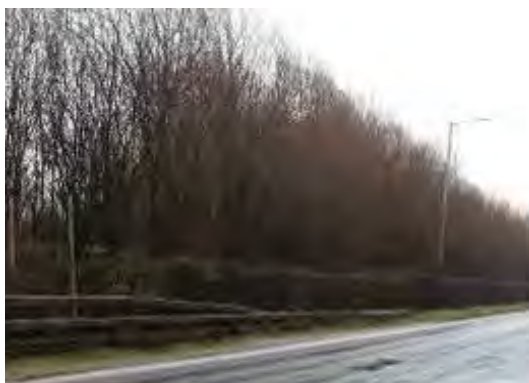
TR4.HH33

This hedgerow is approximately 97 m in length, 1.5 m tall and 1 m wide. There are no associated gaps, ditches or mature trees. The dominant woody species is hawthorn, additional species include ash, blackthorn, rose sp., elder and elm sp. (total of six species). No schedule 2 ground flora species were recorded. Ground flora species include ivy and bramble. The hedgerow connects to a broadleaved woodland (TR4.HTN73) and there is a parallel hedgerow within 15 m (TR4.HH32). The hedgerow is situated at the edge of a broadleaved woodland.

No Wildlife & Countryside Act protected species have been identified to be present.

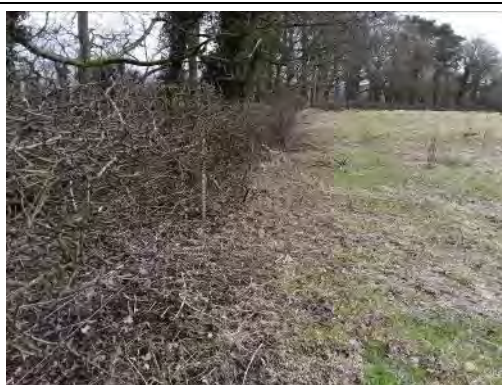
TR4.HH36

This hedgerow is approximately 144 m in length, 1 m tall and 0.75 m wide. There are three associated gaps accounting for approximately 5% of the total length. There are no associated mature trees or ditches. The dominant woody species is blackthorn with additional hawthorn, beech, ash and holly (total of five woody species). Schedule 2 ground flora recorded include lords-and-ladies, lady fern, wood avens and herb Robert. Additional ground flora recorded includes ivy, common nettle, lesser celandine, snowdrops (*Galanthus nivalis*), tufted hairgrass and Himalayan balsam. Himalayan balsam is listed on Schedule 9 of the Wildlife and Countryside Act 1981 (as amended). The hedgerow has previously been laid, felled and topped. The hedgerow is along the western boundary of a woodland.

No Wildlife & Countryside Act protected species have been identified to be present.

Himalayan balsam, a Schedule 9 listed invasive plant of the Wildlife and Countryside Act 1981 (as amended), was noted within the ground flora of two hedgerows; TR4.HH14 and 36.

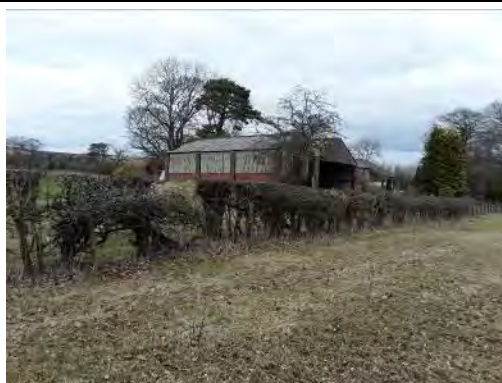
TR4.HH37

This hedgerow is approximately 49 m in length, 1 m tall and 2 m wide. There are three associated gaps accounting for approximately 10% of the hedgerow length. There are three associated mature trees and no ditch. The dominant woody species is blackthorn with additional beech, holly, rose species, willow species and elder (total of six woody species). Schedule 2 ground flora species recorded include lady fern, herb Robert and wood avens. Additional ground flora recorded include common nettle, common mouse ear (*Cerastium fontanum*), cow parsley, Yorkshire fog, cleavers, garlic mustard (*Alliaria petiolata*) and ground elder.

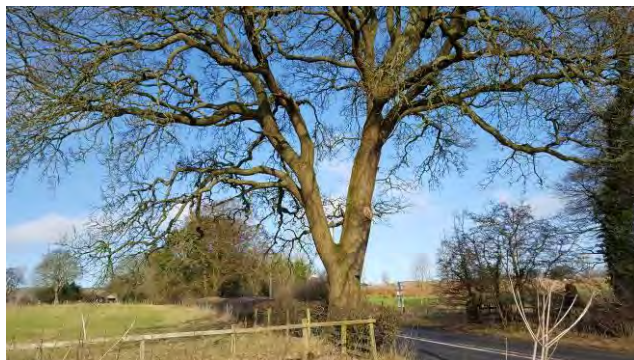
TR4.BT34

NGR: SD 72251 45131

Species: Oak species (*Quercus* sp.)

Categorisation: Low potential

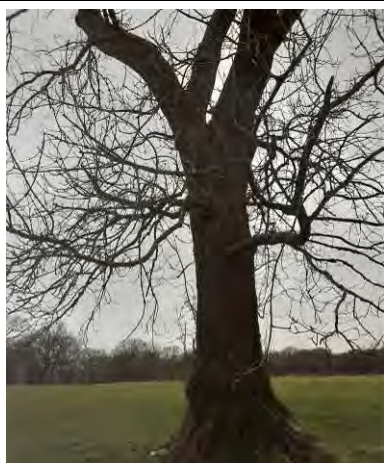
TR4.HBT1

NGR: SD 70402 49244

Species: Ash (*Fraxinus excelsior*)

Categorisation: Moderate potential

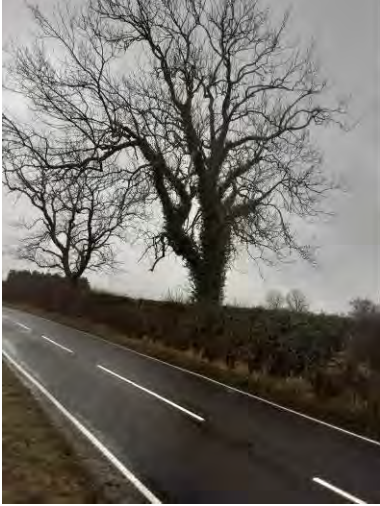
TR4.HBT2

<p>NGR: SD 70337 49394</p> <p>Species: Ash</p> <p>Categorisation: Low potential</p>
TR4.HBT3

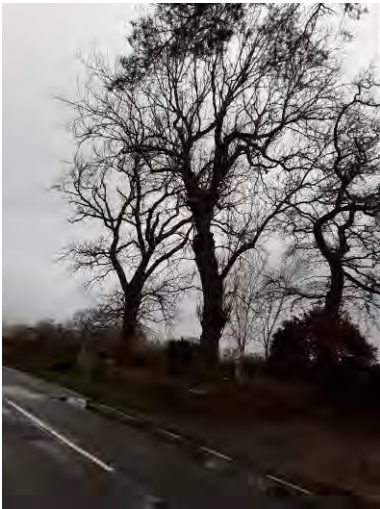
<p>NGR: SD 70407 49233</p> <p>Species: Ash</p> <p>Categorisation: Moderate potential</p>
TR4.HBT4

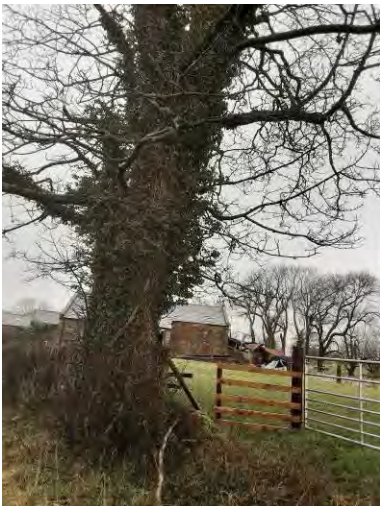
<p>NGR: SD 70352 49531</p> <p>Species: Sycamore (<i>Acer pseudoplatanus</i>)</p> <p>Categorisation: Low potential</p>

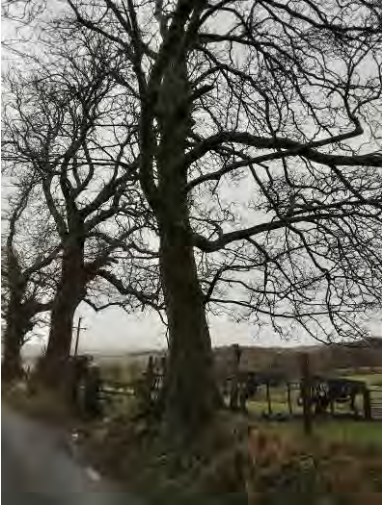
TR4.HBT5

<p>NGR: SD 70315 49787</p> <p>Species: Sycamore</p> <p>Categorisation: Low potential</p>
TR4.HBT6

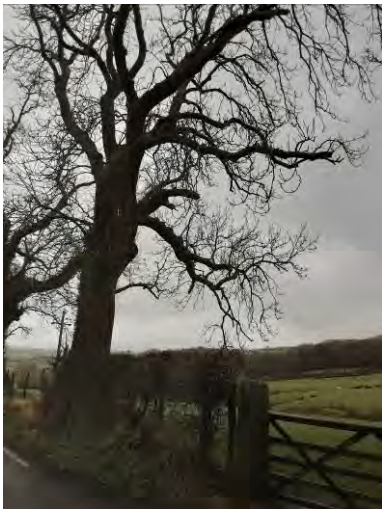
<p>NGR: SD 70324 49792</p> <p>Species: Ash</p> <p>Categorisation: Low potential</p>
TR4.HBT7

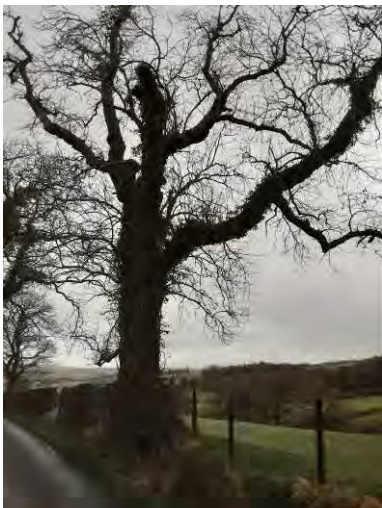
<p>NGR: SD 70330 49799</p> <p>Species: Ash</p> <p>Categorisation: Moderate potential</p>

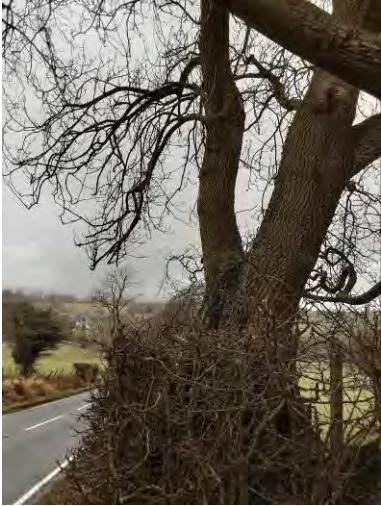
TR4.HBT8

<p>NGR: SD 70110 50014</p> <p>Species: Alder (<i>Alnus glutinosa</i>)</p> <p>Categorisation: Moderate potential</p>
TR4.HBT9

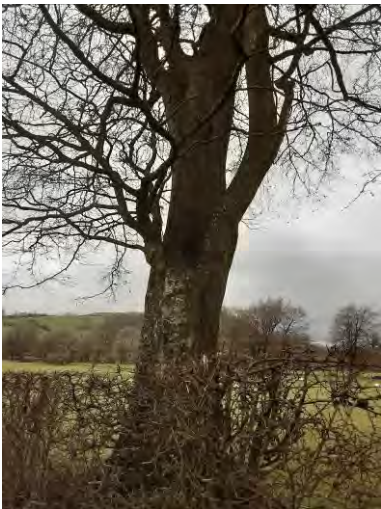
<p>NGR: SD 70060 50097</p> <p>Species: Beech (<i>Fagus sylvatica</i>)</p> <p>Categorisation: Low potential</p>
TR4.HBT10

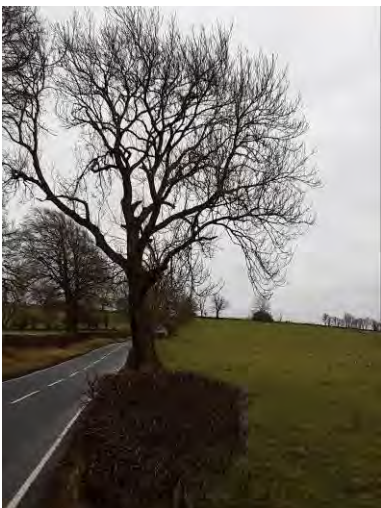
<p>NGR: SD 70004 50143</p> <p>Species: Ash</p> <p>Categorisation: Moderate potential</p>

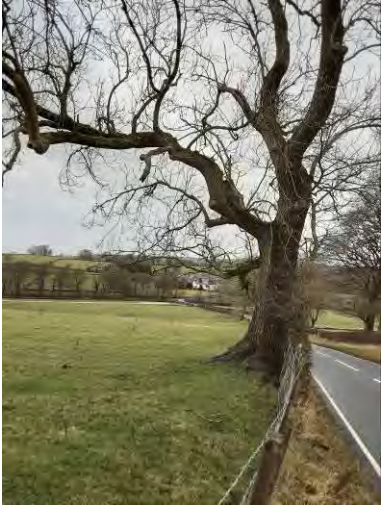
<p>TR4.HBT11</p>

<p>NGR: SD 70071 50058</p> <p>Species: Ash</p> <p>Categorisation: Moderate potential</p>
<p>TR4.HBT12</p>

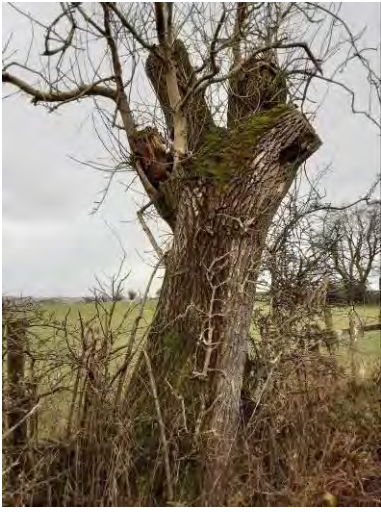
<p>NGR: SD 70202 49669</p> <p>Species: Ash</p> <p>Categorisation: Low potential</p>
<p>TR4.HBT13</p>

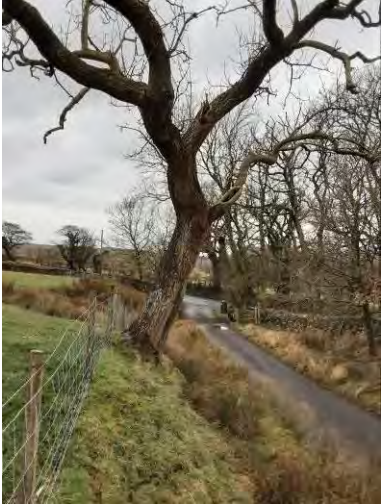
<p>NGR: SD 70539 48992</p> <p>Species: Ash</p> <p>Categorisation: Moderate potential</p>

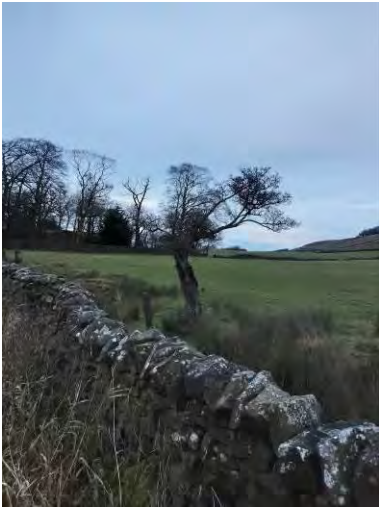
TR4.HBT14

<p>NGR: SD 70475 48790</p> <p>Species: Alder</p> <p>Categorisation: Low potential</p>
TR4.HBT15

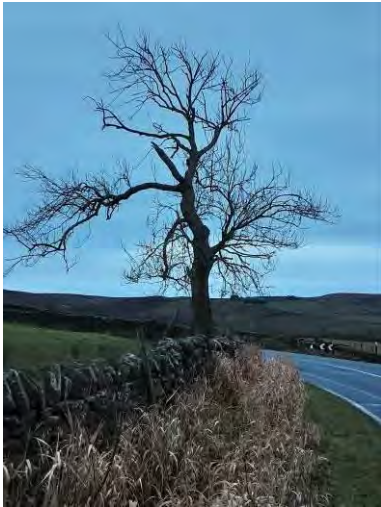
<p>NGR: SD 70463 48764</p> <p>Species: Ash</p> <p>Categorisation: Moderate potential</p>
TR4.HBT16

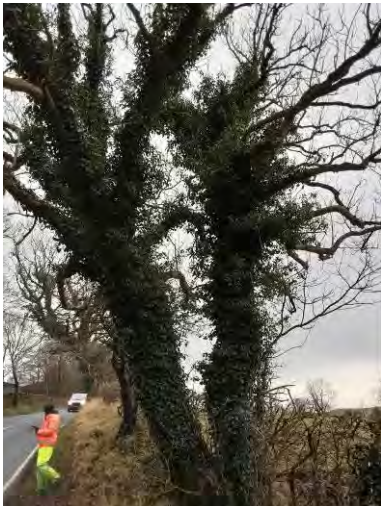
<p>NGR: SD 70486 49007</p> <p>Species: Ash</p> <p>Categorisation: Low potential</p>

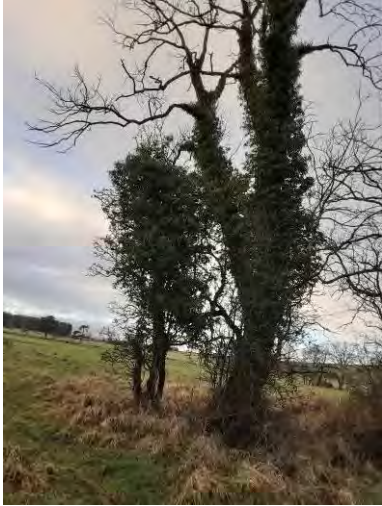
TR4.HBT17

<p>NGR: SD 72222 45511</p> <p>Species: Ash</p> <p>Categorisation: Low potential</p>
TR4.HBT18

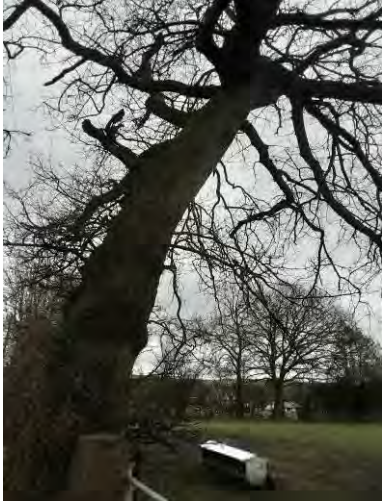
<p>NGR: SD 72235 45535</p> <p>Species: Oak species</p> <p>Categorisation: Moderate potential</p>
TR4.HBT19

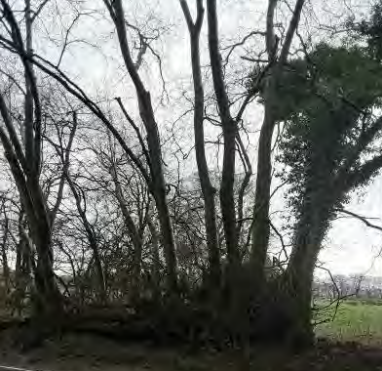
<p>NGR: SD 72249 45447</p> <p>Species: Elm species (<i>Ulmus</i> sp.)</p> <p>Categorisation: Low potential</p>

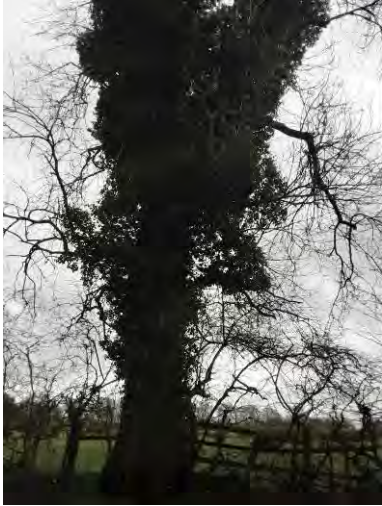
TR4.HBT20

<p>NGR: SD 72256 45405</p> <p>Species: Ash</p> <p>Categorisation: Low potential</p>
TR4.HBT21

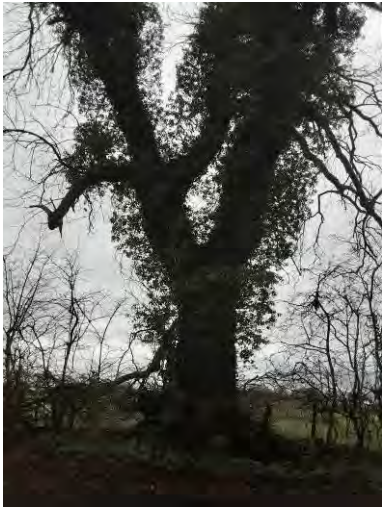
<p>NGR: SD 72259 45358</p> <p>Species: Ash</p> <p>Categorisation: Low potential</p>
TR4.HBT22	
<p>No photo.</p>	<p>NGR: SD 72263 45129</p> <p>Species: Alder</p> <p>Categorisation: Low potential</p>

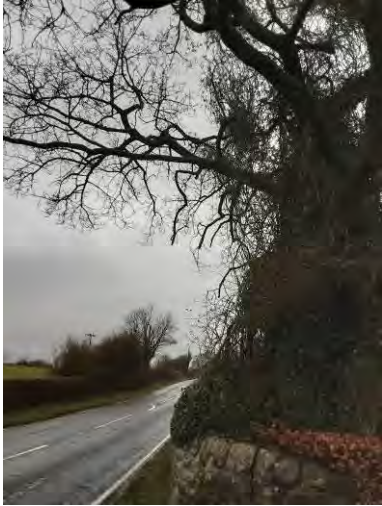
TR4.HBT23

<p>NGR: SD 72324 44891</p> <p>Species: Oak species</p> <p>Categorisation: Low potential</p>
TR4.HBT24	
<p>No photo.</p>	<p>NGR: SD 70160 50114</p> <p>Species: Ash</p> <p>Categorisation: Moderate potential</p>
TR4.HBT25

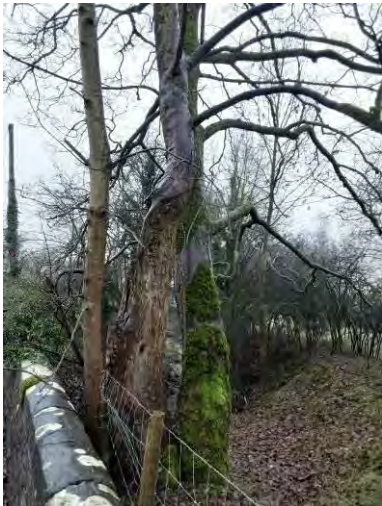
<p>NGR: SD 72576 44083</p> <p>Species: Sycamore</p> <p>Categorisation: Moderate potential</p>

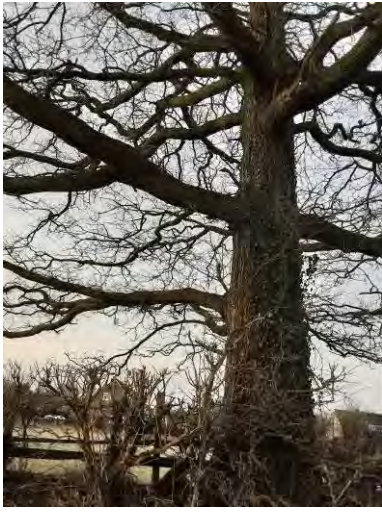
<p>NGR: SD 74682 44706</p> <p>Species: Oak species</p> <p>Categorisation: Low potential</p>
<p>TR4.HBT28</p>

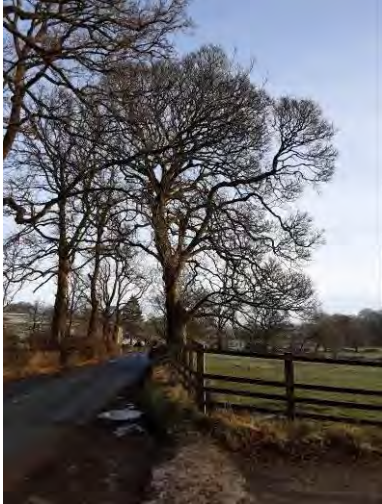
<p>NGR: SD 75557 45003</p> <p>Species: Sycamore</p> <p>Categorisation: Moderate potential</p>

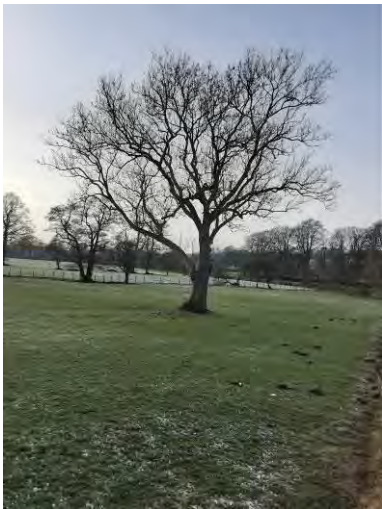
<p>NGR: SD 76056 44928</p> <p>Species: Ash</p> <p>Categorisation: Moderate potential</p>
TR4.HBT31

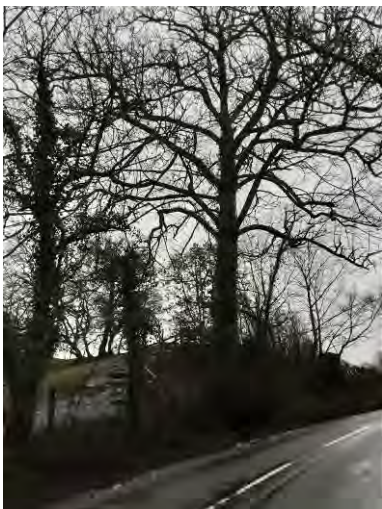
<p>NGR: SD 76464 44705</p> <p>Species: Sycamore</p> <p>Categorisation: Moderate potential</p>

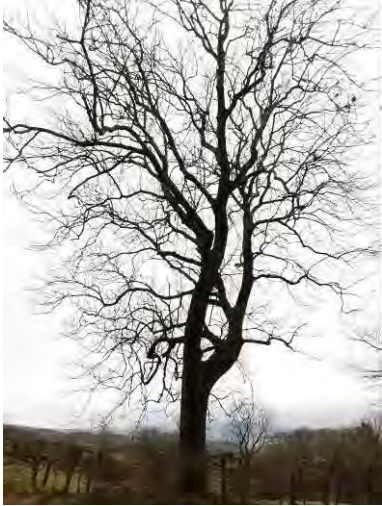
TR4.HBT32

<p>NGR: SD 70489 48903</p> <p>Species: Ash</p> <p>Categorisation: Low potential</p>
<b>Groups</b>	
TR4.HBG1

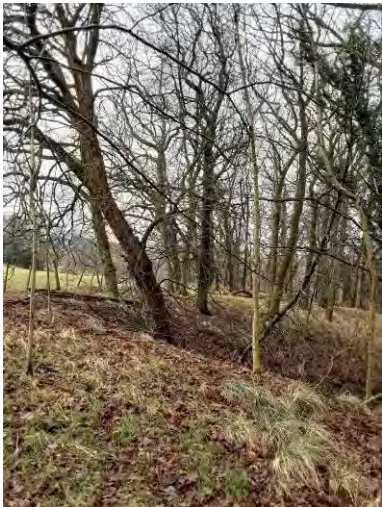
<p>NGR: SD 70407 49158</p> <p>Species: Willow species (<i>Salix</i> sp.), sycamore, holly (<i>Ilex aquifolium</i>), beech, alder, oak species, hawthorn (<i>Crataegus monogyna</i>), pine species (<i>Pinus</i> sp.) and fir species (<i>Abies</i> sp.).</p> <p>Number of trees: over 50</p> <p>Categorisation: Moderate potential</p>
TR4.HBG2

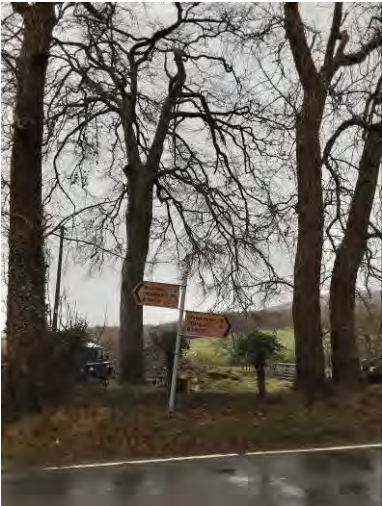
<p>NGR: SD 70268 49735</p> <p>Species: Ash and beech</p> <p>Number of trees: 4</p> <p>Categorisation: Low potential</p>

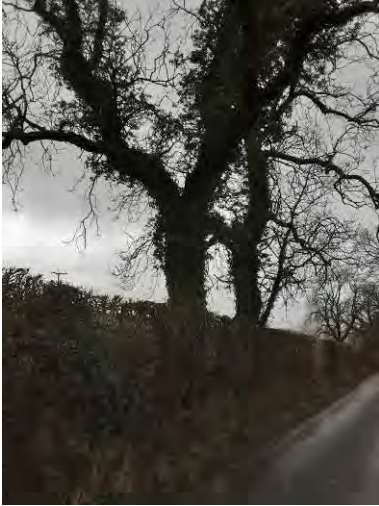
TR4.HBG3

<p>NGR: SD 70330 49813</p> <p>Species: Ash</p> <p>Number of trees: 2</p> <p>Categorisation: Moderate potential</p>
TR4.HBG4

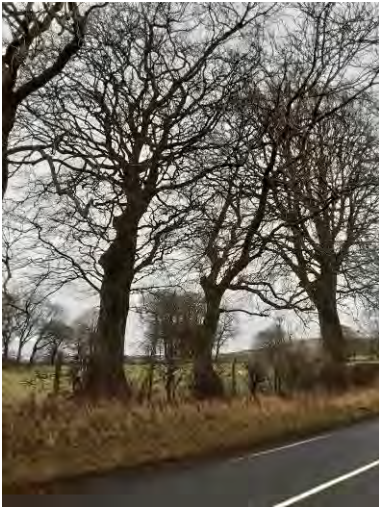
<p>NGR: SD 70007 50153</p> <p>Species: Ash and beech</p> <p>Number of trees: 7</p> <p>Categorisation: Moderate potential</p>
TR4.HBG5

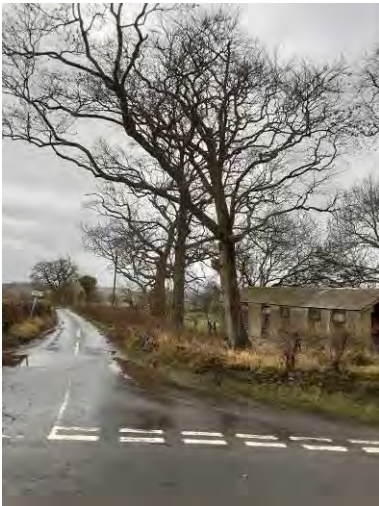
<p>NGR: SD 70262 49712</p> <p>Species: Ash and beech</p> <p>Number of trees: 4</p> <p>Categorisation: <b>High potential</b></p>

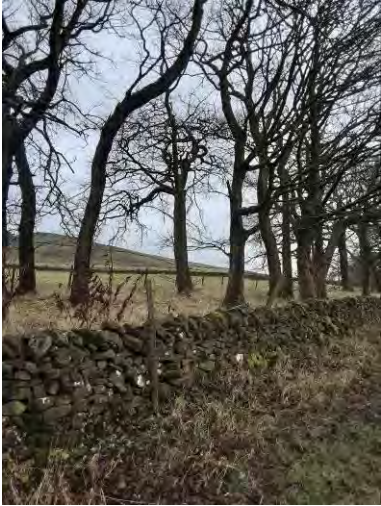
TR4.HBG6

<p>NGR: SD 70477 49106</p> <p>Species: Ash, sessile oak (<i>Quercus petraea</i>), sycamore and beech</p> <p>Number of trees: over 50</p> <p>Categorisation: <b>High potential</b></p>
TR4.HBG7

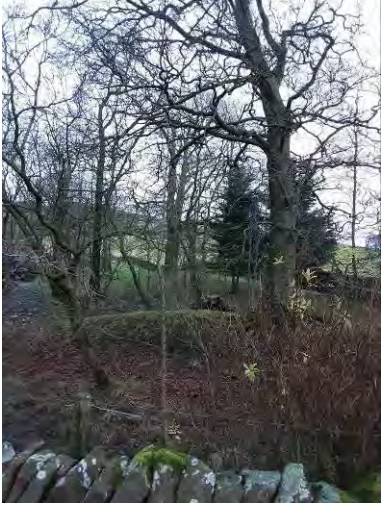
<p>NGR: SD 70511 48857</p> <p>Species: Beech, alder, ash and chestnut species (<i>Castanea</i> sp.)</p> <p>Number of trees: over 20</p> <p>Categorisation: Moderate potential</p>
TR4.HBG8

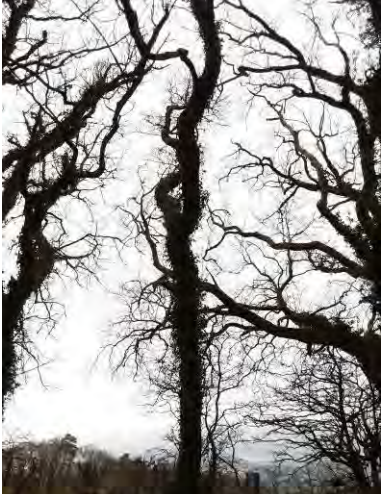
<p>NGR: SD 70490 48982</p> <p>Species: Ash and alder</p> <p>Number of trees: 3</p> <p>Categorisation: Low potential</p>

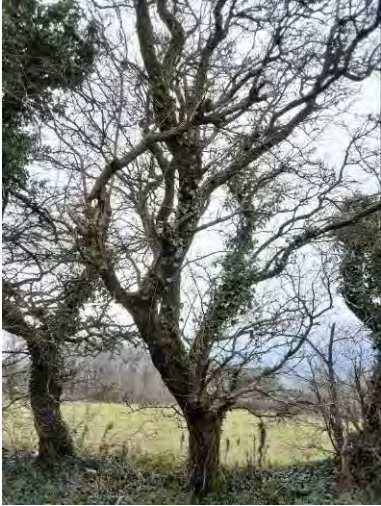
TR4.HBG9

<p>NGR: SD 70489 48945</p> <p>Species: Alder</p> <p>Number of trees: 4</p> <p>Categorisation: Moderate potential</p>
TR4.HBG10
