Document reference: LCC-RVBC-BO-SEI Appendix B7

**Haweswater Aqueduct Resilience Programme -  
Proposed Bowland Section**

**Appendix B7: Ecology Assessment - Off-Site Highways Works**

February 2022

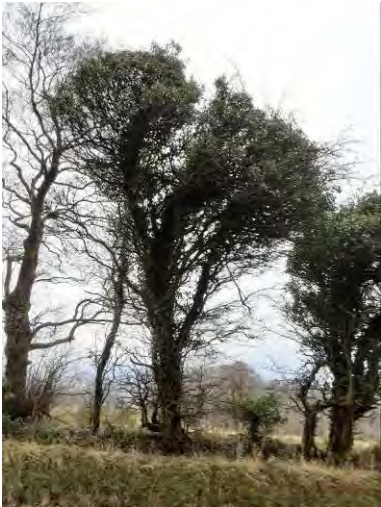
<p>NGR: SD 70490 48922</p> <p>Species: Alder</p> <p>Number of trees: 5</p> <p>Categorisation: Moderate potential</p>
TR4.HBG11

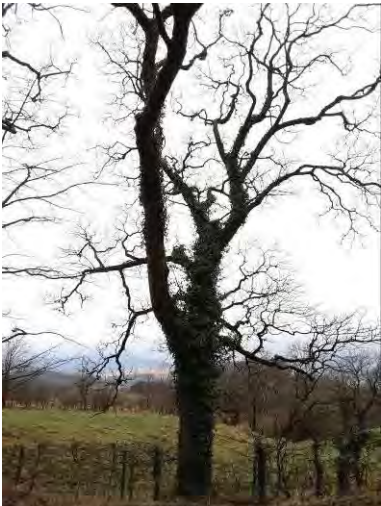
<p>NGR: SD 70490 48876</p> <p>Species: Sycamore</p> <p>Number of trees: 2</p> <p>Categorisation: Moderate potential</p>

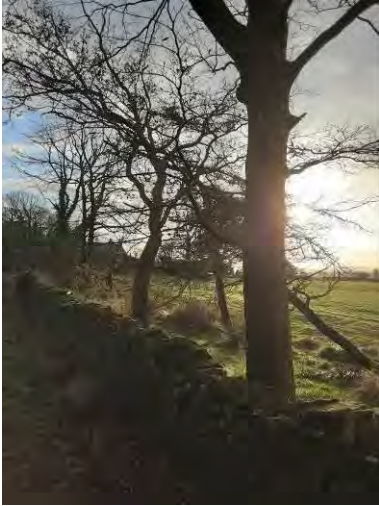
TR4.HBG12

<p>NGR: SD 72211 45583</p> <p>Species: Scots pine (<i>Pinus sylvestris</i>), oak species, alder and beech</p> <p>Number of trees: 7</p> <p>Categorisation: Moderate potential</p>
TR4.HBG13

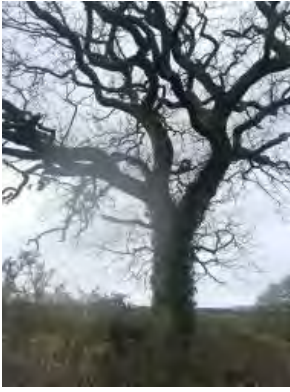
TR3.HBT9

Protected Species Assessment			Summary of Constraints		
<ul style="list-style-type: none"> <li>One tree within the works area has moderate potential to support roosting bats (TR3.BT9). Removal of this tree may be required to facilitate works.</li> <li>Another tree in close proximity to the works has low potential to support roosting bats (TR3.BT8). This tree will not be removed to facilitate works but there is a risk overhanging branches may require removal.</li> <li>The hedgerow has nesting bird potential.</li> <li>The SI grassland has ground nesting bird potential</li> <li>The mix of habitats on and adjacent to the site could support a range of foraging and commuting species (e.g. reptiles, bats, badger, brown hare, hedgehog, invertebrates).</li> <li>Amphibians are unlikely to be present due to distance of nearest potential breeding pond (&gt; 450m).</li> </ul>			<ul style="list-style-type: none"> <li>Habitats will be reinstated on completion of the works</li> <li>Both sides of the road contain mature, species-rich hedgerows (TR3.H8 and TR3.H9). The hedgerows are located on banks with occasional mature trees.</li> <li>Current proposals will require removal of approximately 40 m of species-rich intact hedgerow and associated bank habitat.</li> <li>Hedgerow could be classed as important under the Hedgerow Regulations 1997.</li> <li>Mitigation for hedgerow loss will be required which needs agreeing with the LPA, either as part of the reinstatement proposals or improvement of adjacent areas of hedgerow.</li> <li>Loss of a small area of adjacent species-poor semi-improved grassland is unlikely to have a significant adverse effect but there could be disturbance to ground nesting species using the wider field.</li> <li>Works should avoid the nesting bird season or be subject to nesting bird checks.</li> <li>It appears the tree with moderate bat roost potential may require removal to facilitate the works. Consideration should be given to retaining this tree. If removal is required, further surveys will be required in relation to roosting bats before works can commence.</li> <li>Works should avoid any impacts to trees with bat potential in proximity of the site. If any branches require removal to facilitate works, further surveys will be required in relation to roosting bats before works can commence.</li> </ul>

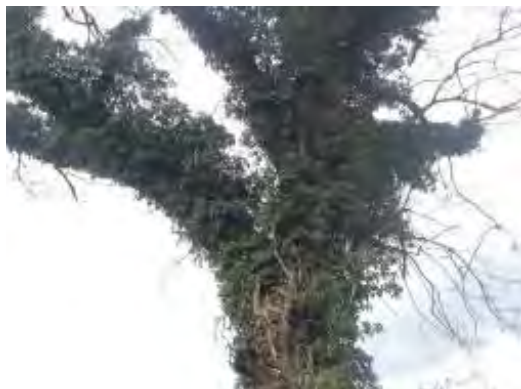
Protected Species Assessment			Summary of Constraints		
<ul style="list-style-type: none"><li>One tree within the hedgerow to be removed has low potential to support roosting bats (TR3.BT13).</li><li>The hedgerows have nesting bird potential.</li><li>The adjacent SI grassland (field not verge) and marshy grassland have ground nesting bird potential</li><li>The mix of habitats on and adjacent to the site could support a range of foraging and commuting species (e.g. reptiles, bats, badger, brown hare, hedgehog, invertebrates).</li><li>Amphibians are unlikely to be present due to distance of nearest potential breeding pond (&gt; 350 m).</li></ul>			<ul style="list-style-type: none"><li>Habitats will be reinstated on completion of the works</li><li>Current proposals will require removal of approximately 130 m of species-rich intact hedgerow and associated SI grass verge that is connected to woodland habitat.</li><li>Hedgerow could be classed as important under the Hedgerow Regulations 1997.</li><li>Mitigation for hedgerow loss will be required which needs agreeing with the LPA, either as part of the reinstatement proposals or improvement of adjacent areas of hedgerow.</li><li>It appears the tree with low bat roost potential is likely to require removal to facilitate the works. Consideration should be given to retaining this tree by siting road widening works within the verge on the south side of the road (extending RW20). If this tree requires removal further surveys will be required in relation to roosting bats before works can commence.</li><li>Works will result in the small loss of SI grassland associated with the roadside verge and adjoining fields. This loss is unlikely to have a significant adverse effect, but there could be disturbance to ground nesting species using the wider fields.</li><li>Works should avoid the nesting bird season or be subject to nesting bird checks.</li><li>No direct impacts to the nearby watercourse are anticipated.</li></ul>

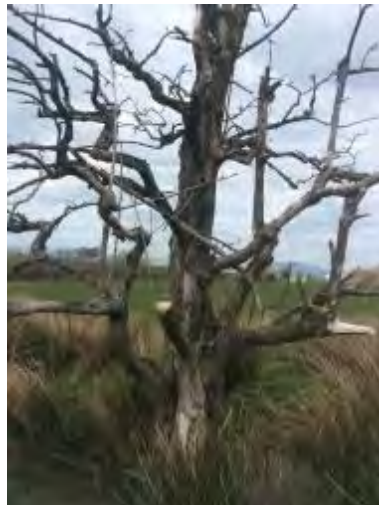
<div>TR3.BT22</div>

Protected Species Assessment			Summary of Constraints		
<ul style="list-style-type: none"><li>One tree adjacent to the site (within 10 m) has low potential to support roosting bats (TR3.BT22).</li><li>The adjacent woodland and scattered scrub has potential to support nesting birds, foraging and commuting bats and badger setts although no evidence found.</li><li>The adjacent SI grassland (field not verge) has ground nesting bird potential.</li><li>The mix of habitats on and adjacent to the site could support a range of foraging and commuting species (e.g. reptiles, bats, badger, brown hare, hedgehog, invertebrates).</li><li>Terrestrial amphibians could be present across the site due to distance of nearest potential breeding pond (c 240m).</li></ul>			<ul style="list-style-type: none"><li>Habitats will not be reinstated on completion of the works.</li><li>Current proposals indicate possible loss of the edge of semi-natural broadleaved woodland – assumed that this loss could be avoided though tree branch removal may be required (no significant impact).</li><li>Loss of single scrub (tree – likely hawthorn)</li><li>Loss of relatively small areas of species-poor semi-improved grassland is unlikely to have a significant adverse effect, but there could be disturbance to ground nesting species using the wider field (not applicable for verge).</li><li>Works should avoid the nesting bird season or be subject to nesting bird checks.</li><li>ECoW required to check site for protected species prior to site clearance (amphibians/reptiles)</li><li>Works in proximity to tree with low potential to support roosting bats (TR3.BT22) considered unlikely to be impacted as offsite and on and embankment higher than the works.</li></ul>

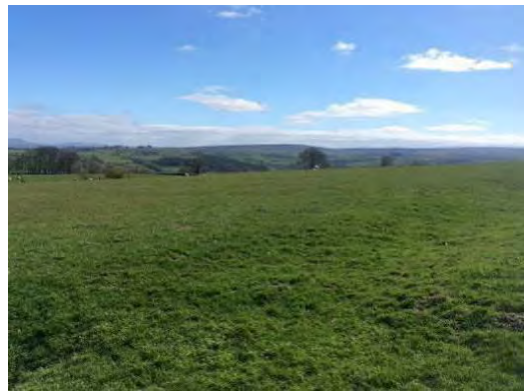
<div>TR3.TN22</div>

Protected Species Assessment			Summary of Constraints		
<ul style="list-style-type: none"><li>Improved grassland adjacent to the site has potential to support ground nesting birds.</li><li>Limited diversity in habitats in and adjacent to the site could support a limited range of foraging and commuting species (e.g. reptiles, bats, badger, brown hare, hedgehog, invertebrates).</li><li>Amphibians are unlikely to be present due to limited suitable habitat and distance of nearest potential breeding ponds (c 400 m which are relatively isolated in the wider landscape).</li></ul>			<ul style="list-style-type: none"><li>Habitats will be reinstated on completion of the works</li><li>Works will result in the small loss of improved grassland associated with the roadside verge and adjoining field. This loss is unlikely to have a significant adverse effect, but there could be disturbance to ground nesting species using the wider field.</li><li>Works should avoid the nesting bird season or be subject to nesting bird checks.</li></ul>

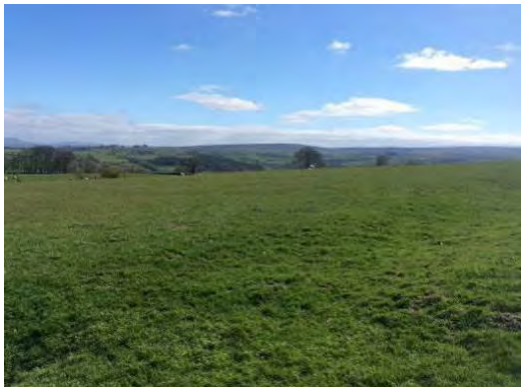
TR3.TN22

Protected Species Assessment			Summary of Constraints		
<ul style="list-style-type: none"><li>Improved grassland adjacent to the site has potential to support ground nesting birds.</li><li>Dry stone wall has some potential to support nesting birds.</li><li>Limited diversity in habitats in and adjacent to the site could support a limited range of foraging and commuting species (e.g. reptiles, bats, badger, brown hare, hedgehog, invertebrates).</li><li>Amphibians are unlikely to be present due to limited suitable habitat and distance of nearest potential breeding ponds (c 400 m which are relatively isolated in the wider landscape).</li></ul>			<ul style="list-style-type: none"><li>Habitats will be reinstated on completion of the works</li><li>Works will result in the small loss of improved grassland and dry stone wall associated with the roadside verge and adjoining field. This loss is unlikely to have a significant adverse effect, but there could be disturbance to ground nesting species using the wider field or other species using the dry stone wall.</li><li>Works should avoid the nesting bird season or be subject to nesting bird checks.</li></ul>

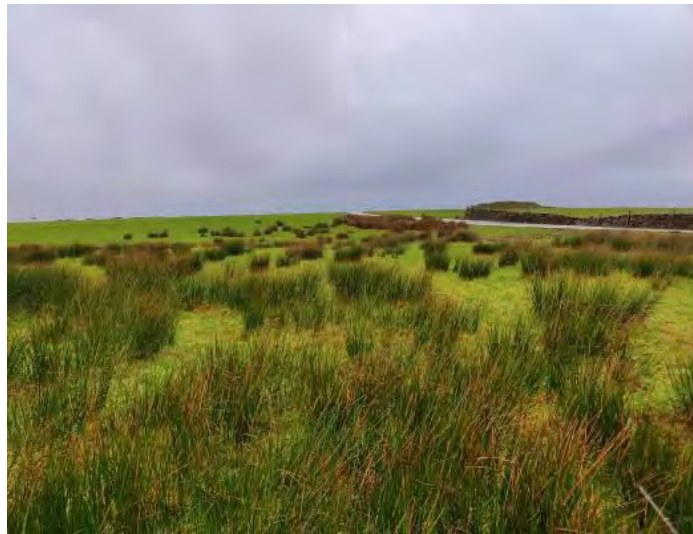
TR3.HTN25

Protected Species Assessment			Summary of Constraints		
<ul style="list-style-type: none"><li>Improved grassland adjacent to the site has potential to support ground nesting birds.</li><li>Limited diversity in habitats in and adjacent to the site could support a limited range of foraging and commuting species (e.g. reptiles, bats, badger, brown hare, hedgehog, invertebrates).</li><li>Amphibians are unlikely to be present due to limited suitable habitat and distance of nearest potential breeding ponds (c 360 m).</li><li>Small watercourse associated with field drainage passes under the road. It is unlikely to support water vole or otter.</li></ul>			<ul style="list-style-type: none"><li>Habitats will be reinstated on completion of the works</li><li>Works will result in small losses of improved grassland associated with the roadside verge and adjoining field. A small area of marshy grassland (rush dominated pasture) will also be lost. These losses are unlikely to have a significant adverse effect, but there could be disturbance to ground nesting species using the wider fields.</li><li>Works should avoid the nesting bird season or be subject to nesting bird checks.</li><li>Works likely to require extension of watercourse culvert. No significant impacts anticipated.</li></ul>

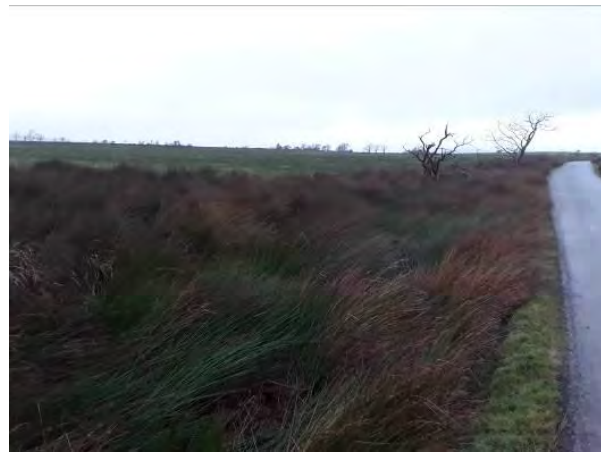
<div>TR3.HTN15</div>

Protected Species Assessment			Summary of Constraints		
<ul style="list-style-type: none"><li>Semi-improved grassland adjacent to the site has potential to support ground nesting birds.</li><li>Limited diversity in habitats in and adjacent to the site could support a limited range of foraging and commuting species (e.g. reptiles, bats, badger, brown hare, hedgehog, invertebrates).</li><li>Amphibians are unlikely to be present due to limited suitable habitat and distance of nearest potential breeding ponds (c 420 m).</li><li>Small watercourse associated with field drainage on the boundary of the works. It is unlikely to support water vole or otter.</li></ul>			<ul style="list-style-type: none"><li>Habitats will be reinstated on completion of the works</li><li>Works will result in small losses of semi-improved grassland and marshy grassland (rush dominated pasture) associated with the roadside verge and adjoining fields. These losses are unlikely to have a significant adverse effect, but there could be disturbance to ground nesting species using the wider fields.</li><li>Works should avoid the nesting bird season or be subject to nesting bird checks.</li><li>Works are on the edge of a watercourse. Assumed impacts could be avoided but even if a culvert is required no significant impacts are anticipated.</li></ul>

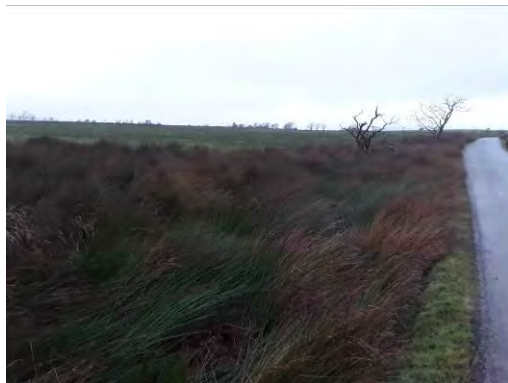
<div>TR3.HTN15</div>

Protected Species Assessment			Summary of Constraints		
<ul style="list-style-type: none"><li>Marshy grassland (rush dominated pasture) and semi-improved grassland adjacent to the site has potential to support ground nesting birds.</li><li>Limited diversity in habitats in and adjacent to the site could support a limited range of foraging and commuting species (e.g. reptiles, bats, badger, brown hare, hedgehog, invertebrates).</li><li>Amphibians are unlikely to be present due to limited suitable habitat and distance of nearest potential breeding ponds (c 420 m).</li></ul>			<ul style="list-style-type: none"><li>Habitats will be reinstated on completion of the works</li><li>Works will result in the small loss of marshy grassland (rush dominated pasture) associated with the roadside verge and adjoining fields. This loss is unlikely to have a significant adverse effect, but there could be disturbance to ground nesting species using the wider fields.</li><li>Works should avoid the nesting bird season or be subject to nesting bird checks.</li></ul>

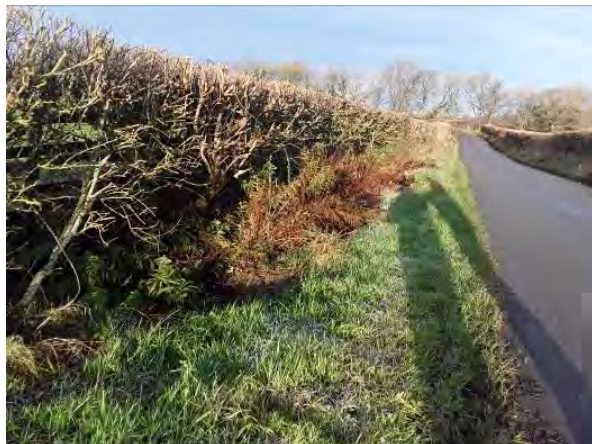
TR3.HTN21

Protected Species Assessment			Summary of Constraints		
<ul style="list-style-type: none"><li>Semi-improved grassland adjacent to the site has potential to support ground nesting birds.</li><li>Hedgerow and dry stone wall has potential to support nesting birds.</li><li>Limited diversity in habitats in and adjacent to the site could support a limited range of foraging and commuting species (e.g. reptiles, bats, badger, brown hare, hedgehog, invertebrates).</li><li>Amphibians are unlikely to be present due to limited suitable habitat and lack of potential breeding ponds (none within 500m).</li></ul>			<ul style="list-style-type: none"><li>Habitats will be reinstated on completion of the works</li><li>Current proposals will require removal of approximately 40 m of species-rich intact hedgerow and associated SI grass verge.</li><li>Hedgerow could be classed as important under the Hedgerow Regulations 1997.</li><li>Mitigation for hedgerow loss will be required which needs agreeing with the LPA, either as part of the reinstatement proposals or improvement of adjacent areas of hedgerow.</li><li>Works will result in the small loss of semi-improved grassland and dry stone wall associated with the roadside verge and adjoining field. This loss is unlikely to have a significant adverse effect, but there could be disturbance to ground nesting species using the wider field or other species using the dry stone wall.</li><li>Works should avoid the nesting bird season or be subject to nesting bird checks.</li></ul>

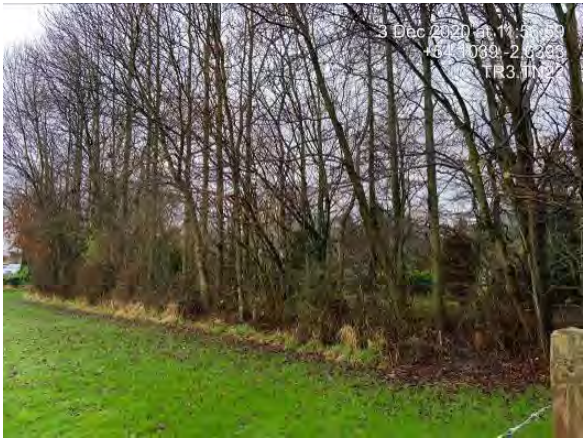
TR3.HTN22

Protected Species Assessment			Summary of Constraints		
<ul style="list-style-type: none"> <li>Arable land adjacent to the site has potential to support ground nesting birds and wintering birds (NB Whooper Swan Major Feeding Area 300m west).</li> <li>Dry stone wall has some potential to support nesting birds.</li> <li>Limited diversity in habitats in and adjacent to the site could support a limited range of foraging and commuting species (e.g. reptiles, bats, badger, brown hare, hedgehog, invertebrates).</li> <li>Amphibians are unlikely to be present due to limited suitable habitat and lack of potential breeding ponds (none within 500m).</li> <li>One tree adjacent to the site has high potential to support roosting bats (TR3.HBT11), this tree is on the opposite side of a single carriageway and appears from the photos that limbs/branches overhanging the road have already been removed/lost – no impacts anticipated.</li> </ul>			<ul style="list-style-type: none"> <li>Habitats will be reinstated on completion of the works</li> <li>Current proposals will require removal of approximately 60 m of species-rich intact hedgerow and 140 m of species-poor intact hedgerow with associated SI grass verge.</li> <li>Hedgerows could be classed as important under the Hedgerow Regulations 1997.</li> <li>Mitigation for hedgerow loss will be required which needs agreeing with the LPA, either as part of the reinstatement proposals or improvement of adjacent areas of hedgerow.</li> <li>Works will result in the small loss of semi-improved grassland, arable land and dry stone wall associated with the roadside verge and adjoining field. This loss is unlikely to have a significant adverse effect, but there could be disturbance to ground nesting species using the wider field or other species using the dry stone wall, as well as wintering birds.</li> <li>Works should avoid the nesting bird season or be subject to nesting bird checks.</li> <li>Works in the winter should be subject to a winter bird assessment prior to works commencing.</li> </ul>

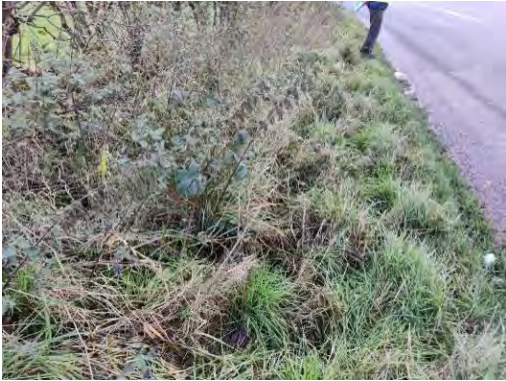
TR3.WTN4

<b>Protected Species Assessment</b>			<b>Summary of Constraints</b>		
<ul style="list-style-type: none"> <li>Improved grassland adjacent to the site has potential to support ground nesting birds.</li> <li>Limited diversity in habitats in and adjacent to the site could support a limited range of foraging and commuting species (e.g. reptiles, bats, badger, brown hare, hedgehog, invertebrates).</li> <li>Amphibians are unlikely to be present due to limited suitable habitat and lack of potential breeding ponds (none within 500m).</li> </ul>			<ul style="list-style-type: none"> <li>Habitats will be reinstated on completion of the works</li> <li>Current proposals will require removal of approximately 20 m of species-rich intact hedgerow and associated SI grass verge.</li> <li>Hedgerow could be classed as important under the Hedgerow Regulations 1997.</li> <li>Mitigation for hedgerow loss will be required which needs agreeing with the LPA, either as part of the reinstatement proposals or improvement of adjacent areas of hedgerow.</li> <li>Works will result in the small loss of semi-improved grassland and improved grassland associated with the roadside verge and adjoining field. This loss is unlikely to have a significant adverse effect, but there could be disturbance to ground nesting species using the wider field.</li> <li>Works should avoid the nesting bird season or be subject to nesting bird checks.</li> </ul>

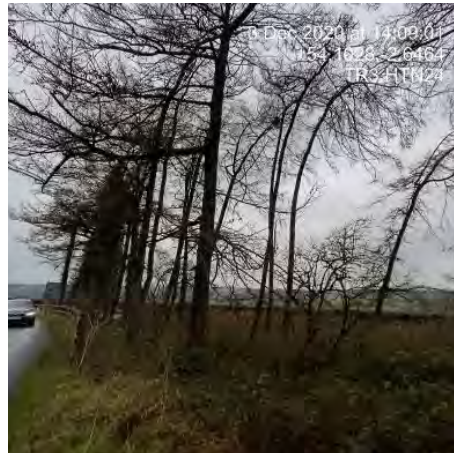
TR3.HTN24

Protected Species Assessment			Summary of Constraints		
<ul style="list-style-type: none"><li>Semi-improved grassland adjacent to the site has potential to support ground nesting birds.</li><li>Dry stone wall has some potential to support nesting birds.</li><li>The woodland adjacent to site provides suitable habitat for nesting birds, small mammals, amphibians and foraging / commuting bats (TR3.HTN24).</li><li>Limited diversity in habitats in and adjacent to the site could support a limited range of foraging and commuting species (e.g. reptiles, bats, badger, brown hare, hedgehog, invertebrates).</li><li>Amphibians are unlikely to be present due to limited suitable habitat and lack of potential breeding ponds (none within 500m).</li></ul>			<ul style="list-style-type: none"><li>Habitats will be reinstated on completion of the works</li><li>Works will result in the small loss of scattered scrub, semi-improved grassland and dry stone wall associated with the roadside verge and adjoining field. This loss is unlikely to have a significant adverse effect, but there could be disturbance to nesting birds and ground nesting species using the wider field.</li><li>Works should avoid the nesting bird season or be subject to nesting bird checks.</li></ul>

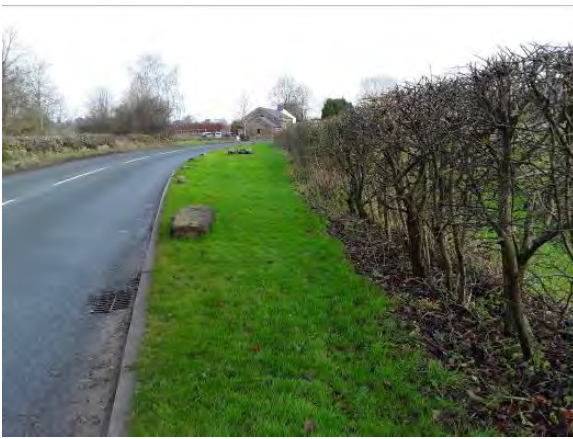
<div>TR3.HTN33</div>

Protected Species Assessment			Summary of Constraints		
<ul style="list-style-type: none"><li>Hedgerow, woodland, wall and dense/continuous scrub provide linear features for commuting bats, foraging resources for commuting bats and is suitable for nesting birds, small mammals and as terrestrial refugia for amphibians.</li><li>Small watercourse present at the end of the works which appears culverted under the road. It is unlikely to support water vole or otter but may be a tributary of the River Wenning approx. 30 m west of the proposals.</li><li>One tree approximately 30 m from the site has low potential to support roosting bats (TR3.HBT14). This tree is set back from the road – no impacts anticipated.</li></ul>			<ul style="list-style-type: none"><li>Habitats will be reinstated on completion of the works.</li><li>Current proposals will require removal of approximately 100 m of species-rich intact hedgerow and associated SI grass verge.</li><li>Hedgerow could be classed as important under the Hedgerow Regulations 1997.</li><li>Mitigation for hedgerow loss will be required which needs agreeing with the LPA, either as part of the reinstatement proposals or improvement of adjacent areas of hedgerow.</li><li>Works will result in the small loss of semi-improved grassland associated with the roadside verge and adjoining field. This loss is unlikely to have a significant adverse effect, but there could be disturbance to nesting birds and ground nesting species using the wider field.</li><li>Works should avoid the nesting bird season or be subject to nesting bird checks.</li><li>ECoW required to check site for protected species prior to site clearance (amphibians/reptiles).</li><li>Small section of watercourse assumed could be avoided but if lost/culverted (approx. 15 m) no significant impacts anticipated.</li></ul>

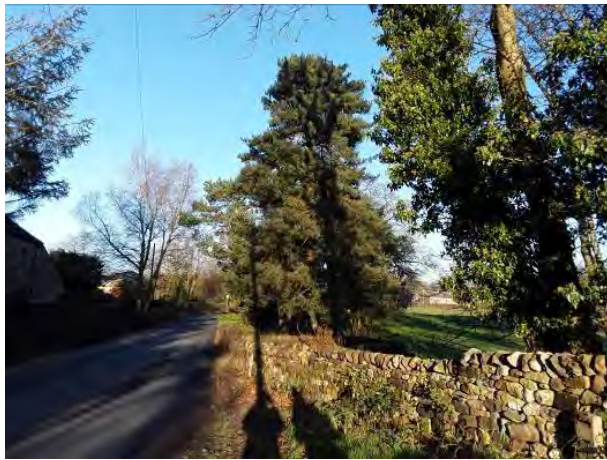
<div>TR3.HTN14</div>

Protected Species Assessment			Summary of Constraints

<ul style="list-style-type: none"><li>Hedgerow, woodland, wall and dense/continuous scrub provide linear features for commuting bats, foraging resources for commuting bats and is suitable for nesting birds and small mammals.</li><li>Adjacent building complex noted to contain a bat roost. Closest building is set away from the road with associated dry stone wall at a sufficient distance to prevent encroachment of traffic.</li><li>Watercourse adjacent to the site appears to be a significant tributary of River Wenning. Could have suitability to support commuting and foraging riverine species (otter/water vole).</li><li>Amphibians are unlikely to be present due distance of nearest potential breeding ponds (c 400 m).</li></ul>			<ul style="list-style-type: none"><li>Habitats will be reinstated on completion of the works</li><li>Works are noted to be minor widening therefore assumptions presume works can be micro-sited to avoid impacts to habitats. This includes:<ul style="list-style-type: none"><li>No impacts to adjacent watercourse or associated bank habitat – anticipated wall removal likely to be required this should be done by hand (as practicably possible) in the presence of an ECoW</li><li>No loss of adjacent tree habitat (inc woodland edge). If minor loss required no significant impacts are anticipated</li><li>Minor loss of grassland verge</li></ul></li><li>If vegetation clearance required, works should avoid the nesting bird season or be subject to nesting bird checks.</li></ul>

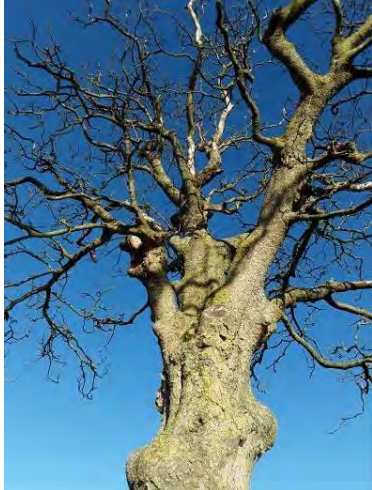
TR3.HBT8

<b>Protected Species Assessment</b>			<b>Summary of Constraints</b>		
<ul style="list-style-type: none"> <li>One tree adjacent to the site has low potential to support roosting bats (TR3.HBT8). This tree will not be removed to facilitate works but there is a risk overhanging branches may require removal.</li> <li>Another tree in close proximity to the works has moderate potential to support roosting bats (TR3.HBT7). This tree will not be removed to facilitate works but there is a risk overhanging branches may require removal.</li> <li>Hedgerow has potential to support nesting birds</li> <li>Poor semi-improved grassland and marshy grassland adjacent to the site have potential to support ground nesting birds.</li> <li>Limited diversity in habitats on and adjacent to the site could support a limited range of foraging and commuting species (e.g. reptiles, bats, badger, brown hare, hedgehog, invertebrates).</li> <li>Amphibians are unlikely to be present due to distance of nearest potential breeding pond (c 340 m).</li> </ul>			<ul style="list-style-type: none"> <li>Habitats will be reinstated on completion of the works.</li> <li>Current proposals will require removal of approximately 50 m of species-rich intact hedgerow and associated SI verge habitat.</li> <li>Hedgerow could be classed as important under the Hedgerow Regulations 1997.</li> <li>Mitigation for hedgerow loss will be required which needs agreeing with the LPA, either as part of the reinstatement proposals or improvement of adjacent areas of hedgerow.</li> <li>Loss of a small area of adjacent species-poor semi-improved grassland is unlikely to have a significant adverse effect but there could be disturbance to ground nesting species using the wider field.</li> <li>Works should avoid the nesting bird season or be subject to nesting bird checks.</li> <li>Works should avoid any impacts to trees with bat potential in proximity of the site. If any branch removal is required to facilitate works, further surveys will be required in relation to roosting bats before works can commence.</li> </ul>

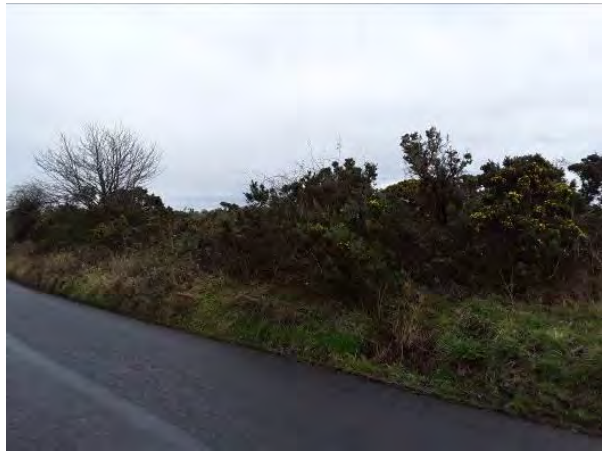
<div>TR3.HTN6</div>

Protected Species Assessment			Summary of Constraints		
<ul style="list-style-type: none"><li>The dense scrub and broadleaved tree have nesting bird potential.</li><li>The SI grassland adjacent to the works has ground nesting bird potential.</li><li>The mix of habitats on and adjacent to the site could support a range of foraging and commuting species (e.g. reptiles, bats, badger, brown hare, hedgehog, invertebrates).</li><li>Amphibians are unlikely to be present due to distance of nearest potential breeding pond (&gt; 330m).</li></ul>			<ul style="list-style-type: none"><li>Habitats will not be reinstated on completion of the works</li><li>Current proposals will require removal of dense scrub, a single tree and associated SI grass verge. Loss of these habitats is unlikely to have a significant adverse effect, but there could be disturbance to nesting birds and ground nesting species using the wider field.</li><li>Works should avoid the nesting bird season or be subject to nesting bird checks.</li></ul>

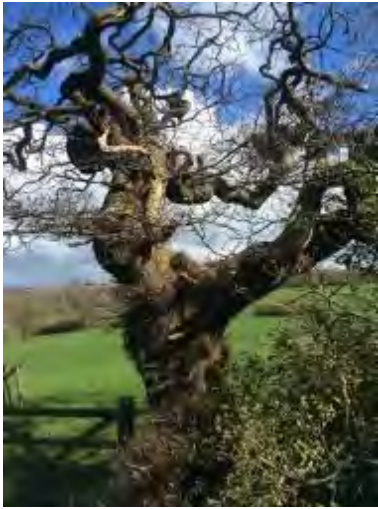
TR3.BT3

Protected Species Assessment			Summary of Constraints		
<ul style="list-style-type: none"> <li>One tree adjacent to the site has high potential to support roosting bats (TR3.BT3) and two trees adjacent to the site have low potential to support roosting bats (TR3.BT2, TR3.BT1). These trees will not be removed to facilitate works but there is a risk overhanging branches may require removal.</li> <li>The hedgerows provide nesting bird habitat as well as suitable habitat for small mammals (TR3.HTN20).</li> <li>The SI grassland adjacent to the works has ground nesting bird potential.</li> <li>The mix of habitats on and adjacent to the site could support a range of foraging and commuting species (e.g. reptiles, bats, badger, brown hare, hedgehog, invertebrates).</li> <li>Amphibians are unlikely to be present due to distance of nearest potential breeding pond (&gt; 500m).</li> </ul>			<ul style="list-style-type: none"> <li>Habitats will be reinstated on completion of the works</li> <li>Current proposals will require removal of approximately 40 m of species-poor intact hedgerow and associated SI grass verge.</li> <li>Hedgerow could be classed as important under the Hedgerow Regulations 1997.</li> <li>Mitigation for hedgerow loss will be required which needs agreeing with the LPA, either as part of the reinstatement proposals or improvement of adjacent areas of hedgerow.</li> <li>Works will result in the small loss of semi-improved grassland associated with the roadside verge and adjoining field. This loss is unlikely to have a significant adverse effect, but there could be disturbance to ground nesting species using the wider field or other species using the dry stone wall.</li> <li>Works should avoid the nesting bird season or be subject to nesting bird checks.</li> <li>Works should avoid any impacts to trees with bat potential in proximity of the site. If any branch removal is required to facilitate works, further surveys will be required in relation to roosting bats before works can commence.</li> </ul>

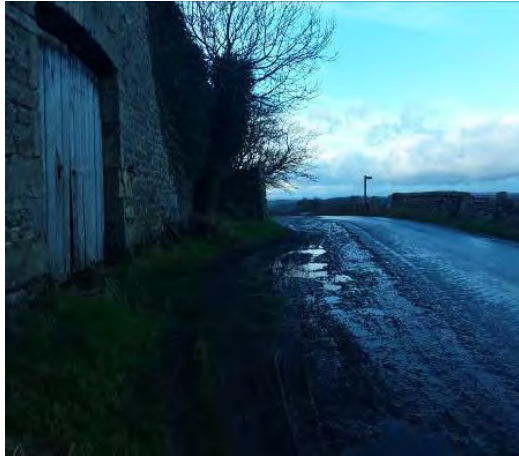
TR3.HTN19

Protected Species Assessment			Summary of Constraints		
<ul style="list-style-type: none"> <li>The adjacent stone barn has potential for nesting birds, including barn owl (<i>Tyto alba</i>), and has moderate roosting potential for bats. Nesting and roosting opportunities exist within gaps between stones, roof tiles, open access above the doorways and a collapsed area of roof. If impacts to the barn are anticipated, further bat and bird (barn owl) surveys may be required (TR3.HTN19 &amp; TR3.TN7).</li> <li>A single tree grows up the wall of the adjacent building and has potential to support nesting birds.</li> <li>Other habitats impacted have limited potential to support protected species.</li> </ul>			<ul style="list-style-type: none"> <li>Works largely limited to bare ground associated with an unofficial passing place next to a barn. May require minor removal of grass verges, dry stone wall and a single tree.</li> <li>Works should avoid the nesting bird season or be subject to nesting bird checks.</li> <li>It is assumed the adjacent building with bat roosting and barn owl potential will be adequately protected. No significant impacts on these species are likely to occur as a result of minor road widening in this location.</li> </ul>

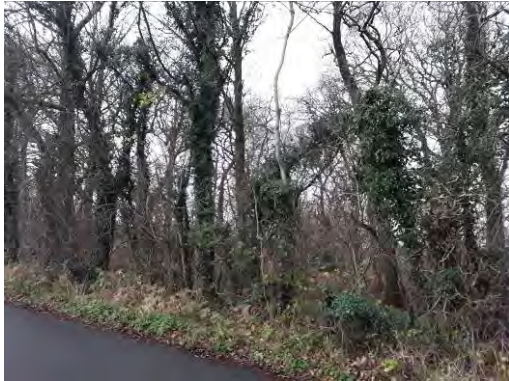
<p>Semi-natural broadleaved woodland that borders Eskew Lane to the east, along the length of the proposed road widening (RW08), and borders Eskew Beck (TR3.HWC1) to the west. Canopy species present include oak (<i>Quercus</i> sp.), sycamore (<i>Acer pseudoplatanus</i>), ash (<i>Fraxinus excelsior</i>), hazel (<i>Corylus avellana</i>), hawthorn (<i>Crataegus monogyna</i>), beech (<i>Fagus sylvatica</i>), willow sp. (<i>Salix</i> sp.), lime (<i>Tilia x europaea</i>) and silver birch (<i>Betula pendula</i>). Semi-mature conifer trees are present towards the south of the woodland. The woodland has a mixed age structure, with many young trees as well as coppiced hazel and some more mature oak trees. Fallen and standing deadwood are present throughout the woodland. The woodland has been previously managed as evidenced from coppiced and felled trees. Understory is generally sparse, but is occasionally dense at the road edge and includes the species blackthorn (<i>Prunus spinosa</i>), hawthorn, hazel, snowberry (<i>Symphoricarpos albus</i>) and immature tree saplings. The ground layer is sparse and includes pendulous sedge (<i>Carex pendula</i>), cock's foot grass (<i>Dactylis glomerata</i>), bramble (<i>Rubus fruticosus</i> agg.), honeysuckle (<i>Lonicera periclymenum</i>), dogs mercury (<i>Mercurialis perennis</i>), barren strawberry (<i>Potentilla sterilis</i>), woodruff (<i>Galium odoratum</i>), ivy (<i>Hedera helix</i>), tufted hair grass (<i>Deschampsia cespitosa</i>), holly (<i>Ilex aquifolium</i>), sedge species, lady fern (<i>Athyrium filix-femina</i>), hart's-tongue fern (<i>Asplenium scolopendrium</i>) and common polypody fern (<i>Polypodium vulgare</i>). There is some tipped garden waste at the entrance gates and evidence of recreational use within the woodland. Bird boxes are present on some trees and a possible mammal hole (likely rabbit) was also identified.</p> <p>The woodland provides suitable habitat for nesting birds, large mammals (including badger <i>Meles meles</i>), small mammals as well as roosting, foraging and commuting bats.</p> <p>Habitat condition (provisional): Moderate (Score 2)</p>

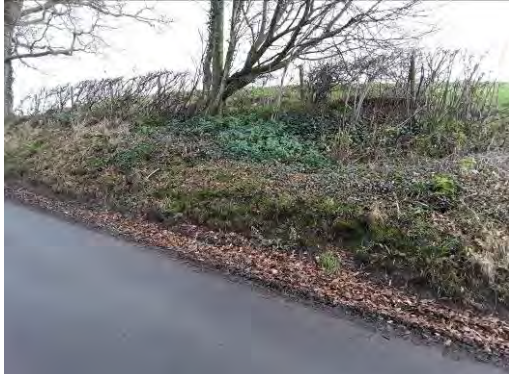
TR3.HTN2

The eastern road verge becomes a steep hedge bank towards the southern end of the survey area. The bank has ground flora characteristic of woodland ground flora and is species rich (species listed in the TR3.HH1 description). This area may require re-assessment during the spring if works are to directly impact the verge.

Hedgerows provide linear habitat for commuting and foraging bats, as well as nesting bird and small mammal habitat and also terrestrial habitats for amphibians within the root systems of the trees and hedgerow woody species.

Habitat condition (provisional): Good (Score 3)

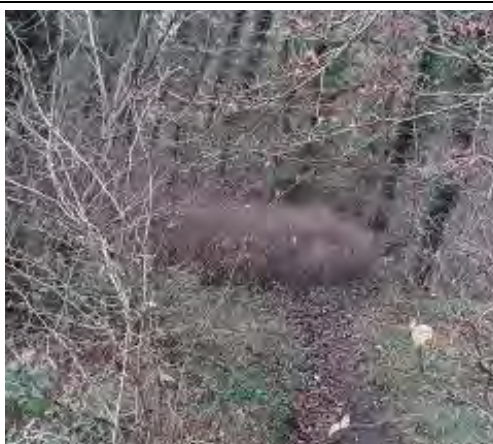
TR3.HTN3

Large stand of snowberry within the woodland (TR3.HTN1). Whilst this species is not listed on Schedule 9 of the Wildlife and Countryside Act 1981 (as amended), it is invasive in nature and its spread should be avoided where possible. Scrub and shrub species can provide habitat for nesting birds, small mammals and amphibians.

Habitat condition (provisional): Poor (Score 1)

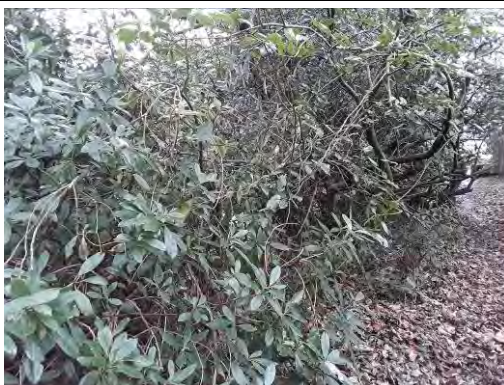
TR3.HTN4

Stand of rhododendron (*Rhododendron ponticum*) within the understory of woodland adjacent to the river. This species is listed on Schedule 9 of the Wildlife and Countryside Act 1981 (as amended). Scrub and shrub species can provide habitat for nesting birds, small mammals and amphibians.

Habitat condition (provisional): Poor (Score 1)

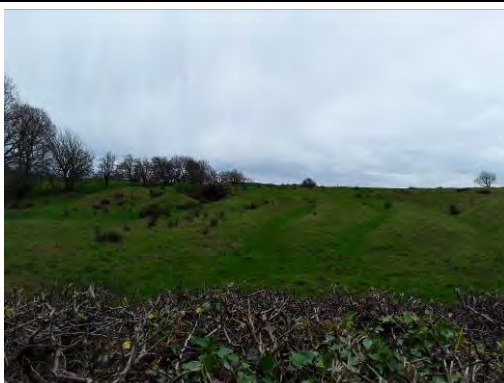
TR3.HTN5

Species-poor semi-improved grassland field which has unusual drainage channels with ridge and furrow features. At the

time of survey the species composition was not particularly diverse and characteristic of species poor semi-improved grassland, with species tolerant of wetter conditions in the furrows. If impacted the area should be re-surveyed in summer to assess species richness.

Habitat condition (provisional): Poor (Score 1)

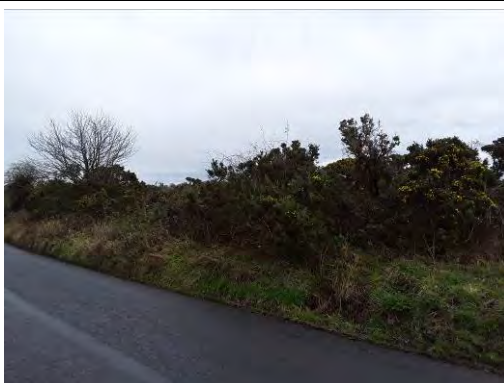
TR3.HTN6

A steep area of the road verge which is a mosaic of habitats including dense gorse (*Ulex europaeus*) scrub, scattered bramble scrub, scattered trees and semi-improved neutral grassland. The tree species is rowan (*Sorbus aucuparia*) and hedgerow TR3.HH8 runs behind the scrub towards the eastern edge. Towards the south the scrub transitions into wet semi-improved neutral grassland and includes the species; wild angelica (*Angelica sylvestris*), common hogweed (*Heracleum sphondylium*), common sorrel (*Rumex acetosa*), herb Robert (*Geranium robertianum*), ribwort plantain (*Plantago lanceolata*), sharp flowered rush (*Juncus acutiflorus*), creeping cinquefoil (*Potentilla reptans*), smooth meadow grass (*Poa pratensis*), cock's foot, black knapweed (*Centaurea nigra*), soft rush (*Juncus effusus*), creeping buttercup (*Ranunculus repens*), Yorkshire fog (*Holcus lanatus*), common nettle (*Urtica dioica*), selfheal (*Prunella vulgaris*), red fescue (*Festuca rubra*) and cow parsley (*Anthriscus sylvestris*). The ground slopes up towards the south and is damp. The mosaic provides habitat for nesting birds, small mammals, terrestrial habitat for amphibians as well as foraging and commuting habitat for bats.

Habitat condition (provisional): Moderate (Score 2)

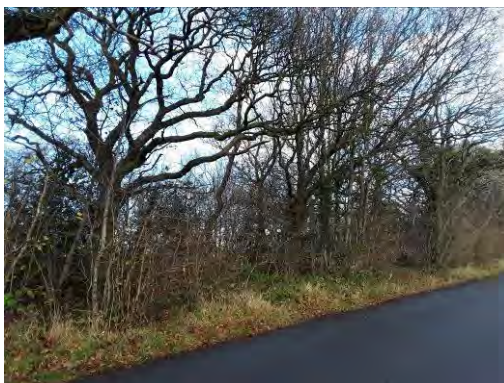
TR3.HTN7

Narrow area of semi-natural broadleaved woodland which is parallel to the road. The canopy comprises; silver birch, English oak (*Quercus robur*), ash, beech, hazel, rowan and sycamore. The trees range in age from mature, semi mature and immature trees. The understorey is generally dense and is composed of hazel, holly and willow. The ground flora includes; ivy, bramble, fern species, tufted hair grass, cock's foot, meadowsweet (*Filipendula ulmaris*), common nipplewort (*Lapsana communis*), rose sp. (*Rosa* sp.), polypody fern and dog's mercury. The ground is mostly flat and there are historic planting bunds and a clearing / glade within the centre. Deadwood is limited to small diameter fallen deadwood and there is good regeneration with a thick understorey. The glade in the centre of the woodland is characterised as bramble scrub.

The woodland provides suitable habitat for nesting birds, large mammals (including badger), small mammals as well as roosting, foraging and commuting bats.

Habitat condition (provisional): Moderate (Score 2)

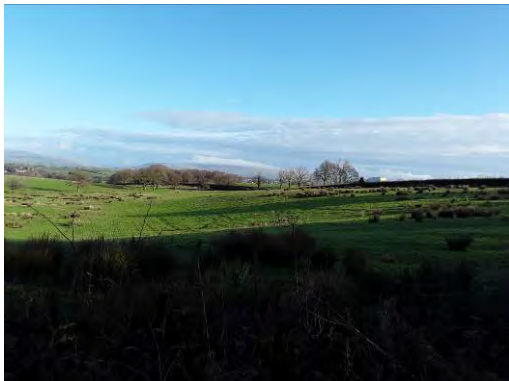
TR3.HTN8

<p>A field which is characterised as species-poor semi-improved grassland. The field is intensively managed and slopes gently to the north-west. There are small areas of marshy grassland within the field which are dominated by soft rush. The soft rush is particularly prevalent in the south-eastern corner, likely where the ground is wetter.</p> <p>Habitat condition (provisional): Poor (Score 1)</p>	
TR3.HTN9	No photo.
<p>Semi-natural broadleaved woodland which borders the road located adjacent to the River Wenning (TR3.HWC2). The woodland gently slopes south towards the river. Canopy species include sycamore, ash, alder (<i>Alnus glutinosa</i>) and oak. The trees are semi-mature and immature. There is an understory of tree saplings and is generally sparse and open. The ground flora includes low lying bramble, ivy, dog's mercury, tufted hair grass, cock's foot, soft rush, broadleaved dock (<i>Rumex obtusifolium</i>), creeping buttercup, Yorkshire fog, false oat grass (<i>Arrhenatherum elatius</i>), bugle (<i>Ajuga reptans</i>) and hart's-tongue fern. There is an open glade in the woodland which contains tall ruderal and grassland species. Sections of the river embankment are dominated by snowberry. Further west the woodland contains a row of leylandii (<i>Cupressus leylandii</i>) trees. Ivy grows on a number of the more mature trees and dead wood is limited.</p> <p>The woodland provides habitat for small and large mammals (including badger), nesting habitat for birds as well as roosting, foraging and commuting habitat for bats. Being adjacent to the river it may also provide lay-up sites for otter (<i>Lutra lutra</i>).</p> <p>Habitat condition (provisional): Moderate (Score 2)</p>

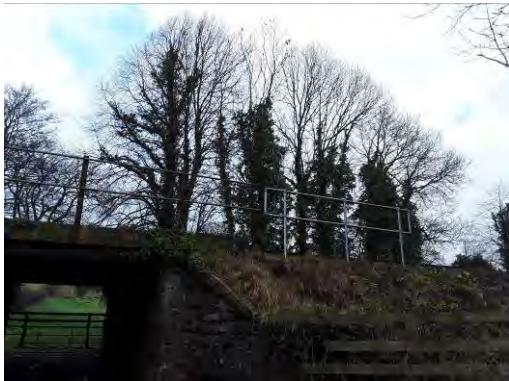
TR3.HTN10

<p>Railway embankments which comprise a mosaic of mature trees, tall ruderals, dense scrub and bare ground (ballast). The embankments slope down away from the railway. Tree species are lime and ash. The scrub is dominated by bramble and additional vegetation recorded includes herb Robert, Yorkshire fog, rosebay willowherb (<i>Chamerion angustifolium</i>) and ivy. Ivy grows on some of the trees, particularly the more mature species.</p> <p>The embankments provide a linear feature for commuting and foraging bats, as well as habitat for nesting birds, amphibians and small mammals.</p> <p>Habitat condition (provisional): Moderate (Score 2)</p>

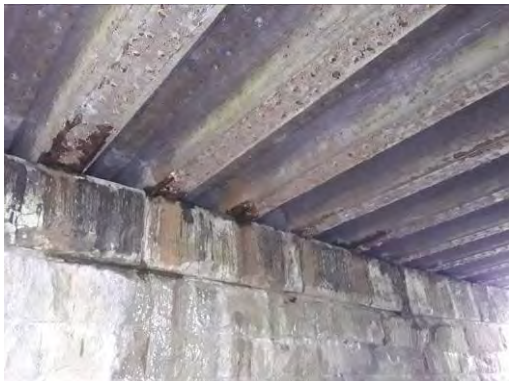
<p>Railway underpass bridge. Comprising steel girders and stone abutments. The stone abutments are well-sealed; however, gaps extend between the steel girders at the top of the stone abutments towards the back wall. These are suitable for use by roosting bats. Further survey may be required if impacts to the bridge are anticipated. The gaps are also suitable for use by nesting birds. The bridge is single span and narrow, with bare ground / species-poor semi-improved grassland beneath.</p> <p>Habitat condition (provisional): Not applicable (no assessment required)</p>	
TR3.HTN12

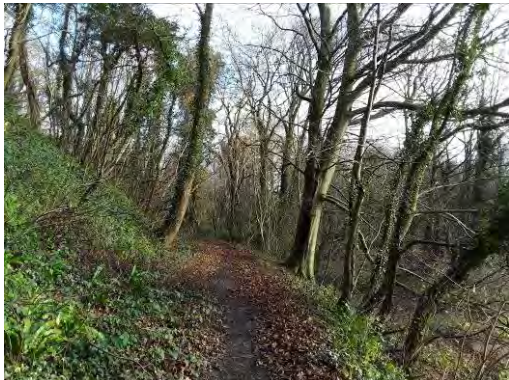
<p>Broadleaved semi-natural woodland adjacent to the River Wenning (TR2.HWC2). The woodland slopes steeply from the road towards the river. Directly adjacent to the river the ground is of a gentler gradient. The trees are semi-mature to mature and saplings are present. Canopy species include; sycamore, oak and beech. The understorey includes pockets of hazel, holly, ash, elder and elm (<i>Ulmus procera</i>) with occasional snowberry to the east. Dead wood from fallen trees is occasionally present. The ground flora comprises; low lying bramble, ivy, hart's-tongue fern, common nettle, speedwell species (<i>Veronica</i> sp.), wood avens (<i>Geum urbanum</i>), dog's mercury, wood melick (<i>Melica uniflora</i>), broad buckler fern (<i>Dryopteris dilatata</i>), male fern (<i>Dryopteris filix-mas</i>), wood sedge (<i>Carex sylvatica</i>), opposite leaved golden saxifrage (<i>Chrysosplenium alternifolium</i>), herb Robert, as well as English bluebell (<i>Hyacinthoides non-scripta</i>). A well-marked footpath runs through the centre of the woodland and there is evidence of recent tree planting.</p> <p>The woodland provides habitat for nesting birds, small mammals, large mammals (including badger), roosting / foraging / commuting bats as well as terrestrial habitat for otter and amphibians.</p> <p>Habitat condition (provisional): Good (Score 3)</p>

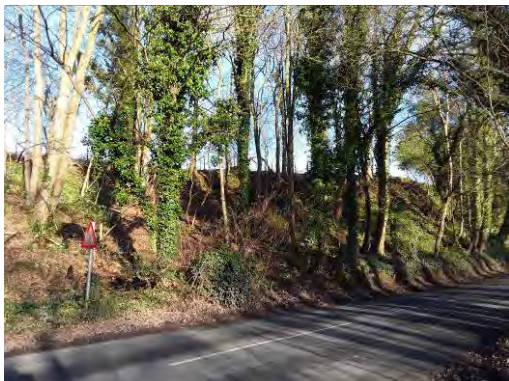
TR3.HTN13

Broadleaved semi-natural woodland on a moderately steep gradient bordering the road. The tree species are mainly mature and include; oak, beech, ash and lime. The understorey is generally sparse with elder, hazel and holly. There is occasional deadwood present and ivy densely clads some of the trees. The ground flora comprises; dog's mercury, bramble, ivy, hart's-tongue fern, broad buckler fern, violet species (*Viola* sp.), male fern, wood avens and soft rush. The woodland is privately owned and contains a recently installed pathway and bird observatory close to the residential properties towards the east. Near the houses there are several mature rhododendron (*Rhododendron ponticum*) bushes. Rhododendron is listed as an invasive species on Schedule 9 of the Wildlife and Countryside Act 1981 (as amended).

The woodland provides habitat for nesting birds, foraging / commuting / roosting bats, small mammals, large mammals and amphibians.

Habitat condition (provisional): Moderate (Score 2)

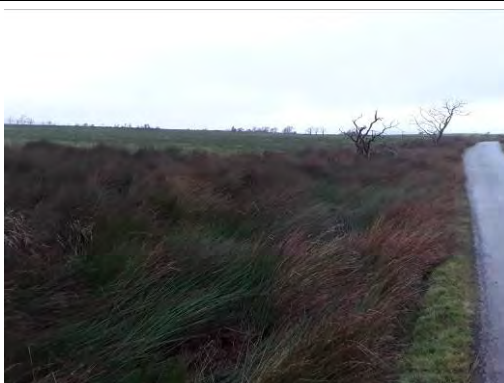
TR3.HTN15

Belt of dense marshy grassland bordering and choking a ditch adjacent to road. Species dominated by soft rush with occasional mature scattered scrub. The adjacent field is grazed / degraded marshy grassland, which is intensively grazed and poached by livestock (sheep) and has been topped/mown.

Habitat condition (provisional): Moderate (Score 2)

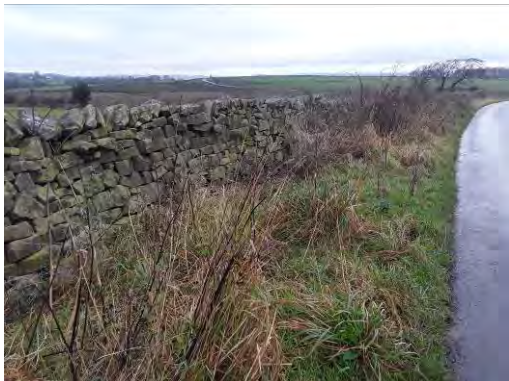
TR3.HTN16

<p>A semi-improved grassland roadside verge adjacent to a dry stone wall. Species present include; Yorkshire fog, common nettle, common knapweed (<i>Centaurea nigra</i>), cow parsley, creeping buttercup, meadow grass sp., creeping bent (<i>Agrostis stolonifera</i>), common hogweed, cock's foot grass, creeping thistle (<i>Cirsium arvense</i>), cleavers (<i>Galium aparine</i>), vetch sp. (<i>Vicia</i> sp.), bramble, yarrow (<i>Achillea millefolium</i>), purple moor grass (<i>Molinia caerulea</i>), and creeping cinquefoil (<i>Potentilla reptans</i>).</p> <p>Verges provide suitable habitat for amphibians, small mammals and nesting birds.</p> <p>Habitat condition (provisional): Moderate (Score 2)</p>
TR3.HTN17

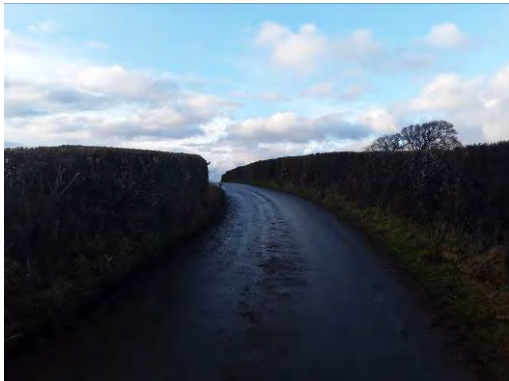
<p>Proposed road widening RW22. Both sides of the road contain species-rich hedgerows classified as ecologically important (TR3.H8, TR3.H10 and TR3.H11). The hedgerows are mature, with species-rich ground flora and impacts to these should be avoided where possible.</p> <p>Habitat condition (provisional): Not applicable (no assessment required)</p>

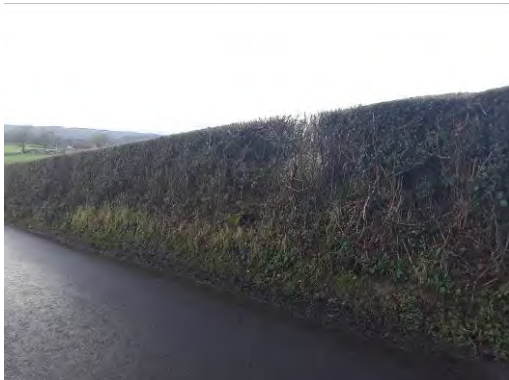
TR3.HTN18

<p>Proposed road alterations (PP04). Both sides of the road contain mature, species-rich hedgerows classified as ecologically important (TR3.H8 and TR3.H9). The hedgerows are located on banks with occasional mature trees. Impacts to the hedgerows should be avoided where possible. <b>A potential alternative passing place is noted, slightly down hill (west) where the road is already slightly widened.</b></p> <p>Habitat condition (provisional): Not applicable (no assessment required)</p>

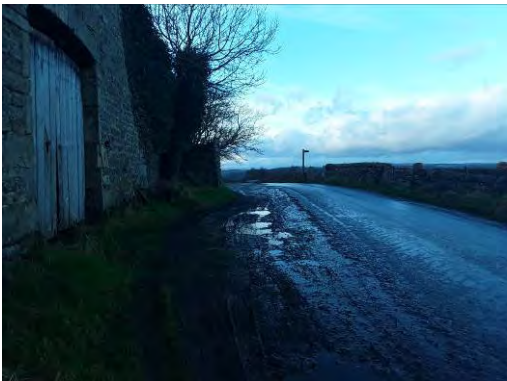
TR3.HTN19

<p>Area of proposed road alterations (PP06) off the road. This area is already an unofficial passing place of bare ground and species-poor semi-improved grassland. The adjacent stone barn has potential for nesting birds, including barn owl (<i>Tyto alba</i>), and has moderate roosting potential for bats. Nesting and roosting opportunities exist within gaps between stones, roof tiles, open access above the doorways and a collapsed area of roof. If impacts to the barn are anticipated, further bat and bird (barn owl) surveys may be required.</p> <p>Habitat condition (provisional): Not applicable (no assessment required)</p>
TR3.HTN20

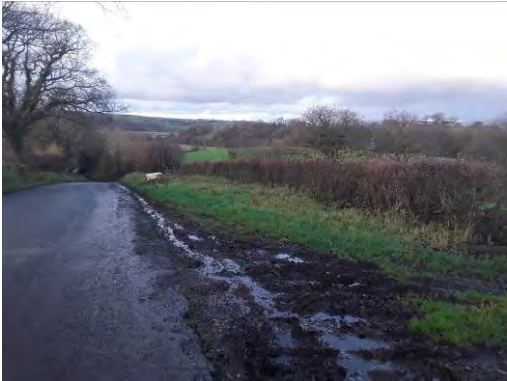
<p>Proposed road alterations (PP05) within semi-improved neutral grassland verge and adjacent to a hedgerow (TR3.H5). The hedgerow is ecologically important and impacts to this should be avoided. Species present within the grassland include; red clover (<i>Trifolium pratense</i>), greater plantain (<i>Plantago major</i>), creeping thistle, common hogweed, Yorkshire fog, creeping bent, creeping buttercup, common nettle, dandelion sp., meadow grass, cow parsley, bramble, blinks (<i>Montia fontana</i>), horsetail species (<i>Equisetum</i> sp.), sedge species (<i>Carex</i> sp.) and false oat grass.</p> <p>The adjacent hedgerow provides nesting bird habitat as well as suitable habitat for small mammals and amphibians.</p> <p>Habitat condition (provisional): Moderate (Score 2)</p>

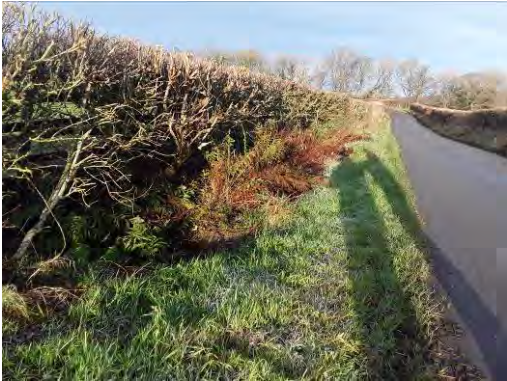
TR3.HTN21

<p>Location of proposed road widening (RW12). The adjacent parallel hedgerows (TR3.HH21 and TR3.HH20) are classified as ecologically 'important' according to the Hedgerow Regulations; they are species rich and likely to have Schedule 5 ground flora species. Avoid impacts to these hedgerows due to age and diversity of the features. A collapsed field or road drain has left a large hole in the verge.</p> <p>Habitat condition (provisional): Not applicable (no assessment required)</p>

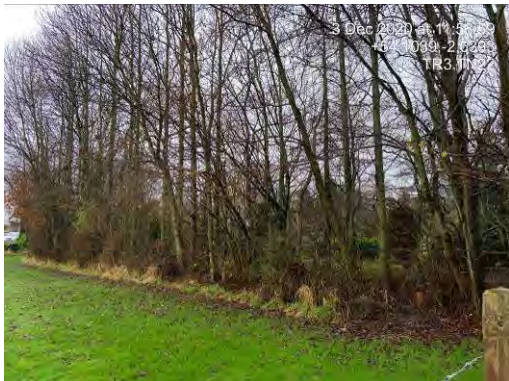
TR3.HTN22

<p>Strip of planted broadleaved woodland adjacent to an area of amenity grassland and improved grassland field. Canopy species include; oak, beech, elm, ash, willow and hazel. The understorey is dense as a result of the management of the woodland on the edge of the tree line. The ground layer is dominated by leaf litter and is otherwise sparse, with occasional bramble and cock's foot grass.</p> <p>The woodland provides suitable habitat for nesting birds, roosting / foraging / commuting bats, small and large mammals and amphibians.</p> <p>Habitat condition (provisional): Moderate (Score 2)</p>
TR3.HTN23

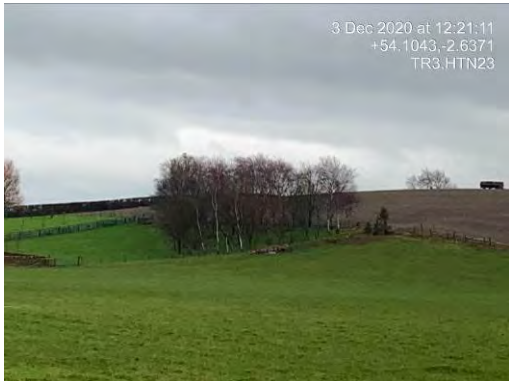
<p>Small area of plantation broadleaved woodland within amenity grassland, possibly in a residential garden. The canopy species comprise silver birch, there is no understorey layer. The woodland provides suitable habitat for nesting birds and foraging / commuting bats.</p> <p>Habitat condition (provisional): Poor (Score 1)</p>

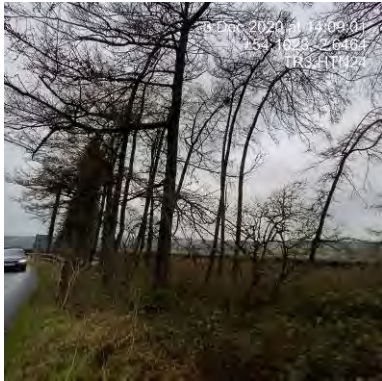
TR3.HTN24

<p>Mixed plantation woodland situated between two roads. Canopy species include semi-mature larch, with mature oak and ash and beech at the woodland perimeter. The understorey is dominated by bramble, with rare elder and holly. Ground flora includes; common hogweed, common nettle, Yorkshire fog and raspberry.</p> <p>The woodland provides suitable habitat for nesting birds, small mammals, amphibians and foraging / commuting bats.</p> <p>Habitat condition (provisional): Poor (Score 1)</p>
