Document reference: LCC-RVBC-BO-SEI Appendix B7

**Haweswater Aqueduct Resilience Programme -  
Proposed Bowland Section**

**Appendix B7: Ecology Assessment - Off-Site Highways Works**

February 2022

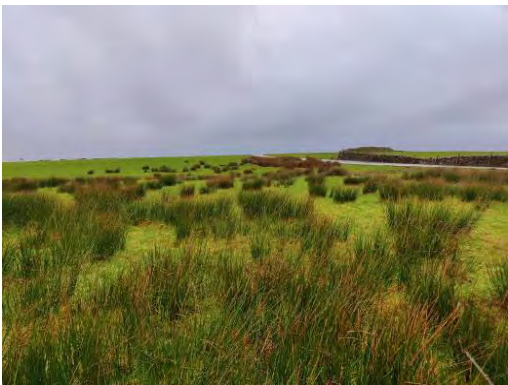
TR3.HTN25

<p>Area of marshy grassland, dominated by soft rush tussocks over closely grazed poor semi-improved grassland, that is not considered a ground water dependent ecosystem (GWDTE) and is assessed to align with NVC community MG10 (<i>Holcus lanatus</i> - <i>Juncus effusus</i> rush-pasture).</p> <p>Habitat condition (provisional): Not applicable (no assessment required).</p>	
TR3.HTN26

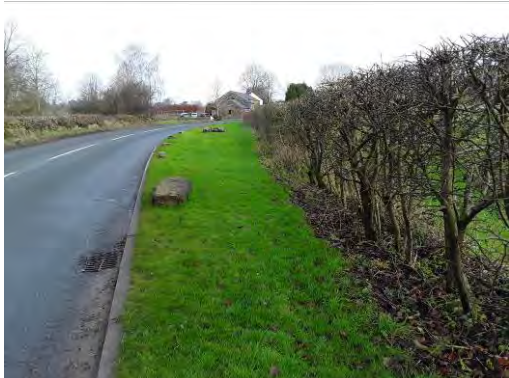
TR3.HTN33

Area of proposed road widening (RW05). The area is characterised as species-poor semi-improved grassland and includes; Yorkshire fog, creeping buttercup, dandelion and meadow grass sp.. The adjacent hedgerow is species-rich (TR3.HH42). A well is located within the centre of the grassland, with dry stone walls and is approximately 0.25m high. Running water can be heard within and the walls are vegetated with hart's-tongue fern and male fern.

The grassland and well offer potential for amphibians and small mammals.

Habitat condition (provisional): Poor (Score 1)

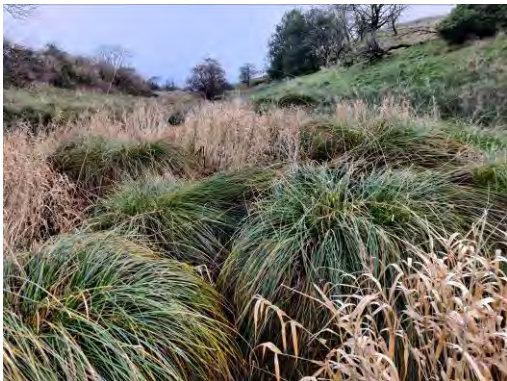
TR3.HTN37

<p>A dense area of swamp surrounding a small watercourse (TR3.WC4). The habitat is located on flat ground within a shallow valley. Species present include greater tussock sedge (<i>Carex paniculata</i>), soft rush, reed canary grass, common nettle and bittercress species. The swamp is surrounded by an area of marshy grassland on the slopes of the valley and species here include wild angelica, creeping buttercup, marsh willowherb (<i>Epilobium palustre</i>), Yorkshire fog, horsetail species, bittercress species, water mint (<i>Mentha aquatica</i>), jointed rush (<i>Juncus articulatus</i>) and soft rush.</p> <p>The area provides suitable habitat for nesting birds as well as small mammals and amphibians.</p> <p>Habitat Condition (provisional): Moderate (Score 2)</p>	
<p><b>The following target note descriptions are from "TR3 Wray Compound Target Note Report V1" (Bowland Ecology, 2020).</b></p>

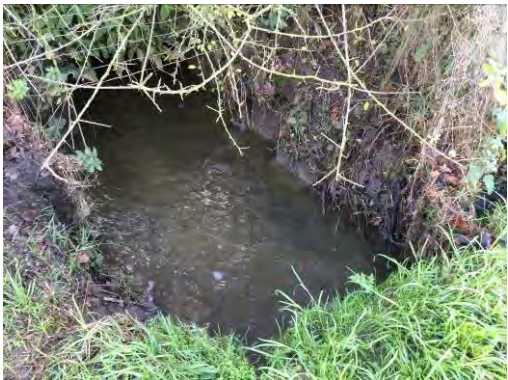
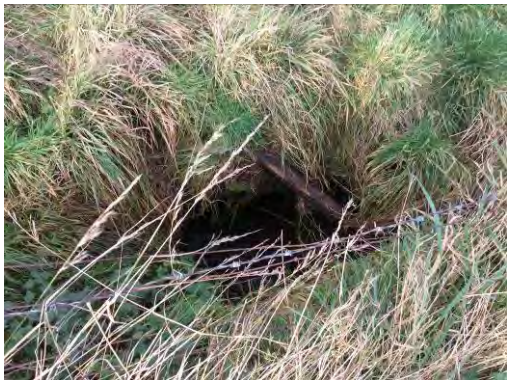
TR3.WTN1

<p>TR3.WTN1 refers to two areas of the same watercourse which are briefly open outside the culvert channel at opposite sides of the field. The surrounding habitats are grassland dominated, with a hedgerow (TR3.WH1) adjacent to the southern open culvert section.</p> <p>Habitat Condition (provisional): Not applicable (no assessment required).</p>	
TR3.WTN2

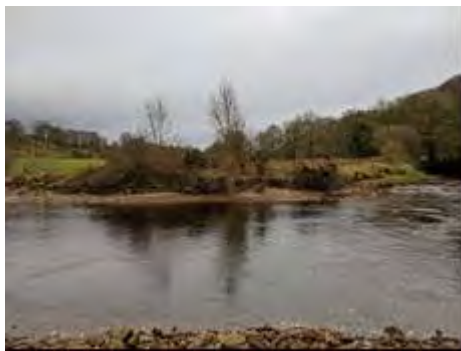
TR3.WCPTN3

<p>At the confluence of two rivers (River Hindburn and River Roeburn; TR3.WCPWC1 and TR3.WCPWC2) the banks have a significant build-up of deposited stone, gravels and sand. The eastern bank has an area of bramble, raspberry and gorse scrub with hawthorn and rose shrubs and two sapling ash trees. The bank forms a cliff in which sand martins (<i>Riparia riparia</i>) have nested. The scrub also provides sheltered and undisturbed nesting bird habitat. Levels of disturbance from dogs and pedestrians on the western stone and gravel bank limits its potential for nesting birds.</p> <p>Habitat condition (provisional): Moderate (Score 2)</p>	
TR3.WCPTN4	No Photo
<p>Himalayan balsam (<i>Impatiens glandulifera</i>) scattered within the bramble scrub along the riverbank; a Schedule 9 species (Wildlife and Countryside Act, 1981 (as amended)). It is likely to be much more widespread as the majority of plants have died back at the time of the survey.</p> <p>Habitat condition (provisional): Poor (Score 1)</p>

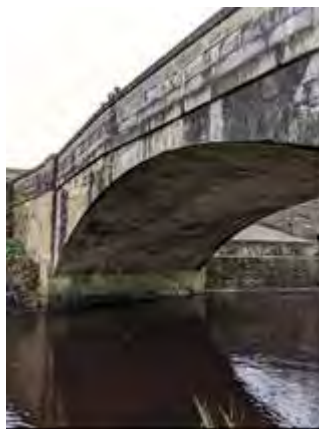
TR3.WCPTN5

<p>A stone, single span road bridge over the River Roeburn (TR3.WCPWC2), which is in a good state of repair, with well-sealed mortar work between the stone blocks on the underside of the arch and the side parapet walls. It has negligible potential for roosting bats.</p> <p>Habitat condition (provisional): Not applicable (no condition score necessary)</p>	
TR3.WCPTN6

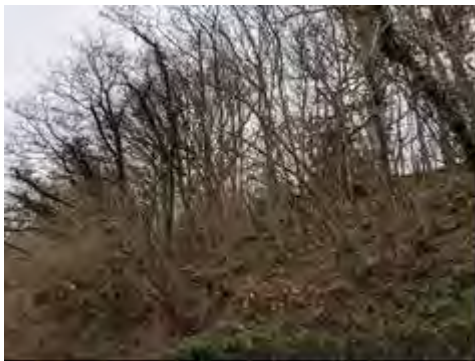
Semi-natural broadleaved woodland (with one scot's pine) on a steep hillside above the road and supported by a retaining wall. The woodland comprises semi-mature trees with a few mature oak trees along the upper edge, and a limited number of saplings. Species present include; alder, silver birch, hazel, sycamore, English oak, beech, holly and wild cherry (*Prunus avium*). The understory is sparse and dominated by ferns, with dog's mercury, bramble and tufted hair grass. It is likely to have English bluebells in spring. The woodland is considered to be high risk for badger setts, but no setts were visible at the time of the survey. If impacted by the proposals, further survey may be required. Potential for nesting birds, foraging and commuting bats, amphibians and small mammals.

Habitat condition (provisional): Moderate (Score 2)

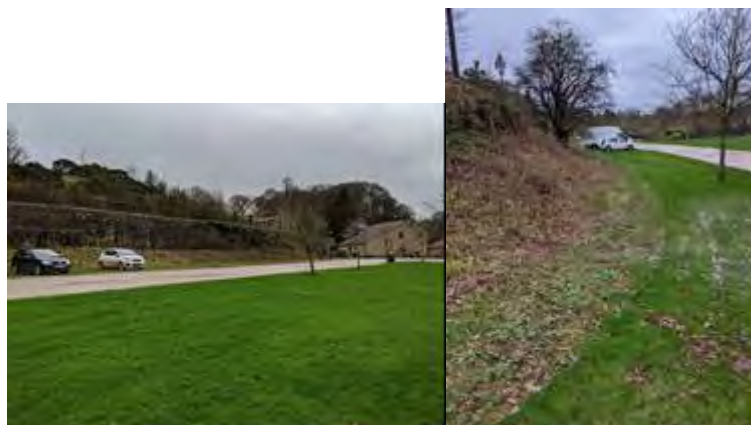
The proposed parking area comprises species poor semi-improved grassland, on a grasscrete strengthened base, along with bare ground. Immediately adjacent to the parking area (south) is a bank of rough grassland (also classified as species poor semi-improved) with (cut back) scrub and tall ruderals. A stone retaining wall borders the property. Scattered young broadleaved trees are present around the parking area. The scrub covered embankment has potential for small mammals.

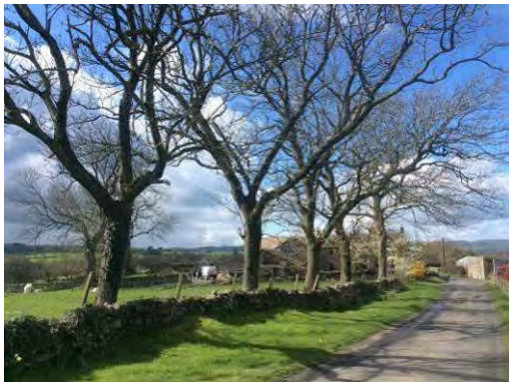
<p>A line of five mature ash trees alongside a drystone wall and wide grass verge with abundant springy turf moss (<i>Rhytidiadelphus squarrosus</i>), which may be managed as amenity grassland. The verge supports species such as ivy, lesser celandine, cow parsley, creeping buttercup, dock sp. and dandelion. This feature forms the boundary of farm property. The trees are mature but not of significant size, with some sparse ivy cladding on the main trunks. The trees have been assessed separately for bat roost potential. Potential for nesting birds and commuting bats.</p> <p>Habitat Condition (provisional): Moderate (Score 2).</p>

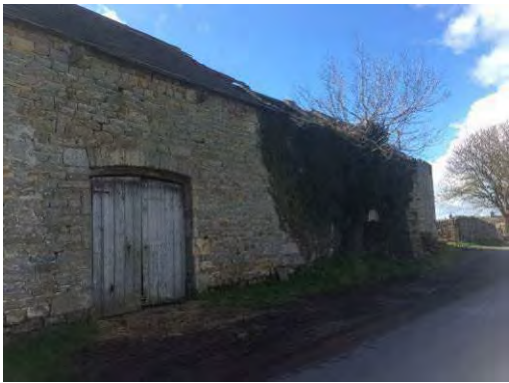
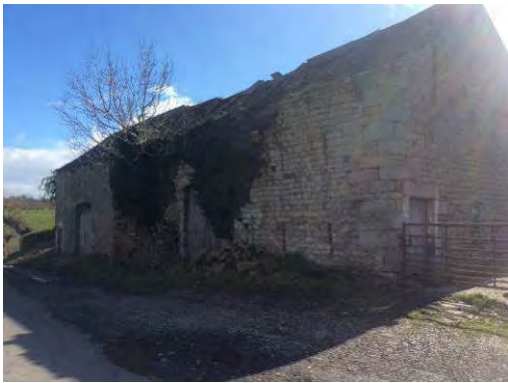
TR3.TN7

<p>A large, stone farm building with a partially collapsed roof and ivy cladding. The barn provides potential bat roosting habitat and potential for birds associated with the building including barn owl, as well as nesting birds in the ivy. The southern part of the building has a pitched, slate tiled roof. The roof is collapsed in places and is covered in parts with corrugated metal sheeting but is still open to the elements. There are gaps in the mortar work providing potential access gaps/roosting crevices for bats. Overall the building is assessed to have moderate roosting potential for bats.</p> <p>Habitat Condition: Not applicable (no assessment required)</p>

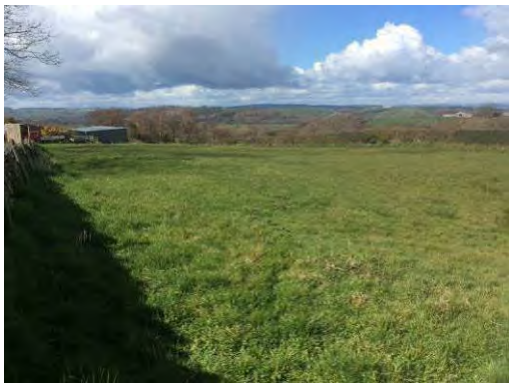
TR3.TN8

<p>Grassland which appeared less improved than those in surrounding area during Spring surveys (early April 2019). This area was checked during peak flowering season and found not to be species-rich. Potential for net gain through appropriate management to develop a more species-rich sward.</p> <p>Habitat Condition (provisional): Poor (Score 1)</p>	
TR3.TN9

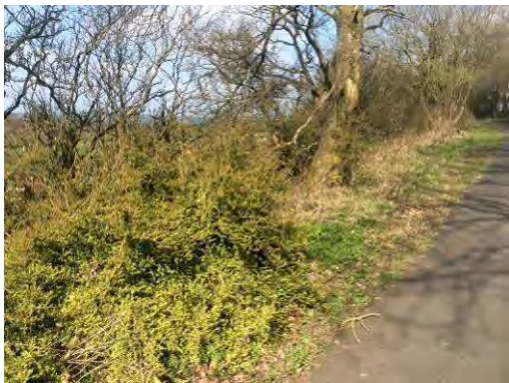
TR3.TN12

<p>Stand of potential <i>Cotoneaster</i> and a stand of Montbretia (<i>Crocsmia x crocosmiiiflora</i>) (Schedule 9 invasive species). These specimens are beside the road, opposite a residential property so ornamentals may have been planted or are garden escapes.</p> <p>Habitat Condition: Not applicable (no assessment required).</p>	
TR3.TN13

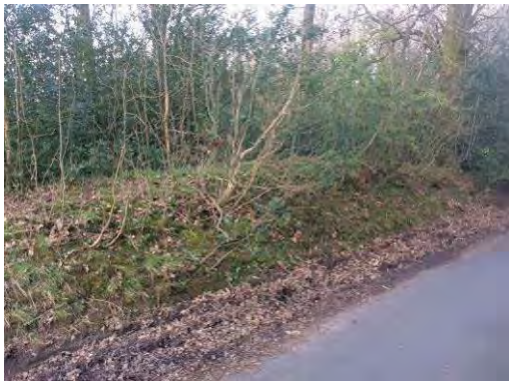
TR3.TN14

<p>Sloping roadside bank approximately 1 m to 1.5 m with interesting flora including; pignut (<i>Conopodium majus</i>), barren strawberry, wood sage (<i>Teucrium scorodonia</i>), wood sorrel, English bluebell, wood avens, lesser celandine, field woodrush (<i>Luzula campestris</i>), germander speedwell (<i>Veronica chamaedrys</i>) and broad buckler fern. Scattered scrub of holly, hawthorn and honeysuckle is also present. Potential for nesting birds, small mammals and as terrestrial habitat for amphibians.</p> <p>Habitat Condition (provisional): Good (Score 3).</p>	
TR3.TN15	No photo
<p>Species-poor semi-improved grassland with pair of oystercatchers (<i>Haematopus ostralegus</i>) and calling curlew. Potential for net gain through management to develop a more species-rich grassland.</p> <p>Habitat Condition: Not applicable (no assessment required).</p>	
TR3.TN16

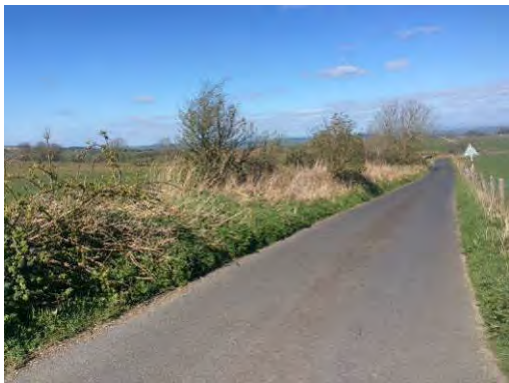
TR3.TN21

<p>Wide roadside verge vegetated with tall ruderals, scrub and a small number of trees. The verge is approximately 4 m wide and separated from the adjacent improved grassland by a post and wire fence. The verge is mounded and uneven. The tall ruderal vegetation comprises; dominant broad-leaved dock, lesser burdock (<i>Arctium minus</i>), cow parsley, creeping buttercup, common nettle, common sorrel, hogweed, cleavers, garlic mustard, dandelion, bent grass (<i>Agrostis</i> sp.), cock's-foot and soft rush. There is also patchy bramble, with occasional honeysuckle. Scrub comprises; hawthorn, elder, holly and willow with two small scrubby ash trees (negligible bat roost potential). The majority of scrub is along the fence line and is possibly an old, outgrown hedgerow. Potential reptile (slow worm (<i>Anguis fragilis</i>)) habitat if present in the area. Potential for nesting birds, and potential terrestrial habitat for amphibians.</p> <p>Habitat Condition: Poor (Score 1)</p>

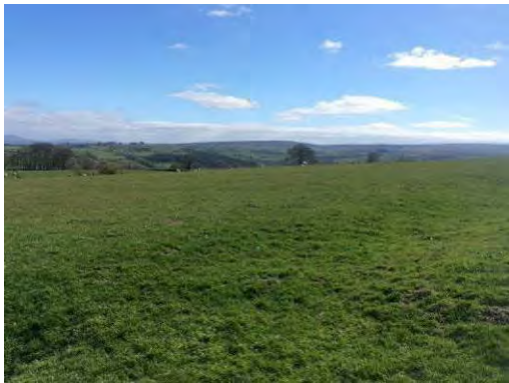
TR3.TN22

<p>Species-poor semi-improved grassland with two pairs of oystercatchers using the dry stone wall as post to call from. Potential for net grain through management to a more species diverse grassland sward.</p> <p>Habitat Condition: Not applicable (no assessment required).</p>
TR3. TN23

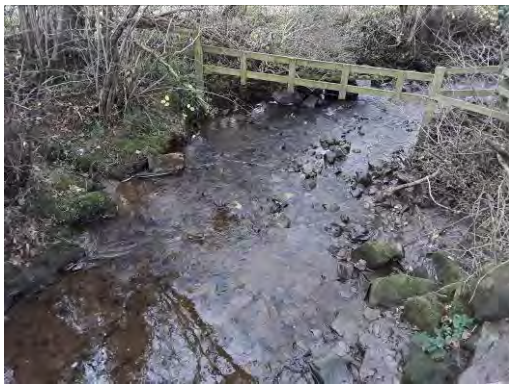
Watercourses	
TR3.HWC1

<p>Moderate flowing stream approximately 1.5 to 5 m wide. 0.1-0.5 m deep with some pools and riffles. Flowing over cobbles, stones, gravels and silt. Shallow banks are earth and stone, with some larger rocks. Downstream the watercourse has some sections of much steeper embankments, which are bare rock with some vertical and undercut areas. Bordered by broadleaved woodland on the eastern bank and species-poor semi-improved grassland, with some small areas of marshy grassland and possible semi-improved neutral grassland to the west. The watercourse flows in a northerly direction. Potential for salmonids, otter, and white-clawed crayfish (<i>Austropotamobius pallipes</i>) but is low risk for water vole (<i>Arvicola amphibius</i>).</p> <p>Habitat condition (provisional): Poor (Score 1)</p>
TR3.HWC2

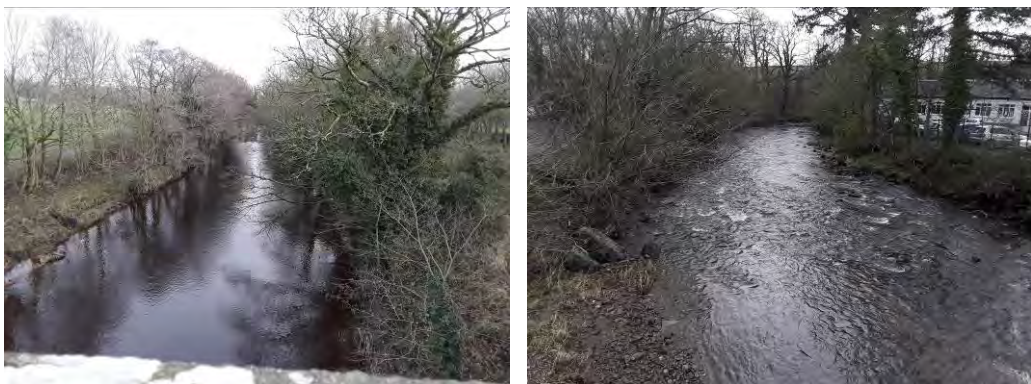
<p>River Wenning. A fast flowing river approximately 18 m wide and up to 0.5 m deep. Flows over a bed of boulders, cobbles, small stones and gravels. Banks are steep to vertical, earth, rock and boulders with engineered banks as it passes beneath the bridge and upstream of bridge close to RW08. Bordered by broadleaved woodland on the east bank downstream of bridge with scattered conifer and broadleaved trees on the west bank. Upstream of bridge both banks are dominated by broadleaved woodland. The bridge itself is well mortared (viewed from the side) and assessed to provide low bat roosting potential, and would need further survey if impacted by works. A mid-stream gravel bank is present upstream of bridge.</p> <p>Further downstream close to RW07, the river is approximately 20 m wide, with an unknown depth and a moderate flow. the embankment to north is broadleaved woodland and semi-improved sheep-grazed field to the south. Roots of trees are present in the watercourse which provide suitable holt locations for otter.</p> <p>Further downstream, within Wennington close to RW06, the river is approximately 20 m wide and up to approximately 1 m deep. The riverbed is as above and the banks range from steep and undercut to shallow (maximum 1 m high) and composed of earth and sand. No root systems present within channel at this location.</p> <p>Overall the river has potential for salmonids, otter, kingfisher (<i>Alcedo atthis</i>) and other nesting birds. Low risk for water vole and white-clawed crayfish due to the fast speed of flow.</p> <p>Habitat condition (provisional): Moderate (Score 2)</p>

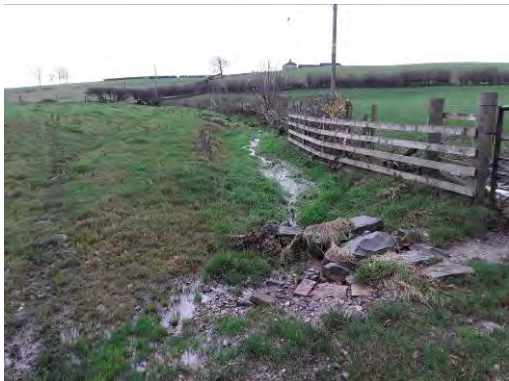
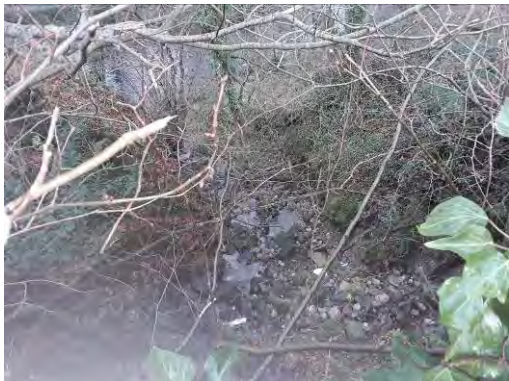
TR3.HWC3

<p>A small watercourse flowing through fields along a field boundary, then is culverted underneath the road before flowing through the woodland and joining River Wenning (TR3.HWC2). It is approximately 0.3 m wide and 0.1 m deep where it flows through the field east of the road. It has moderately steep earth banks, likely to be poached by sheep/livestock in summer. Bed of silt, gravels and occasional large rocks. Within the woodland the bed comprises cobbles and slopes steeply down to river. Low potential for protected species due to low flow, culvert and steep profile through woodland. Dominated by grasses with brooklime (<i>Veronica beccabunga</i>) within the field.</p> <p>Habitat condition (provisional): Poor (Score 1)</p>	
TR3.HWC4	No photo.
TR3.HWC5

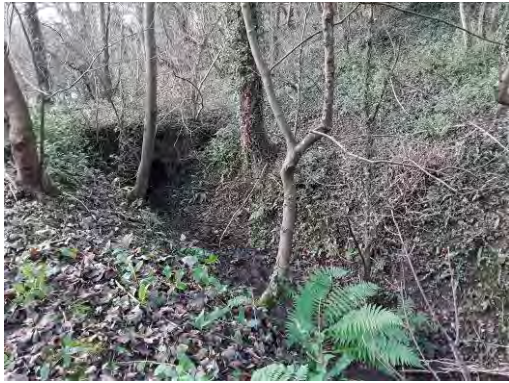
TR3.HWC6

<p>Slow to stagnant flowing stream within woodland that flows into the River Wenning (TR3.HWC2). The channel is choked by leaf litter and completely shaded by overhanging mature trees. The watercourse is likely to have variable water levels depending on rainfall. Steep, muddy banks which are vegetated with hart's-tongue fern, ivy and leaf litter on embankment. Width is approximately 1 m and depth 5 cm at the time of survey. The stream culverts under a stone bridge before reaching the river. Possible otter use for foraging or access to woodland lie-up sites.</p> <p>Habitat condition (provisional): Poor (Score 1)</p>
TR3.HWC7

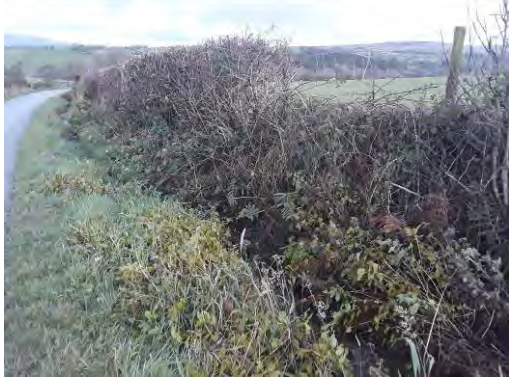
TR3.HWC8

<p>Moderate to fast flowing wet ditch adjacent to TR3.HH29 and grassland field, flowing in a northerly direction. The watercourse culverts under the road for approximately 40 m. Banks and substrate are soil and sand. The width is up to 1 m in places and 30 cm tall. No aquatic vegetation was noted. Negligible potential for otter, water vole or crayfish due to the culvert. Upstream of the culvert, the watercourse runs adjacent to a stone wall and species-poor semi-improved grassland field. Here the watercourse is slower flowing and approximately 50 cm deep.</p> <p>Habitat condition (provisional): Poor (Score 1)</p>	
TR3.HWC9	No photo.
<p>Small stream running along the edge of broadleaved woodland. Dense scrub surrounds the water course, restricting visibility. The dense scrub is comprised of bramble, elder and hawthorn. The watercourse is culverted at both ends. The watercourse has negligible protected species potential.</p> <p>Habitat condition (provisional): Poor (Score 1)</p>

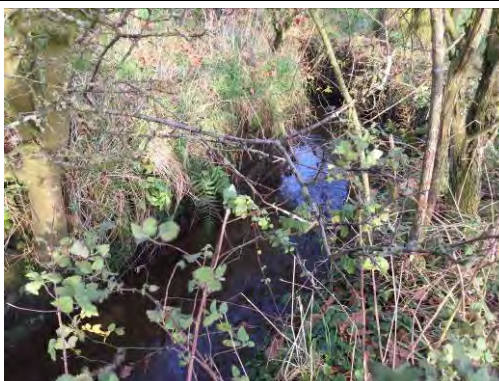
TR3.WWC1

A slow to moderately flowing watercourse which emerges from a culvert and flows roughly east to west along a field boundary at the edge of the survey area. The embankments are vertical dry-stone walls, apart from a small section which is livestock poached where the embankments are shallower. The watercourse is mostly fenced on both sides apart from the small section with livestock access. The width is approximately 1.2 m and depth approximately 30 cm. Brooklime occurs rarely along the surveyed length and otherwise there is no in-channel vegetation. The embankments are vegetated with mature blackthorn and hawthorn scrub, with occasional opposite-leaved golden saxifrage, hart's-tongue fern, male fern, bramble and common nettle. At the eastern edge of the watercourse is a mature English oak. There is negligible potential for protected aquatic species, although foraging bats may utilise the embankment vegetation.

Habitat Condition (provisional): Poor (Score 1)

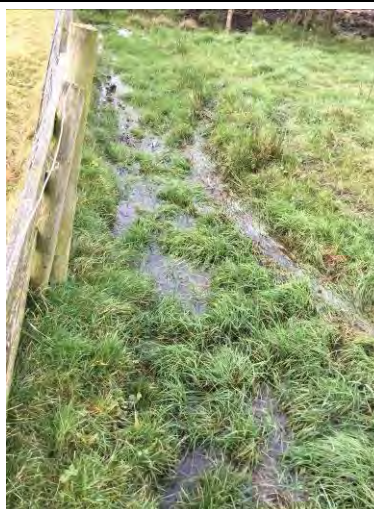
TR3.WWC2

A wet, partially stagnant ditch runs along a field boundary before dispersing into a species poor semi-improved grassland field. There is little to no flow, the ditch width is approximately 30 cm and depth 10 cm. The channel is indistinct from the grassland field in places. There is a small pool which is overgrown with algae, otherwise the channel is overgrown with meadow grass. There is negligible potential for protected species.

Habitat Condition (provisional): Poor (Score 1)

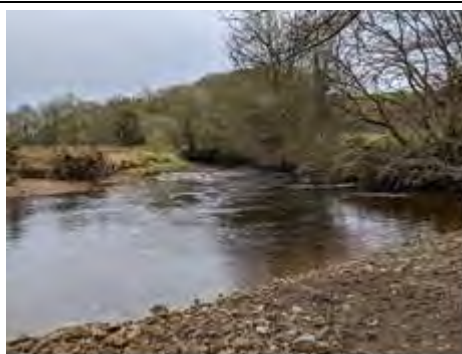
TR3.WCPWC1

The River Hindburn; a fast flowing river approximately 8-10 m wide and over 2 m deep in places. It flows over a bed of boulders, cobbles, small stones and gravels. The north eastern bank is more gradual with a small sand cliff set back from the river, in which sand martin nest holes are present (breeding bird risk). The south western bank is steep to vertical or undercut in places and vegetated with a belt of broadleaved trees, comprising alder, sycamore and willow. The ground flora comprises great woodrush (*Luzula sylvatica*), bramble, tufted hair grass, wood avens, dog's mercury, herb Robert, red campion, hart's tongue fern, ivy and cow parsley. The river provides habitat for salmonids, otter and breeding birds, including kingfisher. It is considered to be low risk for water vole and white clawed crayfish due to the high speed and depth of flow. Tree root plates, overhanging the watercourse provide lie up sites for otter. The works may have the potential to cause pollution of the watercourse.

Habitat condition (provisional): Moderate (Score 2)

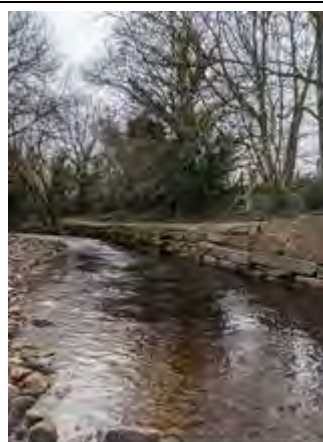
TR3.WCPWC2

The River Roeburn; a fast flowing river that flows over a bed of boulders, cobbles, large stones and gravels. It is approximately 5-6 m wide and up to 0.5 m deep. The banks are steep to gradual earth and stone banks, with some sections of both banks being engineered and reinforced with large boulders as well as mortared stone walls. The watercourse is considered to be high risk for otter and salmonids, and low risk for water vole and white clawed crayfish. There is little/ no instream vegetation within the section surveyed and the bankside vegetation comprises broadleaved trees (woodland belt), bramble scrub and plants characteristic of broadleaved woodland understory. This river flows into the River Hindburn (TR3.WCPWC1) within the survey area at TR3.WCPTN1.

Habitat condition (provisional): Moderate (Score 2)

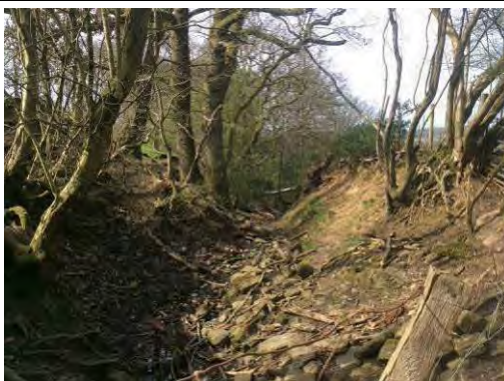
TR3.WC1

A shallow, slow flowing stream between a row of mature trees and roadside hedgerow. The width is less than half a metre, and the depth is less than 5 cm. The banks are steep earth and are bare of vegetation, with rocks and dead wood abundant. There appears to be a drain present as broken clay pipes were observed. It is not fenced from the adjacent sheep grazed field and therefore heavily poached. It possibly flows beneath a road and the watercourse is likely heavily shaded when the trees are in leaf. Unsuitable for water vole, otter and white-clawed crayfish.

Habitat Condition (provisional): Poor (Score 1).

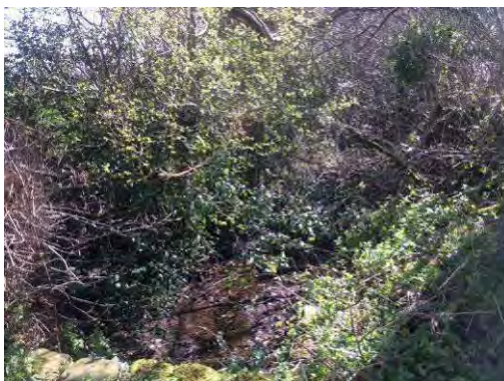
TR3.WC2

A shallow roadside ditch with a slow flow of water, with accumulated mud, leaf litter and dead wood present. It is densely shaded by an adjacent hedgerow to the east and further scrub and trees to the west along the roadside. It flows into a small stone culvert. The earth banks are shallow and are sparsely vegetated with shade loving vegetation such as ivy, lords-and-ladies and dog's mercury. The water is clear but the flow is very limited. Scrub shading the watercourse from the west comprises hawthorn, sycamore, hazel, bramble, blackthorn and oak. The ground flora comprises dog's mercury, primrose, lords-and-ladies, common male fern, herb Robert and cleavers. The banks become steeper towards the south where they are approximately 2 to 3 m in height. The surrounding wooded area widens towards the south and includes a couple of mature oak trees. There is negligible potential for protected species.

Habitat Condition (provisional): Moderate (Score 2).

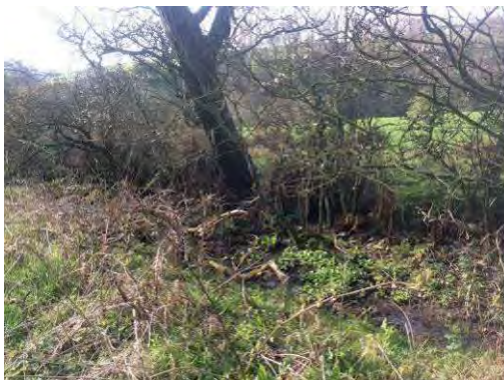
TR3.WC3

A shallow roadside ditch which is silted up with mud and accumulated leaf litter. It is approximately 1.5m wide and without clearly defined banks as such, it just grades into the adjacent vegetation. The watercourse is shaded by trees and scrub from TR3.TN11 including oak, blackthorn, hawthorn and willow. The depth is a few centimetres and flow is very limited. The water clarity is good. Vegetation within ditch comprises meadowsweet, brooklime, rosebay willowherb, forget-me-not sp. (*Myosotis* sp.), water starwort (*Callitriche* sp.), horsetail sp. and flag iris (*Iris pseudacorus*). On the banks, common nettle, creeping buttercup, daffodil, primrose, lungwort (*Pulmonaria officinalis*), garlic mustard, crane's-bill species (*Geranium* sp.), chickweed (*Stellaria media*), red campion, ground elder (*Aegopodium podagraria*), herb Robert, wood sorrel and Italian lords-and-ladies (variegated form) (*Arum italicum*) are present. On the muddy margins, small mammal prints were noted, the size of mouse or bank/field vole. This watercourse is opposite the garden of a residential property so ornamentals may have been planted/escaped. Negligible protected species potential.

Habitat Condition (provisional): Poor (Score 1).

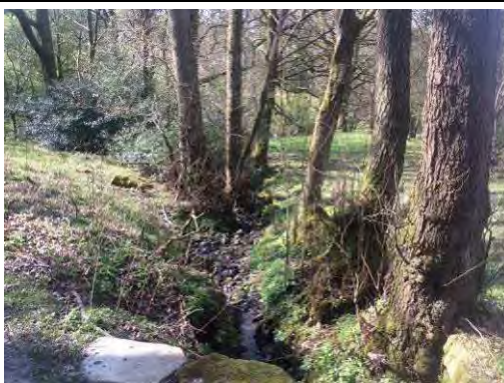
TR3.WC4

A 1 m wide watercourse (stream) with a moderate to fast flow of clear water with a depth of approximately 5 cm. There are moss covered boulders and cobbles within the channel itself. The banks are fairly steep and comprise earth and boulders. The base of the watercourse is stones and pebbles. The banks are unshaded for the majority of section within survey area with three trees located at the road end. The banks are vegetated with marsh marigold (*Caltha palustris*), opposite leaved golden saxifrage, water avens (*Geum rivale*), lesser celandine, large bittercress (*Cardamine amara*), valerian (*Valeriana officinalis*), herb Robert, common nettle, wood sorrel, wood avens, common male fern and meadowsweet. The eastern bank is relatively grassy with a few small mammal holes noted. There is some bankside scrub and saplings including ash, holly and elder. Otter may commute along the watercourse but there is no couch or holt potential as the cover is sparse. There is also potentially suitable habitat for salmonids, bullhead (*Cottus gobio*), white-clawed crayfish and water vole. Numbered nest boxes are located on trees to the south.

Habitat Condition (provisional): Moderate (Score 3).

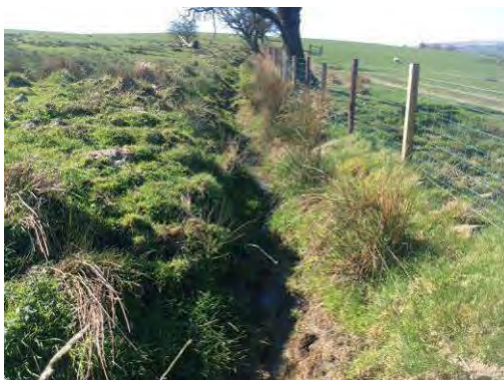
TR3.WC5

A narrow ditch approximately 30 cm wide and unfenced from the surrounding rush pasture. As such, the banks are poached. The ditch is unshaded with only occasional bankside mature oak trees. The water flow is moderate and depth is up to 10 cm. Water clarity is good and the substrate is silty. There is some filamentous algae within the water column. The banks are 0.8 m high and vegetated with grasses and patches of soft rush with common nettle. The ditch flows into a circular pipe beneath the road. It is a marshy seepage inflow into the watercourse from the adjacent field which originates from a pipe set in a concrete block. There are patches of aquatic vegetation including floating sweet grass (*Glyceria fluitans*), water starwort species, crowfoot species (*Ranunculus sp.*), brooklime and, at the water's edge, blinks. Negligible protected species potential.

Habitat Condition (provisional): Moderate (Score 2).

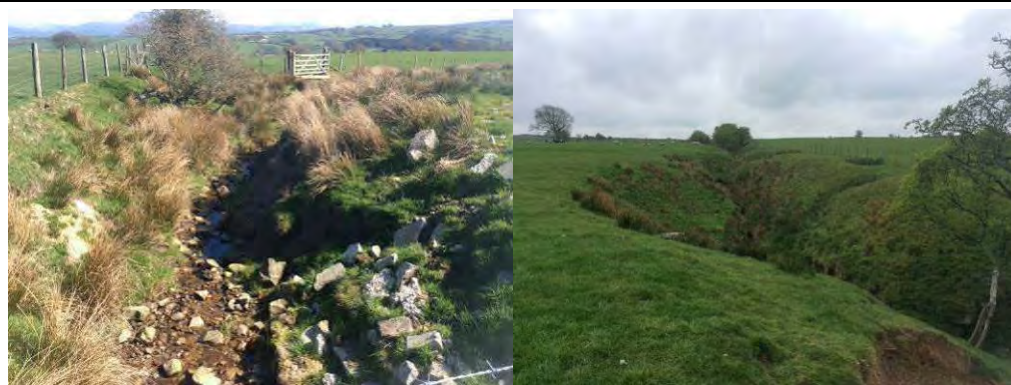
TR3.WC6

A ditch which flows beneath the road. There are occasional bankside hawthorn but other than that the watercourse is unshaded. To the east the watercourse is approximately 1 m wide with a moderate flow of clear water, to a depth of 10 to 15 cm. The banks are tall in places, up to 2 to 3 m and steep sided, comprised of mud and rocks. The banks are vegetated with the species of the surrounding field i.e. dominant soft rush. The base of the stream comprises rocks of various sizes and it is unfenced from adjacent sheep-grazed fields. To the west of the road the channel is less rocky and densely vegetated with soft rush such that the channel is indistinguishable in places. In slower flowing sections, particularly where the stream changes direction abruptly and flows along the edge of the road there are shallower sections vegetated with the same species as at TR3.WC5 i.e. crowfoot sp., floating sweet grass, blinks and water starwort species. A pair of snipe were flushed from the banks during survey. Potential nesting bird habitat. Potential for water vole or potential reintroduction site to provide net gain. Some potential for white-clawed crayfish in sections. Otter may forage and commute through the watercourse but there are no suitable holt or couch locations in the survey area.

Habitat Condition (provisional): Moderate (Score 2).
